## **Property Inspection Report**

**18726 Haughland Dr, Cypress, TX, 77433**

*Inspection Date: 5/31/2024*

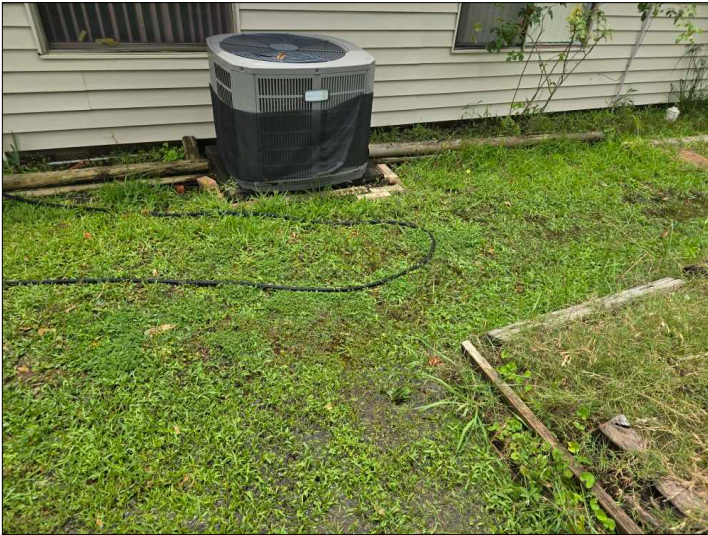
There is poor drainage in some areas around the perimeter of the foundation. This should be corrected to help minimize future foundation problems. As a rule of thumb water should not sit against the foundation for more than 48 hours.  
Mainly at - rear

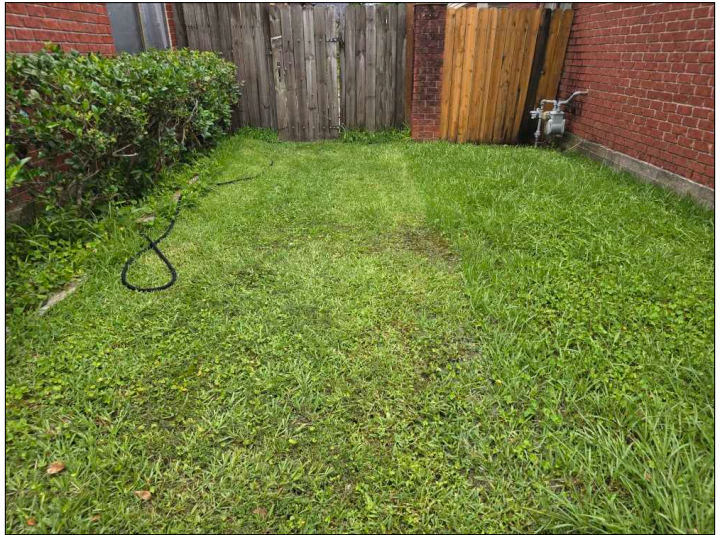
Poor drainage is noted at the fence line between the homes. Due to the construction methods being used today homes are being built so close to each other, there is often not enough room for proper drainage. Recommend proper sloping or adding proper drainage to help remove excess water more rapidly and keep this area dryer during wet weather and help extend the life of the fences. Mainly at - right

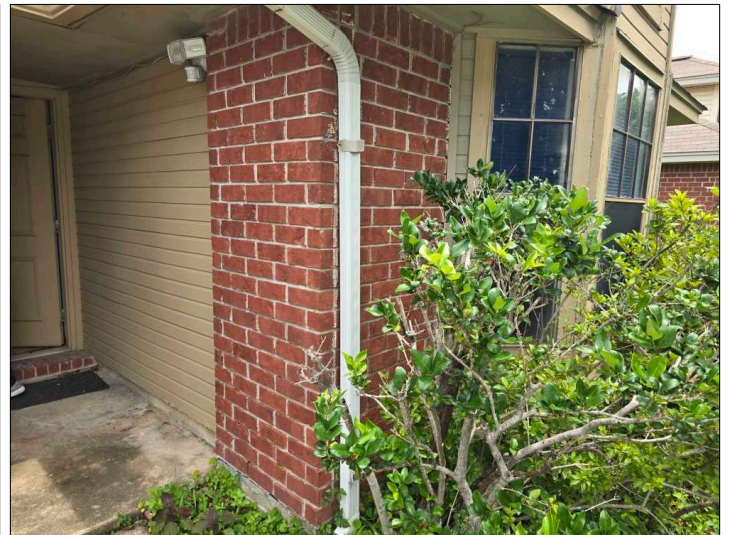
The downspout on the gutter was loose from the wall. Mainly at - front

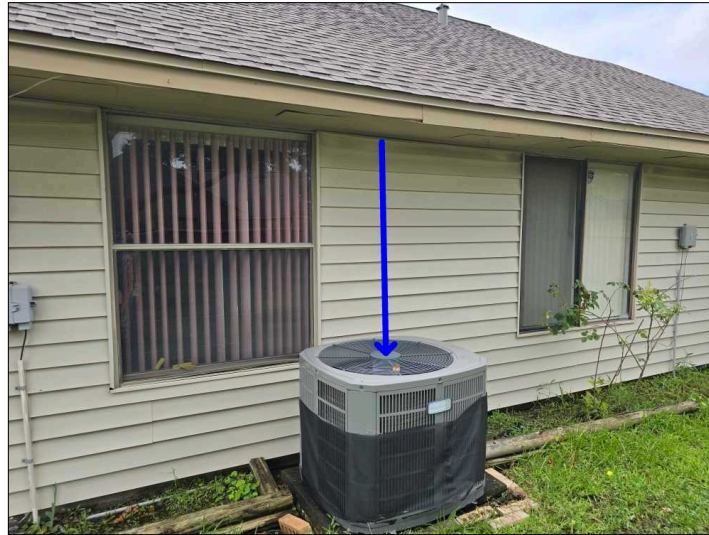
There is no gutter system or flashing installed at the roofs edge to prevent water from shedding directly on to the Condenser as recommended by most manufacturers. Recommend installation of gutters or flashing materials to deflect shedding water away from the Condenser to help prevent premature failure.

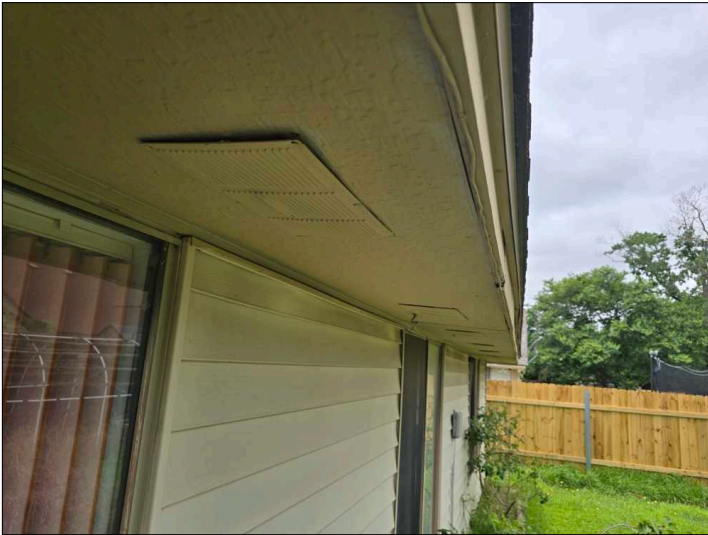
The attic vent screen is loose, damaged or missing, recommend repairs to help prevent unwanted entry.

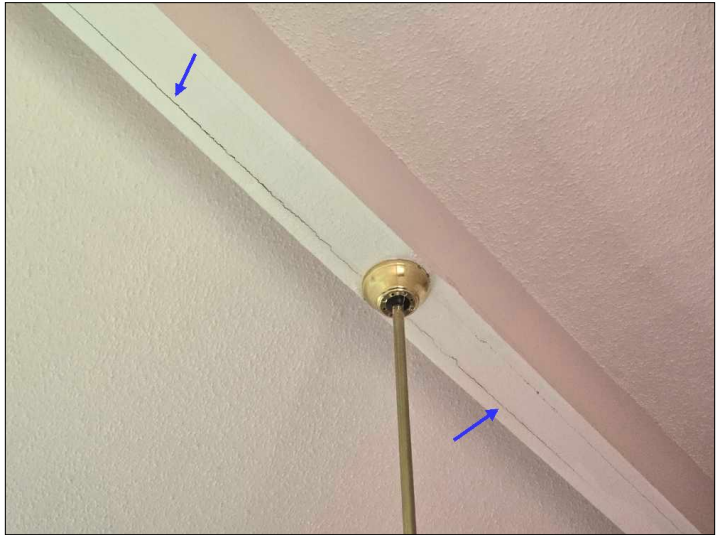
There are broken or split headers in the attic, recommend repairs to the header usually done by sistering the rafter with another next to it or by adding metal bracing for proper support. Mainly at - primary bedroom

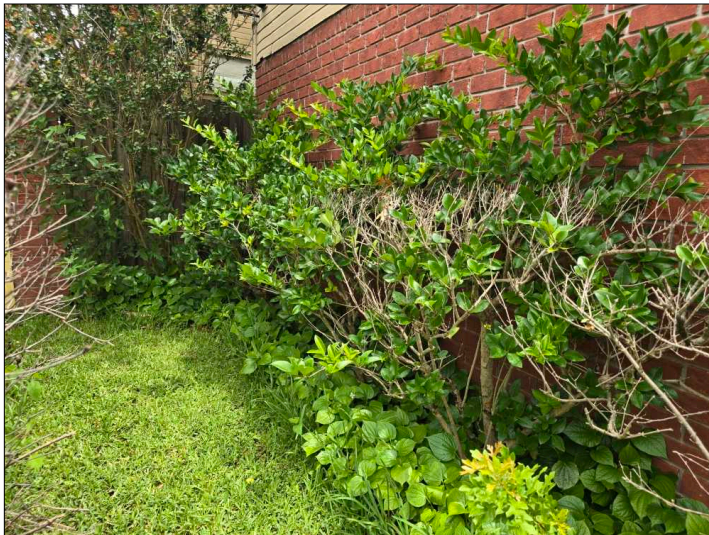
Recommend trimming vegetation so that it is not in contact with the house. Vegetation in contact with the structure can hold moisture against the structure and promote damage to building materials and conducive conditions for wood destroying insects.

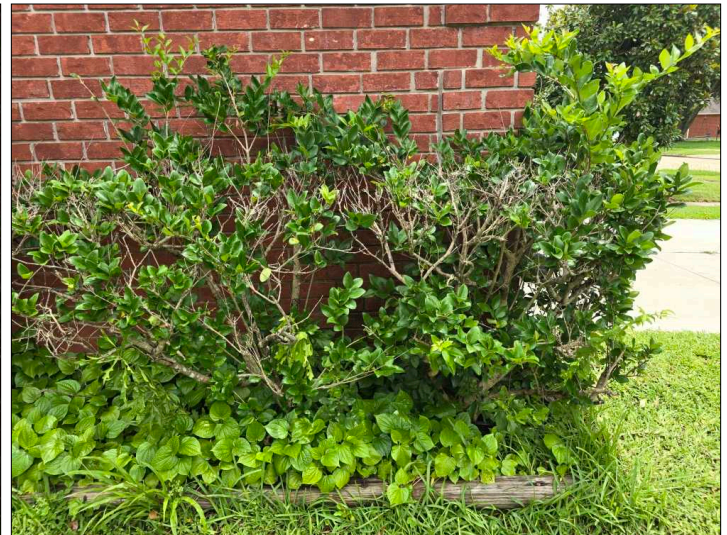
Recommend trimming vegetation so that it is not in contact with the house. Vegetation in contact with the structure can hold moisture against the structure and promote damage to building materials and conducive conditions for wood destroying insects.

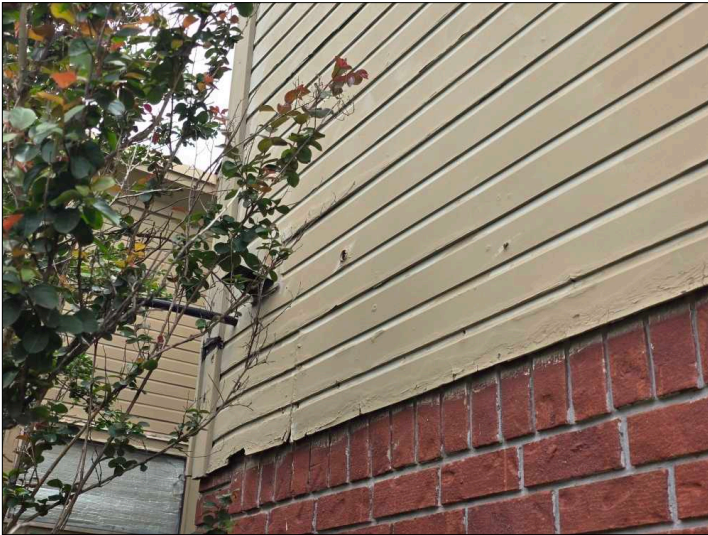
Deterioration was noted at the siding, recommend replacing all deteriorated siding to help prevent further deterioration and water penetration. Unable to determine the condition of the underlying materials. Mainly at - left

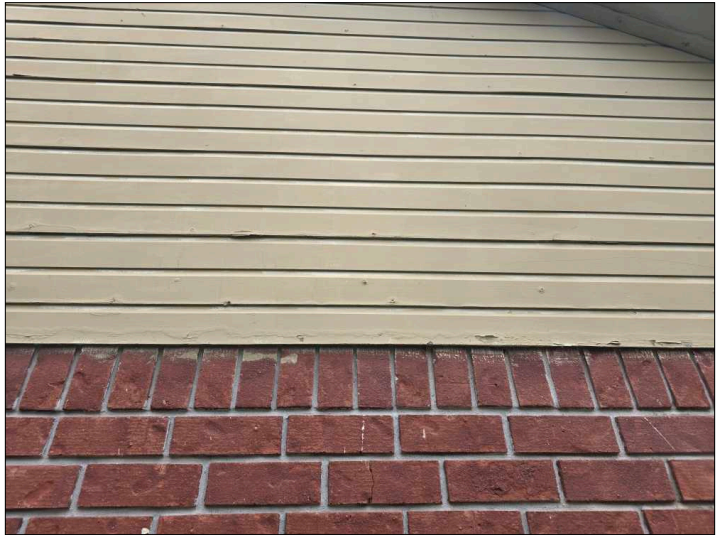
Deterioration was noted at the siding, recommend replacing all deteriorated siding to help prevent further deterioration and water penetration. Unable to determine the condition of the underlying materials. Mainly at - left

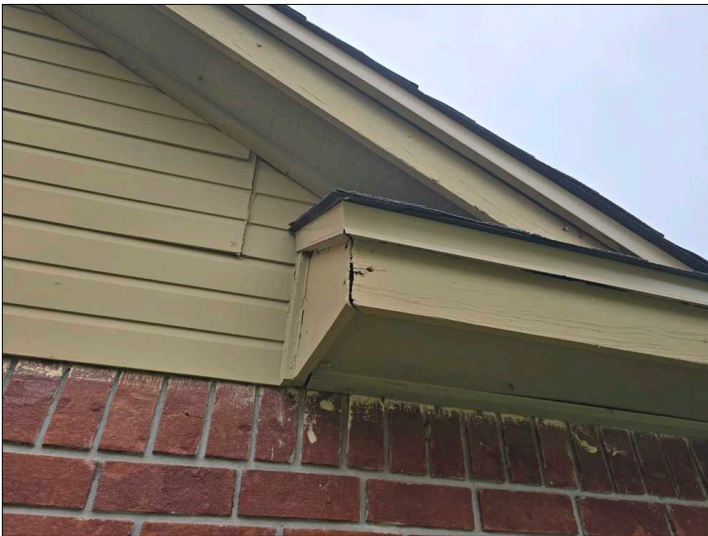
Deterioration was noted at the trim, recommend replacing all deteriorated trim. Unable to determine the condition of the underlying materials. Mainly at - left

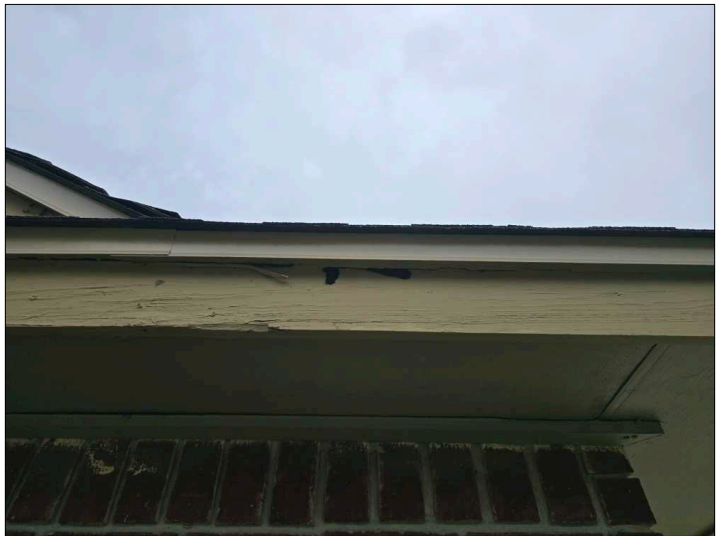
Deterioration was noted at the trim, recommend replacing all deteriorated trim. Unable to determine the condition of the underlying materials. Mainly at - left

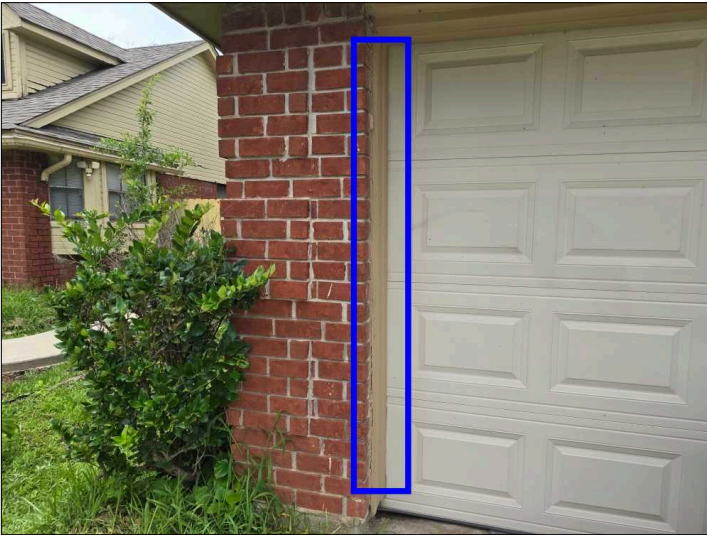
Recommend sealing between the trim and brickwork to help prevent water penetration. Mainly at - front

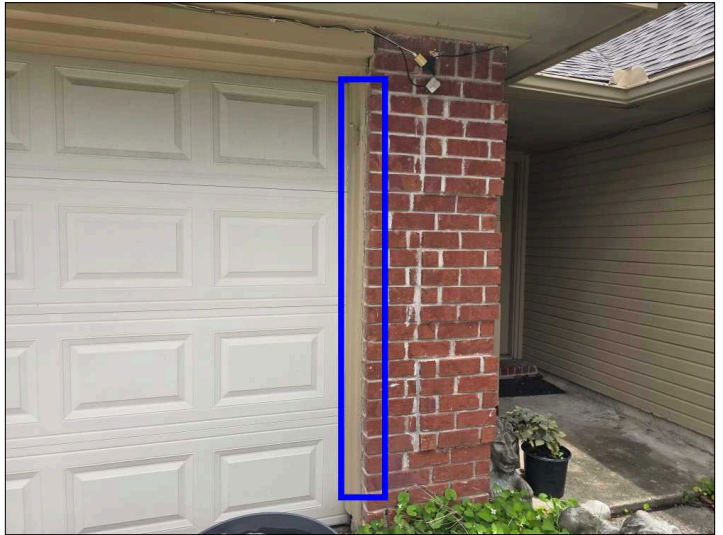
Recommend sealing between the trim and brickwork to help prevent water penetration. Mainly at - front

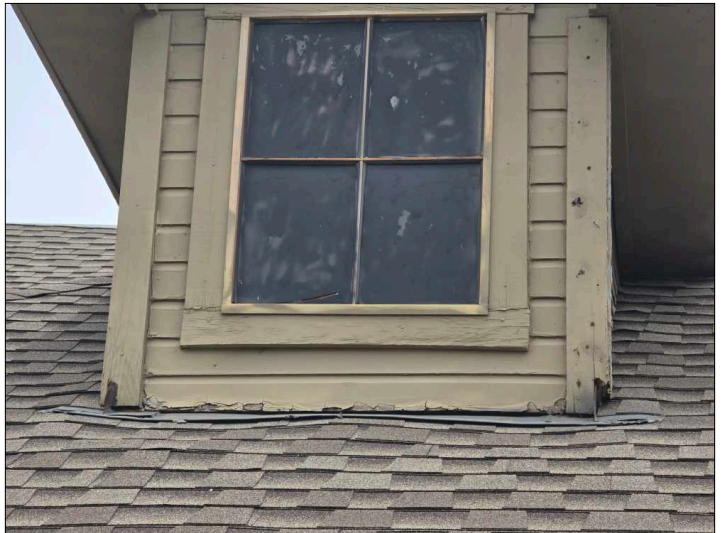
There is some damage to the exterior trim, recommend repairs to help prevent water penetration. Unable to determine the condition of the underlying materials. Mainly at - front

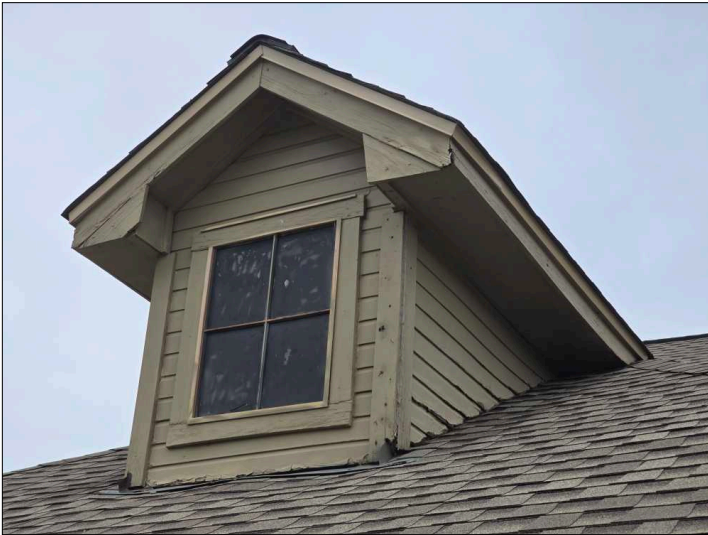
Deterioration was noted at the siding, recommend replacing all deteriorated siding to help prevent further deterioration and water penetration. Unable to determine the condition of the underlying materials. Mainly at - front

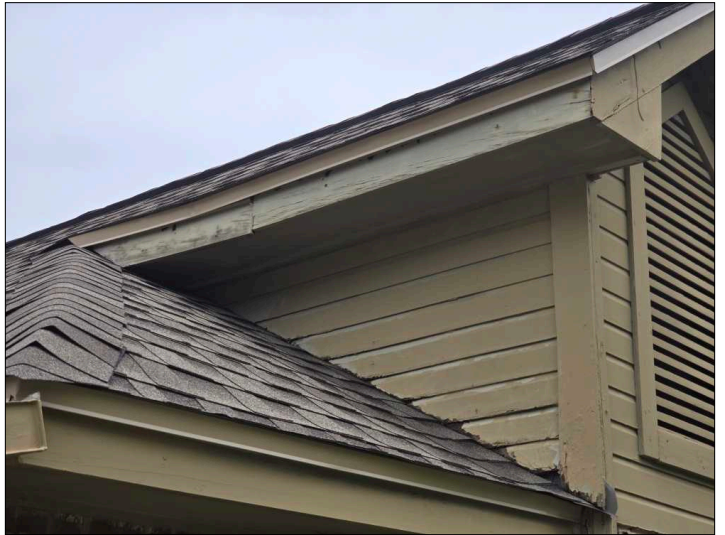
The siding is closer than recommended or in contact with the roof. It is recommended that there be a separation to help prevent water from wicking up into the siding material causing deterioration.

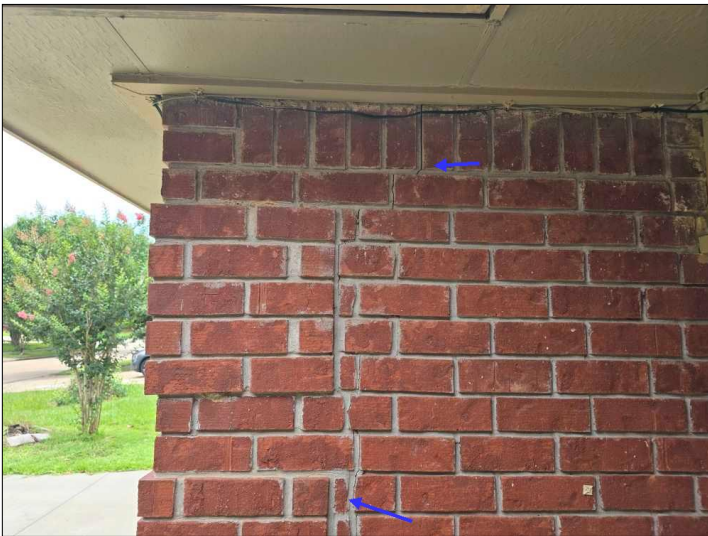
Settlement cracks were noted in the brickwork. Mainly at - front

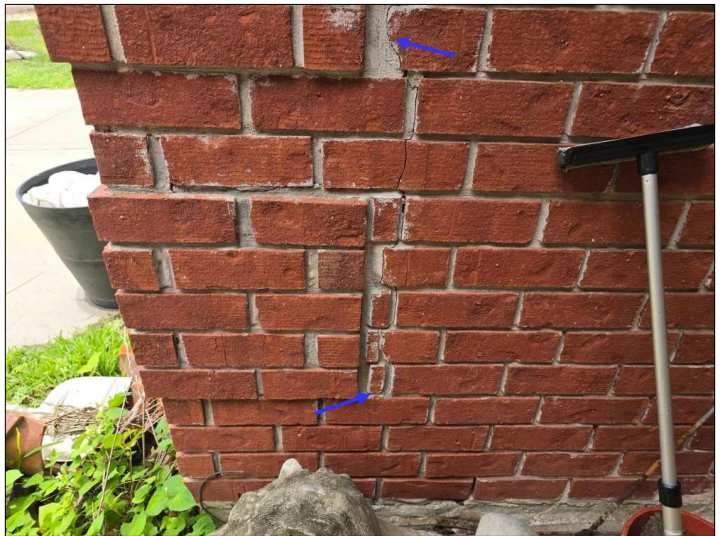
Settlement cracks were noted in the brickwork. Mainly at - front

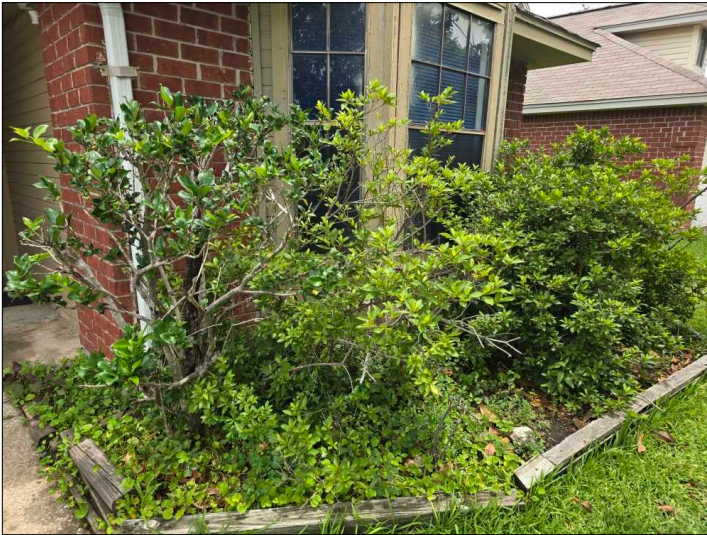
Recommend trimming vegetation so that it is not in contact with the house. Vegetation in contact with the structure can hold moisture against the structure and promote damage to building materials and conducive conditions for wood destroying insects.

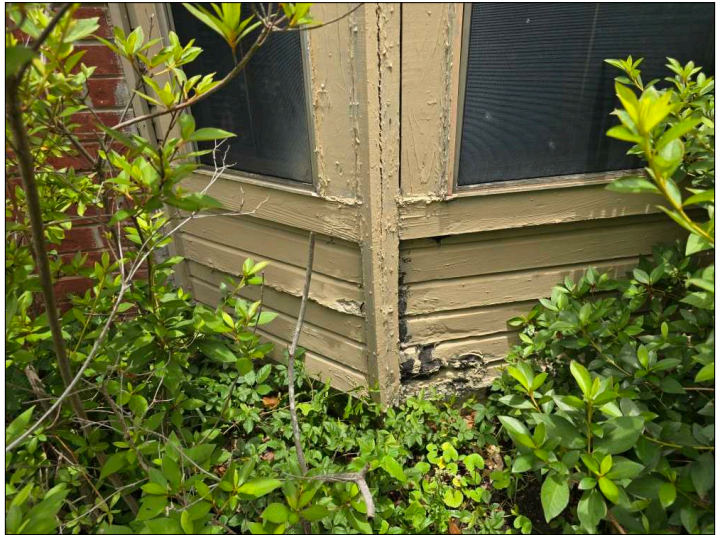
Deterioration was noted at the siding, recommend replacing all deteriorated siding to help prevent further deterioration and water penetration. Unable to determine the condition of the underlying materials. Mainly at - front

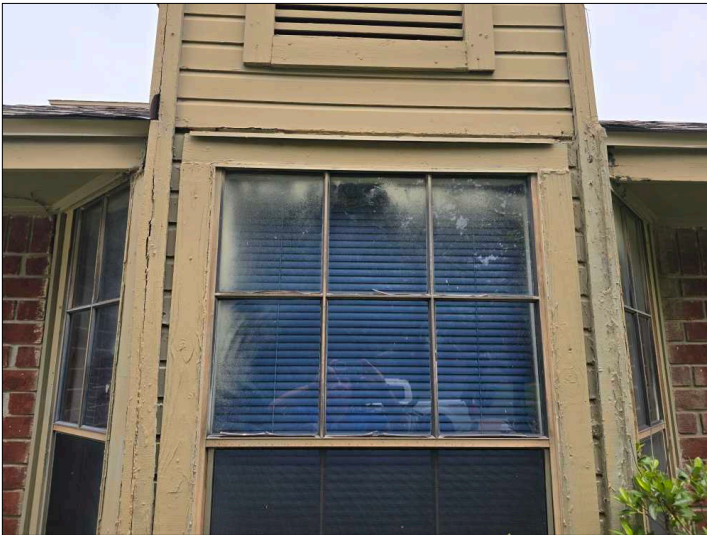
Deterioration was noted at the trim, recommend replacing all deteriorated trim. Unable to determine the condition of the underlying materials. Mainly at - front

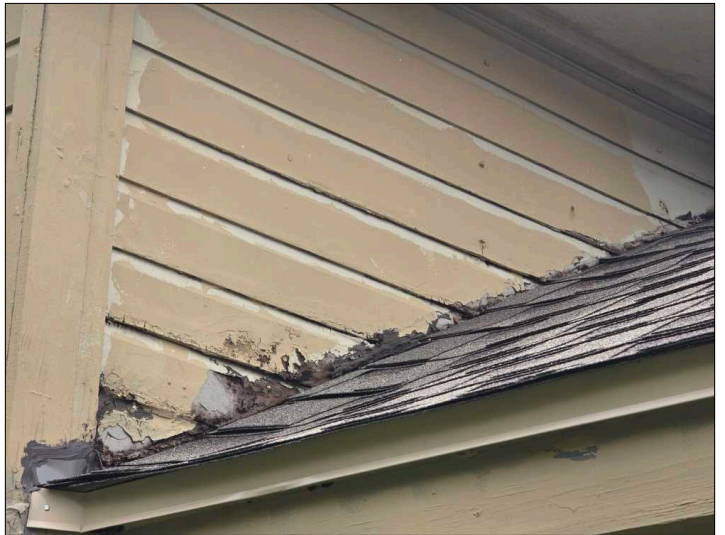
The siding is closer than recommended or in contact with the roof. It is recommended that there be a separation to help prevent water from wicking up into the siding material causing deterioration.

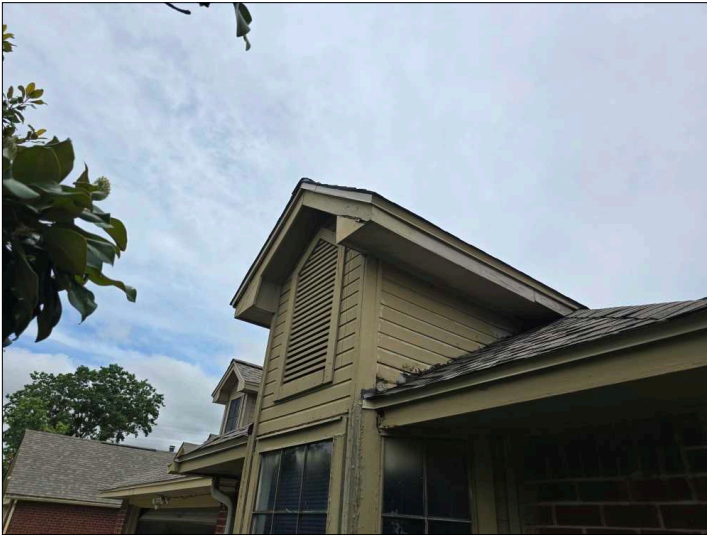
Deterioration was noted at the trim, recommend replacing all deteriorated trim. Unable to determine the condition of the underlying materials. Mainly at - front

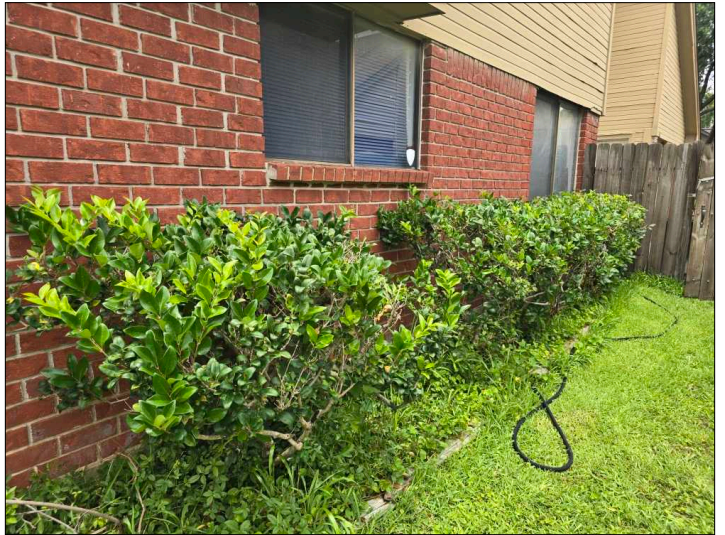
Recommend trimming vegetation so that it is not in contact with the house. Vegetation in contact with the structure can hold moisture against the structure and promote damage to building materials and conducive conditions for wood destroying insects.

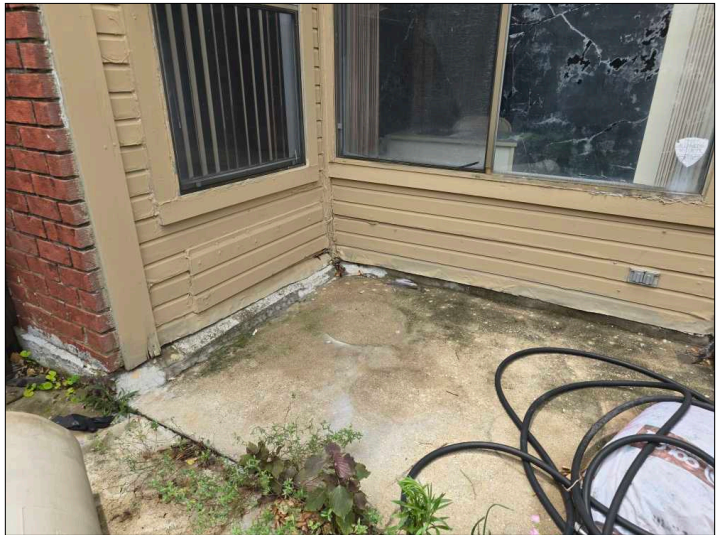
Deterioration was noted at the siding, recommend replacing all deteriorated siding to help prevent further deterioration and water penetration. Unable to determine the condition of the underlying materials. Mainly at - right

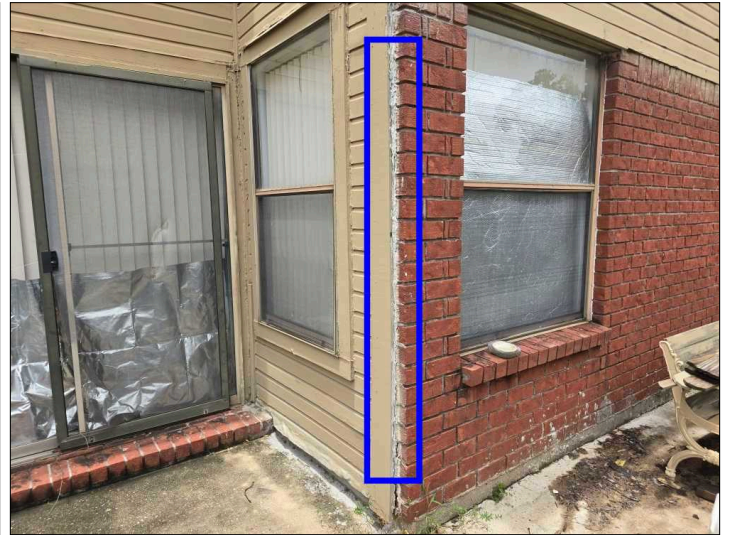
Recommend sealing between the trim and brickwork to help prevent water penetration. Mainly at - right

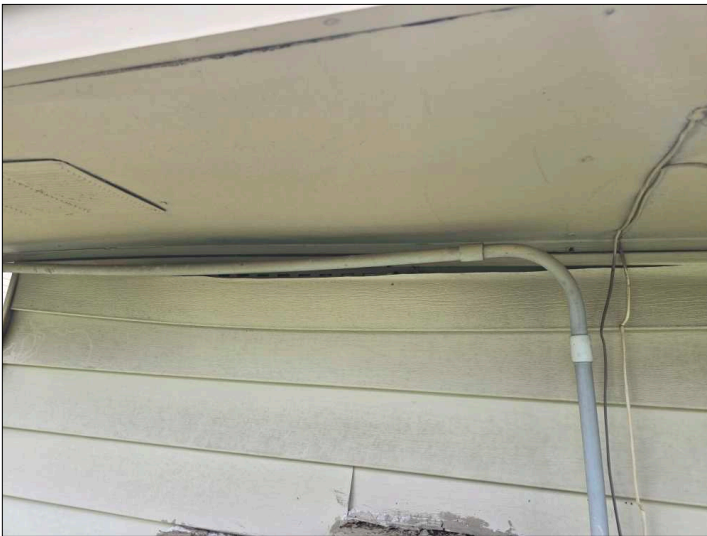
There is loose siding on the home, recommend securing all loose siding to help prevent damaged and water penetration. Mainly at - rear

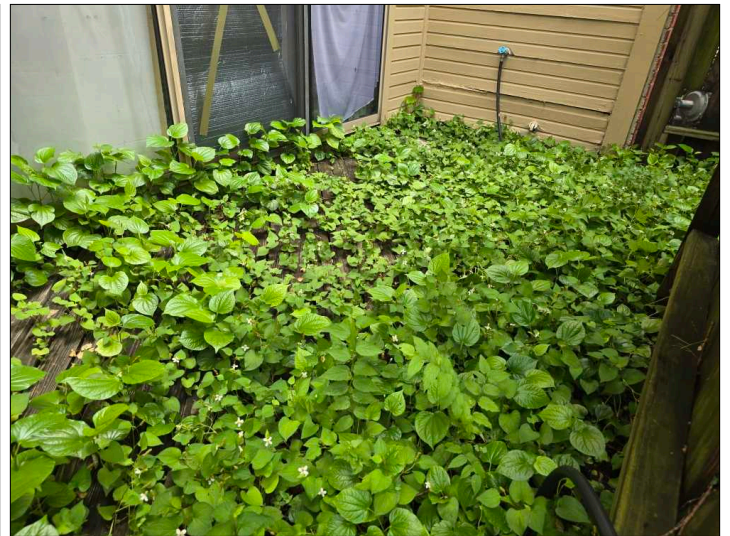
Recommend trimming vegetation so that it is not in contact with the house. Vegetation in contact with the structure can hold moisture against the structure and promote damage to building materials and conducive conditions for wood destroying insects.

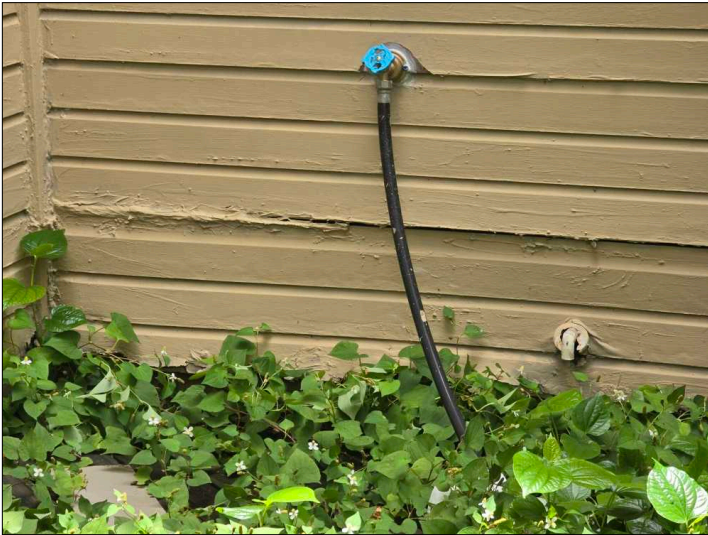
There is some damage to the exterior siding, recommend repair or replacement to help prevent water penetration. Unable to determine the condition of the underlying materials. Mainly at - left

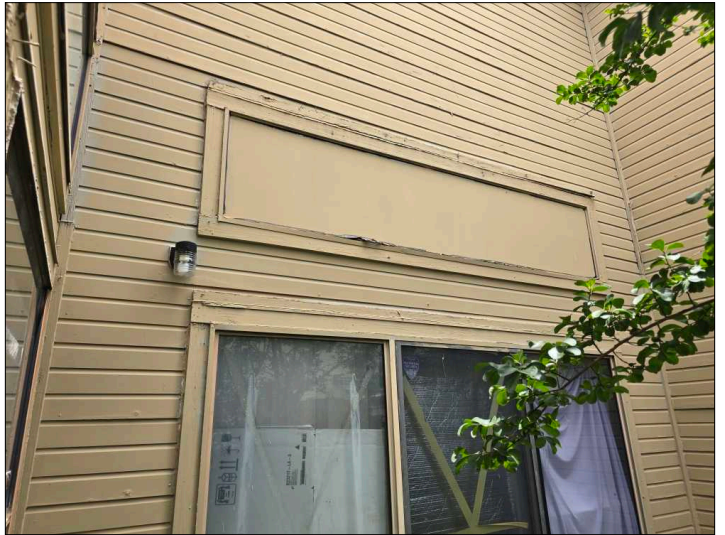
Deterioration was noted at the siding, recommend replacing all deteriorated siding to help prevent further deterioration and water penetration. Unable to determine the condition of the underlying materials. Mainly at - left

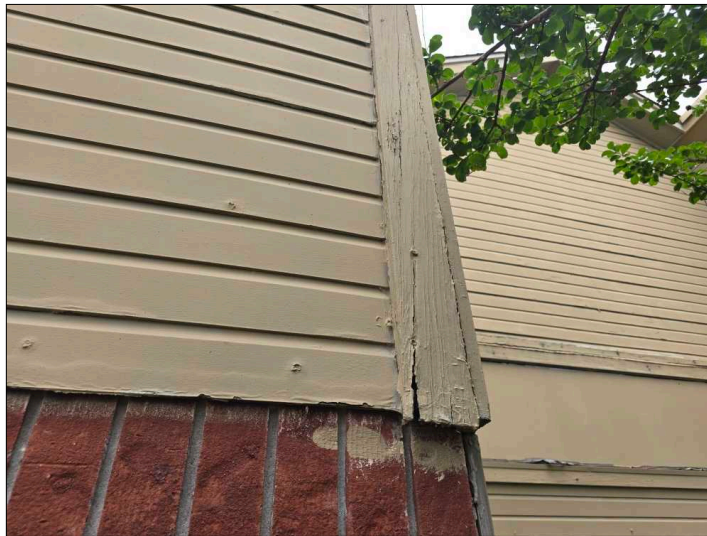
Deterioration was noted at the trim, recommend replacing all deteriorated trim. Unable to determine the condition of the underlying materials. Mainly at - left

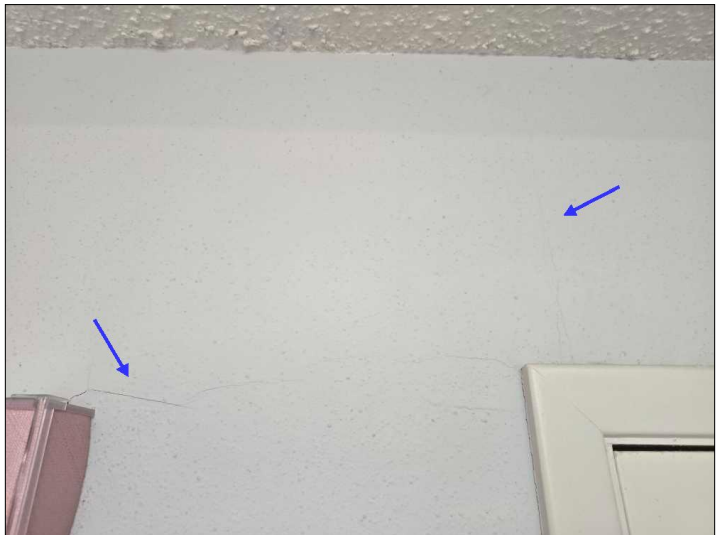
Settlement cracks were noted in the drywall. Mainly at - right rear bedroom

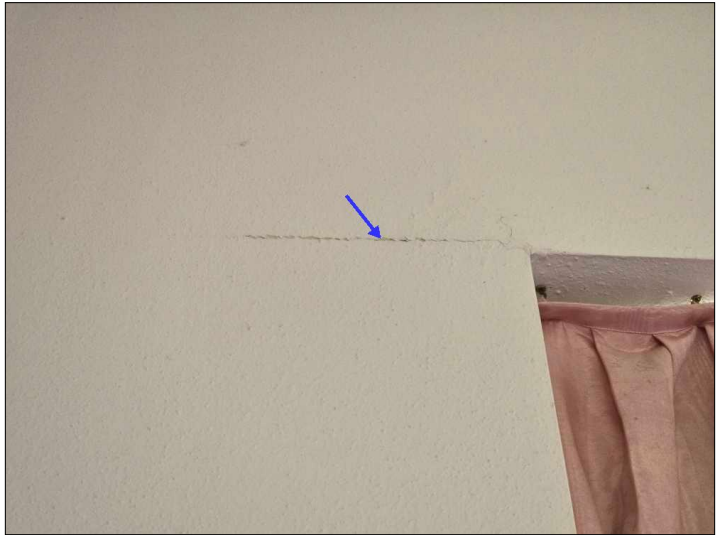
Settlement cracks were noted in the drywall. Mainly at - primary bedroom

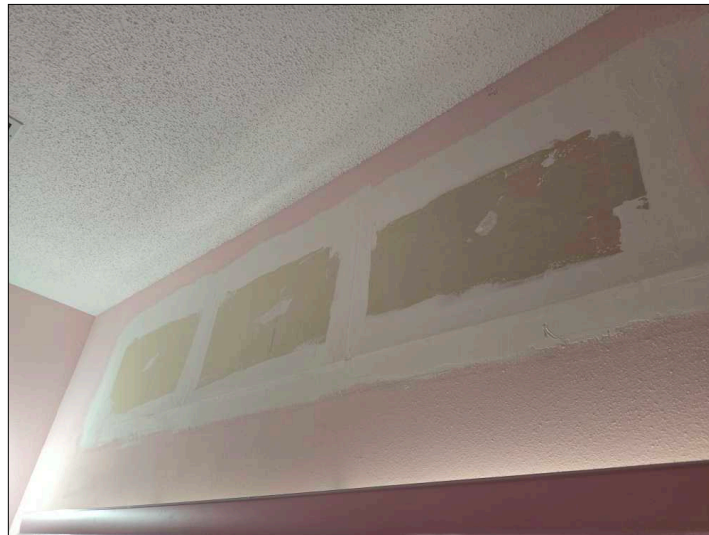
There is evidence of previous patch work and or painting on the interior finishes. This condition may limit the inspector's visual observations and ability to render accurate opinions as to the performance of the structure. Recommend contacting homeowner for more information. Mainly at - primary bathroom

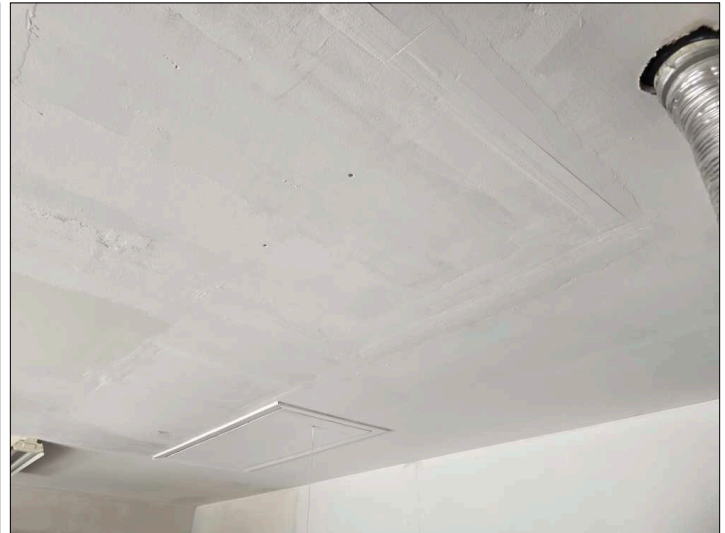
There is evidence of previous patch work and or painting on the interior finishes. This condition may limit the inspector's visual observations and ability to render accurate opinions as to the performance of the structure. Recommend contacting homeowner for more information. Mainly at - garage

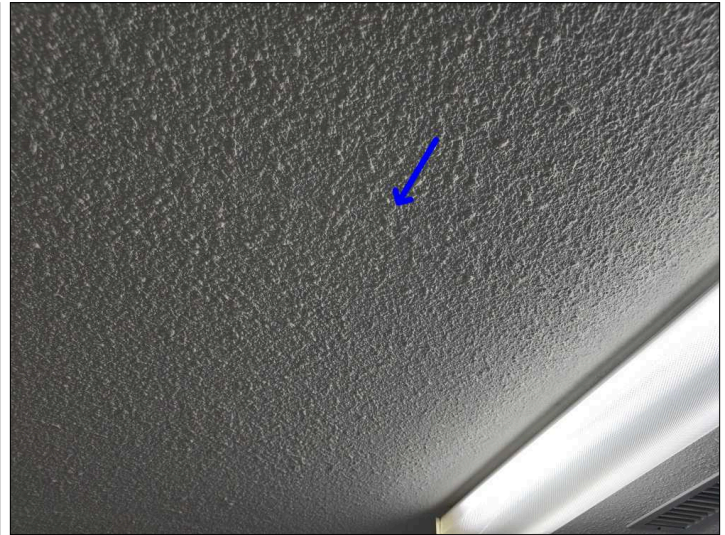
Settlement cracks were noted at the tape joint in the drywall. Mainly at - kitchen

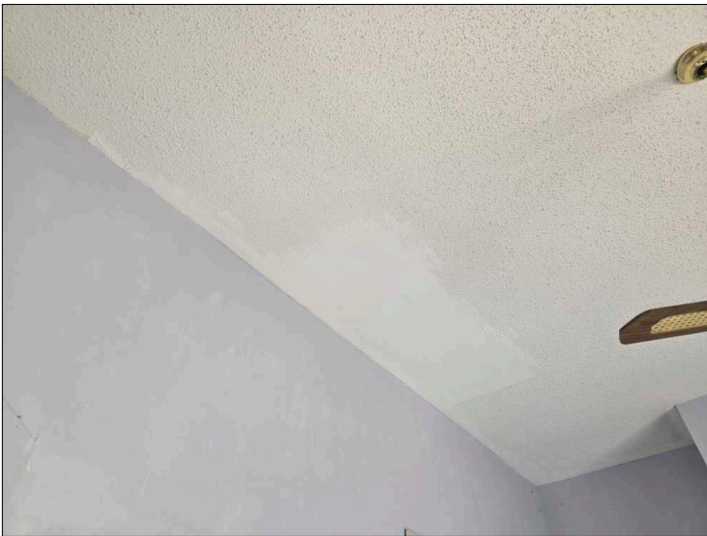
There is evidence of previous patch work and or painting on the interior finishes. This condition may limit the inspector's visual observations and ability to render accurate opinions as to the performance of the structure. Recommend contacting homeowner for more information.  
Mainly at - living room

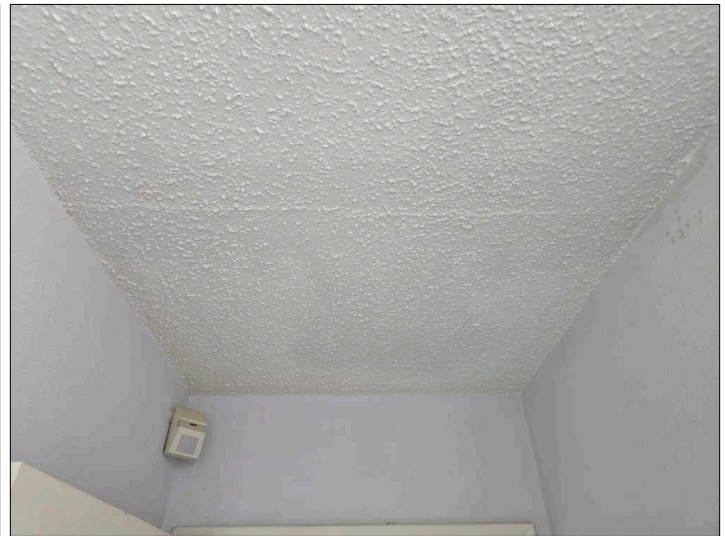
Settlement cracks were noted in the drywall. These are generally considered cosmetic only, unless otherwise noted. Mainly at - right rear bedroom

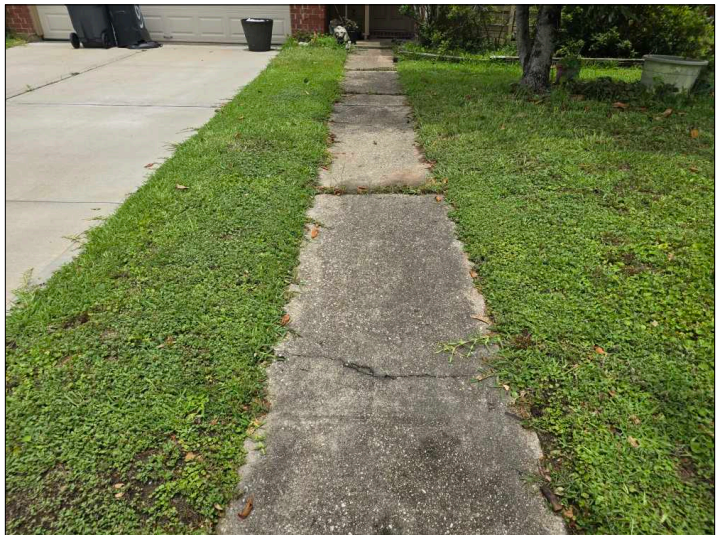
Cracks were noted in the pavement. These are cosmetic in nature at this time. Recommend sealing to help prevent further deterioration. Mainly at - sidewalk

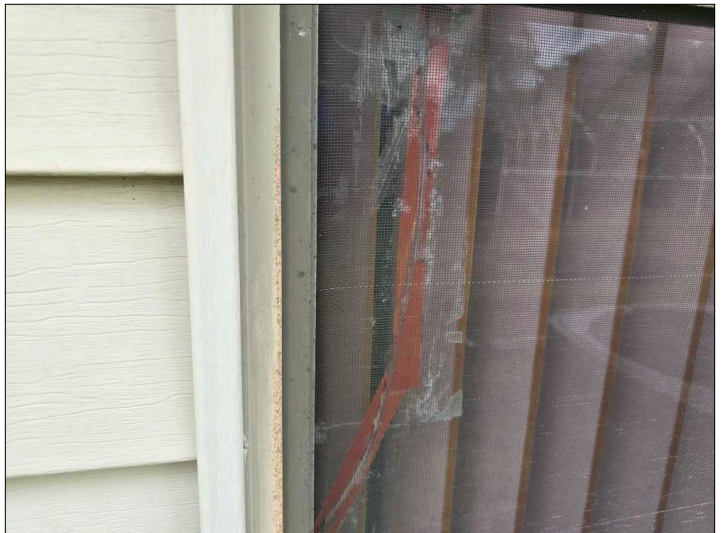
The window frame is damaged. Mainly at - right

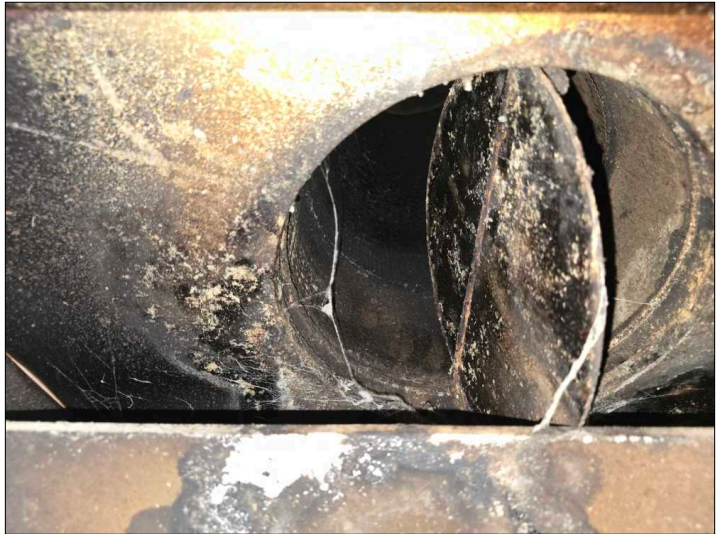
The fireplace damper is missing a damper clamp to ensure proper ventilation for the gas logs, recommend adding damper clamp to help prevent damper from closing.

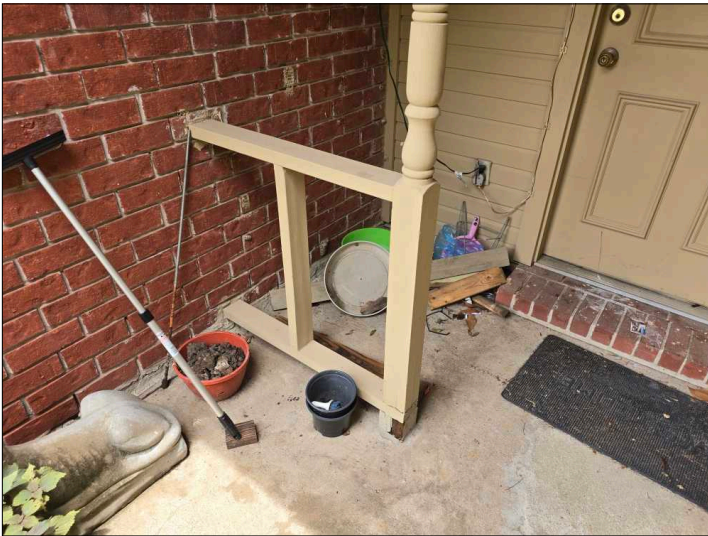
The porch post are showing signs of deterioration, recommend repairs or replacement to prevent further deterioration.

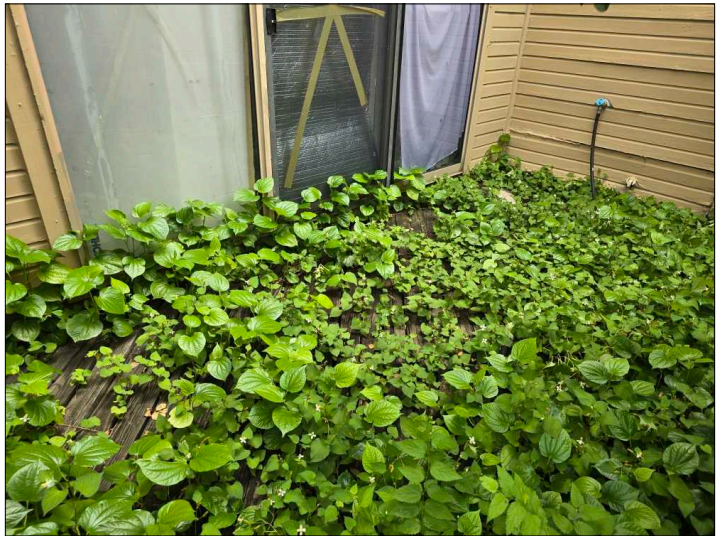
The deck is damaged, recommend repairs.

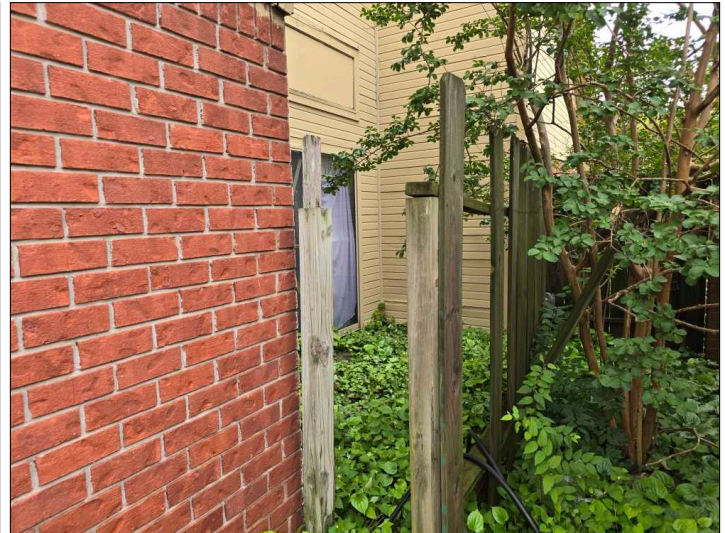
Although fences are not inspected it was noted that the fence is showing some signs of damage or deterioration.

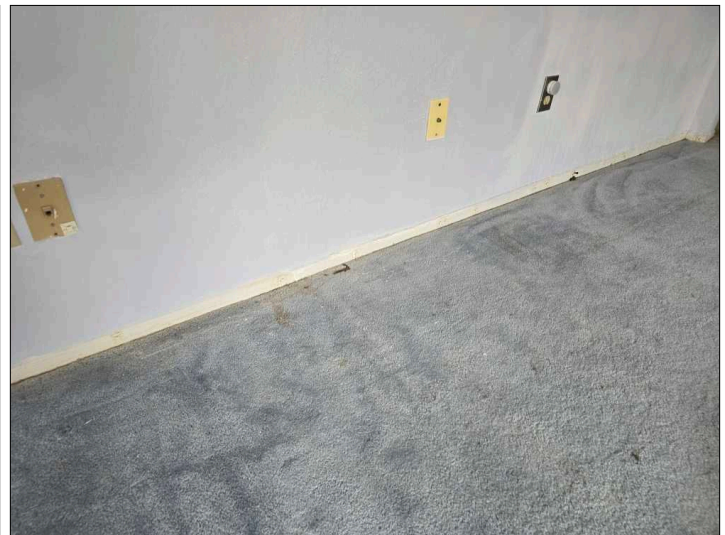
It appears that the baseboards throughout the house have sustained water damage. It is advised to either replace or rectify these issues in order to prevent further deterioration.

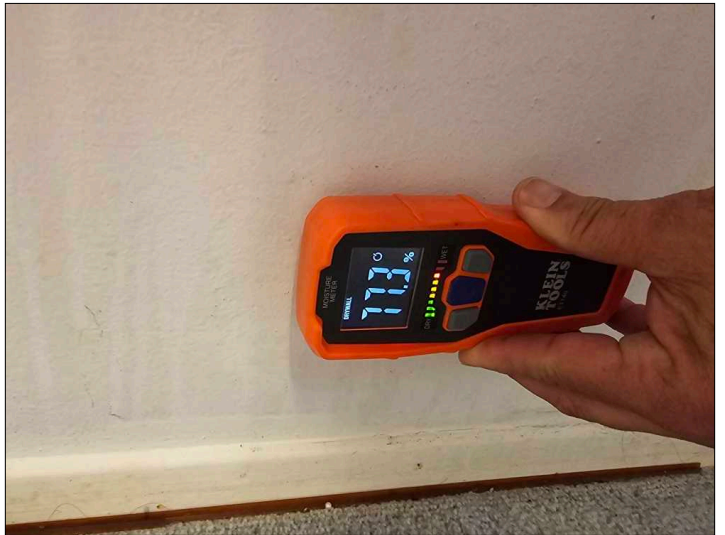
Checked water stain on the walls with a moisture meter and found to be at higher than normal moisture level. Unable to determine condition of the underlying materials. Mainly at - living room

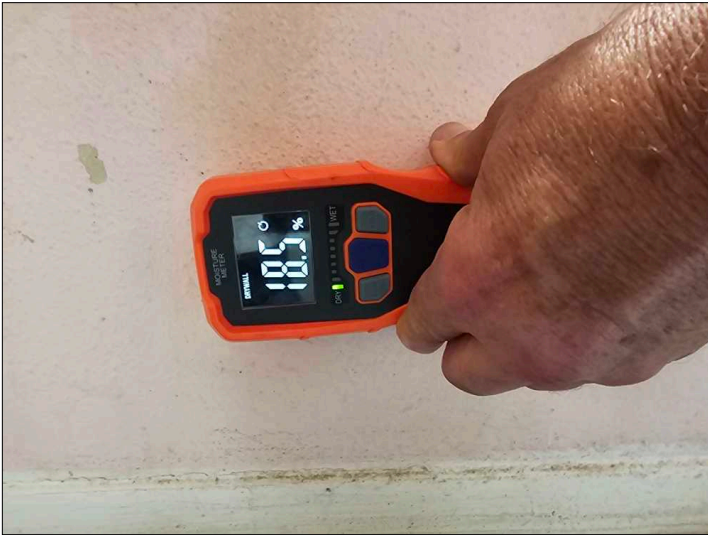
Checked water stain on the walls with a moisture meter and found to be at higher than normal moisture level. Unable to determine condition of the underlying materials. Mainly at - primary bedroom

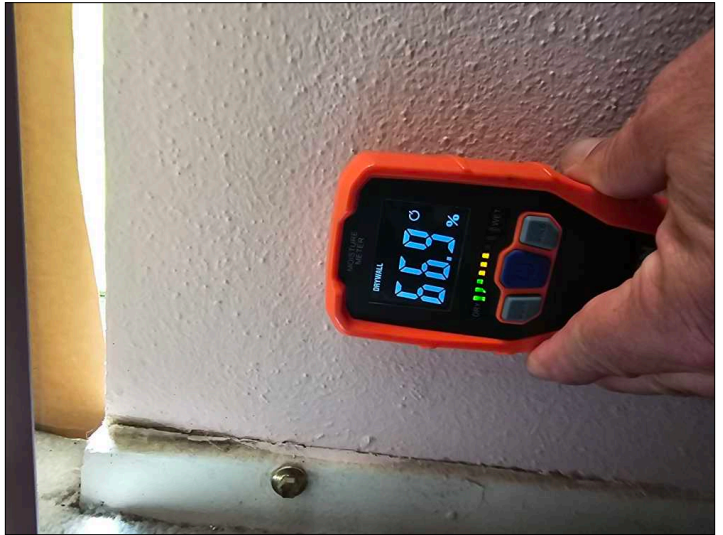
Checked water stain with a moisture meter and found it to be at a high moisture level. Unable to determine condition of the underlying materials. Mainly at - primary bathroom

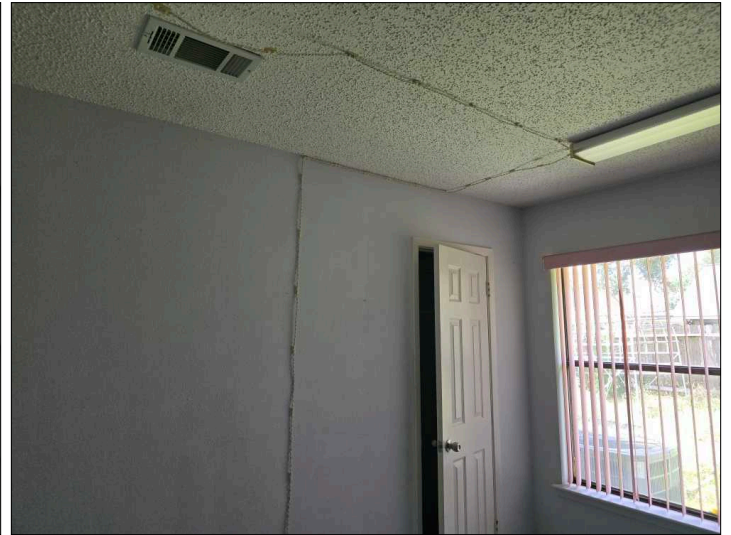
There is some extension cord type electrical wiring present. Recommend wiring be replaced with permanent wiring. Mainly at - bedrooms

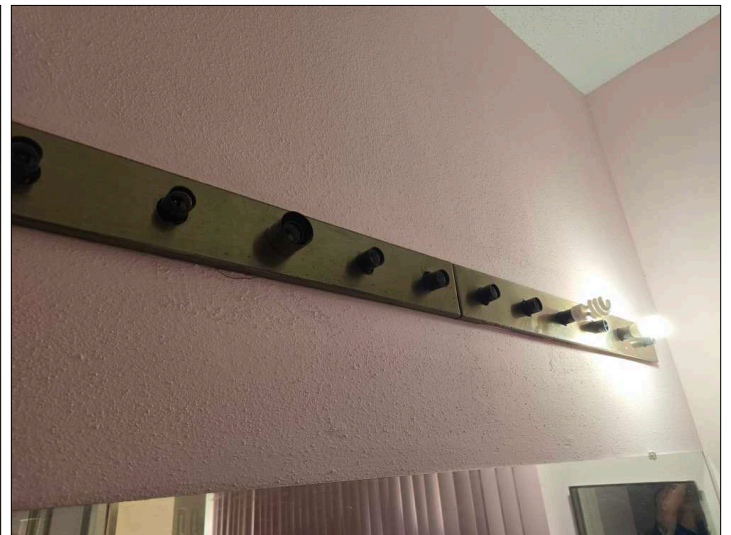
Some bulbs in the light fixture(s) were noted to be missing. Recommend replacing or installing bulb(s) to verify fixture is operating correctly. Some fixture may be on motion or photo cells and are not tested during the inspection. Mainly at - primary bathroom

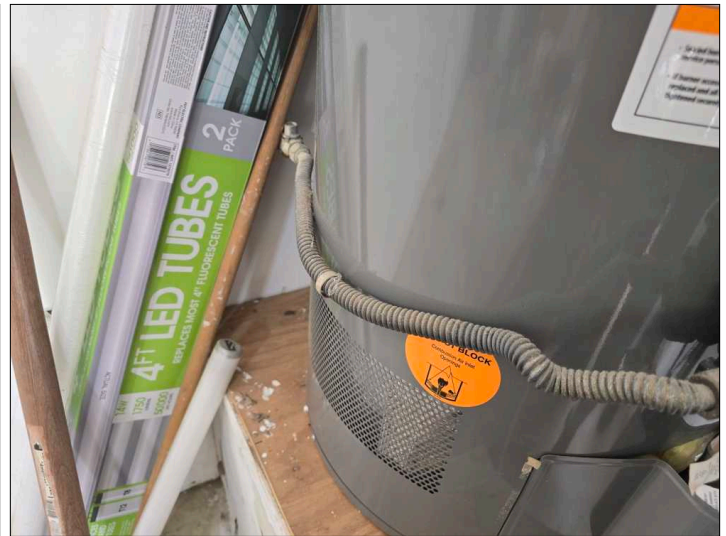
No drip leg or sediment trap for gas line on water heater. This helps prevent trash from clogging jets.

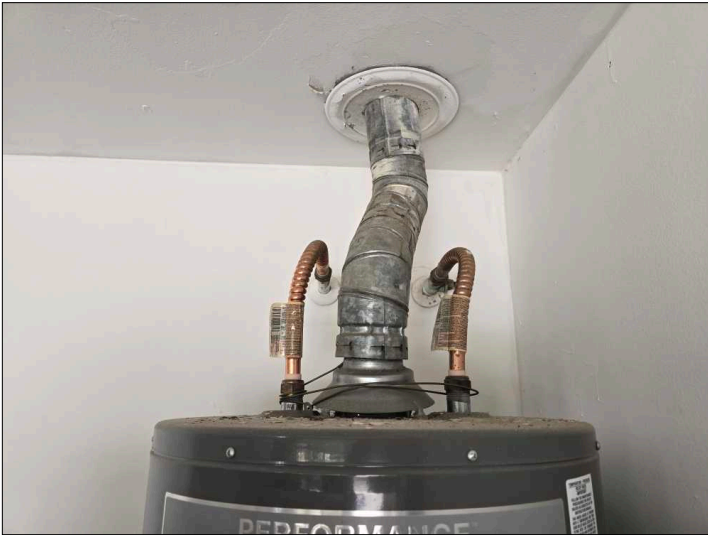
There should be a minimum of 12 inches of vertical venting between the draft hood outlet and the first elbow or connector. When using direct venting, any semi-horizontal piping should have a minimum upward slope of one-quarter inch per foot.
