## **Property Inspection Report**

**18726 Haughland Dr, Cypress, TX, 77433**

*Inspection Date: 5/31/2024*

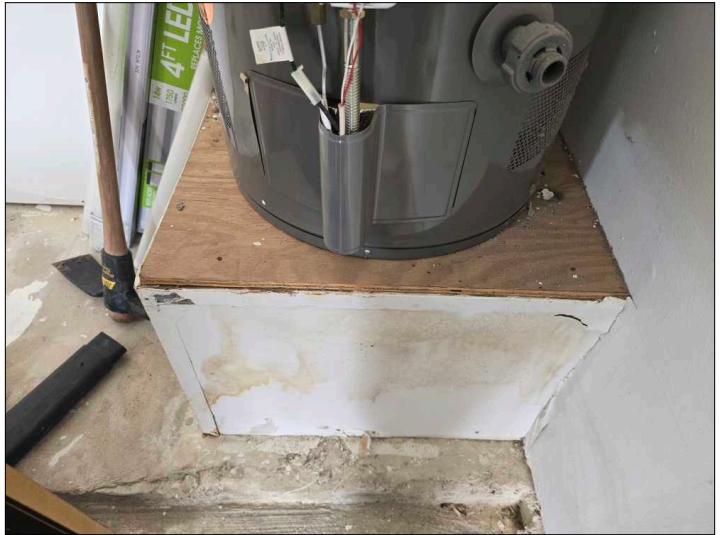
There is no drip pan for the water heater installed in the garage. It is recommended that if the water heater is installed in the home or attic that a pan be installed and drain to the exterior of the home. If the water heater is installed on the upper level of the garage it should drain to the exterior or at least drain to the lower level of the garage to help prevent the water heater from flooding the home in case of a failure.
