Property Inspection Report #5/16/2022 2832 Lockett Street
8616 Daffodil St. Houston, TX 77063

PROPERTY INSPECTION REPORT FORM

<u>Juan Echeverry</u>	<u>5/16/2022</u>
<i>Name of Client</i>	<i>Date of Inspection</i>
<u>2832 Lockett Street , Houston, TX 77021</u>	
<i>Address of Inspected Property</i>	
<u>Josh Burk</u>	<u>22850</u>
<i>Name of Inspector</i>	<i>TREC License #</i>
<u> </u>	<u> </u>
<i>Name of Sponsor (if applicable)</i>	<i>TREC License #</i>

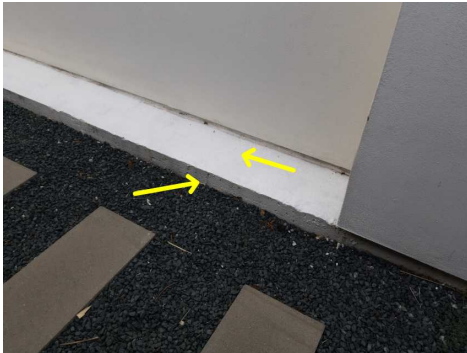
Observed one or more small cracks in the foundation; West exterior.

Small crack at West exterior

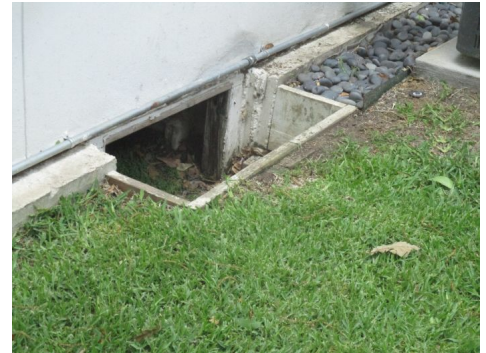
Foundation access door missing. Allow for rodent entry.

Crawlspace access missing a door

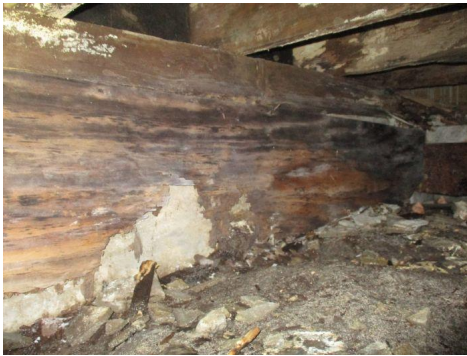
Earth wood contact in some areas - conducive condition to termite activity and wood rot.

Form board/ wood to ground contact at multiple locations

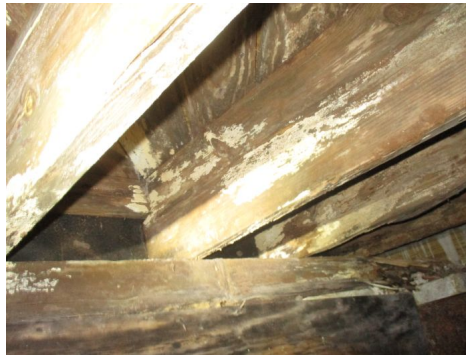
Wood rot/fungus on various wood members in crawl space observed below the house. This condition if left untreated will eventually result in structural damage to wood members. The rot/fungus feeds off the cellulose fibers of the wood.

Wood rot/fungus on various wood members in crawlspace observed below the house.

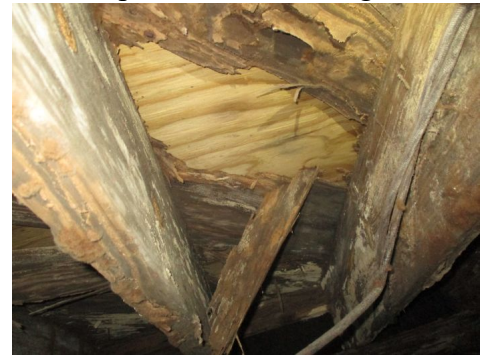
Subfloor has damage and or repairs at multiple locations.

Damaged/ repaired sub floor at multiple locations

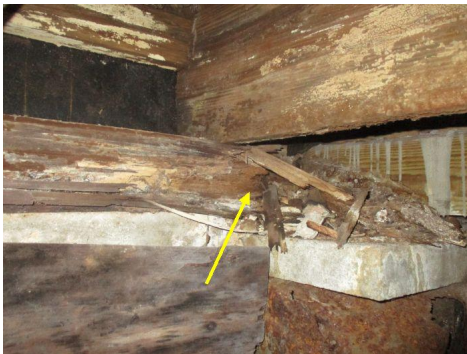
Multiple areas observed below the house with various degrees of damage from water and/or wood-destroying insects. Damage found to be in my opinion as in need of repair was observed at Southeast corner, below guest bath,.etc. Recommend qualified contractor be retained/consulted regarding the scope of all repairs needed/required and deemed necessary to effect a proper repair that the contractor deems adequate and is willing to warrant.

Southeast corner needs further evaluation/ repair

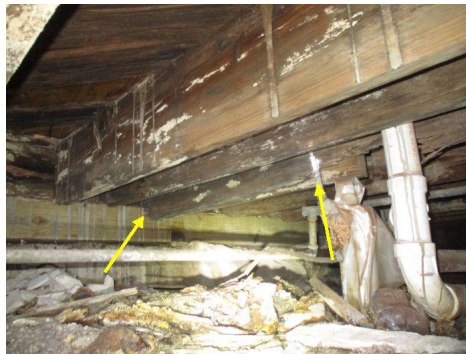
Joists under guest bath need repair

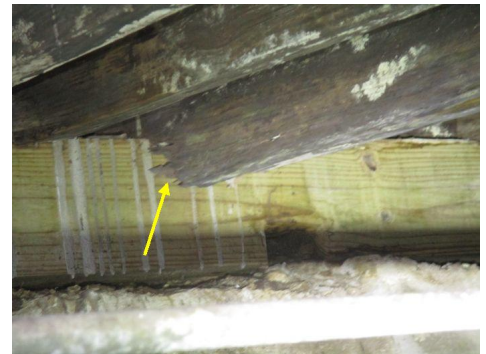
Damaged joists below guest bathroom

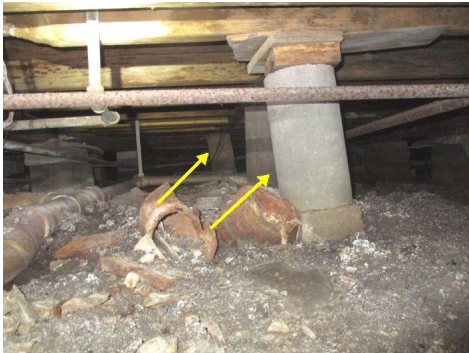
Pier(s) appear to be leaning/or tipped at one or more locations. Recommend repair.

Piers leaning under center of home

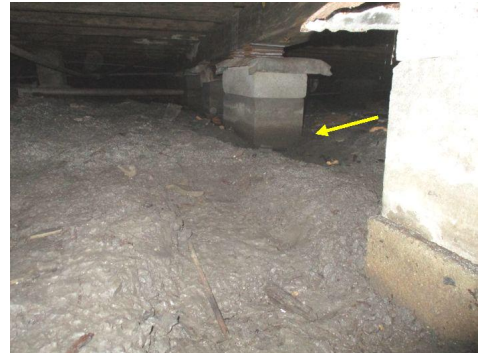
Evidence of water staining, below the house, indicates a history of substantial standing water below the house during the rainy season, This condition is detrimental to adequate foundation performance of pier and beam foundation systems and should be corrected through proper site drainage/grading.

Ground is very soft in areas, water stains at piers

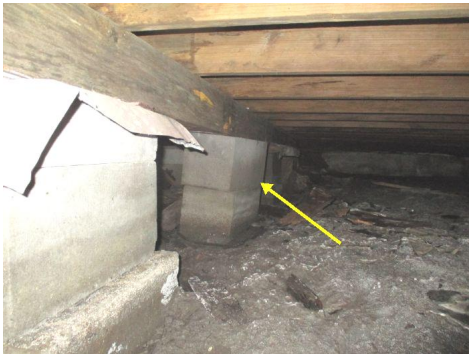
Pier leaning Northwest

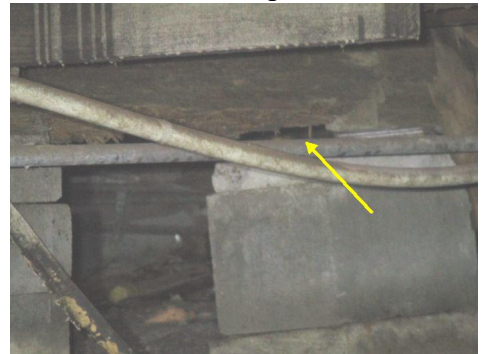
Observed one or more areas where beams are not in contact with floor joists or piers.

Joist/ beam not in contact with pier

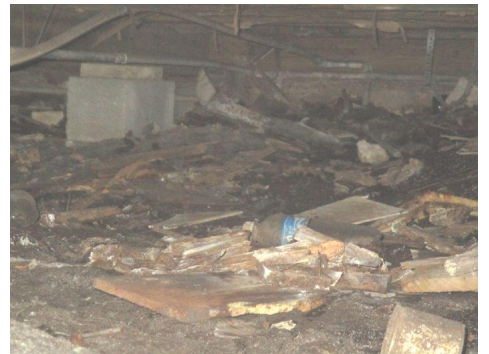
Scrap wood below the house is considered a conducive condition for wood-destroying insects. Recommend removal of debris/junk from below the house.

Scrap wood/ debris/ junk below home should be removed

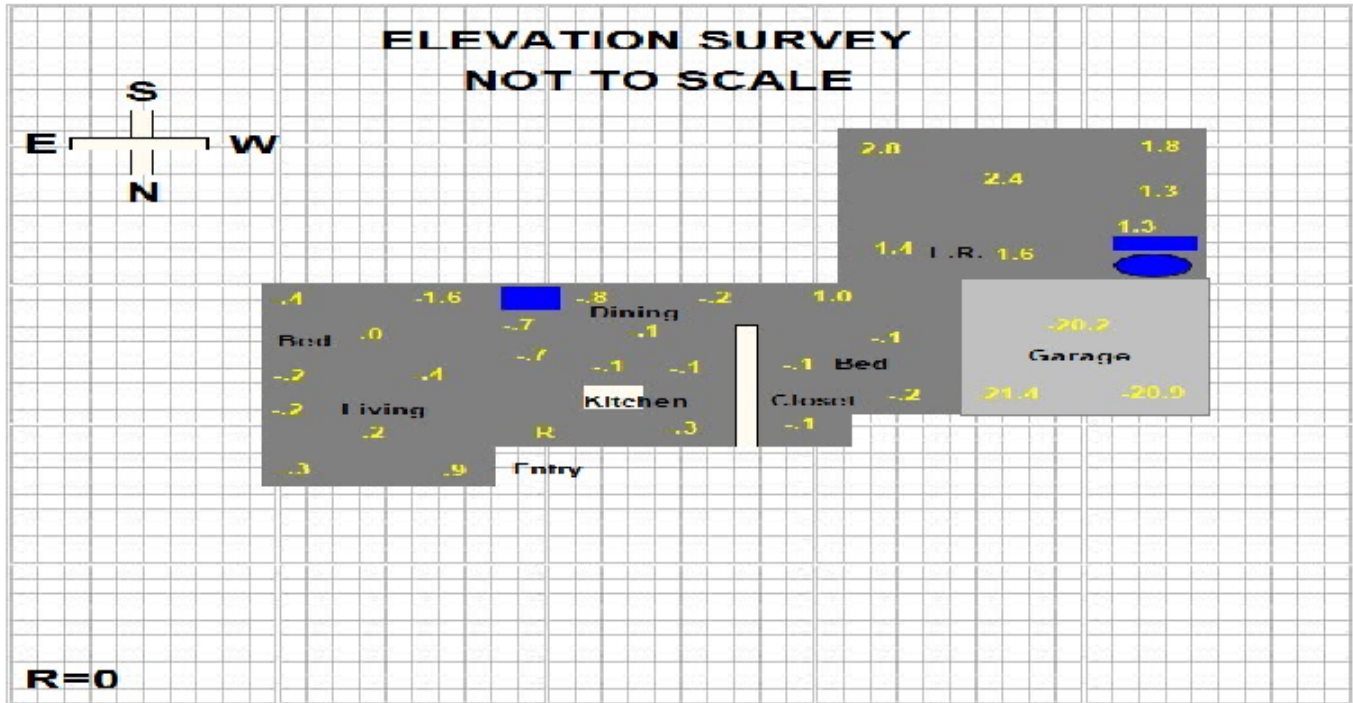
A foundation elevation survey was conducted during the inspection. The floor plan below represents data gathered using a Zip Level and adjusting for floor covering height differences, i.e. differences between tile, carpet and wood flooring (except step down to the garage). Measurements are listed to the nearest 1/10th of an inch. The greatest variance of original house was 0.9 to -1.6, overall 2.8 to -1.6

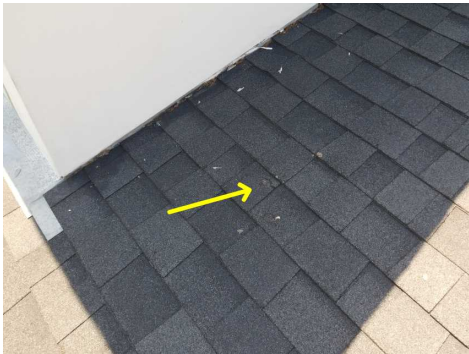
Observed scuffed/damaged shingles . Scuffing the mineral surface off of a composition shingle exposes the asphalt to ultraviolet light which causes it to deteriorate and can greatly reduce the life of the shingle. Replace scuffed shingles.

Scuffed/ damaged shingles at front dormer

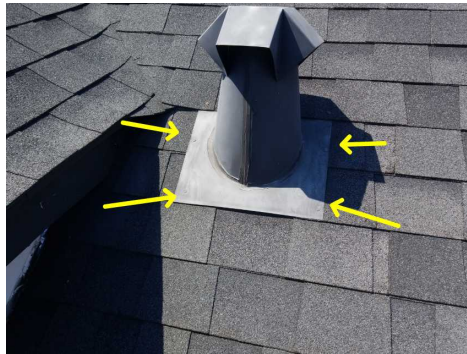
Exposed staples/nail-heads/fasteners observed on the roof are not properly sealed. Water entry possible.

Exposed nail heads and not shingle fashion

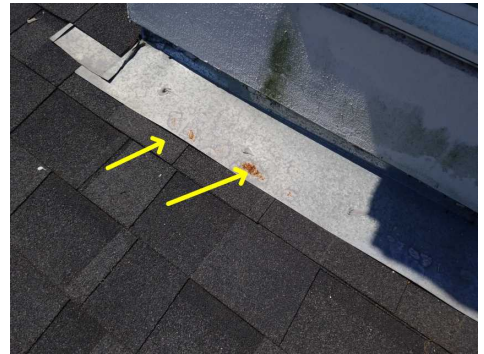
Observed rusted flashing; front dormers

Rusted flashing at front dormers

Recommend painting all exposed metal above roof line to prevent rusting and extend service life.

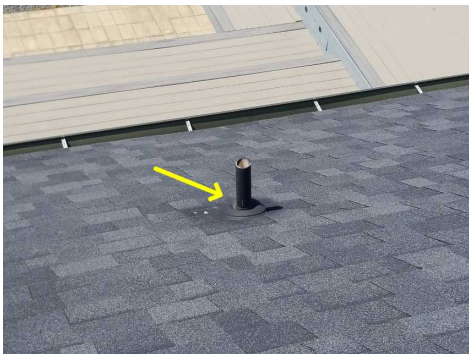
Rubber gasket of one or more drain waste vents was observed to have an inverted rubber gasket. This condition can allow rainwater to accumulate and penetrate.

Rubber boot flashing inverted at South exterior

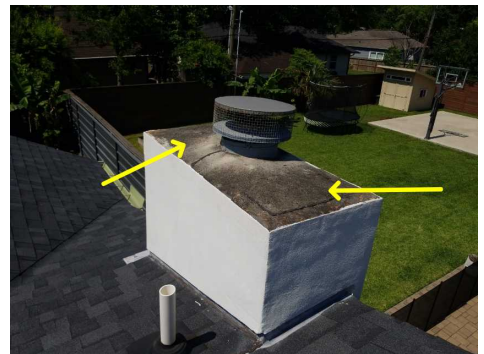
Missing cap flashing at chimney

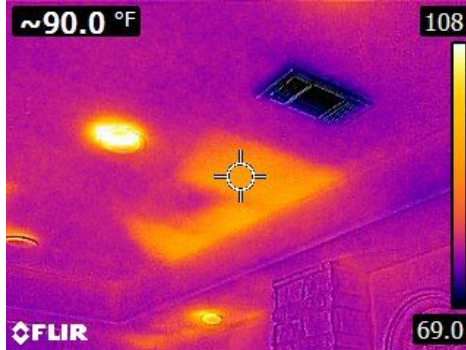
Insulation not properly positioned/missing in areas, etc.

Thermal image of missing insulation at living room

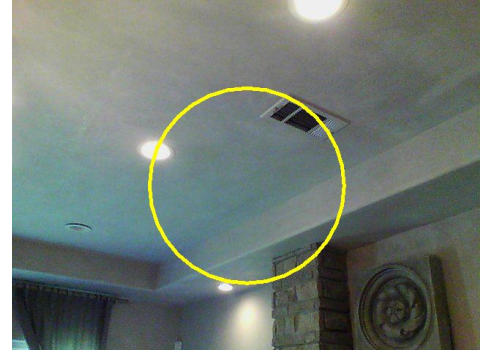
Missing insulation at living room

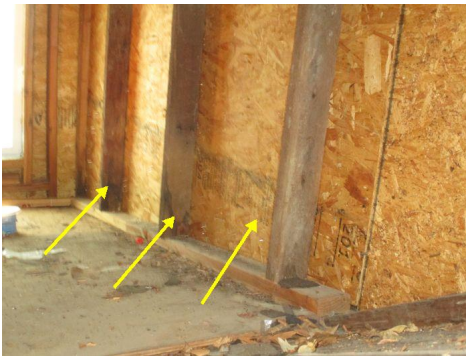
Water stains at front dormers

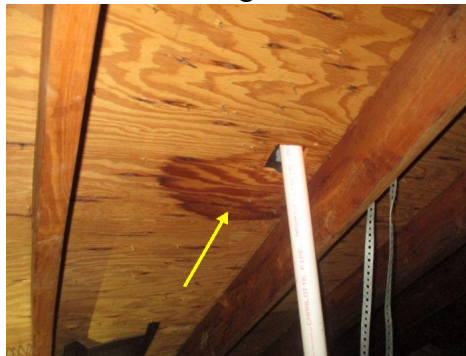
Water stains at South DWV

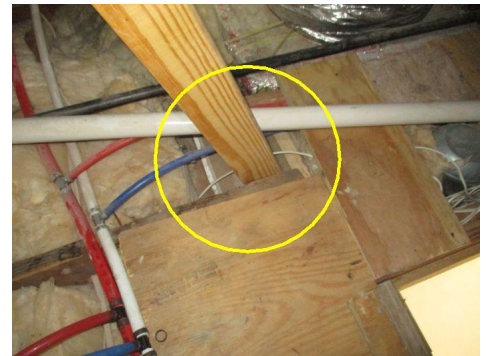
Observed improper installation of bracing from roof rafters down to ceiling joists.

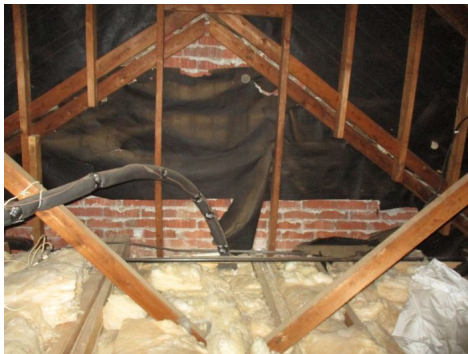
Observed damaged paper vapor barrier in attic.

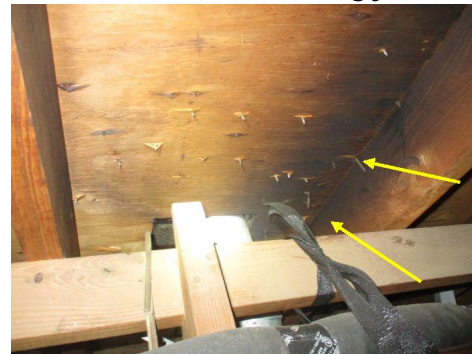
Discolored wood in attic indicates improper venting of the gas-fired furnace and recognized fire hazard,

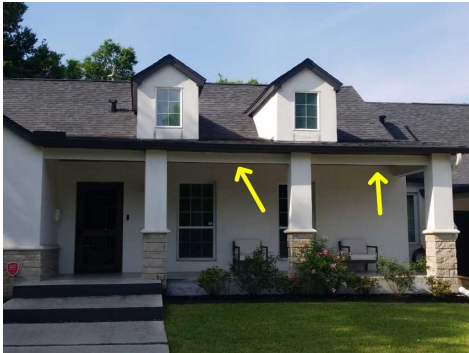
Sag in the double header over front porch, Possible indication of improper/inadequate framing and/or foundation settlement.

Header sagging or leaning, at front porch

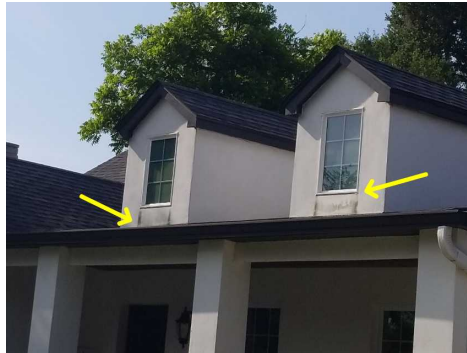
Stains on stucco surfaces

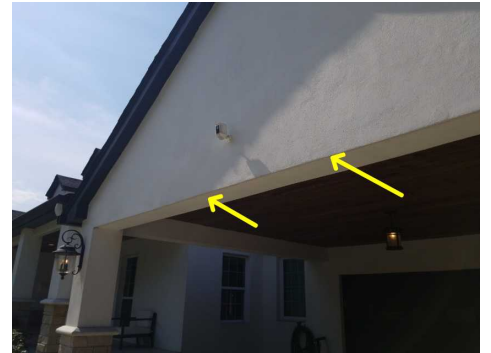
Weep screed holes are blocked/ sealed over.

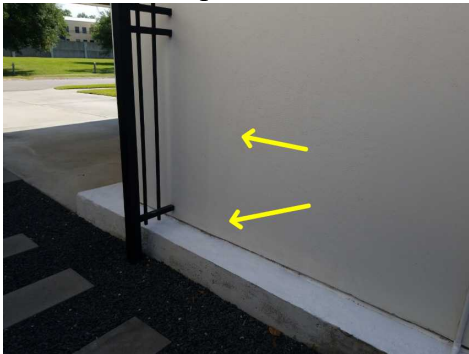
Seal cracks in stucco, West exterior

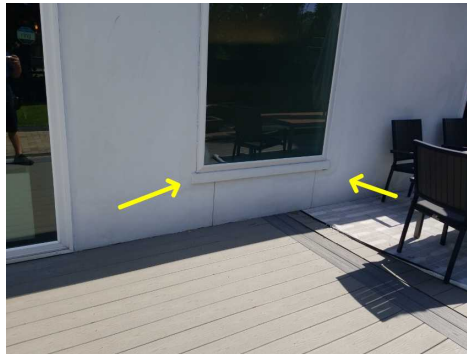
Seal stucco cracks

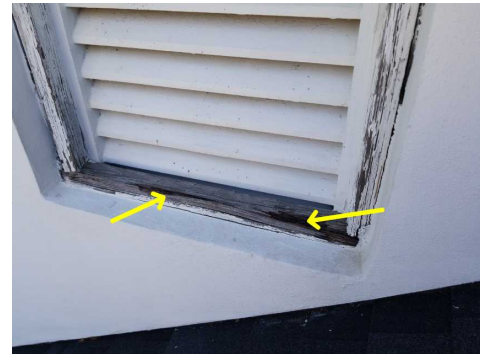
Wood rot at West attic vent

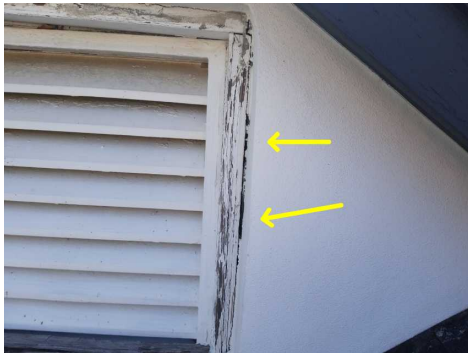
Caulk attic vent

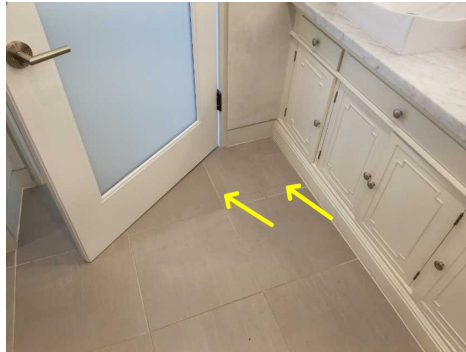
Cracked/chipped and/or loose floor tile observed; master bath,

Cracked tiles at master bath

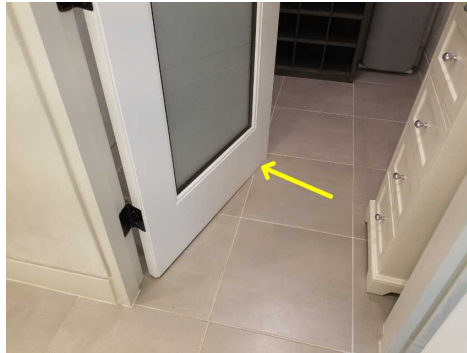
Master closet door will not open/ close, in contact with floor

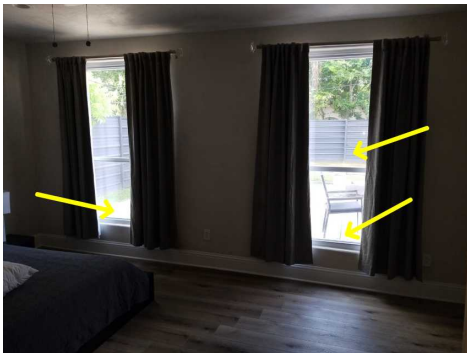
East bedroom windows lost their seals

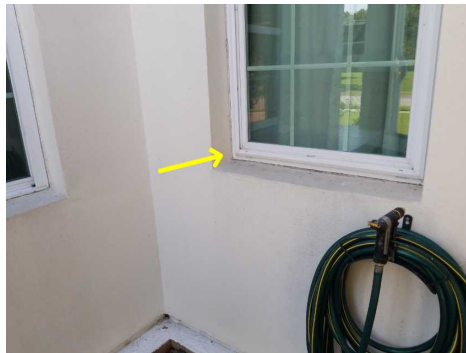
Window frame is cracked/ damaged; North exterior.

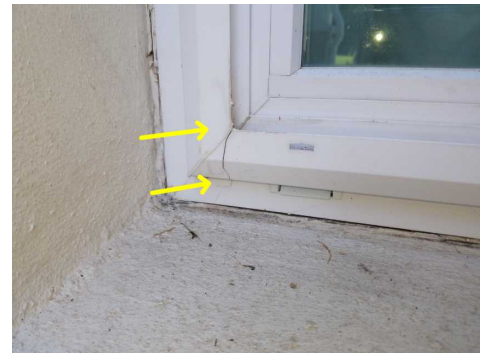
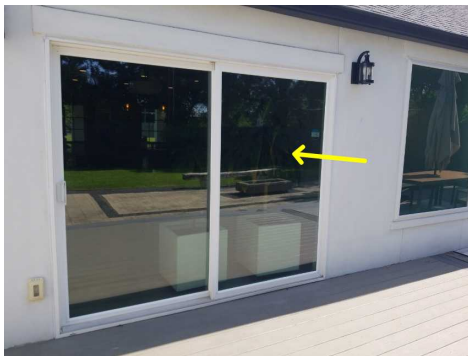
Sliding door system lost its seal

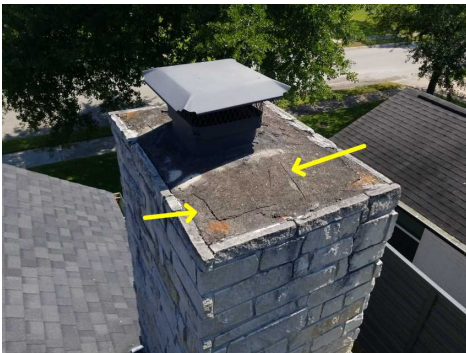
Masonry coping cracked or in need of improvements on top of the chimney.

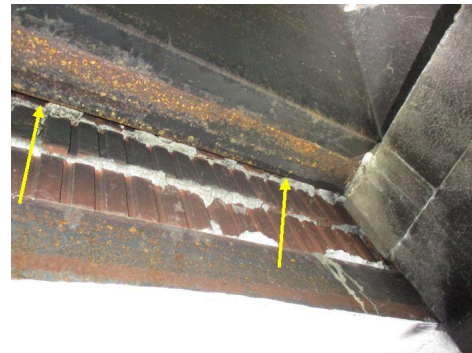
Hearth not sealed properly around the perimeter of damper and/or on the interior backside of the lintel - potential fire hazard.

Hearth not sealed properly around the perimeter of damper and/or on the interior backside of the lintel

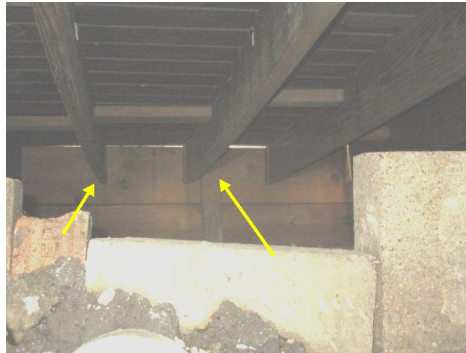
Joist hangers not properly installed, fasteners not installed at all required locations below deck.

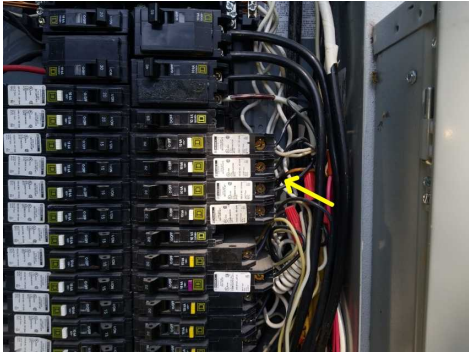
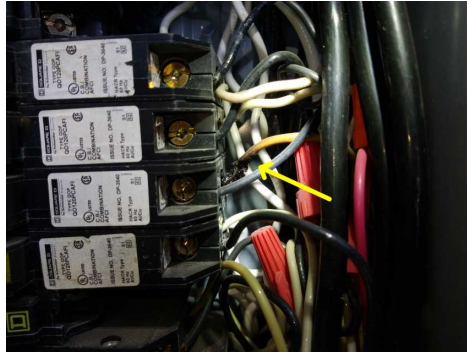
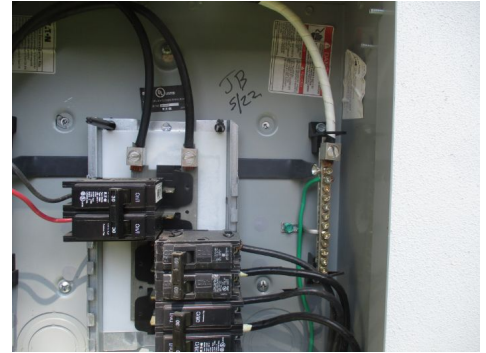
Wire insulation damaged from overheating; breaker # 16 at main panel

Improper wiring to sub-panel - the neutral and ground wires are not on separate bus bars as required on sub-panels.

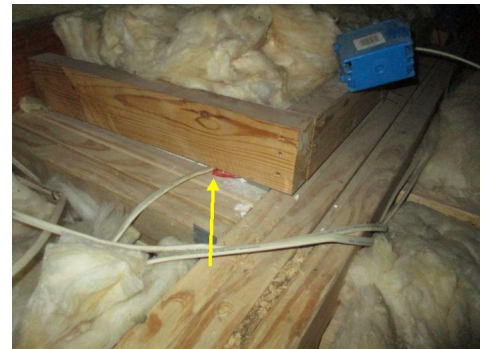
Framing in attic improperly installed on top of electrical wiring above living room/ hallway in attic.

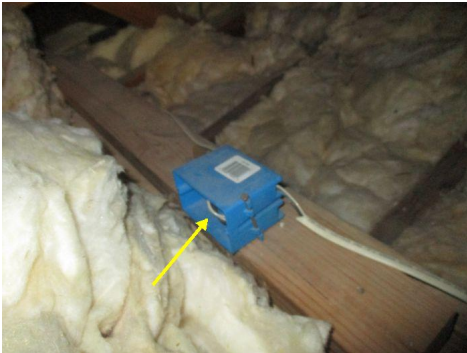
Junction boxes missing covers above living room

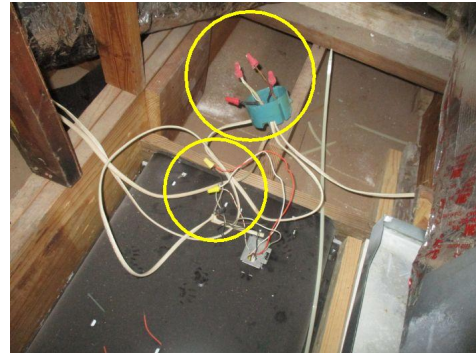
Wire connections not in junction boxes and missing covers at garage attic

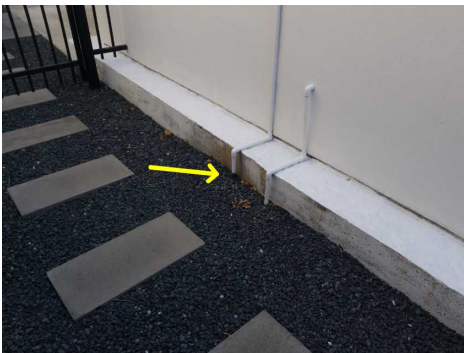
Primary drains near foundation

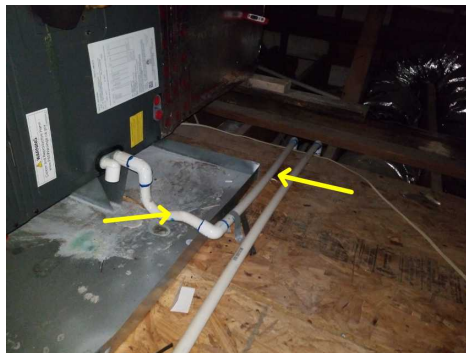
Primary drain line is missing insulation; West unit

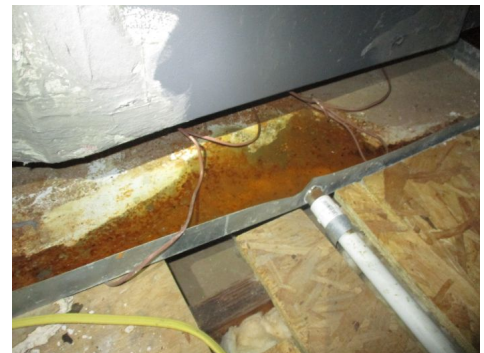
The secondary drain pan contains water, correct existing conditions; East unit.

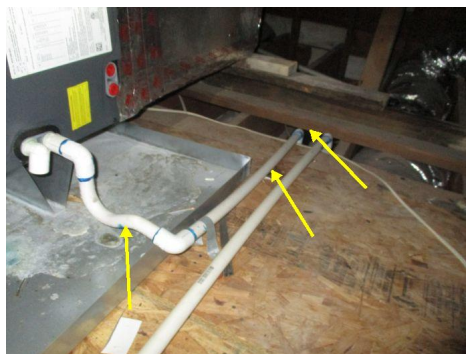
Primary drain line missing insulation; West unit

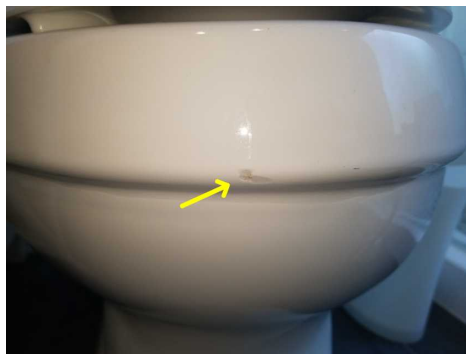
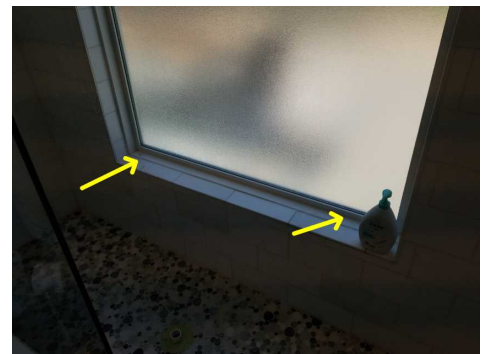
Caulk/ seal screws to prevent water damage inside wall

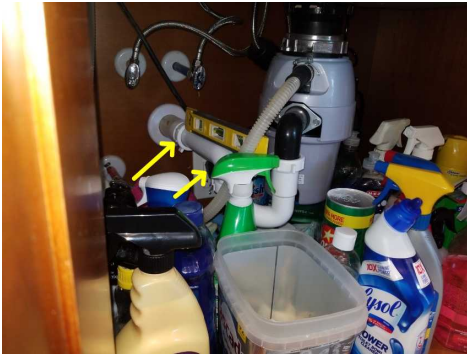
Reverse slope of drain line. Does not tilt towards downhill for proper drainage; kitchen sink.

Reverse slope of drain line. kitchen sink.

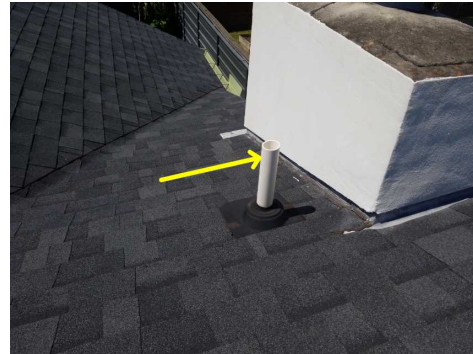
Painting of exterior plastic PVC vents above the roof line required to prevent UV damage.

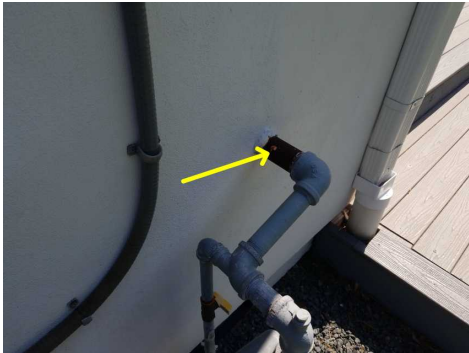
Exposed exterior gas piping not protected from corrosion

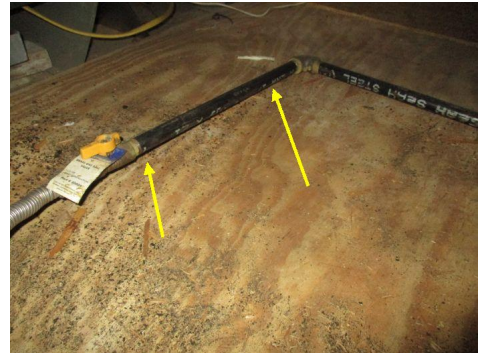
Gas line near furnace is not supported/ or secured to decking

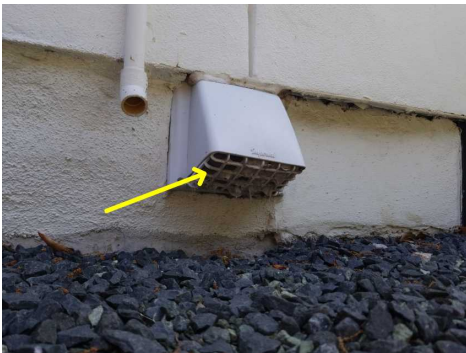
Dryer vent contains lint buildup. Recommend cleaning dryer vent to reduce drying time and risk of fire hazard.

Dryer vent is clogged and has a screen

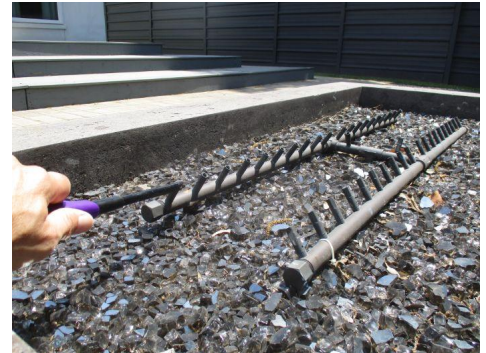
The outdoor firepit was not operational, not performing its intended function. Inspector turned both valves on (at gas meter, and below unit). Valves and or unit in need of repair/replacement.

No gas observed
