Confidential Inspection Report

LOCATED AT:
4919 Southpoint Wy
Fulshear, TX 77441

INSPECTED ON:
Tuesday, October 31, 2023

Inspector, Chris Beasley, Paul Ferguson
A Plus Inspections of Texas

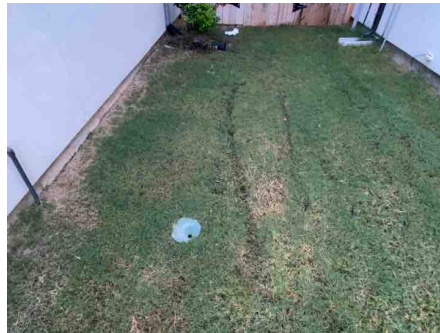
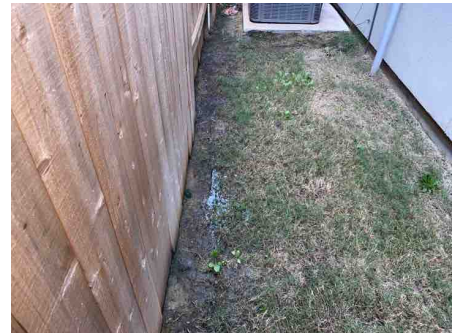
REP 1: There were low and muddy areas where water will stand on the lot and next to the home and some areas may affect the foundation. Grading and drainage adjustments and repairs should be performed. See IRC R401.3

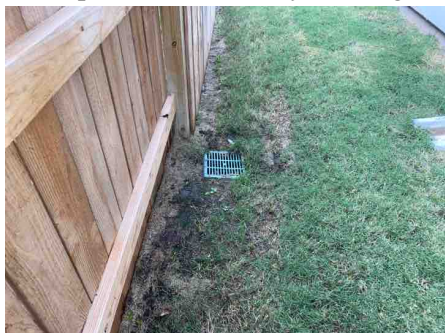
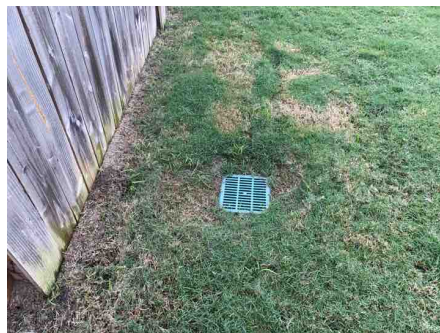
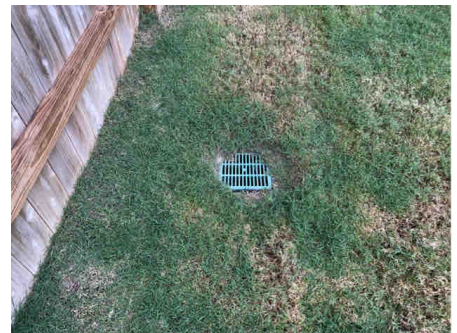
MONI 2: There were some surface drains at the yard areas with some damages and irregularities. The surface water drainage system was below grade and could not be viewed or evaluated. Designs and materials for these systems vary widely. They often clog and may require repair from time to time. We recommend they be periodically tested and repaired as necessary. A budget should be maintained for this.

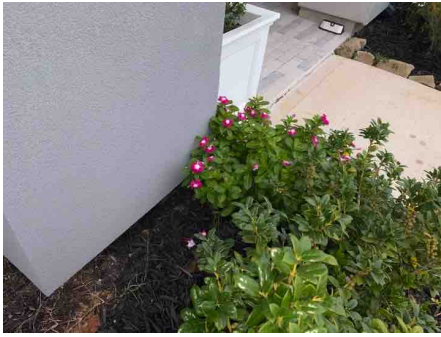
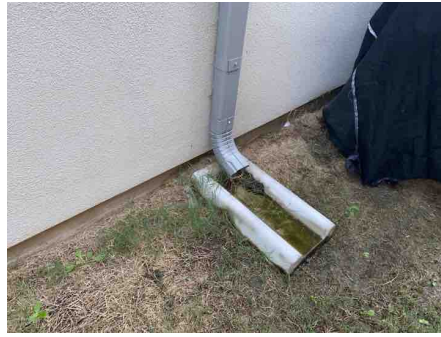
REP 3: Foliage was in contact with the home and close to it that needs to be trimmed back to reduce chances of damage and pest infestation such as carpenter ants.

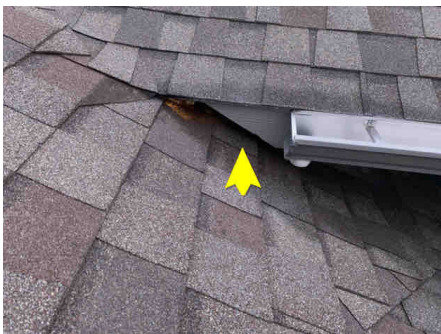
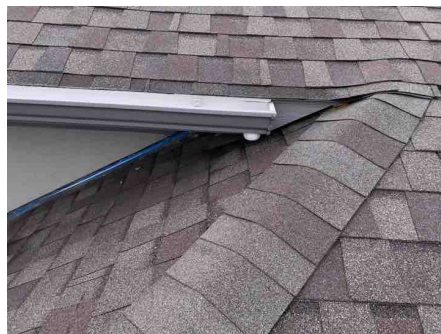
REP 4: There were gaps at the soffit and roofing areas that need to be covered with flashing, to reduce chances wind driven rain entry, and to keep out small animals such as rodents, bats or birds. See IRC 1503.2.1

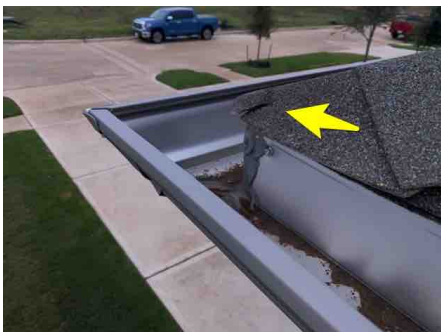
Lower roof front right corner

REP 5: The shingles had limited damages, gaps and loose parts that need to be repaired by a qualified roofing contractor.

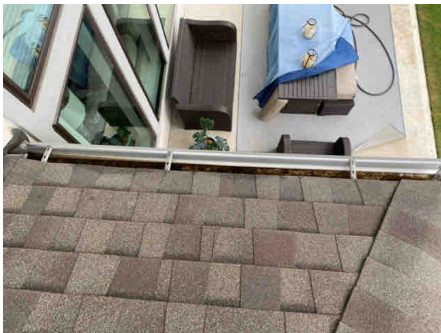
Lower back right

REP 6: Water was standing in some of the rain gutters. Adjustments are needed.

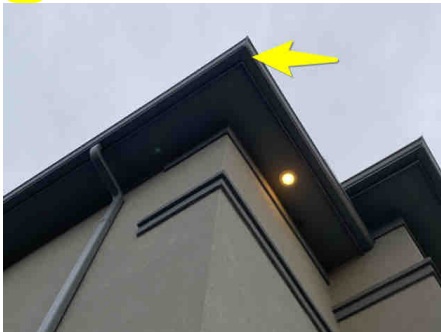
Front left

REP 7: The rain gutters and related parts had some signs of leakage. Repairs are needed.

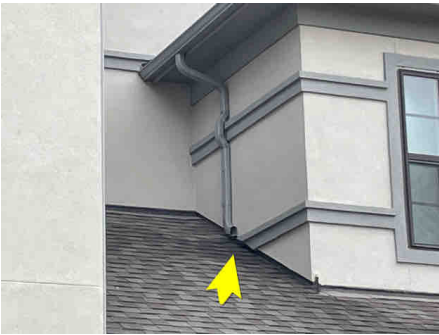
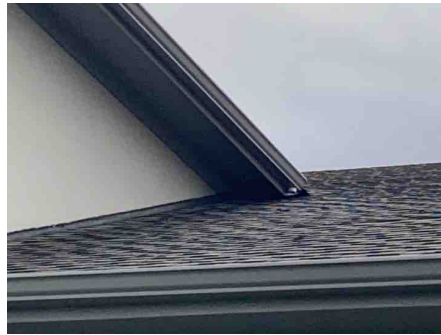
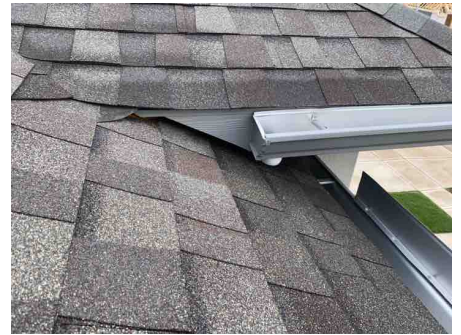
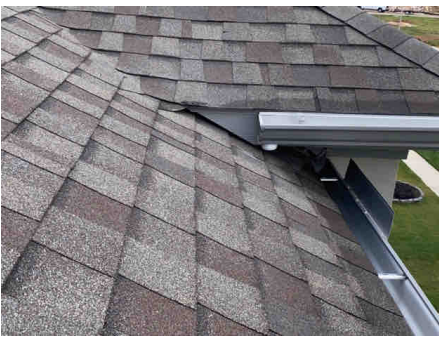
REP 9: Some of the rain gutters and gutter downspouts terminated at the roof surfaces as is found at many homes of this type. It is recommended that they be extended to the roof edges/lower rain gutters/soil areas, to reduce chances of damage and wear, and leaks at the shingles and flashings. See GAF Technical Bulletin No. TAB-R-2011-150

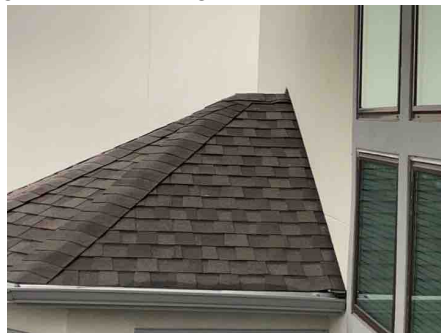
IMPR 10: J flashing was used where the walls meet the roofs as is found at most newer homes. Shingle manufacturers normally recommend using step flashing here. No damage was visible as a result of this.

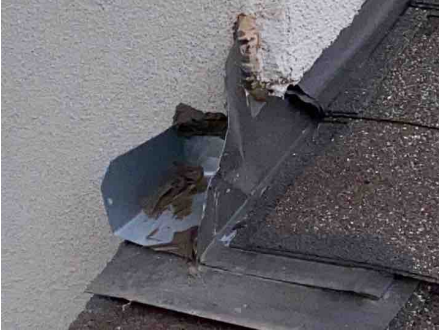
REP 11: Some of the flashing parts had not yet been painted. They should be painted, to reduce chances of deterioration, and to help prevent them from rusting out.

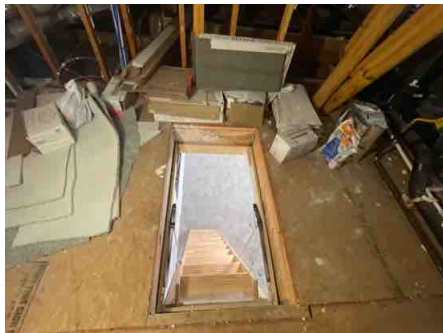
SAFT 14: The attic floor decking was limited and where present had gaps, unsupported areas, and did not have a guard or handrail at the perimeter areas. Repairs are recommended as a safety precaution.

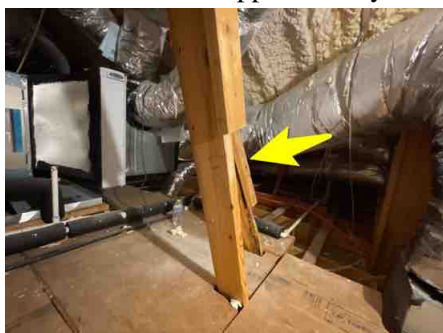
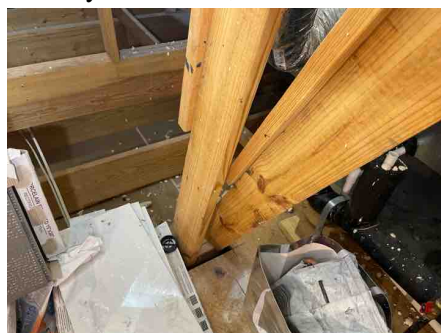
REP 16: Some of the T bracing boards did not have bracing that extended the full length of the boards at the roof structure vertical supports. They should be fully reinforced, to reduce chances of bowing and damage.

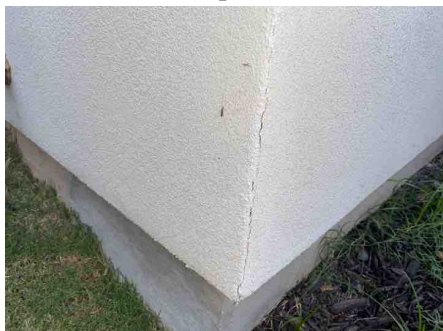
REP 17: The stucco walls had signs of settling and movement, and had gaps and damages. There may also be concealed conditions requiring repairs present. Further evaluation by a qualified stucco testing specialist is recommended. Repairs at areas with damages should be performed by a qualified stucco repair contractor.

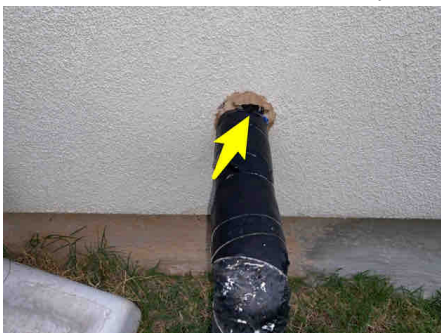
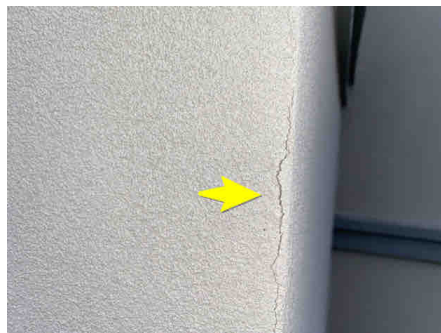
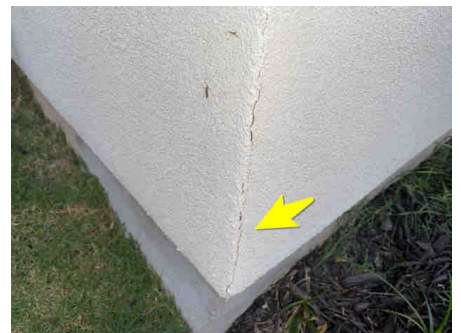
REP 18: There were gaps at the exterior wall surfaces at multiple locations. Gaps and damages should be repaired, to reduce chances of moisture entry. See R703.8

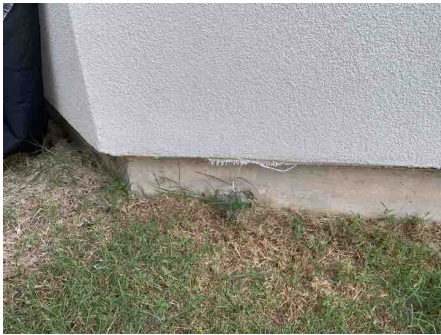
REP 19: Some of the house wrap material was hanging out from below the exterior walls and needs to be trimmed off.

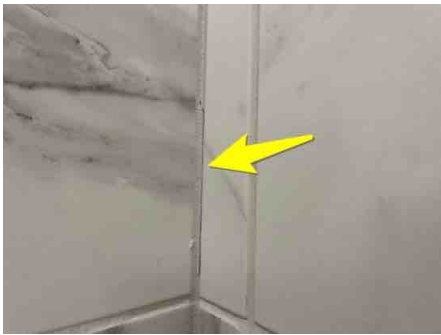
Downstairs guest bathroom

REP 20: There were gaps and limited damages at the tub and shower walls that should be repaired and sealed, to reduce chances of moisture entry and damages.

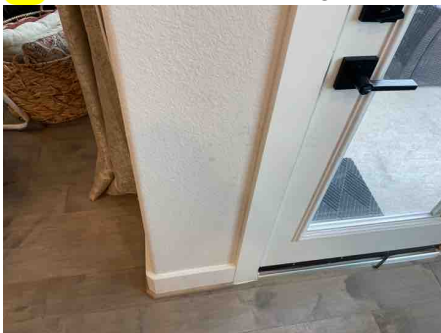
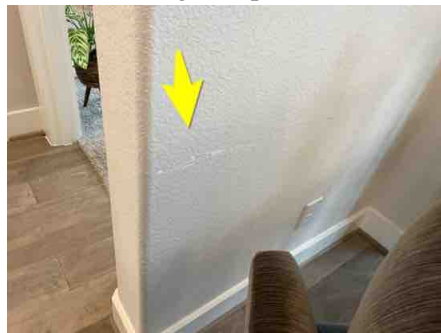
REP 21: The walls had irregularities, marks, and damage. Repairs are recommended.

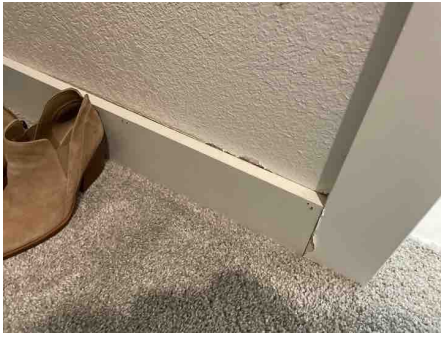
Primary closet

REP 22: There were limited gaps at the caulk and trim at the perimeter of the floor areas that could be touched up and repaired.

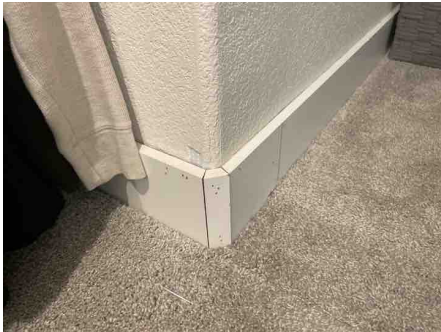
Primary closet

MONI 23: Some of the floor and floor trim parts had marks, damage, and irregularities as are found at many homes and could be repaired.

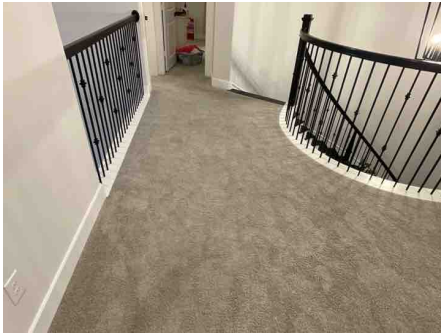
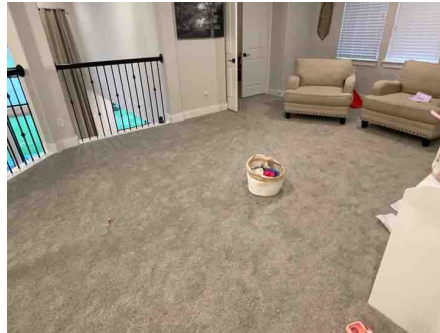
REP 24: The upstairs floor coverings and floor boards creaked and made some noise when they were walked on. This is found at many homes. Areas with excessive creaking could be repaired.

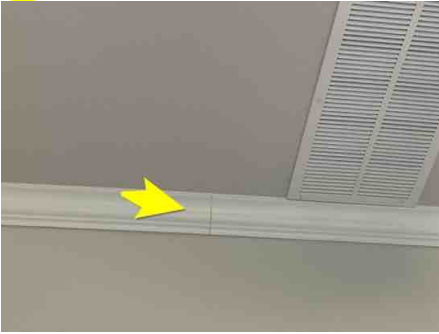
Primary bedroom

REP 25: The ceilings had signs of settling and movement that can be repaired.

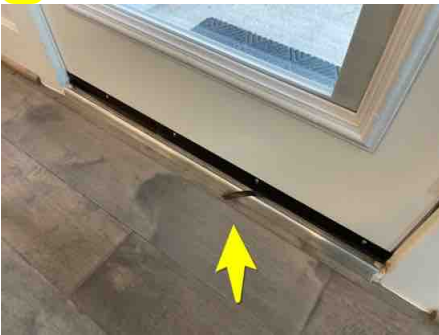
REP 27: The exterior door weather stripping parts and sweeps had some gaps and damages that could be repaired.

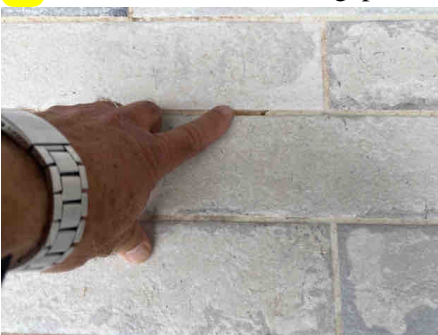
REP 31: There were limited gaps at the porch tiles that should be repaired.

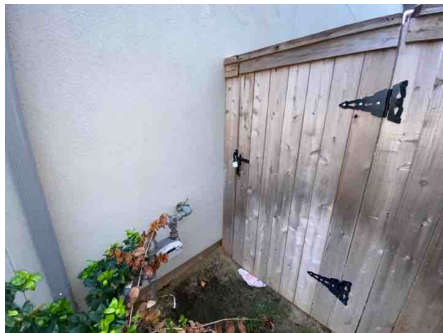
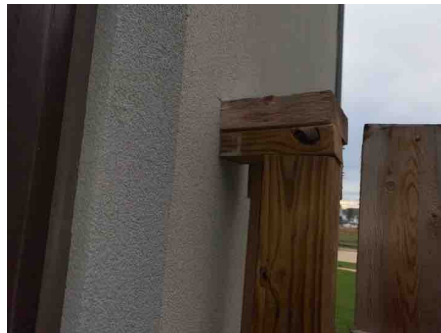
REP 32: The fence was in contact with the exterior walls. It should be trimmed back, to reduce chances of pest infestation.

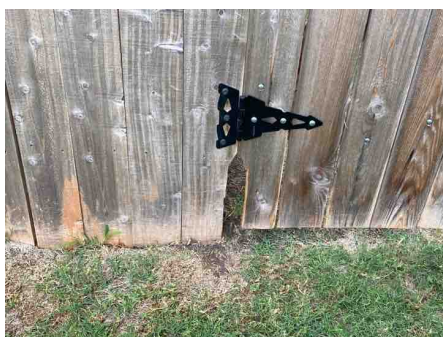
Left gate

REP 33: The fences and gates had some damages and deterioration. Fences are often not part of real estate negotiations, however we note them as in need of repair when they are found to be damaged. Repairs are recommended.

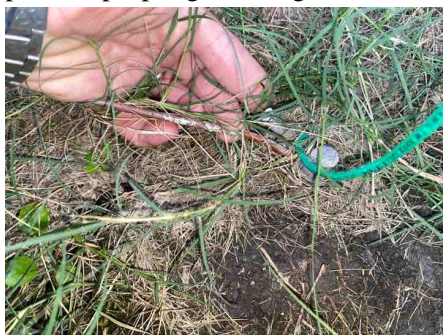
SAFT 35: The clamp on the grounding conductor by the service entrance is loose. The ground clamp be tightened to provide proper grounding.

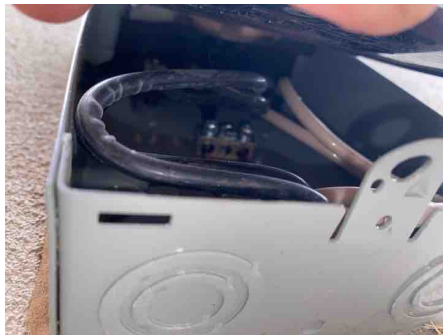
SAFT 36: White wires were connected to some of the breakers and disconnects. They should be marked at both ends with red or black electrical tape, to indicate they are carrying a positive current.

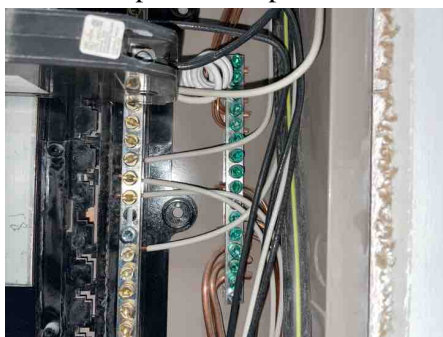
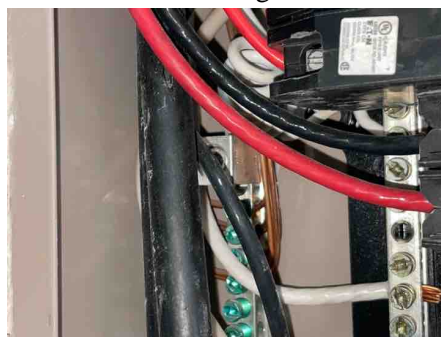
IMPR 37: There were instances of more than one ground wire secured under each screw at the ground buss bars. This could be repaired as a precaution, to reduce chances of loose ground connections.

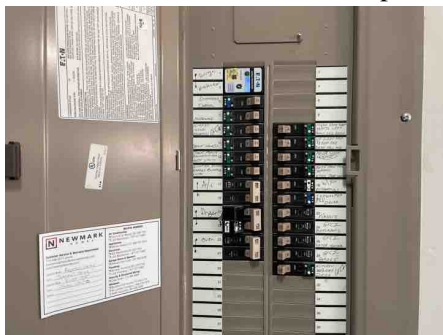
MONI 38: The breaker panel had AFCI breakers for parts of the home. The breakers and AFCI breakers were not tested, since the home was occupied and multiple items were connected that could be damaged by tripping them.

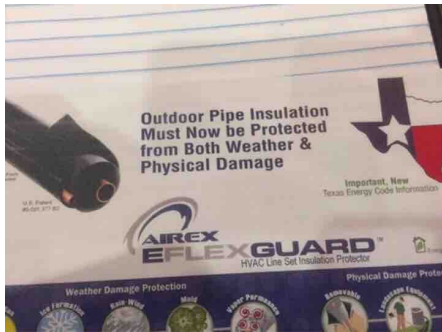
REP 40: The air-conditioner condenser unit refrigerant line insulation did not have a weatherproof protective sleeve, which should be installed. See IECC, C402.2.10.1

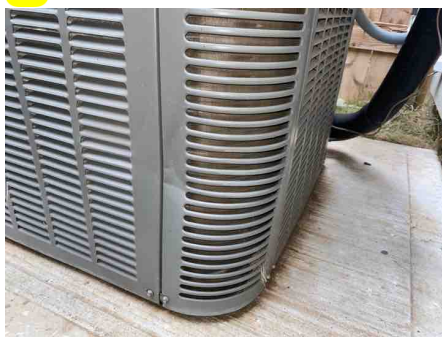
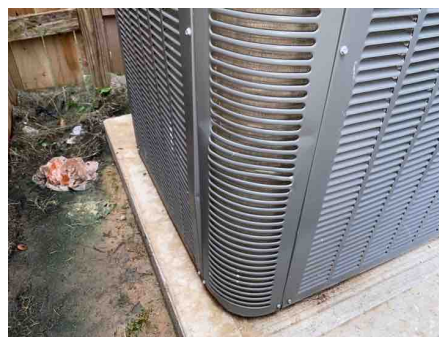
REP 41: The air conditioner condenser unit enclosure surfaces had some damages. Repairs are recommended.

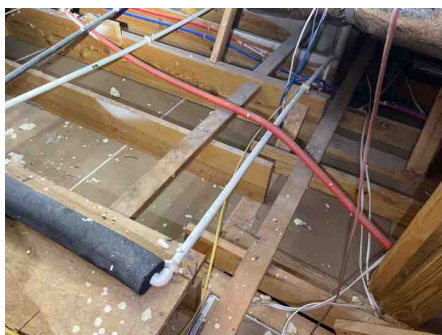
REP 42: The air conditioner condensation drain line did not have insulation the full length of the drain line, which should be installed, so that moisture does not drip from it when it is cold.

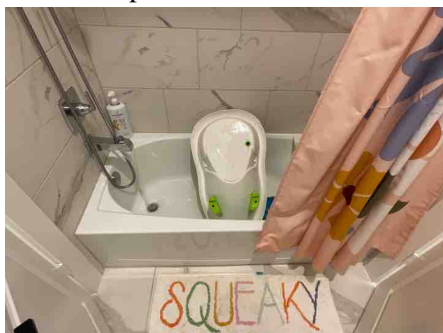
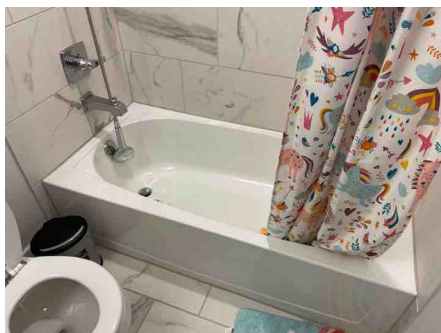
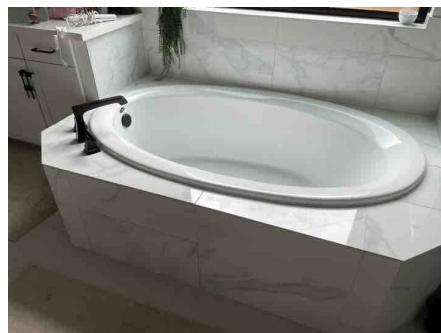
REP 49: Access to view under the tub and shower areas, such as to check for plumbing and drain leaks was not readily available. Access should be present, and further evaluation and any necessary repairs should be performed by a licensed plumber.

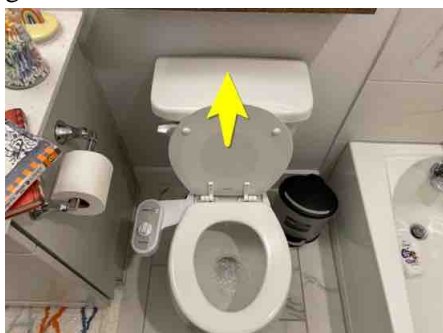
Upstairs right guest bathroom

REP 50: Some of the toilet reservoirs were in contact with or close to the walls, which could allow for organic growth formation and moisture damage. It is recommended that at least 1 inch of clearance be present.

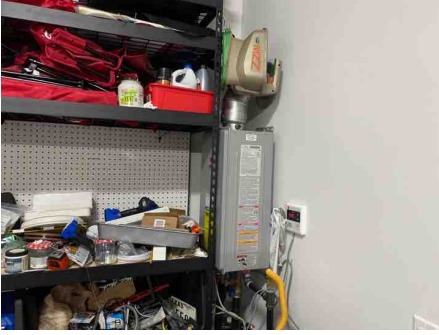
SAFT 52: There was not sufficient clearance around the water heater. Proper clearance should be provided as a fire safety precaution.

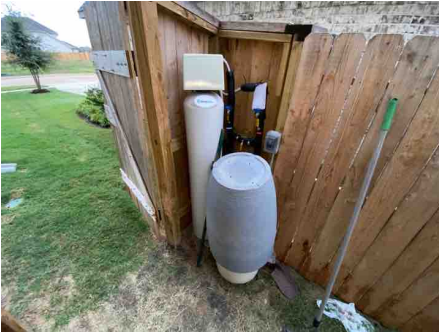
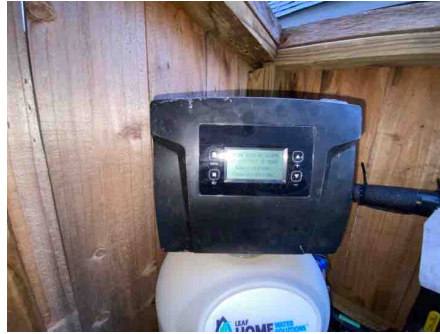
MONI 53: A water softener was present that was not evaluated or tested. Further investigation and repairs should be performed by a qualified water softener evaluation and maintenance specialist.

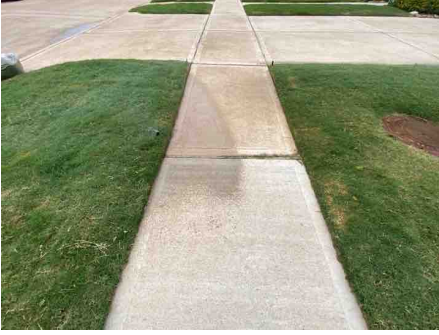
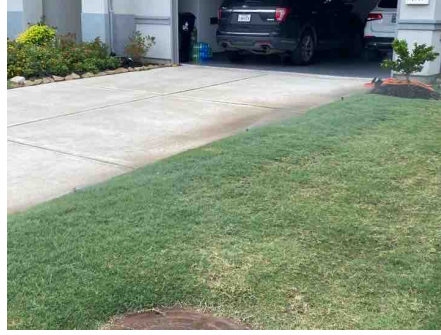
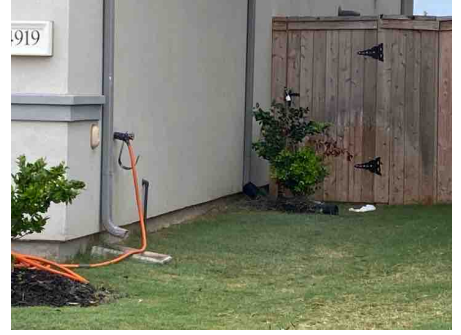
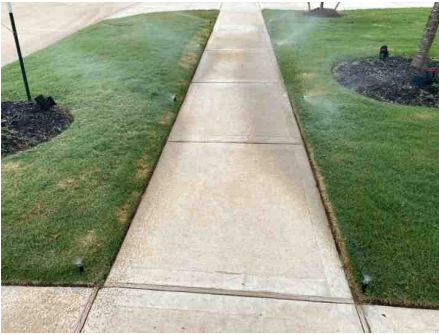
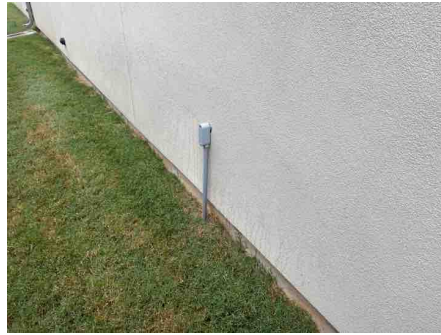
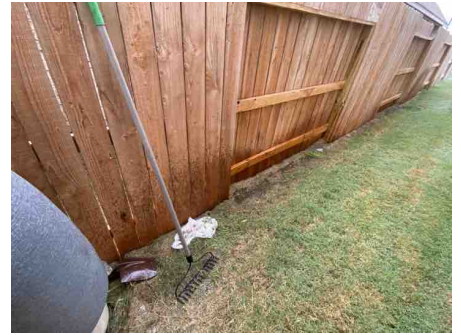
REP 61: The sprinkler system over-sprayed onto the fences, flatwork, building, etc. Adjustments are needed to reduce chances of moisture damage, slip hazards, and to prevent wasted water.

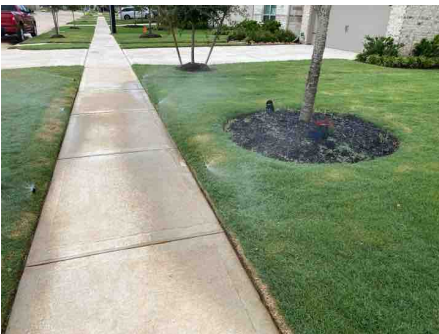
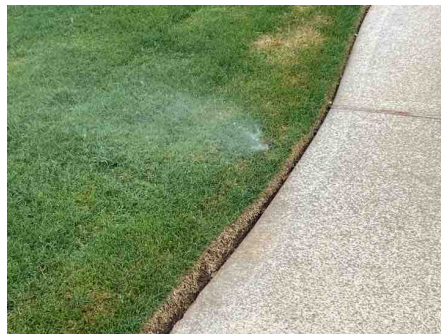
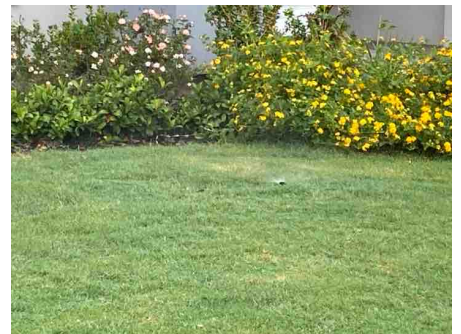
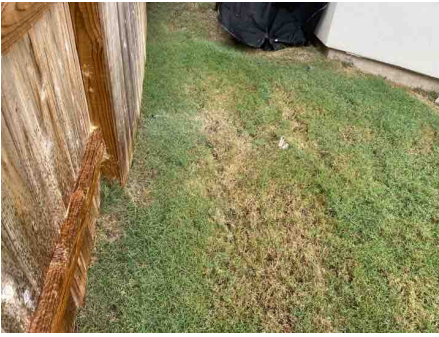
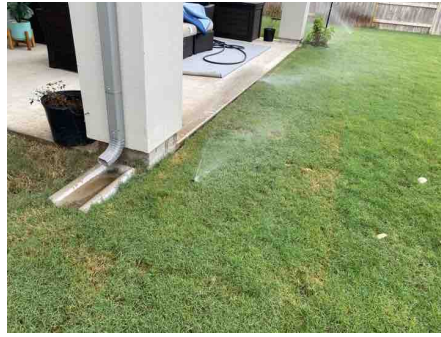
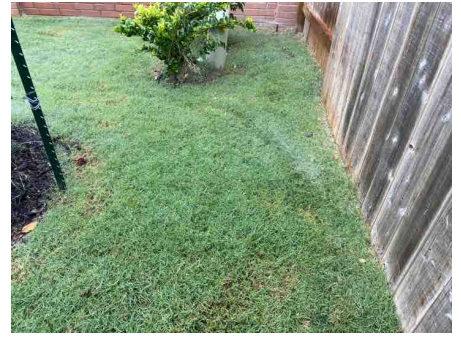
REP 62: Some of the sprinklers were obstructed by the grass and foliage around them. They need to be adjusted and raised.
