# Legacy Inspection Service

# PROPERTY INSPECTION REPORT FORM

08/29/2023

3905 Pleasant Hill Ct., Port Arthur, TX 77640

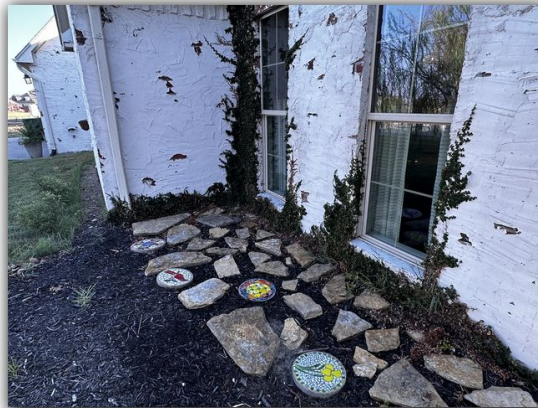
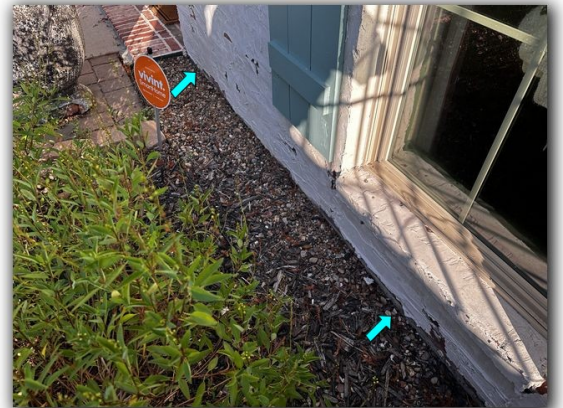
Some vines/Ivy are growing onto the exterior veneer on the left side of the home. Consider removal.

Inadequate grading clearance to exterior wall surface was observed in the front and left side of the home. Expose 3-4 inches of foundation below the brick veneer.

Level lot, does not facilitate proper drainage. If standing water is found at the foundation perimeter 24 hours after heavy rainfall. Route water away from the foundation using grade slope, ditches or sub surface drains.

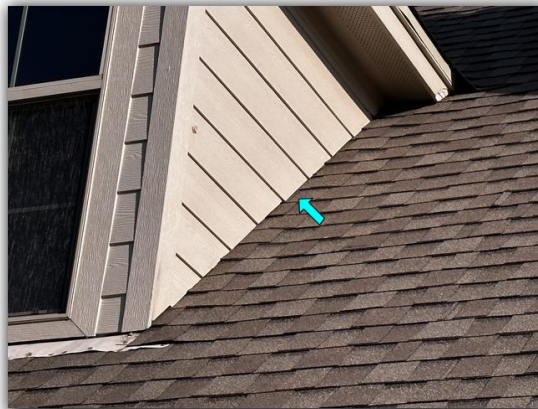
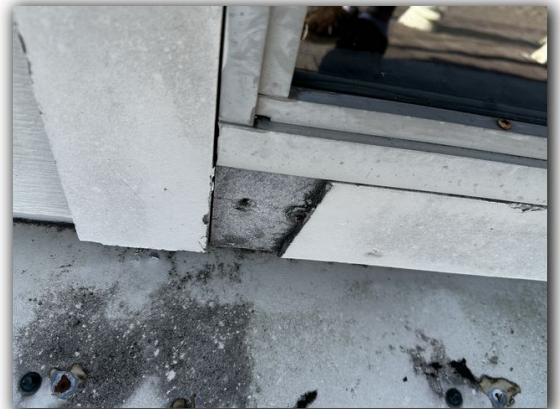
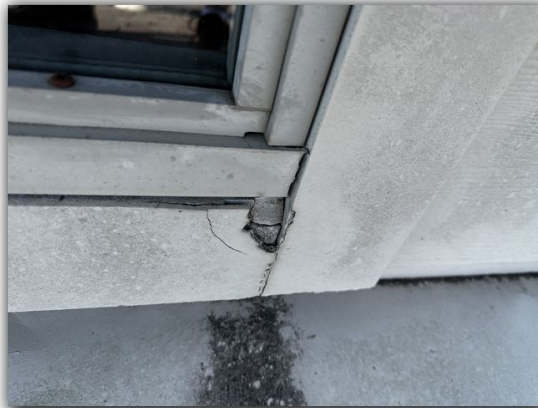
The sidewall cladding/veneer is in contact with the roof covering at the upstairs dormer walls. There should be a 2 inch clearance between the cladding and roof covering. FYI: the cladding is cement board siding and is not prone to rot/water damage.

Cement siding window trim in the back upstairs is damaged and in need of repair.

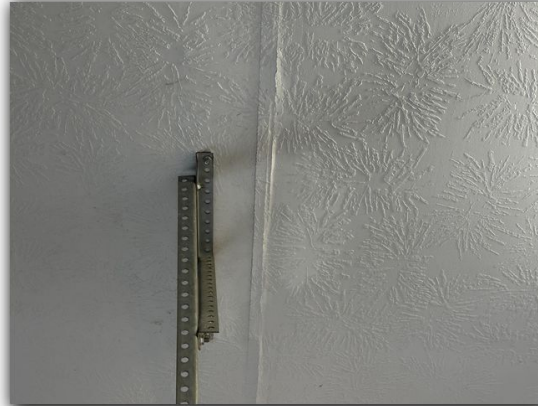
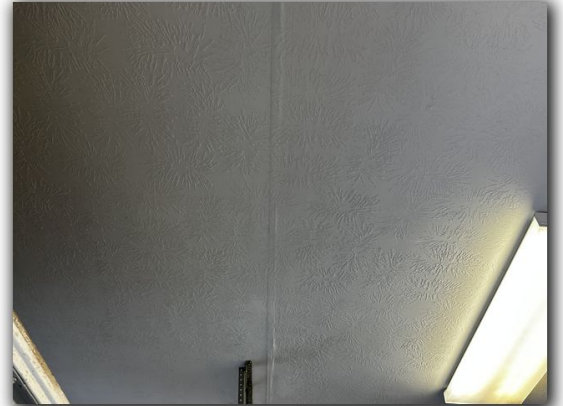
- Ceiling cracks were observed in the garage. This is typical due to our areas high average humidity and the garage is not climate controlled.

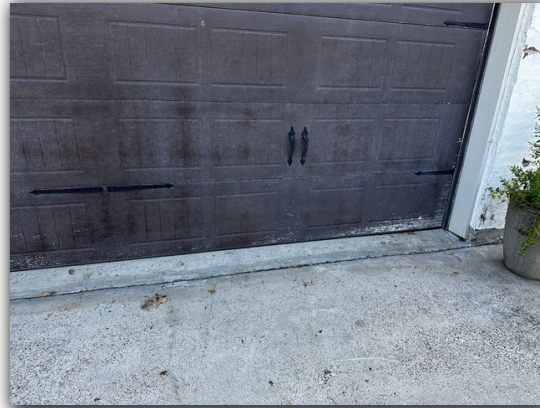
- Some doors are tight or rub the jamb. Some adjustment is recommended.
- The pop latches at the top of the study French doors do not engage the latch. Adjust or replace.

- Type:**  Metal    Wood    Fiberglass
- Some paint is missing/peeling on the large garage door.

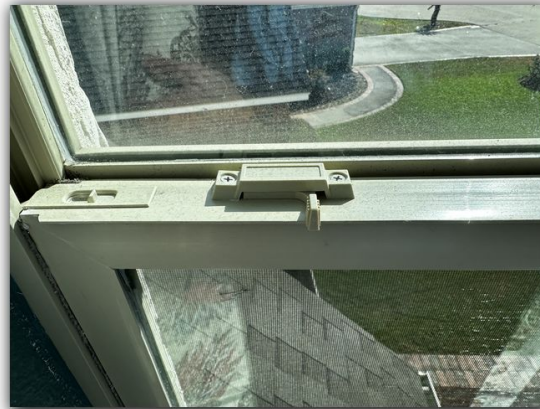
- Some windows are difficult to open or close. Clean and lubricate the tracks for ease of access/operation.
- Glass pane is cracked in the kitchen above the sink.
- Window in the upstairs front right bedroom on the right side does not lock.

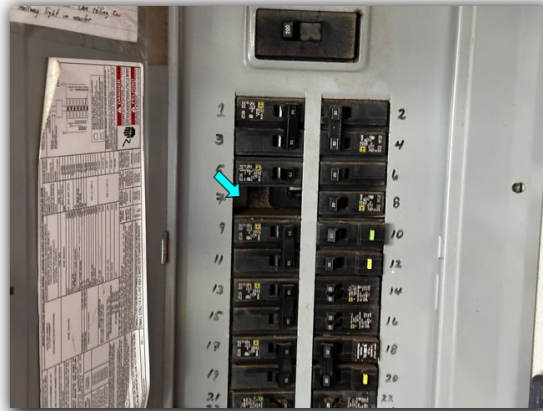
One or more breaker blanks are missing in the garage main panel. Install blanks for safety.

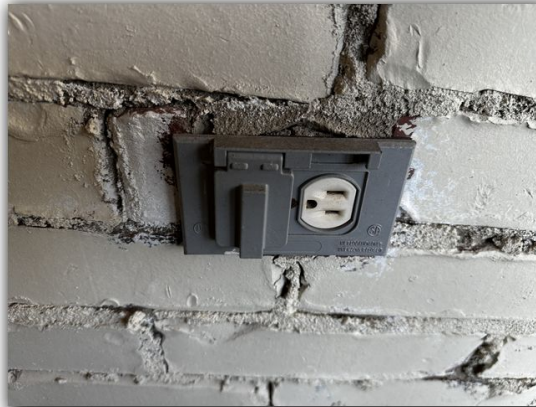
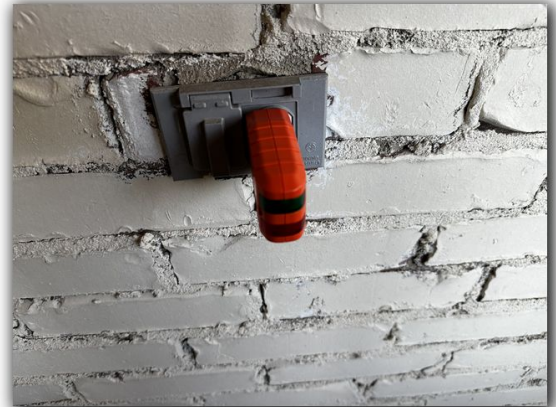
No power was observed at 2 back patio outlets, the AC condenser outlet on the right side of the home and 1 outlet in the garage all marked with orange labels.

Test indicate open grounds at 3 outlets in the dining room marked with green labels.

A weather proof outlet cover on the back patio is broken and in need of replacement.

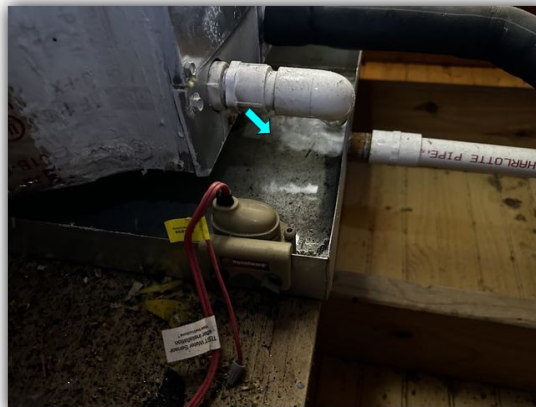
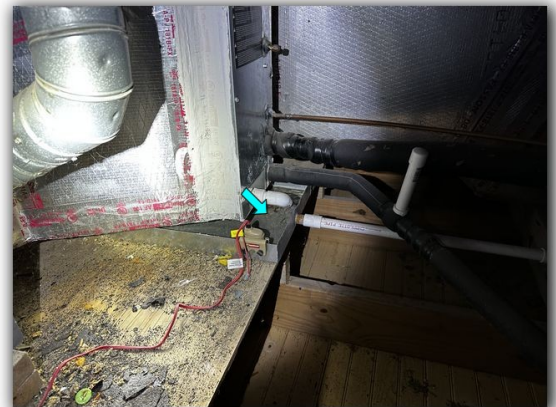
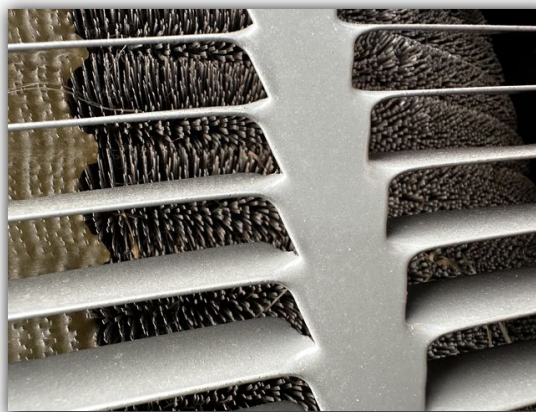
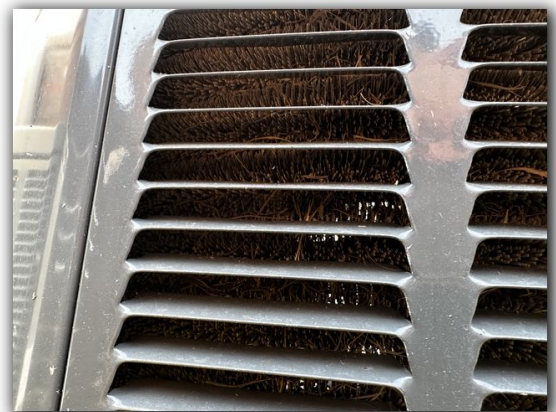
Supply Air Temp: 74 °F      Return Air Temp: 82 °F      Temp. Differential: 8 °F Deficient

- Temperature differential at the upstairs unit is not within range of 15-20 degrees Fahrenheit. Service by a Licensed HVAC contractor is recommended.
- Condenser unit coil fins are dirty on both outdoor units. Regular cleaning is recommended.
- Water was observed in the auxiliary/secondary drain pan in the middle attic. The seller was home and was going to clear the line. Confirm no water is in the overflow pan prior to closing.
- Lack of GFCI outlet/protection near the outdoor units for a service technician

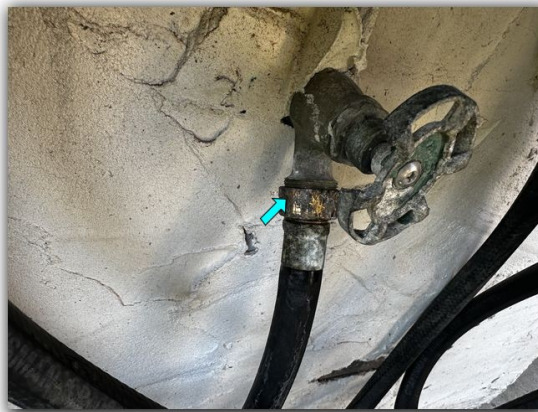
- Exterior hose bib in the back does not have back-flow prevention

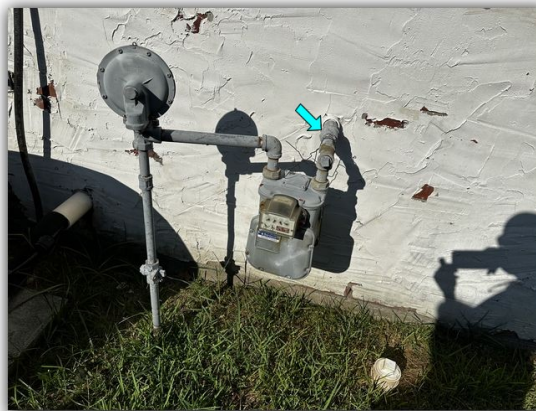
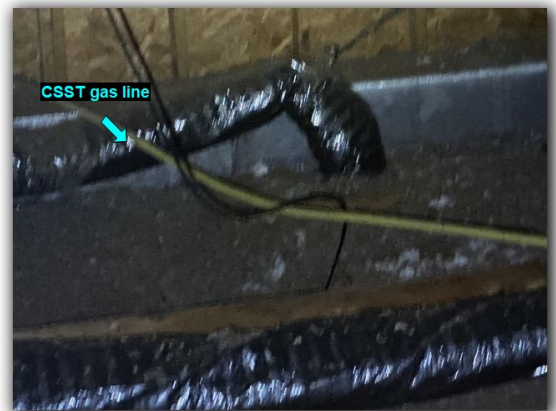
Lack of visible bonding was observed between the meter and house to the gas line. It is recommended that a Licensed Electrical contractor confirm proper bonding of the gas line to the homes electrical grounding system .
