**2328 Jackson St.
Houston 77004**

PROPERTY INSPECTION REPORT FORM

Paul Homeyer <i>Name of Client</i>	03/11/2024 <i>Date of Inspection</i>
2328 Jackson St., Houston 77004 <i>Address of Inspected Property</i>	
Ruben Santillan <i>Name of Inspector</i>	5570 <i>TREC License #</i>
<i>Name of Sponsor (if applicable)</i>	<i>TREC License #</i>

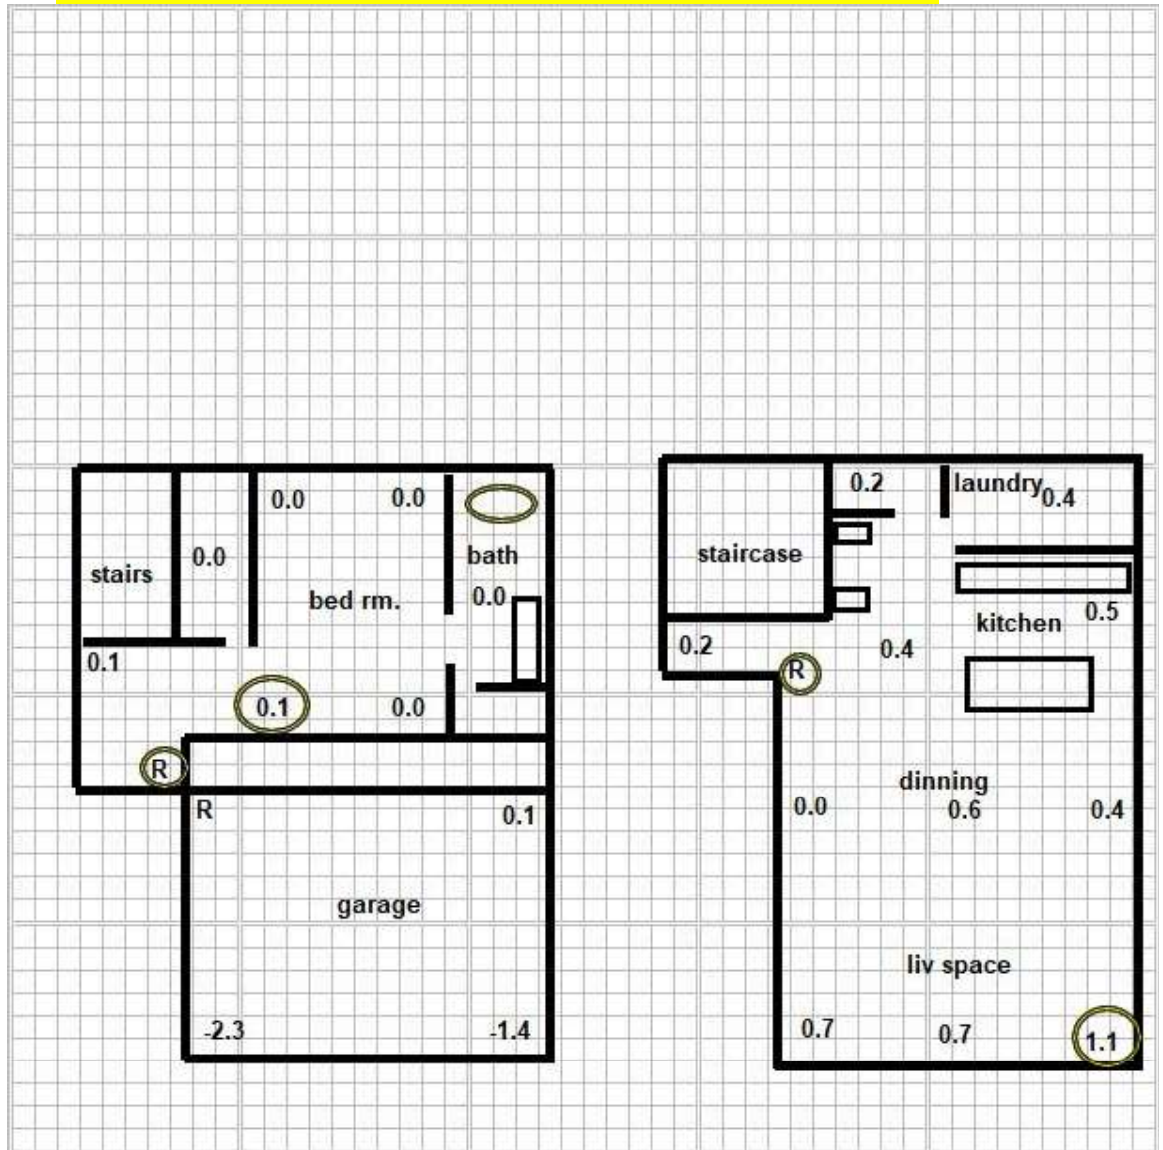
A foundation elevation survey was conducted during the inspection. The table below represents data gathered using a Zip Level or similar instrument and adjusting for floor covering height differences. i.e. differences between tile, carpet and wood flooring. Measurements are listed to the nearest .1". Measurements were taken along the respective walls listed below-North, East South, West, etc. Greatest variance was 0.1 of an inch for the 1st floor and 1.1 inch variance for the 2nd floor

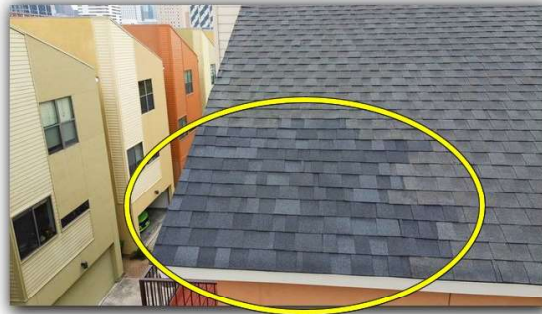
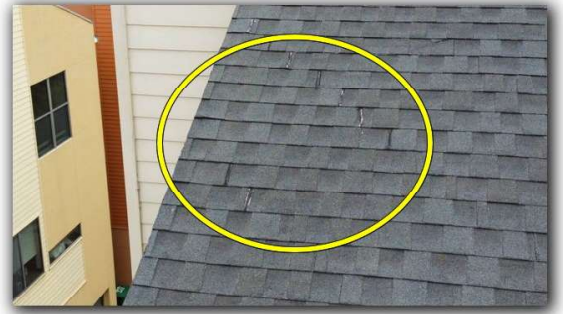
Observed spot repairs to roof surface.

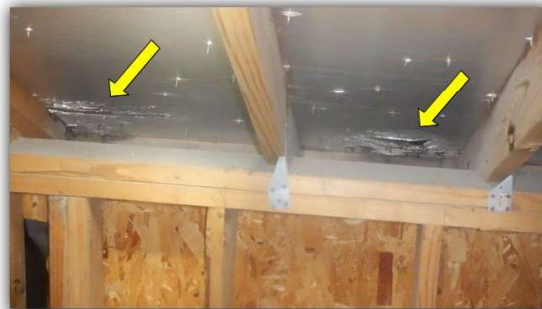
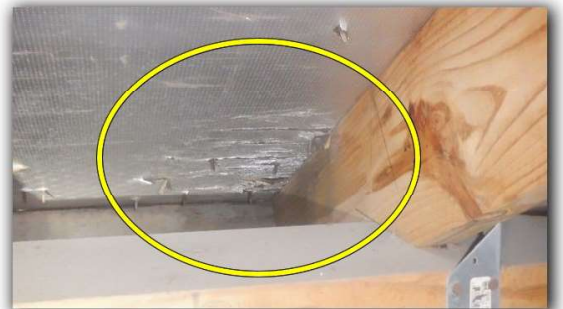
Area(s) of soft/spongy and/or rotted roof decking observed while walking on roof. (northwest, central west edge, and south center over the master bedroom)

All roofing deficiencies have been repaired

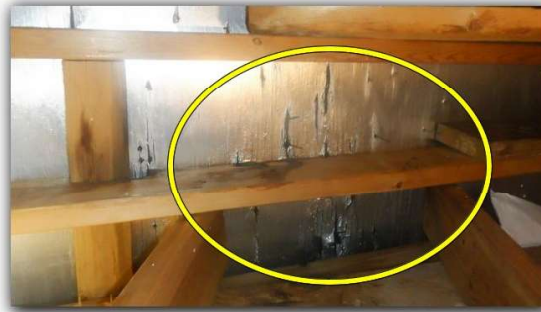
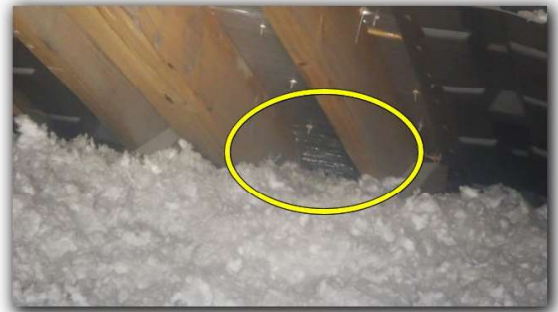
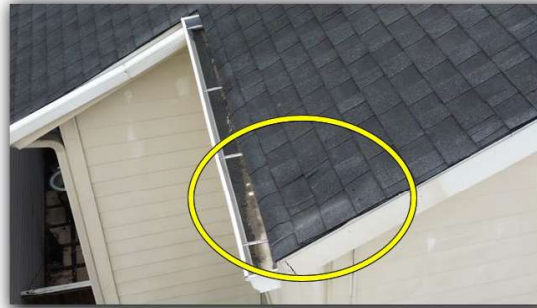
Roof water penetration observed at the following location(s): evidence of water intrusion observed at 3 different locations in the attic. See pictures above. This condition should be further evaluated by a qualified roofing company.

ALL ROOFING DEFICIENCIES HAVE BEE REPAIRED

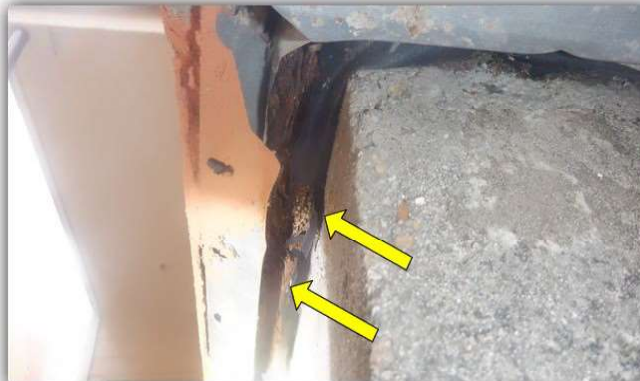
Recommend additional stucco intrusive inspection be conducted to rule out the possibility of unseen / undetected / latent / hidden water damage behind areas of the stucco exterior. Sections of the exterior appear to be traditional hard coat / cement-based stucco. A limited visual inspection by this inspector has created concerns regarding the possibility of latent damage from water penetration behind the stucco at one of more locations that can only be verified by drilling / intrusive testing. Recommend client contact our office or another third party stucco inspector of your choice prior to the expiration of any option period to conduct an intrusive stucco inspection.

THE 2328 JACKSON STREET EXTERIOR HAS BEEN CAULKED/WATERPROOFED

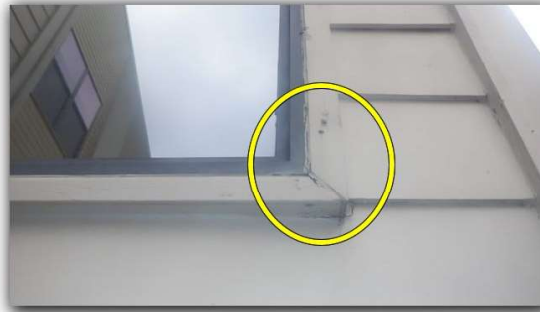
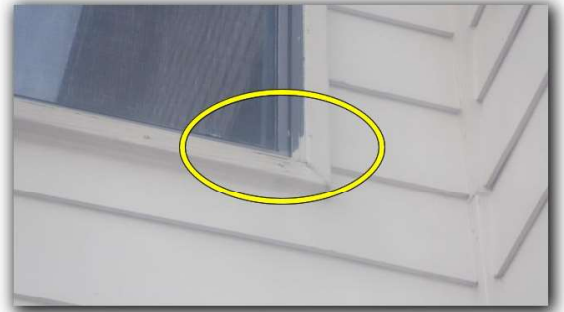
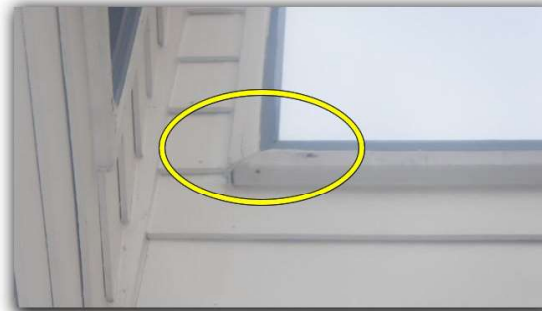
Need sealing / caulking around all holes and exterior siding penetrations on top and both sides, (leave bottom open) to prevent water entry. Including but not limited to dryer, bath and range top vents, light fixtures, etc.

Recommend general maintenance, painting, sealing, or repairing wood deterioration to help prevent possible water intrusion.

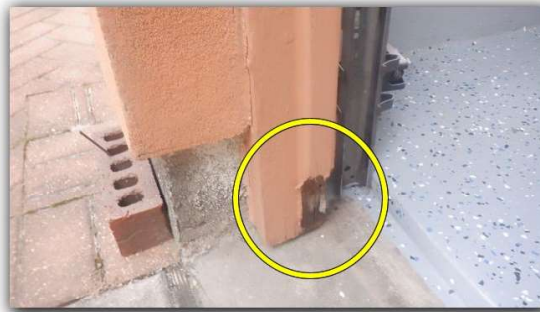
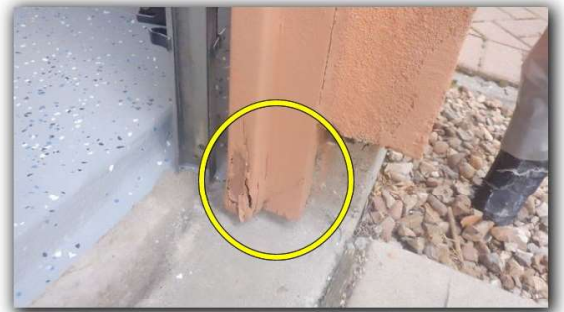
Wood rot observed on areas of house / garage. (window trim pieces, garage door trim, patio decking fascia etc)

THE WOOD ROT AREAS HAVE BEEN REPAIRED

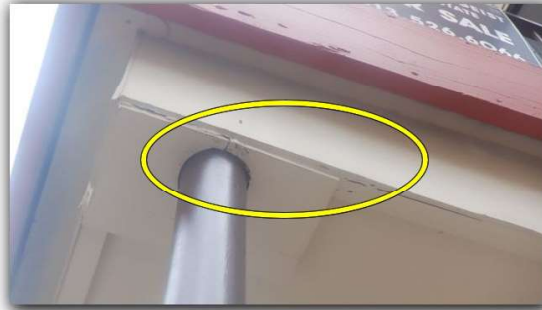
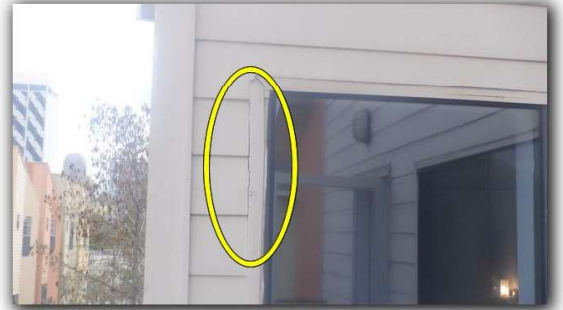
Caulking missing and/or deficient at vertical joints in siding; may allow wind driven rain entry.

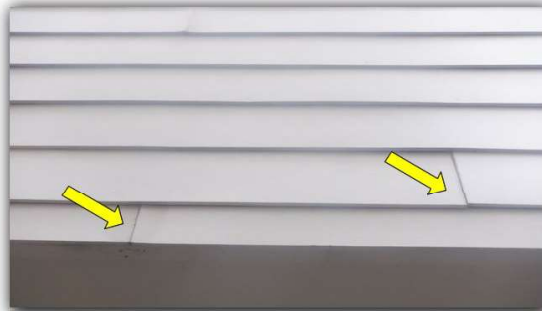
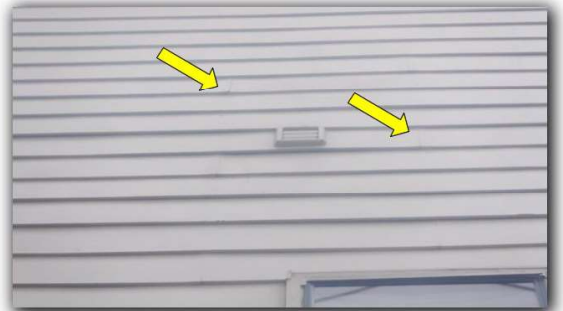
Caulking missing and/or deficient around vertical trim boards may allow wind driven rain entry.

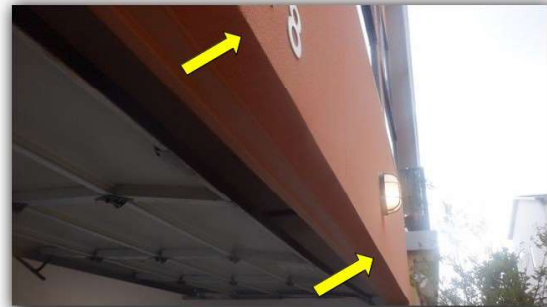
Did not observe weep screed at bottom of the stucco wall, where it intersects with the soffit. The following diagram depicts a “best practice” procedure as defined in the Texas Lathing and Plastering Contractor's Association (TLPCA) Stucco Resource Guide. This detail provide a means for moisture to exit from behind the stucco if the wall assembly leaks (we seldom see a weep screed at these locations on most stucco homes / buildings). If this exhibits a problem with moisture collecting in this area, a weep screed should be installed.

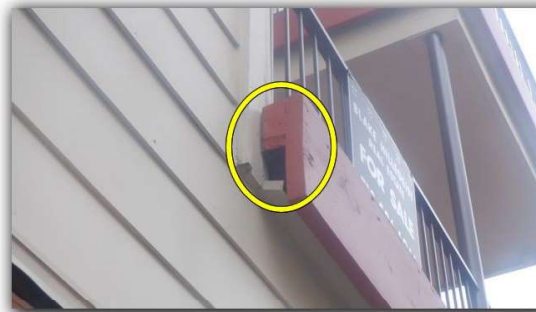
THE EXTERIOR OF THE 2328 JACSKON STREET HOME HAS BEEN CAULKED WATERPROOFED
A section of small trim at the 2nd floor patio observed to be missing.

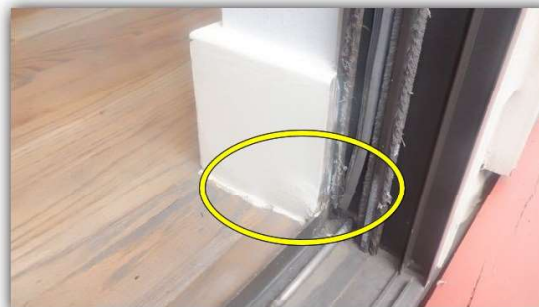
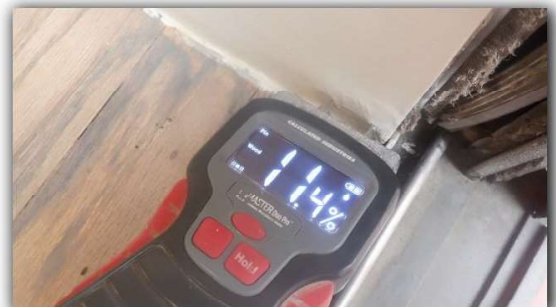
Water penetration observed at the following location(s):evidence of water penetration observed adjacent to the sliding door in the living room. Low moisture meter readings were taken at the time of this inspection.

PAST MOISTURE EVIDENCE. AREA IS DRY

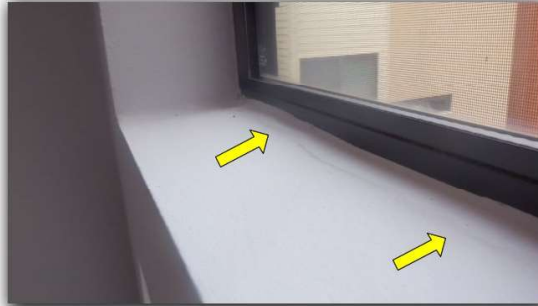
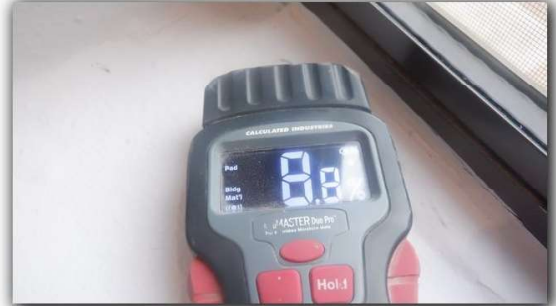
Possible water intrusion repairs observed on the staircase window between the 2nd and 3rd floor. Low moisture meter readings were taken at the time of this inspection.

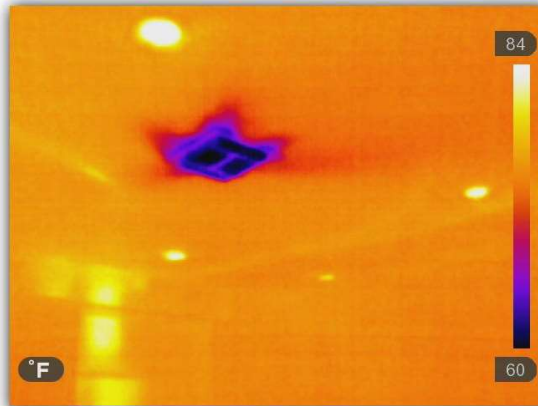
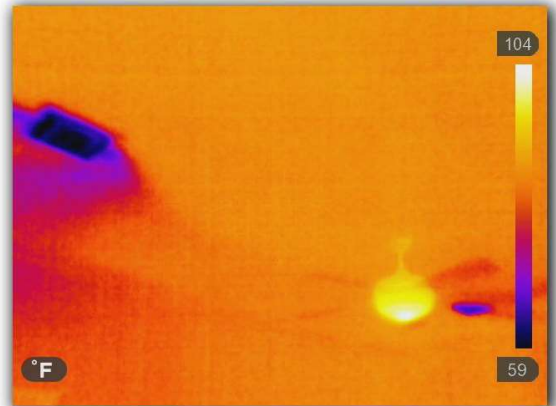
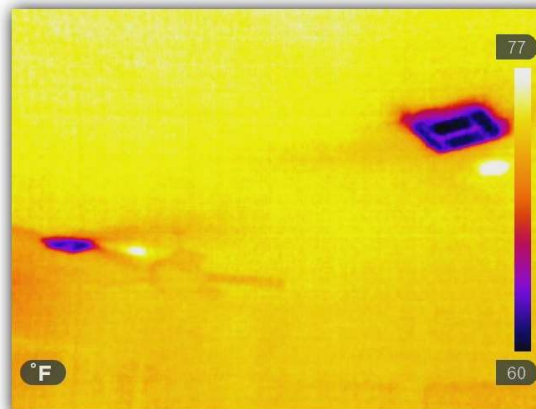
Evidence of painting and patching observed at one or more locations.

Thermal imaging of the interior was taken and no anomalies were observed.

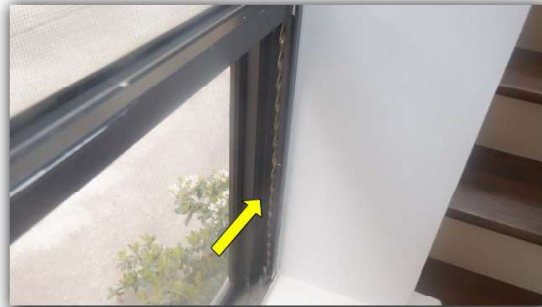
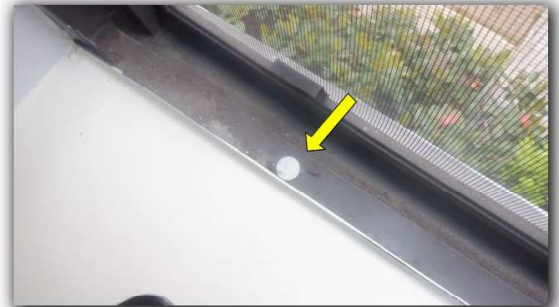
One or more window spring(s) were observed to be sprung/broken/detached. (**1st floor landing**)

Window jamb alarm sensors need to be sealed with silicone seal to prevent water entry. (1st floor landing)

WINDOW JAMB ALARM SENSORS HAVE BEEN CAULKED.

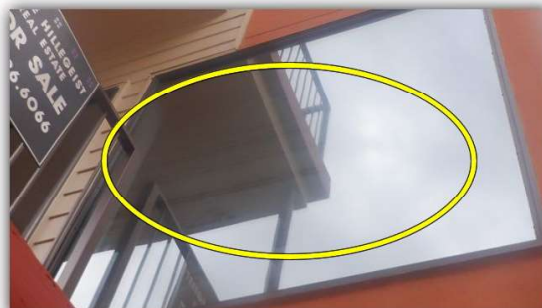
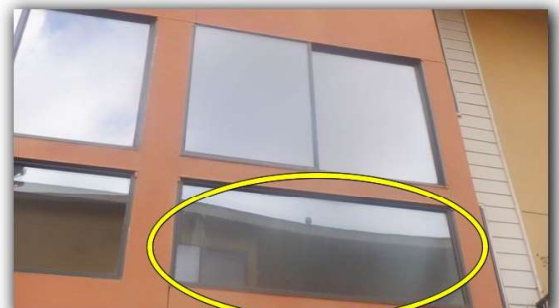
One or more of the thermal pane windows observed to have lost their seals. This has resulted in condensation and/or a fog like film to develop between the panes of glass. The thermal pane windows no longer function as designed when they loose their seals. The windows that have noticeably lost their seals are listed but may not be limited to the following: **living room 4, staircase between the 1st and 2nd floor 1, 3rd floor landing 1, master bedroom 1,**

WINDOWS ARE FOGGED

Special Notice: Signs of lost seals in the thermal pane windows may appear and disappear as temperature and humidity change. **Some windows with lost seals may not be evident at the time of this inspection.** Windows are only checked for obvious fogging. If some lost thermal pane window seals were noted, we recommend all windows be rechecked by a window specialist for further evaluation.

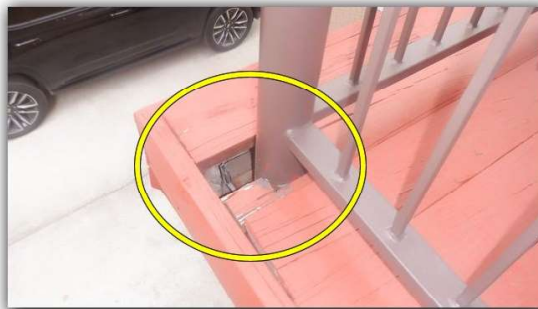
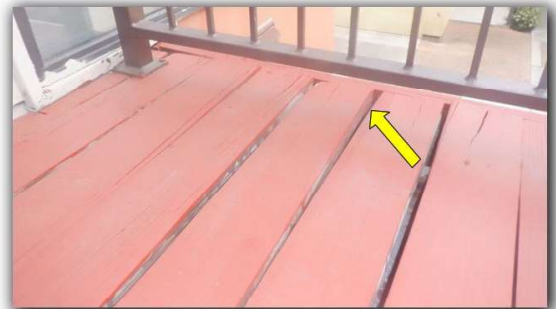
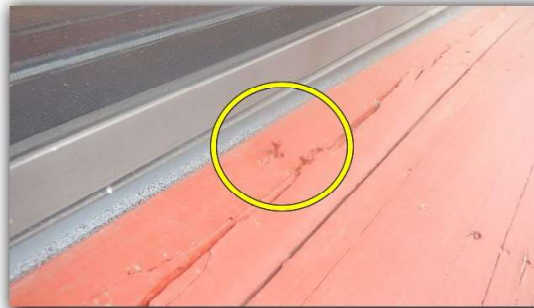
Balcony floor boards observed to be pulling loose, poor condition, and deteriorated. One or fasteners also observed to be pulling loose.

BALCONY FLOOR BOARD'S HAVE BEEN SECURED

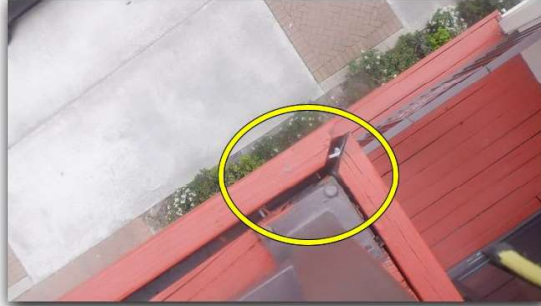
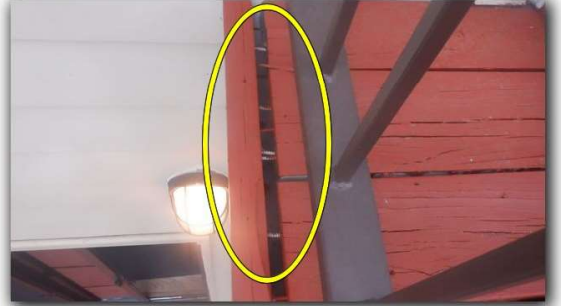
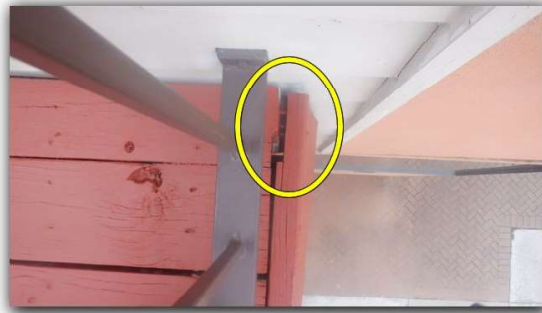
Perimeter fascia at both of the balconies observed to be in poor condition, loose and improperly fastened.

PERIMETER FASCIA BOARDS HAVE BEEN SECURED/FASTENED

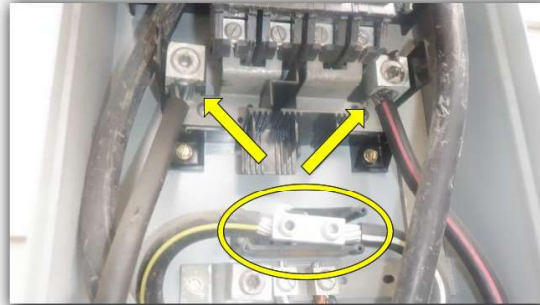
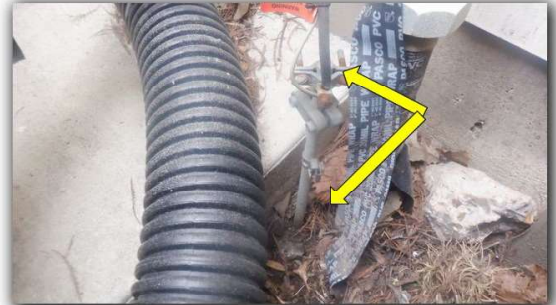
The ground electrode is not driven the proper depth into the ground. Most of the 8 foot rod should be embedded in the earth with the exception of the clamp connection at the top. The electrode was not pulled up but feels loose, may not be the required 8 feet in length. **GROUND ROD DROVE TO PROPER DEPTH INTO THE GROUND**

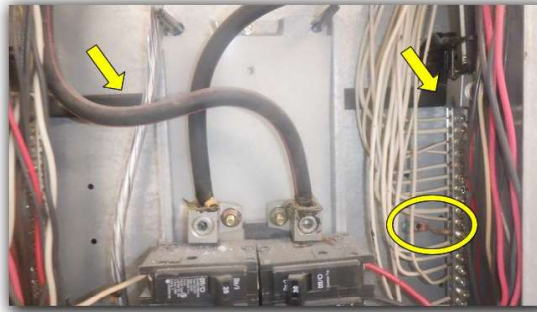
Improper connection at sub-panel, need to remove bonding jumper from ground bus bar to isolate ground from neutral.

IMPROPER CONNECTION AT SUB-PANEL CORRECTED

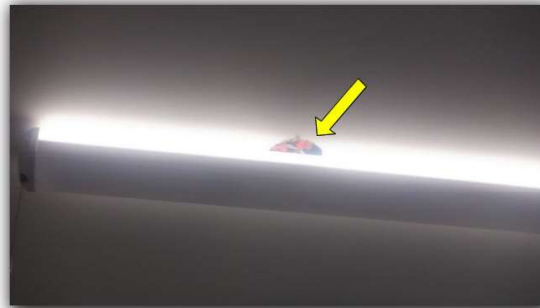
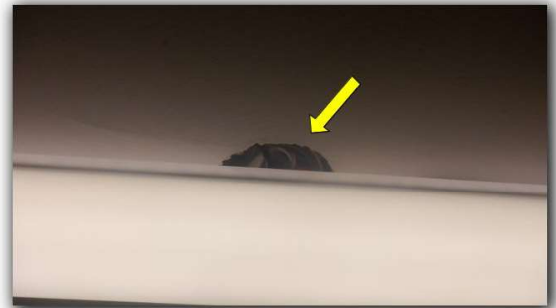
Open junctions observed on the ceiling fixtures in the garage and master closet area.

Recommend installing proper covers to prevent possible arcing or sparks from falling onto one self/ground.

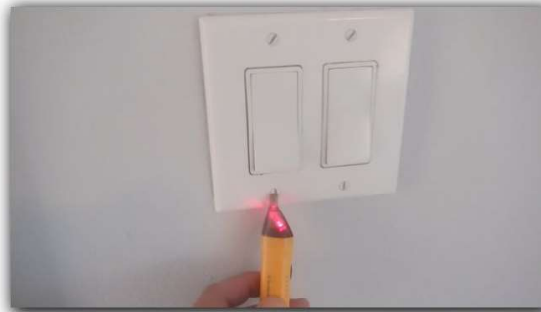
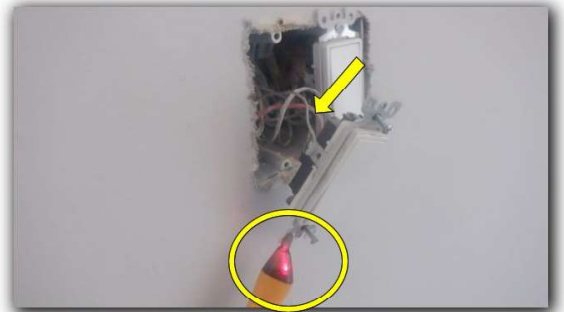
Random sampling showed switch(s) are not grounded as required by current industry standards / code; 1999 NEC 380-9(b) “Provisions for snap switch faceplates; Snap switches, including dimmer switches, shall be effectively grounded and provide a means to ground metal face-plates, whether or not a metal face-plate is installed.” Recommend grounding of all switches with ground lug.(master bedroom and 3rd floor landing only) Ground wires are connected to the switches, however a ground fault still exist. The cause and remedy should be investigated and corrected as necessary.

SWITCHES: ALL SWITCHES HAVE BEEN INSPECTED AND GROUNDED

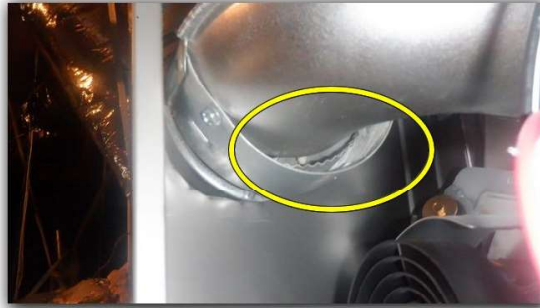
The 3rd floor unit vent is not properly connected at the vent connection inside the furnace cabinet. Fasteners observed to be missing, exposing a gap at the base. This may allow harmful gases to vent into the attic.

3rd floor vent has been properly connected

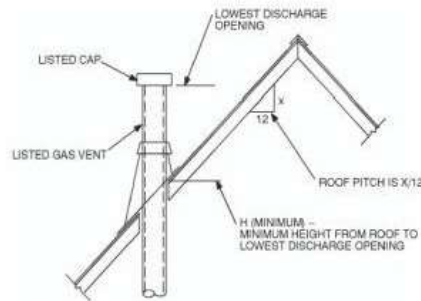
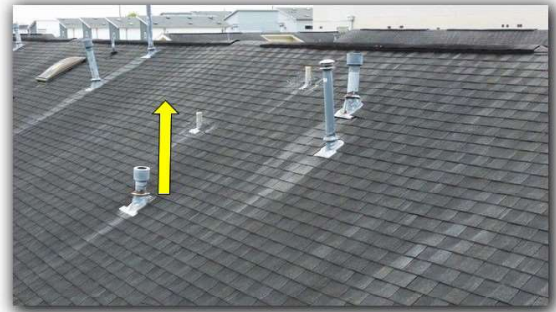
Improperly vented, does not extend high enough above roof. Vent pipe is required to extend and terminate at least 24 inches above roof line to the lowest discharge opening of the vent cap. (Ref: IRC 2004 Section 2427.6.5 Gas Vent Termination) (1st and 2nd floor unit)

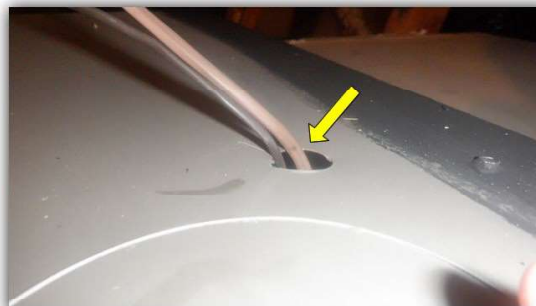
Thermostat wiring not secured to attic unit(s), missing small fitting that secures wiring to cabinet to prevent pulling loose by service personnel or homeowner.

THERMOSTAT(S): THERMOSTAT WIRING HAS BEEN SECURED TO UNIT

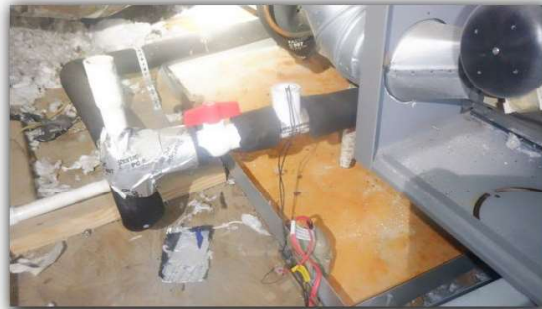
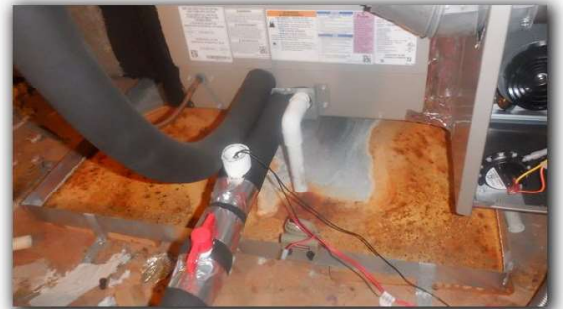
Secondary drain pan is very rusted, recommend replacement.(both units)

BOTH DRAIN PANS HAVE BEEN REPLACED

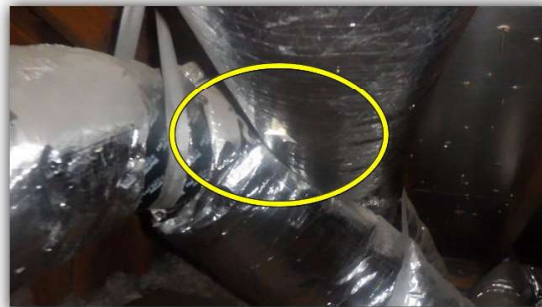
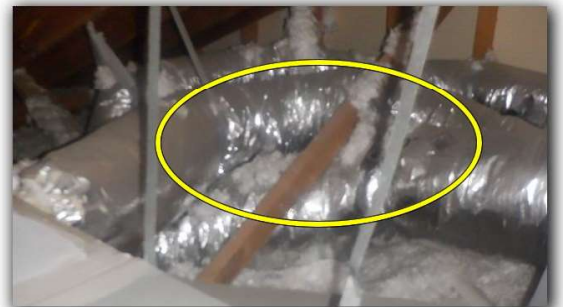
Observed several / multiple areas in attic where flex duct touch and are missing required 1" clearance from other ducts to prevent condensation between ducts that touch. Recommend general maintenance to flex ducts in attic, Re-support where needed, seal/tape minor air leaks, repair torn/damaged vapor seal, etc.

FLEX DUCT HAS BEEN INSPECTED AND DEFICIENCIES HAVE BEEN CORRECTED

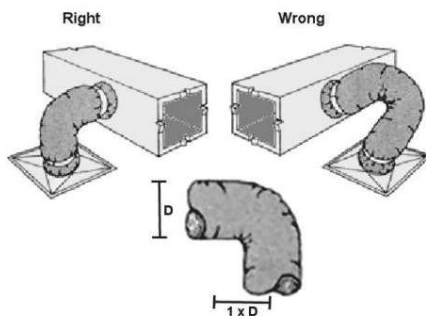
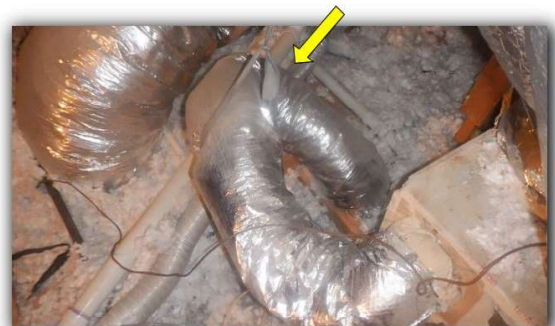
Some flex duct observed to be improperly routed with sharp bends and / or excess material in bends. Improper routing increases frictional loss in the duct and reduces heating and cooling efficiency. Radius at centerline of the bend should be no less than the diameter of the duct.

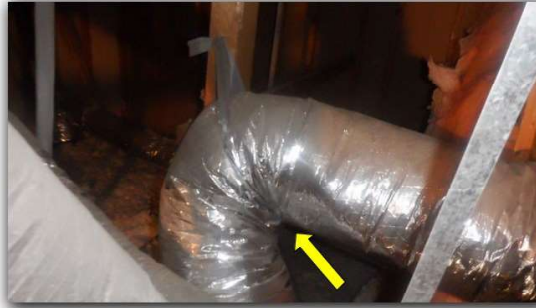
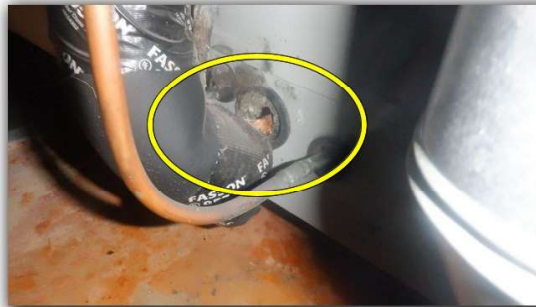
Excessive air loss at evaporator coil around drain and Freon line connections.(1st and 2nd floor unit)

ALL AC DEFICIENCIES HAVE BEEN CORRECTED

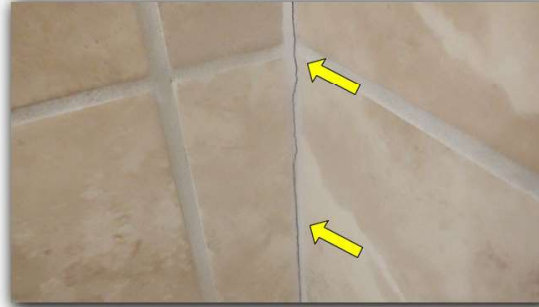
Grout / caulking needed at vertical tile corners, cracks in tile and/or mortar between tiles, and where tile meets tub to prevent water entry behind wall. (1st floor bath)

TUB/SHOWER AREA HAS BEEN CAULKED

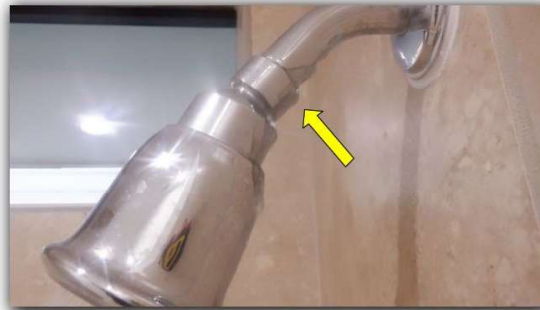
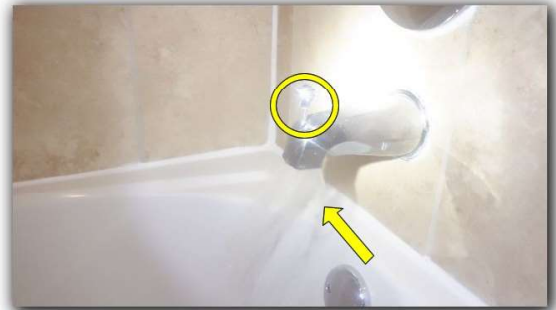
Shower diverter valve is not fully functional, does not direct all water to shower head during operation, 3rd floor back bathroom.

SHOWER DIVERTER HAS BEEN REPLACED

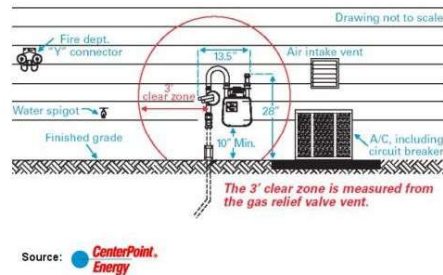
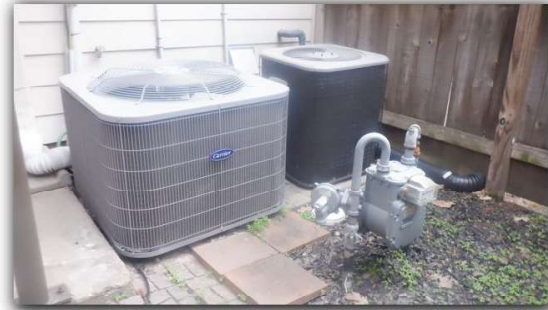
Close proximity to gas meter is potential hazard and NEC code violation.

GAS METER INSTALLED PER CITY OF HOUSTON BUILDING CODE YEAR 2006

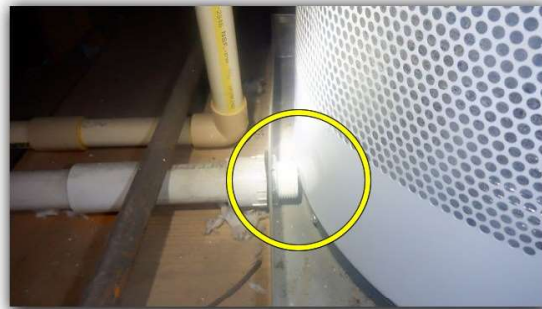
The water heater was set too close to the water heater emergency pan drain blocking the pipe opening.

WATER HEATER HAS BEEN INSPECTED BY A PLUMBER AND FOUND TO BE IN GOOD WORKING ORDER

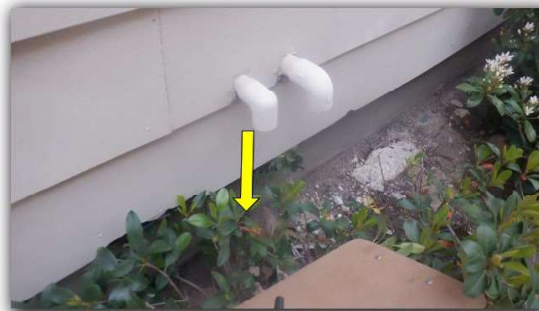
Drain line terminates improperly, current industry standards (Code) require drain line terminate within 6 inches from grade. Recognized safety hazard, repair IRC 2803.6.1.

PLUMBER HAS CHECKED T&P VALVE. VALVE FOUND TO BE IN GOOD WORKING ORDER

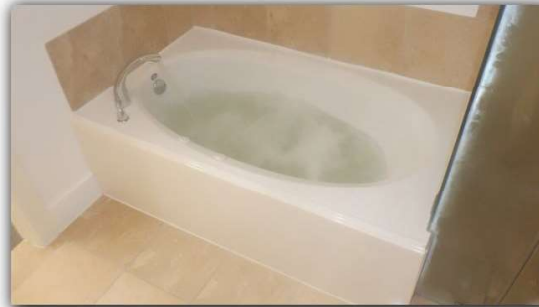
Was not able to access motor for visual inspection. Does not fully comply with National Electric Code (Reference NEC 680-72. Accessibility. "hydromassage bathtub electrical equipment shall be accessible for repair / replacement without damaging the building structure or building finish".) Should have access panel installed for servicing / access to pump motor IRC 4109.3.

ACCESS TO MOTOR FOR VISUAL INSPECTION CAN BE OBTAINED BY CUTTING FRONT PANEL CAULKED AREA

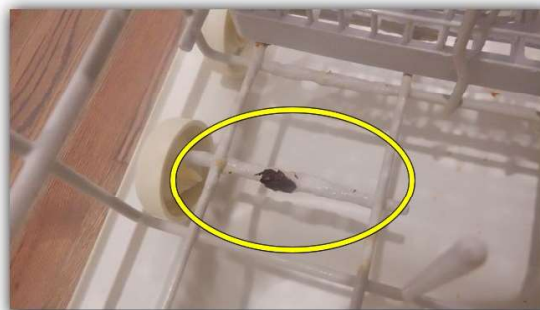
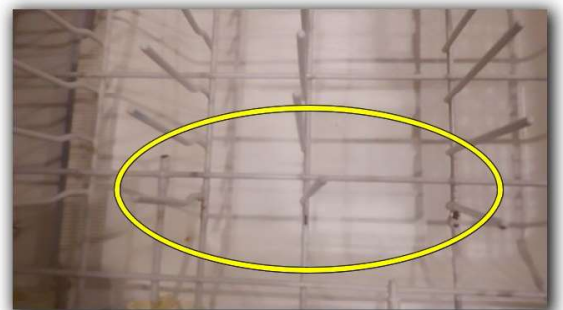
Rust observed on interior of cabinet and/or dish racks.

DISHWASHER IS WORKING AS INTENDED

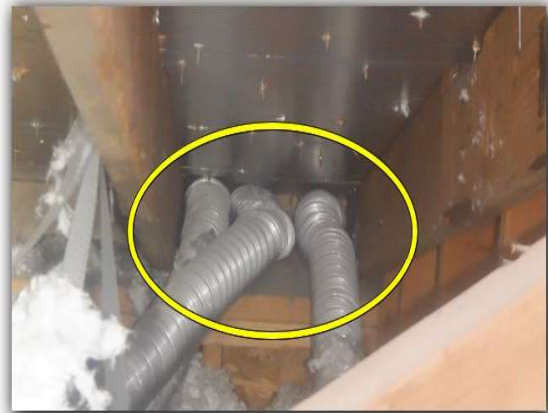
Fig. 7

Improperly vents to soffit. Should vent to exterior.

Terminating exhaust fans to soffits/eaves builds up condensation moisture within the soffit that can deteriorate the fascia board, soffit and/or plywood roof decking and cause paint peeling. A soffit/eave is part of attic air space where exterior air is drafted in to the attic space with the exhaust duct fumes and moisture.

CURRENT OWNER PREFERS NOT TO CUT HOLES IN THE HOMES ROOF. VENTING TO THE HOMES SOFFIT WAS CITY OF HOUSTON BUILDING CODE YEAR 2006.

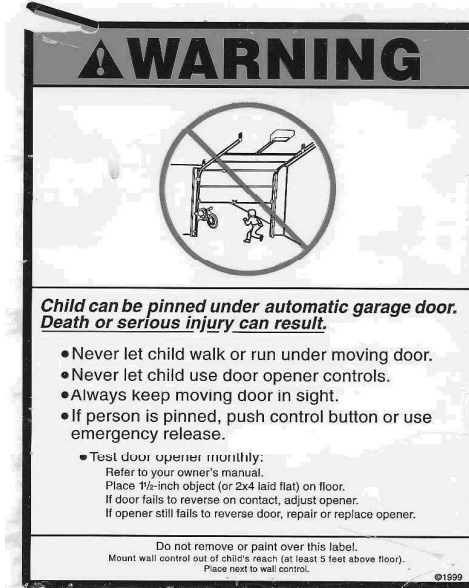
Missing required safety sticker / decal next to operator button.
