**MLC Real Estate
Inspections
& Building Consulting**
713.298.9310

Inspection report of: 14318 Splendid Oak, Cypress Texas

Performed for: Anna Weatherstone

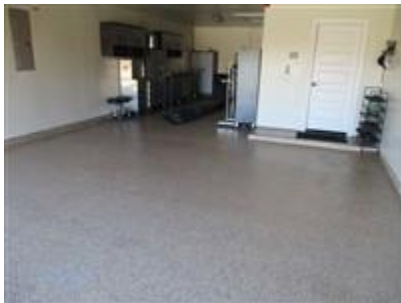
Painted garage floors tend to hide any cracking at that location. Extra care was taken to observe with no cracking found

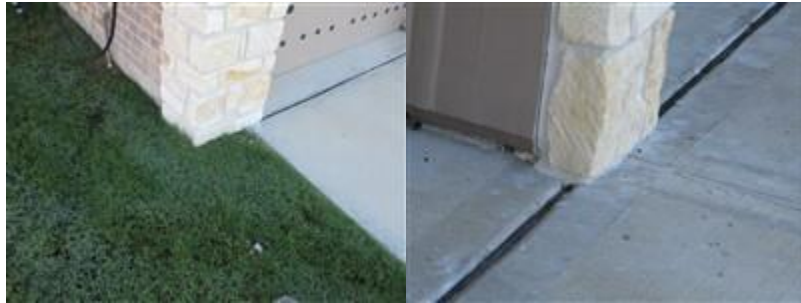
The stone wainscoting on the front of the garage hides the slab allowing for insect entry without visibility. A WDI inspector is recommended.

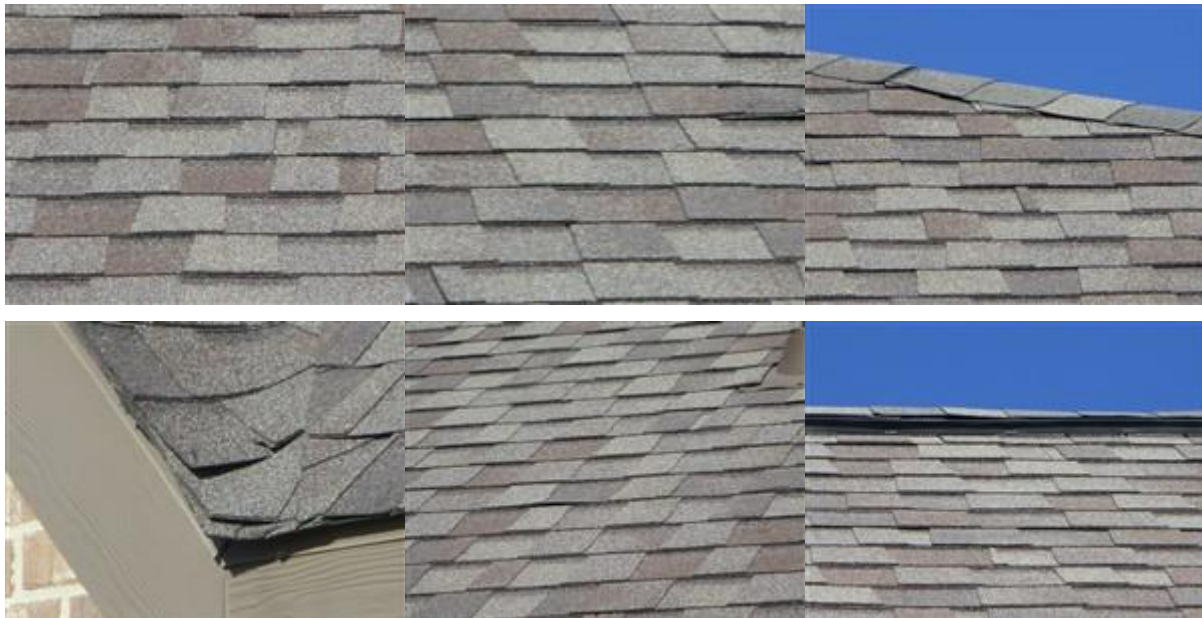
R – The roof is nearing its replacement time. The following deficiencies were observed;

- Shingle damage
- Shingle slippage
- Visible nailing
- Raised shingles – smiling shingles subject to wind event damage
- Same issues found by roofing contractor

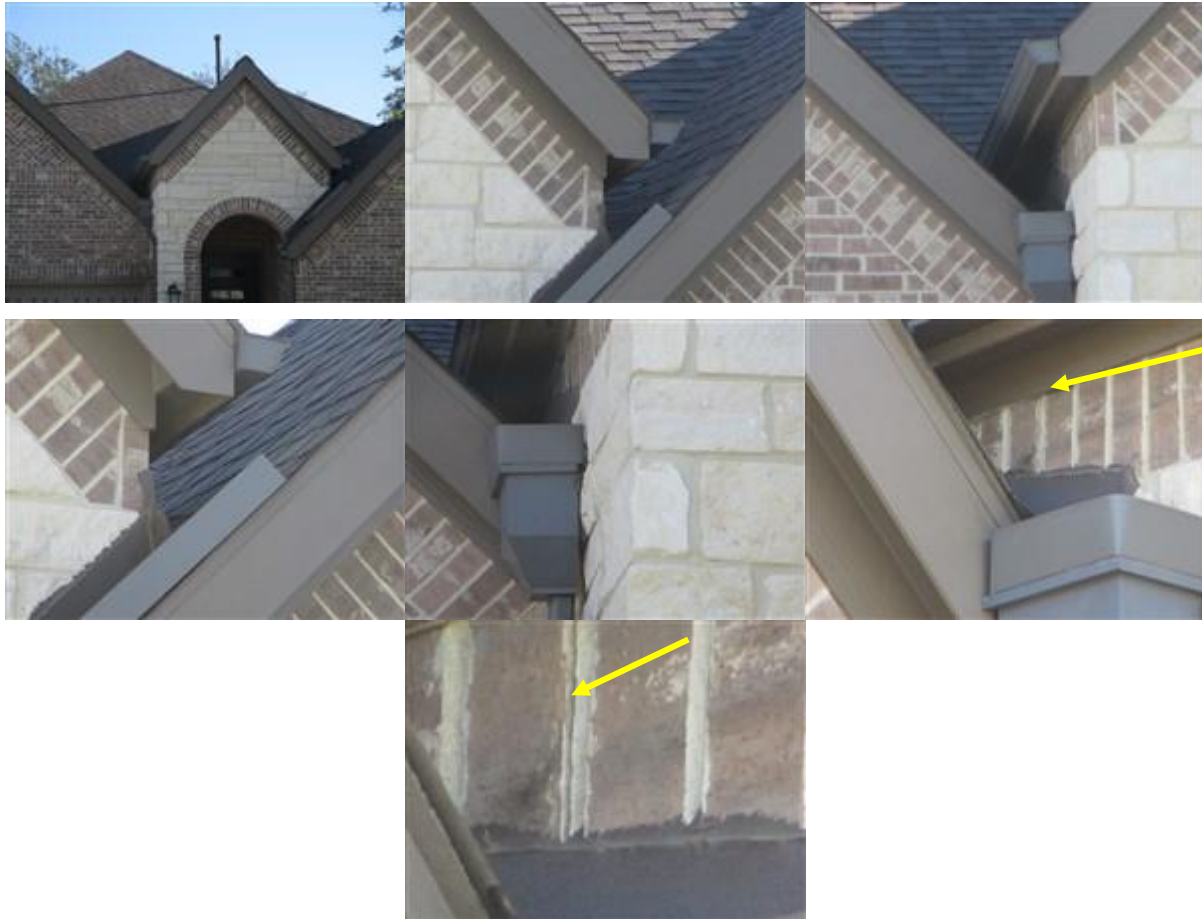
R – The front elevation features most of the water shed exiting the roof in a small area on both sides of the front entry dormer. Both valleys die into the entry side walls. These valleys should be augmented with a cricket to redirect the valley to the front brick corner of the entry dormer. This type of shingle is designed by manufacturer’s instruction to slope to the edge of the roof. Also the gutters of the entry dormer should exit with a downspout at the same front corners with the spout extended to the lower roof gutter. The additional water from the entry dormer should not be directed to the already over-burdened valley which dies into the entry wall. **Additionally on the left side the flashing installer broke the brick and mortar allowing loose brick and water entry.******

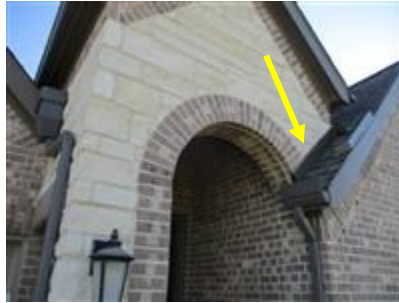
Areas where masonry is support on wood framing is not accessible and not able to be inspected for correct water and support installation.

Full gutters are recommended. Maintenance and cleaning of the gutters is recommended.

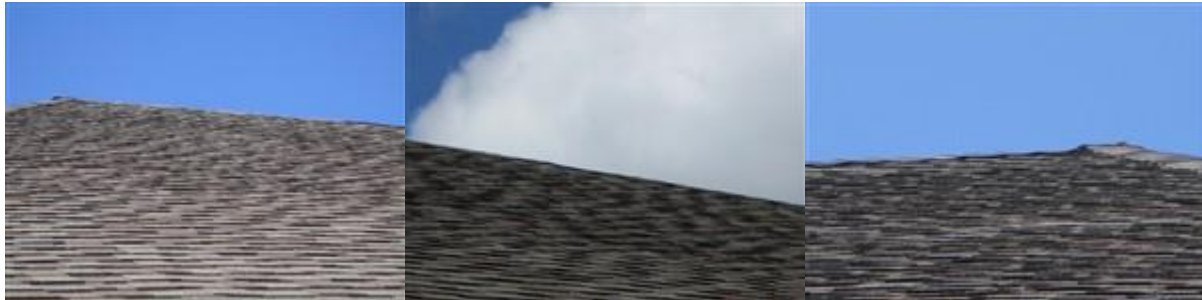
The attic framing and bracing appears adequate for this installation. The load bearing support members were not visible. With the exception of the top portion of the rear roof span which has two deflections. Near are braced and appear to be installed in this manner. Recommend monitoring these areas.

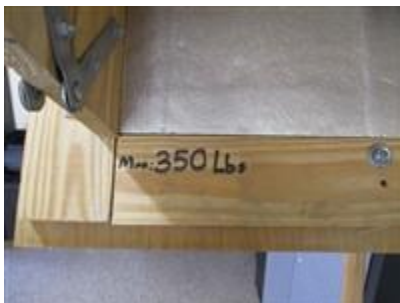
R – The attic stairs has the following deficiencies;

- Does not have a weight rating, magic marker is not adequate or recognized

- Is not fire rated for use in garage

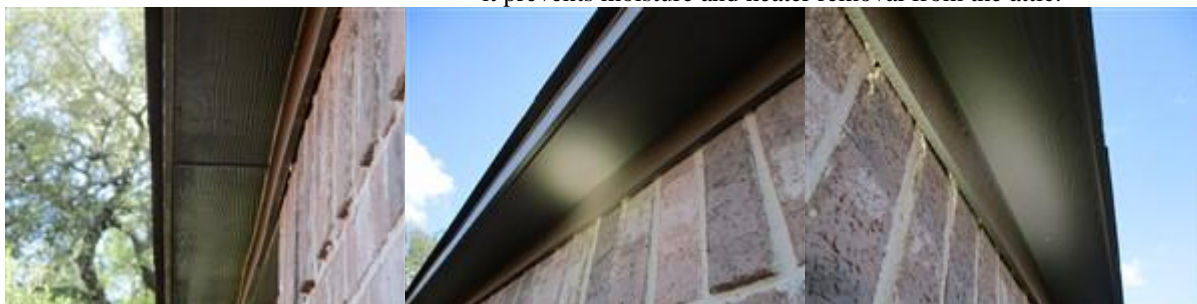
R – Venting requirements...

Most codes use the 1/300 rule for minimum residential attic ventilation recommendations. This means that for every 300 square feet of enclosed attic space, 1 square foot of ventilation is required – with half at the upper portion (exhaust vents) and half in the lower portion (intake vents). Attic venting is very important for heat and moisture removal. The present of the passive and motorized vents prevents the natural flow of air from the lower soffit vents allowing the area under the level of the passive and motorized vents to become stagnant and without air flow. IBC 1203.2 requires 1/150th of the attic area to be ventilated but there is an exception that is commonly used instead. Attic venting is very important for heat and moisture removal year ‘round. The present of the passive and ridge vents prevents the natural flow of air from the lower soffit vents allowing the area under the level of the passive/turbine and ridge vents to become stagnant and without air flow. The ideal is pictured below.

Reader be aware that the seller may be upset at the builder about this issue as it prevents moisture and heater removal from the attic.

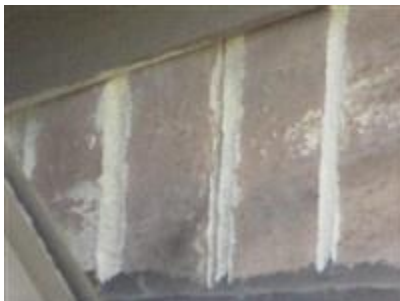
R – Loose brick and cracked mortar on left side wall of entry. See Roof Coverings****

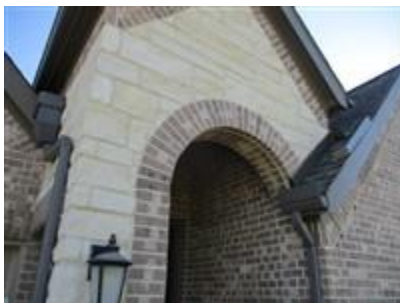
R – The front porch arch is constructed as a self supporting arch but on a flexing foundation is in need of a steel support lintel. IRC R608.8.2 Lintels

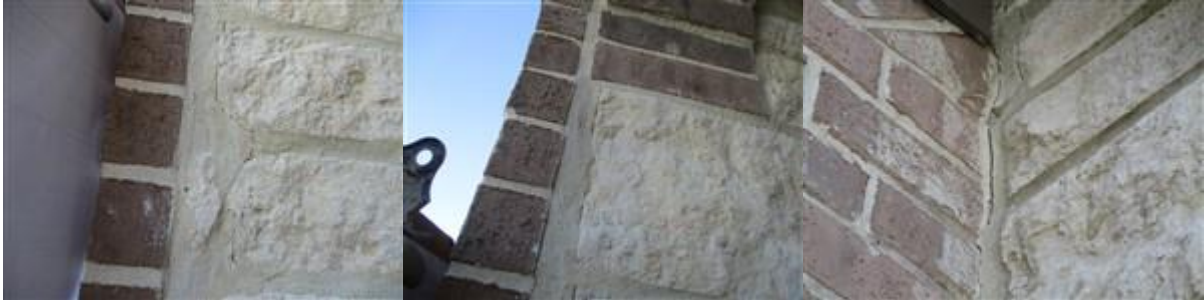
R – The mortar at the brick/stone junctions is cracked as it is too brittle to withstand the expansion/contraction there. Sealant would be appropriate here.

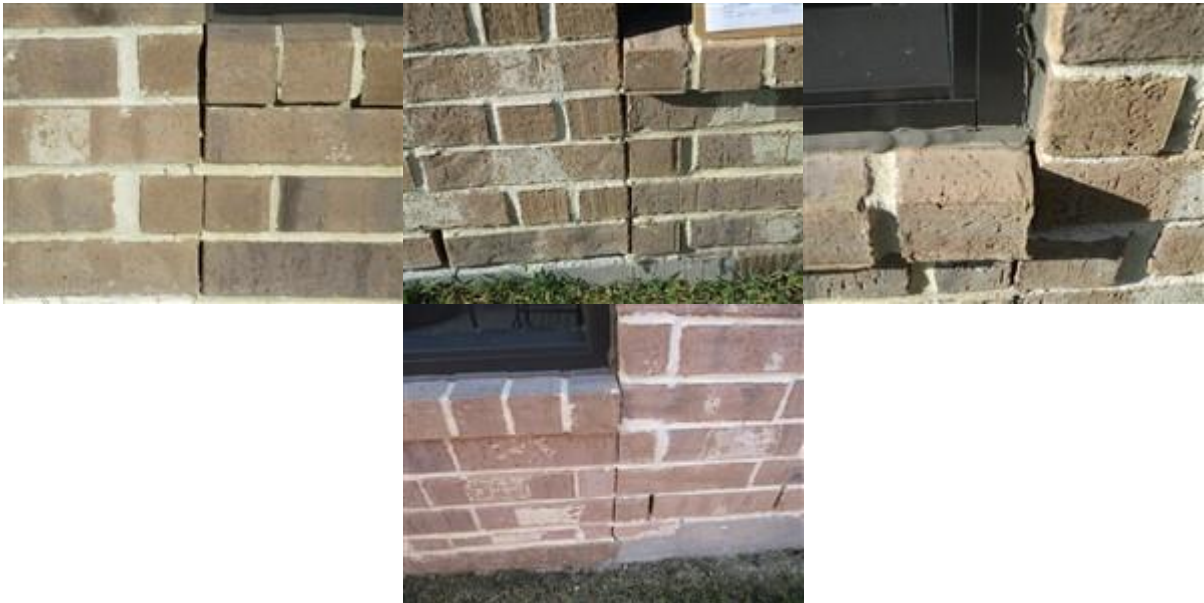
R – Seal other open expansion joints. This prevents water intrusion into the wall cavity.

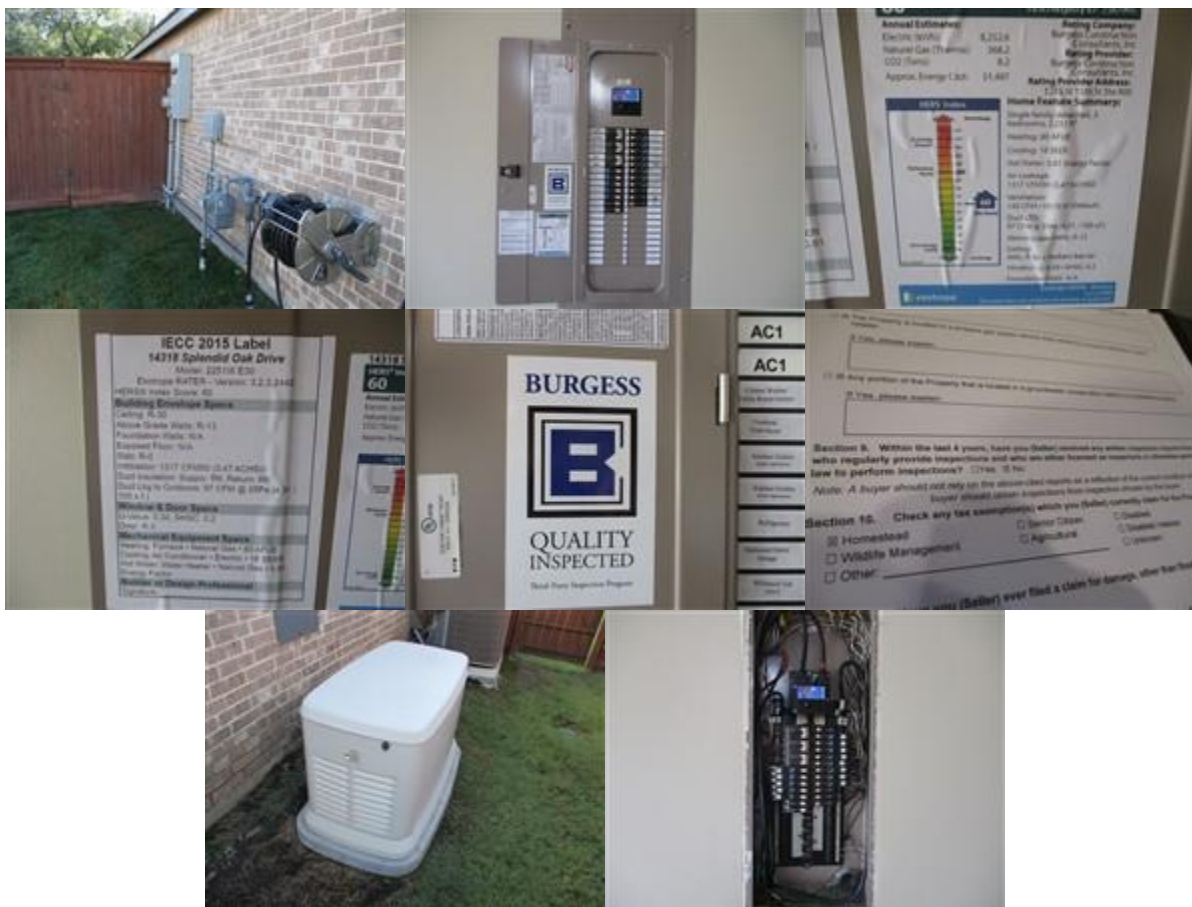
The generac system appears to have been wired to improperly replace the original panel box. This system is not within the scope of this survey. You are recommended to engage a generac installed to evaluate this system.

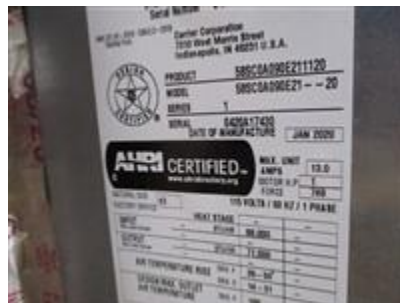
- R – The deficiencies for the heating system are;
 - System thermostat pin engaged and tstat set to 76 when room temperature at 71, system did not engage

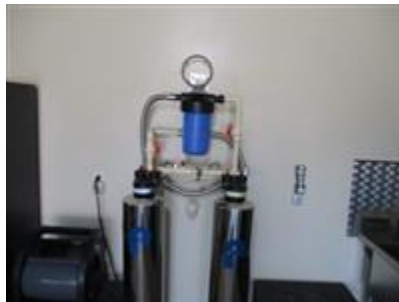
R – This water system does not have an air gap on the drain line.

Water purifiers are not within the scope of this survey. The type of connectors used tend to leak.

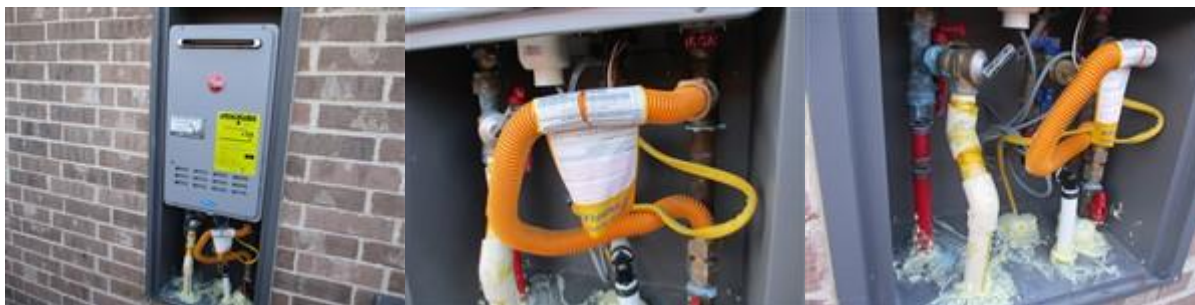
- R – The deficiencies are;
 - Removal of the cover of this outside installed unit revealed;
 - No insulation on water lines
 - No conduit on wiring
 - No bonding jumper on flex gas line
