Inspection Report

Property Address:
6823 Garnet Trail Ln
Richmond TX 77469

Golden Scope Inspection, LLC

PROPERTY INSPECTION REPORT FORM

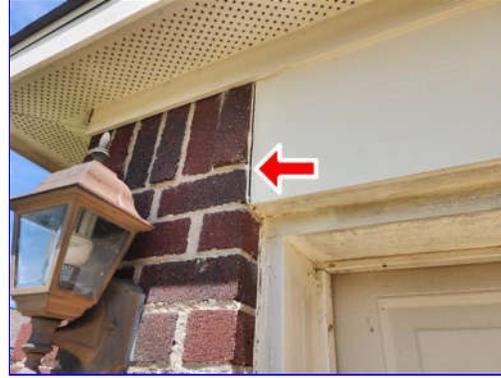
A. Item 1(Picture)

(2) Minor foundation movement were observed. In my opinion these conditions do not represent a failure of the foundation at this time. If concerned with this condition, consultation with a structural engineer or foundation specialist is advisable before purchasing the home, regarding both its current condition, and the best measures to prevent further movement in the future. Some notable indications of foundation movement observed are garage door frames separating at the brick veneer and trims separating or showing movement.

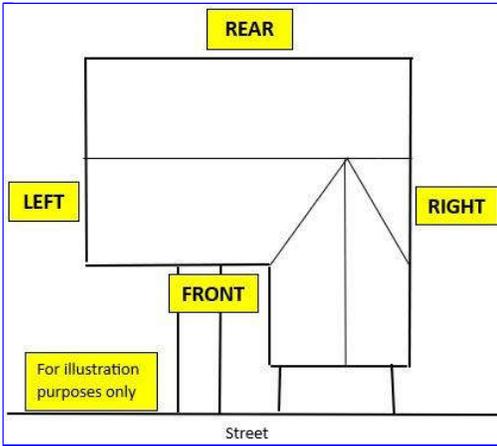
A. Item 3(Picture)

Based on the floor measurements taken, it is my opinion the slab was **reasonably level** at time of the inspection. The foundation level measurements indicated a variance of **+ 0.6" / - 0.3"**. The benchmark was taken at the center of the home. Floor covering is **vinyl/laminate** or similar material. Concrete Slab foundations most often reveal some unevenness due to workmanship at the time of construction. Therefore, these measurements do not necessarily represent the actual degree of deflection from differential movement of the foundation. Although deviations/slopes in the foundation can assist the inspector in evaluating the foundation performance as to the direction and degree of possible movement, these deviations/slopes is not, by themselves, a measurement of foundation movement. Golden Scope Inspectors are not structural engineers and are not acting as a structural engineer. All statements relating to structural movement are based on the professional opinion of this company. The elevation data are used for information purposes only and should not be used for serious negotiations.

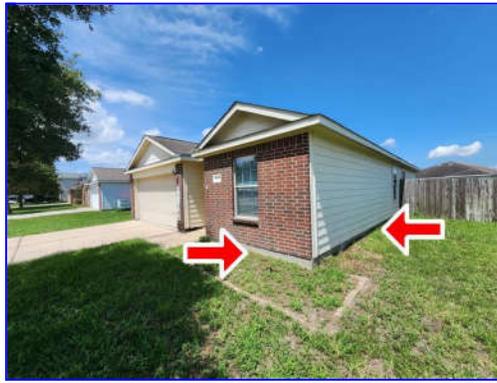
B. Item 1(Picture)

(1) General grade improvements are needed to prevent ponding/standing water. Proper drainage is needed to help prevent water from standing and/or ponding next to the foundation. Corrective measures may be needed if the water stands within 10-feet of the foundation for more than 24-hours. Grading improvements are needed to direct run off water away from the structure. Any area where the ground or grade does not slope away from the structure is to be considered an area of improper drainage. The recommended slope away from the foundation is 6 inches per 10 feet.

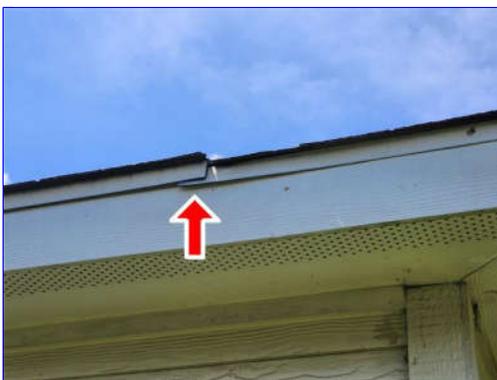
C. Item 31(Picture) Right side

(7) Drip edge flashing along the roof edge was observed to be missing, damaged or installed improperly. Drip edge flashing is needed to support roofing at the roof edge and to protect the roof decking from moisture. A qualified, verified roofing contractor should be consulted regarding this condition or any repairs that may be needed.

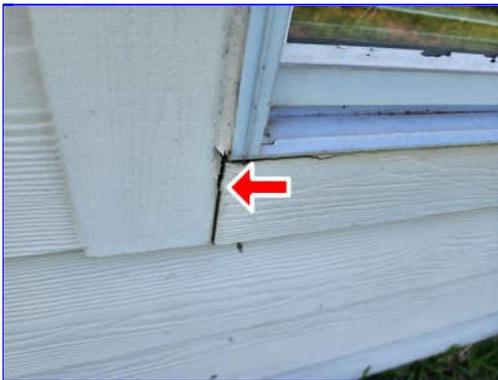
E. Item 13(Picture)

(3) The siding and/or trim was/were observed to have the following defect(s): in poor condition, loose or broken. This condition could lead to moisture intrusion into the home.

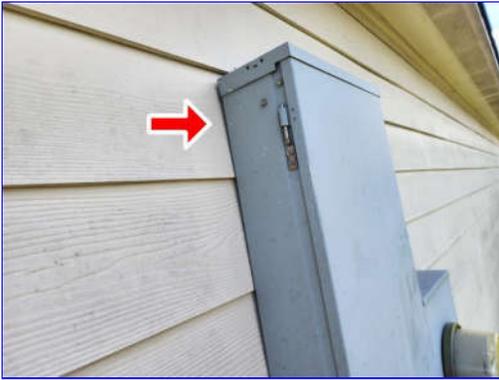
E. Item 23(Picture)

(4) Caulking should be installed at the top and sides of the enclosure. The bottom should not be caulked.

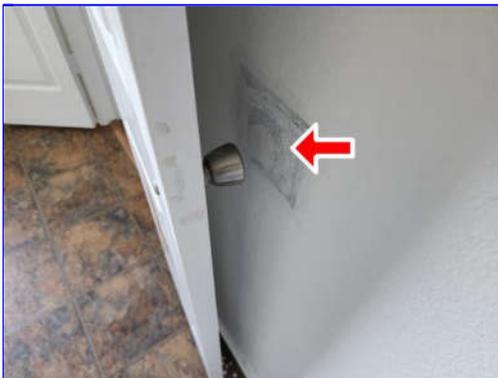
E. Item 28(Picture) Left bedroom

(6) Evidence of repairs/previous damage were observed. The repair should be improved by qualified professional.

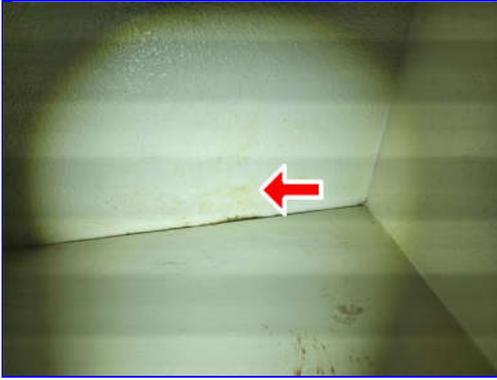
E. Item 30(Picture) Hall bathroom sink

(7) An organic biological substance was/were observed to be present on walls, ceiling or other surfaces. We did not inspect, test or determine if this growth is or is not a health hazard. The underlying cause is moisture or dampness. I recommend you contact a licensed mold inspector for investigation or correction if needed. This is a potential safety hazard and should be investigated further.

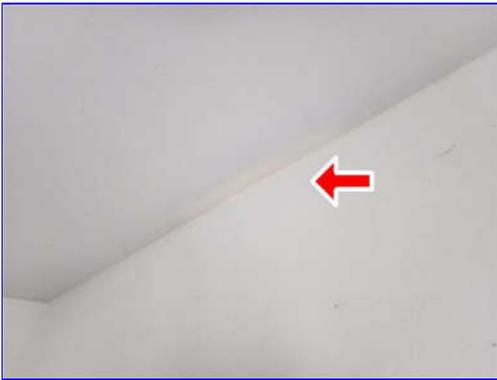
F. Item 1(Picture) Right bedroom

(2) Evidence of repairs/previous damage were observed. No evidence of excessive moisture was observed (confirmed when tested with a moisture meter). The cause of this condition was not determined. If sheetrock and insulation were affected by moisture, it should be removed, replaced and preventive measures for microbial hazards should be undertaken by a qualified, verified, licensed professional. The structural components related to this condition are not accessible to inspect for quality of installation, or possible component failure. This leave some degree of uncertainty regarding the condition. The buyer should obtain any and all information available regarding this condition prior to closing.

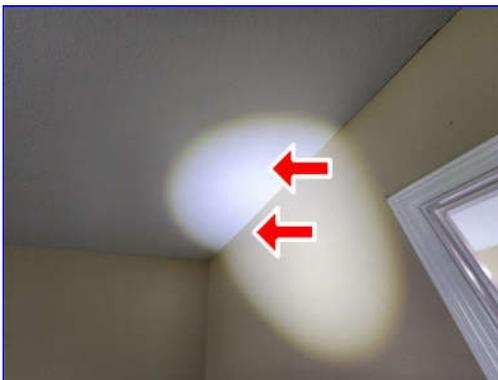
F. Item 4(Picture) Master bedroom

(4) Evidence of moisture intrusion was observed at the ceiling. No evidence of excessive moisture was observed (confirmed when tested with a moisture meter). Sheetrock and insulation were affected by moisture should be removed, replaced. Preventive measures for microbial hazards should be further evaluated or undertaken by a qualified, verified, licensed professional. The buyer should obtain any and all information available regarding this condition prior to closing.

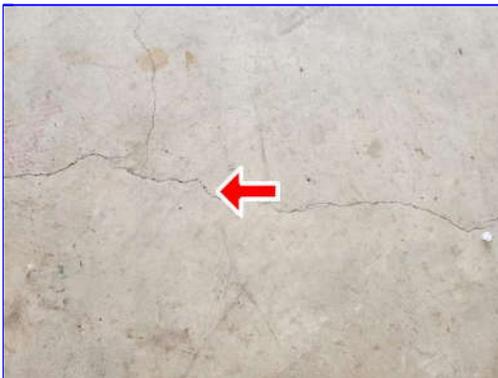
F. Item 9(Picture)

(6) There were cracks in the garage floor. This is typical of concrete and is not considered significant. it should be monitor for large separations or differential movement.

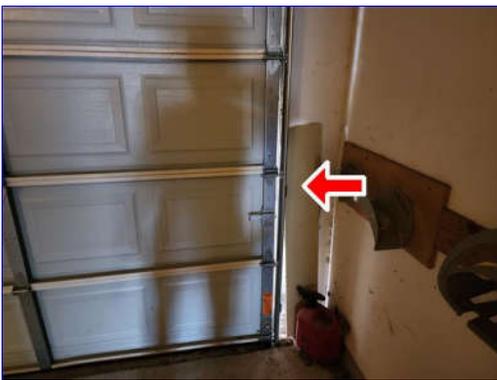
G. Item 3(Picture)

(3) The garage door(s) was/were observed to have the following defect(s): does not close tight at opening. Repair or replacement is needed.

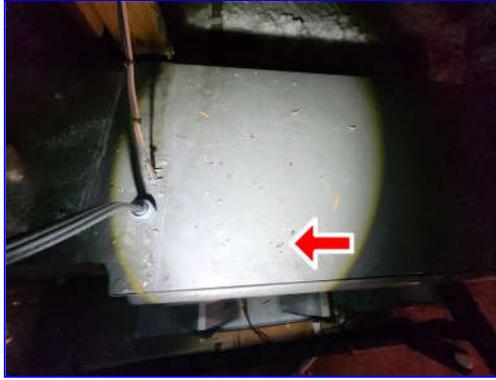
L. Item 25(Picture)

(4) There is evidence of possible vermin activity in the attic. A qualified, verified, licensed pest control specialist should be consulted regarding this condition and remediation.

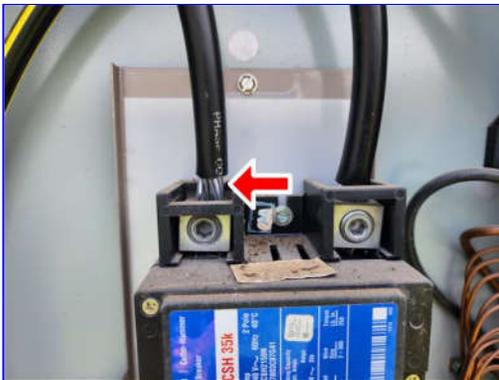
A. Item 5(Picture)

(3) The aluminum feeder wires are not coated with anti-oxidant paste to prevent corrosion.

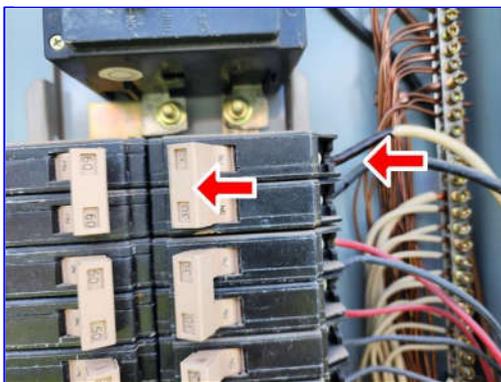
A. Item 6(Picture)

(4) Improper wire size (40 amp) for breaker (30 amp) it services was observed in the main panel.

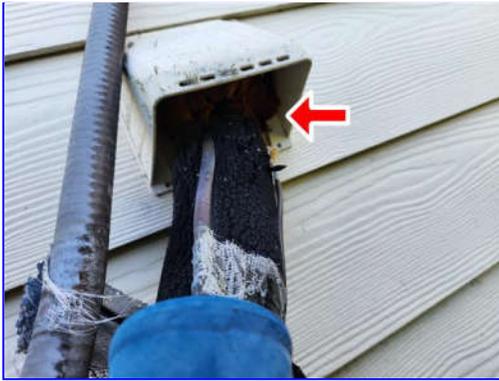
B. Item 11(Picture)

(5) The refrigerant hood is in need of caulking improvements to prevent moisture or insect/vermin entry

points. The top and sides should be caulked, as well as any opening sealed, but the bottom should not be caulked to allow any trapped moisture to escape.

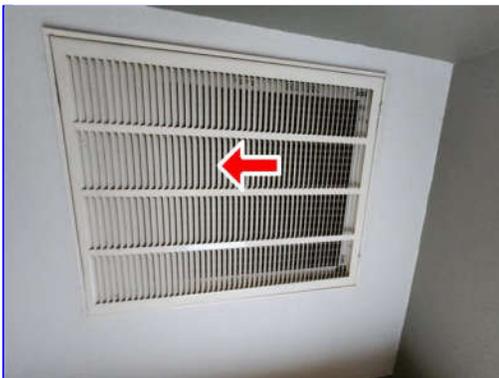
C. Item 1(Picture)

(2) The filter(s) was/were observed to be dirty and should be replaced. Inspector recommends replacing filters according to the manufacturers instructions, typically once monthly for disposable filters and every 6 months for media filter, to ensure the health of the HVAC system. Manufacturer instructions on the unit and filter should be followed.

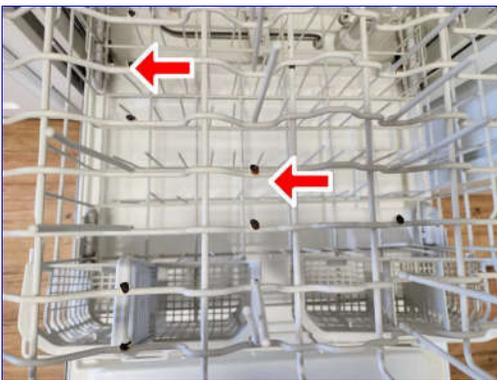
A. Item 5(Picture)

(2) Rust was observed on the dish racks. This may damage fragile dishes.

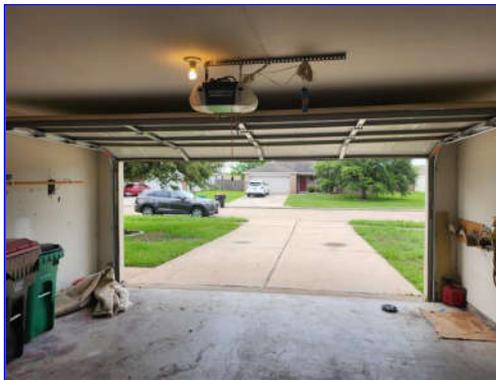
G. Item 2(Picture)

- (2) Garage door sensors were observed to be improperly installed. Garage door sensors should be below 6" of the garage floor. As always with appliances, manufacturer instructions should be followed.
