**Andrew Martinez**  
**726 McDaniel Street**  
**Houston, TX 77022**

**April 2, 2024**

# PROPERTY INSPECTION REPORT FORM

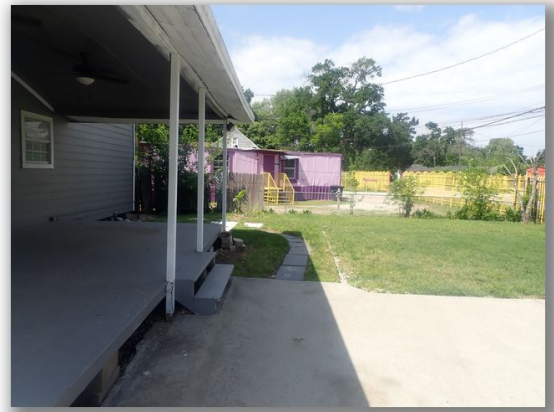
**Gutter & Downspout System**

**Note:** There are no gutters installed at the time of inspection.

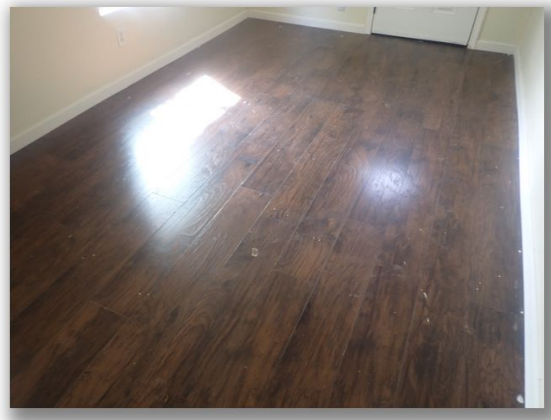
**Floors**

- The floors were observed to be out-of-level in some areas of the house.
- The floor covering is worn and/or damaged in one or more locations of the home.

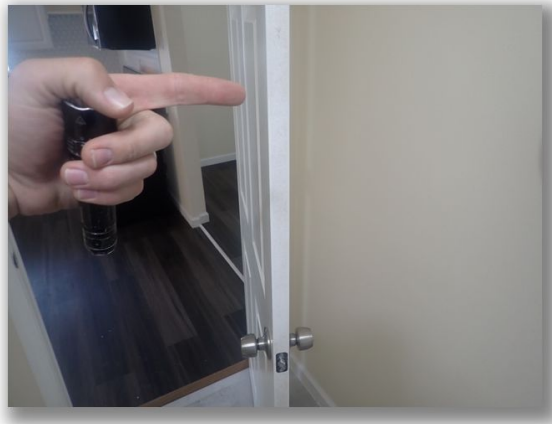
**Exterior Doors**

- Surface damage was observed to the door in the unit A front entry door.
- The door frame is damaged to the unit A front entry door, unit B front entry door.
- Weather-stripping improvements are recommended for the unit A front entry exterior door(s).
- The front entry door rubs the floor in unit A.
- Visible evidence of previous water intrusion was observed at and/or around the exterior unit C front entry door(s). The cause and remedy should be investigated and corrected as necessary.

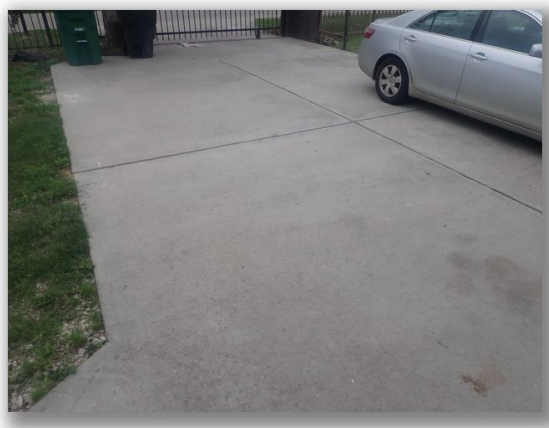
**Driveway**

- Minor cracks and/or deficiencies were observed in the driveway.

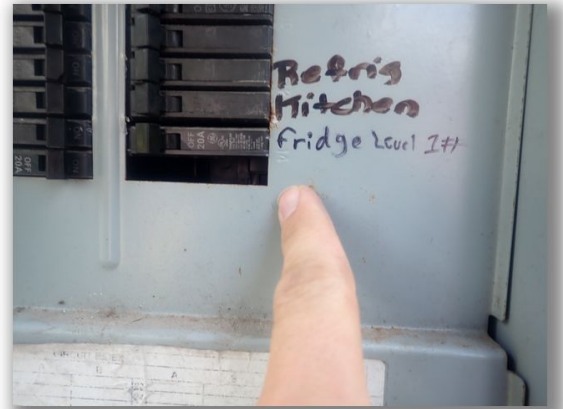
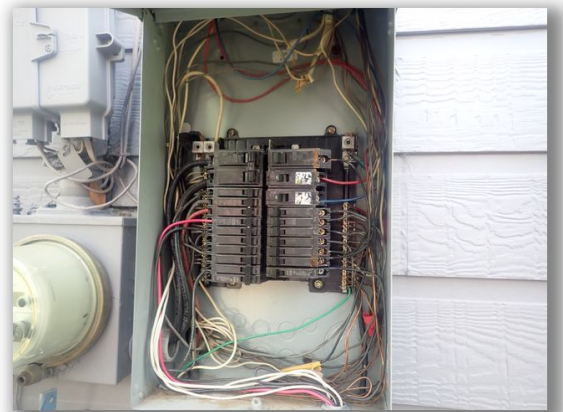
- The breakers (overcurrent devices) in the electrical panel are not properly labeled.
- There is no surge protection device installed at the panel box. Under the current National Electrical Code, all electrical systems should have surge protection. This is an "as built" condition. It is recommended to add a surge protection device to the panel box.
- There is no ground fault circuit interrupter type breaker for the dryer outlet installed at the panel box. This does not meet current building standards.
- All openings (missing knockouts) in the electrical cabinet cover plate (dead front) and /or cabinet should have fillers.
- Some of the electrical cabinet interior components were observed to have some rust and/or corrosion on them. This condition should be further evaluated and corrected as necessary.

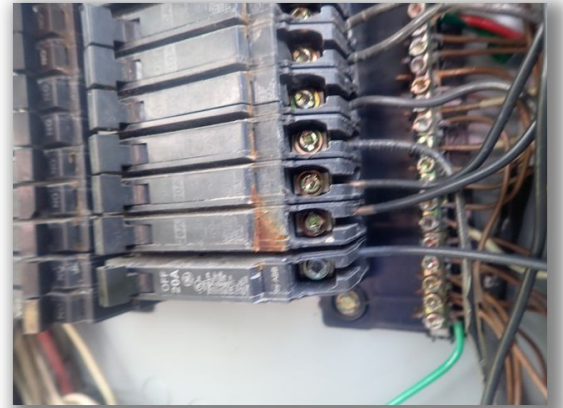
**Arc-Fault Circuit Interrupter Protection (AFCI)**

- None of the required dwelling unit devices, receptacle and lighting outlets (switches, receptacles and fixtures) are connected to an arc-fault circuit-interrupter (AFCI) circuit device. AFCI devices were first required under the 1999 National Electrical Code and under the 2014 NEC, all living space, kitchen and laundry room devices, receptacle and lighting outlets (switches, receptacles and fixtures) should be connected to an arc-fault circuit interrupter (AFCI) device.

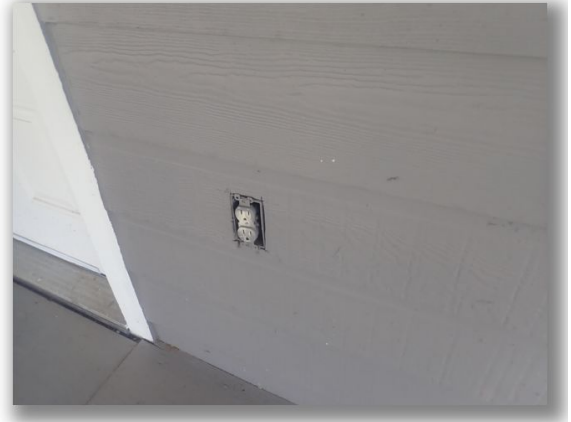
**Arc-Fault Circuit Interrupter Protection (AFCI)**

- None of the required dwelling unit devices, receptacle and lighting outlets (switches, receptacles and fixtures) are connected to an arc-fault circuit-interrupter (AFCI) circuit device. AFCI devices were first required under the 1999 National Electrical Code and under the 2014 NEC, all living space, kitchen and laundry room devices, receptacle and lighting outlets (switches, receptacles and fixtures) should be connected to an arc-fault circuit interrupter (AFCI) device.

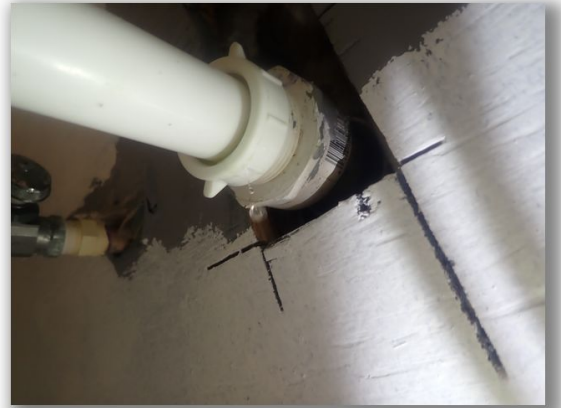
**Unit A Kitchen Sink**

- The faucet has little to no water pressure. The cause and remedy should be further evaluated. Repairs are needed.
- The sprayer head is not working properly.
- There is a S-trap (drain trap) in place under the sink. This type of drain trap does not meet current plumbing standards.
- The shelf in the cabinet under the sink is damaged.
- The drain line is made of corrugated material. It is recommended to use smooth wall/PVC type material to prevent blockage/poor drainage.

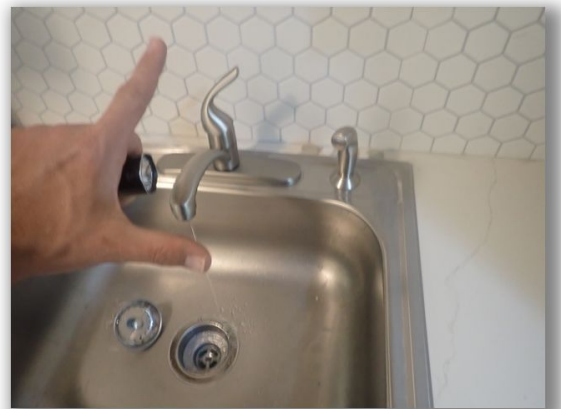
**Unit B Kitchen Sink**

- The faucet has little to no water pressure. The cause and remedy should be further evaluated. Repairs are needed.

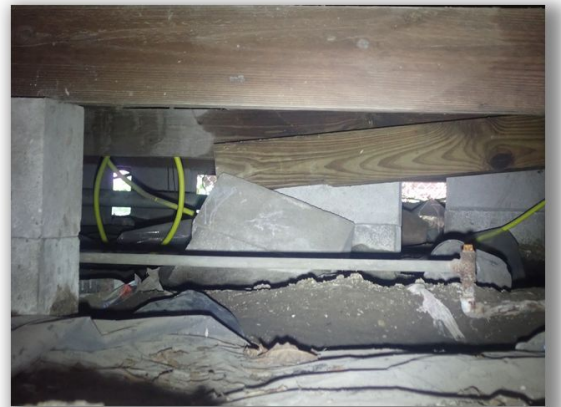
- I was unable to locate the electrical bond connection for the gas piping back to the grounding electrode system. All bond connections should be accessible for inspection, repair or replacement. This condition should be further investigated and corrected if necessary.

- Corrugated Stainless Steel Tubing (CSST) was observed to be in use at the time of this inspection. This product is known to have various installation and grounding / bonding problems or deficiencies. Full evaluation of this product is beyond the scope of this inspection. You are strongly encouraged to have a licensed plumber evaluate the installation and a licensed electrician investigate for proper bonding and grounding of this component of the gas distribution system. **Such follow-up should take place prior to the expiration of any time limitations such as option or warranty periods.** Evaluations by qualified tradesmen may lead to the discovery of additional deficiencies which may involve additional repair costs.

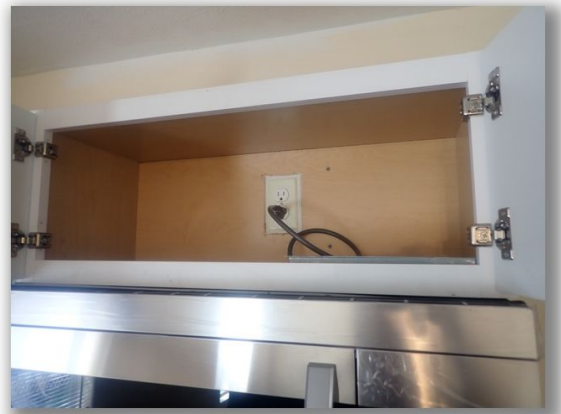
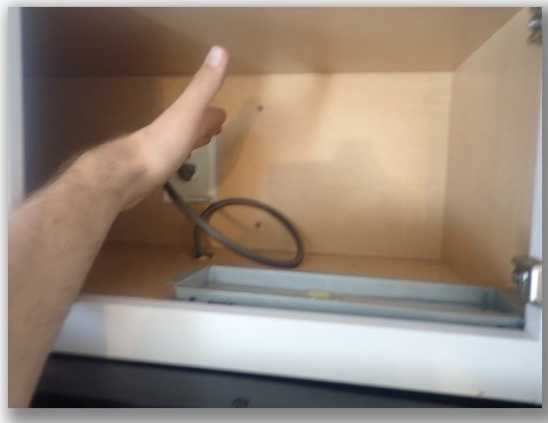
**Unit C**

- The vent hood is blowing air through the top of the unit and not the front vents.

**Note:** The range hood in place is ductless. The range hood does not terminate outside and is dependent on the charcoal filter installed. It is recommended to regularly clean your filter system to prevent damage to the structure.

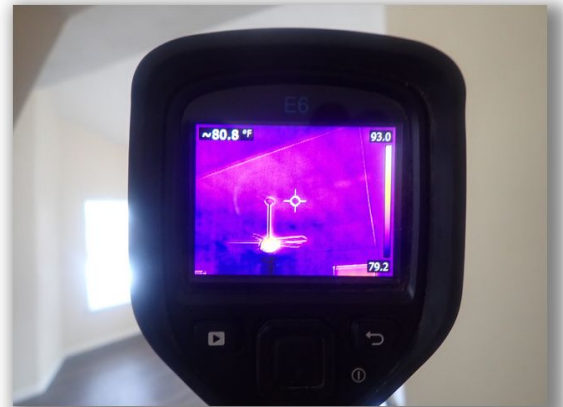
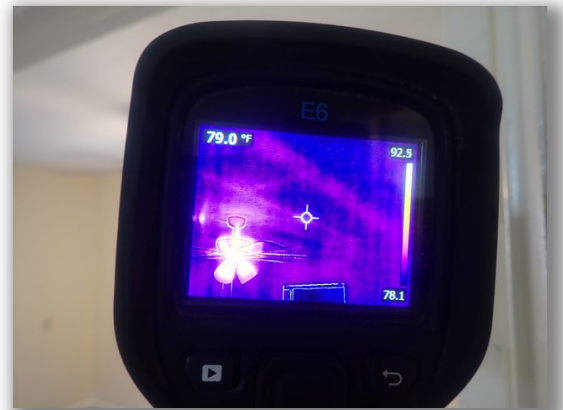
- Elevated moisture was observed in the Unit B rear corner bedroom, unit C kitchen.. The cause should be further evaluated and corrected as necessary. **Additional Note:** Due to the elevated moisture, other adverse conditions such as mold-like substance growth, wood rot/deterioration and wood destroying insects are possible.
- Missing insulation was observed at the ceiling in unit C

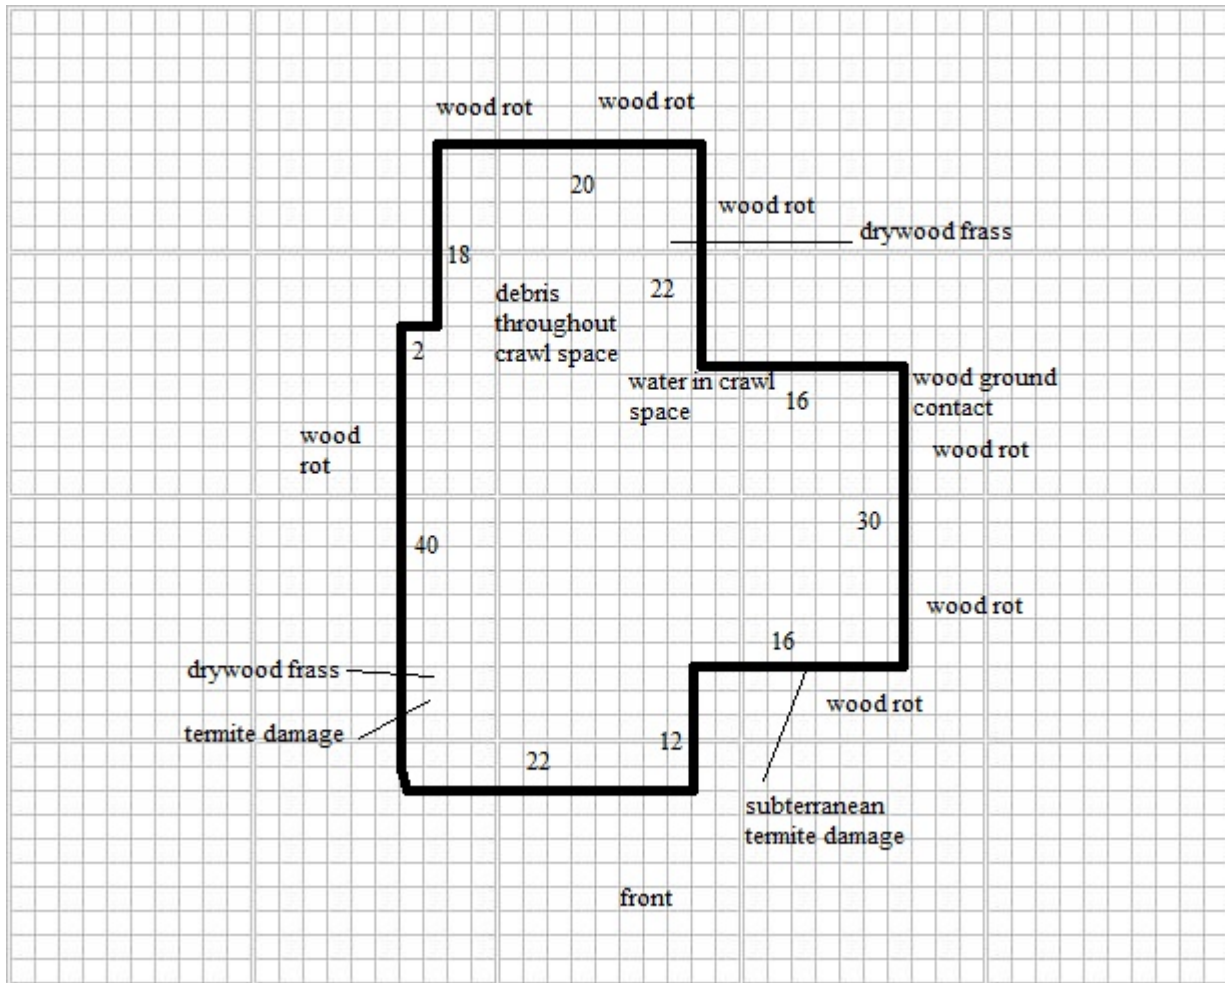
### Diagram of Structure(s) Inspected

Additional Comments An ACTIVE Infestation of termites was discovered at the time of this inspection. See diagram for location(s). Treatment Recommended., There is visible evidence of a previous WDI infestation at the time of this
