SPARTAN HOME INSPECTION, LLC

# PROPERTY INSPECTION REPORT FORM

Neil Doran <i>Name of Client</i>	11/11/2022 5:00 pm <i>Date of Inspection</i>
15207 Lakewood Ave, Mont Belvieu, TX 77523 <i>Address of Inspected Property</i>	
Adam Wright <i>Name of Inspector</i>	TREC # 23898 <i>TREC License #</i>
<i>Name of Sponsor (if applicable)</i>	<i>TREC License #</i>

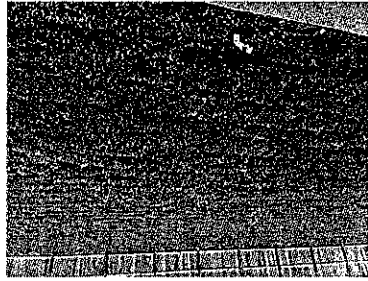
Back yard slopes towards home

Grading is sloping towards the home in some areas. This could lead to water intrusion and foundation issues. Recommend monitoring this and if water is observed to stand next to home have French drains installed or have a qualified landscaper or foundation contractor regrade so water flows away from home.

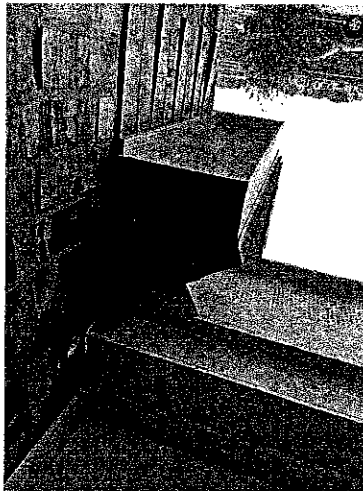
Exposed roof decking near front door not covered by flashing

Missing, damaged, or improper flashing can lead to water intrusion. Recommend having the proper flashing installed to keep water out of the structure of the home.

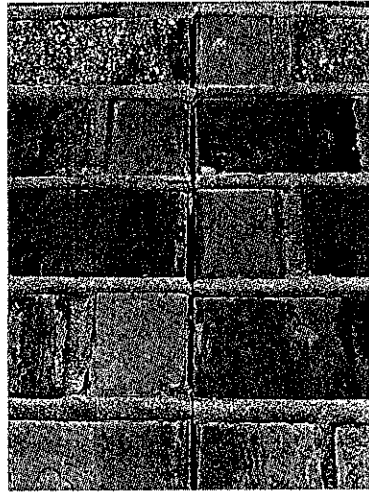
The expansion joint in the wall was not caulked. This can lead to water intrusion and possibly damage. I recommend caulking all expansion joints as this is a cheap way to help ensure water doesn't enter your walls.

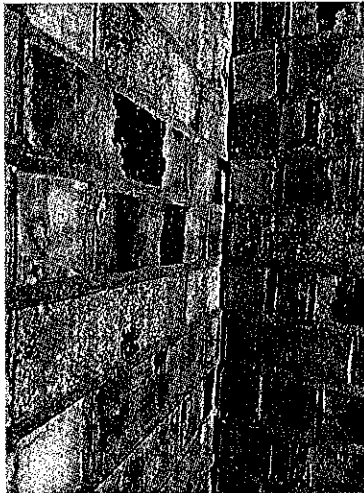
Gap at wall intersection on front porch should be caulked

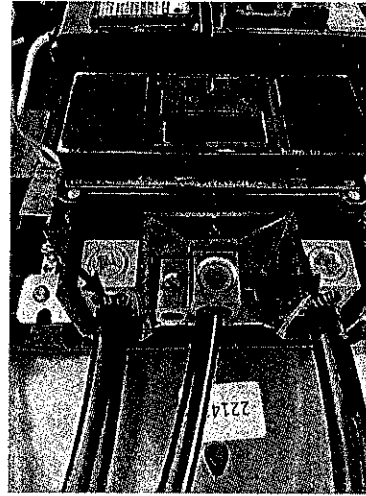
Anti-oxidant paste is required on aluminum wire ends to prevent oxidation and corrosion. If aluminum wire ends are not protected by this paste, the corrosion that results could result in a poor connection.

Anti-oxidant grease not present

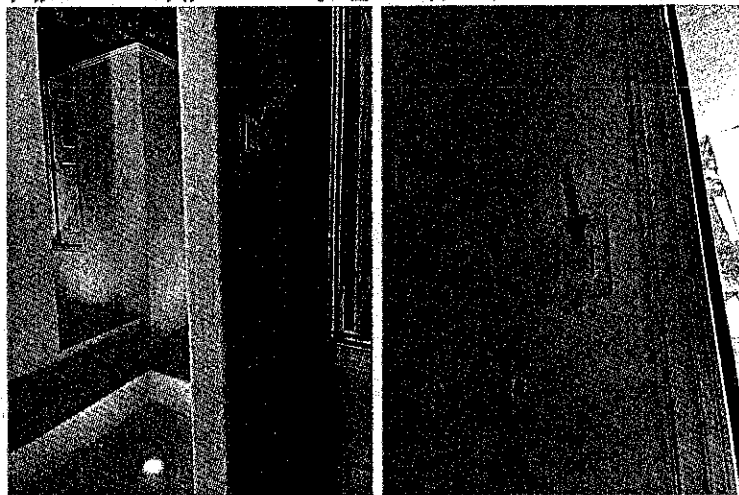
Doesn't appear to control anything  
The front entrance lights are controlled by this switch

There was a switch at the front door that did not appear to control anything. This switch should likely be used to control the lights at the front entrance to the home. These lights are actually controlled by a switch in the hallway.

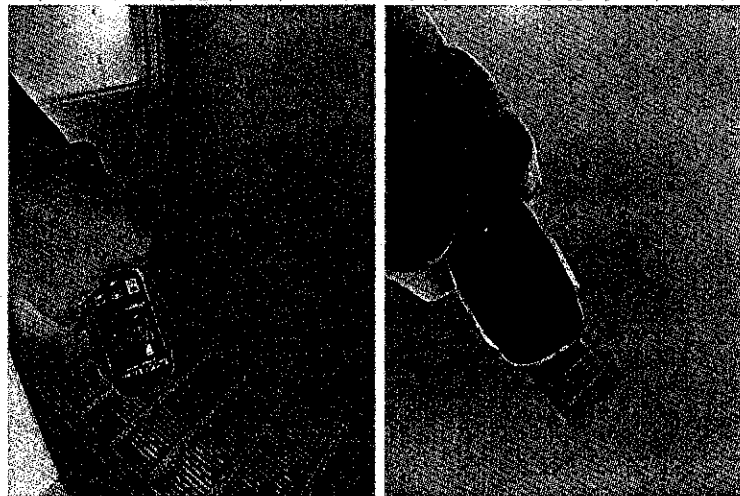
The temperature differential for this system was approximately 15 degrees.

Approximately 59 degree supply air      Approximately 74 degree return air

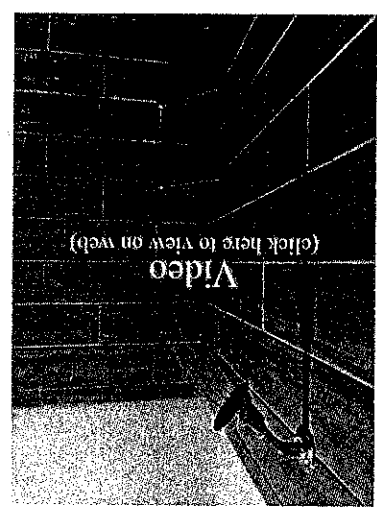
Fixtures were observed that had very low water flow to them. Recommend a plumber evaluate and repair.  
● Deficiency

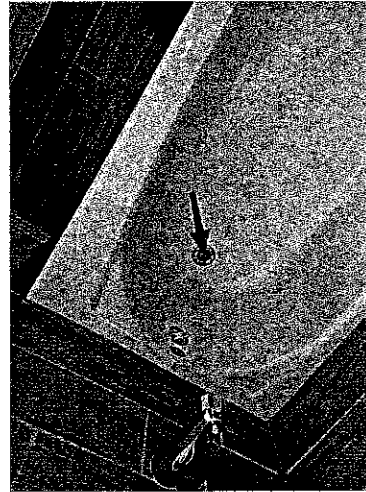
Tubs were observed to be missing the stopper. Recommend installing a tub stopper.

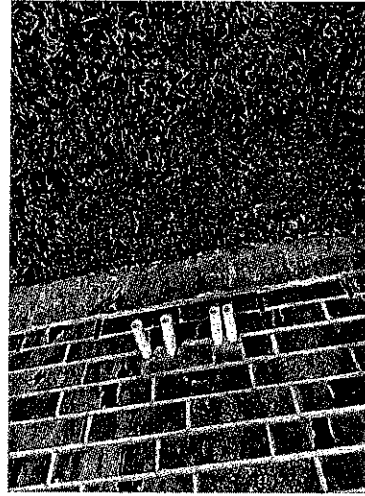
The TPBV valve is improperly routed. The discharge line should be routed to a safe location outside the house as shown in the attached diagram. The outlet piping should discharge within 6 inches of the ground and be pointed in a safe direction to reduce the likelihood of someone being burned with scalding hot water. Also, the valve termination piping is not allowed to be threaded on the end. Having threads on the end of the pipe makes it possible for someone to install a cap, which would defeat the safety valve and cause a SERIOUS safety hazard. I recommend routing this piping to a safe location and having it properly installed immediately.

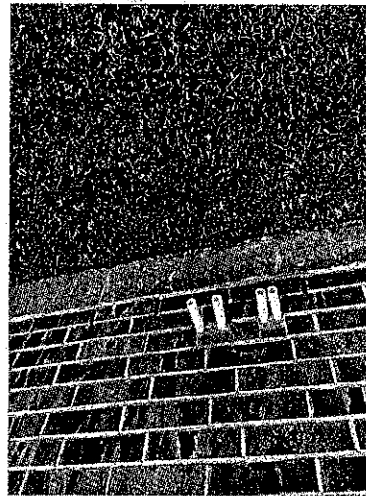
These drains are associated with your water heater. You should NEVER see water coming out of these. Water coming out of these drains indicates a problem with your water heater and you should call a plumber immediately. Water is currently coming out of the drain because of the leaking water heater. Recommend a plumber repair.

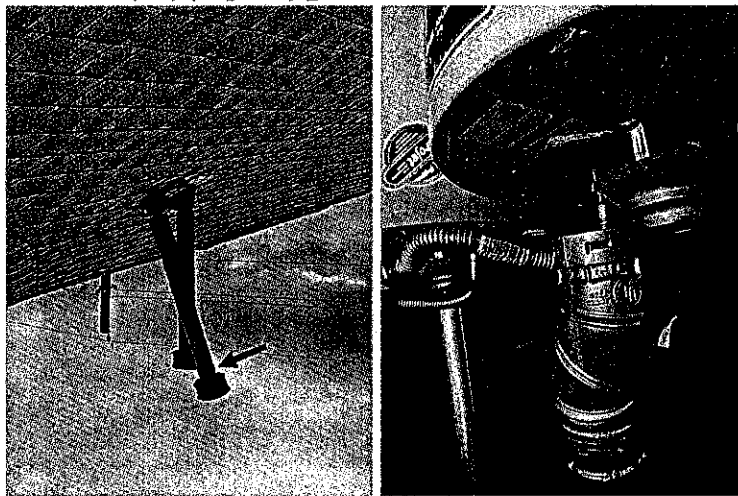
The exhaust flue from the water heater is improperly aligned. This will let exhaust gases into the attic instead of being carried out through the roof.

Exhaust flue is leaning over

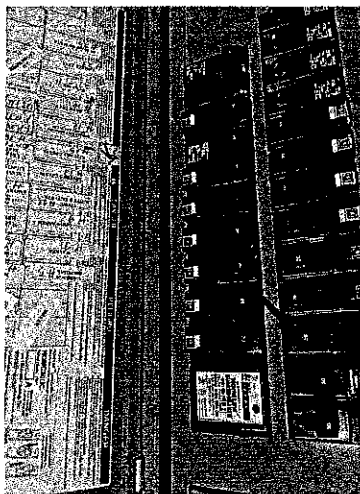
The garbage disposal circuit breaker would not stay powered on and tripped instantly. Recommend an electrician evaluate and repair.

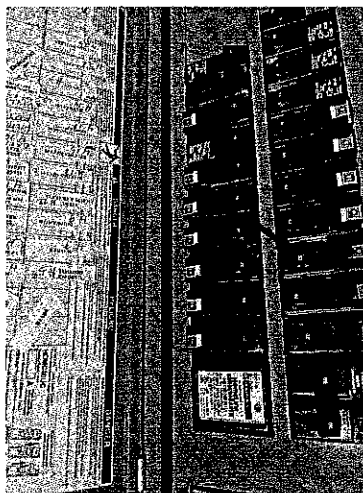
The dishwasher circuit breaker would not stay powered on and tripped instantly. Recommend an electrician evaluate and repair.
