DOOLEY INSPECTIONS LLC.

GENERAL HOME INSPECTION

1578 Co Rd 135
Lincoln, TX 78948

PROPERTY INSPECTION REPORT FORM

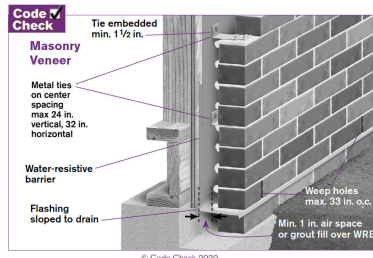
Right Side

Height of soil was too high in areas, which can lead to insect or moisture intrusion via weep holes. A minimum of 6 inches of foundation wall should be exposed under the brick. I recommend lowering grade at the areas noted in pictures.

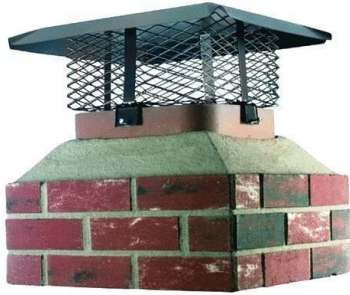
Example of Spark Arrestor

The chimney had no spark arrestor (aka, rain cap and vermin screen) installed. This should be corrected to help prevent sparks from becoming airborne or birds from nesting in the chimney.

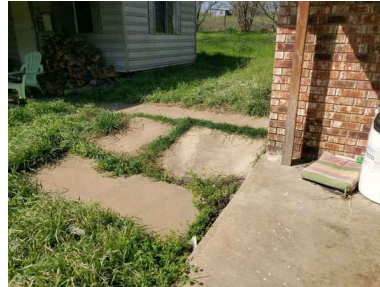
Rear

The back patio and sidewalks were heaved up at several locations. This presents a trip hazard. There are new processes, such as Mudd Jacking, that are low cost and effective methods of leveling side walks. I recommend repair.

Back Patio: 4" gap

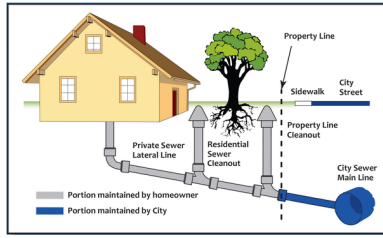
Main Drain Lateral

Most drain, waste and vent pipes are buried and typically not visible in a finished home and a sewer scope camera was not used at the time of inspection.
