Date: February 25, 2022

Subject: Structural Foundation Inspection Report for Inspection Completed 01/11/2022
Slab Foundation
16902 Kilgarth Dr., Richmond, TX 77407

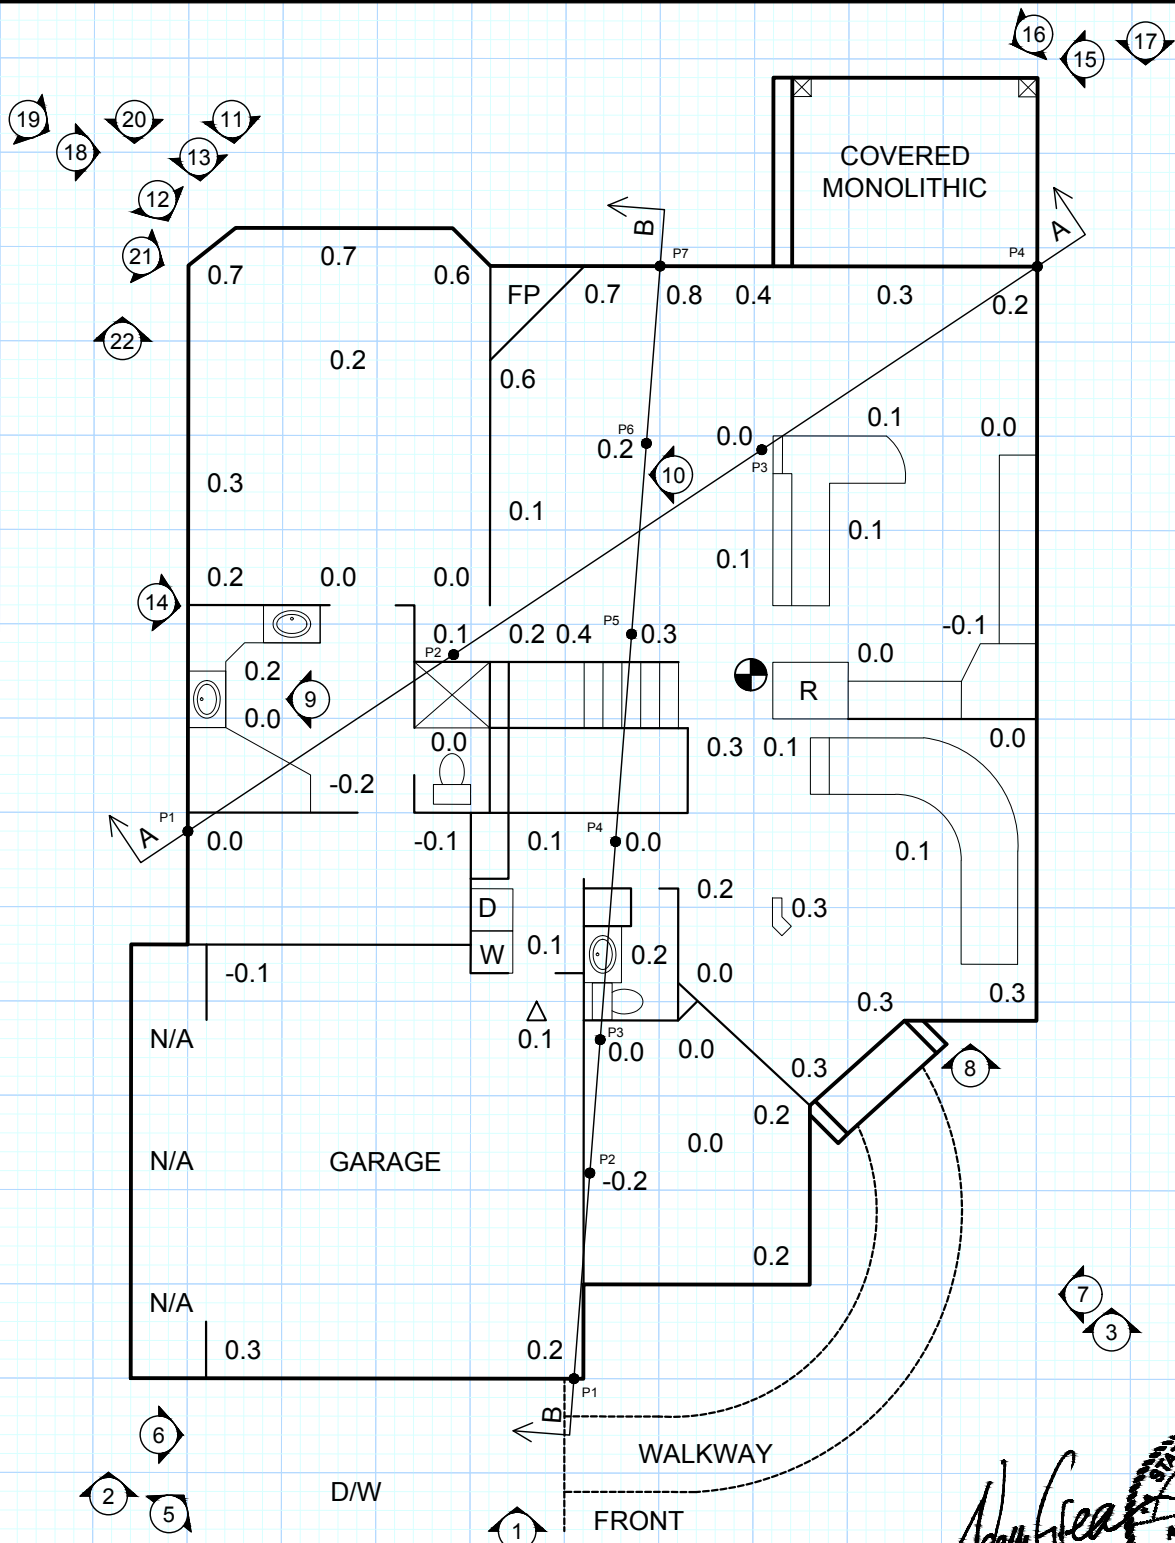
TITLE: ELEVATION MAP | SCALE: 1"=10'-0"

- The measured deflection falls inside the guidelines. .
- The measured tilt falls inside the guidelines.

No foundation repairs recommended at this time.

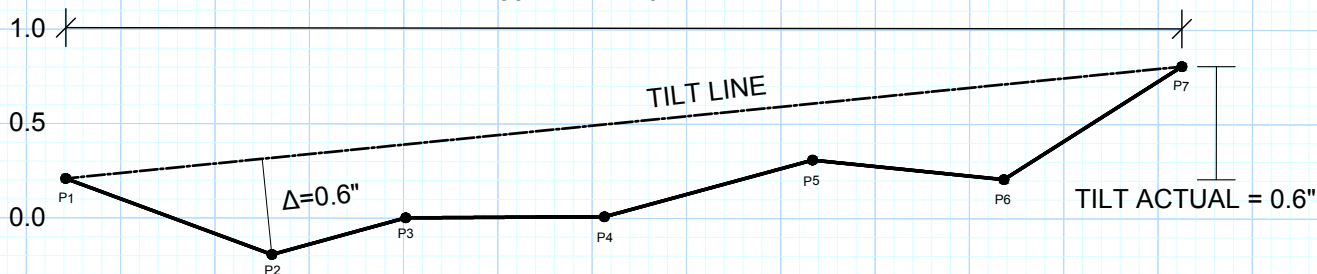
SECTION B-B

$TILT_{ACTUAL} = 0.6" < 7.1" \therefore \text{DOES NOT EXCEED}$

$\Delta_{ACTUAL} = 0.6" < 1.9" \therefore \text{DOES NOT EXCEED}$

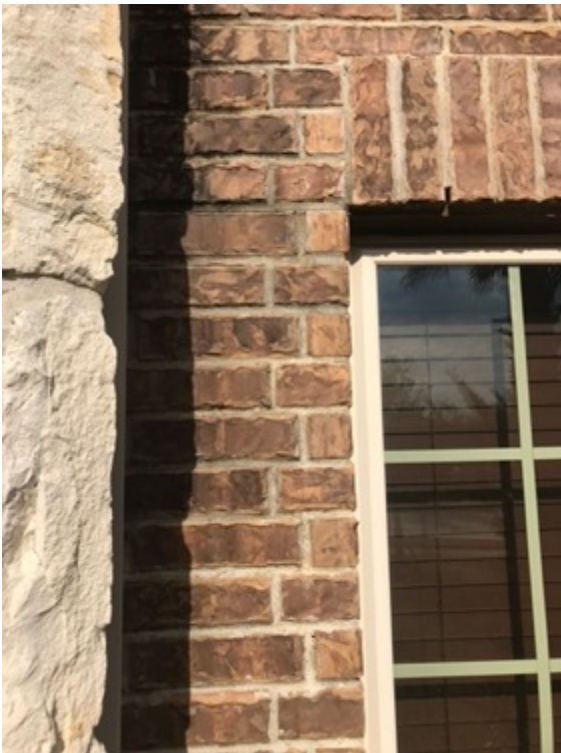
Photograph 8

6. Front slope from left to right.
7. Front slope from right to left.
8. Horizontal brick crack. Minor mortar crack at lintel corner of window.
9. Inside bath on the other side of wall of from the lower expansion joint separation outside -no damage noted.

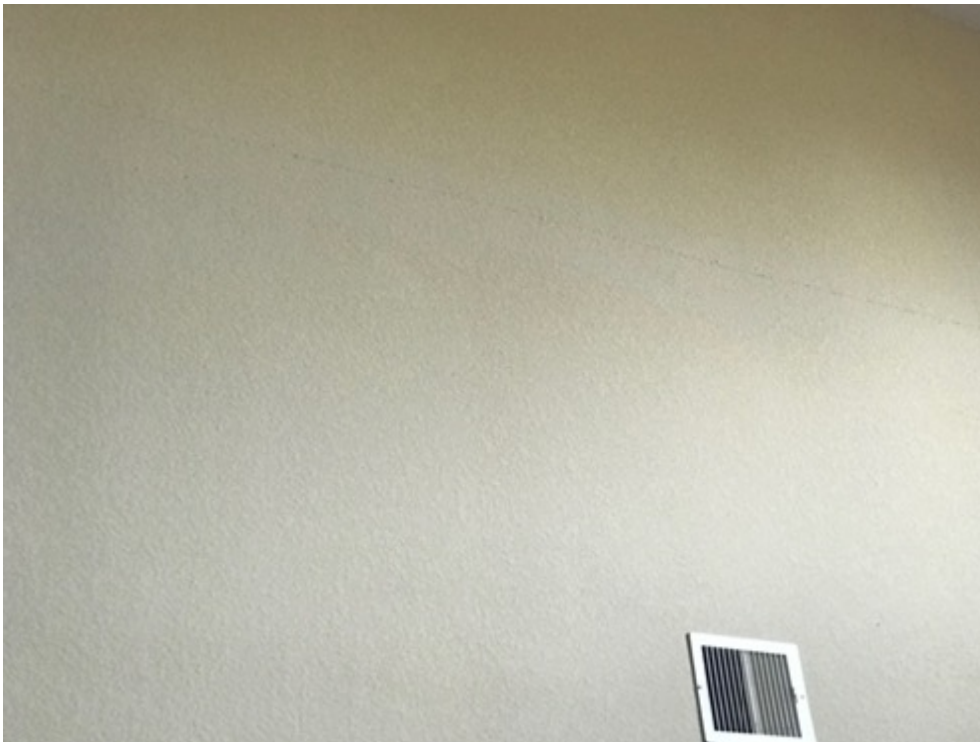
Photograph 10

10. Minor, long sheetrock crack along the sheetrock tape line.
11. Corner pop.
12. Corner pop.
13. Window separation.
14. Lower expansion joint separation.

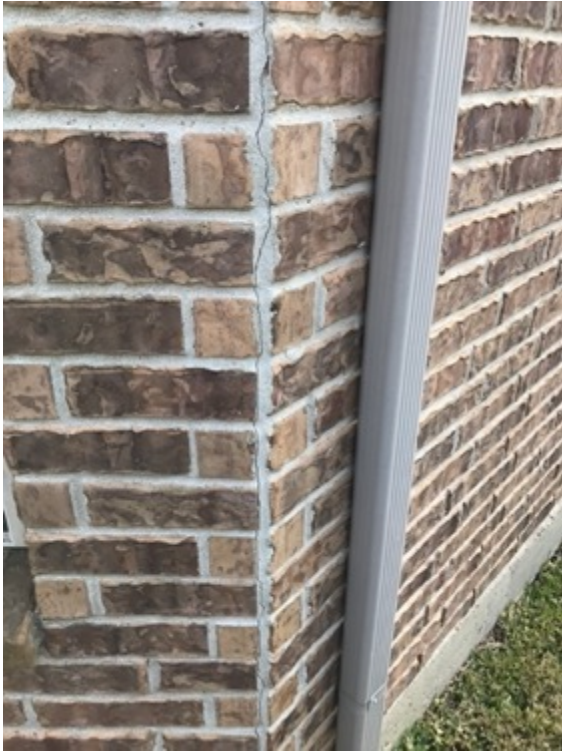
Photograph 21

19. Left right from the rear for further back.
20. Left perimeter from the rear.
21. Mortar crack on left rear corner of home/master.
22. Rear left yard area, near fence at left, of home runs water back toward left rear corner of home.
