RE: Foundation Inspection  
Job #21687

The residence inspected was located at 1203 Lamplight Trail Drive in Katy, Texas.

# 1203 Lamplight Trail Dr.

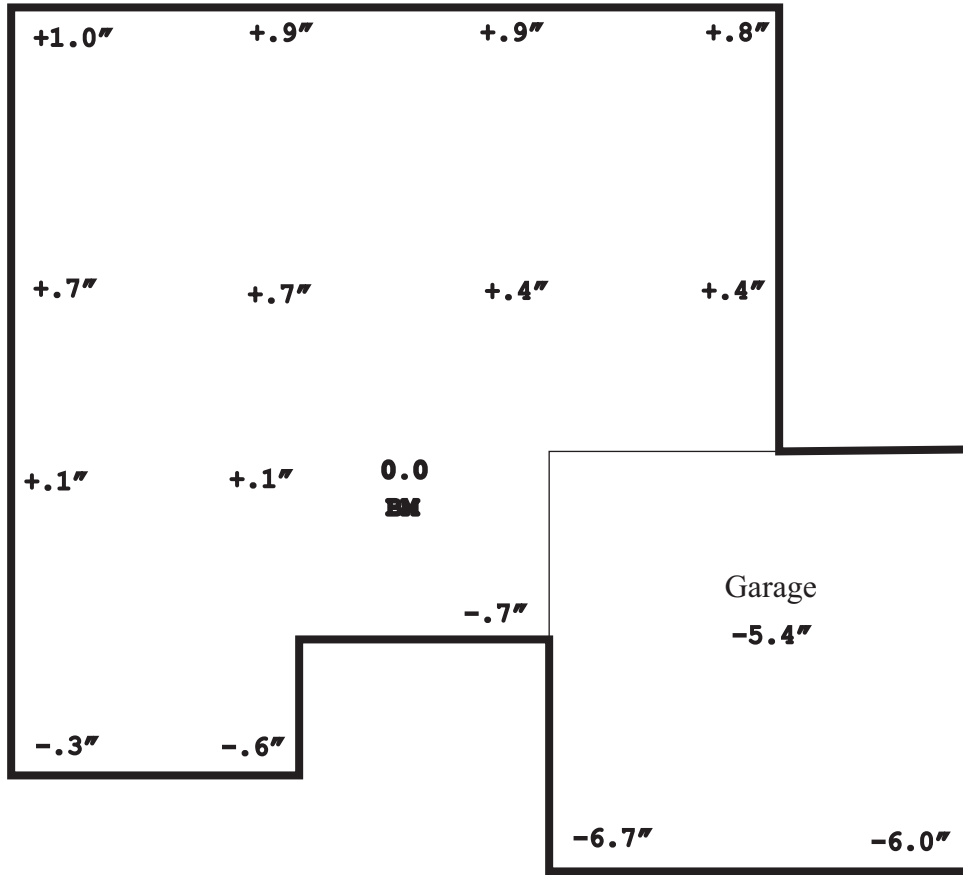
FYI: The 1/16 brick veneer crack on the left side of the house is due to thermal changes.

FYI: The elevation differential 1.7" is not a functionality issue. FYI: During this era, residential construction standards for slab flatness were not enforced.

FYI: The chipped right front corner of the foundation is due to the plastic moisture barrier not extended to the end of the slab allowing brick mortar to bond to the slab – when the house settles just slightly or the brick expands due to thermal expansion the corner spalls off creating a chip – this is a common phenomenon and a non-issue unless the chip is larger than 16” or penetrates a post tension pocket – otherwise considered cosmetic only. A side effect of the chip is it could allow termites to enter the house behind the chip.

Elevation Differential 1.7"  
Instrument Repeatability Error 0.2"

1/16" "Thermal"  
Brick Veneer Crack

Chipped Corner
