Prepared for Emerson Property Management

6/21/2024

711 Avenue A Unit 2

La Marque TX 77568

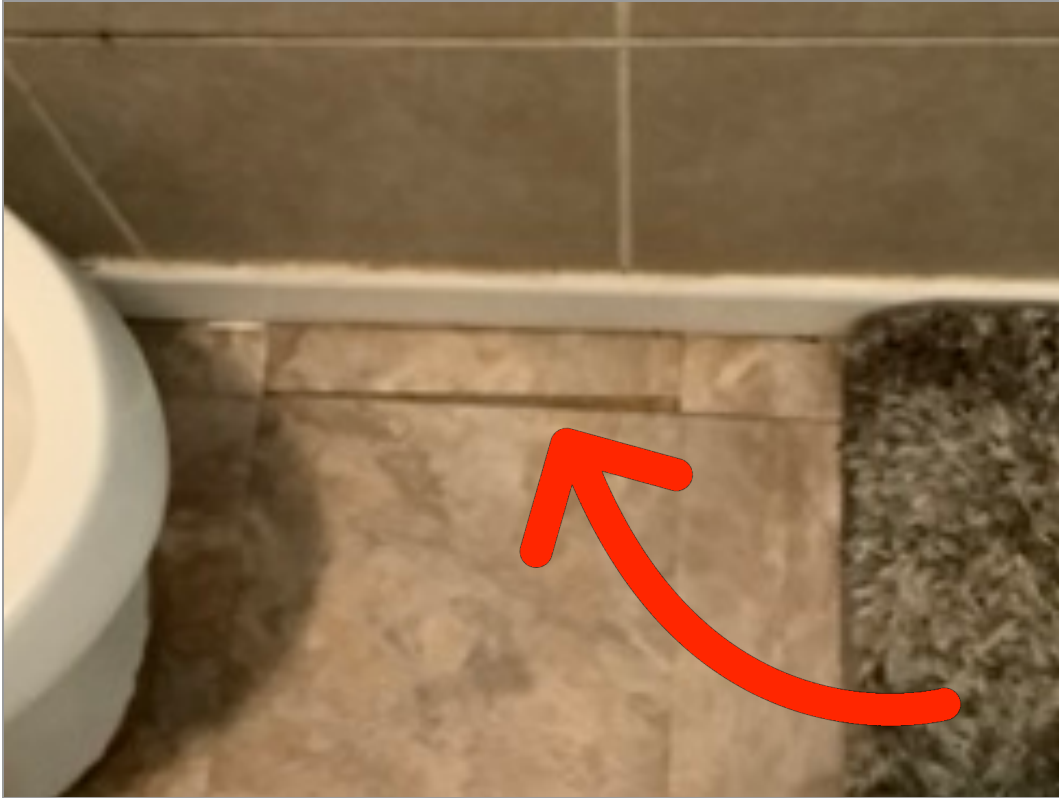
Bathroom 1
Floors
Gap in flooring.

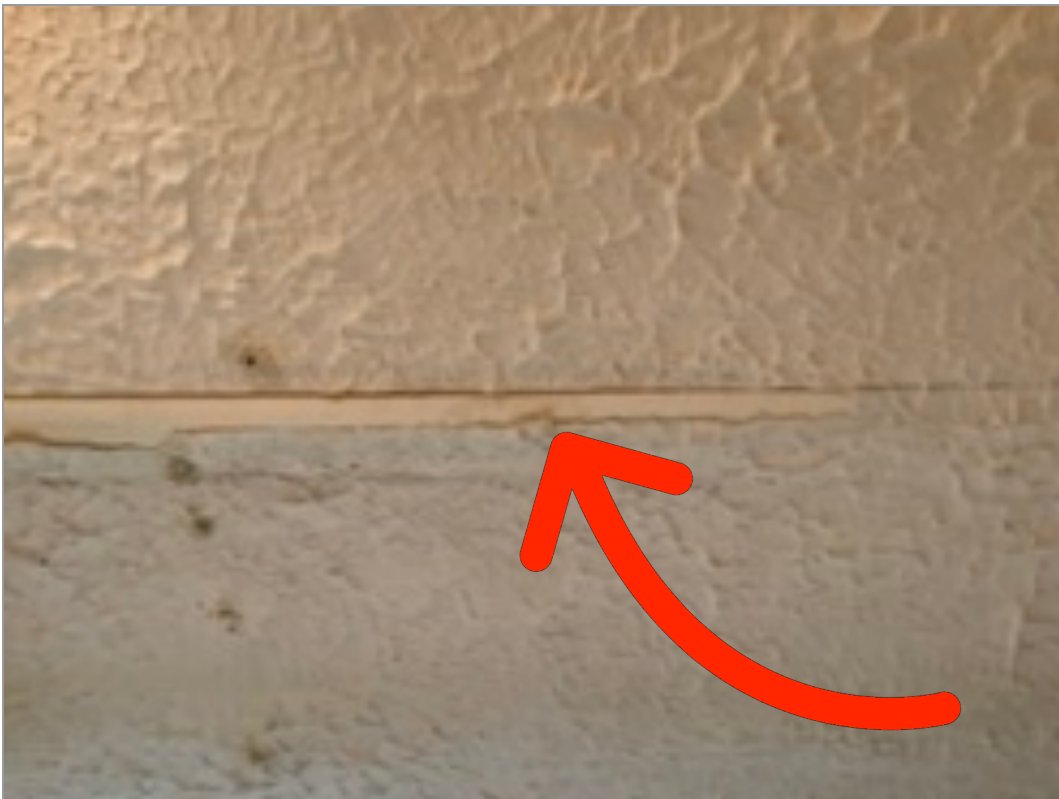
Bathroom 1
Ceiling
Cracks in ceiling.

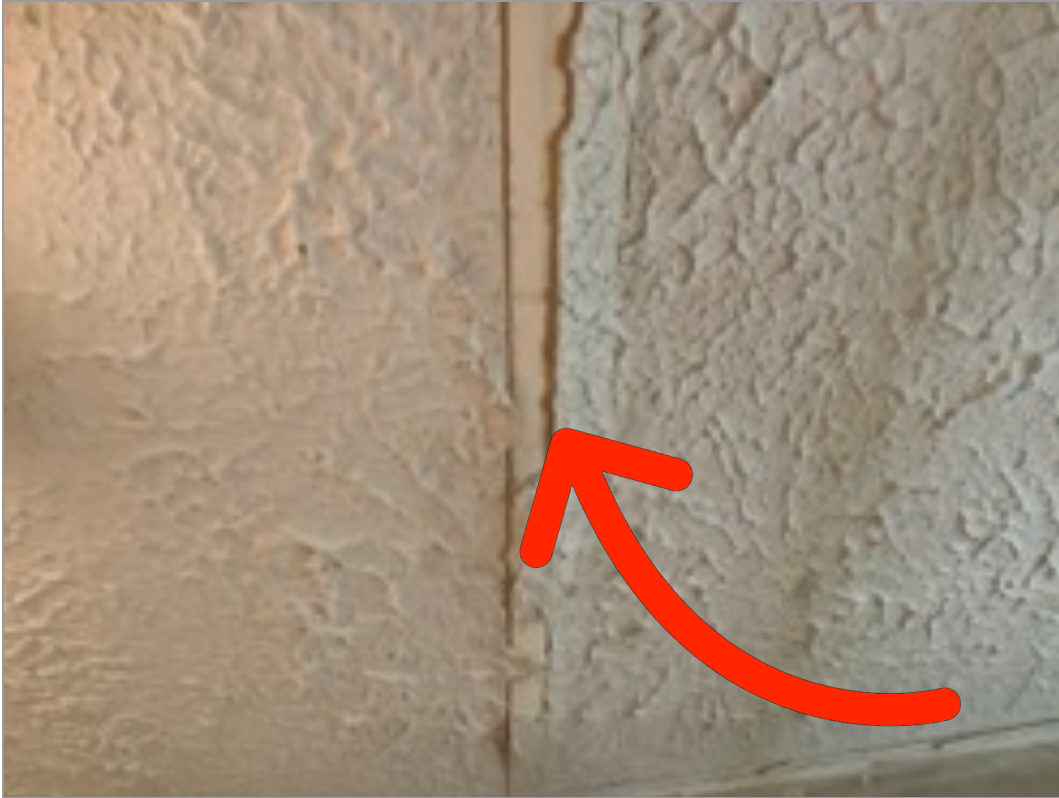
Bathroom 1
Ceiling
Cracks in ceiling.

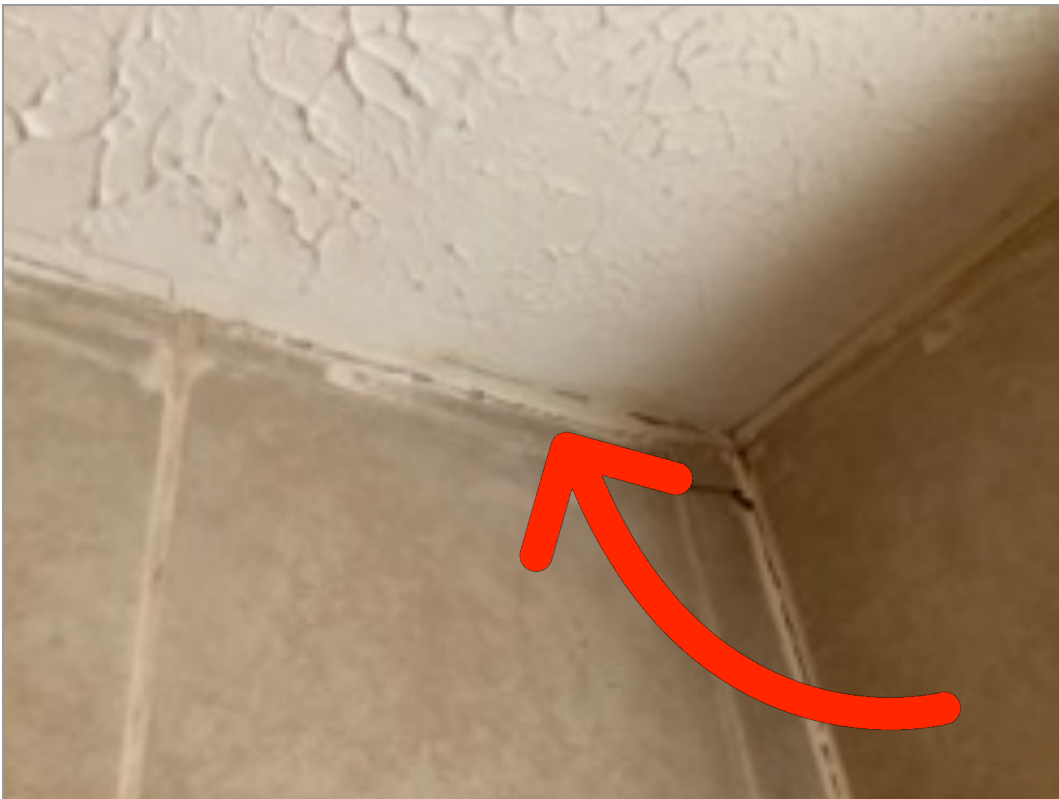
Bathroom 1
Ceiling
Cracks in ceiling.

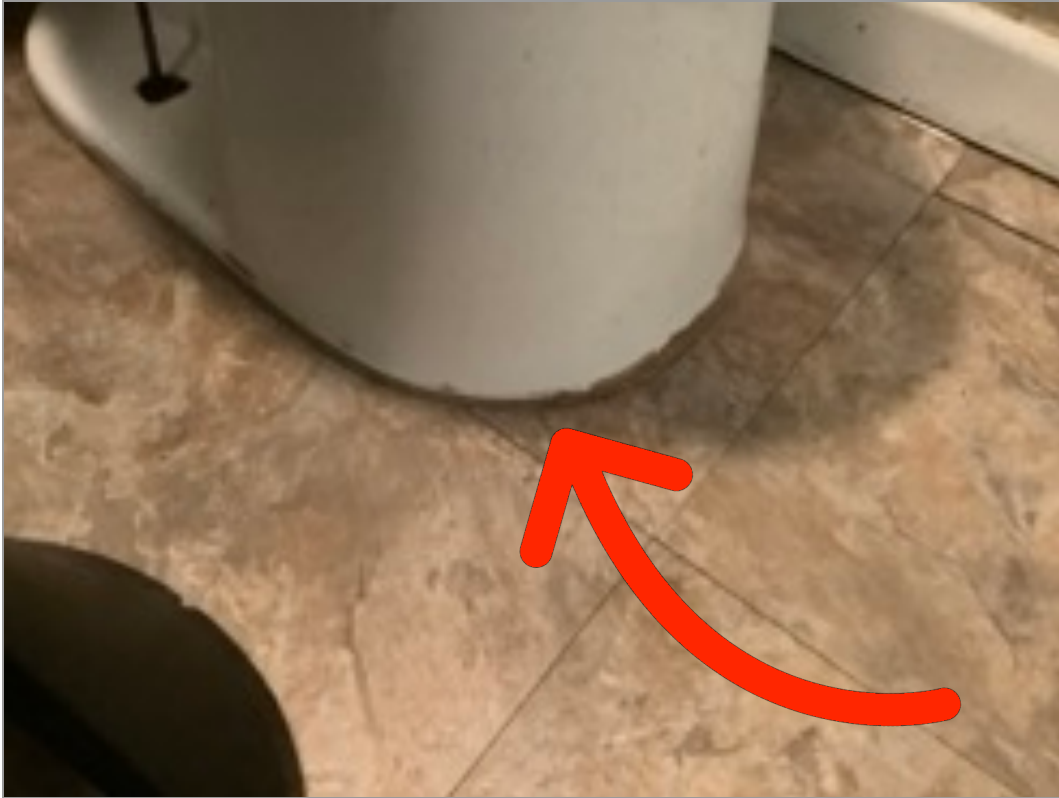
Bathroom 1
Commode
Seal around bottom
of commode is
cracking/
discolored.

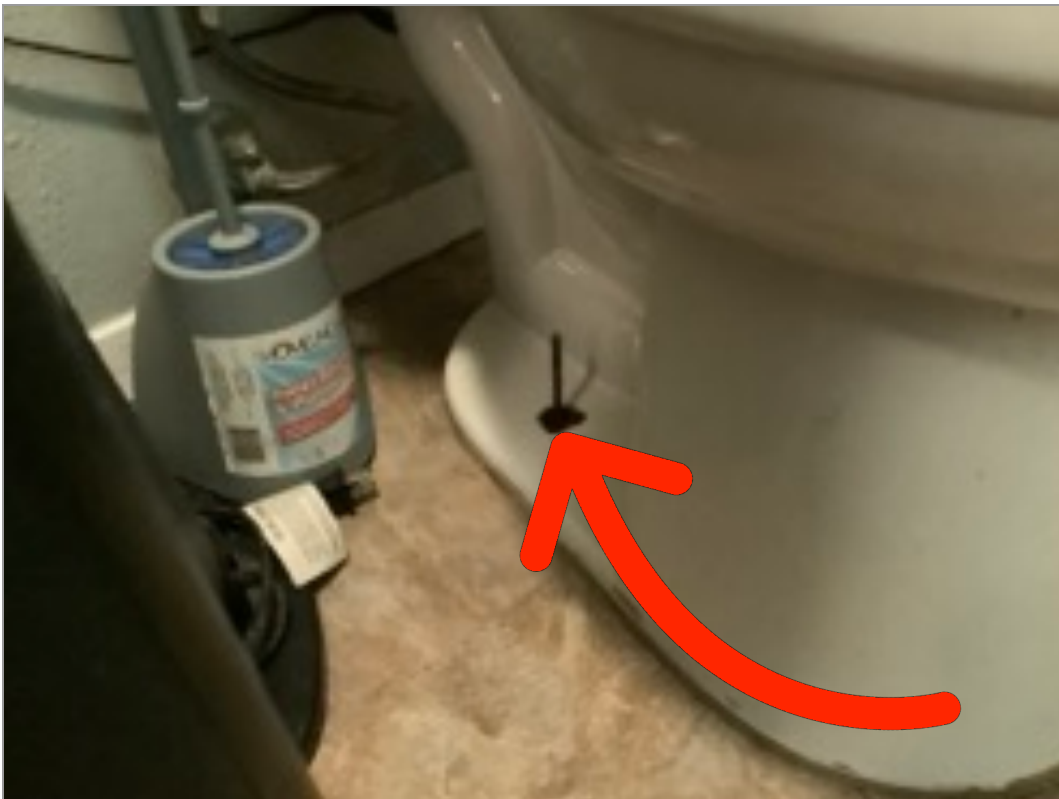
Bathroom 1
Commode
Bolt caps missing

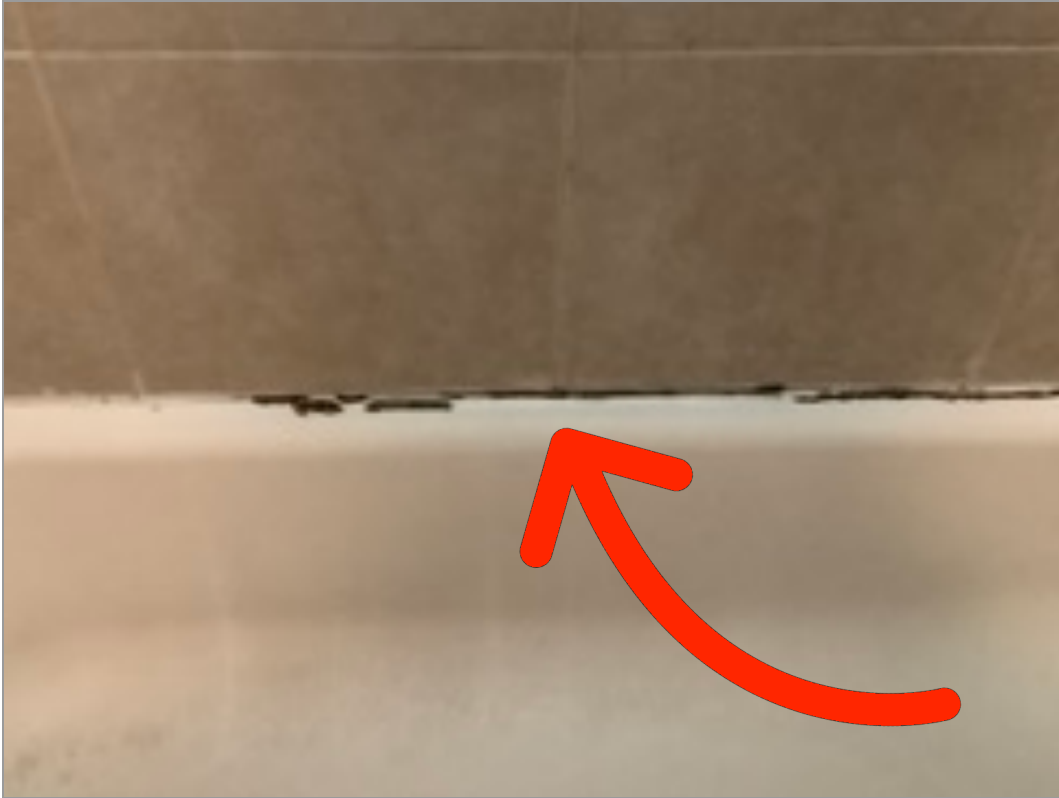
Bathroom 1
Tub/Fixture
Grout is
discolored/cracking

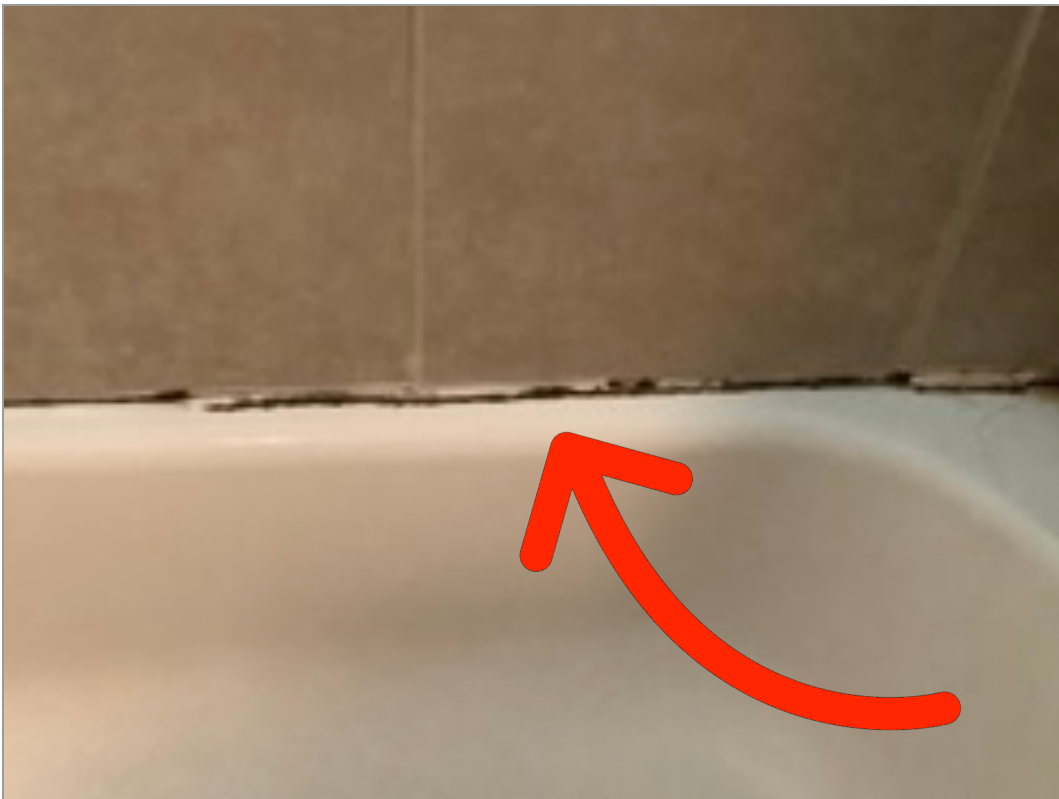
Bathroom 1
Tub/Fixture
Grout is
discolored/cracking

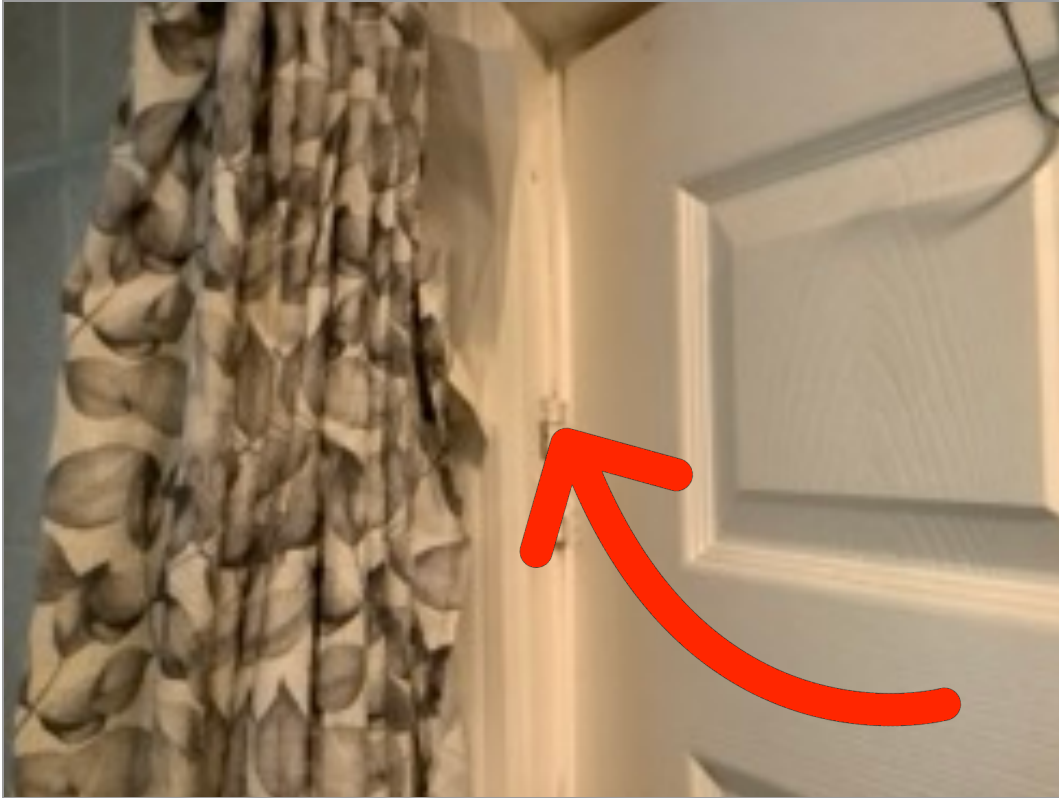
Bathroom 1
Door Stop
Missing- no wall damage noted.

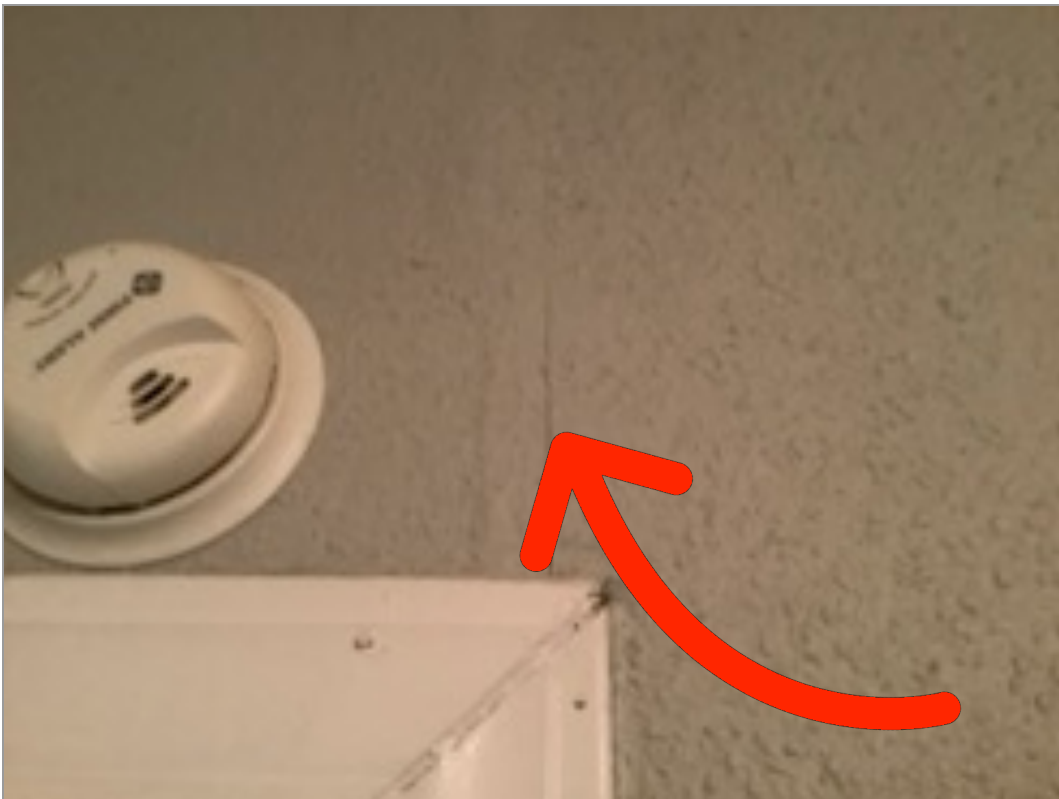
Bedroom 1
Walls/Paint
Cracks in texture

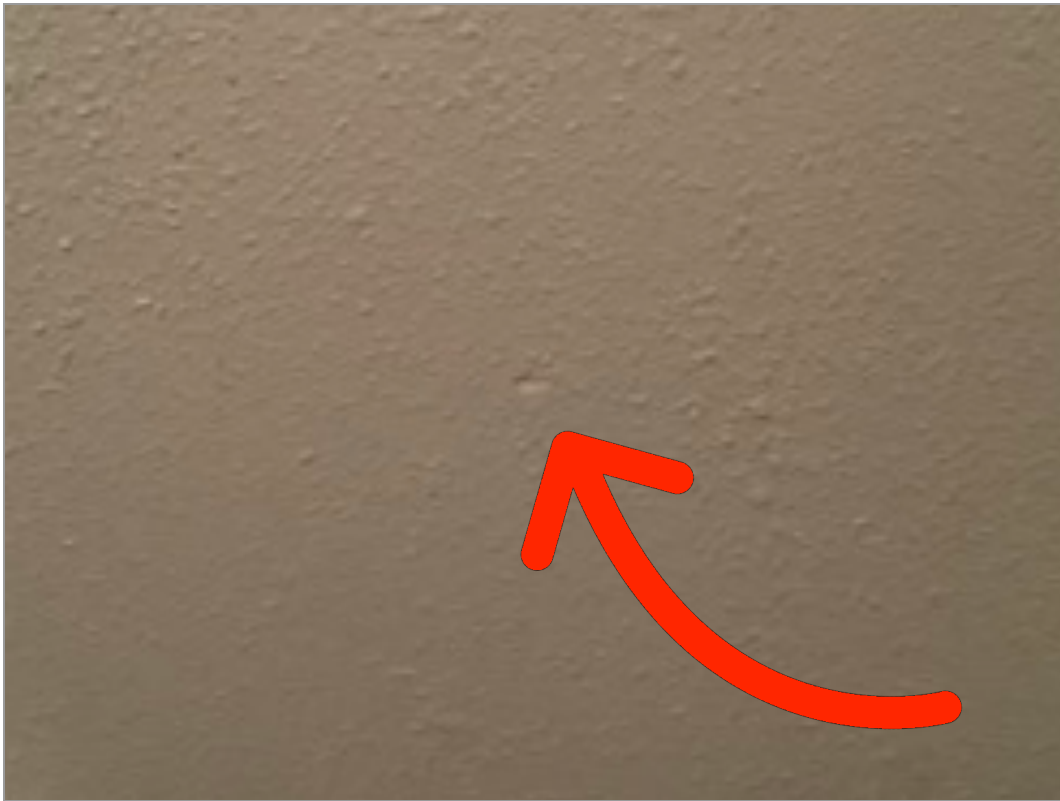
Bedroom 1
Door Stop
Missing- wall
damage noted.

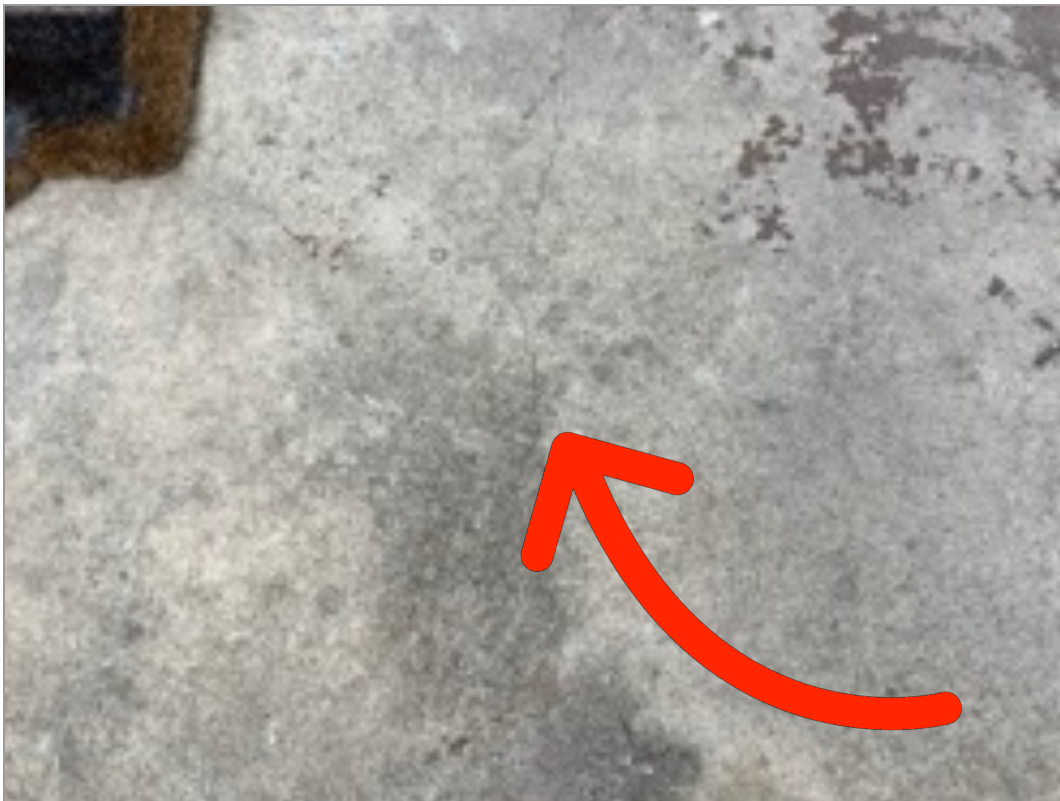
Entry
Patio/Porch
Cracks in concrete;
damage ;
discoloration

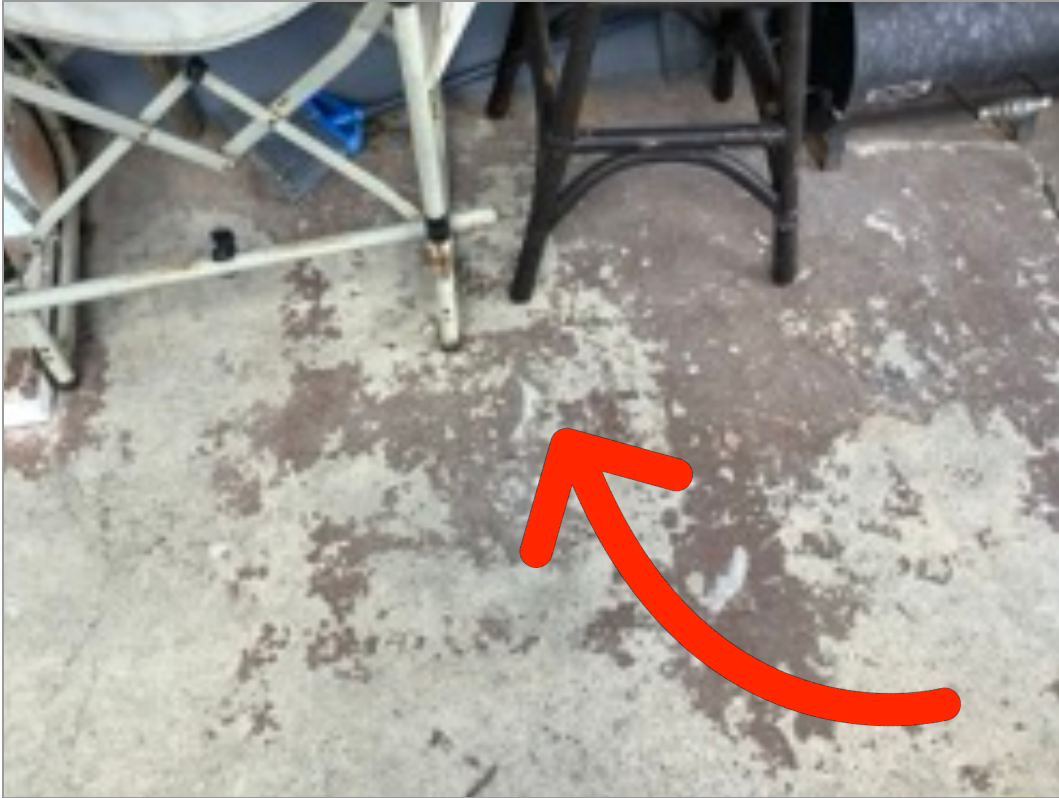
Entry
Patio/Porch
Cracks in concrete;
damage ;
discoloration

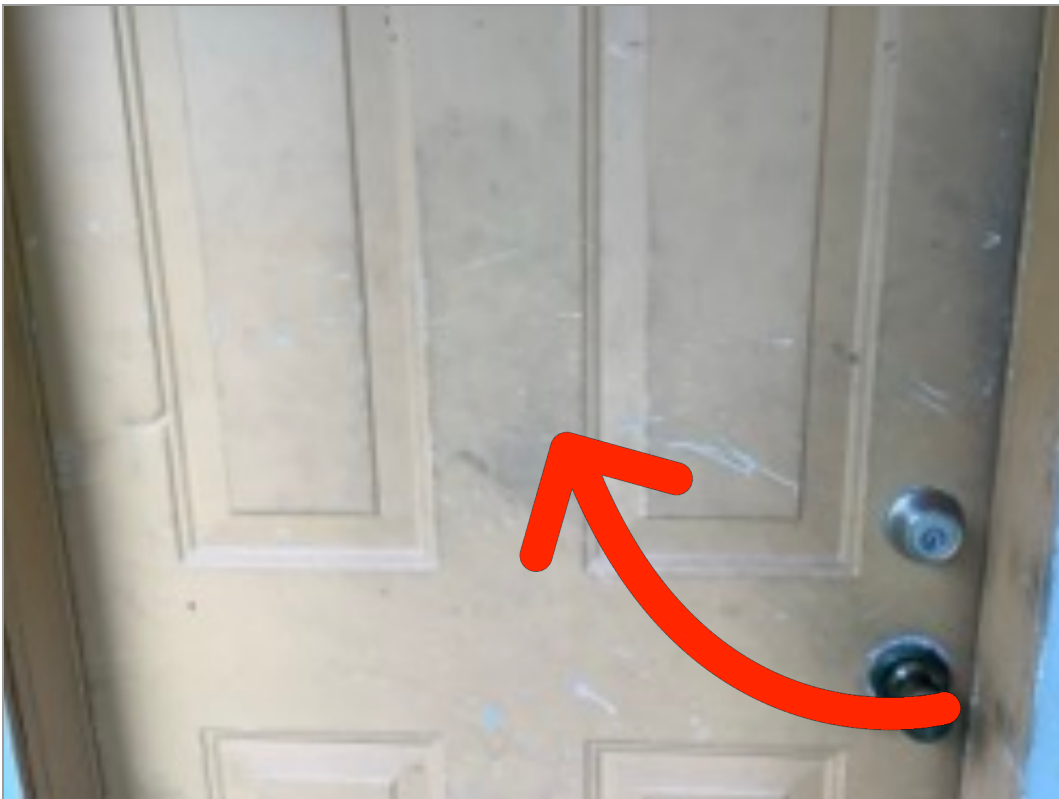
Entry
Front Door Exterior
Scratches; stains;
discoloration or
chipping of door
casing

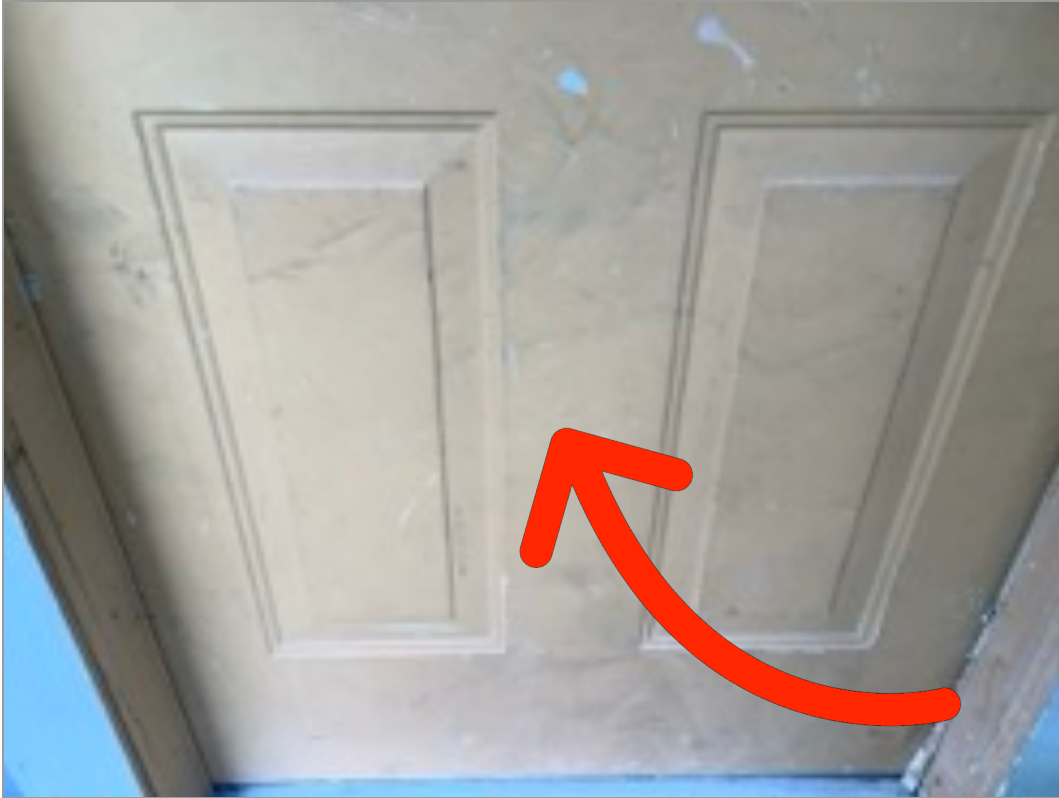
Entry
Front Door Exterior
Scratches; stains;
discoloration or
chipping of door
casing

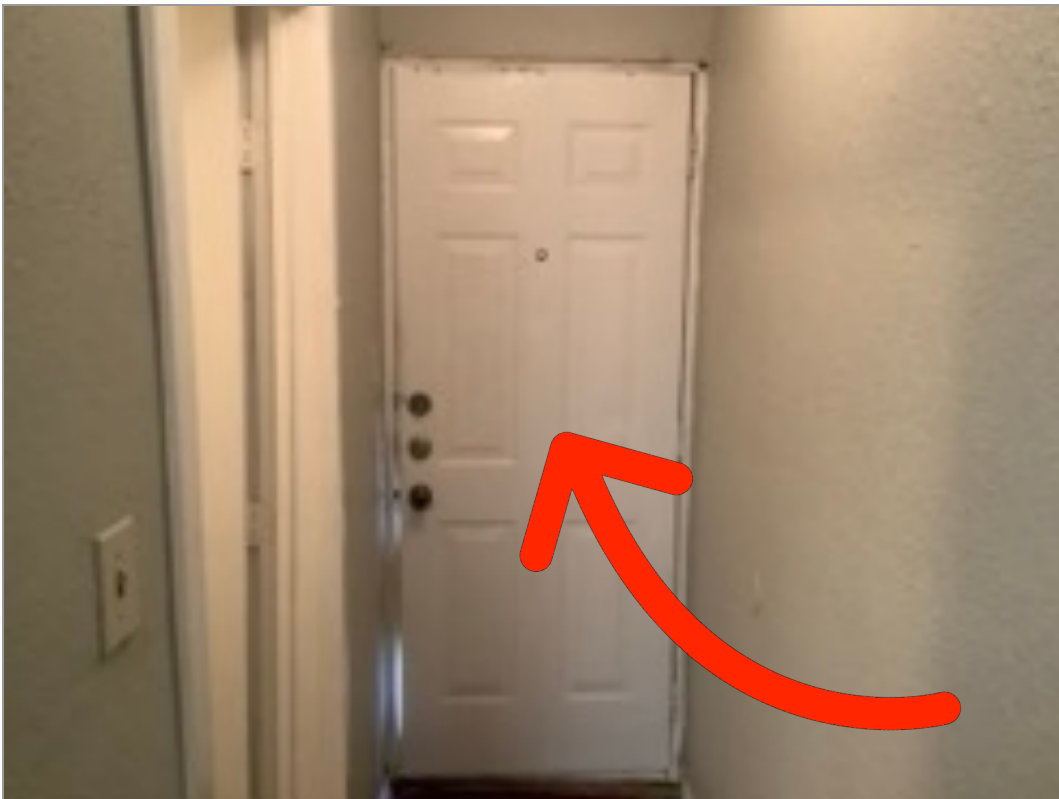
Entry
Front Door Interior
Hard to open front
door

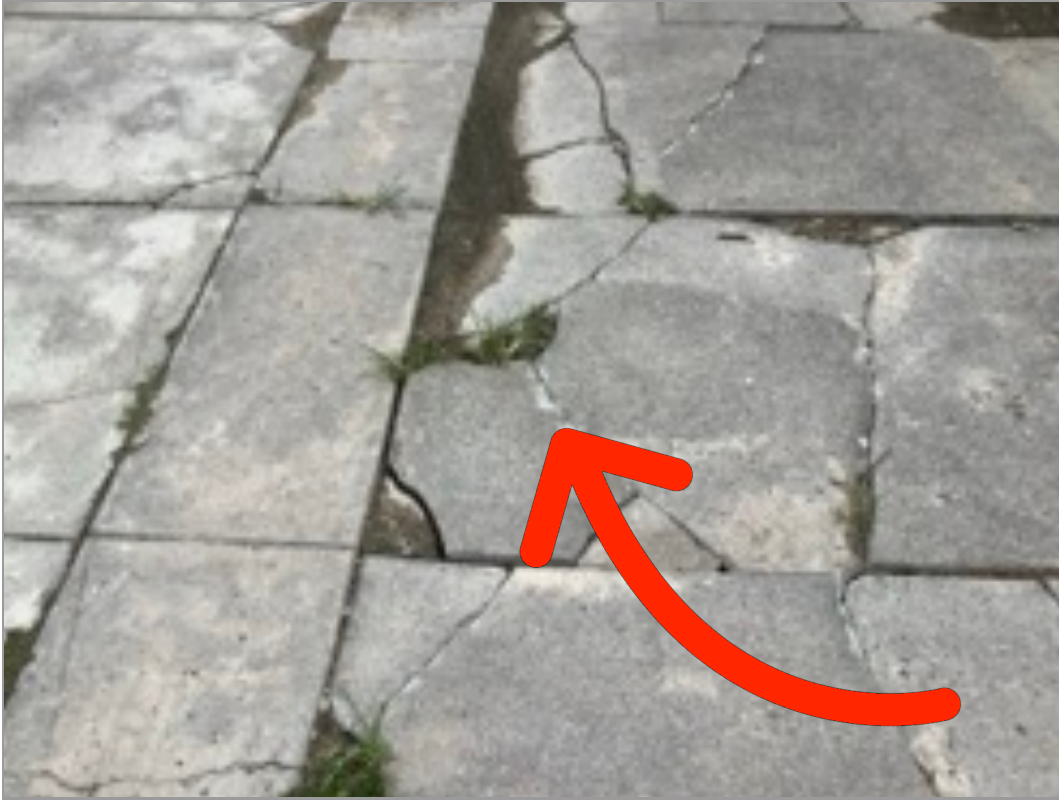
Front Exterior
Driveway
Spider cracks in driveway.

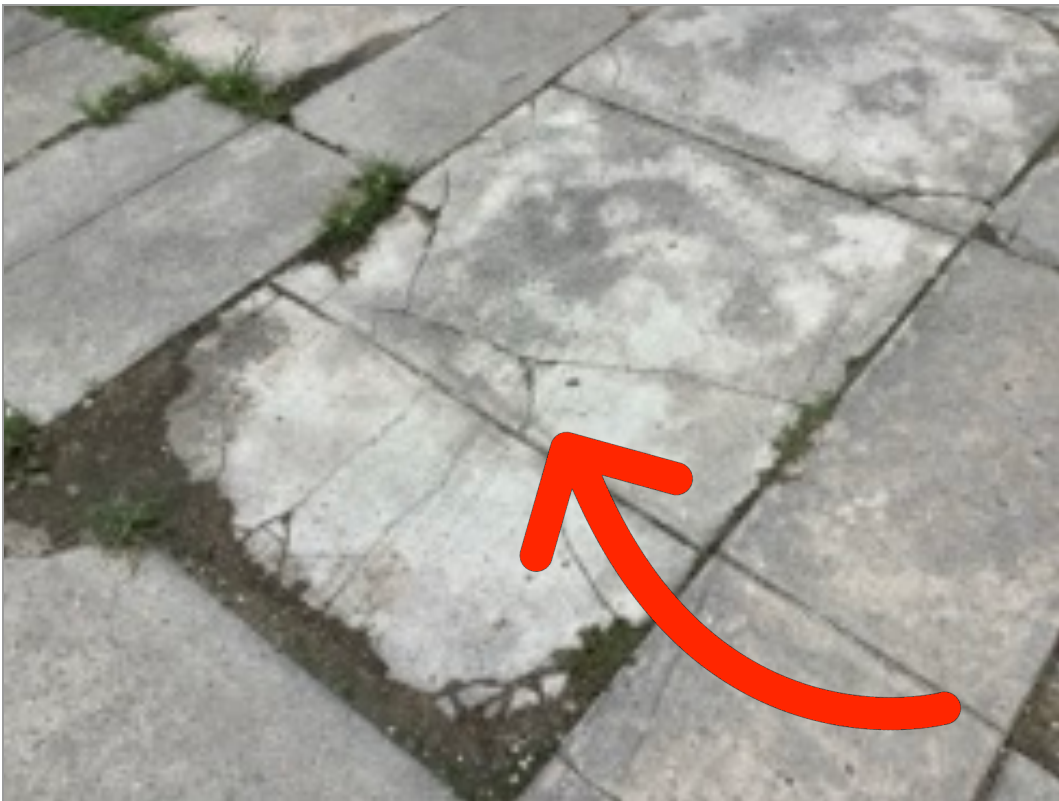
Front Exterior
Driveway
Spider cracks in driveway.

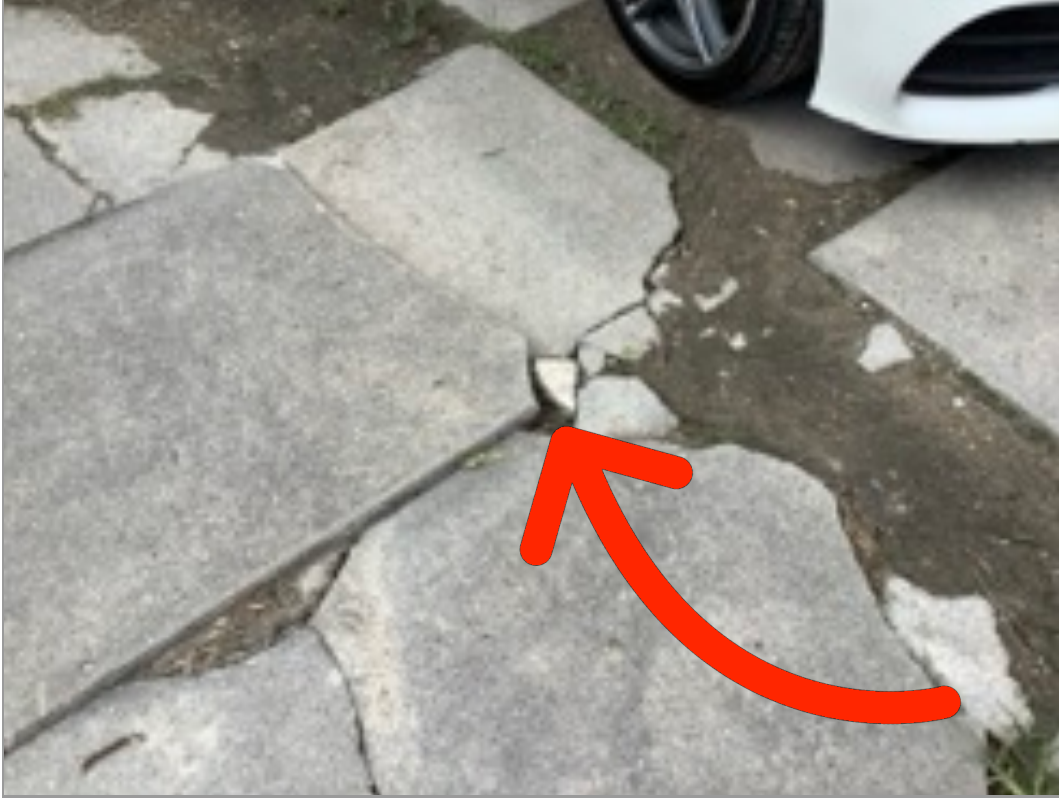
Front Exterior Driveway
Driveway crack appears unlevel (see closeup).

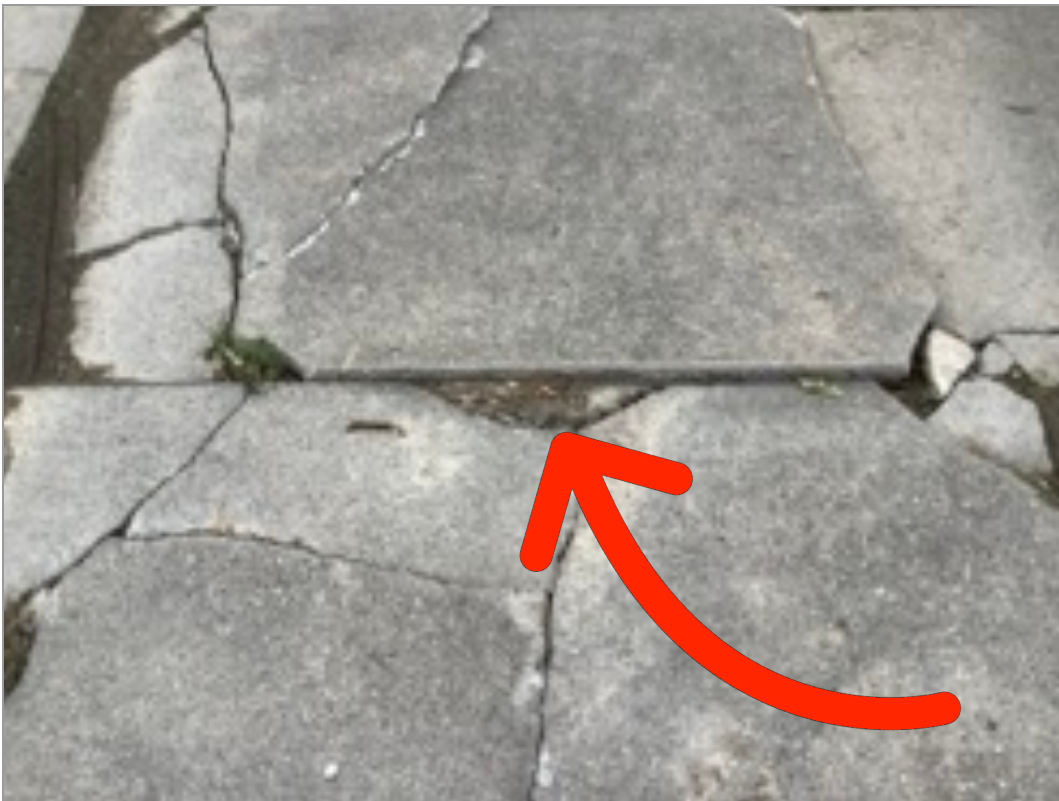
Front Exterior Driveway
Driveway crack appears unlevel (see closeup).

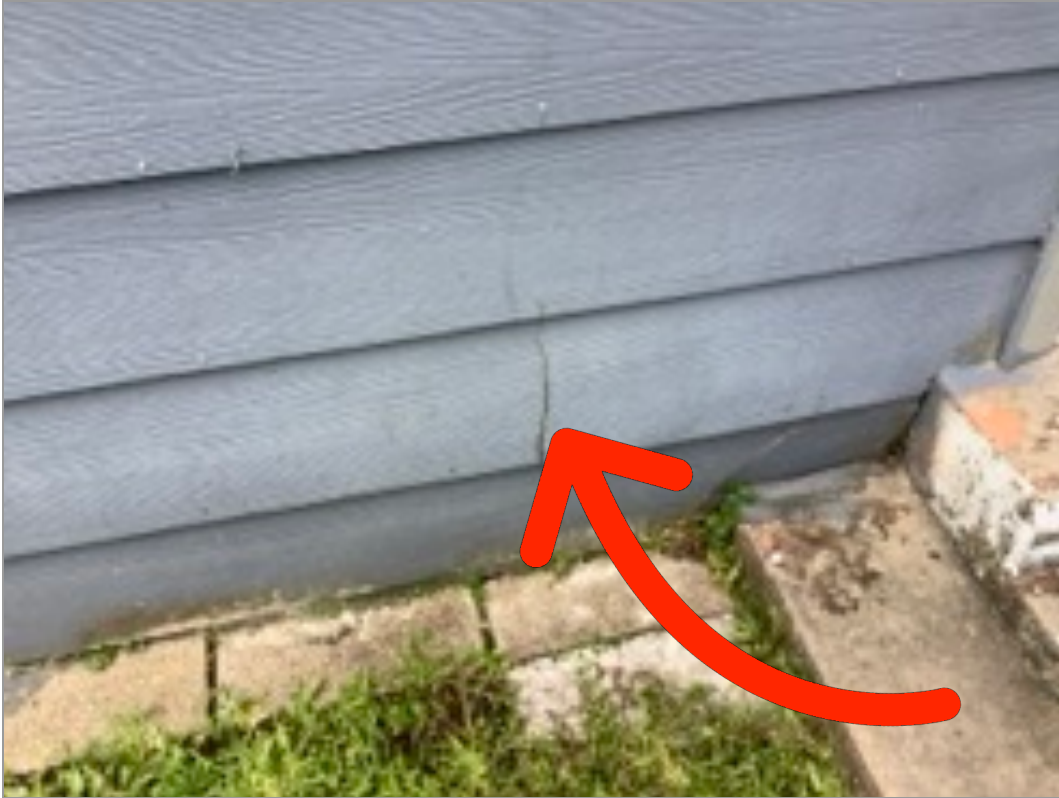
Front Exterior
Walls/Siding/Trim
Siding
warping/pulling
away

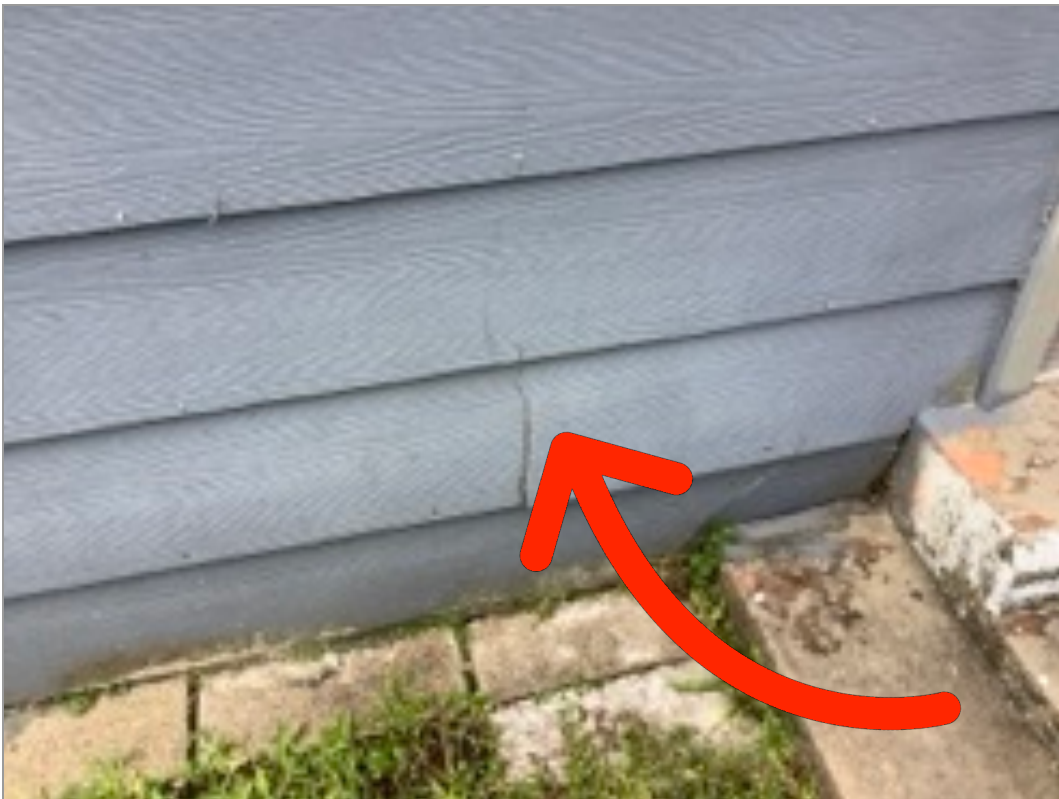
Front Exterior
Walls/Siding/Trim
Cracked/peeling
paint

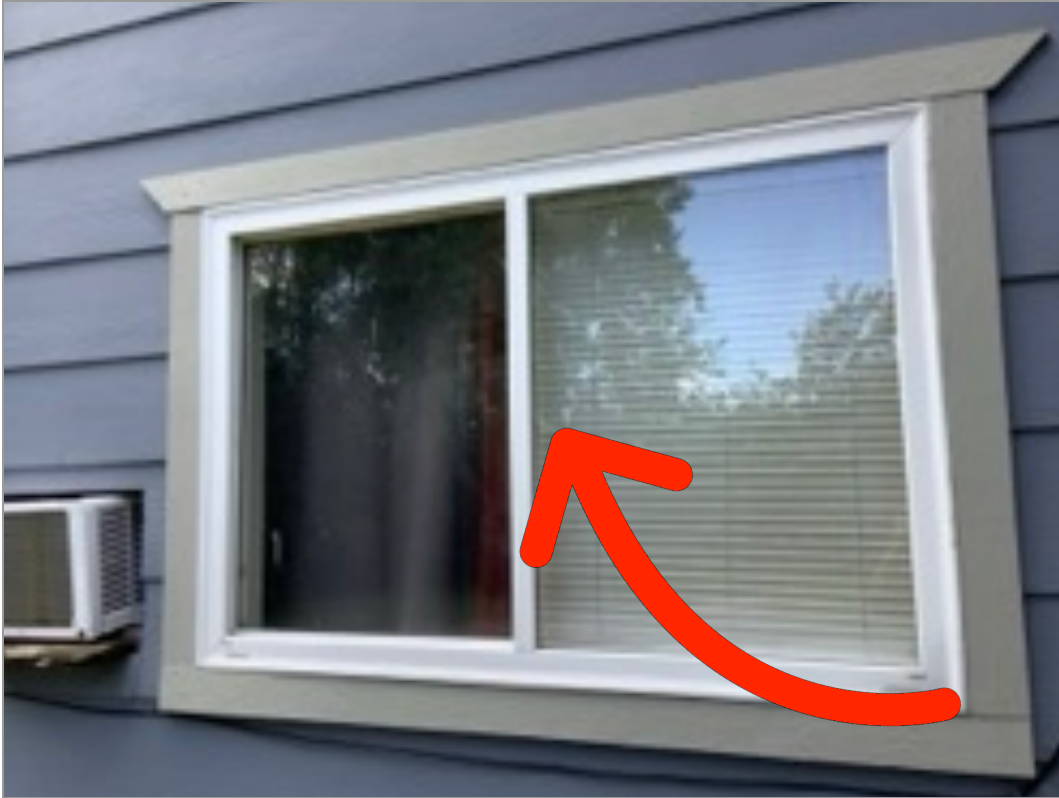
**Front Exterior
Window Screens**
Screen(s) are
missing

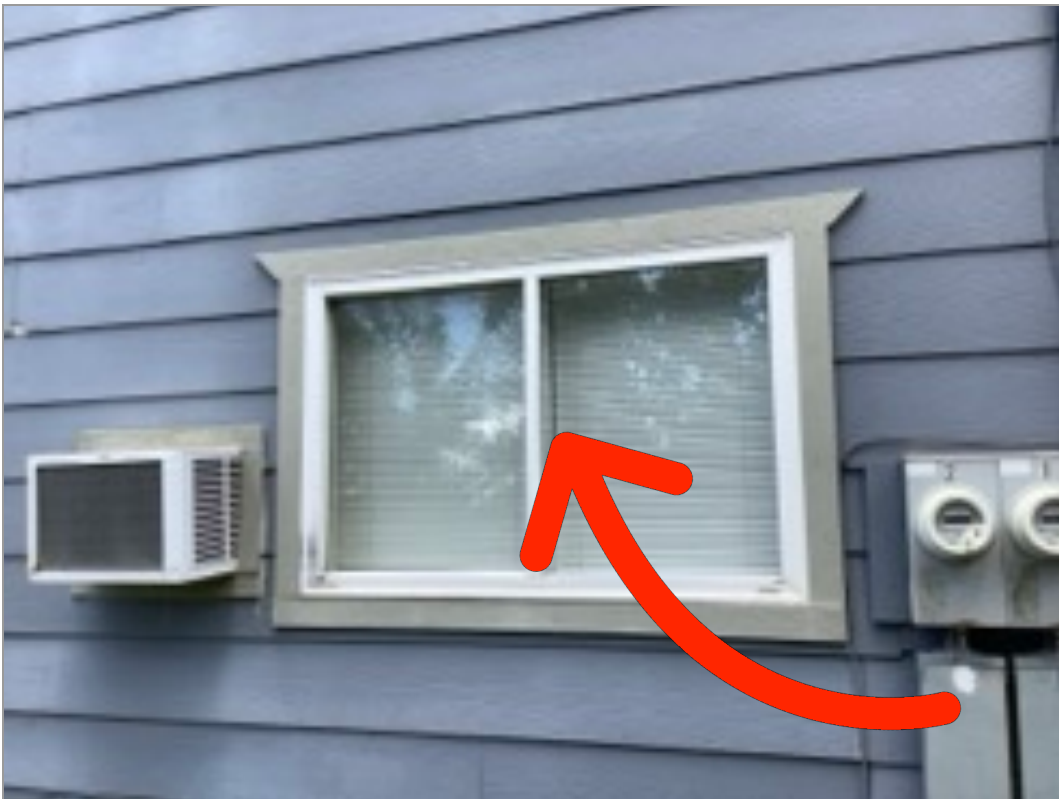
**Front Exterior
Window Screens**
Screen(s) are
missing

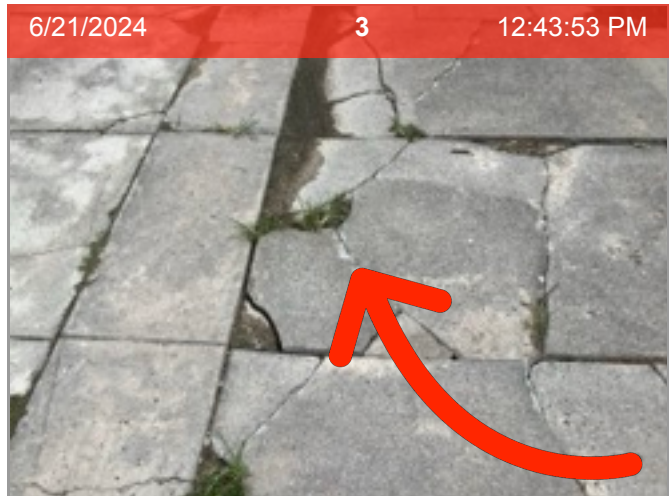
Driveway | Spider cracks in driveway.

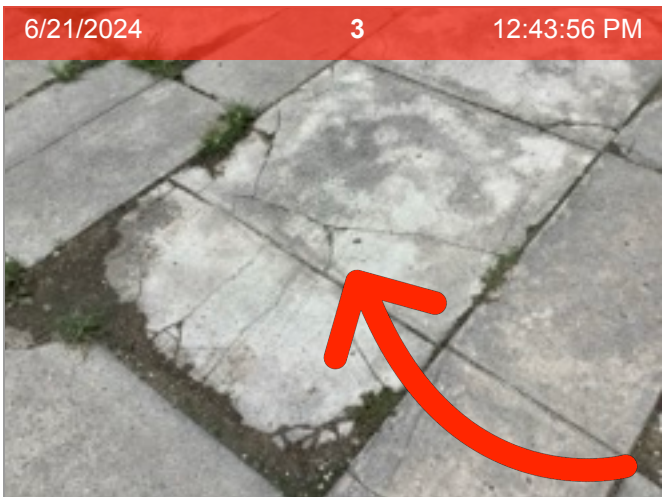
Driveway | Spider cracks in driveway.

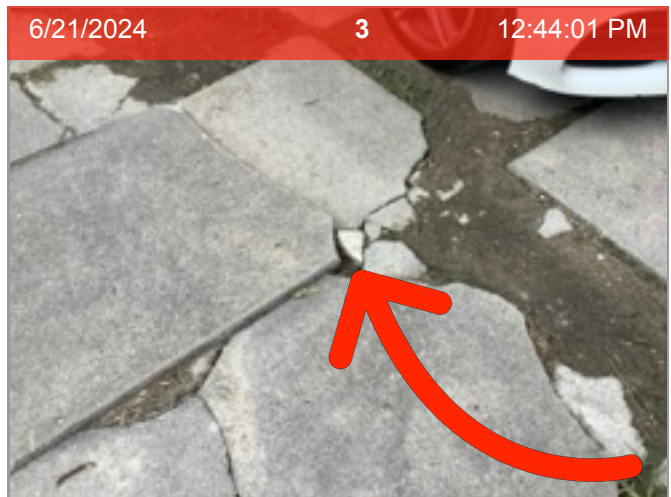
Driveway | Driveway crack appears uneven (see closeup).

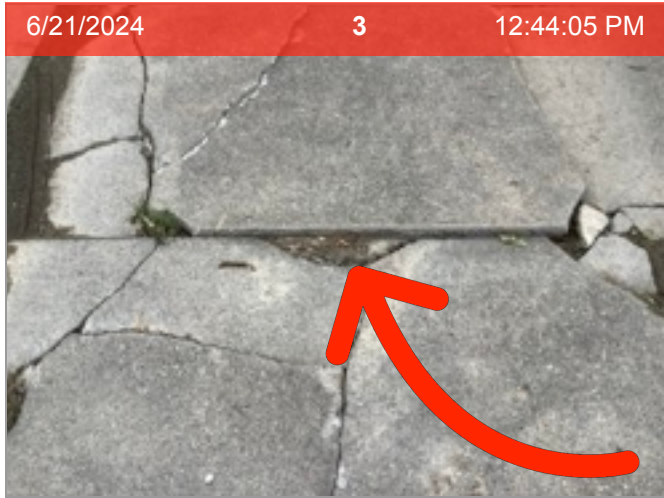
Driveway | Driveway crack appears unlevel (see closeup).

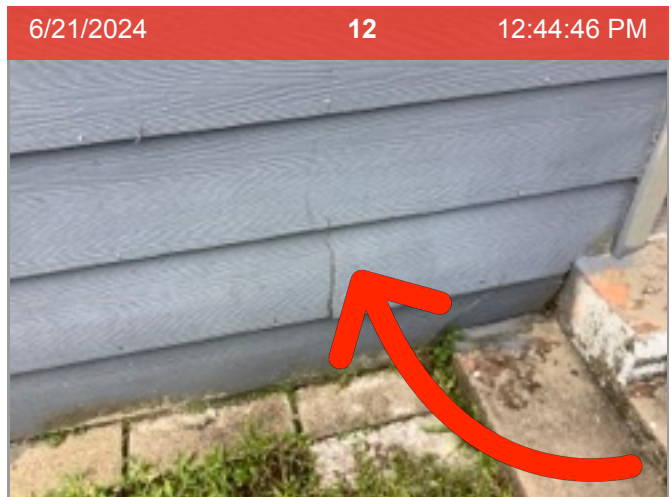
Walls/Siding/Trim | Cracked/peeling paint

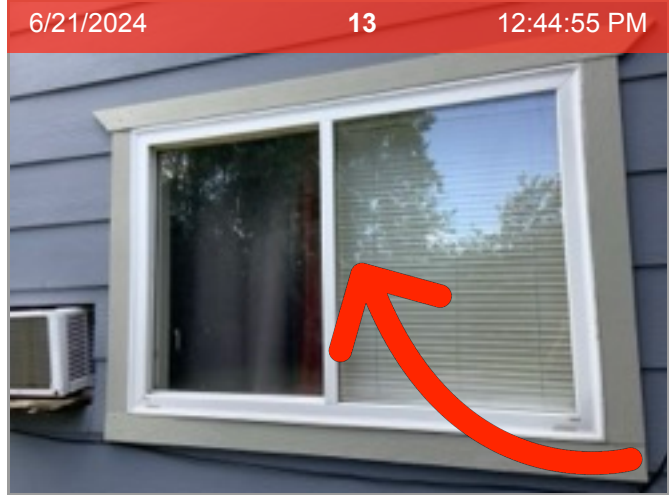
Window Screens | Screen(s) are missing

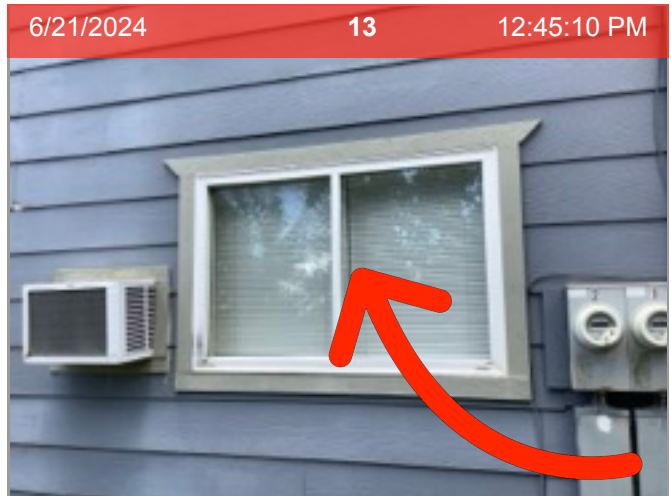
Window Screens | Screen(s) are missing
