Prepared for Emerson Property Management

6/21/2024

711 Avenue A Unit 2

La Marque TX 77568

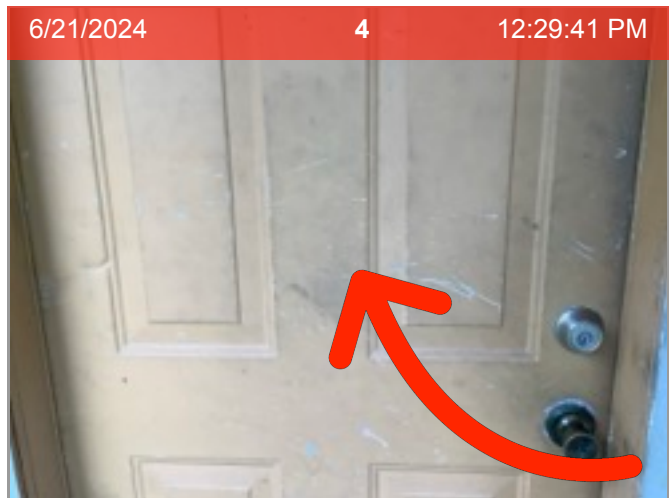
Front Door Exterior | Scratches; stains; discoloration or chipping of door casing

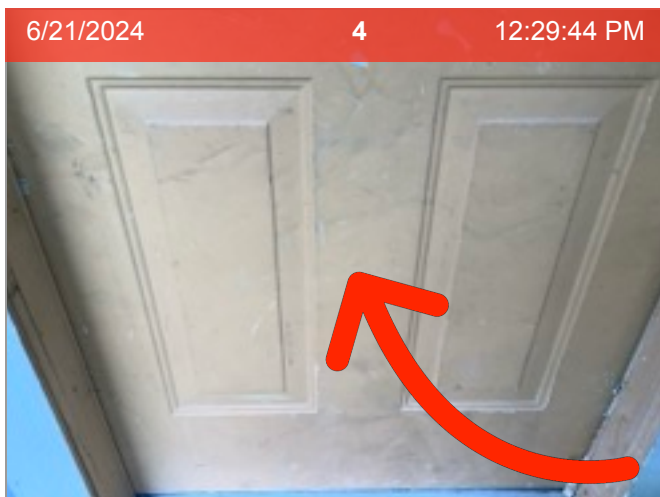
Front Door Exterior | Scratches; stains; discoloration or chipping of door casing

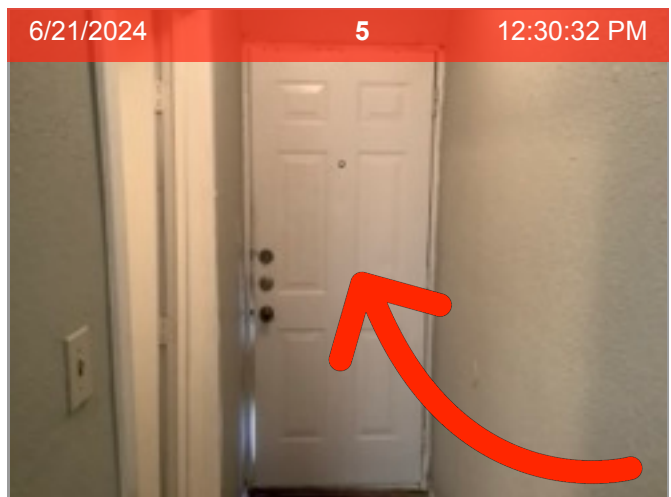
Front Door Interior | Hard to open front door

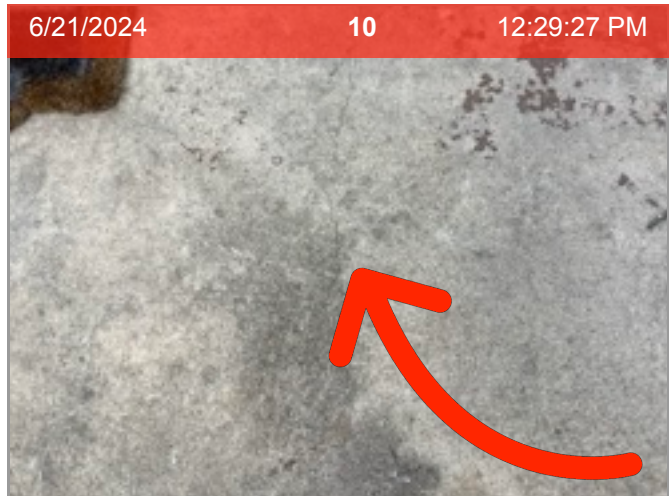
Patio/Porch | Cracks in concrete; damage ; discoloration

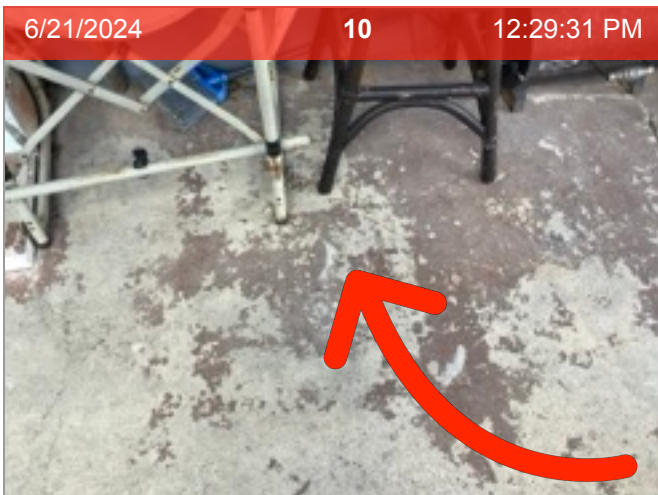
Patio/Porch | Cracks in concrete; damage ; discoloration

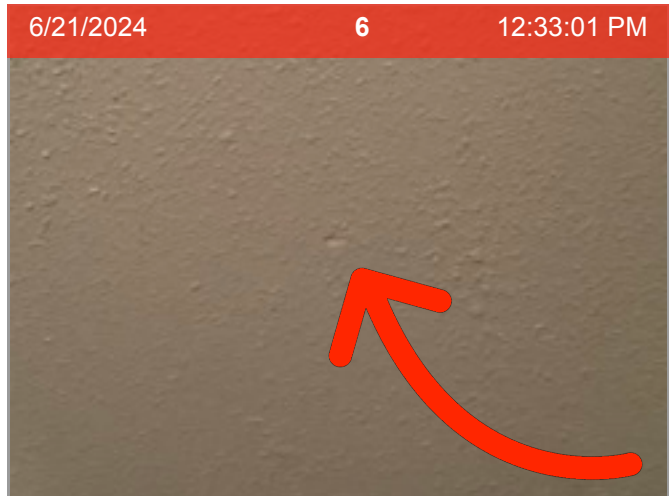
Door Stop | Missing- wall damage noted.

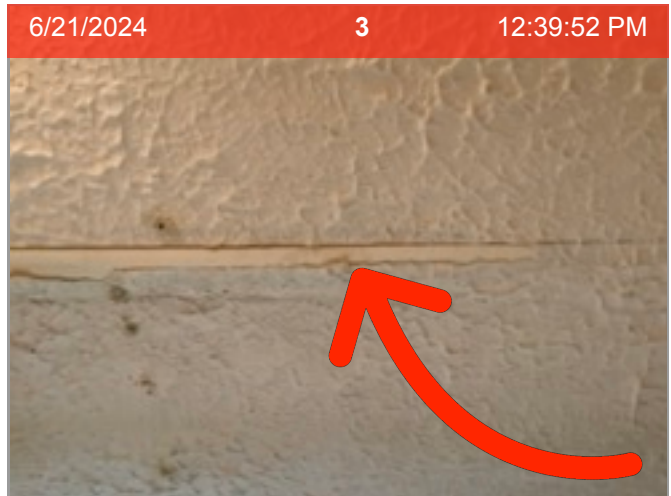
Ceiling | Cracks in ceiling.

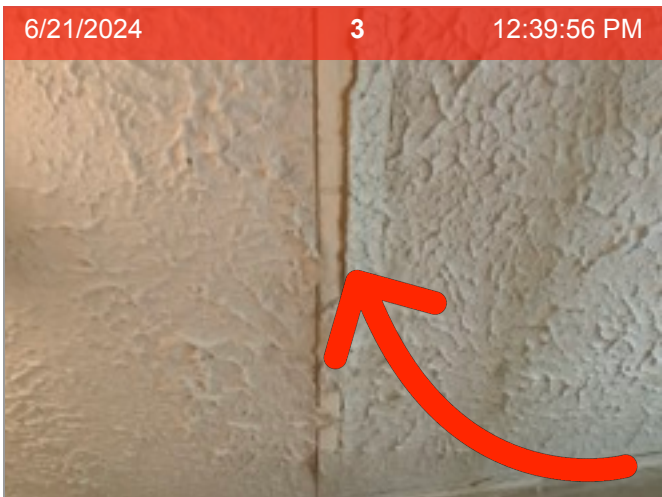
Ceiling | Cracks in ceiling.

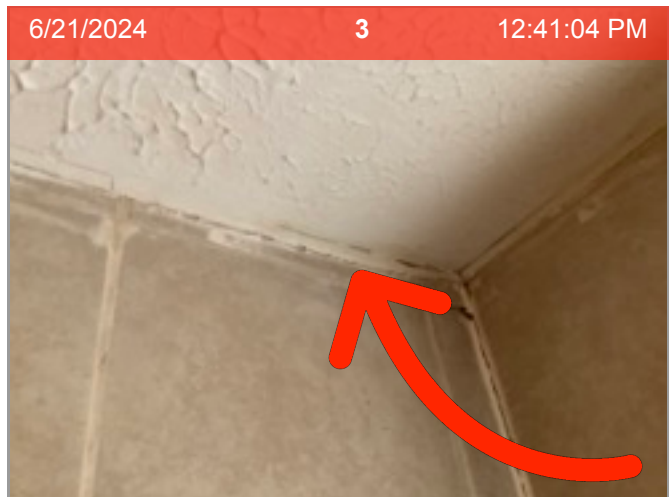
Ceiling | Cracks in ceiling.

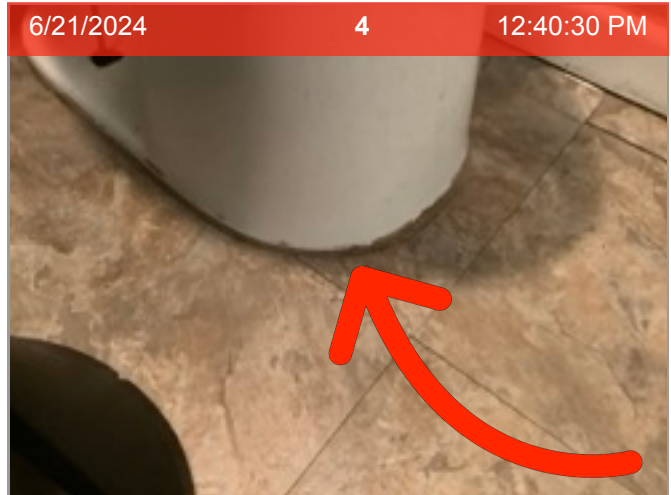
Commode | Seal around bottom of commode is cracking/ discolored.

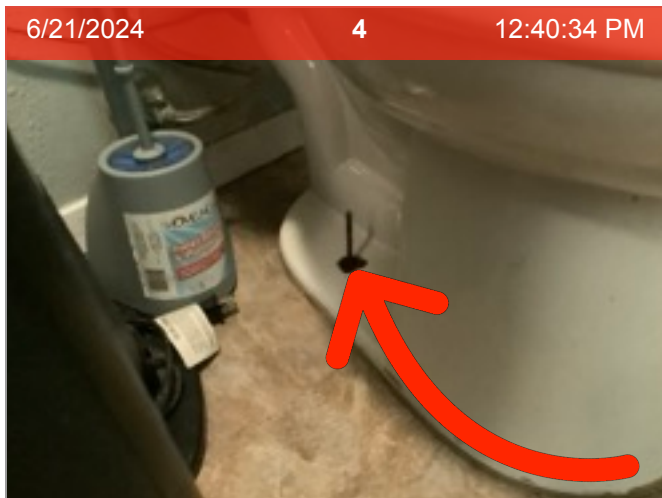
Commode | Bolt caps missing

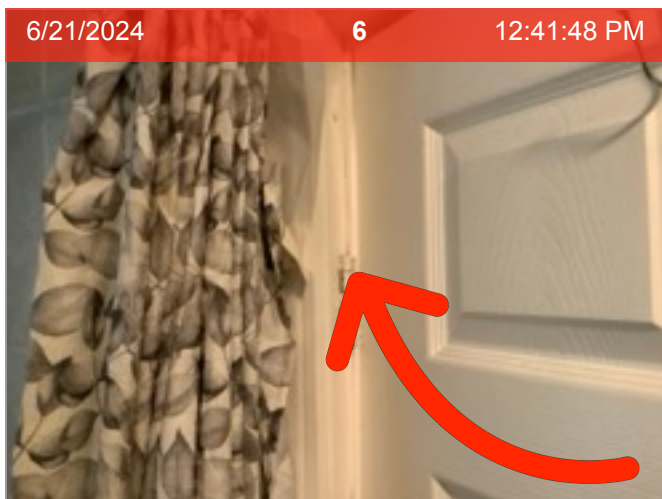
Door Stop | Missing- no wall damage noted.

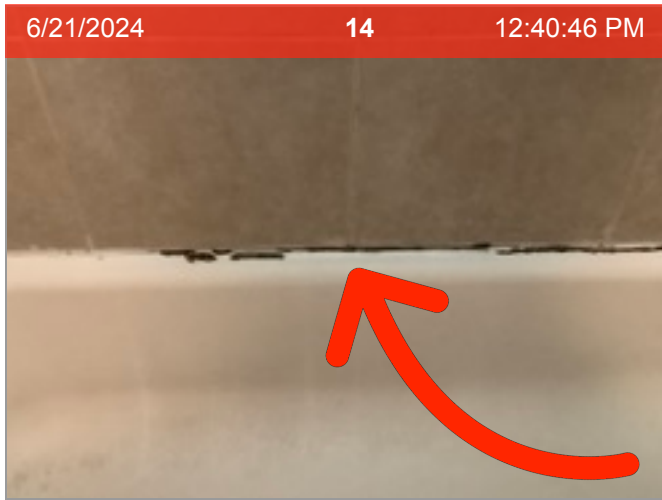
Tub/Fixture | Grout is discolored/cracking

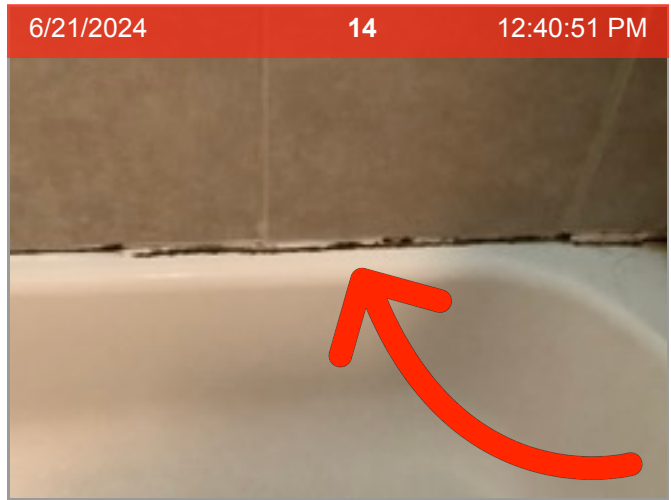
Tub/Fixture | Grout is discolored/cracking
