Move-in Report

Prepared for Emerson Property Management

711 Avenue A #4

La Marque TX 77568

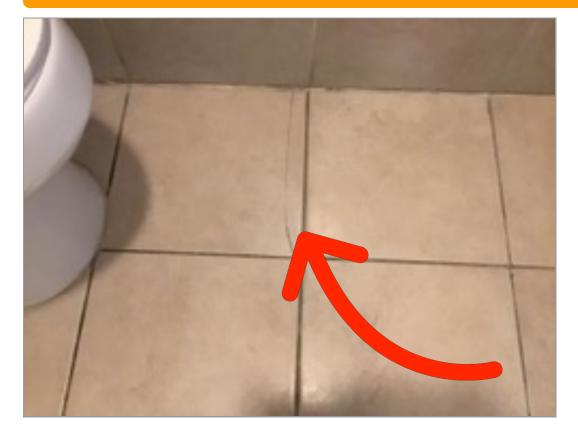
Bathroom 1 Floors Crack in flooring.

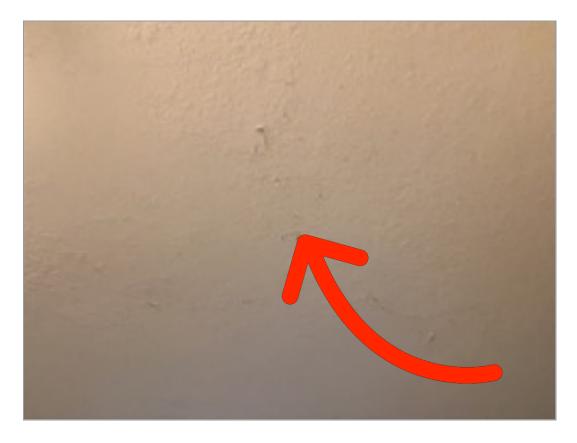
Bathroom 1 Ceiling
Cracks in ceiling.

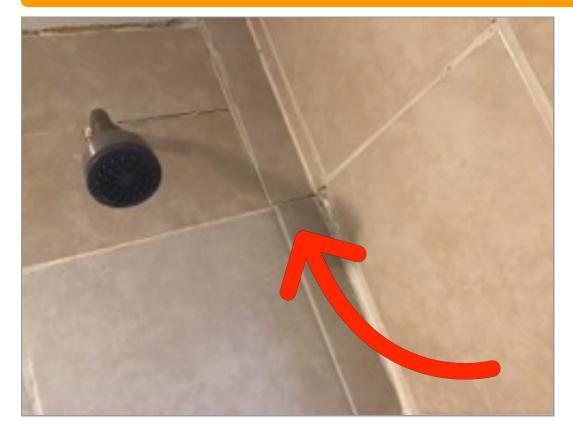
Bathroom 1 Shower/Fixture Grout is dicolored/cracking.

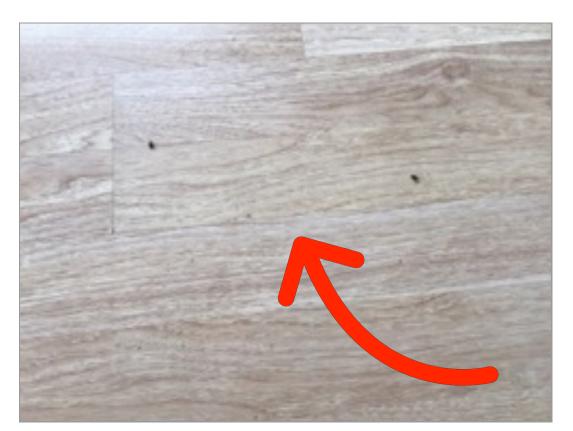
Bedroom 1 Floors Dirty

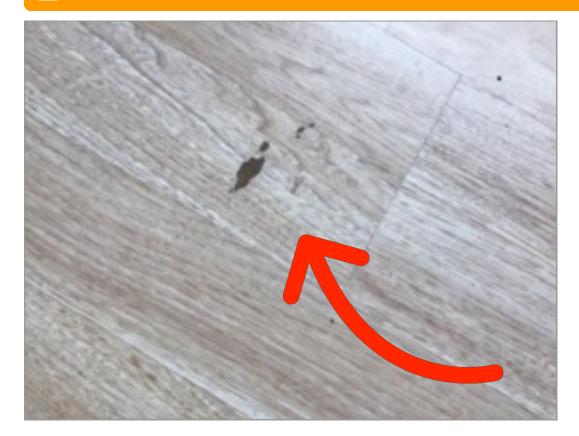
Bedroom 1 Floors Flooring is scratched.

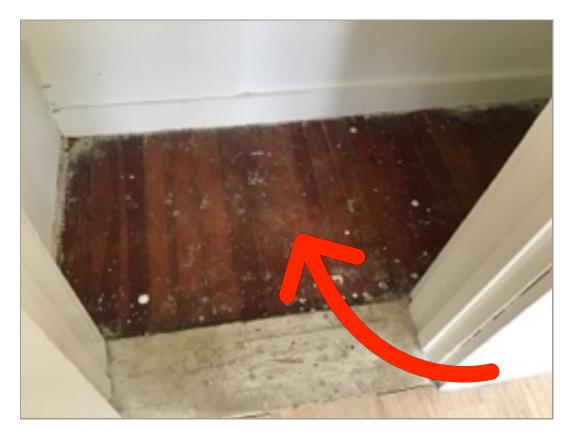
Bedroom 1 Closets Stains on flooring

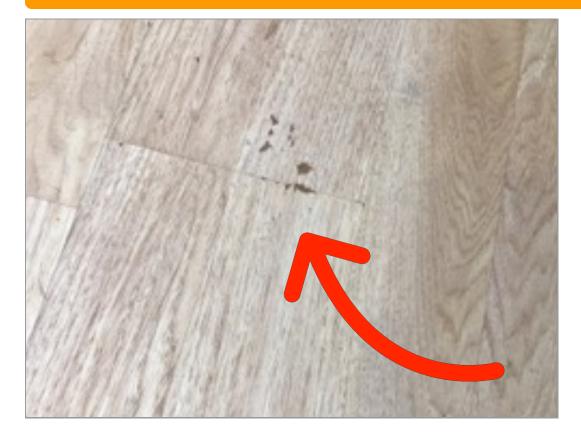
Bedroom 2 Floors Flooring is scratched.

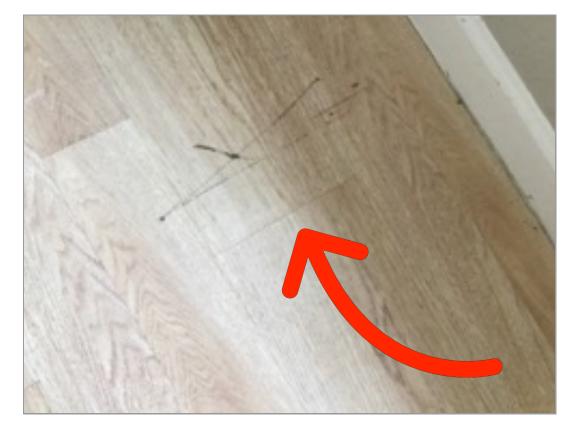
Bedroom 2 Floors Flooring is scratched.

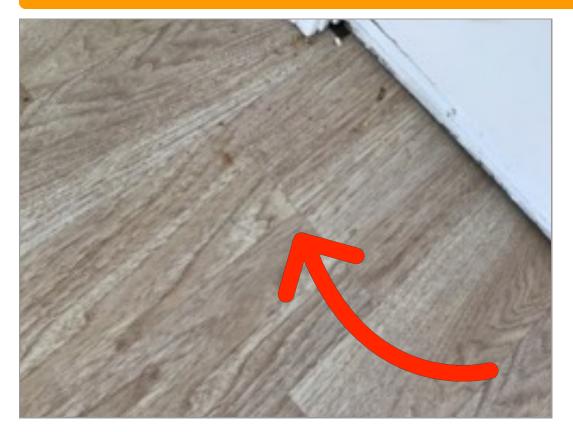
Entry Floors Dirty

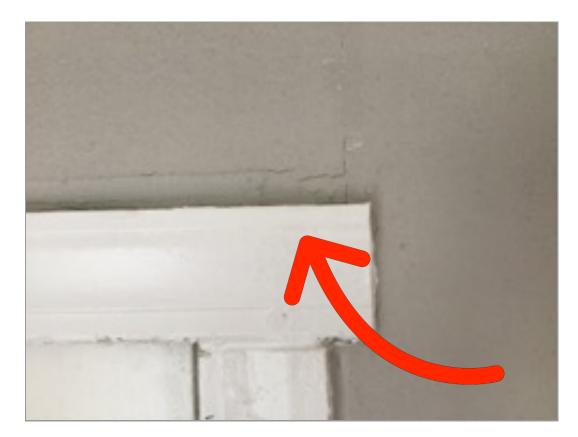
Entry Walls/Paint Cracks in texture

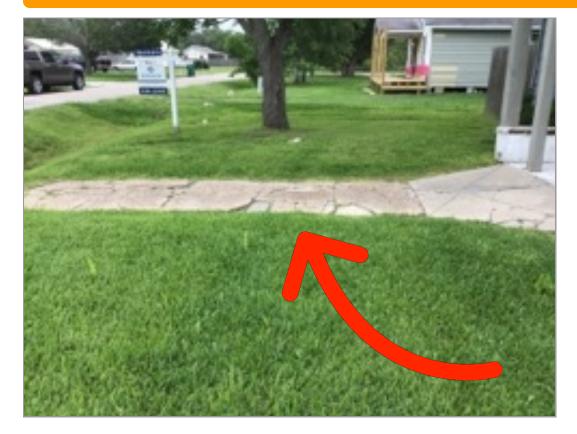
Front Exterior Walkways
Cracked or uneven

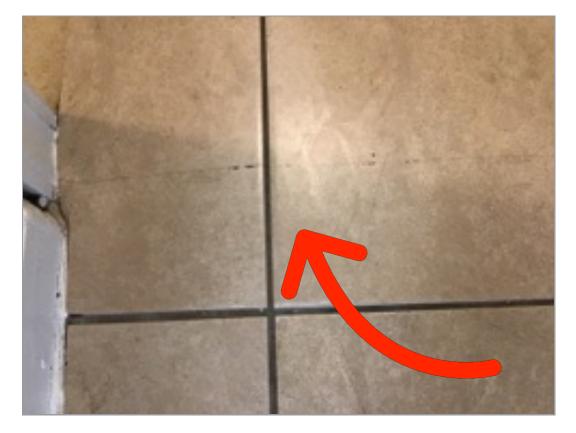
Hallway/Stairway Floors Crack in flooring.

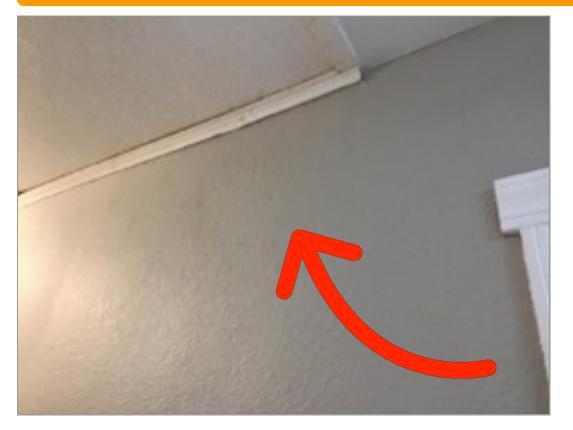
Hallway/Stairway Smoke Alarm Alarm in place

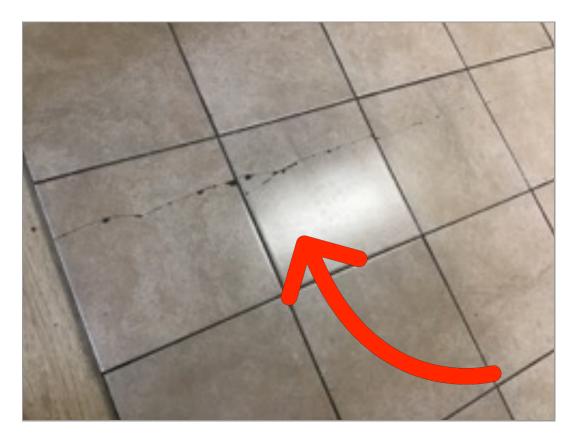
Kitchen Floors Crack in flooring.

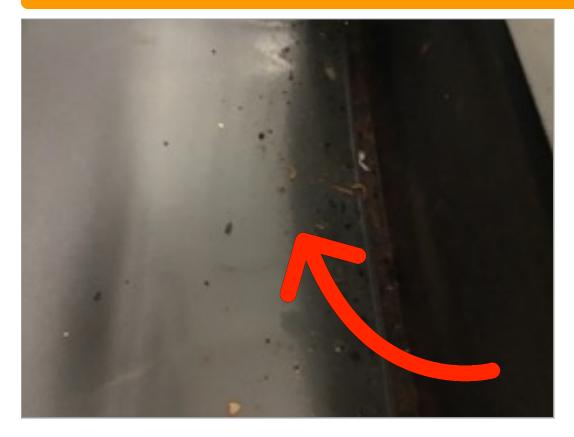
Kitchen Range/Cooktop/Ov Build up

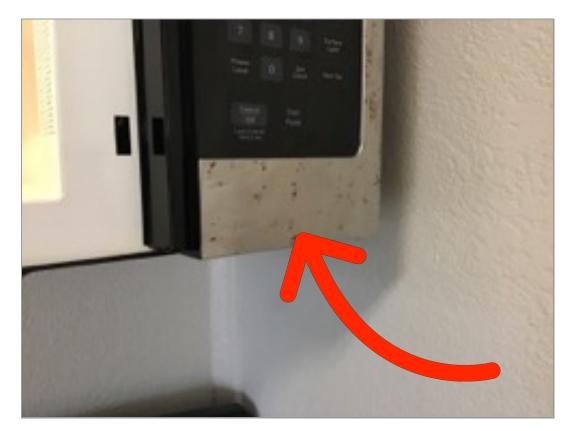
Kitchen Microwave Oven Build up

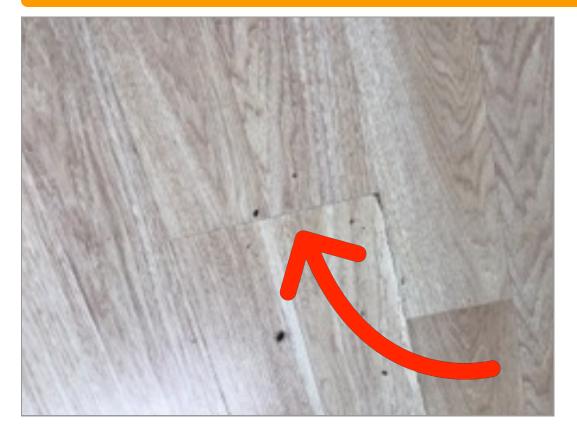
Living Room *Floors*Dirty

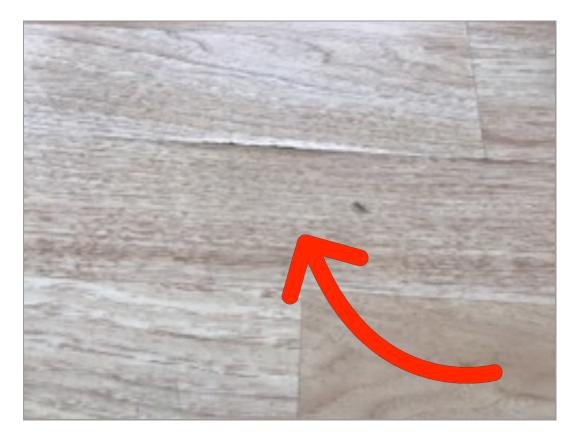
Living Room Floors Crack in flooring.

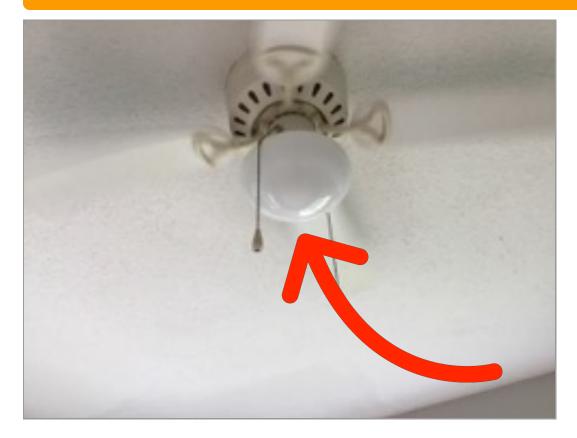
Living Room
Light Fixtures
Light did not turn

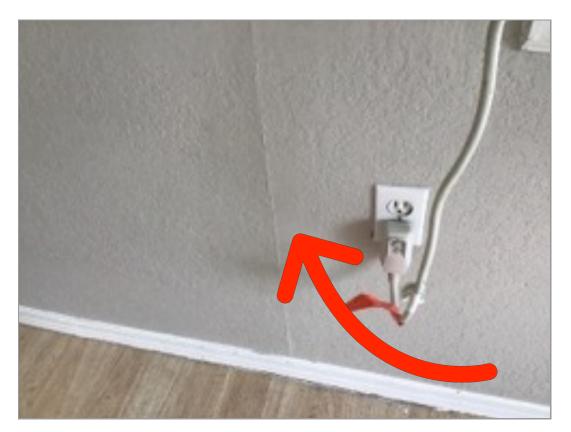
Living Room Walls/Paint Cracks in texture

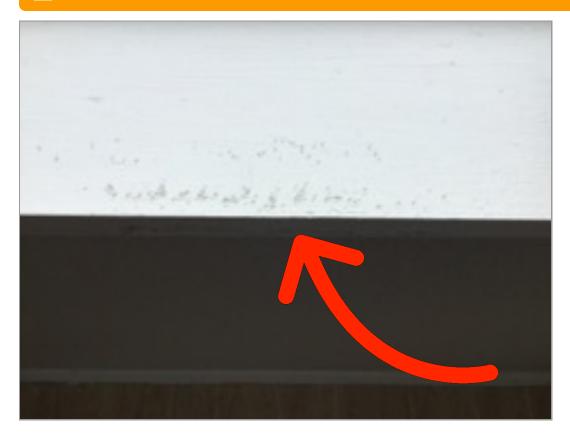
Living Room Windows The window sill is cracking

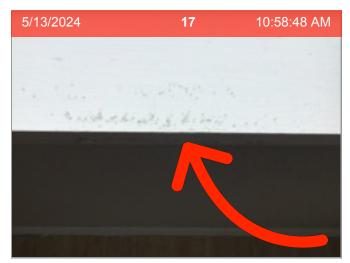
Windows | The window sill is cracking
