## PROPERTY INSPECTION REPORT

Prepared For: Crystal Hawkins  
(Name of Client)

Concerning: 315 South Silvershire Circle , Spring, TX 77381  
(Address or Other Identification of Inspected Property)

By: Tim Carpenter Lic.#: 23947 07/02/2021  
(Name and License Number of Inspector) (Date)

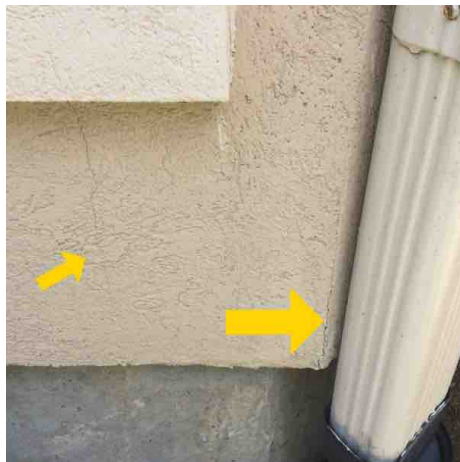
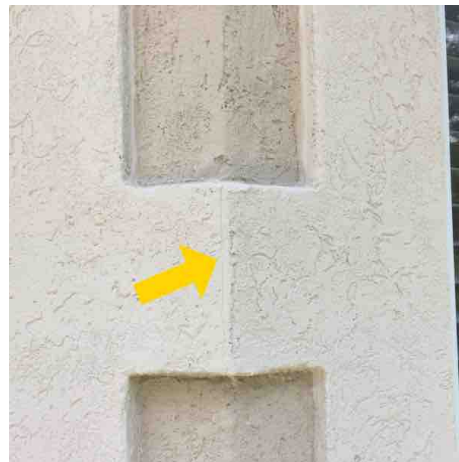
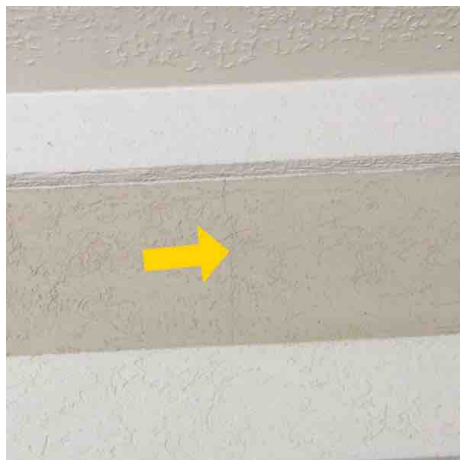
- **Several cracks noted in stucco type finish on exterior walls, these conditions could be conducive to unwanted moisture and insect intrusions. Recommend licensed stucco contractor evaluate and repair.**

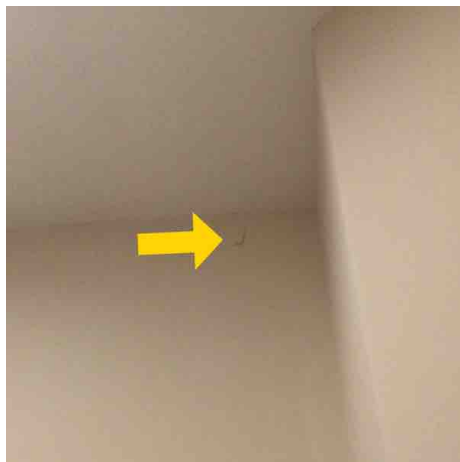
• Drywall flaw noted outside of the office. Recommend licensed contractor repair.

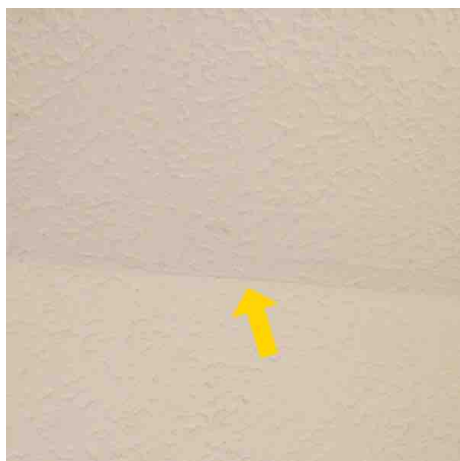
• Typical minor settlement cracks noted, this is typical of structures this age and should be considered cosmetic in nature.

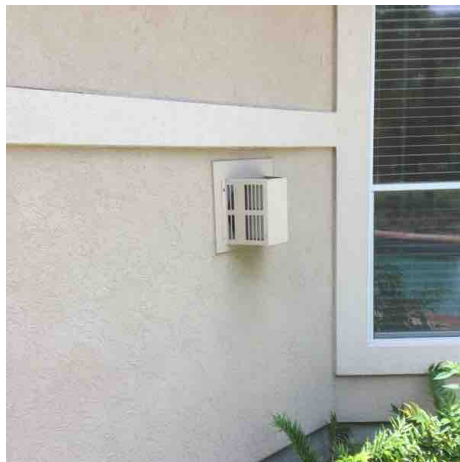
- **Safety Note: Exhaust vent is located on the rear wall, approximately 4 feet from the ground. Recommend installing a safety cage around the vent to prevent accidental contact by young children.**

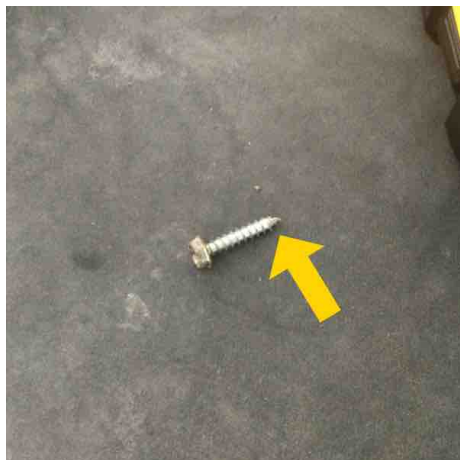
- **Non-standard screws being used to hold inner security cover, screws have sharp points and can pose a wire intrusion issue.**

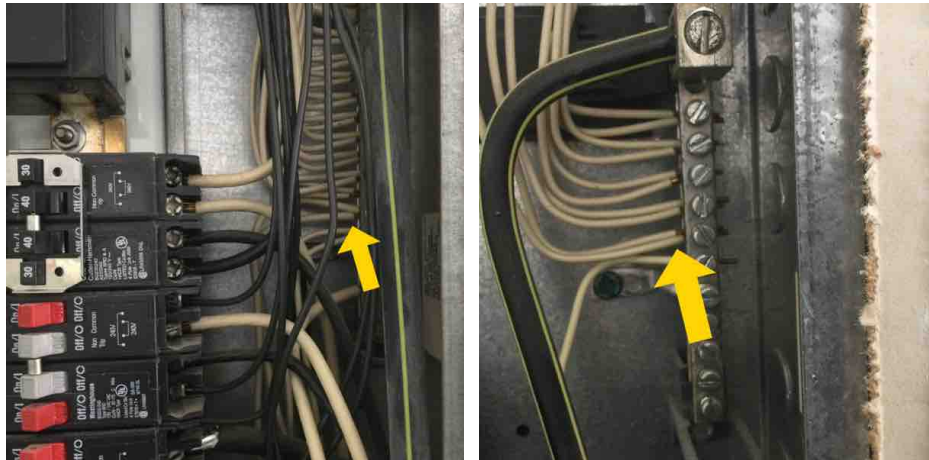
• Double lugging of neutral wiring observed at bus bar (multiple wires per screw down port). This condition does not meet current electrical standards. No more than one wire per port is considered proper. Recommend further evaluation by a qualified electrical contractor to make repairs as needed

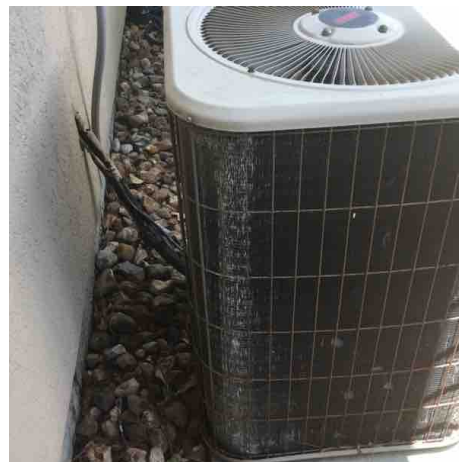
• Fins on Condensing unit are damaged which lowers efficiency. Unit #1

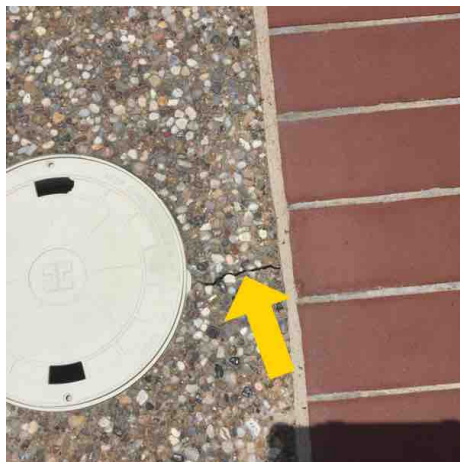
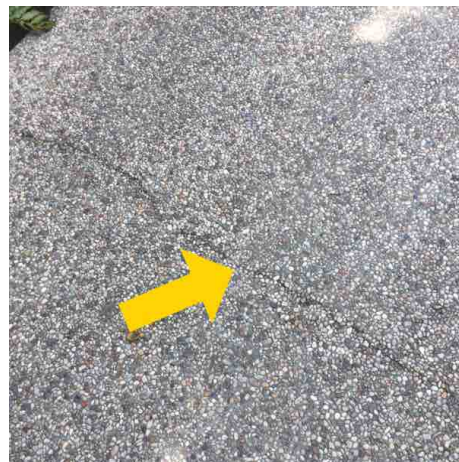
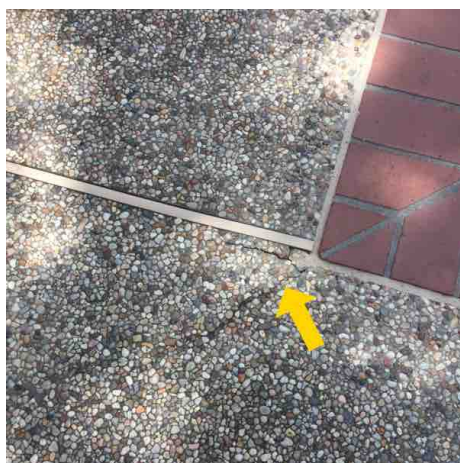
• Minor cracks were observed on Decking/coping. Recommend sealing to prevent moisture intrusion.

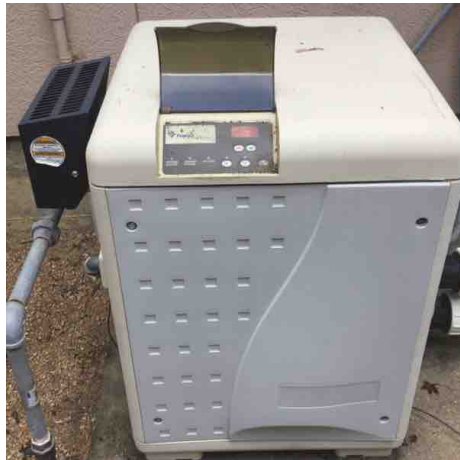
- **Pool/spa heater did not function properly.**

**Recommend that a qualified pool contractor/service review pool structure and equipment and rectify all affected areas as necessary to promote overall best and safe operation/function.**

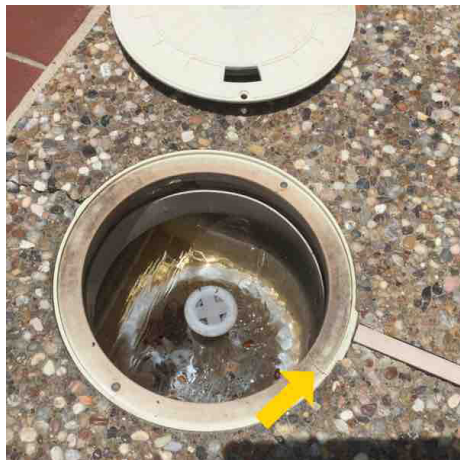
- **Skimmer is cracked/broken, have repaired or replaced.**

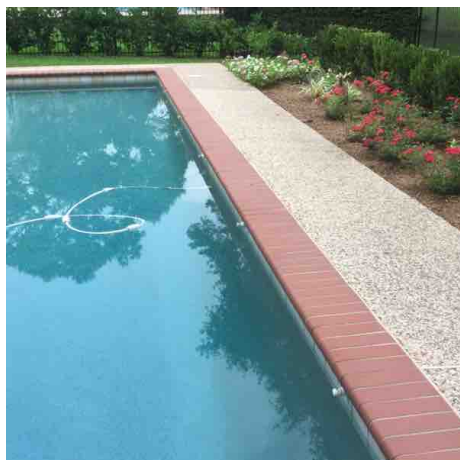
- **Water feature did not function properly.**
