Inspection Report

Property Address:
16018 Limestone Lake Dr
Tomball TX 77377

Sunbelt Inspections

PROPERTY INSPECTION REPORT FORM

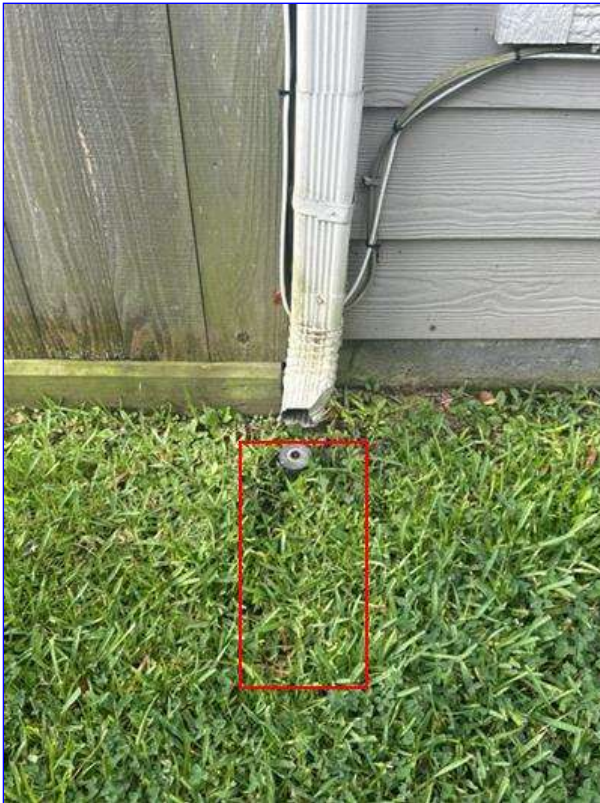
Concrete splash blocks or downspout extensions, are absent at some gutter downspouts. Gutter downspouts should discharge a minimum of 18" away from the foundation.

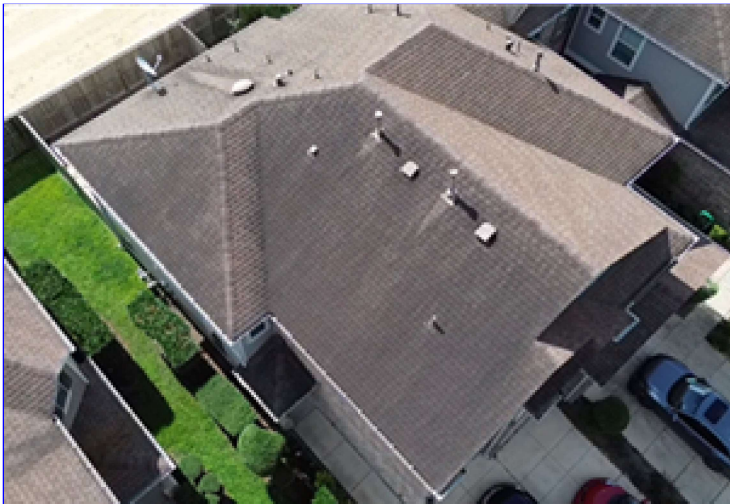
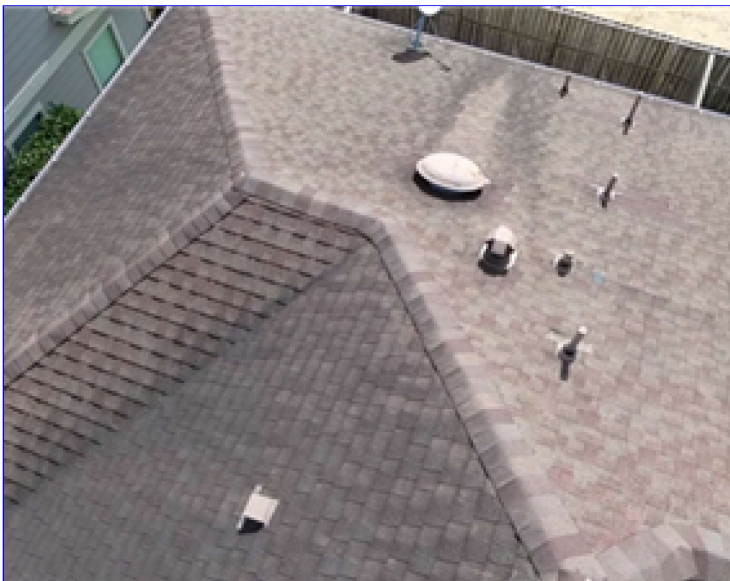
(1) The roof covering, is not new and shows signs of wear consistent with its age. No signs of any current moisture penetration into the structure were observed. This type of architectural style composition shingles typically lasts about 20 years in this climate.

A general seal up of roof penetrations, exposed nail heads and flashings is recommended as routine maintenance.

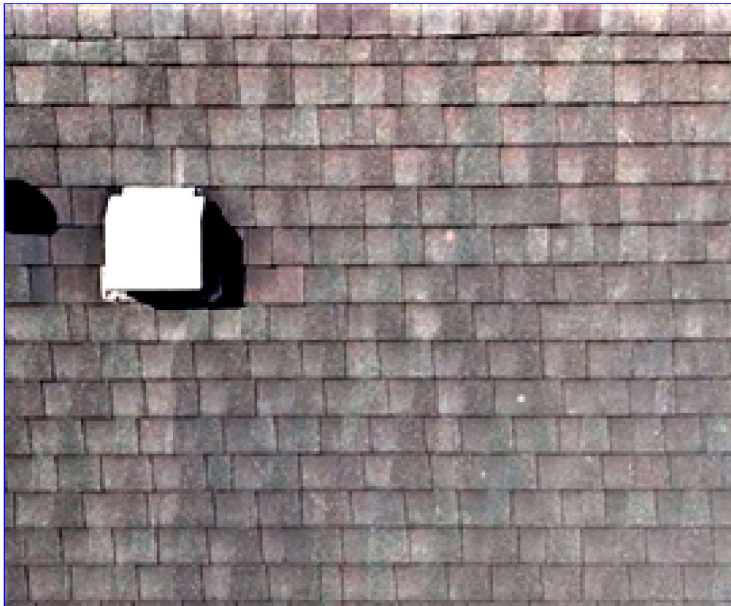
(2) Areas of possible hail damage were observed.

I recommend, you consult with a competent and qualified roofing contractor to evaluate further, determine the best repair methods, estimate costs, and to perform the repairs.

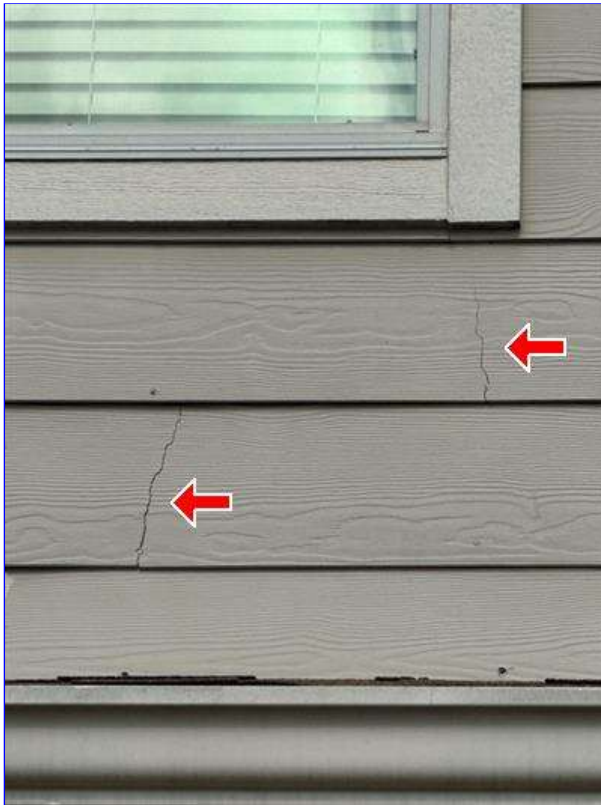
(1) At the back of the home, two cracked pieces of siding were observed.

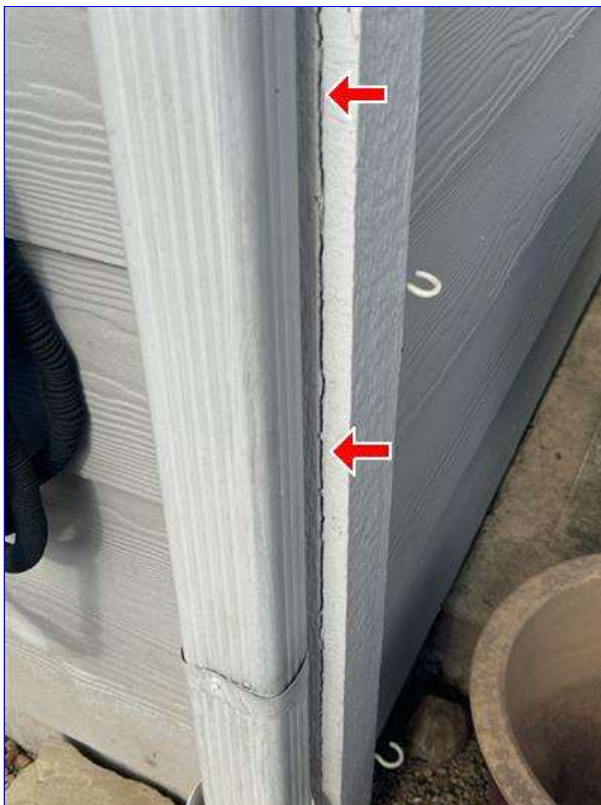
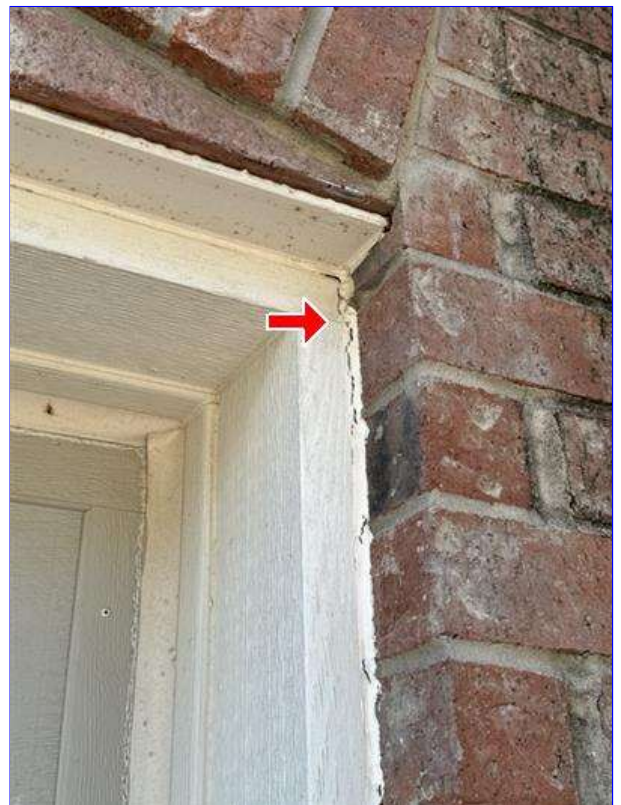
(2) Areas were observed, where the brick, stone, stucco, siding and/or trim needs to be sealed.

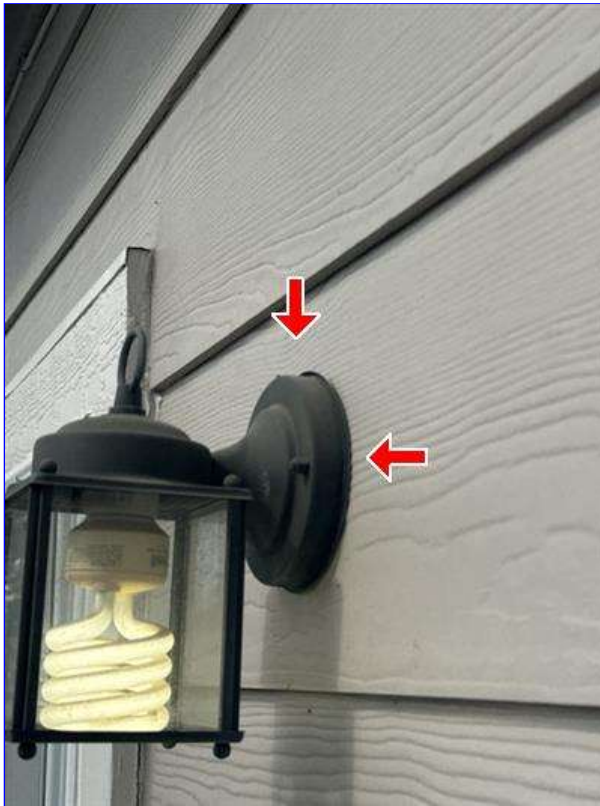
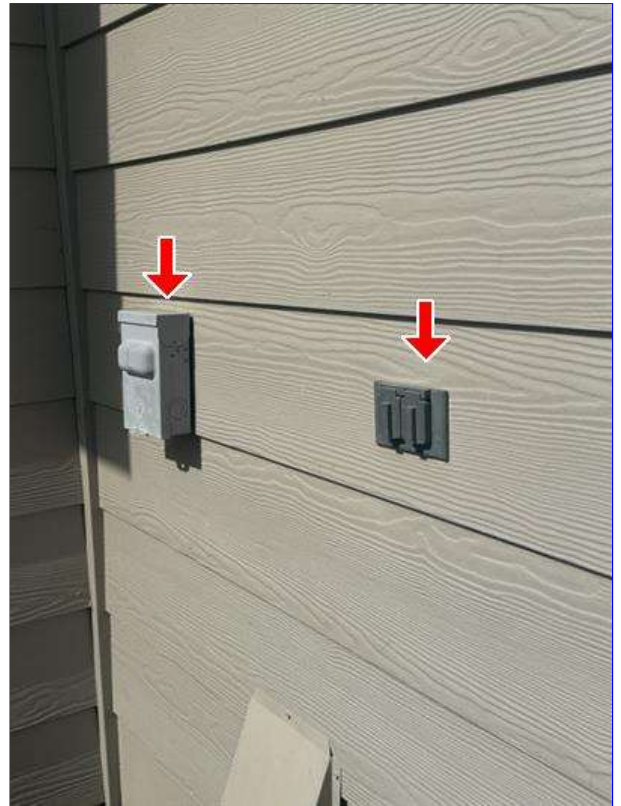
(3) All exterior electrical panels, outlets and wall fixtures need to be sealed at the wall.

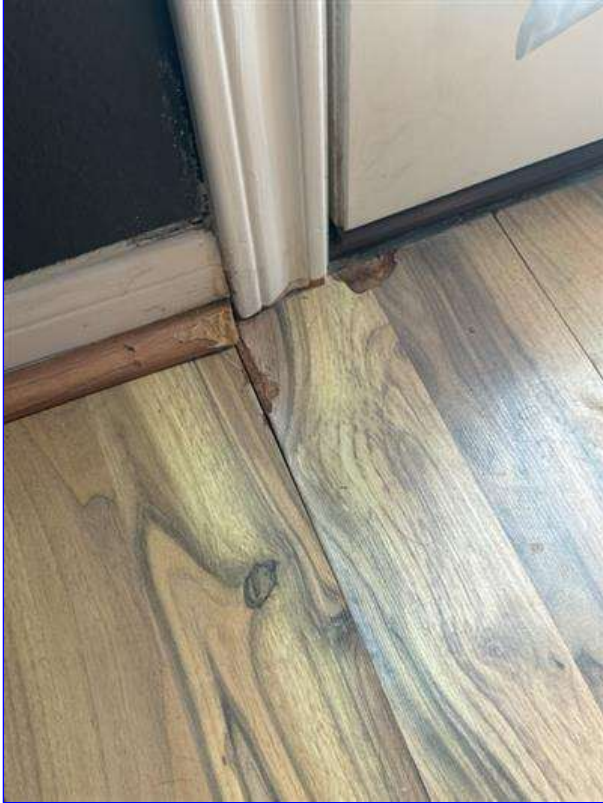
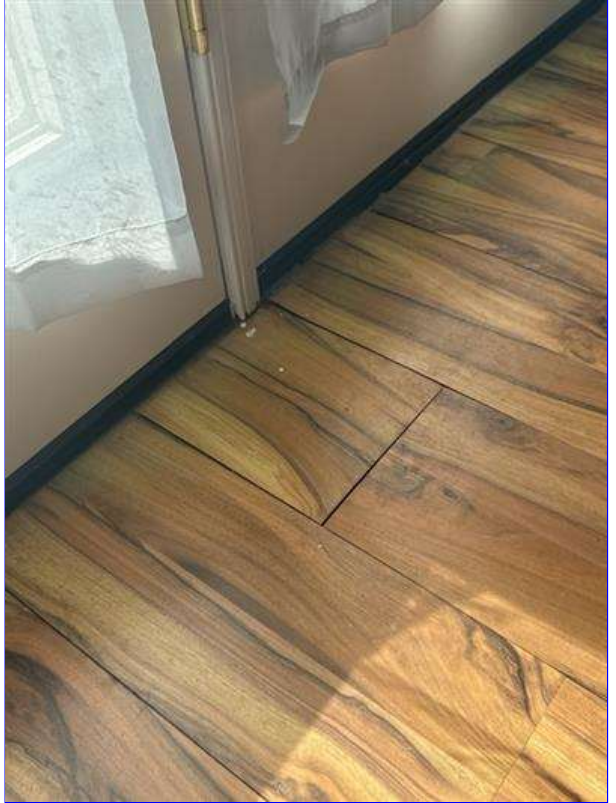
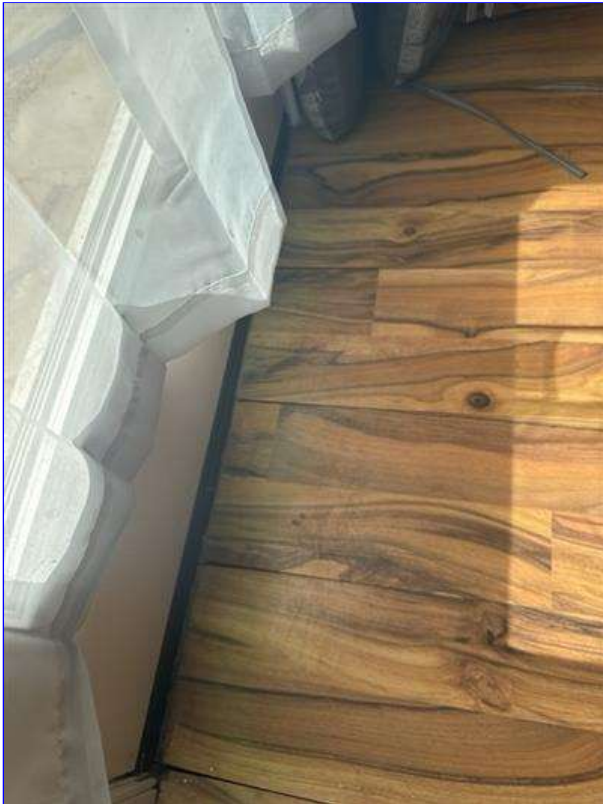
Areas of previous moisture damage was observed around the back door.

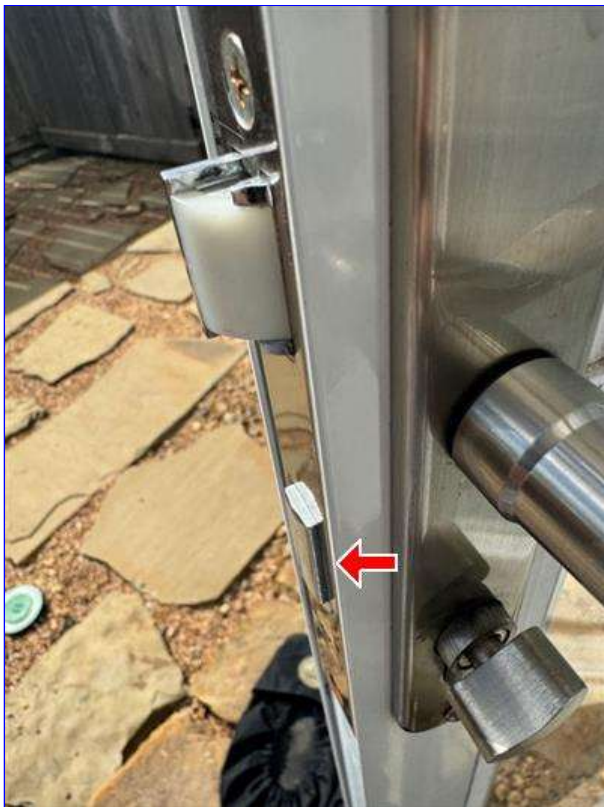
(1) The back, storm door is rubbing the frame at the top and the lock does not fully retract, causing the door to stick.

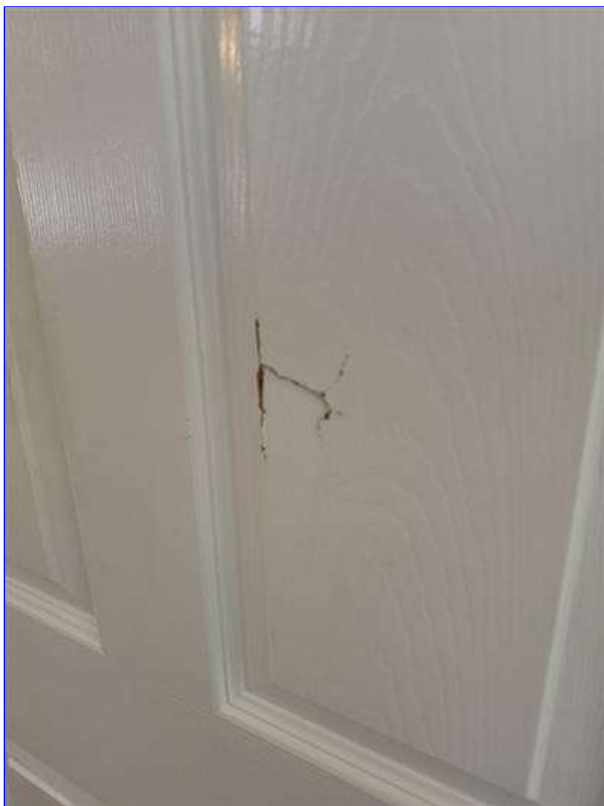
(2) The upstairs front left bedroom door does not latch and damage was observed on the door.

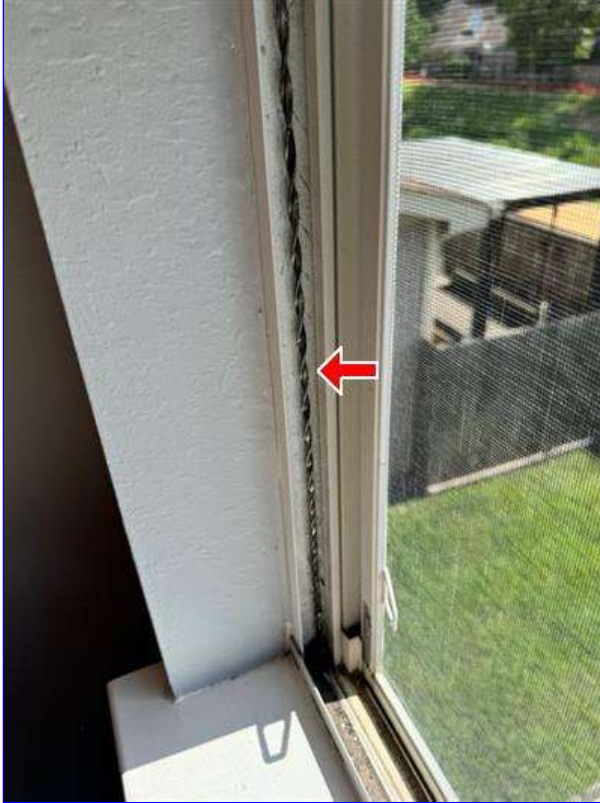
In the primary bedroom, on the back wall, the window on the left has a loose window spring.

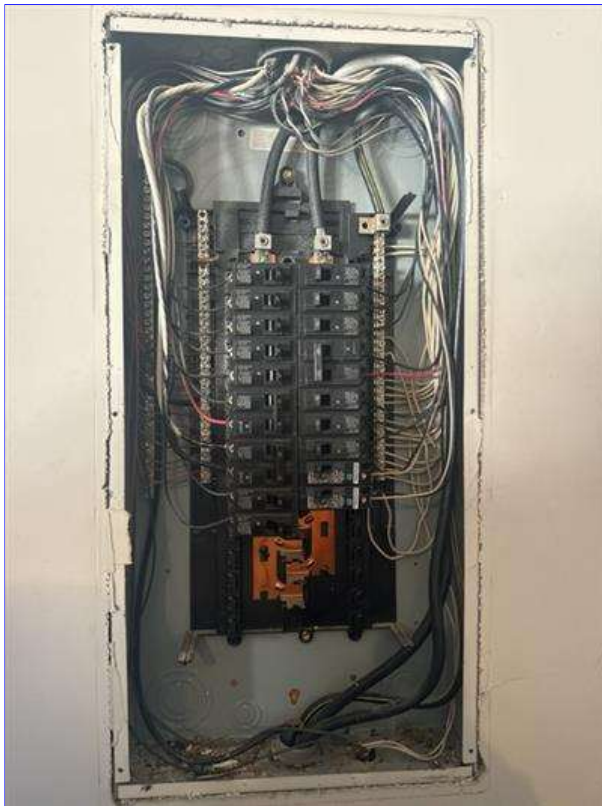
(1) The main electrical service panel, shown with dead front cover removed for inspection purposes. The panel inspected okay.

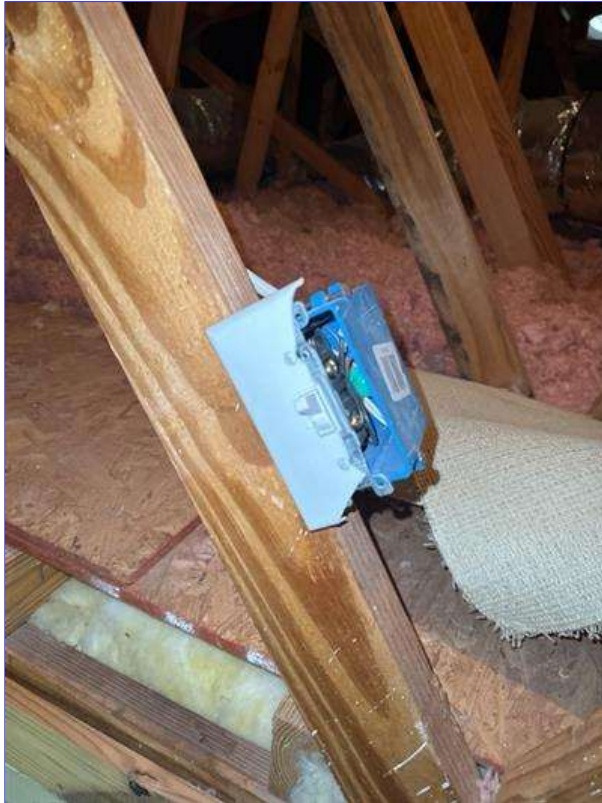
(4) There are damaged/missing receptacle/switch, cover plates. These plates should be replaced for safety reasons.

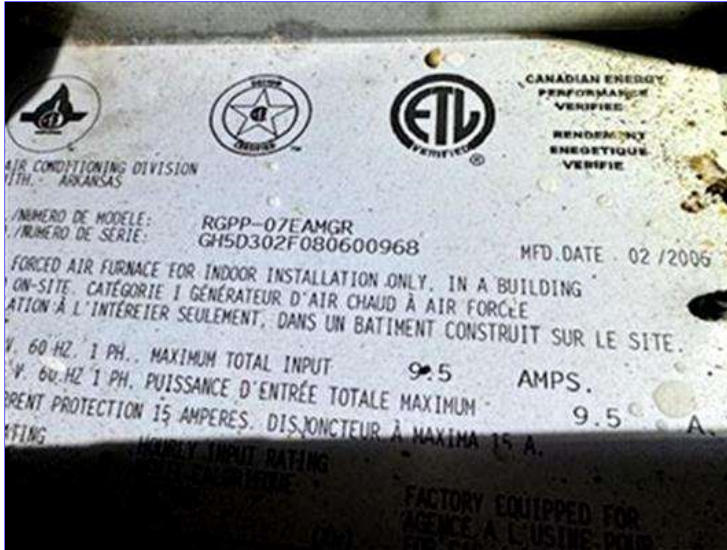
(1) Furnace service tag(s).

Manufacture date(s); 2006

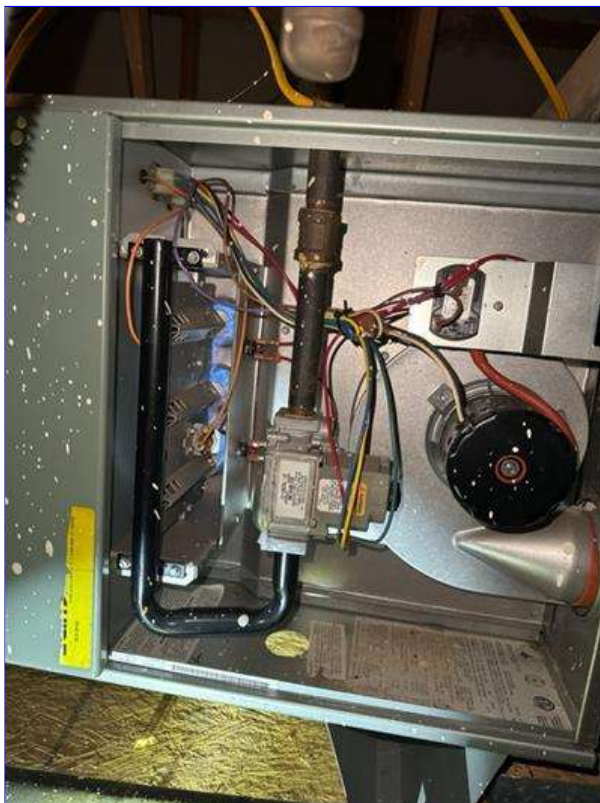
(2) The unit appeared to operate normally using the standard controls. I could not determine if the heat exchanger is cracked or not without dismantling the furnace. Dismantling of components is outside of the scope of a standard home inspection.

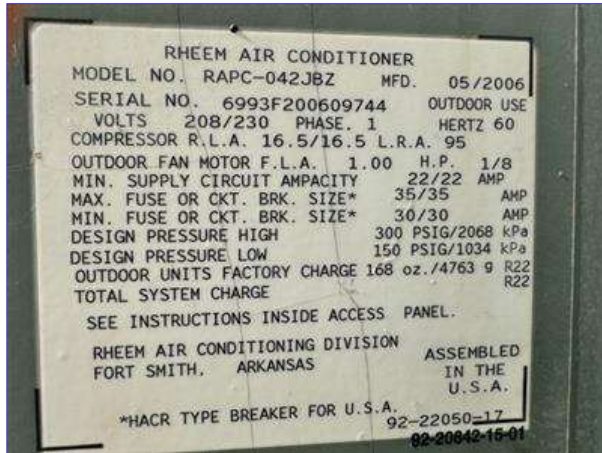
Central Air Manufacturer: RHEEM
Type of Systems: Air conditioner unit
A/C Tonnage: 3.5 Ton
A/C Amperage: 30 AMPS
Comments:
(1) Air Conditioning service tag(s).

Manufacture date(s); 2006

The compressor(s) (outside AC unit) appears to be the original unit(s) installed when the house was built. With proper annual maintenance, modern compressor units can last 15+ years. I cannot determine how long your AC will last before a replacement is necessary.

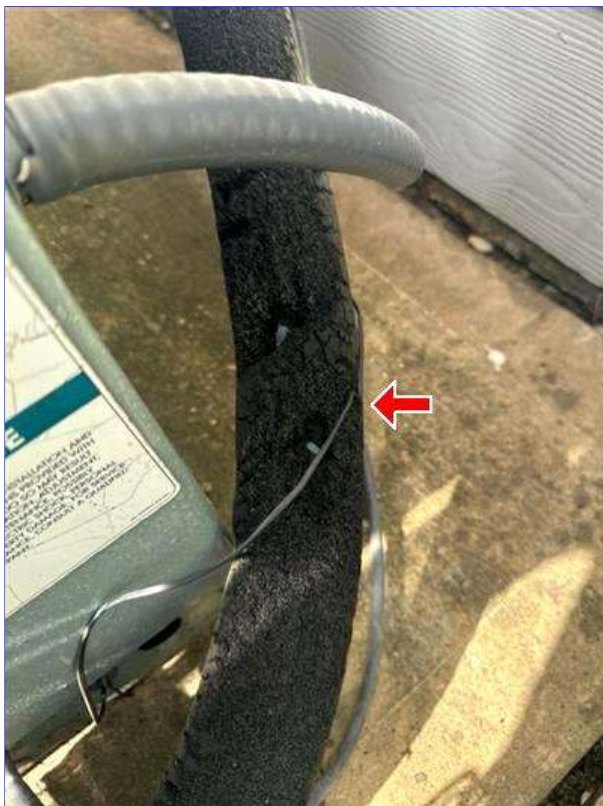
(2) The insulation, on the refrigeration line(s) is deteriorated. I recommend it be repaired or replaced.

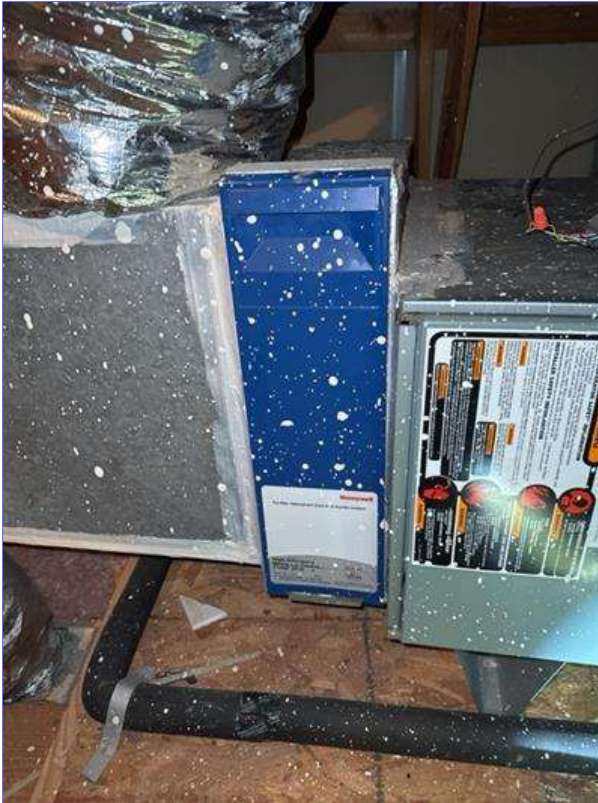
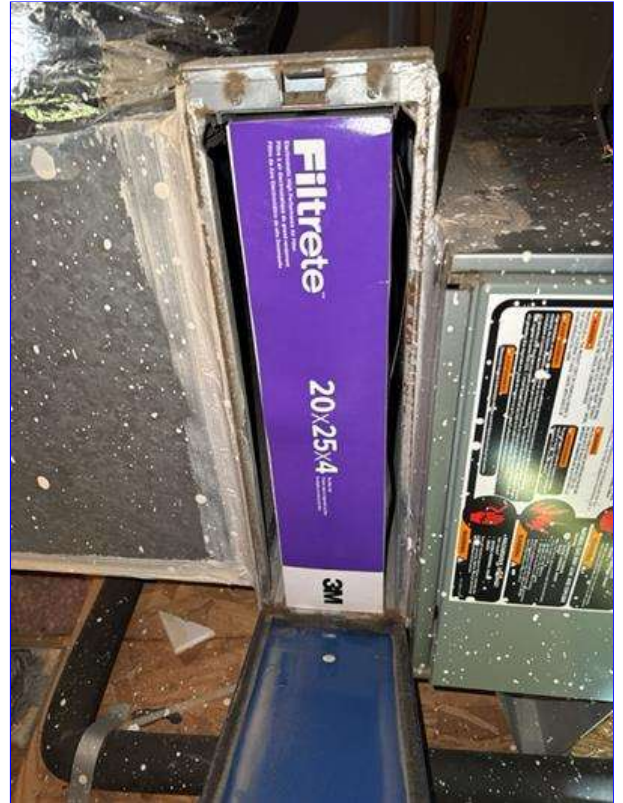
(1) The air filter is located at the unit, in the attic. This type of filter should be replaced every 6 months.

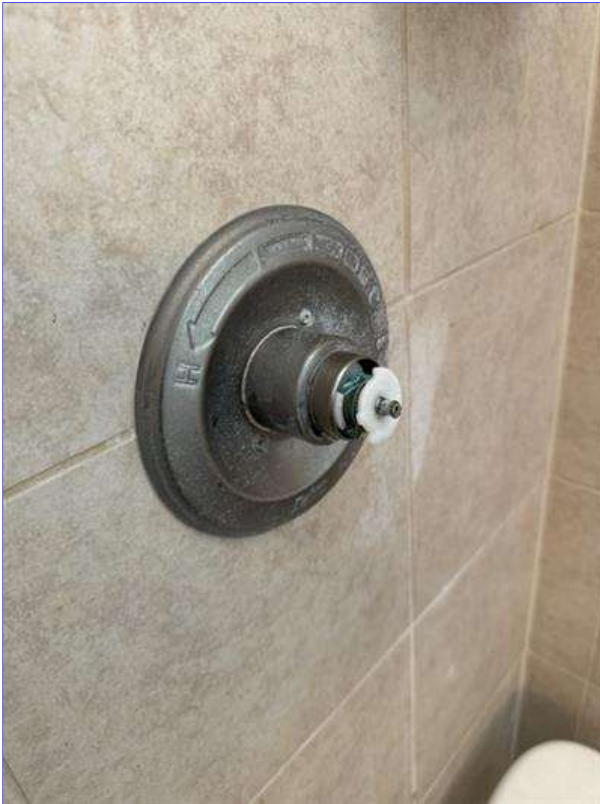
(1) In the primary bathroom, the shower faucet handle has come off. At the time of inspection, the occupant was in the process of trying to make the necessary repairs. Verify with seller.

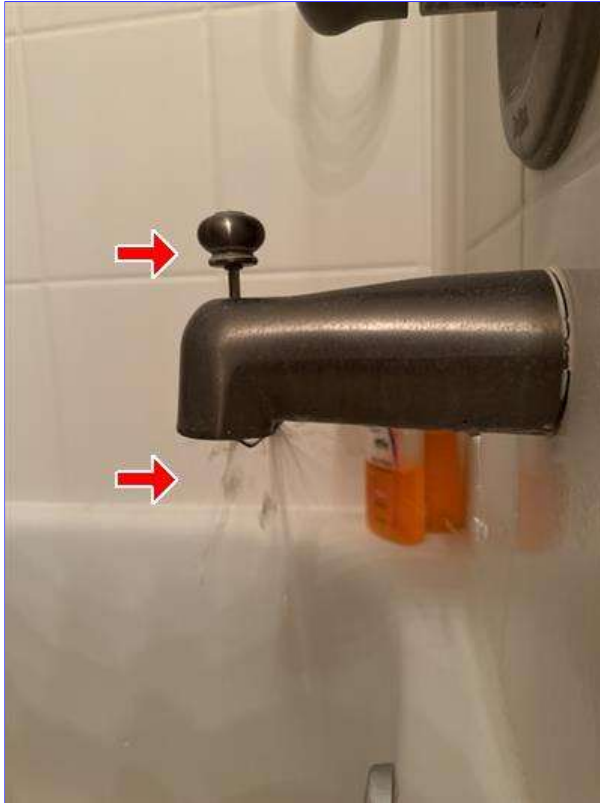
(2) Water does not fully divert from tub spigot to shower head in some bathrooms. Recommend correction.

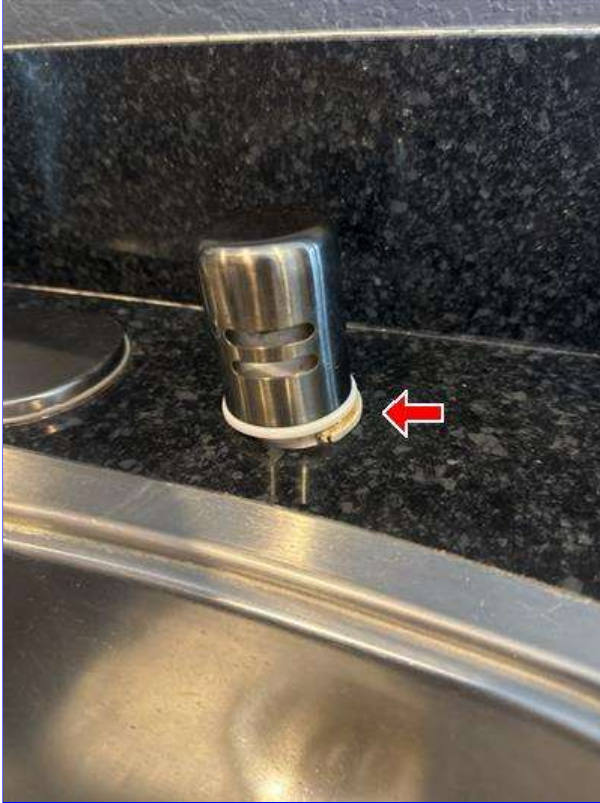
(1) The dishwasher air gap has a damaged countertop gasket and is loose at the countertop.

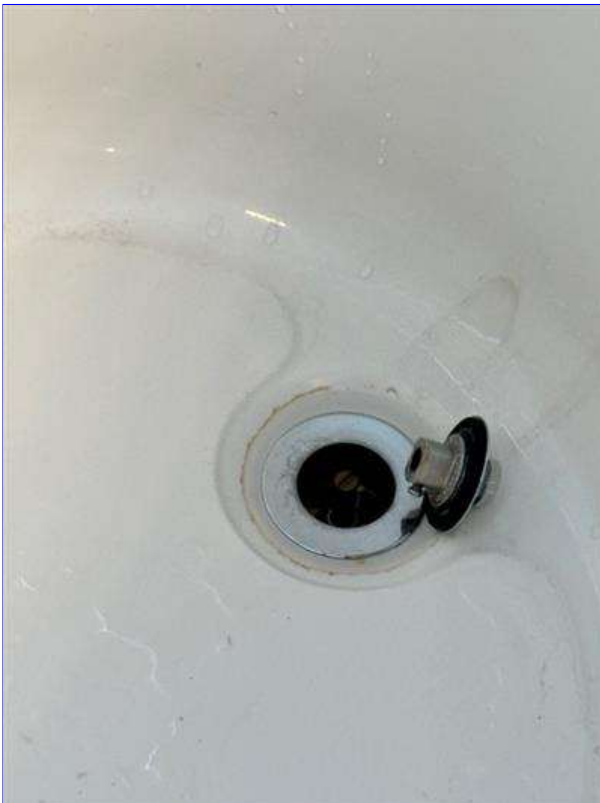
(2) The stopper is missing or inoperative, from some fixtures.

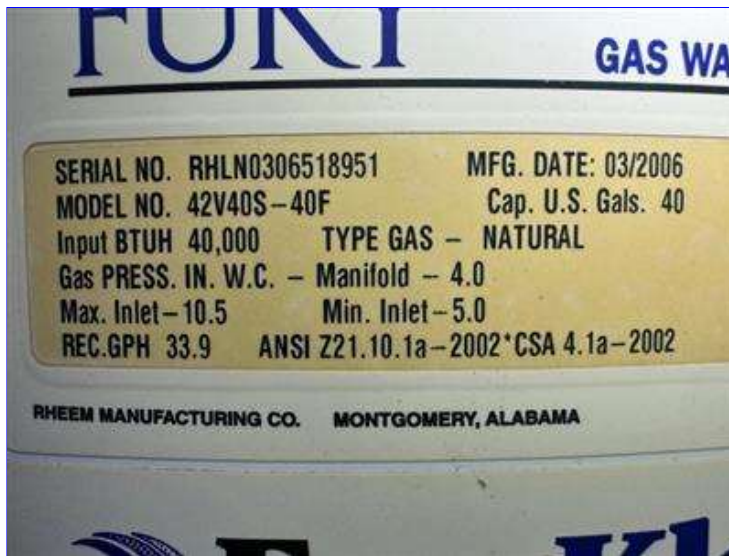
Manufacture date(s); 2006

NOTE: The water heater is old. Although the heater appears to be currently operating, it is nearing, or has exceeded, the end of the average useful service life of typical gas fired water heater (about 15 years). The heater may last a few years longer or may not. I cannot determine how long the unit will continue to operate. I recommend that you budget for replacement.

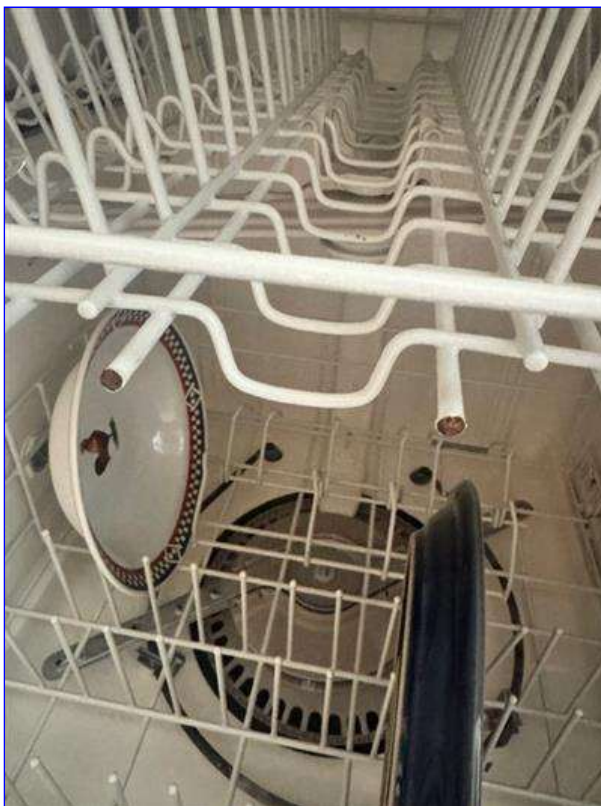
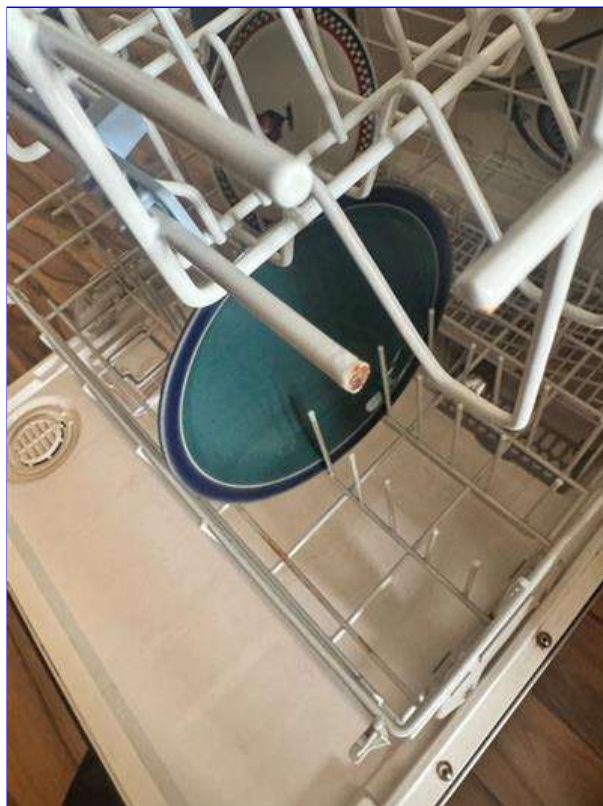
(1) Small areas of rust were observed on the dishwasher baskets.

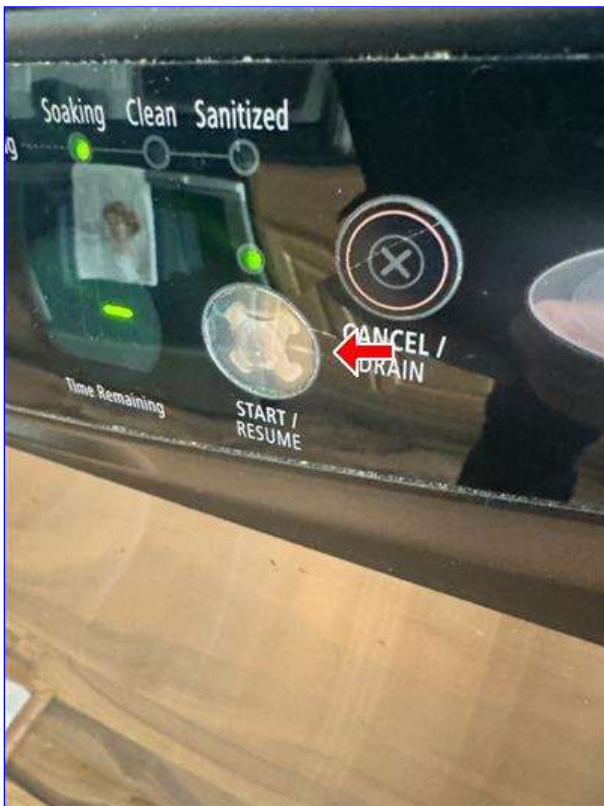
(2) The start button on the dishwasher has worn off.

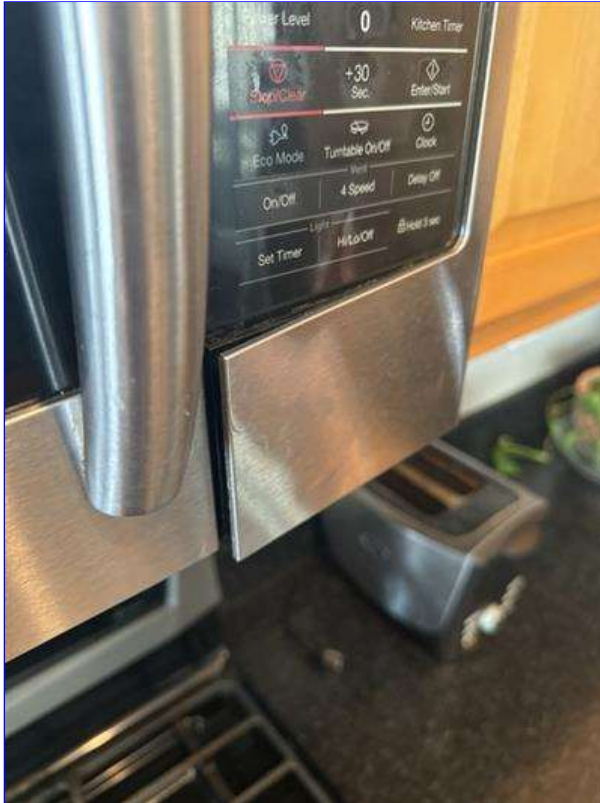
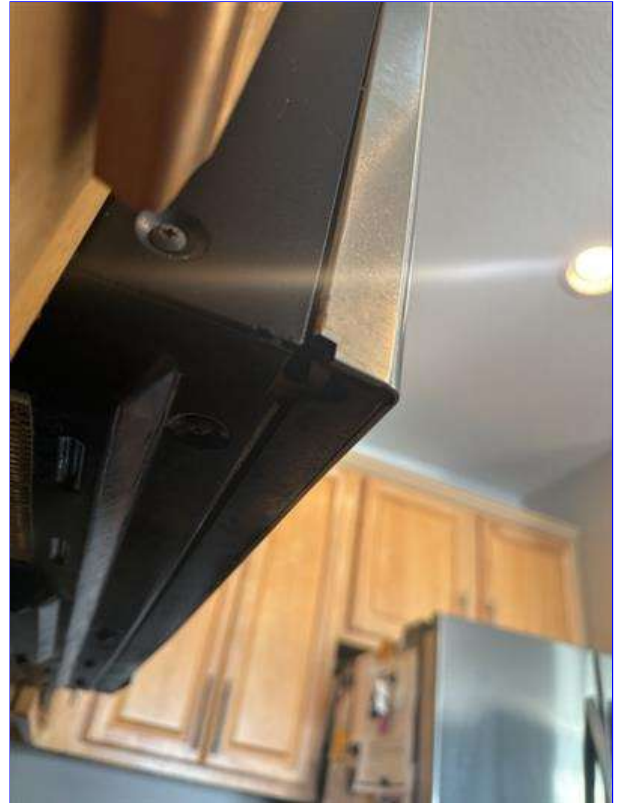
Built in Microwave: SAMSUNG
Comments:
The microwave was inoperable at the time of inspection and the Stainless Steel cladding on the door and control panel is delaminating.

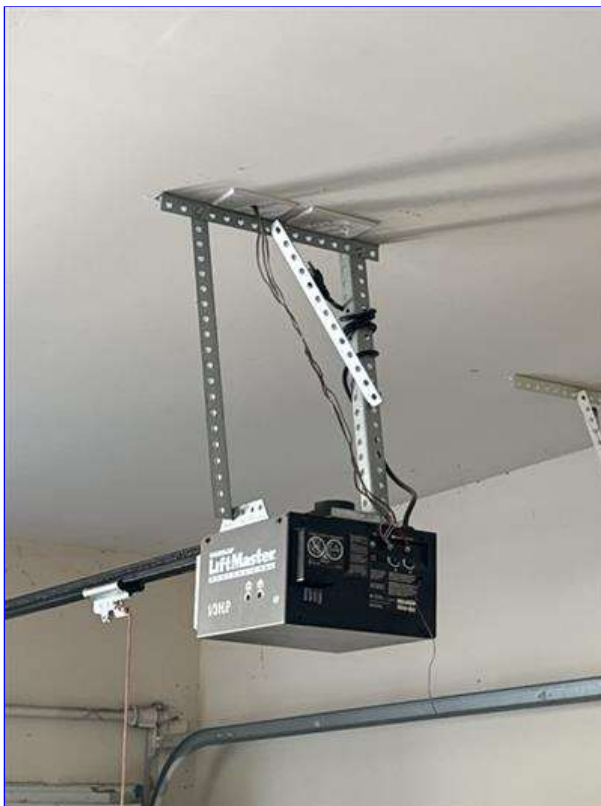
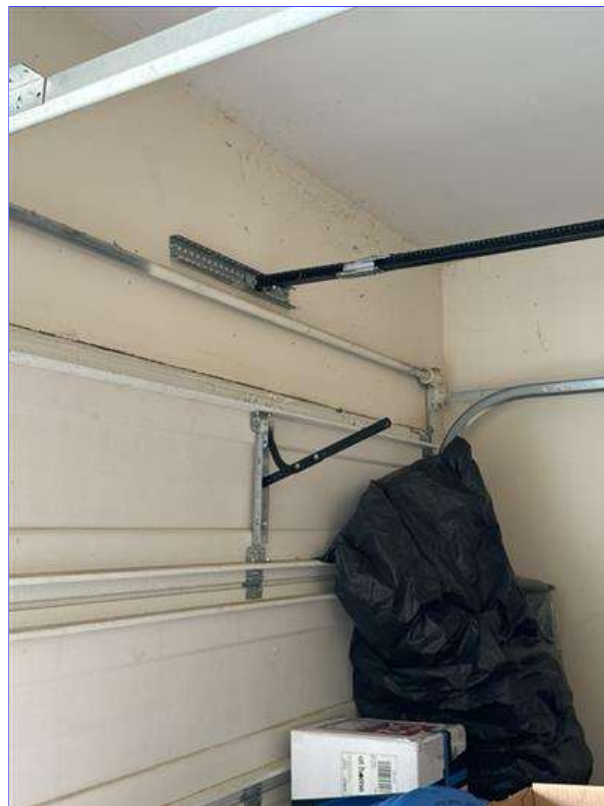
(2) Sensors are in place and will reverse the door. The auto reverse on obstruction feature does not function normally and is in need of adjustment for safety reasons.

I recommend that you consult with a qualified, competent garage door operator installation/repair company to determine the best method for repair, estimate cost and perform the repair.
