HOME INSPECTION REPORT

Monica Perez and Orlando Urdeneta	6-14-2024
<i>Name of Client</i>	<i>Date of Inspection</i>
19147 Sprintwood Ct, Humble, TX 77346	
<i>Address of Inspected Property</i>	
Bob Wiesner (# 22223) Ronald Randle (# 26218)	22223
<i>Name of Inspector</i>	<i>TREC License #</i>
Bob Wiesner	22223
<i>Name of Sponsor (if applicable)</i>	<i>TREC License #</i>

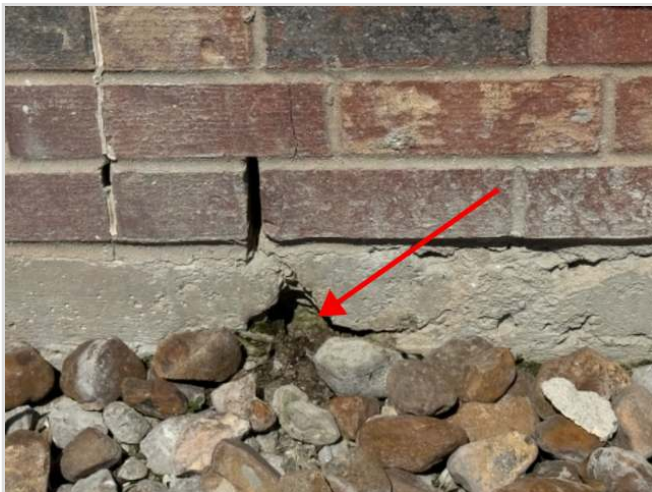
There was a void in the foundation exterior beam on the left side under the kitchen window box and at the front left corner

Void in left exterior beam

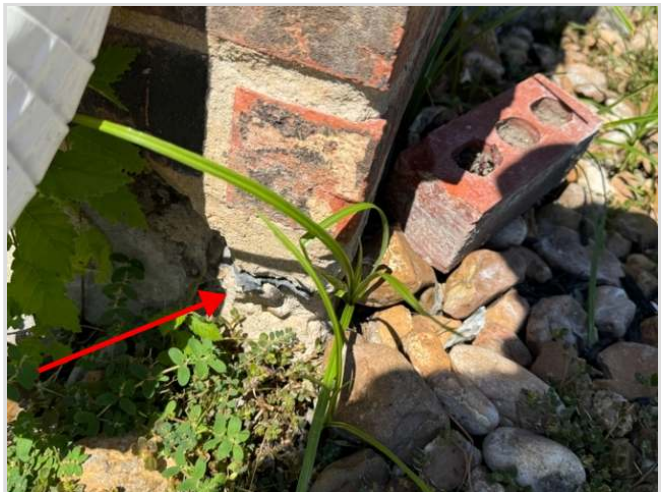
Deterioration of exterior beam - left front corner

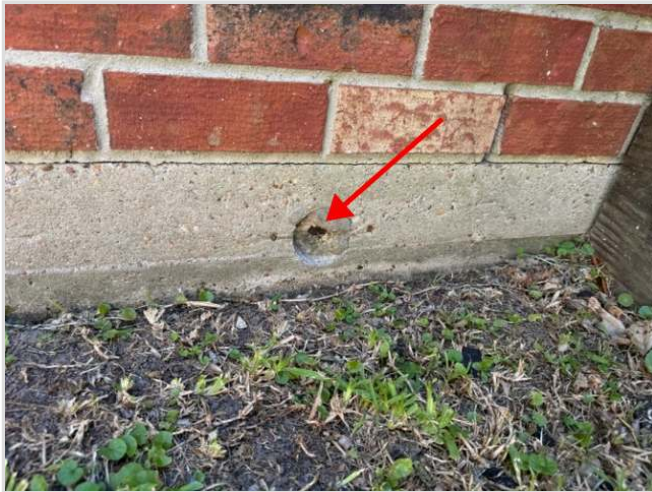
Post-tension end not protected on right side

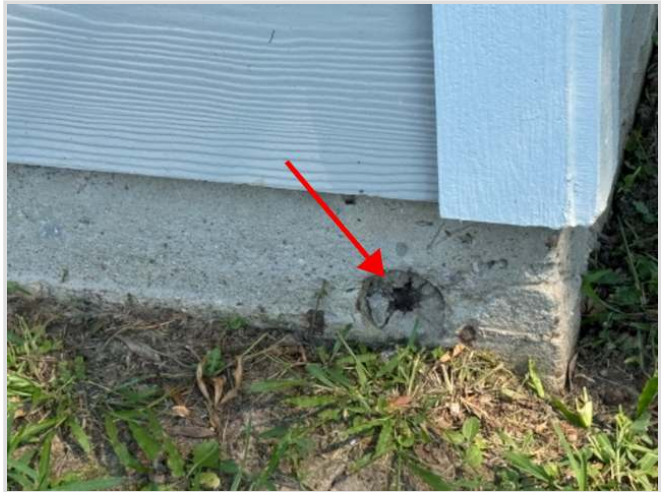
Post-tension end not protected on garage rear wall

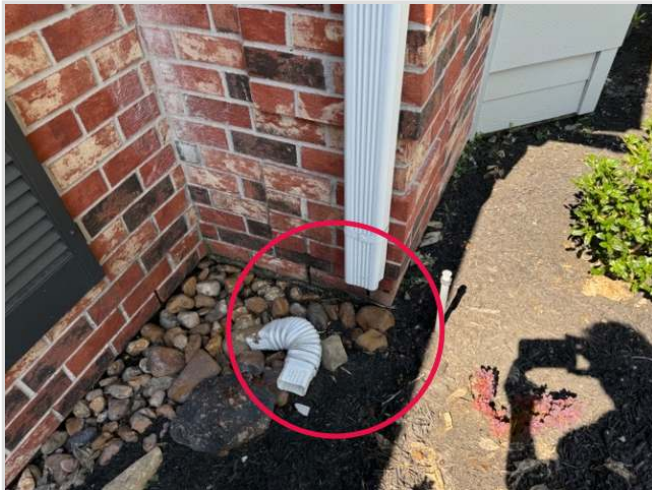
There was a disconnected piece to a downspout on the front wall

Bottom piece detached from downspout

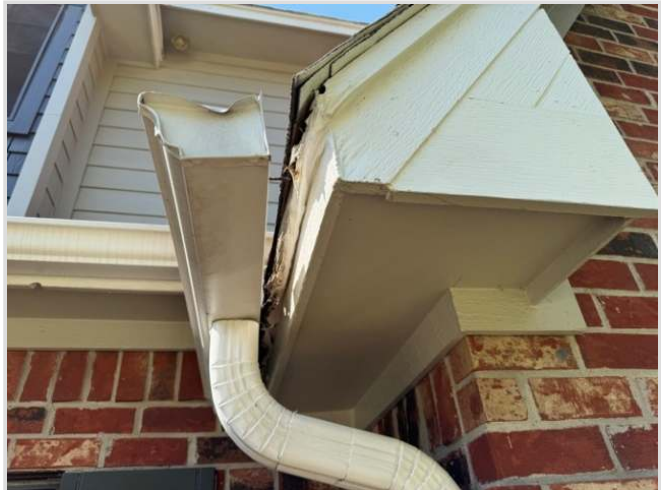
The gutter was pulling away/partially detached from the front wall on the center right.

Gutter not secured to front wall

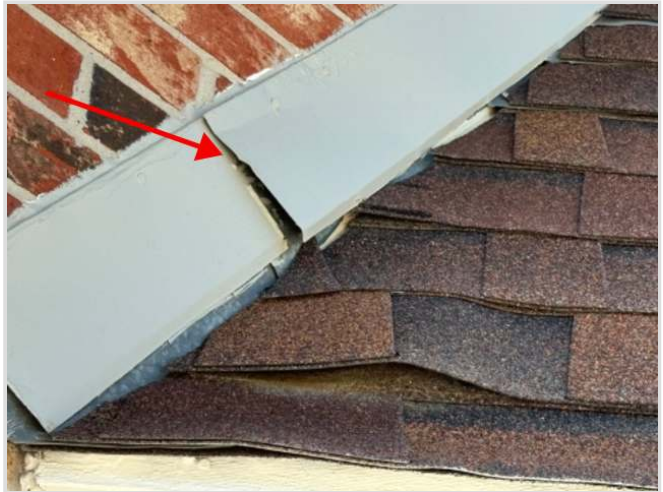
Counter flashing was loose above the dining room bay window box and above the right side bay window on the front wall.

Loose counter-flashing on front wall

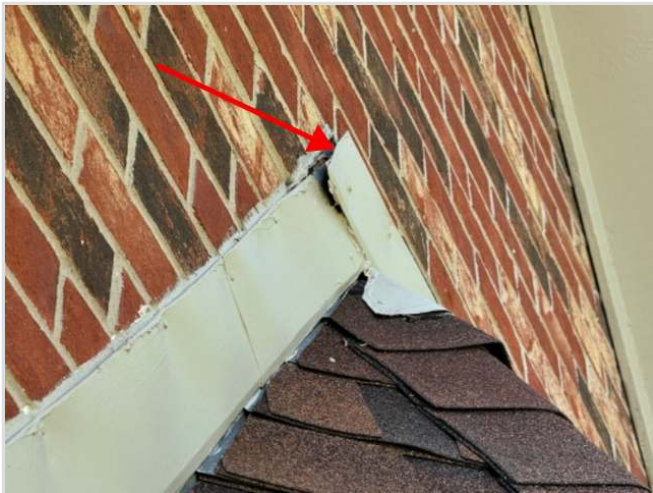
Loose counter flashing on front wall

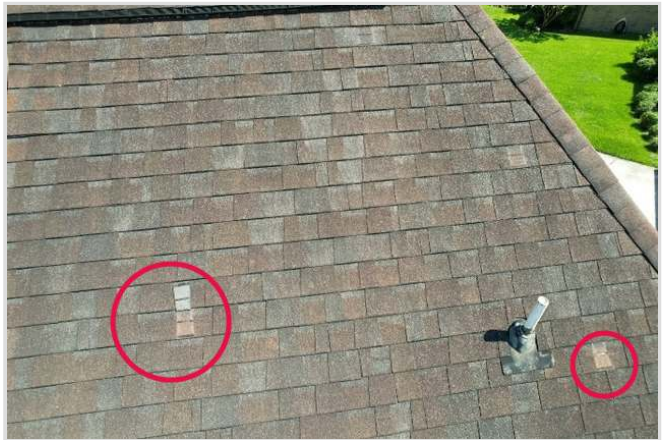
There were some damaged shingles.

Damaged shingles on the rear left slope

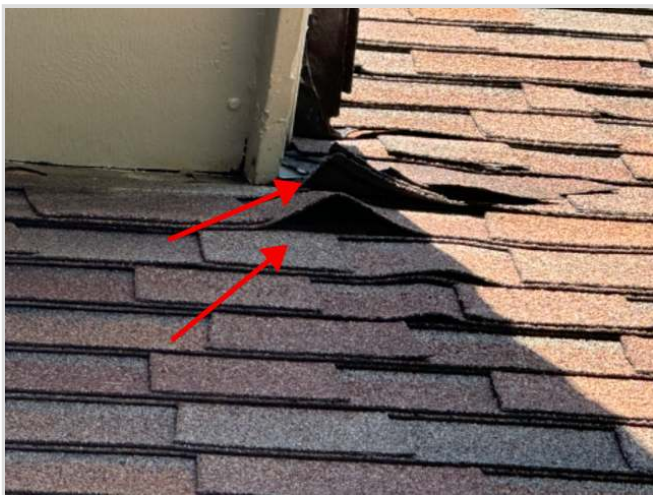
Lifted shingles - right side slope over left gable

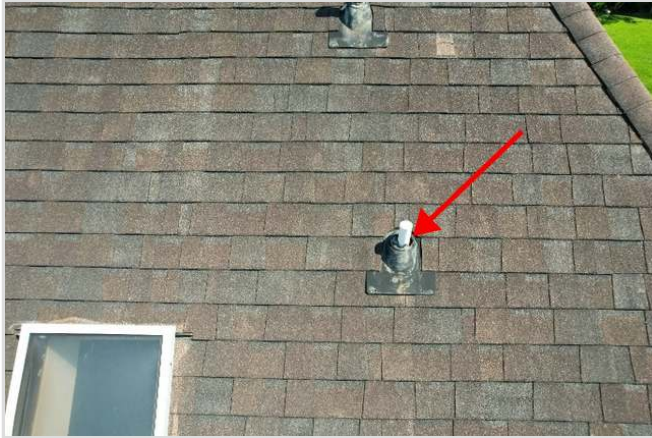
A plumbing vent boot on the rear slope and to the left of the sky lights and the front plumbing vent boot on the left side had deteriorated seals. It is recommended that the boots be replaced as soon as possible.

Deteriorated seal - rear slope

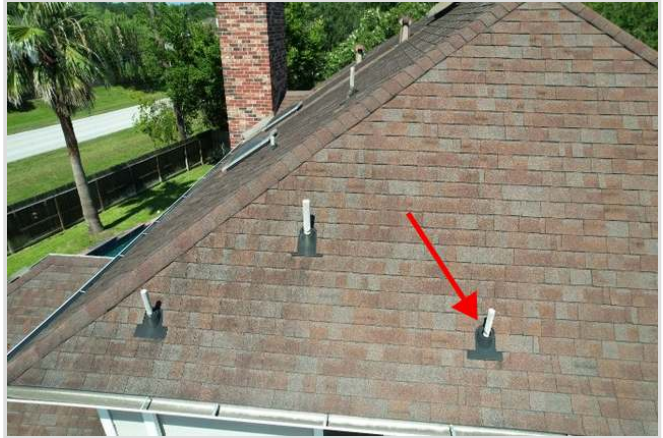
Deteriorated seal - left side

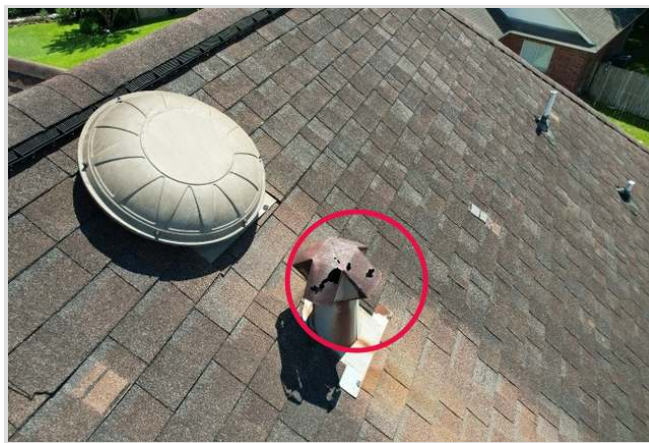
One of the 4-way vents on the rear slope (flue cap for one of the furnaces) was rusted through and needed to be replaced.

Vent cap rusted through (flue cap for one of the furnaces)

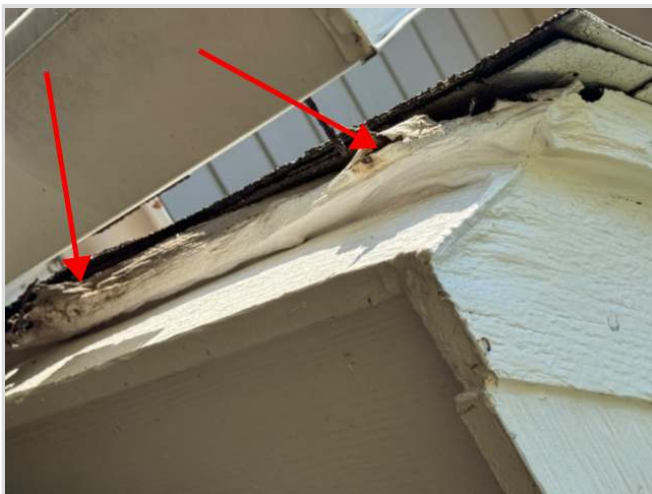
There was an excessive amount of wood damage, water penetration on the left side of the right gable on the front wall.

Wood damage at the right side gable on the front wall

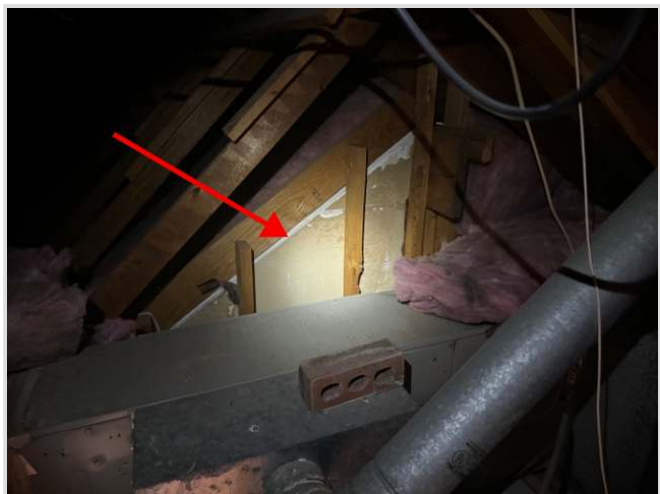
Fallen vertical insulation

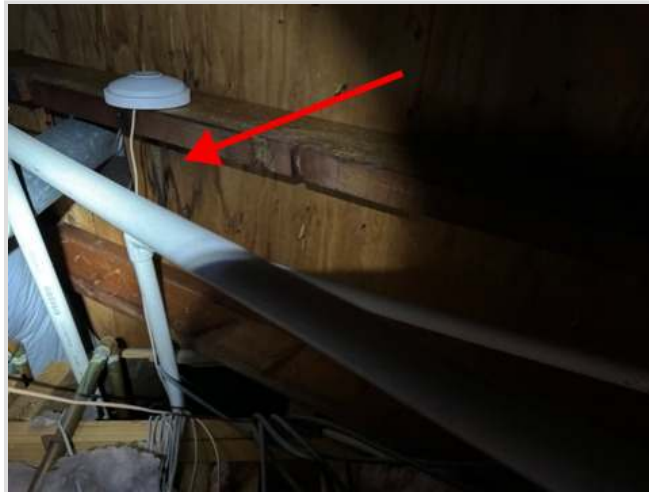
There were indication of prior water penetration around the water heater flue.

Indications of prior water penetration around the water heater flue

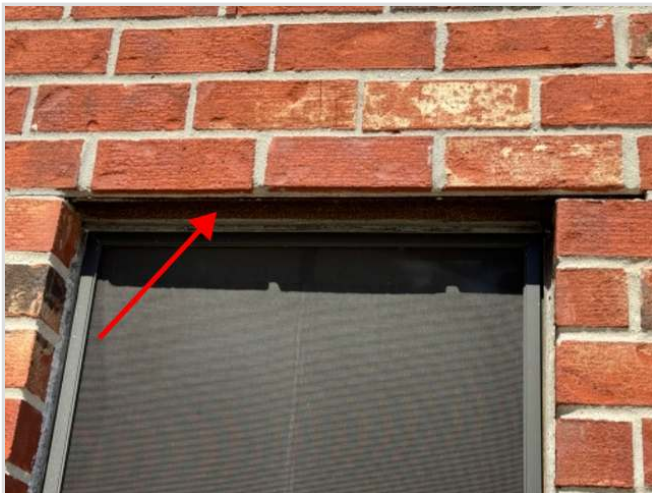
Lintels over several windows were rusted.

Rusted lintel - left side

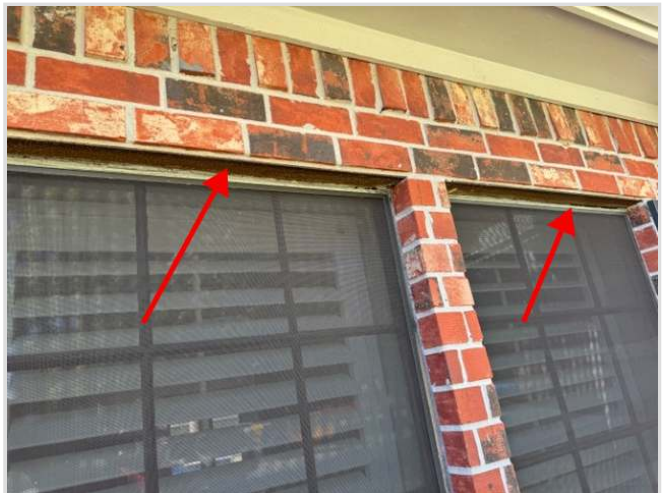
Rusted lintels - front wall

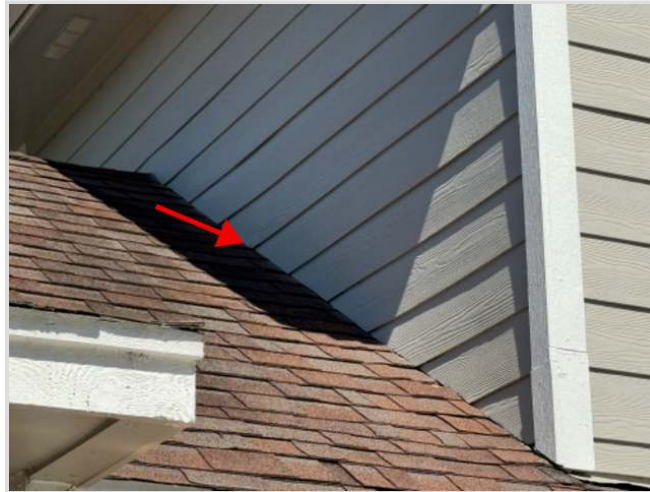
The siding was making contact with adjacent shingles in several areas. Industry standards recommend that siding be cut back approximately 1" in order to avoid contact with shingles and prevent water damage to the edges of the siding.

Siding in contact with adjacent shingles

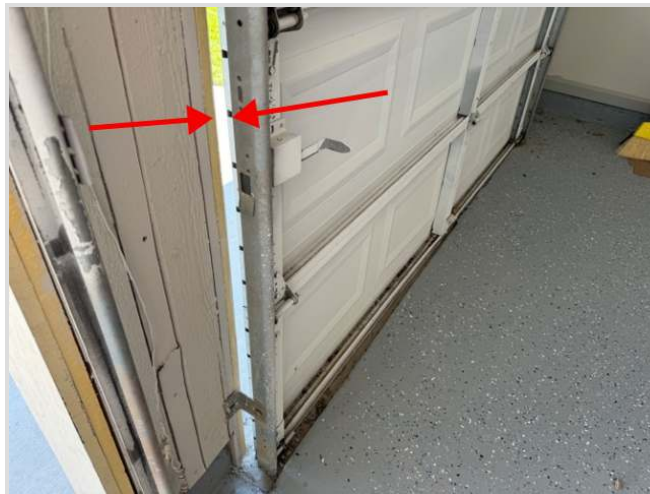
The left side (single car) garage door had a large gap between it and the frame on the right side.

Large gap - right side of left overhead garage door

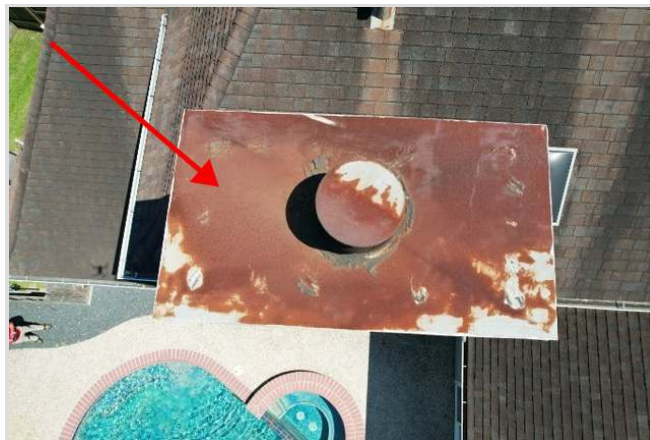
The chimney cap was rusted.

Rusted chimney top

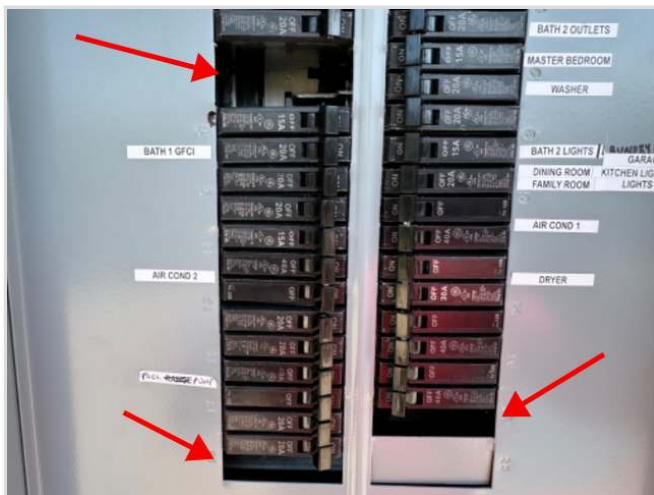
Knockouts were missing.

Knockouts missing

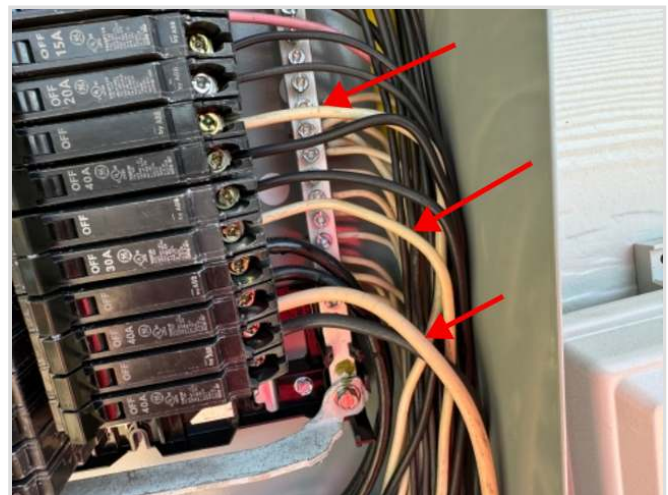
White wires were used as hot (ungrounded conductors) without being properly marked. It is recommended that they be marked with a black marker to designated the white wires are being used as hot wires and not neutral.

White wires not marked for use at hot wires

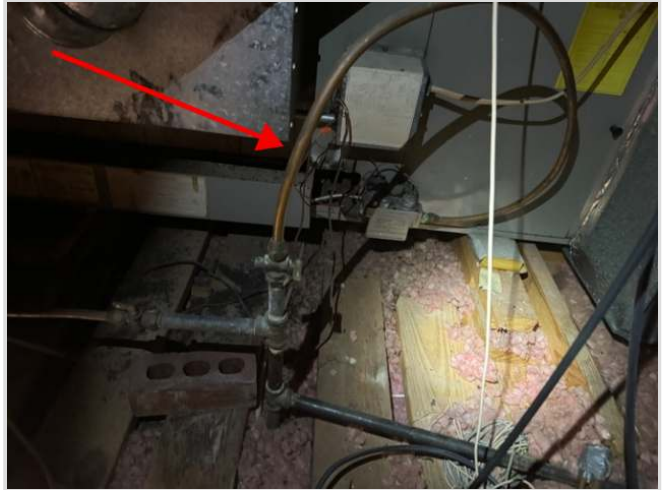
The gas to both house units was delivered via copper pipe. Some types of copper pipe are not compatible with natural gas delivery. And there were no sediment traps on either furnace (see plumbing - gas). It is recommended that the copper pipe installation be further evaluated by an HVAC technician.

Copper gas line pipe to Unit #2

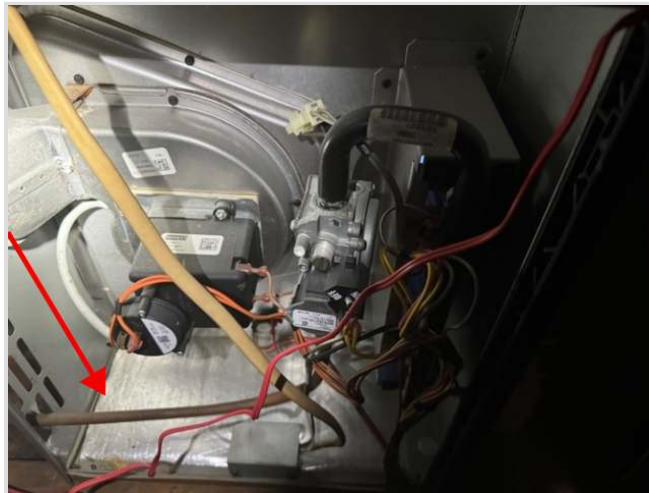
Copper gas line pipe to Unit #1

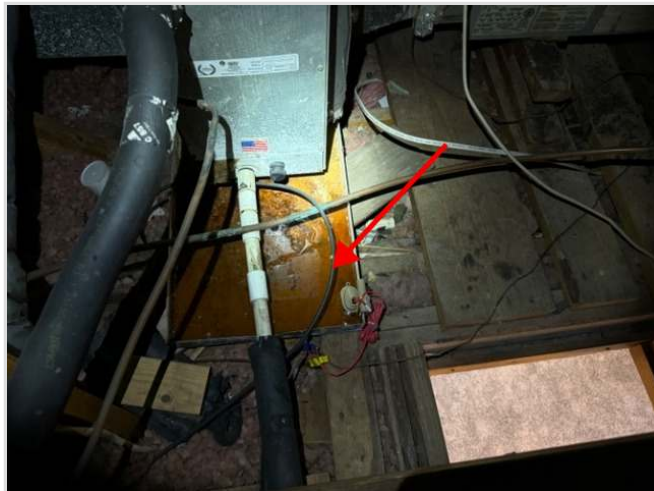
Unit #2: Water in the pan

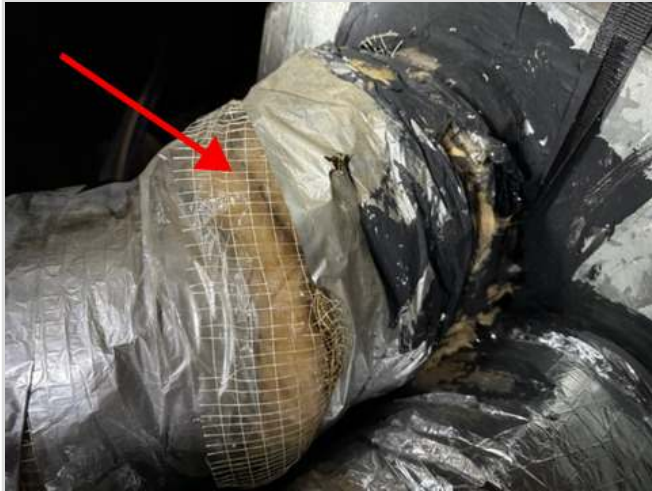
There was damaged duct covering in several areas.

Damage HVAC duct covering above the garage

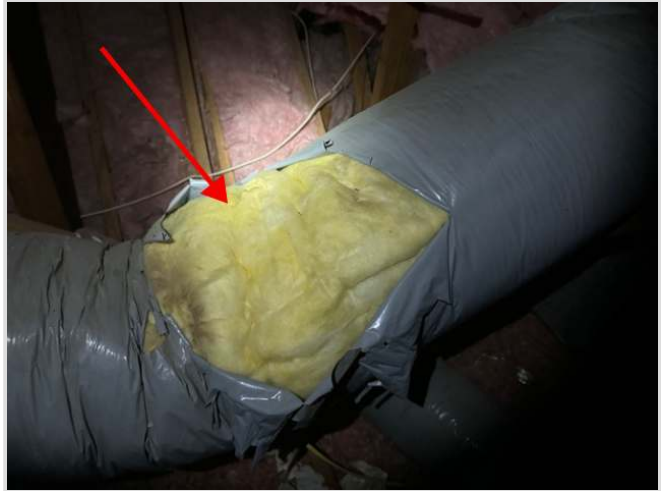
Damaged HVAC duct covering in the upper attic

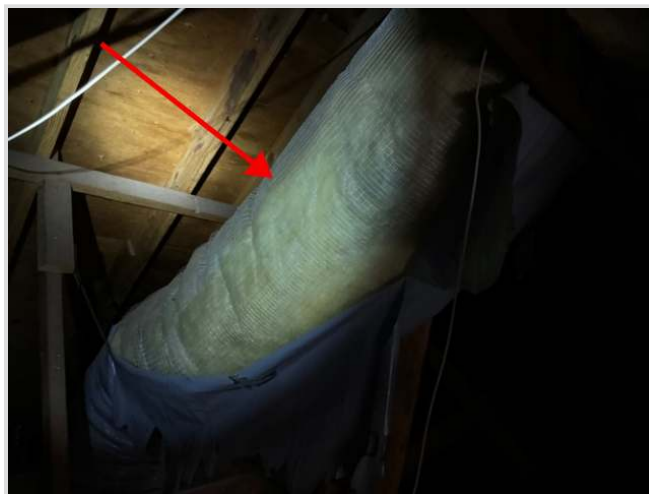
Damaged HVAC duct cover in the second floor right side attic

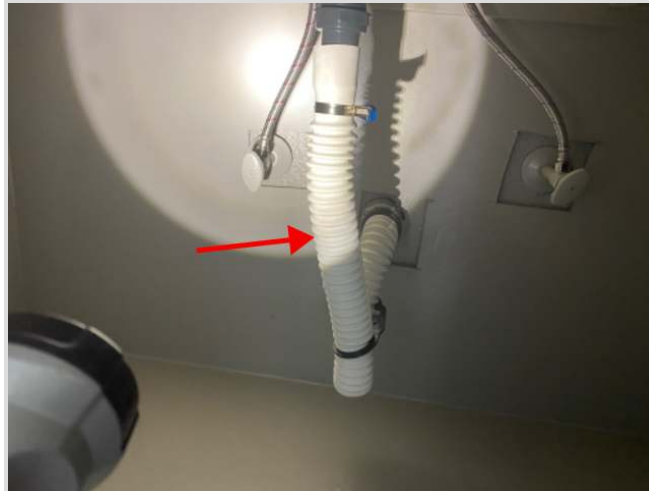
The tailpipes below the upstairs left side sinks were corrugated. Corrugated tail pipes are not self-cleaning / self-scouring and could trap organic material in the drain creating a place for bacteria to grow. Also, the pipe at the rear sink was leaking.

Corrugated tail pipe

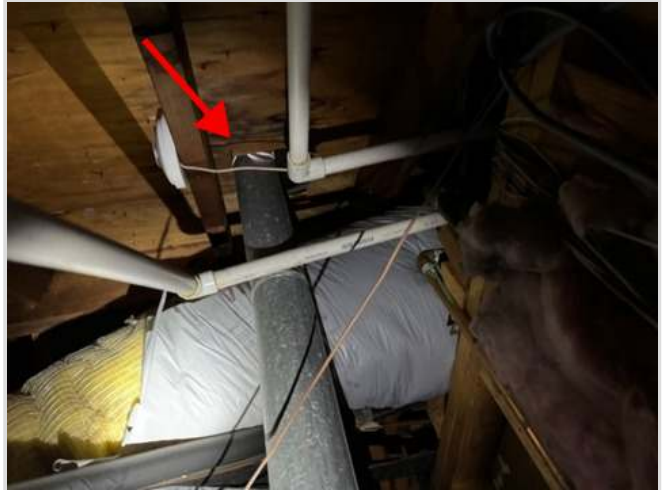
Flue pipe in contact with roof decking

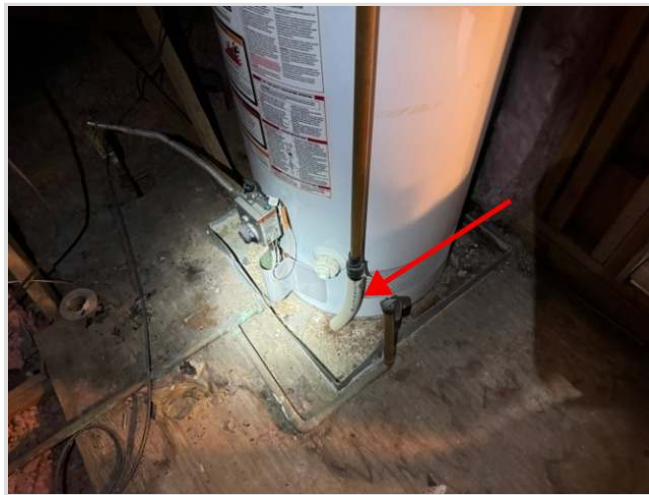
TPR discharge pipe did not terminate to the exterior

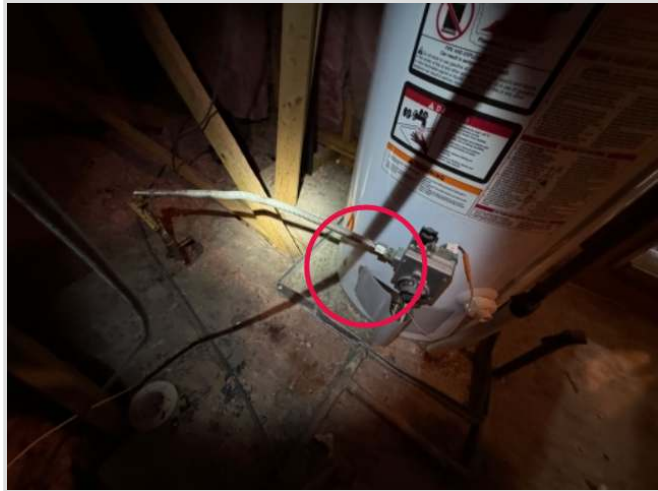
Sediment traps were missing on the gas lines to the water heater and house furnaces

No sediment trap on the gas line to the water heater

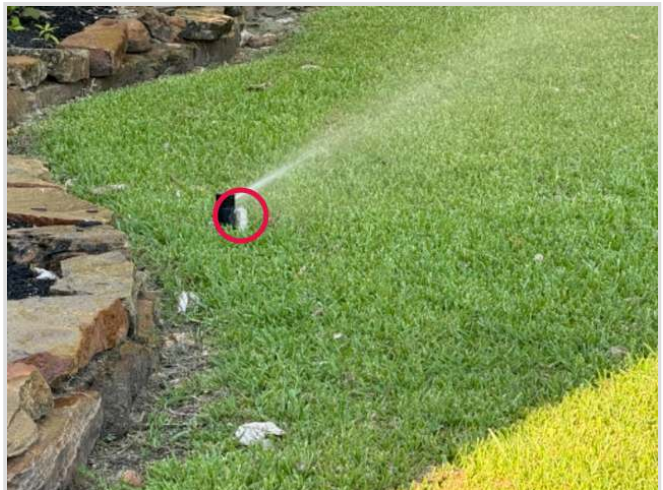
Zone 2 -- 5 rotating heads in the front grass. The center rotating head closest to the house was leaking.

Leak - Zone 2 rotating head

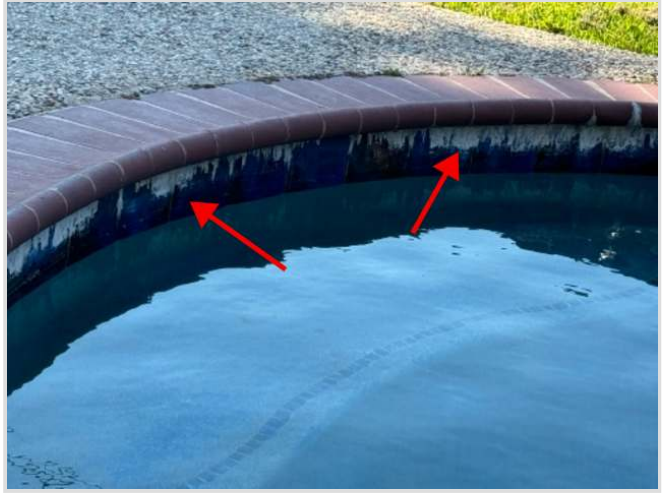
Dirty tile

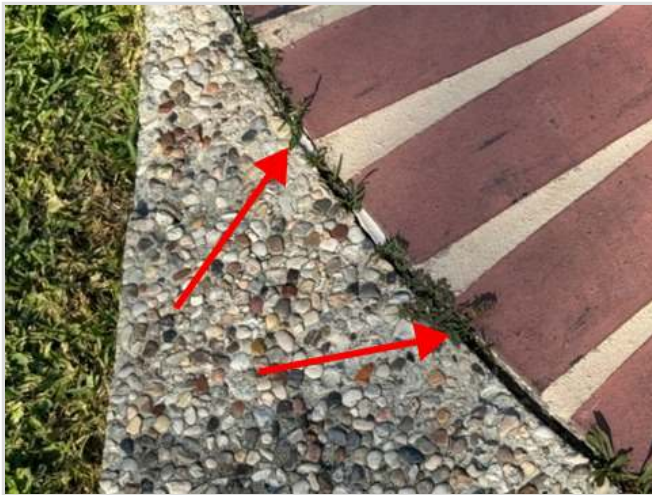
Gap in sealant between coping and deck

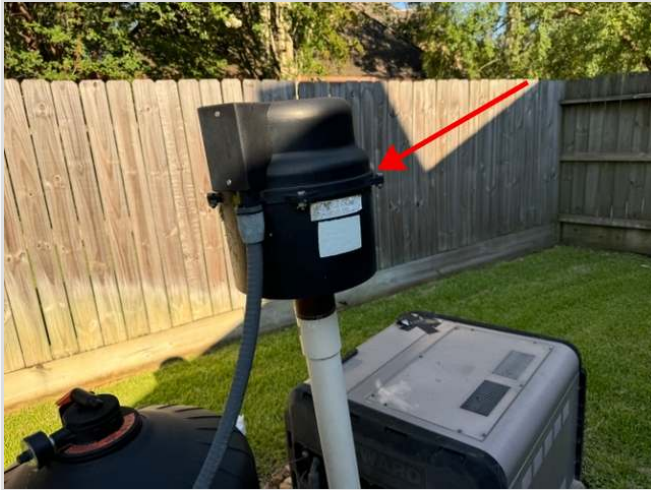
Blower motor did not appear to be functioning

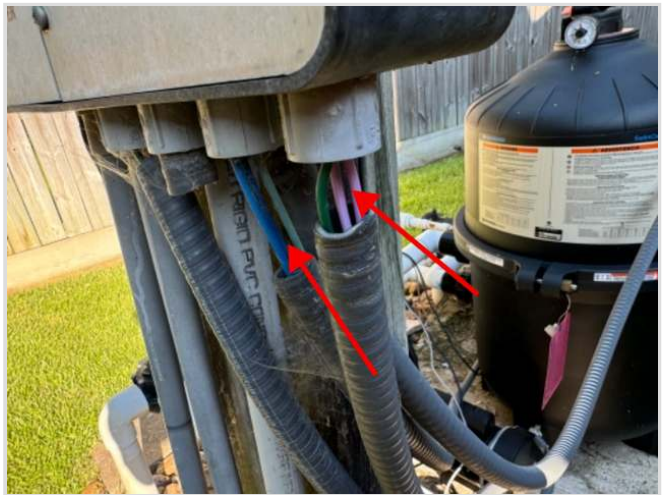
Conduit detached at ends exposing wire

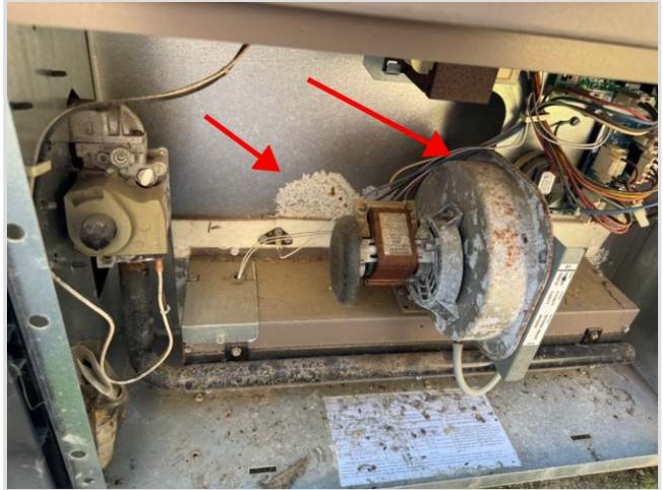
Light corrosion in the heater unit
