**7814-7816-7818 Glass St  
Houston, TX 77016**

**July 5, 2024**

# PROPERTY INSPECTION REPORT FORM

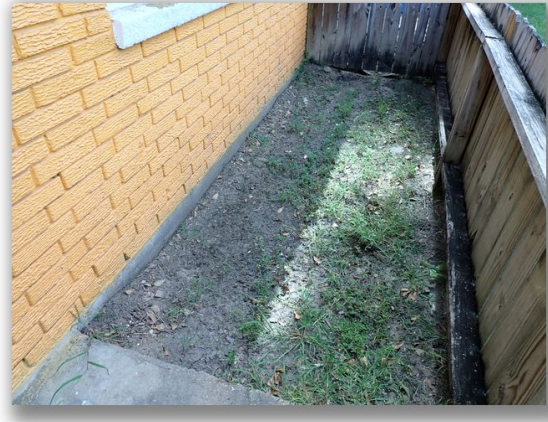
**Gutter & Downspout System**

**Note:** There are no gutters installed at the time of inspection.

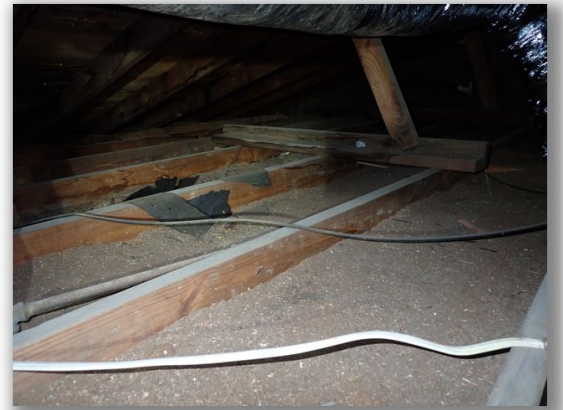
**Attic Insulation**

- The attic insulation is lower than typical and it is recommended to add additional insulation to achieve at least a R-38 rating.
- The attic floor insulation was observed to be missing over several locations throughout the house.

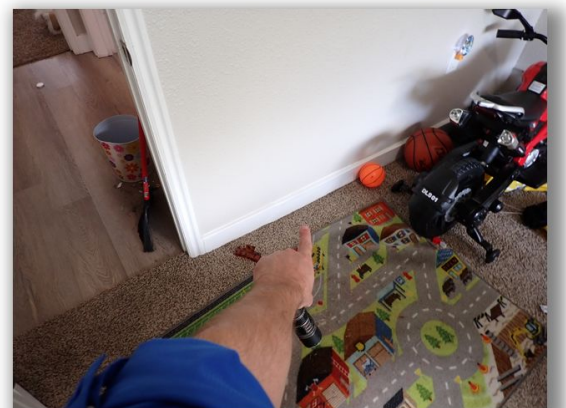
**Note:** Visible evidence of rodent activity was observed in the interior of the home. It is recommended to have a Certified Pest Control Operator further evaluate this condition and make corrections as necessary.

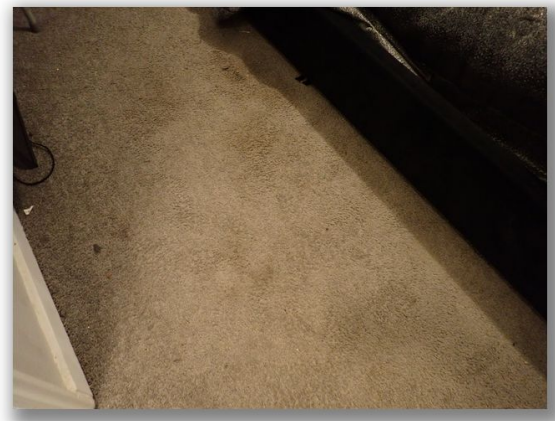
**Floors**

- The floors were observed to be out-of-level in some areas of the structure.
- The floor covering is stained in one or more locations of the home.

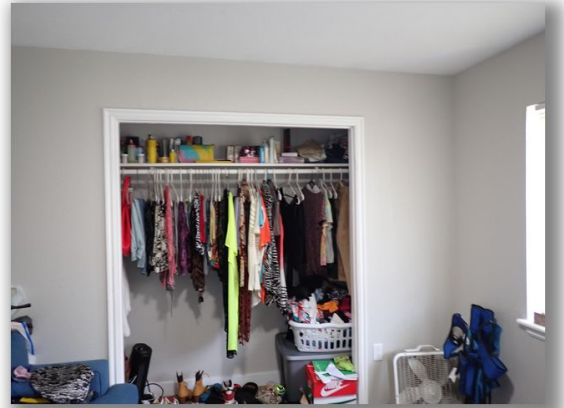
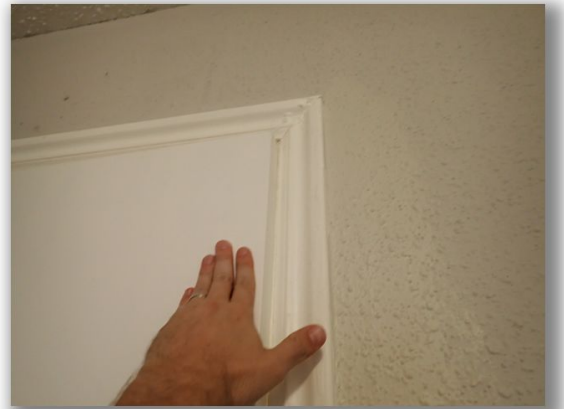
- The door is not latching properly to the 7814, 7818 front corner bedroom closet.
- The door is sticking to the 7818 front corner bedroom.
- The door is missing to the 7818 rear corner bedroom closet.

**Note:** There are no doors installed on the 7816 front corner bedroom closet.

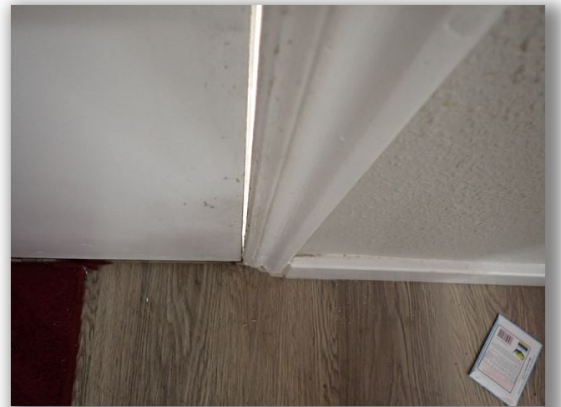
**Exterior Doors**

- Weather-stripping improvements are recommended for all units backyard entry, front entry exterior door(s).
- The door is not latching properly to the 7814, 7816 backyard entry door.
- Surface damage was observed to all units front entry door, backyard entry door.
- The exterior door frame has deterioration and/or damage to all units front entry, backyard entry door(s).
- Visible evidence of previous water intrusion was observed at and/or around the 7816 backyard entry exterior door(s). The cause and remedy should be investigated and corrected as necessary.
- There was an unknown mold like substance observed at the 7818 front entry exterior door. Evaluation of this substance is beyond the scope of this inspection. If any concerns exist on the type and/or nature of this substance, we recommend further evaluation by a professional in the Air Quality sampling field.

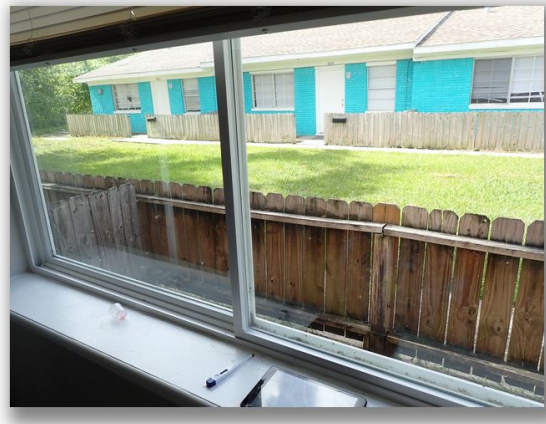
**Window Screens**

- One or more of the window screens were observed to be damaged.
- One or more of the window screens were observed to be missing.

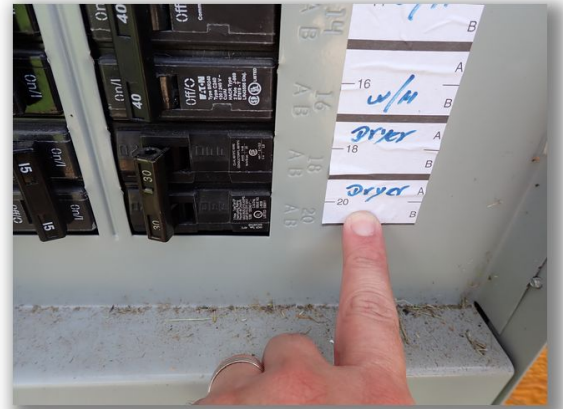
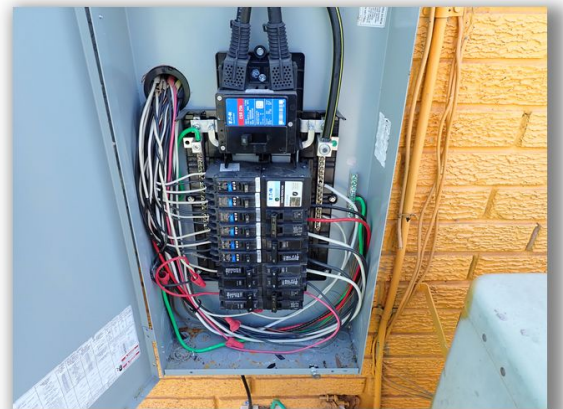
- There is no ground fault circuit interrupter type breaker for the dryer outlet installed at the panel box. This does not meet current building standards.
- There was no anti-oxidant gel observed on the exposed aluminum conductor terminations.

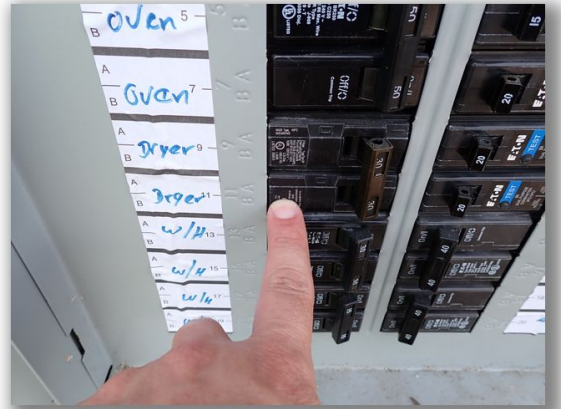
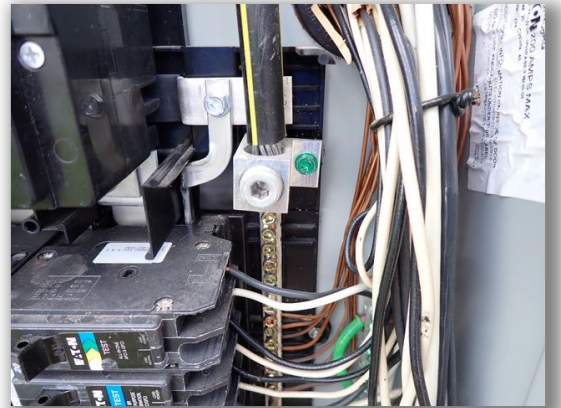
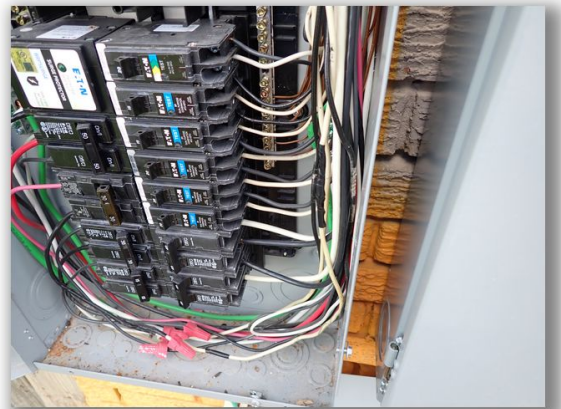
- There was no anti-oxidant gel observed on the exposed aluminum conductor terminations.

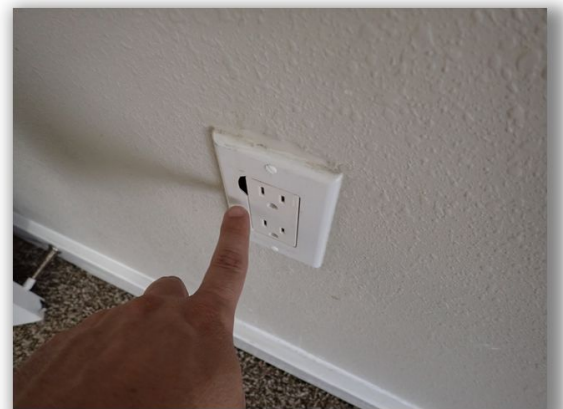
- There is no receptacle installed at the AC outside condenser. Under current building standards, there should be a receptacle installed within 25 feet and on the same level as the condenser.
- One or more of the receptacle cover plates are damaged in the 7814 rear corner bedroom.
- All exterior receptacles should have weather tight covers. The receptacle weather cover plate is damaged and/or missing on the north exterior wall.

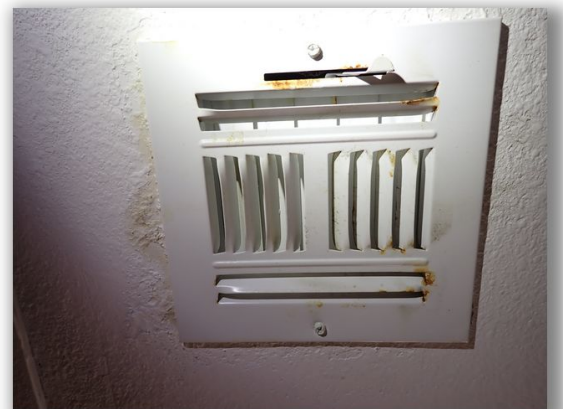
- The duct work in the attic area has sags between the supports. This condition can cause pressure loss and affect the airflow through the duct system.
- There is rust on the air registers in several locations throughout the house.
- The register box is damaged in the 7814 front corner bedroom.
- The air register has poor air flow in the 7816 rear corner bedroom.

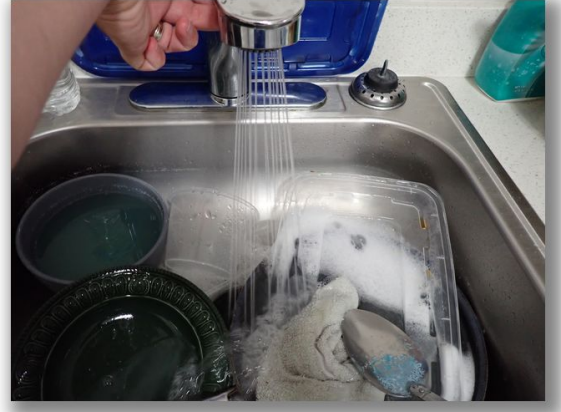
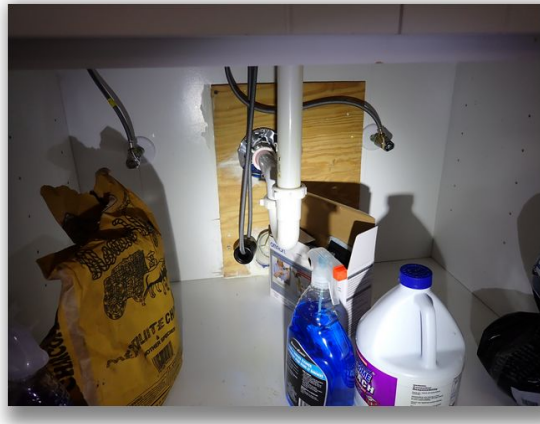
**7814 Kitchen Sink**

- The faucet assembly is loose.

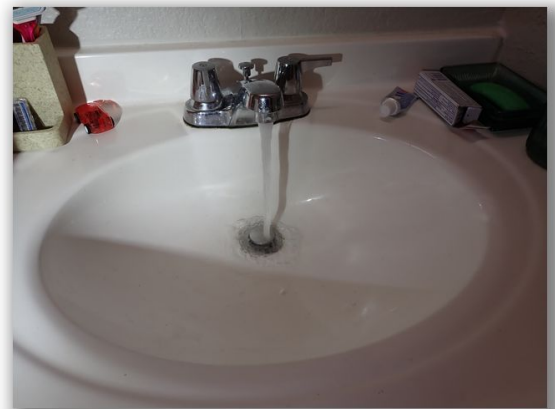
- The drain line is made of corrugated material. It is recommended to use smooth wall/PVC type material to prevent blockage/poor drainage.

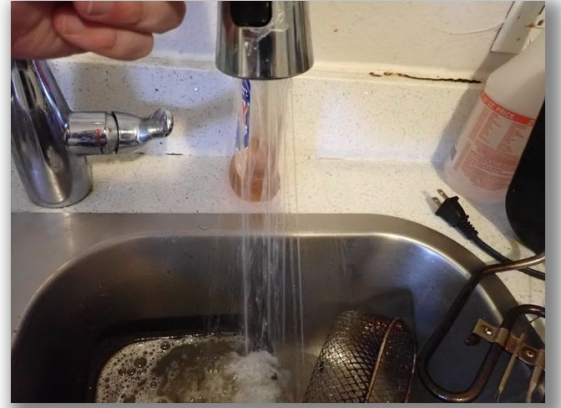
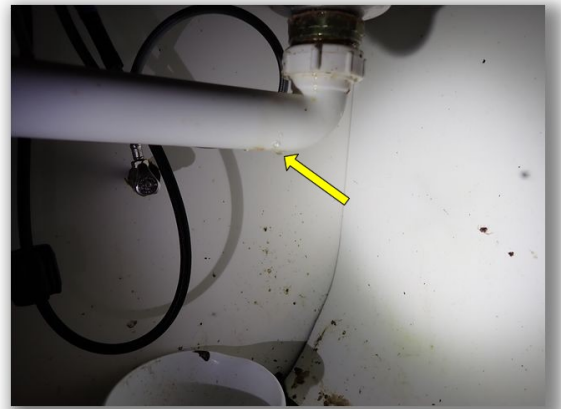
**7818 Kitchen Sink**

- The drain leaks water into the cabinet.

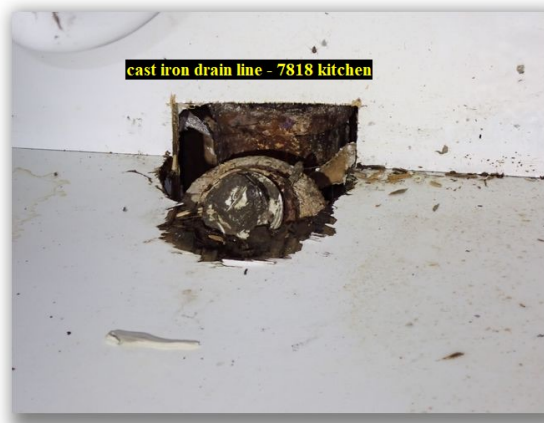
- Cast iron material was observed to be present in the drains, wastes and vents system. Full evaluation of the integrity of this type of material is beyond the scope of this inspection. Due to the known latent defects that are associated with this type of older material, it is recommended to have the integrity of the drain system further evaluated by a qualified plumber. It is recommended to have a hydrostatic test performed and to have the inaccessible and buried pipes scoped with a camera as part of this evaluation. This evaluation should occur prior to the expiration of any time limitations such as option or warranty periods.

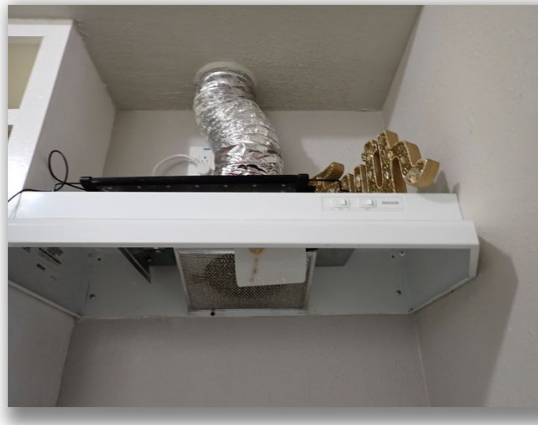
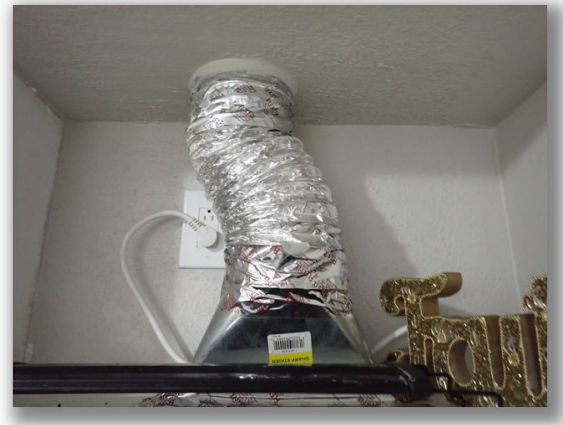
##### 7814 Kitchen Range Exhaust Systems

- The light at the range hood is inoperative.
- There is aluminum ductwork in place for the range hood vent. Under current installation standards, aluminum flex ducting should not be used for the range exhaust vent connection.

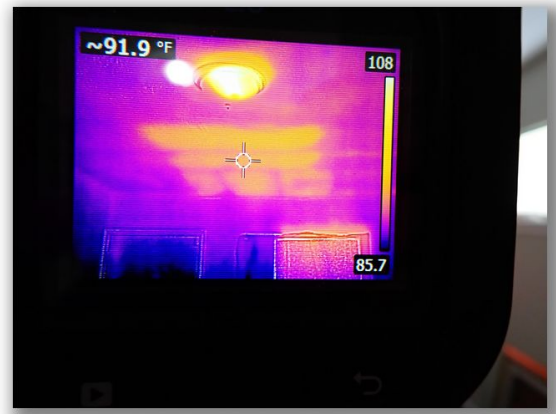
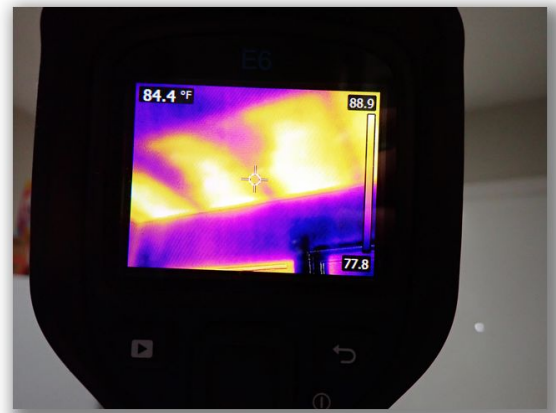
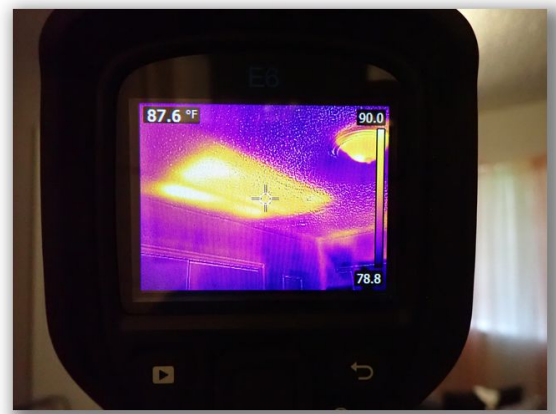
- Missing insulation was observed at the ceiling in several locations throughout the house.

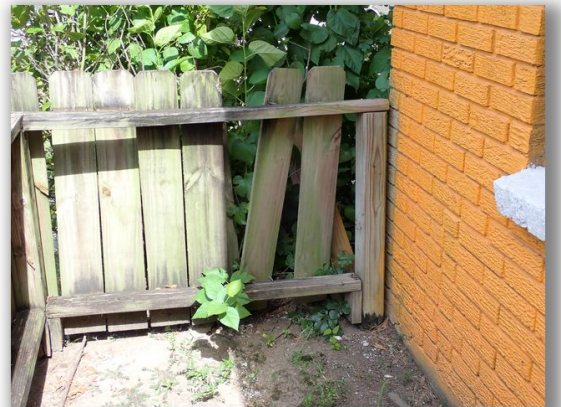
**B. Fences**

- One or more of the fence boards are pulling loose.
- One or more of the fence boards are damaged / deteriorated and repairs are recommended.
