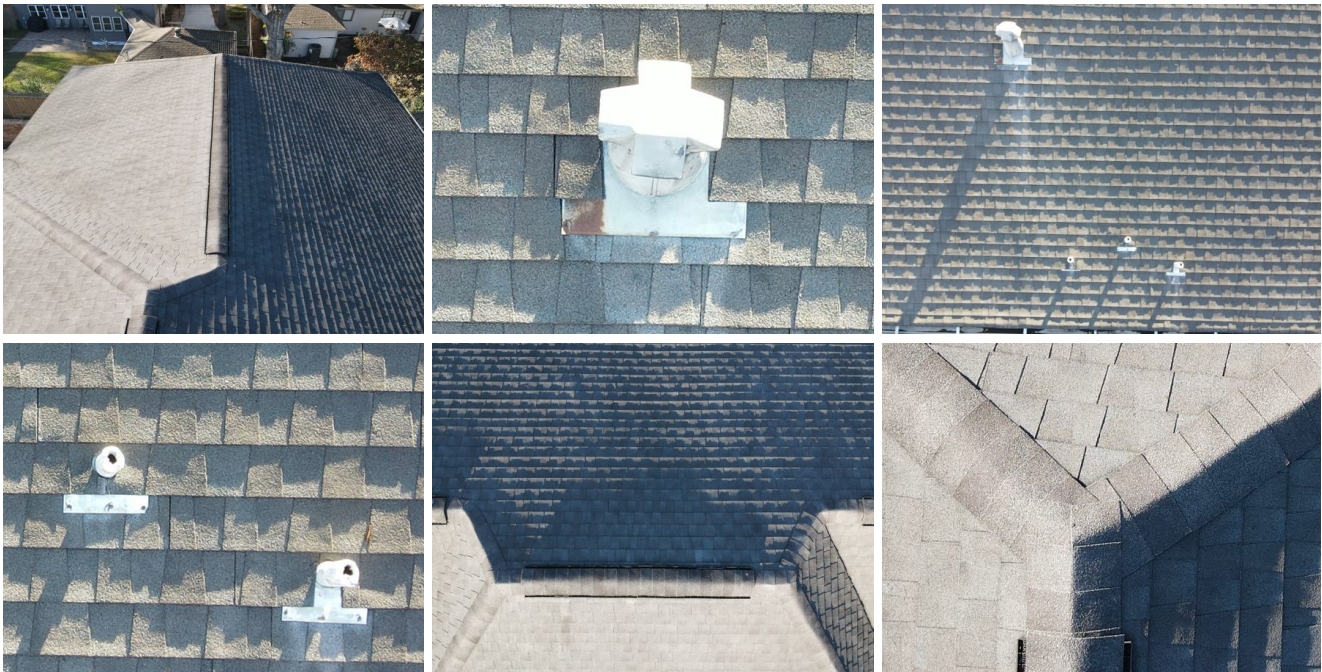
Wear and Deterioration: Composition - Some

Nail Heads not Sealed, Discolored

The composition roof surface was showing evidences of some deterioration of the roof surface as described above and shown below.

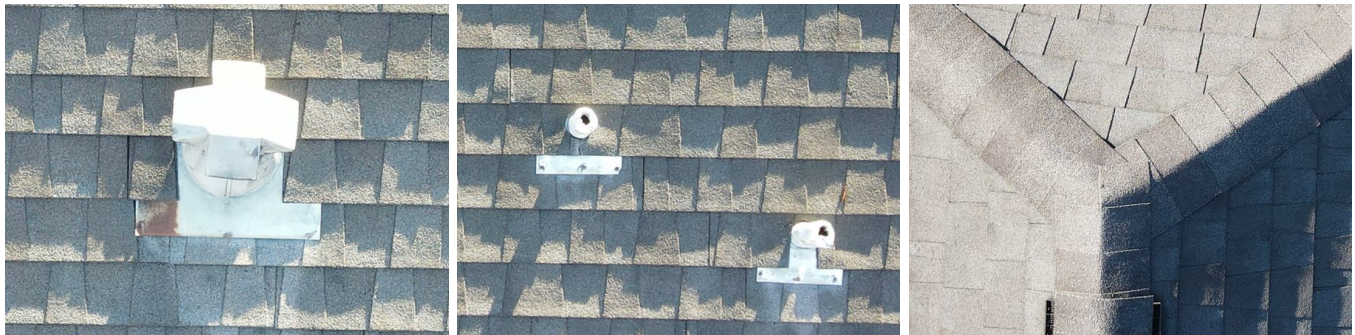
5.8.1 Roof Details

DETERIORATED/MISSING SEALANTS

We observed sealants that were cracked/separated/missing and repair is needed.

Obtain Cost Estimate

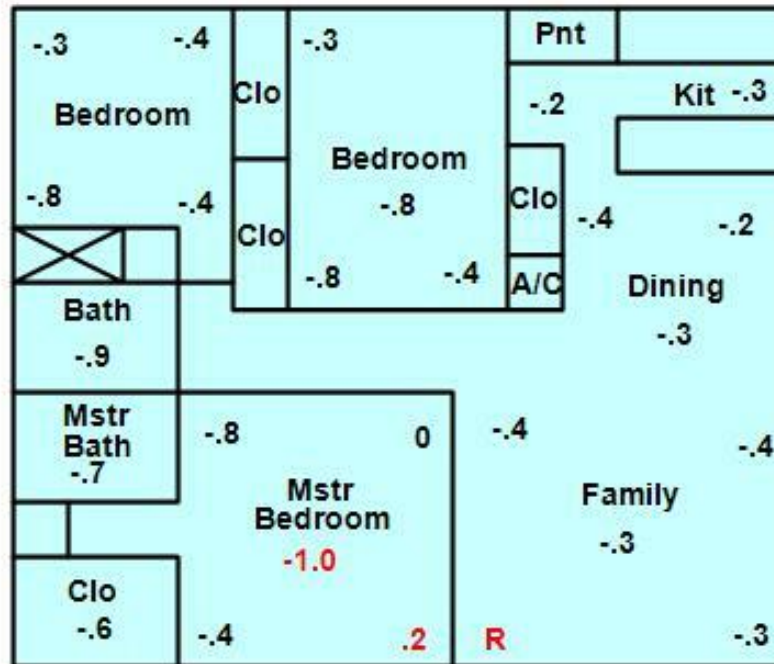
**Elevation Readings
14333 Memorial Drive #75**

The floors were checked with an electronic level, and were observed to be acceptably level throughout the house. The difference in elevation between the high point and low point was 1.2 inches. The high point and the low point were located at the master bedroom. The unlevelness takes place over a horizontal distance of approximately 10 to 15 feet.

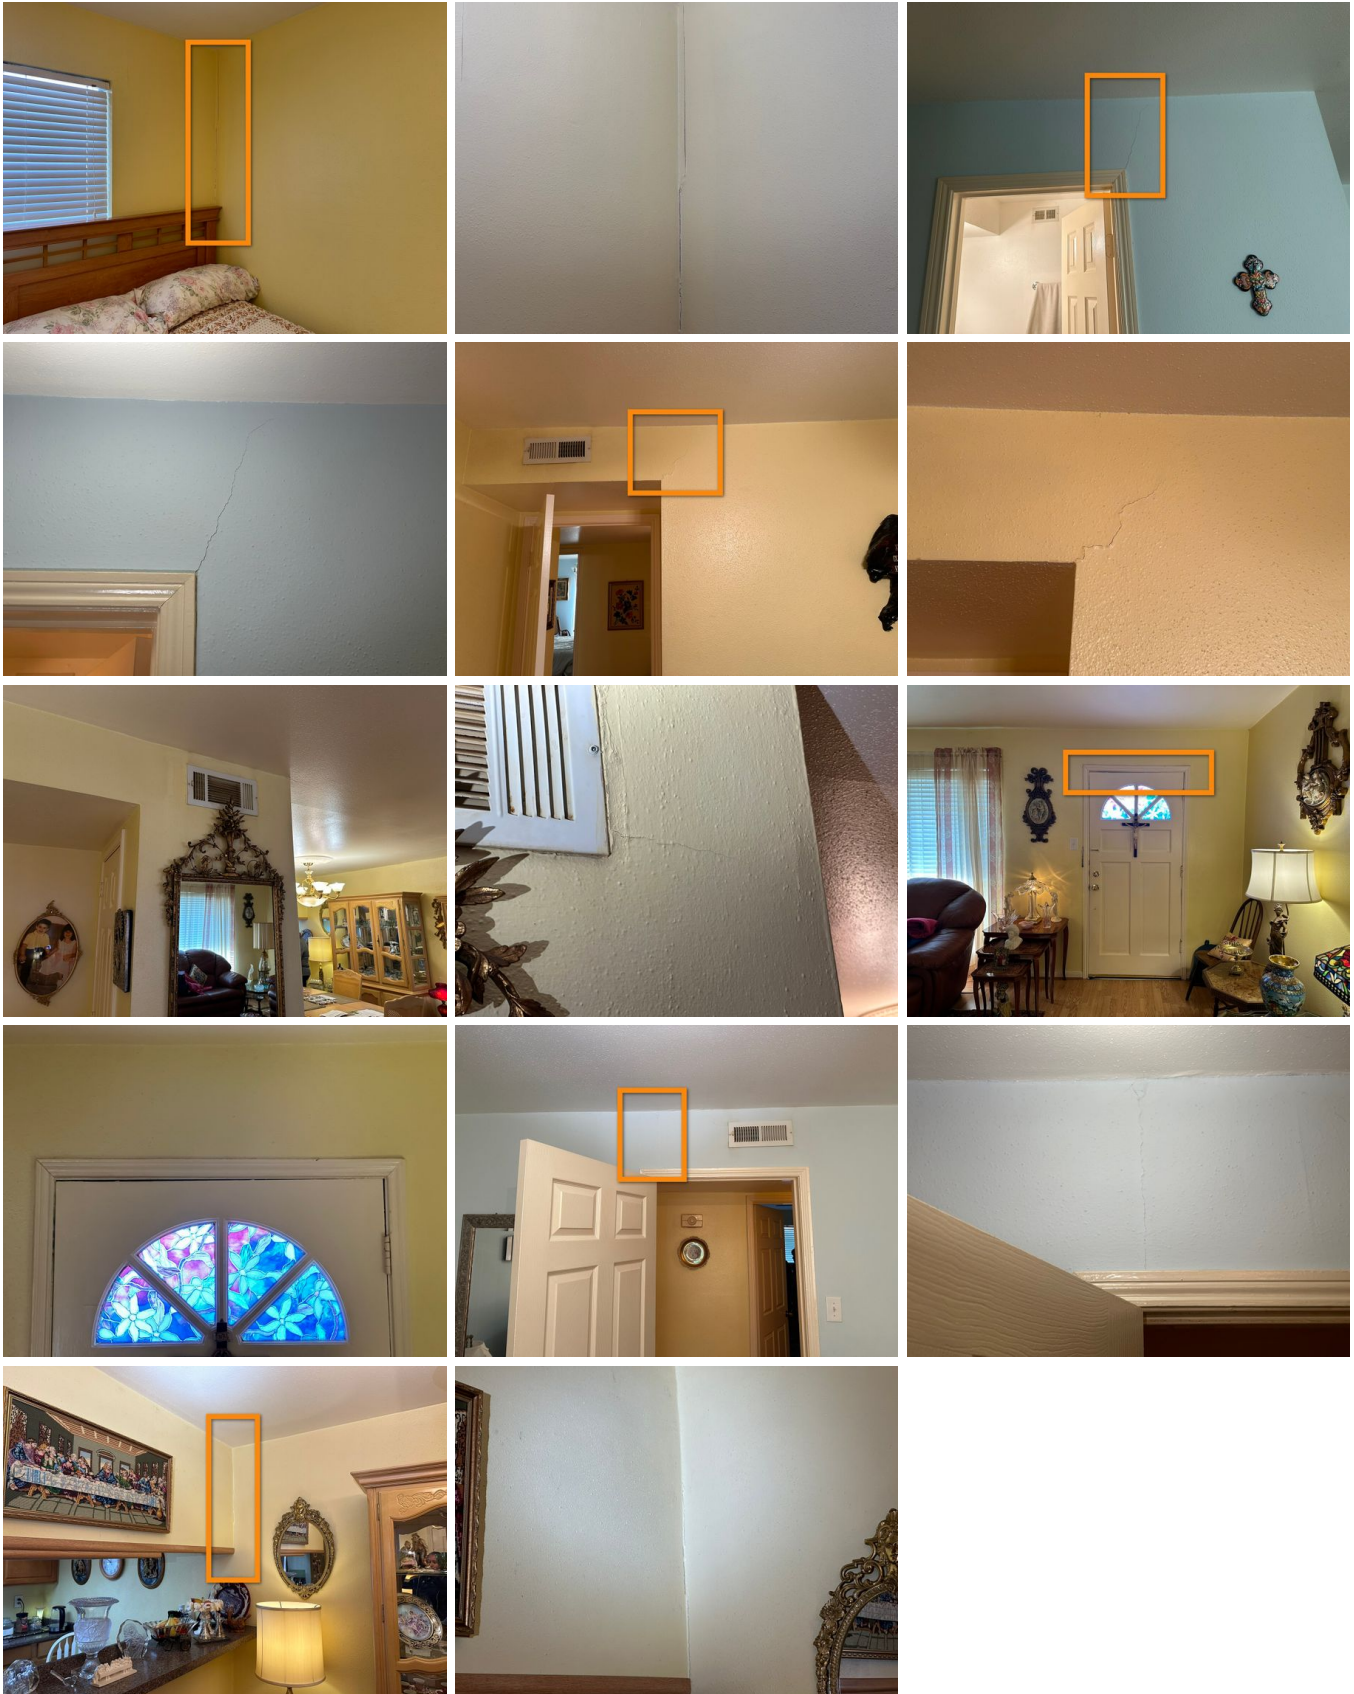
6.4.1 Floor Framing

EVIDENCES OF MOVEMENT RELATED TO THE FRAMING

Sheetrock Cracks, Sheetrock Wrinkled, Non-latching doors, Door triangles at top

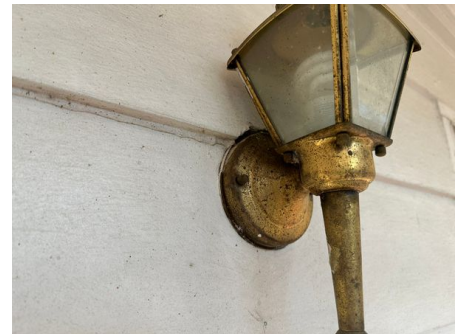
7.1.1 Water Penetration

VULNERABILITY TO WATER PENETRATION

Sealants deteriorated/missing

A substantial vulnerability to water penetration was observed at penetrations/openings through the exterior building envelope, and it is recommended that all penetrations/openings be sealed against water penetration. Typical examples on a structure may include light fixtures, air conditioning refrigerant lines, water piping, gas piping, vent caps, windows, doors, expansion joints, etc. Below is a representative sample of locations and/or photographs showing some, but not necessarily all, locations where there is a vulnerability to water penetration. Have a contractor provide a cost estimate to seal all vulnerable areas on the exterior building envelope against water penetration and/or open up any clogged weepholes in the veneer.

Obtain Cost Estimate

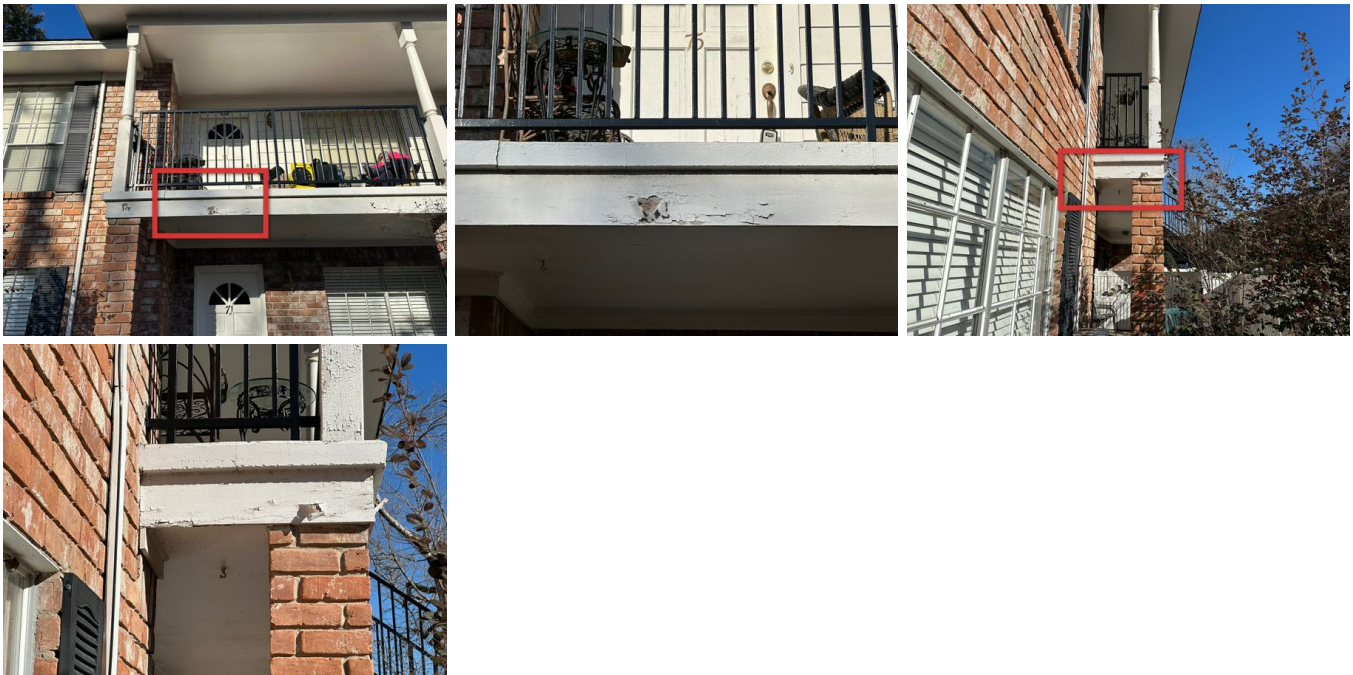
10.4.1 Wood Rot

WEATHERED

We observed weathered wood at the exterior of the house. The wood does not appear to be rotted at this time, but if the wood is not sealed and painted, it can be anticipated that deterioration will occur quickly, with replacement of the wood becoming necessary. Further investigation with a contractor is recommended to obtain a cost estimate to seal and paint the exterior wood.

Obtain Cost Estimate

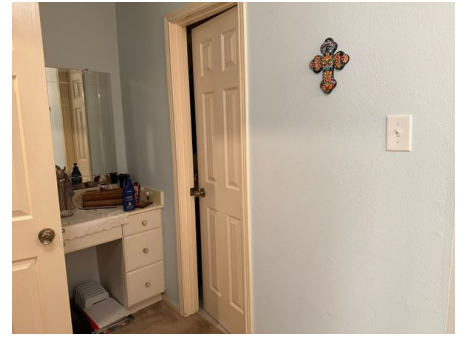
11.2.1 Doors

NON-LATCHING AT STRIKER PLATE

MASTER BATHROOM

We observed non-latching doors that were in need of adjustment to the striker plate on the door frame.

Obtain Cost Estimate

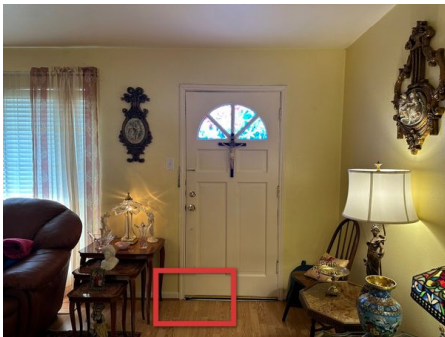
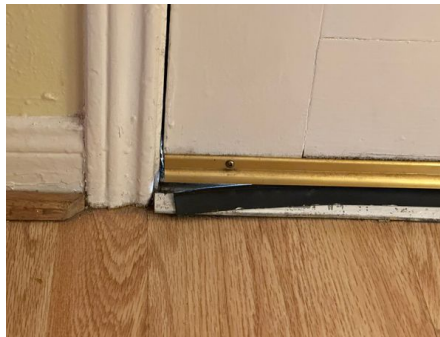
11.2.2 Doors

DAYLIGHT VISIBLE AT EXTERIOR DOOR

We observed daylight at the exterior door when in the closed position, and the condition needs to be repaired.

Obtain Cost Estimate

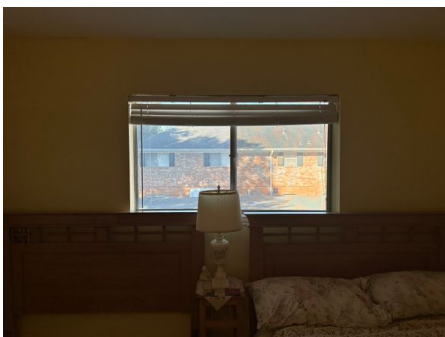
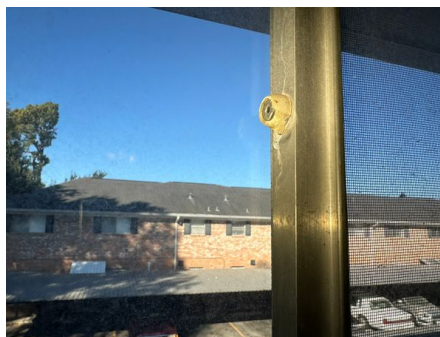
11.3.1 Windows

DAMAGED LOCK

NORTH BEDROOM

We observed windows with a damaged lock that needs to be replaced.

Obtain Cost Estimate

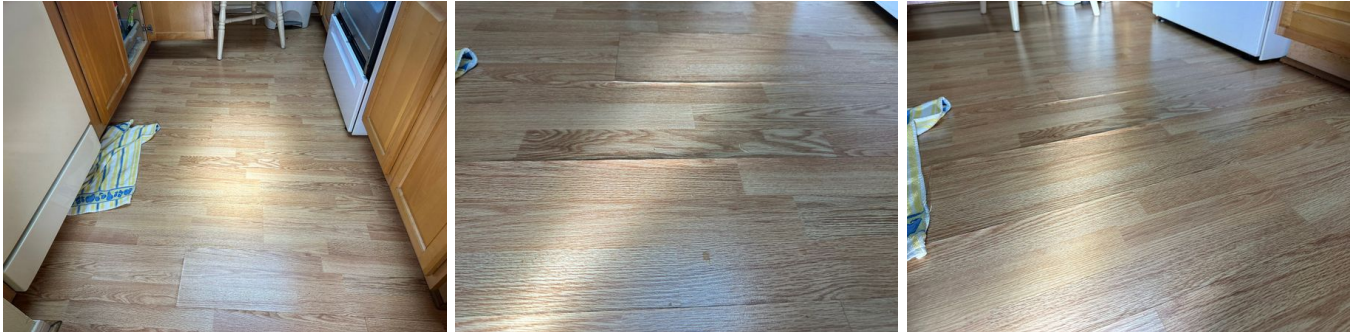
11.4.1 Floor coverings

VINYL FLOOR CUPPING

KITCHEN

The floor was observed to be cupped, with the edges of the boards curling downwards into a "cupping" effect. This condition is typically caused when the floors have excessive moisture in them. Potential sources of moisture could be coming from the dishwasher or the kitchen sink. Further investigation with a floor specialist and/or a service company is recommended to determine the source of the condition, and to provide a cost estimate for any needed repairs.

Obtain Cost Estimate

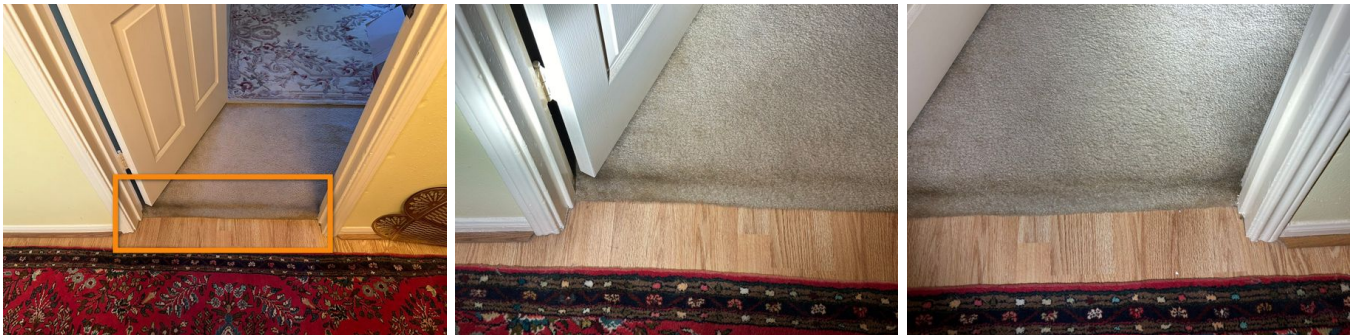
11.4.2 Floor coverings

CARPET STAINED

NORTH BEDROOM

The carpet was observed to be stained, and it is recommended that it be cleaned or replaced.

Obtain Cost Estimate

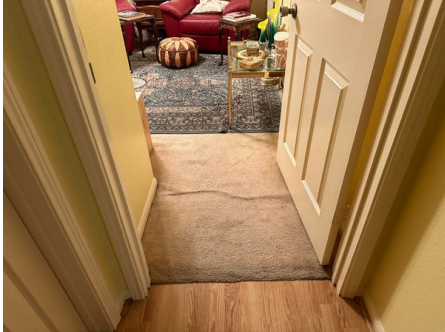
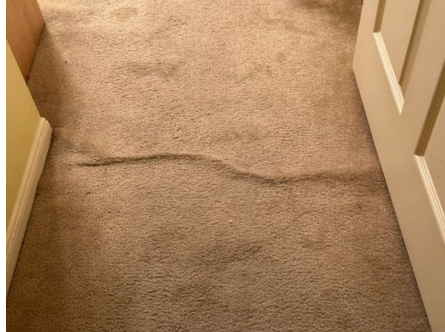
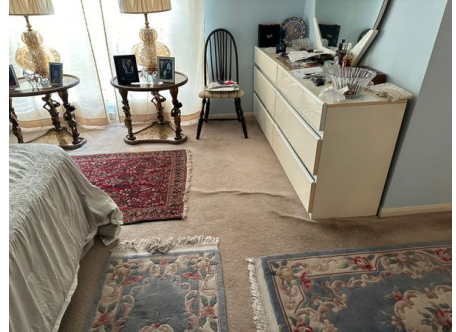
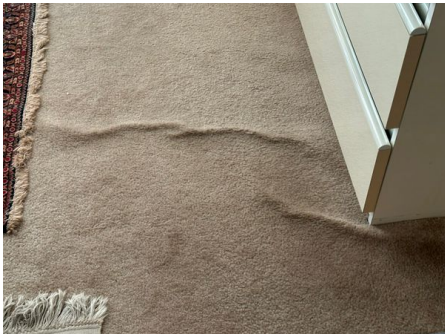
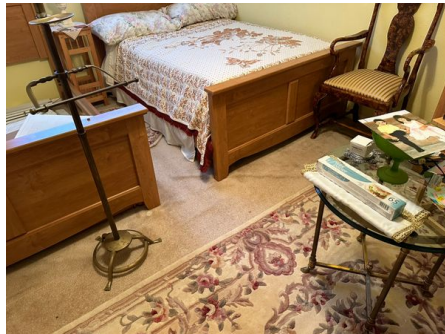
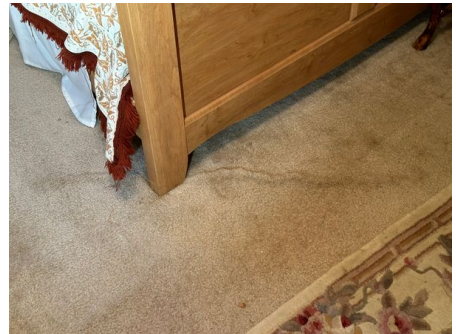
11.4.3 Floor coverings

CARPET LOOSE/DAMAGED

BEDROOMS

The carpet was observed to be loose/damaged, and repair is needed. Contact a service company for a cost estimate.

Obtain Cost Estimate
