Property Inspection Report

Address: 5 Oakwoods Lane
Huntsville, TX, 77320

By: Peter van Dongen
Texas Professional Engineer (PE 87926)

PROPERTY INSPECTION REPORT

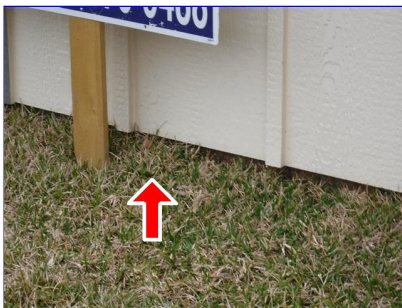
High soil front

B. Item 1(Picture) High soil front

Recommend 3 to 4 inches of foundation exposure on slab on grade foundations

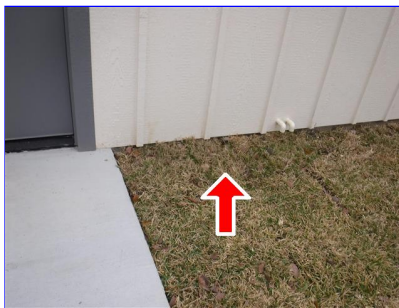
High soil right side

B. Item 2(Picture) High soil right side

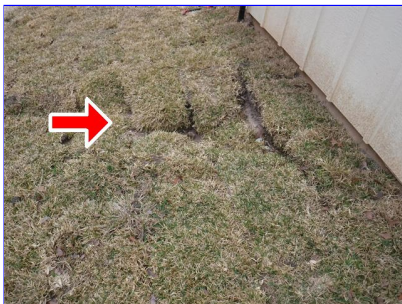
Noted ground settlement right side at electrical

B. Item 3(Picture) Ground settlement right side at electric

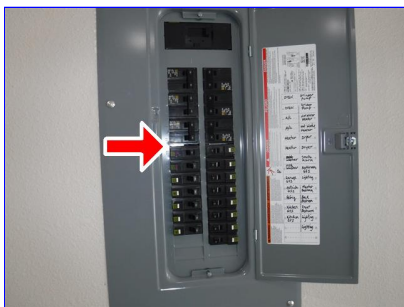
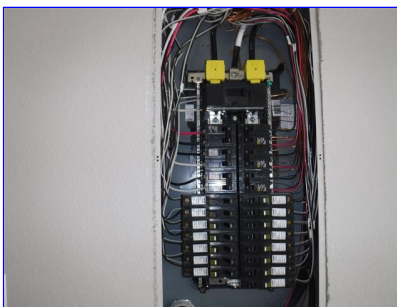
Square D breaker panel with 200 amp main breaker located in garage
Copper wire
Panel labeled
Panel bonded
Ground rod not visible
Secondary ground rod in garage
Panel labeled
AFCI and GFCI protected circuits.

A. Item 1(Picture) Panel

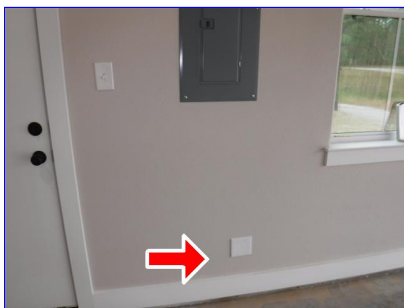
A. Item 3(Picture) Secondary ground

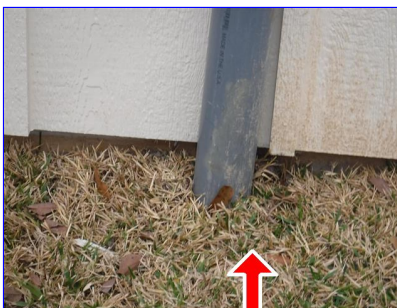
A. Item 4(Picture) Ground rod not visible

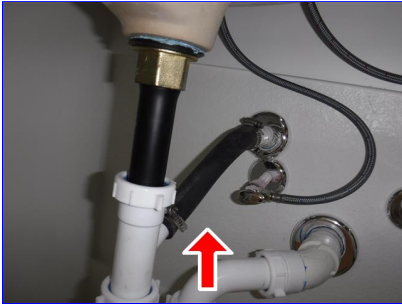
Primary drain line plumbed to the guest bathroom sink trap

A. Item 1(Picture) Primary drain line guest bathroom sink trap

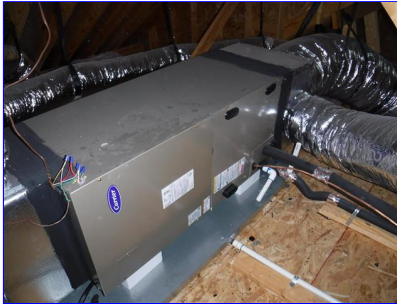
A. Item 2(Picture) Heater / air handler

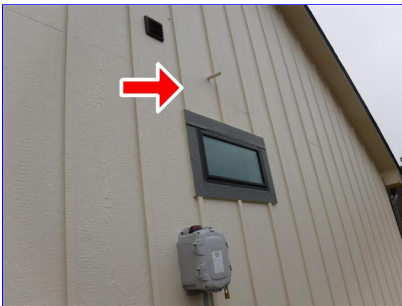
Pan drain plumbed to the left gable

A. Item 3(Picture) Pan drain left gable

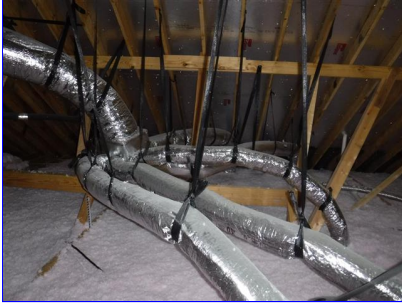
Ductwork: R-6 insulated Flex ducts
Filter Type: Disposable
Comments:
Ducts supported and sealed as needed.
No leaks detected

C. Item 1(Picture) Ducts supported and sealed as needed

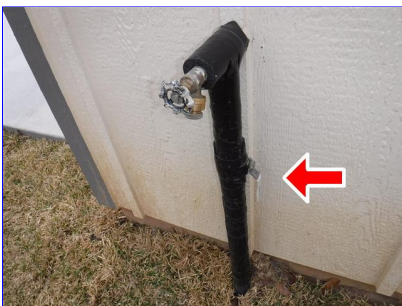
A. Item 1(Picture) Water shutoff right side

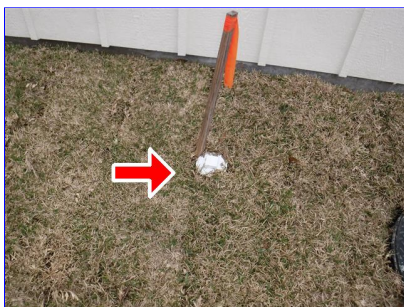
B. Item 1(Picture) Cleanout located on left side

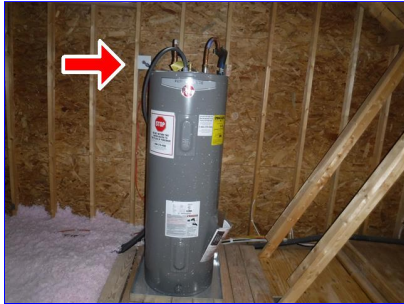
C. Item 1(Picture) Water heater located in attic

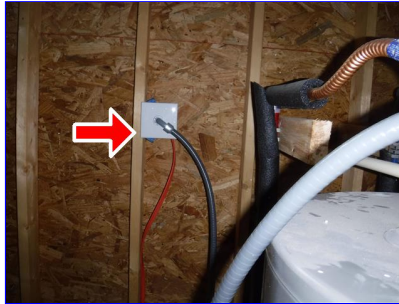
Date of manufacture 08/20
4500 watts located in attic
Drain pan present
Drain pan plumbed to the outside
T&P valve drain line plumbed to the outside
No electric disconnect at water heater

C. Item 2(Picture) No electric disconnect

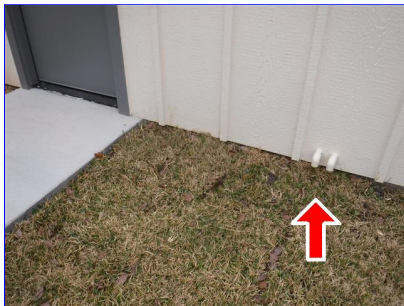
C. Item 3(Picture) Pan and T&P valve drain lines right side

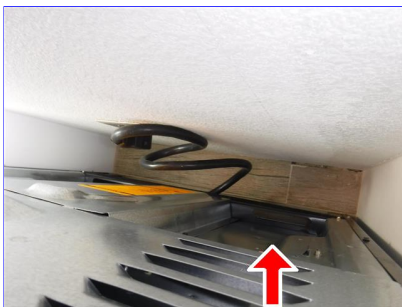
Missing manufactures recommended anti tip device

D. Item 1(Picture) Missing anti tip device

Anti-tip devise recommended by the Manufacture on freestanding ranges for child safety

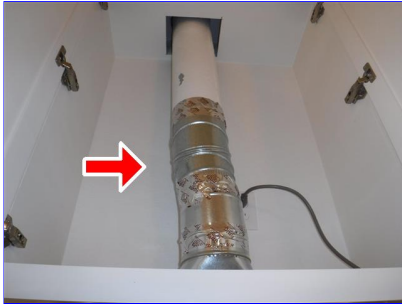
E. Item 1(Picture) Vented to the outside

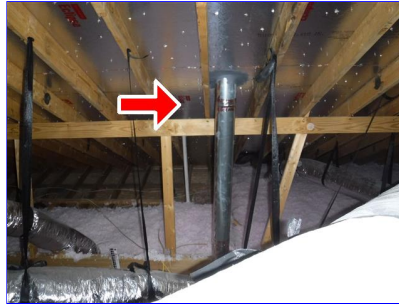
E. Item 2(Picture) Vented through roof

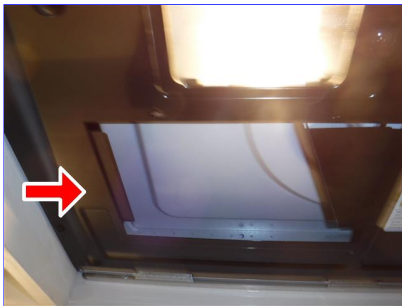
E. Item 3(Picture) Filters are in information packet in microwave

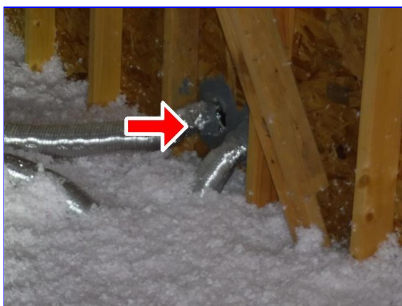
Disconnected duct right side

F. Item 1(Picture) Disconnected vent fan duct

Mechanical exhaust vent fans must terminate on the outside of the structure

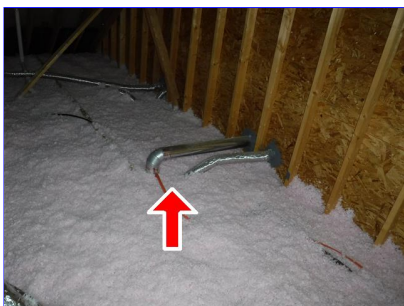
Vented to the outside with smooth 4" metal duct with taped joints.

H. Item 1(Picture) Dryer duct to the outside

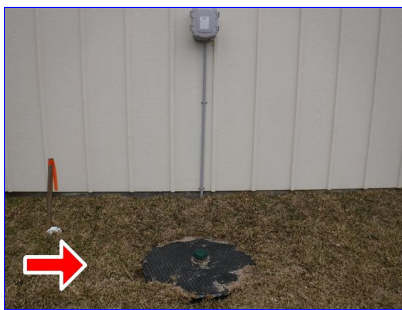
Noted dirt settlement around tank

E. Item 1(Picture) Grinder lift pump left side
