HOUSTON INSPECTIONS

September 1, 2021

PROPERTY INSPECTION REPORT

Concerning: 3001 Murworth Dr, Houston, TX 77025
(Address or Other Identification of Inspected Property)

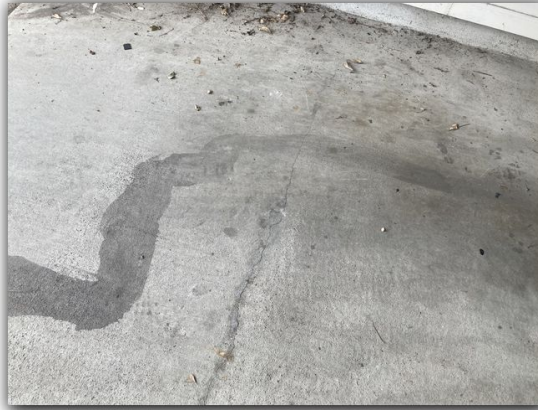
Shrinkage cracks were observed at various visible locations on the foundation / concrete floors. Cracking is a normal property of concrete as it dries and shrinks during the curing process. Additional shrinkage cracks may be present under the floor coverings in the structure.

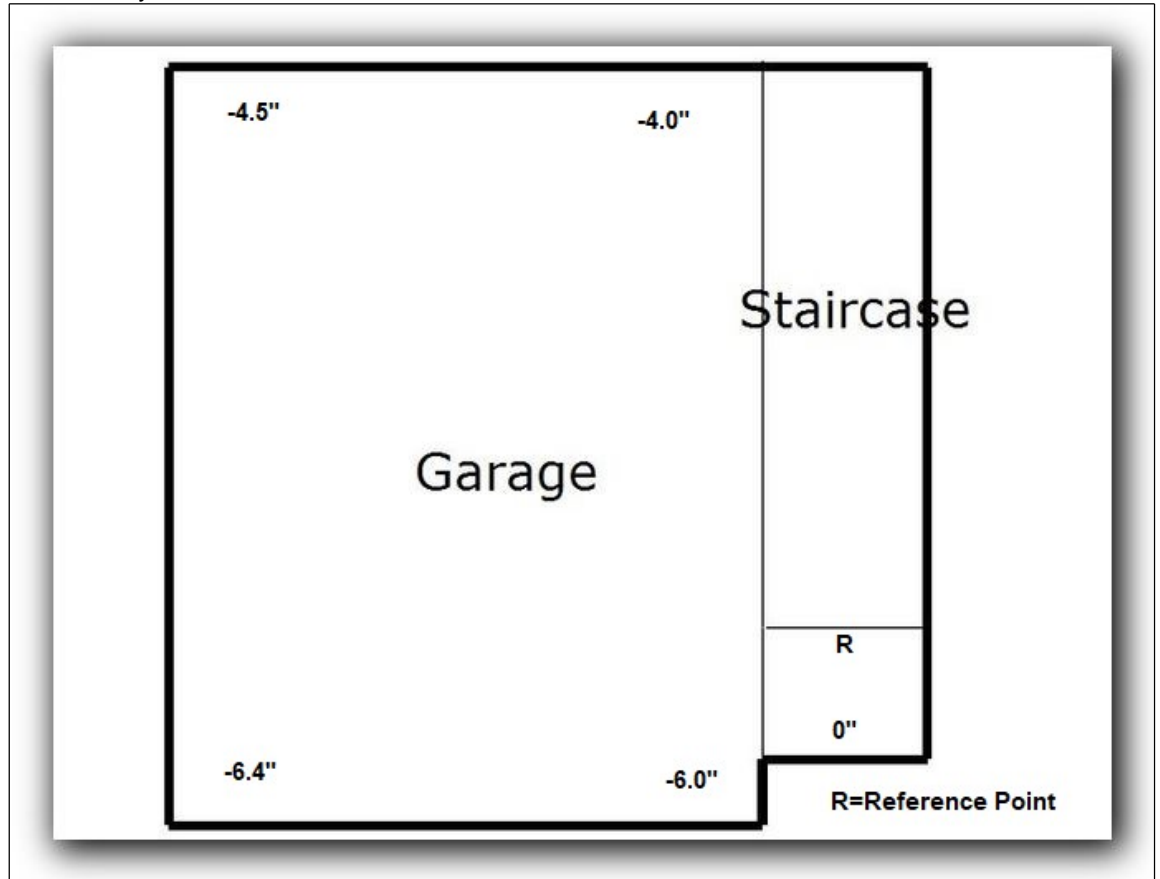
The below graph reflects measurements taken during the inspection to assist with determining the performance of the foundation. The outline / drawing is not to scale and does not accurately reflect every detail of the foundation walls.

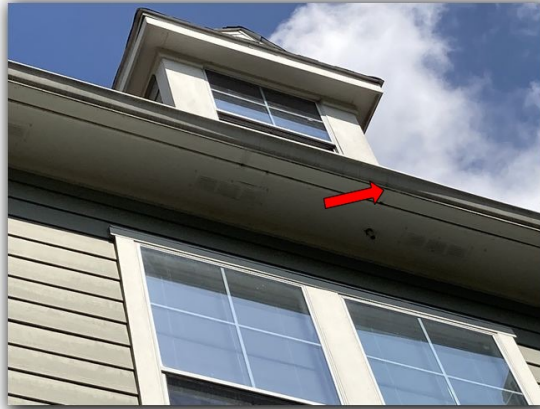
Leaky gutters were found around the perimeter of the roof covering. The leaks should be repaired along with any damage caused by the leaks. The qualified tradesman should also verify that the slope of the gutters is correct.

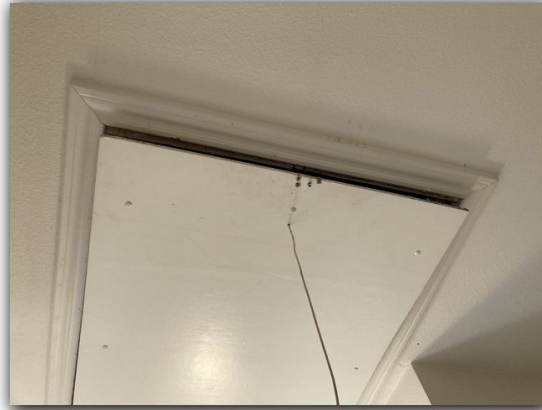
Missing weather-stripping at attic door.

The attic access does not completely close. Recommend repair by a qualified tradesman

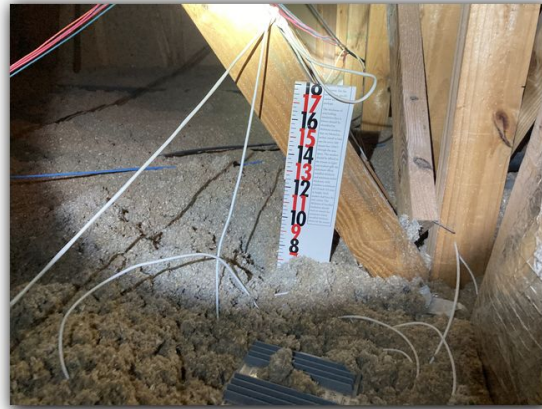
The level / depth of insulation in the attic is considered less than normal in some areas of the attic. The installation of additional insulation or the rearranging of the insulation is recommended to improve the energy efficiency of the building.

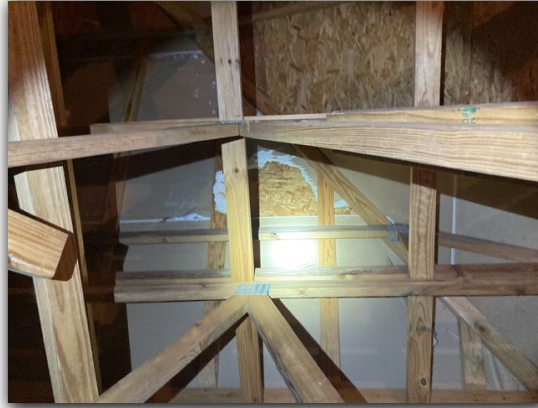
Evidence of previous structural repairs were found in the attic as evident by new lumber at several locations.

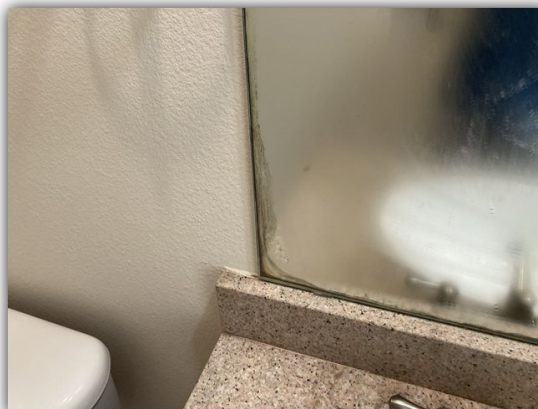
The silvering is wearing and missing at the bathroom mirrors.

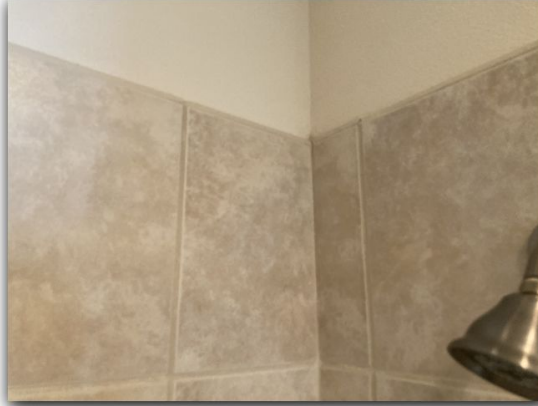
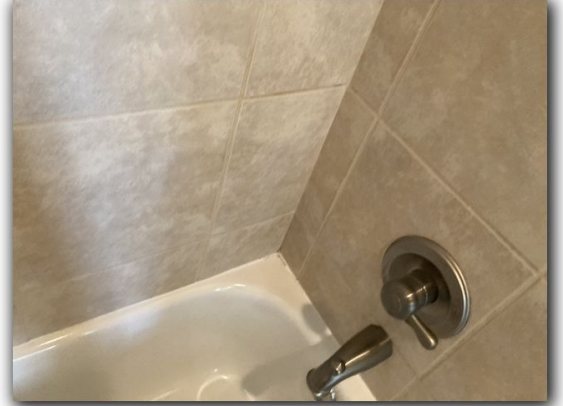
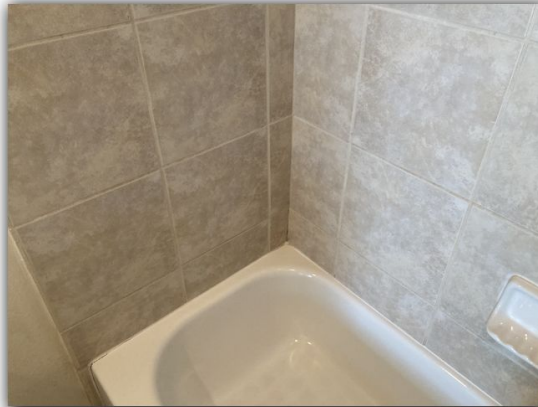
Damaged and missing grout/caulking was noted in the Master Bathroom, Guest Bathroom shower/bathtub enclosure.

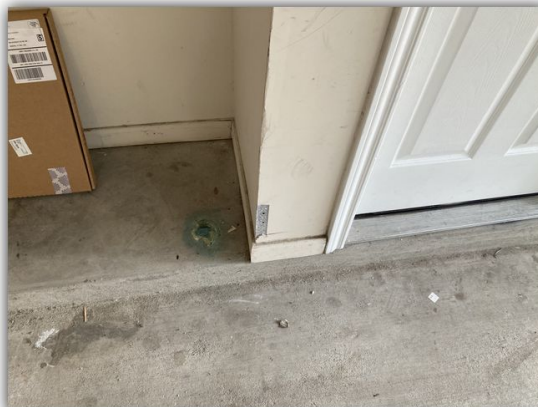
1. Garage

Damaged / missing area(s) were found at the interior of the property being inspected in the following locations:

The problems have been possibly caused by one or more of the following: water penetrations, insects, impact, foundation / structural movement, etc. Repairs should include replacement of damaged underlying materials where needed.

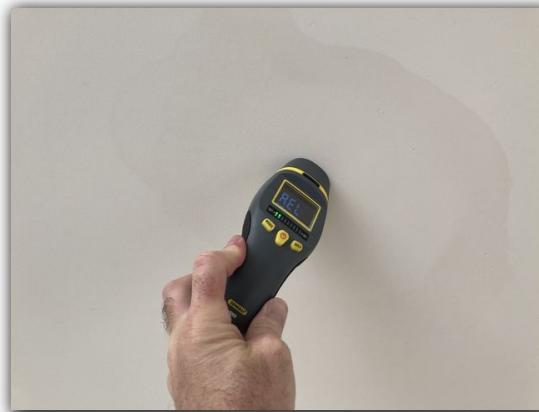
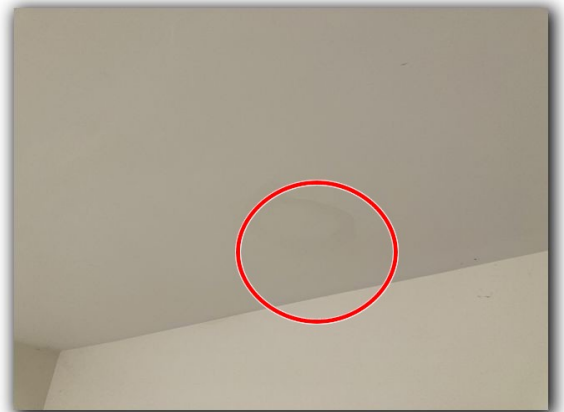
Damaged / discolored drywall was found in the Garage during the inspection. No abnormalities were found at this area with the infrared camera and no elevated moisture readings were observed when inspected with a pinless (non invasive) moisture meter. Recommend further evaluation to determine the needed repairs.

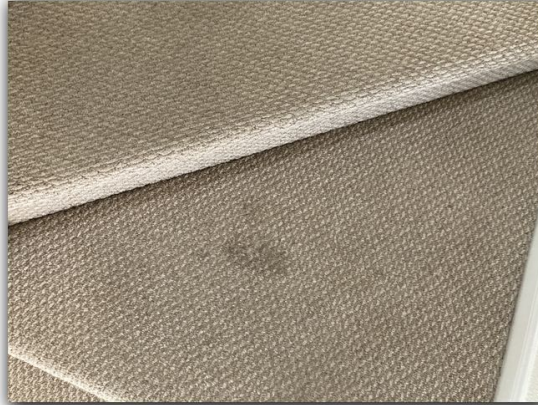
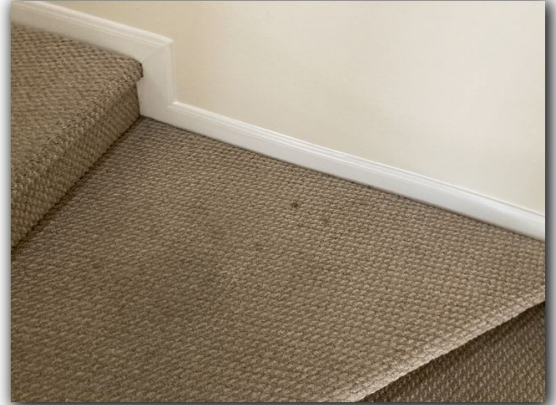
Stained and / or damaged carpet was found on the interior of the building.

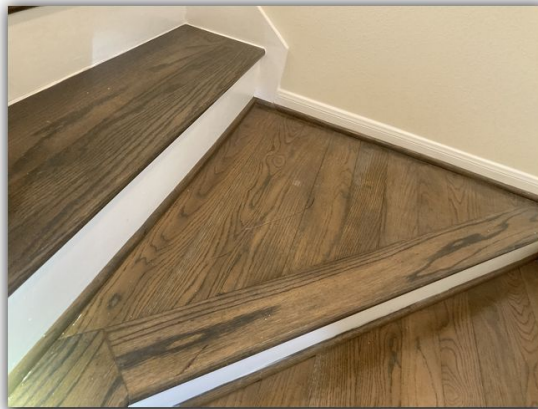
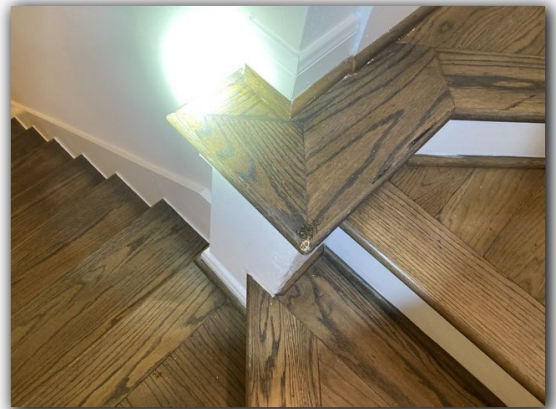
The wood floors are showing signs of wear and tear (ding's, scratches, etc.).

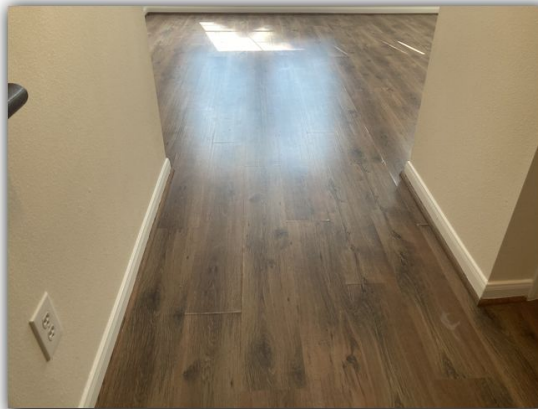
Warped / buckled wood floors were found in the Formal Living Room. A qualified tradesman should be consulted to determine the source of moisture and needed repairs.

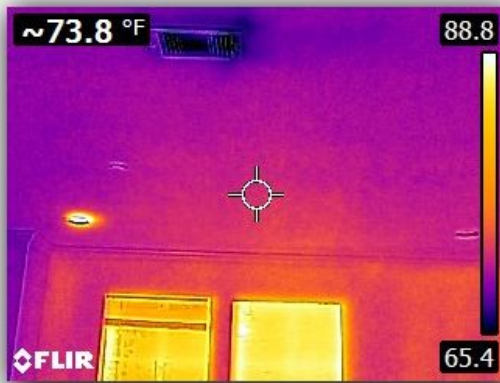
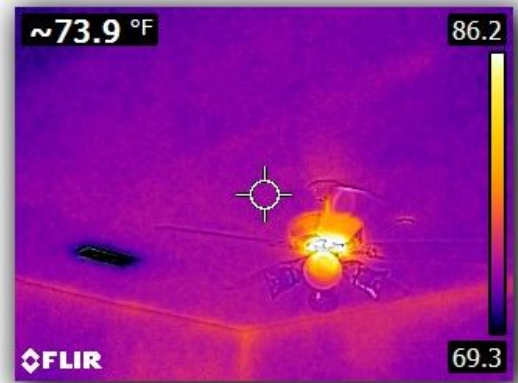
During the inspection of the ceilings on the interior of the structure with a infrared camera abnormalities were not noted. The picture(s) below are a sampling of some image(s) taken during the inspection.

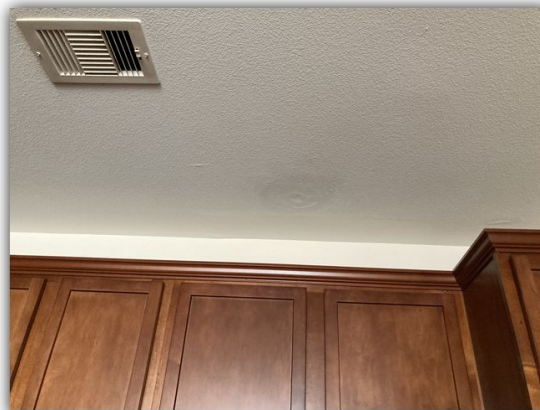
Evidence of patching was found at several sections of the ceilings in the home.

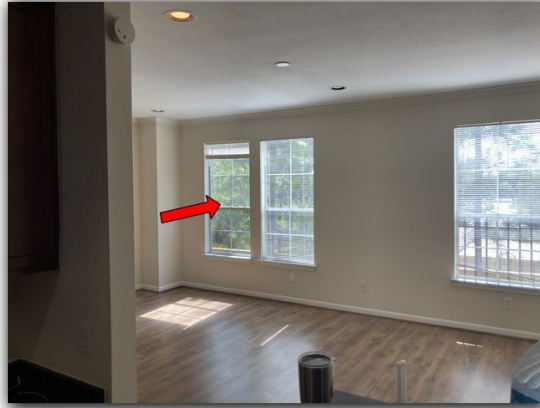
1. Living room

The thermal seals appear to have failed at windows in the follow locations:

This was evident by the build up of condensation and / or discoloration between the two window panes. A qualified tradesman should be consulted to repair or replace the windows found deficient and evaluate the other windows in the property for additional lost seals.

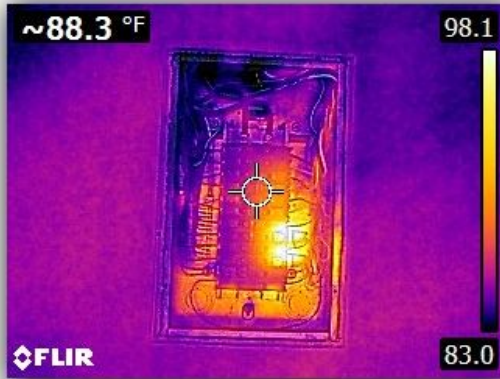
During the inspection of the electrical panel with a infrared camera significant abnormalities were not noted. The picture(s) below are a sampling of some image(s) taken during the inspection.

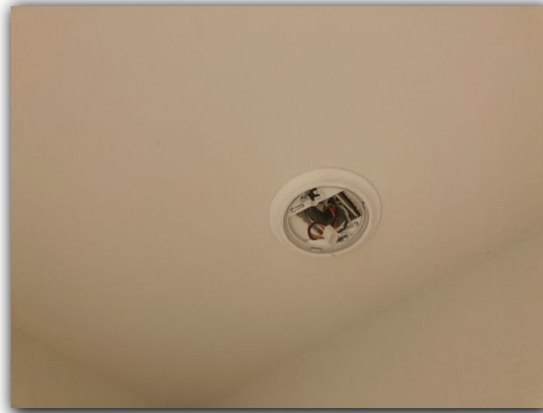
Smoke detectors have not been installed/ and or removed at the property being inspected. Current codes require smoke detectors in all sleeping rooms and in the immediate area outside of each sleeping room. In addition, the smoke detectors are required to be hard wired with battery back ups and be interlinked together. It is recommended that at a minimum, battery-operated smoke detectors be installed at the required locations.

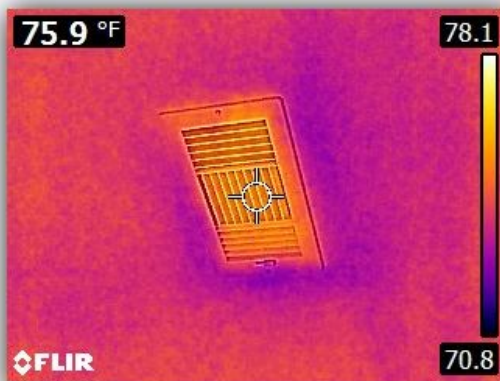
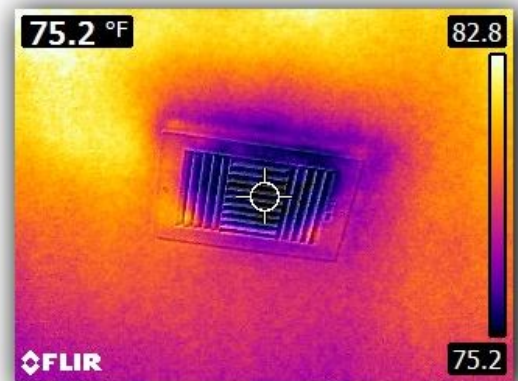
The electric heaters does not appear to be operating at maximum efficiency. After operating for 20 minutes the temperature at the registers was only _75_ degrees. This may indicate a malfunction in one or more of the heating elements or control components. Recommend further inspection, service, & repair by a licensed A/C-Heat technician.

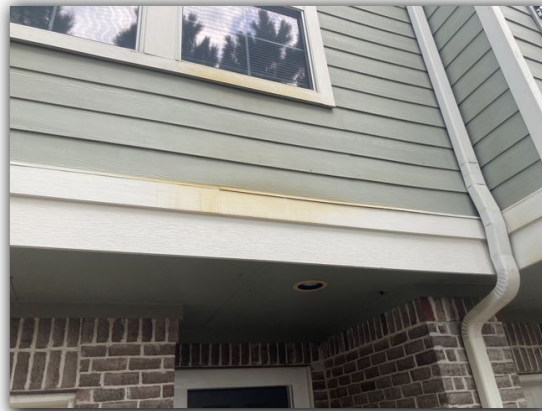
Evidence of previous rust in the pan/clogged primary drain line was noted by rust staining on the front exterior

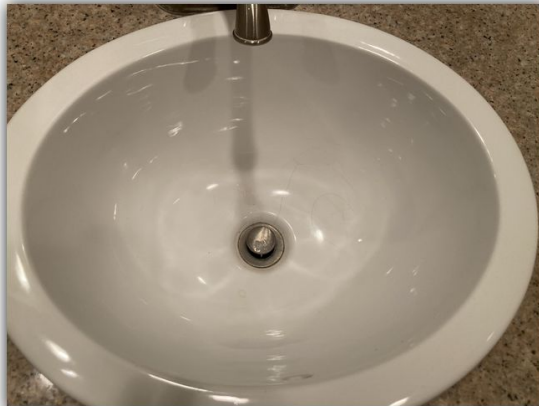
Surface damage was found at the sink. The damage should be repaired to prevent the damage from extending to through the fixture.

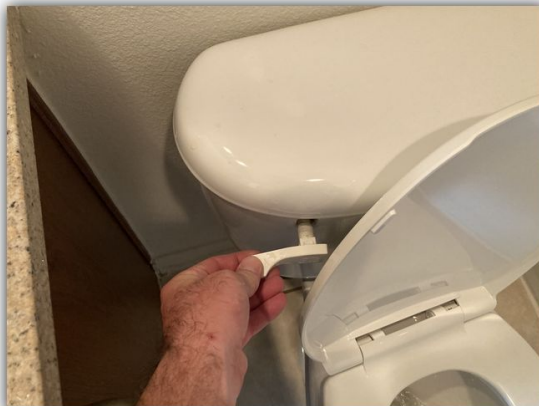
The toilet handle is loose. Recommend securing

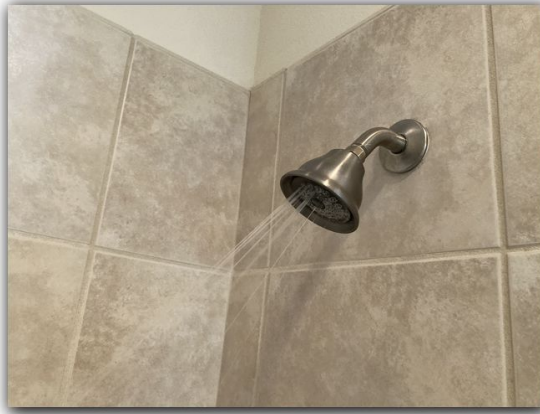
The shower aerator is in need of cleaning.

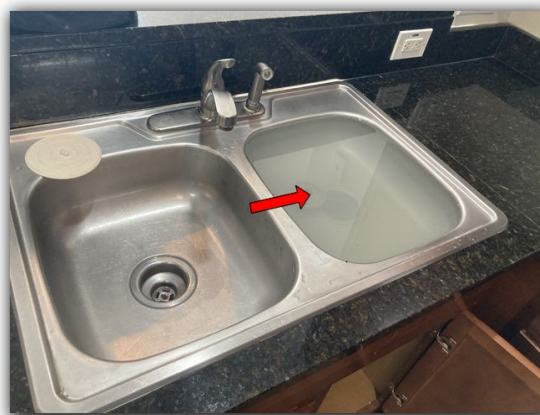
The right sink is draining slowly. It is suspected that the waste piping is obstructed. Further investigation is needed.

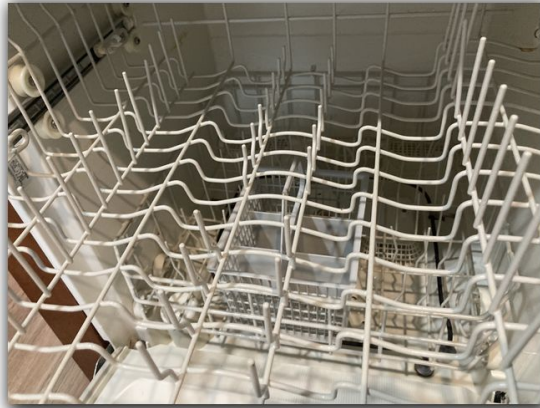
Observed rust on the dishwasher components. Recommend repair with approved materials.

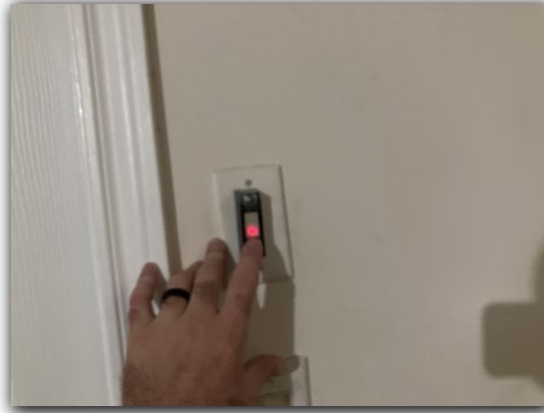
The garage door operator will not close without the button being held in position. Recommend adjustments / repairs.

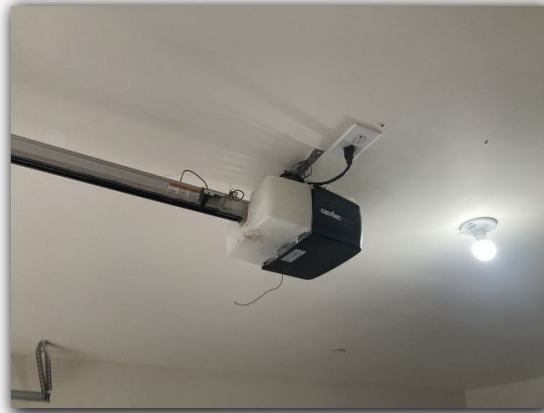
The light is not functioning at the garage door operator.
