Lone Star Stucco, LLC

Moisture Assessment Report

4102 Roseland Street

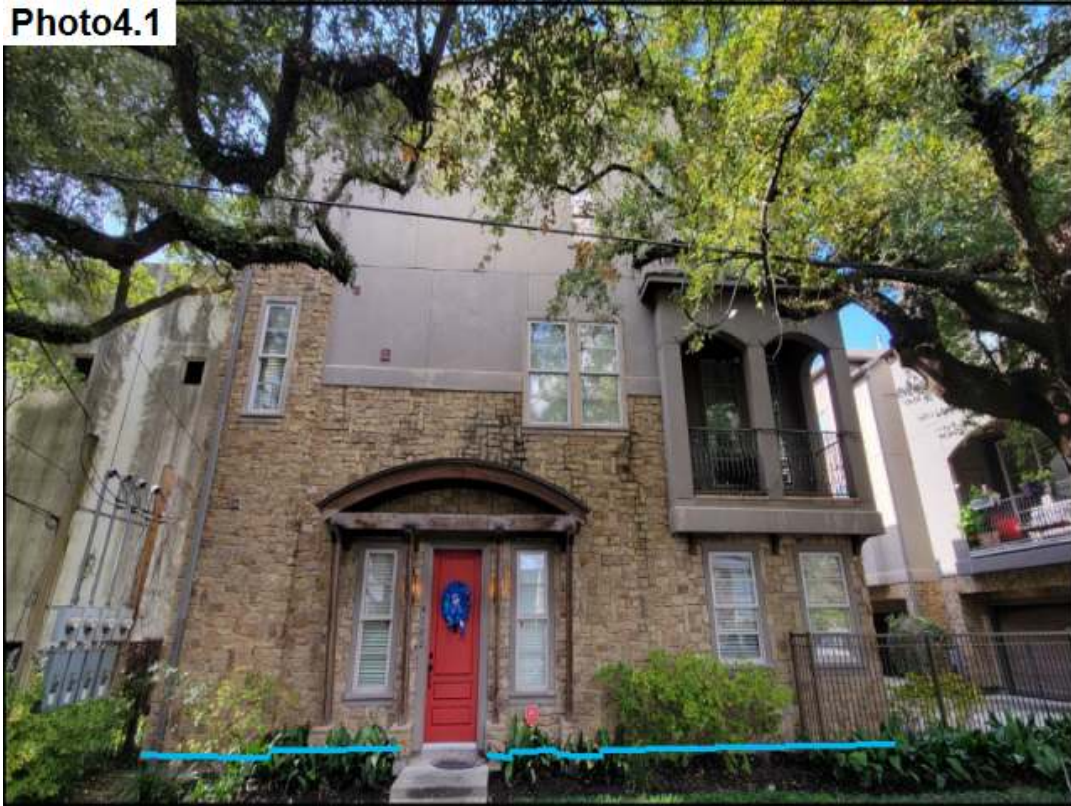
Photo4.1

- Black plastic has been noted in this area. This is when the substrate has been sealed with plastic, which creates a reservoir to hold moisture. The inspector suggests to consult with a qualified waterproofing contractor to cut the plastic in an effort to prevent the substrate from rotting. Please refer to photo #4.1 for more detail.

Grid Location	Item Description	Moisture Readings	Substrate Condition	Observations
Blue Lines	Black Plastic			Black plastic has been noted in this area. This is when the substrate has been sealed with plastic, which creates a reservoir to hold moisture. The inspector suggests to consult with a qualified waterproofing contractor to cut the plastic in an effort to prevent the substrate from rotting. Please refer to photo #4.1 for more detail.

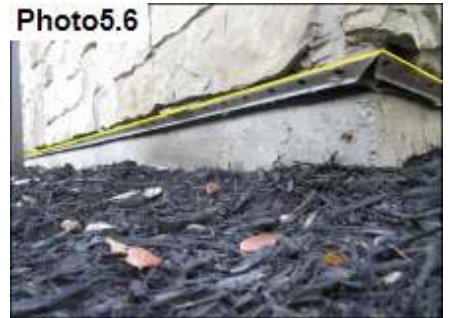
Photo5.6

Proper Grade Termination with Weep Screed / Positive Detail

Grid Location	Item Description	Moisture Readings	Substrate Condition	Observations
Yellow Lines	Grade Termination			Manufactured stone veneer (MSV) appears to be typically detailed at grade for the time of this construction. The inspector suggests that this is a positive detail and recommends no modification at this time but to always keep soil away from the structure. Please refer to photos #5.2, #5.3, #5.4, #5.5 and #5.6 for more detail.

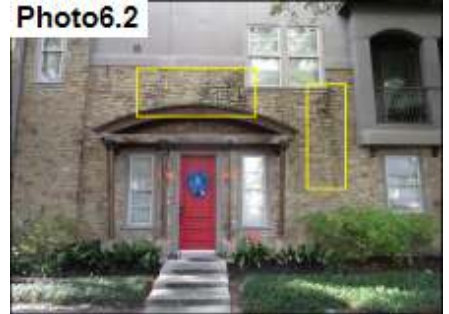
Photo6.2

Mildew & Run-off Stains / Clean (Aesthetic)

Grid Location	Item Description	Moisture Readings	Substrate Condition	Observations
Yellow Boxes	Mildew & Run-off Stains			Mildew and run-off stains have been noted in these areas. The inspector suggests to clean the area as needed from an aesthetic concern only. Please refer to photos #6.2, #6.3, #6.4 and #6.5 for more detail.

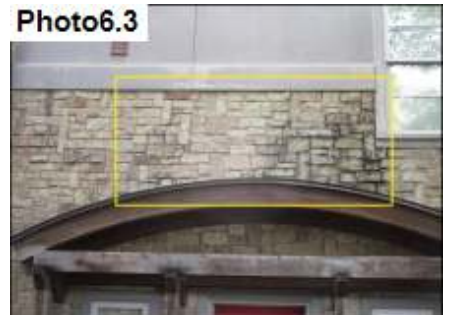
Photo6.3

Mildew & Run-off Stains / Clean (Aesthetic)

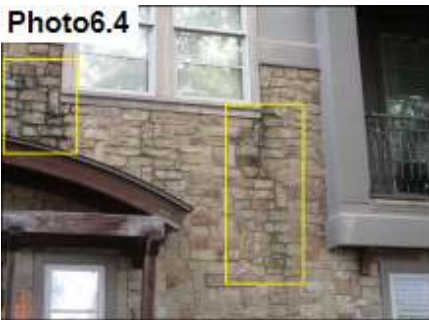
Photo6.4

Mildew & Run-off Stains / Clean (Aesthetic)

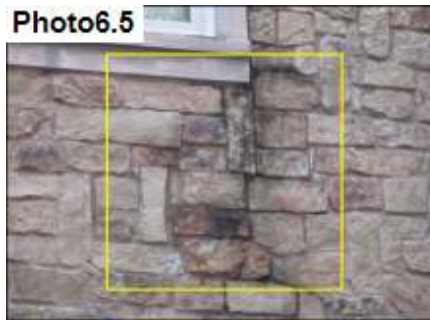
Photo6.5

Mildew & Run-off Stains / Clean (Aesthetic)

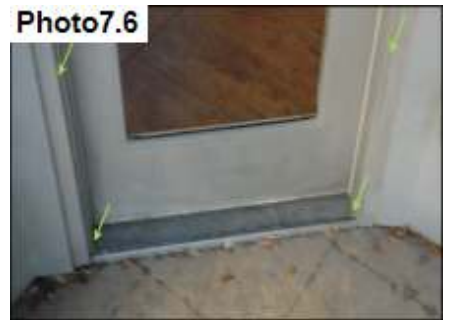
Photo7.6

Door Sealants / Seal

Grid Location	Item Description	Moisture Readings	Substrate Condition	Observations
Green Arrows	Doors			The door trim and miter sealants are aged or separated at these locations. The inspector suggests to have a qualified waterproofing contractor seal these areas with a low modulus sealant in an effort to prevent moisture intrusion. These types of sealants are of high quality and compatible with stucco and other termination points. Please refer to photos #7.2, #7.3, #7.4, #7.5 and #7.6 for more detail.

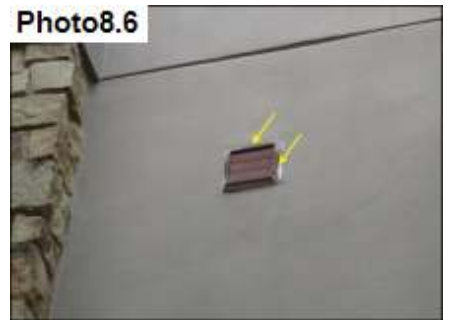
Photo8.6

Penetration Sealants / Seal

Grid Location	Item Description	Moisture Readings	Substrate Condition	Observations
Yellow Arrows	Penetrations			The penetration sealants are aged or missing in these locations. The inspector suggests to have a qualified waterproofing contractor seal these areas with a low modulus sealant in an effort to prevent moisture intrusion. These types of sealants are of high quality and compatible with stucco and other termination points. Please refer to photos #8.2, #8.3, #8.4, #8.5 and #8.6 for more detail.

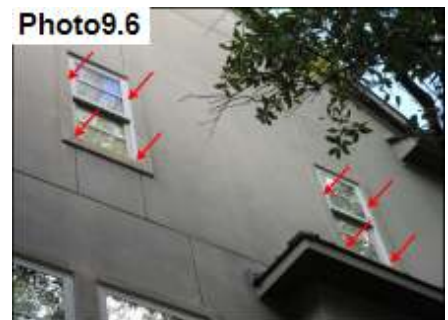
Window Sealants / Seal

Grid Location	Item Description	Moisture Readings	Substrate Condition	Observations
Red Arrows	Windows			The window sealants are aged or separated. The inspector suggests to have a qualified waterproofing contractor further assess and seal these areas with a low modulus sealant in an effort to prevent moisture intrusion. These types of sealants are of high quality and compatible with stucco and other termination points. Please refer to photos #9.2, #9.3, #9.4, #9.5 and #9.6 for more detail.
F5	Window Lower Right	24%	Semi-Firm	A moisture probe was taken at the window lower right. An elevated moisture reading was noted with a semi-firm substrate.
F3 Green	Window Header	17%	Firm	A moisture probe was taken at window header below the window lower left. The substrate was firm with no damage noted at this time.
F3 Yellow	Window Header	16%	Firm	A moisture probe was taken at window header below the window lower right. The substrate was firm with no damage noted at this time.

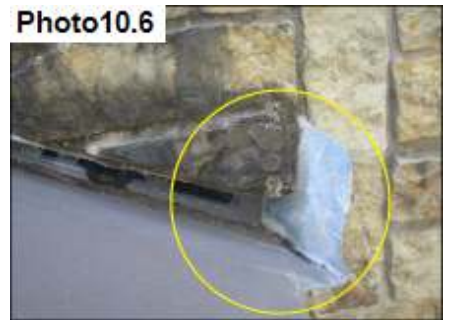
Kickout Flashing / Seal

Grid Location	Item Description	Moisture Readings	Substrate Condition	Observations
Yellow Circles	Kickout			The kickout flashing sealants are aged or separated at these locations. The inspector suggests to have a qualified waterproofing contractor further assess and seal these areas with a low modulus sealant in an effort to prevent moisture intrusion. These types of sealants are of high quality and compatible with stucco and other termination points. Please refer to photos #10.2, #10.3, #10.4, #10.5 and #10.6 for more detail.
D6	Below Kickout Flashing	17%	Firm	A moisture probe was taken below the kickout flashing. The substrate was firm with no damage noted at this time.
F6	Below Kickout Flashing	21%	Firm	A moisture probe was taken below the kickout flashing. An elevated moisture reading was noted with a firm substrate.

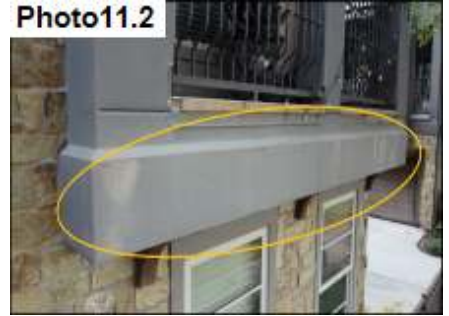
Photo11.2

Efflorescence and Deteriorated Paint / Clean & Repaint

Grid Location	Item Description	Moisture Readings	Substrate Condition	Observations
Orange Circles	Efflorescence			Efflorescence has been noted in this area of the home. This is when a naturally occurring salt migrates to the surface of the system causing a coating or paint deterioration. The inspector suggests to consult with a qualified stucco contractor to treat then paint this area Please refer to photos #11.2, #11.3, #11.4, #11.5 and #11.6 for more detail.

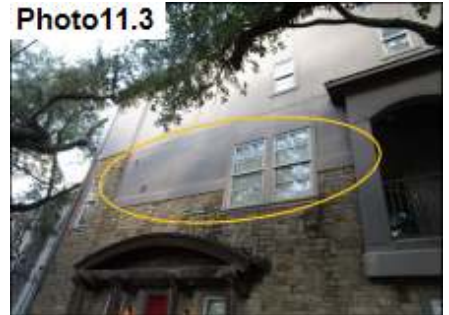
Photo11.3

Efflorescence and Deteriorated Paint / Clean & Repaint

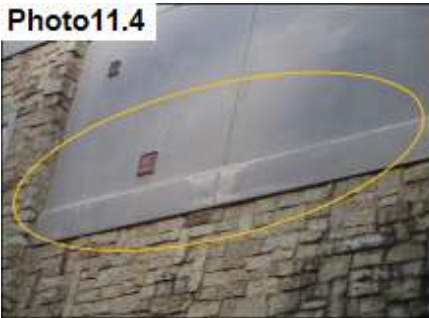
Photo11.4

Efflorescence and Deteriorated Paint / Clean & Repaint

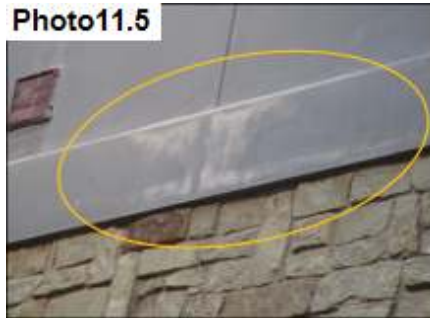
Photo11.5

Efflorescence and Deteriorated Paint / Clean & Repaint

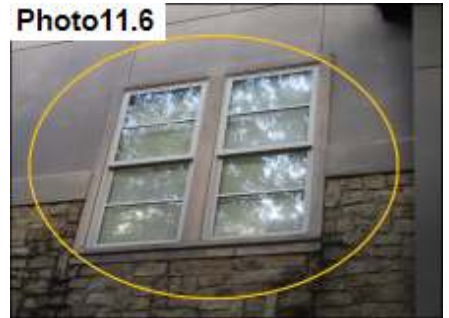
Photo11.6

Efflorescence and Deteriorated Paint / Clean & Repaint

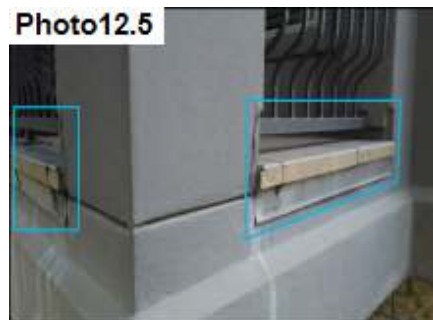
Balcony Flashing / Seal

Grid Location	Item Description	Moisture Readings	Substrate Condition	Observations
Blue Box	Balcony Flashing			The balcony flashing sealants are aged or separated at this location. The inspector suggests to have a qualified waterproofing contractor further assess and seal this area with a low modulus sealant in an effort to prevent moisture intrusion. These types of sealants are of high quality and compatible with stucco and other termination points. Please refer to photos #12.2, #12.3, #12.4 and #12.5 for more detail.
G6	Bottom Balcony	16%	Firm	A moisture probe was taken at the bottom of the balcony. The substrate was firm with no damage noted at this time
H6 Green	Bottom Balcony	18%	Firm	A moisture probe was taken at the bottom of the balcony. The substrate was firm with no damage noted at this time
I6	Bottom Balcony	19%	Firm	A moisture probe was taken at the bottom of the balcony. An elevated moisture reading was noted with a firm substrate.

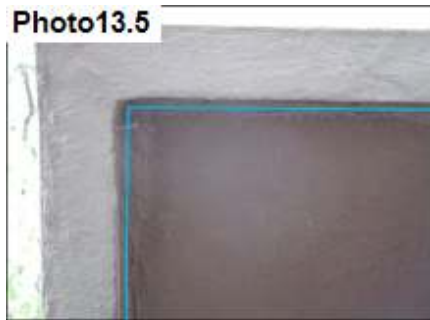
Photo13.5

No Relief / No Modification

Grid Location	Item Description	Moisture Readings	Substrate Condition	Observations
Blue Line	Relief			Although the bottom of the balcony wall noted does not have a proper relief, this was a proper detail at the time of construction. Upon invasive testing at this location, the substrate was firm with low moisture readings. The inspector recommends no modification at this point in time but recommends to maintain all sealants above this location to prevent potential moisture intrusion. Please refer to photos #13.2, #13.3, #13.4 and #13.5 for more detail.

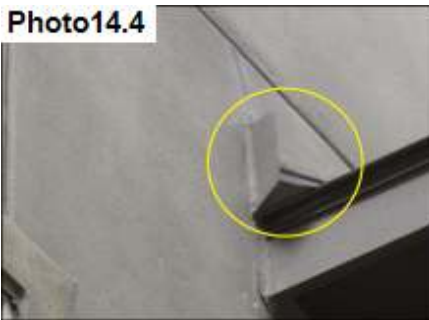
Kickout Flashing / Seal

Grid Location	Item Description	Moisture Readings	Substrate Condition	Observations
Yellow Circle	Kickout			The kickout flashing sealants are aged or separated at this location. The inspector suggests to have a qualified waterproofing contractor further assess and seal this area with a low modulus sealant in an effort to prevent moisture intrusion. These types of sealants are of high quality and compatible with stucco and other termination points. Please refer to photos #14.2, #14.3 and #14.4 for more detail.
G7	Below Kickout Flashing	16%	Firm	A moisture probe was taken below the kickout flashing. The substrate was firm with no damage noted at this time.
G4	Below Kickout Flashing	22%	Semi-Firm	A moisture probe was taken below the kickout flashing. An elevated moisture reading was noted with a semi-firm substrate.
F4	Below Kickout Flashing	19%	Firm	A moisture probe was taken below the kickout flashing. An elevated moisture reading was noted with a firm substrate.

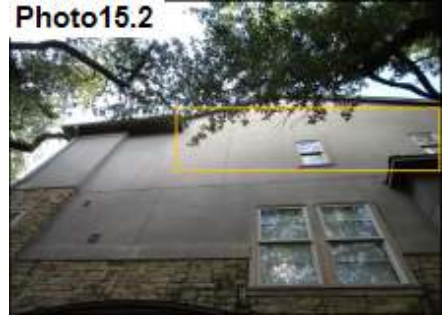
Photo15.2

Crack Noted / Seal, Paint or Repair as Needed

Grid Location	Item Description	Moisture Readings	Substrate Condition	Observations
Orange Box	Cracks			Cracks are noted at this location. The inspector suggests to have a qualified waterproofing contractor further assess and properly seal, paint or repair these cracks to prevent moisture intrusion. All cracking was not necessarily identified in this report. Please refer to photos #15.2, #15.3, #15.4, #15.5 and #15.6 for more detail.

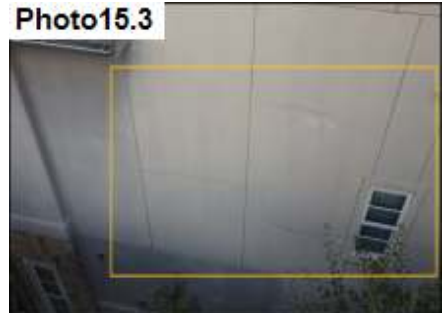
Photo15.3

Crack Noted / Seal, Paint or Repair as Needed

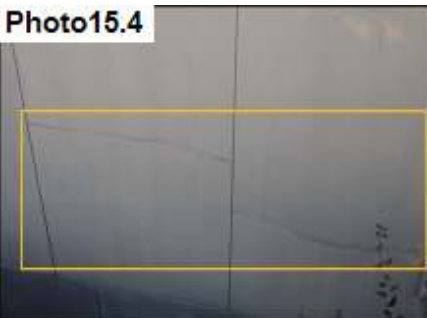
Photo15.4

Crack Noted / Seal, Paint or Repair as Needed

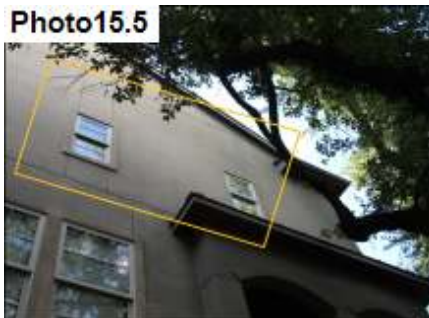
Photo15.5

Crack Noted / Seal, Paint or Repair as Needed

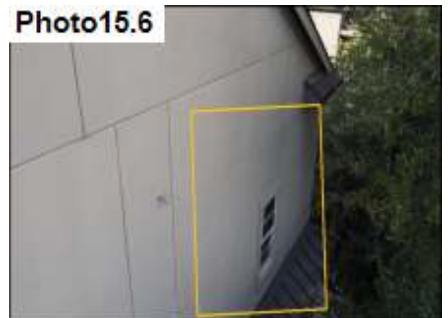
Photo15.6

Crack Noted / Seal, Paint or Repair as Needed

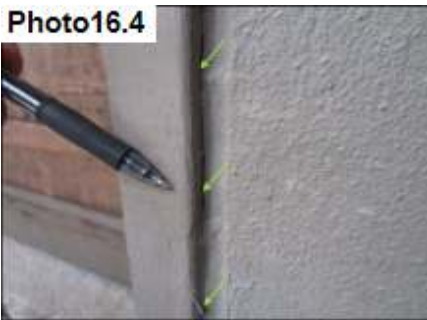
Photo16.4

Door Sealants / Seal

Grid Location	Item Description	Moisture Readings	Substrate Condition	Observations
Green Arrows	Doors			The door trim and miter sealants are aged or separated at this location. The inspector suggests to have a qualified waterproofing contractor seal this area with a low modulus sealant in an effort to prevent moisture intrusion. These types of sealants are of high quality and compatible with stucco and other termination points. Please refer to photos #16.2, #16.3 and #16.4 for more detail.

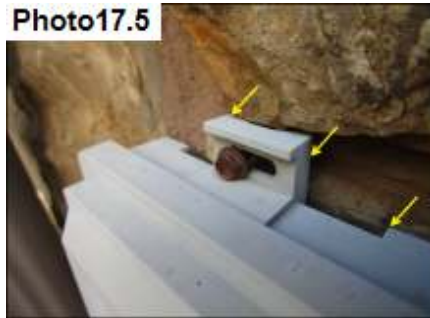
Photo17.5

Penetration Sealants / Seal

Grid Location	Item Description	Moisture Readings	Substrate Condition	Observations
Yellow Arrows	Penetrations			The penetration sealants are aged, separated or missing in these locations. The inspector suggests to have a qualified waterproofing contractor seal these areas with a low modulus sealant in an effort to prevent moisture intrusion. These types of sealants are of high quality and compatible with stucco and other termination points. Please refer to photos #17.2, #17.3, #17.4 and #17.5 for more detail.

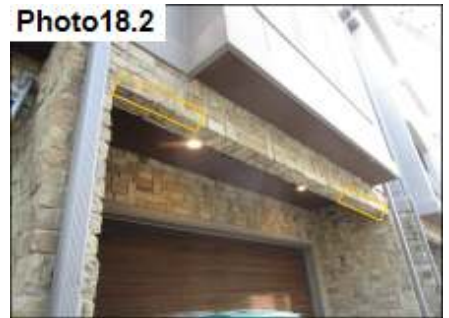
Deteriorated Mortar / Re-point

Grid Location	Item Description	Moisture Readings	Substrate Condition	Observations
Orange Boxes	Deteriorated Mortar			The manufactured stone veneer (MSV) mortar at these locations has deteriorated. The inspector suggests consulting with a qualified mason contractor to further assess and re-point as needed in an effort to prevent moisture intrusion. Please refer to photos #18.2, #18.3, #18.4, #18.5 and #18.6 for more detail.
E6	Bottom Beam	18%	Firm	A moisture probe was taken at bottom beam. The substrate was firm with no damage noted at this time.
G6	Bottom Beam	21%	Firm	A moisture probe was taken at bottom beam. An elevated moisture reading was noted with a firm substrate.

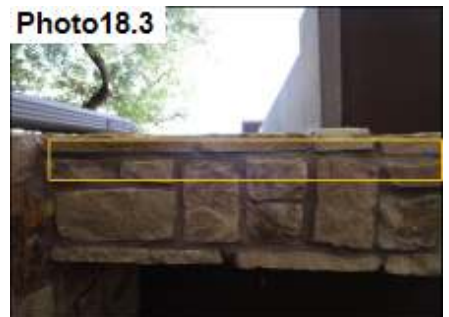
Deteriorated Mortar / Re-point

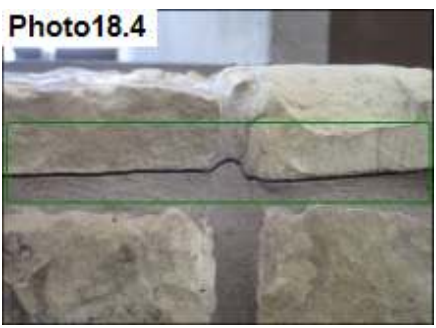
Deteriorated Mortar / Re-point

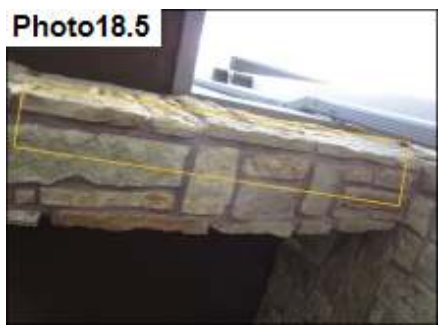
Deteriorated Mortar / Re-point

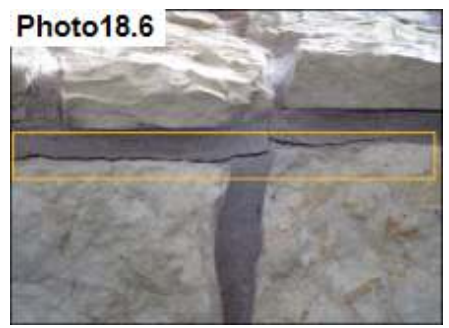
Deteriorated Mortar / Re-point

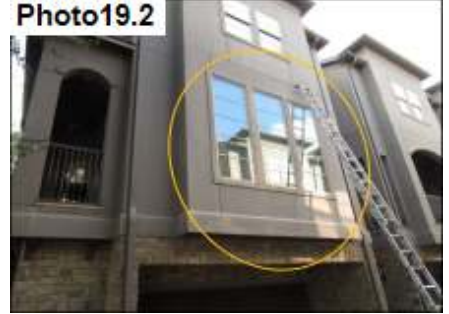
Photo19.2

Efflorescence and Deteriorated Paint / Clean & Repaint

Grid Location	Item Description	Moisture Readings	Substrate Condition	Observations
Orange Circle	Efflorescence			Efflorescence has been noted in this area of the home. This is when a naturally occurring salt migrates to the surface of the system causing a coating or paint deterioration. The inspector suggests to consult with a qualified stucco contractor to treat then paint this area. Please refer to photos #19.2, #19.3, #19.4 and #19.5 for more detail.

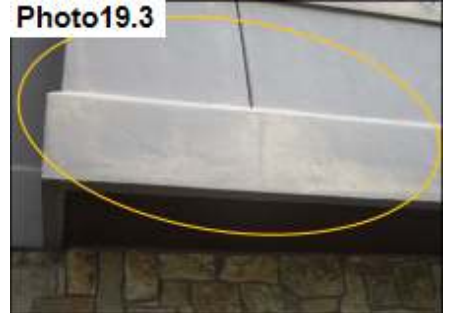
Photo19.3

Efflorescence and Deteriorated Paint / Clean & Repaint

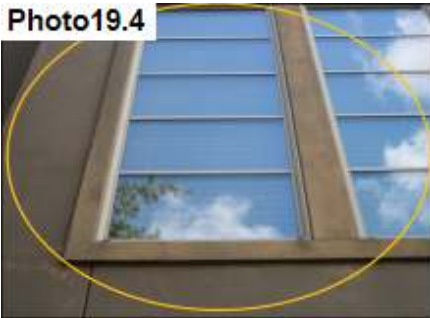
Photo19.4

Efflorescence and Deteriorated Paint / Clean & Repaint

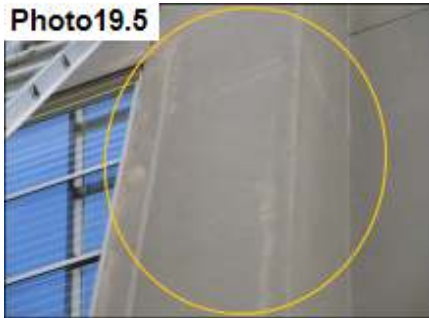
Photo19.5

Efflorescence and Deteriorated Paint / Clean & Repaint

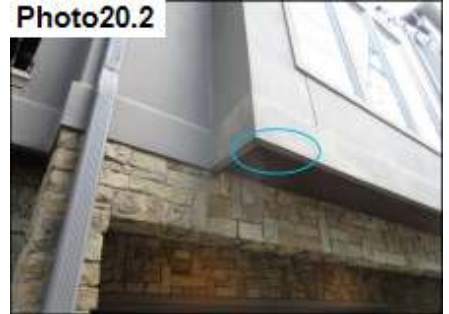
Photo20.2

Broken & Rusted Casing Bead / Repair

Grid Location	Item Description	Moisture Readings	Substrate Condition	Observations
Blue Circle	Broken & Rusted Casing Bead			The casing bead is broken with rust in this location. The inspector suggests to have a qualified contractor further assess and repair this area as needed in an effort to prevent moisture intrusion. Please refer to photos #20.2, #20.3 and #20.4 for more detail.

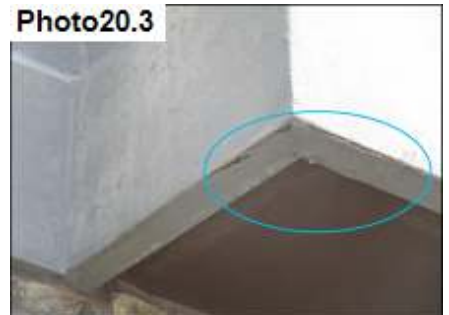
Photo20.3

Broken & Rusted Casing Bead / Repair

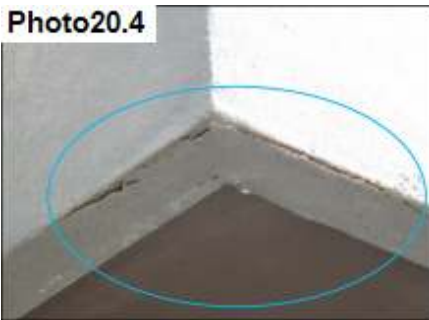
Photo20.4

Broken & Rusted Casing Bead / Repair

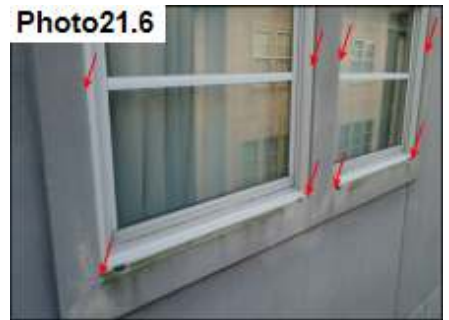
Photo21.6

Window Sealants / Seal

Grid Location	Item Description	Moisture Readings	Substrate Condition	Observations
Red Arrows	Windows			The window sealants are aged or separated. The inspector suggests to have a qualified waterproofing contractor further assess and seal these areas with a low modulus sealant in an effort to prevent moisture intrusion. These types of sealants are of high quality and compatible with stucco and other termination points. Please refer to photos #21.2, #21.3, #21.4, #21.5 and #21.6 for more detail.

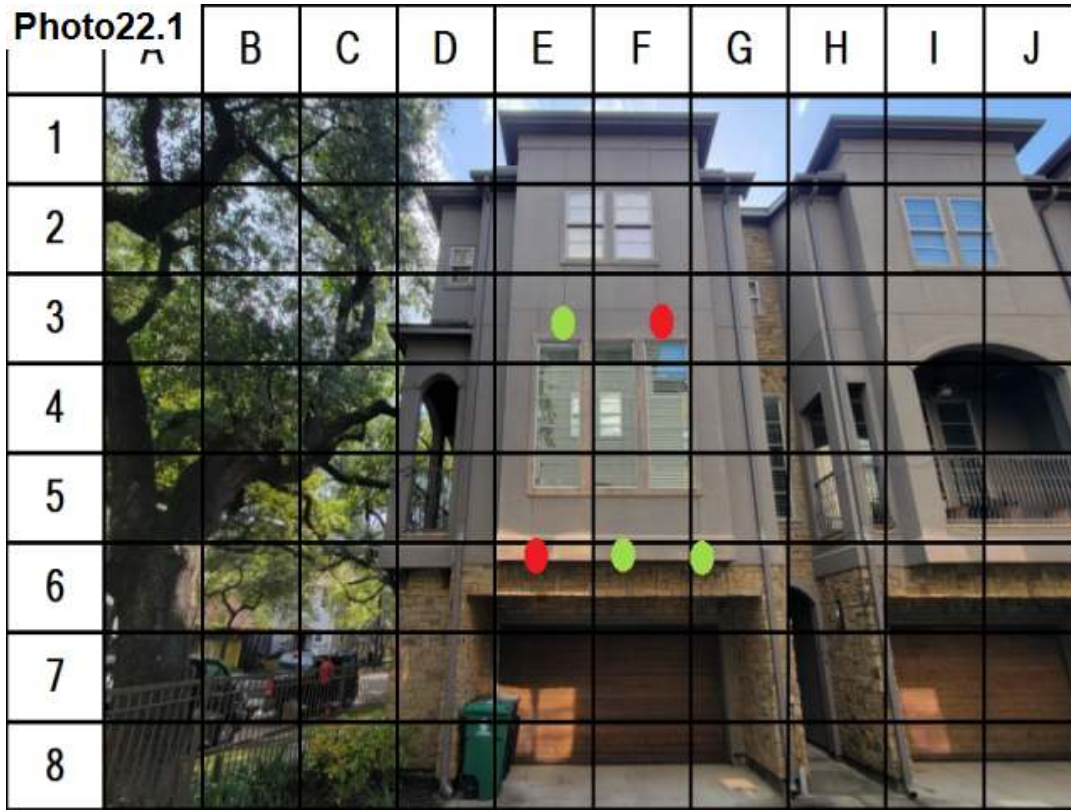
Grid Location	Item Description	Moisture Readings	Substrate Condition	Observations
E6	Bottom Bumpout Wall	22%	Semi-Firm	A moisture probe was taken at bottom bumpout wall below the bank of windows. An elevated moisture reading was noted with a semi-firm substrate.
F6	Bottom Bumpout Wall	12%	Firm	A moisture probe was taken at bottom bumpout wall below the bank of windows. The substrate was firm with no damage noted at this time.
G6	Bottom Bumpout Wall	12%	Firm	A moisture probe was taken at bottom bumpout wall below the bank of windows. The substrate was firm with no damage noted at this time.
E3	Window Header	16%	Firm	A moisture probe was taken at window header below the window lower left. The substrate was firm with no damage noted at this time.
F3	Window Header	19%	Firm	A moisture probe was taken at window header below the window lower right. An elevated moisture reading was noted with a firm substrate.

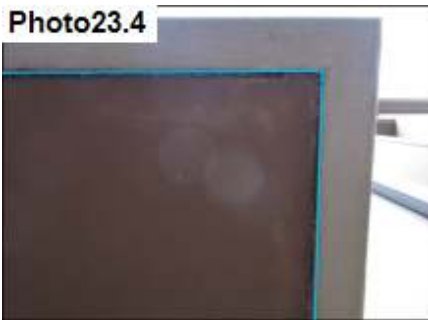
Photo23.4

Relief / Assess and Clean Out

Grid Location	Item Description	Moisture Readings	Substrate Condition	Observations
Blue Line	Relief			The bottom of the bump out wall relief is obstructed, with semi-firm substrate and elevated moisture noted. The inspector suggests having a qualified waterproofing contractor further assess and clean out to allow for proper evacuation of moisture from the system. Please refer to photos #23.2, #23.3 and #23.4 for more detail.

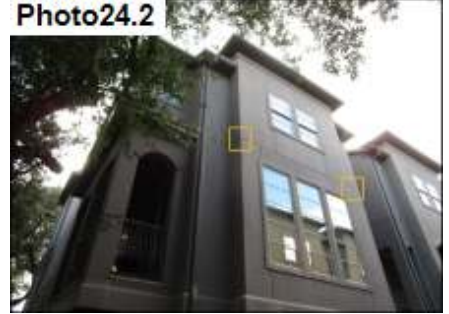
Photo24.2

Control Joint Cracks / Repair

Grid Location	Item Description	Moisture Readings	Substrate Condition	Observations
Orange Boxes	Control Joint Cracks			Control joint cracks are noted at these locations. The inspector suggests to have a qualified waterproofing contractor further assess and properly seal, paint or repair these control joint cracks to prevent moisture intrusion. All cracking was not necessarily identified in this report. Please refer to photos #24.2, #24.3, #24.4, #24.5 and #24.6 for more detail.

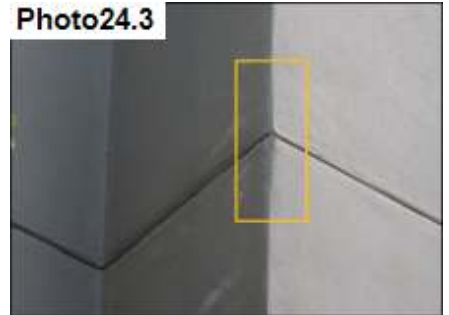
Photo24.3

Control Joint Cracks / Repair

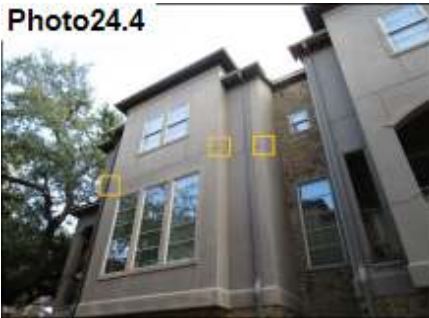
Photo24.4

Control Joint Cracks / Repair

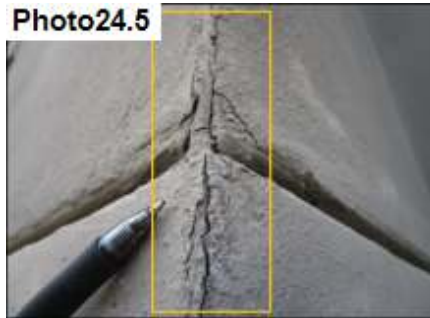
Photo24.5

Control Joint Cracks / Repair

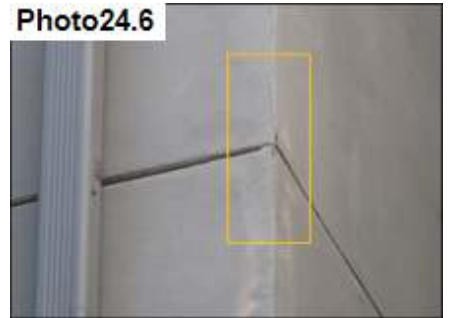
Photo24.6

Control Joint Cracks / Repair

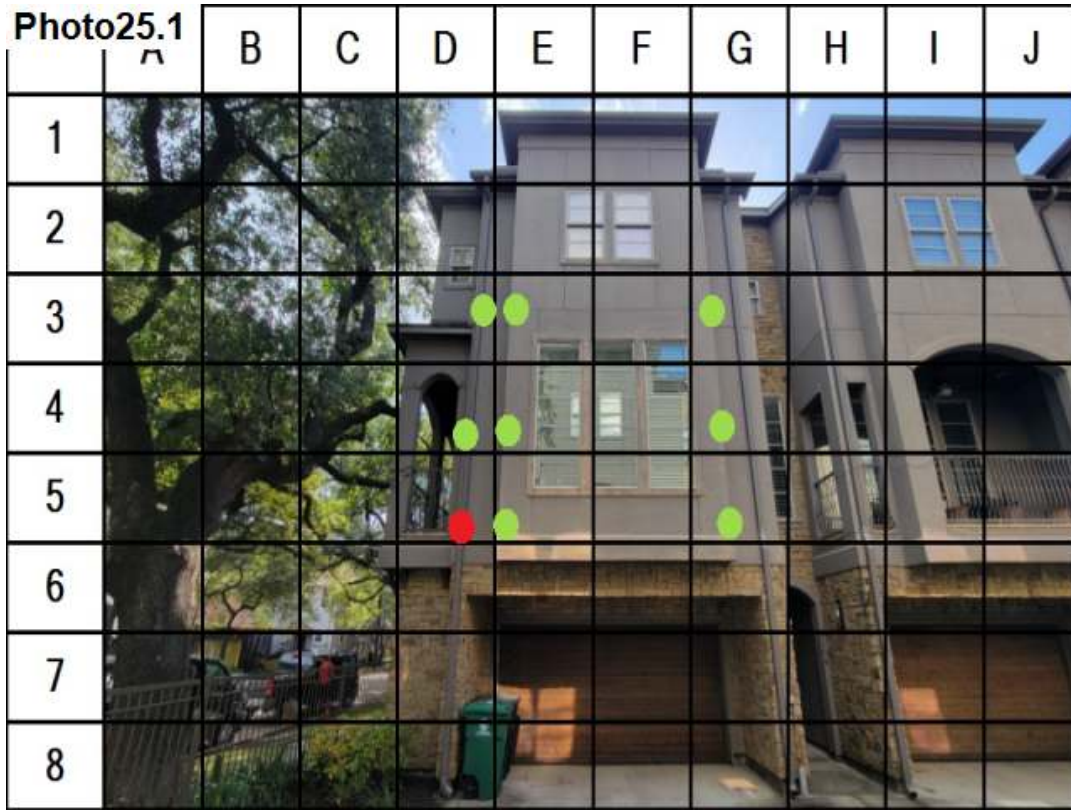
Grid Location	Item Description	Moisture Readings	Substrate Condition	Observations
D5	Below Kickout Flashing	20%	Firm	A moisture probe was taken below the kickout flashing. An elevated moisture reading was noted with a firm substrate.
D4	Below Kickout Flashing	18%	Firm	A moisture probe was taken below the kickout flashing. The substrate was firm with no damage noted at this time.
D3	Below Kickout Flashing	18%	Firm	A moisture probe was taken below the kickout flashing. The substrate was firm with no damage noted at this time.
E5	Below Kickout Flashing	16%	Firm	A moisture probe was taken below the kickout flashing. The substrate was firm with no damage noted at this time.
E4	Below Kickout Flashing	17%	Firm	A moisture probe was taken below the kickout flashing. The substrate was firm with no damage noted at this time.
E3	Below Kickout Flashing	17%	Firm	A moisture probe was taken below the kickout flashing. The substrate was firm with no damage noted at this time.

G5	Below Kickout Flashing	12%	Firm	A moisture probe was taken below the kickout flashing. The substrate was firm with no damage noted at this time.
G4	Below Kickout Flashing	14%	Firm	A moisture probe was taken below the kickout flashing. The substrate was firm with no damage noted at this time.
G3	Below Kickout Flashing	16%	Firm	A moisture probe was taken below the kickout flashing. The substrate was firm with no damage noted at this time.

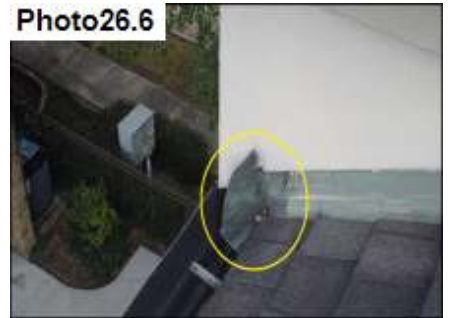
Photo26.6

Kickout Flashing / Seal

Grid Location	Item Description	Moisture Readings	Substrate Condition	Observations
Yellow Circles	Kickout			The kickout flashing sealants are aged or separated at these locations. The inspector suggests to have a qualified waterproofing contractor further assess and seal these areas with a low modulus sealant in an effort to prevent moisture intrusion. These types of sealants are of high quality and compatible with stucco and other termination points. Please refer to photos #26.2, #26.3 #26.4, #26.5 and #26.6 for more detail.

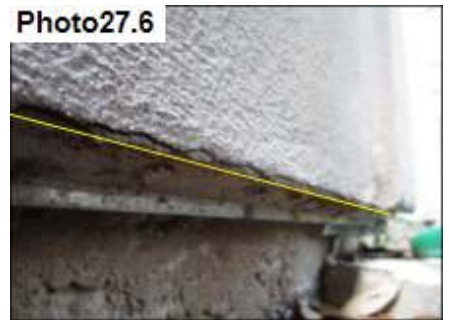
Photo27.6

Proper Grade Termination with Weep Screed / Positive Detail

Grid Location	Item Description	Moisture Readings	Substrate Condition	Observations
Yellow Line	Grade Termination			Stucco appears to be typically detailed at grade for the time of this construction. The inspector suggests that this is a positive detail and recommends no modification at this time but to always keep soil away from the structure. Please refer to photos #27.2, #27.3, #27.4, #27.5 and #27.6 for more detail.

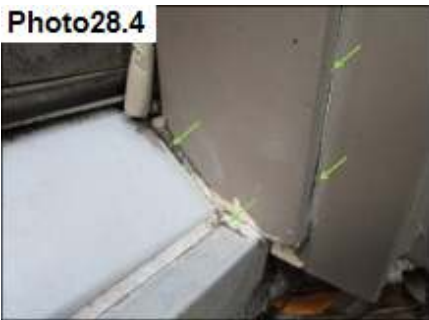
Photo28.4

Door Sealants / Seal

Grid Location	Item Description	Moisture Readings	Substrate Condition	Observations
Green Arrow	Doors			The door trim and miter sealants are aged or separated at this location. The inspector suggests to have a qualified waterproofing contractor seal this area with a low modulus sealant in an effort to prevent moisture intrusion. These types of sealants are of high quality and compatible with stucco and other termination points. Please refer to photos #28.2, #28.3 and #28.4 for more detail.

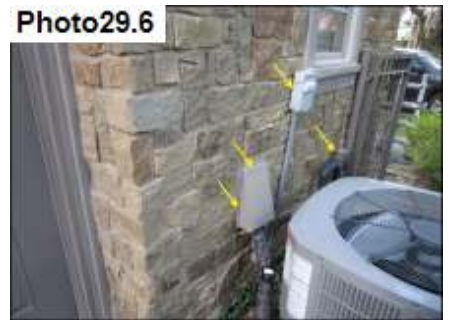
Photo29.6

Penetration Sealants / Seal

Grid Location	Item Description	Moisture Readings	Substrate Condition	Observations
Yellow Arrows	Penetrations			The penetration sealants are aged, separated or missing in these locations. The inspector suggests to have a qualified waterproofing contractor seal these areas with a low modulus sealant in an effort to prevent moisture intrusion. These types of sealants are of high quality and compatible with stucco and other termination points. Please refer to photos #29.2, #29.3, #29.4, #29.5 and #29.6 for more detail.

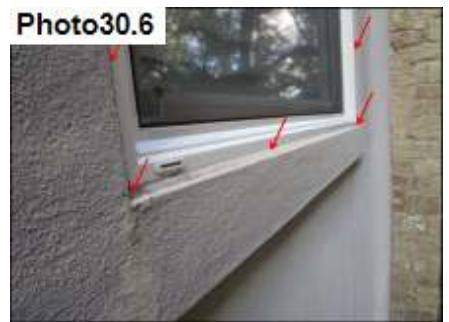
Window Sealants / Seal

Grid Location	Item Description	Moisture Readings	Substrate Condition	Observations
Red Arrows	Windows			The window sealants are aged or separated. The inspector suggests to have a qualified waterproofing contractor further assess and seal these areas with a low modulus sealant in an effort to prevent moisture intrusion. These types of sealants are of high quality and compatible with stucco and other termination points. Please refer to photos #30.2, #30.3, #30.4, #30.5 and #30.6 for more detail.
D8	Window Lower Right	22%	Firm	A moisture probe was taken at the window lower right. An elevated moisture reading was noted with a firm substrate.
D6	Window Header	18%	Firm	A moisture probe was taken at window header below the bank of windows. The substrate was firm with no damage noted at this time.
D5	Window Lower Left	12%	Firm	A moisture probe was taken at the window lower left. The substrate was firm with no damage noted at this time.

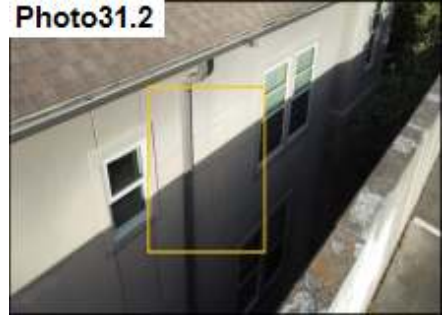
Photo31.2

Crack Noted / Seal, Paint or Repair as Needed

Grid Location	Item Description	Moisture Readings	Substrate Condition	Observations
Orange Box	Cracks			Cracks are noted at this location. The inspector suggests to have a qualified waterproofing contractor further assess and properly seal, paint or repair these cracks to prevent moisture intrusion. All cracking was not necessarily identified in this report. Please refer to photos #31.2, #31.3, #31.4 and #31.5 for more detail.

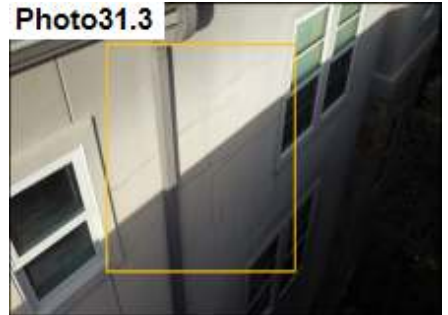
Photo31.3

Crack Noted / Seal, Paint or Repair as Needed

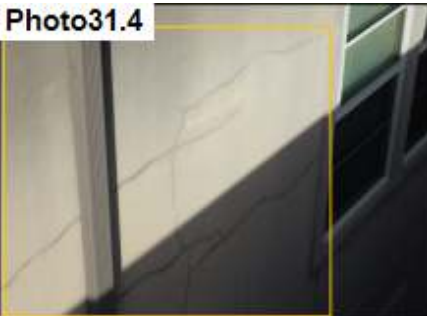
Photo31.4

Crack Noted / Seal, Paint or Repair as Needed

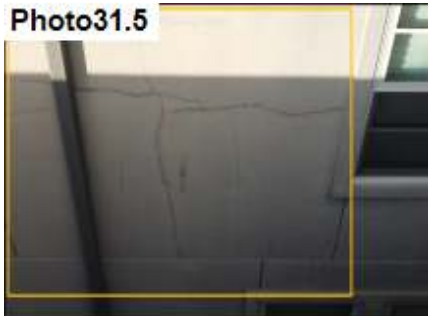
Photo31.5

Crack Noted / Seal, Paint or Repair as Needed

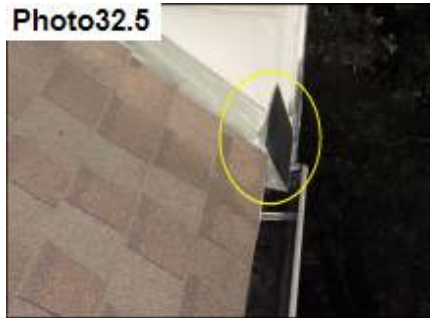
Photo32.5

Kickout Flashing / Seal

Grid Location	Item Description	Moisture Readings	Substrate Condition	Observations
Yellow Circle	Kickout			The kickout flashing sealants are aged or separated at this location. The inspector suggests to have a qualified waterproofing contractor further assess and seal this area with a low modulus sealant in an effort to prevent moisture intrusion. These types of sealants are of high quality and compatible with stucco and other termination points. Please refer to photos #32.2, #32.3, #32.4 and #32.5 for more detail.
