6011 Driscoll Park Dr

Property Inspection Report

**PERFORMANCE
INSPECTIONS, PLLC**

6/26/2022

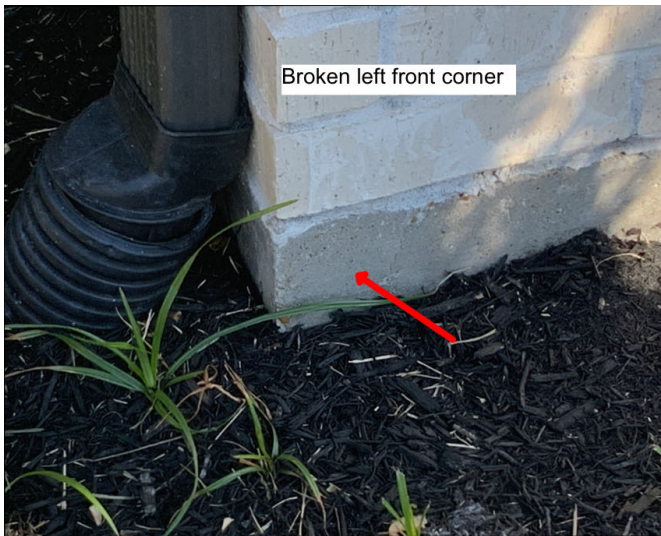
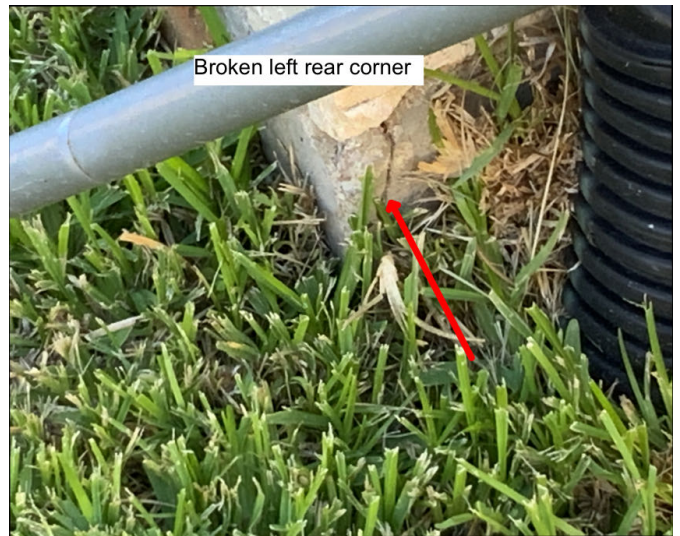
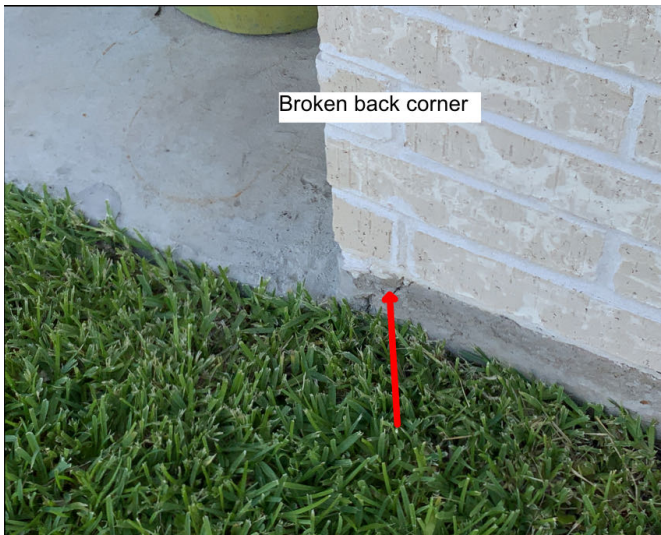
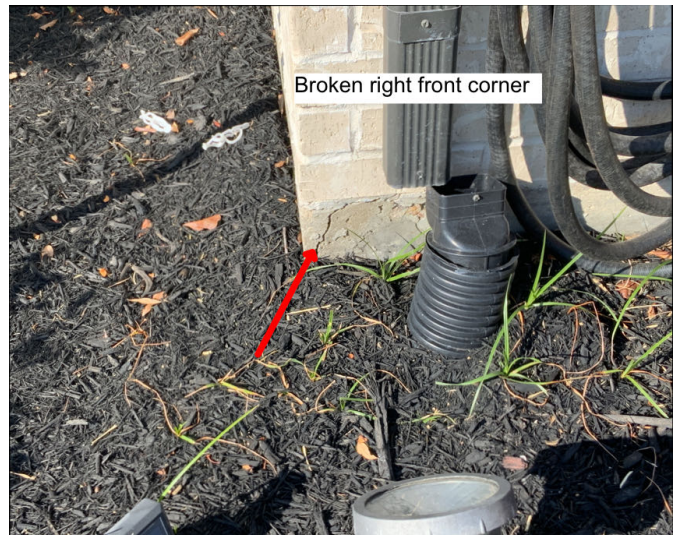
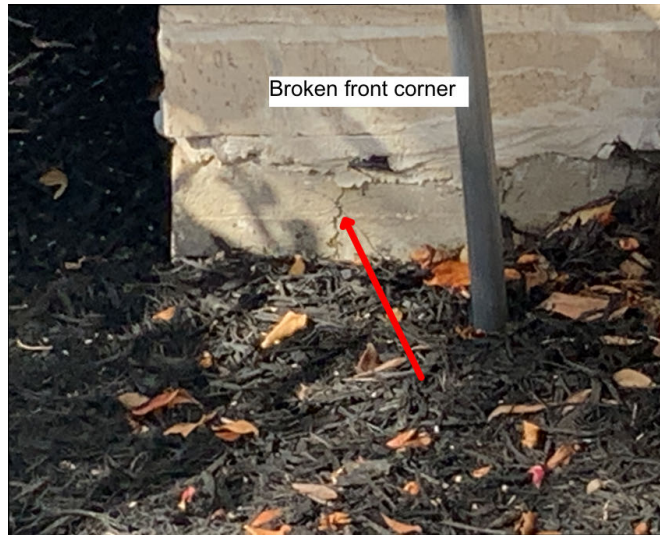
- The Foundation is: In the inspector's opinion, the foundation was found to be performing as intended at the time of inspection, with some notable deficiencies. These deficiencies may or may not require further evaluation by a foundation expert as its not possible to determine full performance on a single inspection. This opinion was formed with a visual evaluation. No measurements, or specialty tools were used while preforming the home inspection.
- Corners of the foundation were found to be broken. This is a common deficiency. Correct repairs of the corner(s) is recommended to reduce the risk of further damage to the exterior finish.

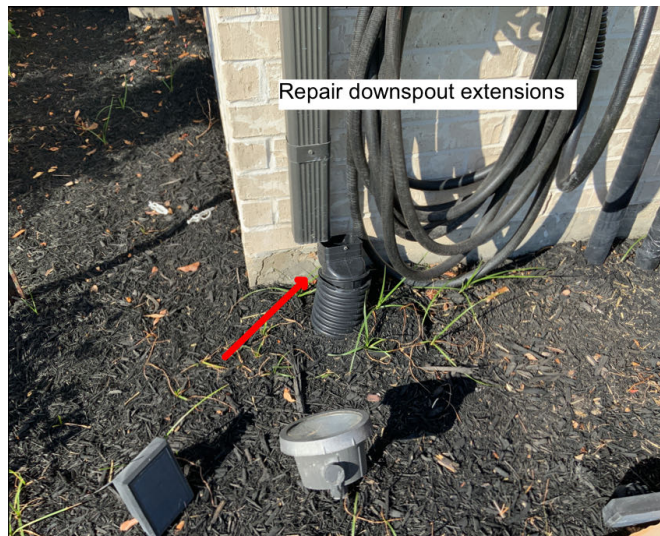
- Downspout extensions were found to be damaged. Repairs/replacement is needed to properly carry water shed away from the foundation as intended.

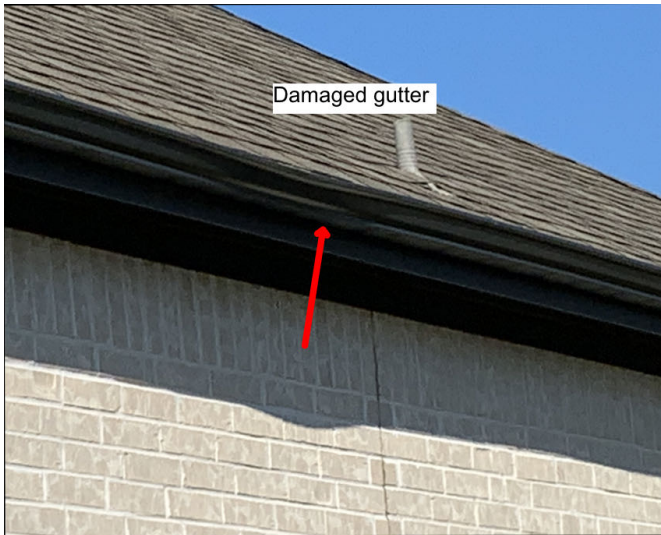
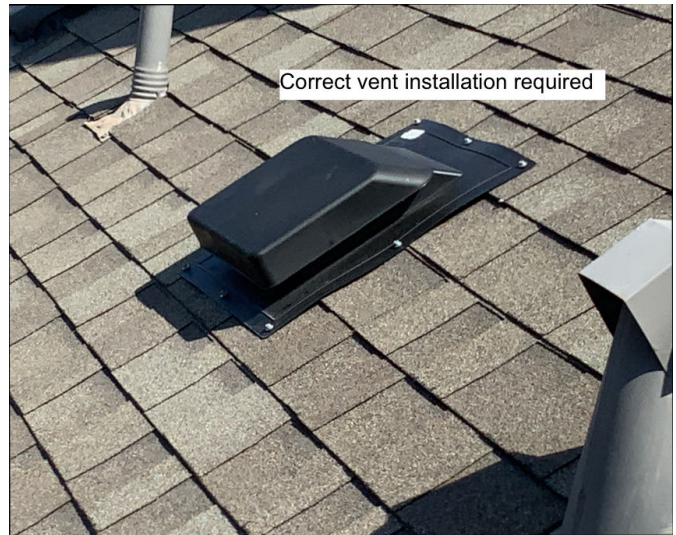
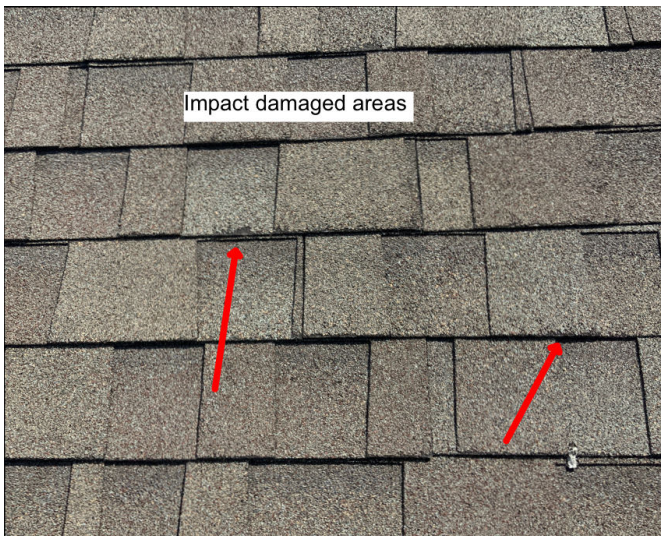
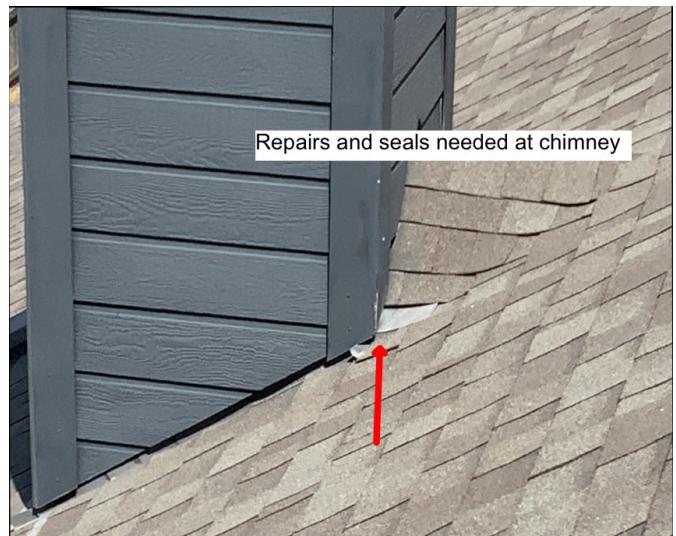
- Lifted flashings should be secured and sealed by a professional roofer, to reduce the risk of water entry to the home.
- Damaged gutters should be repaired or replaced as necessary to avoid spilling roof runoff around the building, a potential source of water entry or water damage.
- Correct roof vent that has been installed incorrect

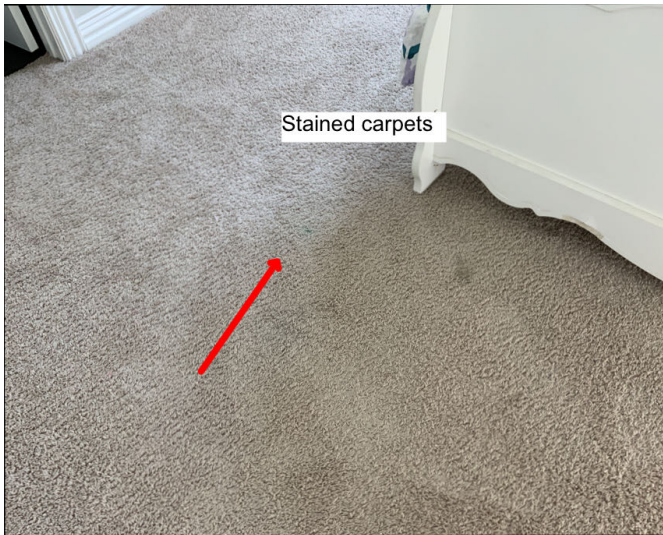
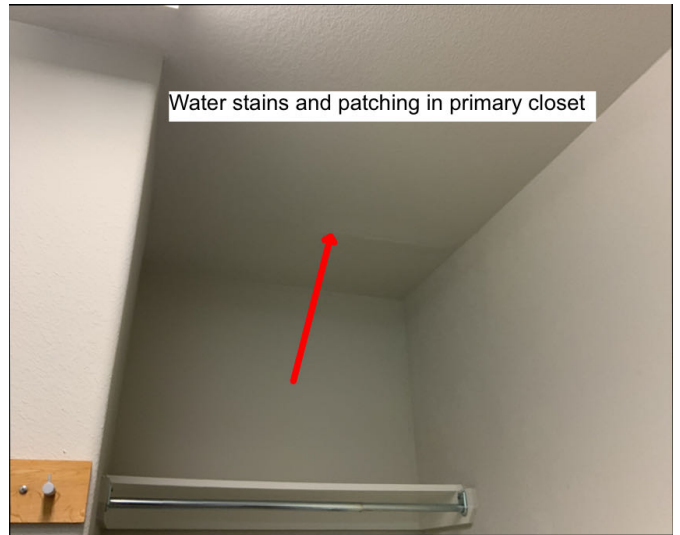
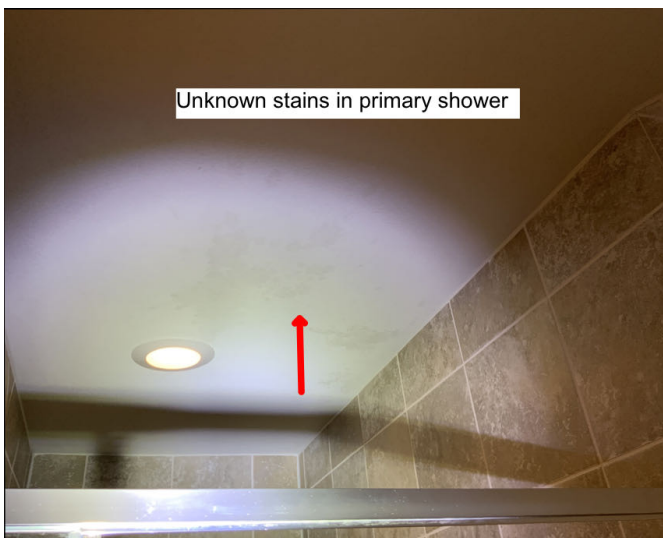
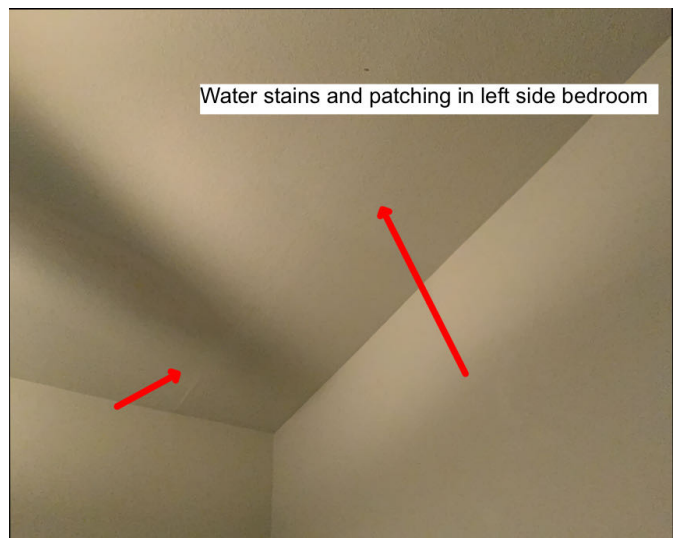
- Drywall seam failures observed. These are common with settlement deficiencies. Recommend repairs to prevent further damage.
- Evidence of patching was detected. Monitoring of these areas is recommended, as the cause for the patching can not be precisely determined.

- Water staining was noted. The cause for the staining should be determined and repairs undertaken, if necessary, to prevent structural damage.
- Staining was noted. The cause for the staining should be determined and repairs undertaken, if necessary, to prevent structural damage.

- Stains were noted on the carpet. Cleaning is recommended, however replacement may be necessary for set in stains. Improvements are discretionary.

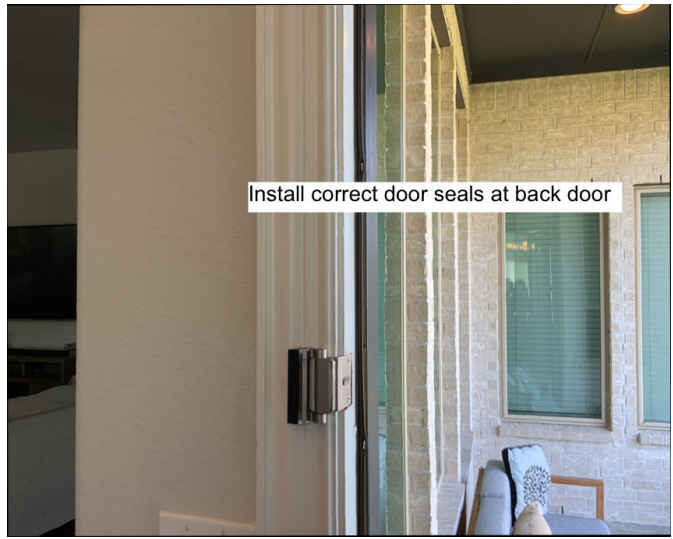
- The seals at the exterior door(s) needs improvements. Repairs should be made to prevent water entry, and improve energy efficiency by preventing drafts.

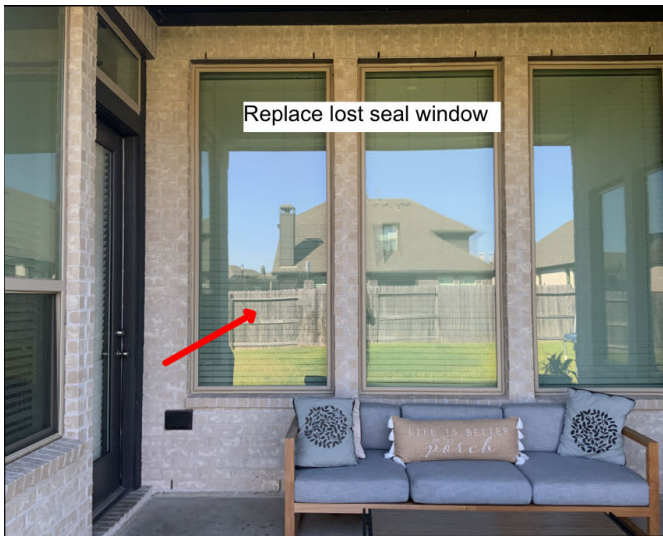
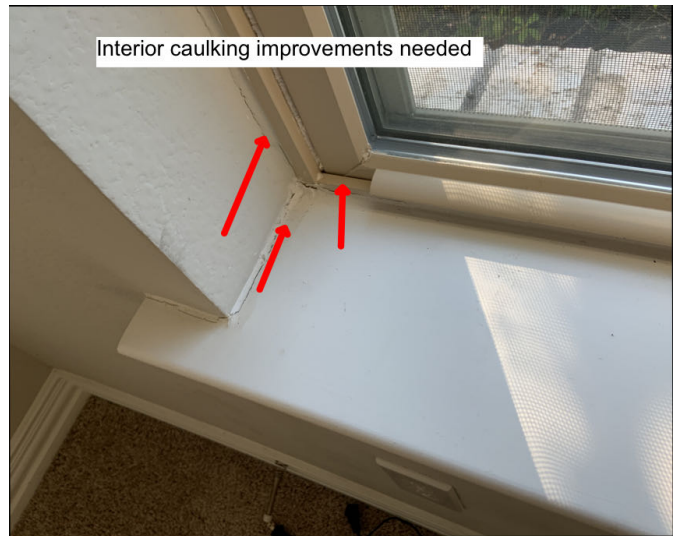
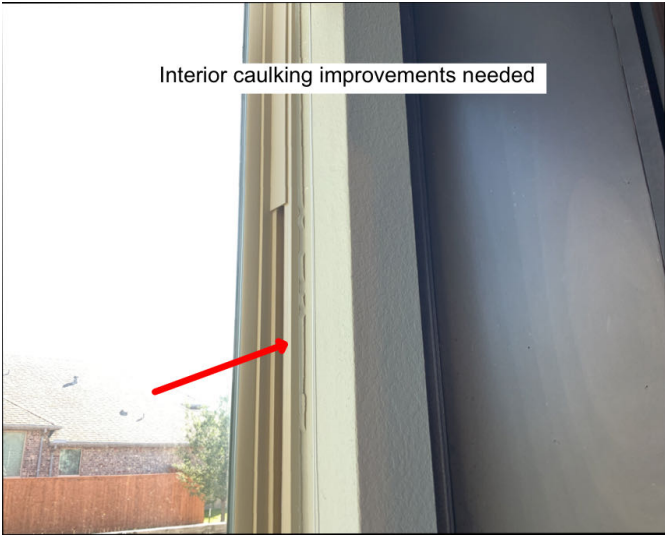
- The window(s) have lost their seal. This has resulted in condensation developing between the panes of glass and can cause the glass to loose it's insulating properties. The glass should be replaced.
- Seal improvements are needed on the interior side of the windows to prevent moisture entry and potential moisture damage, along with improve energy efficiency by preventing drafts.

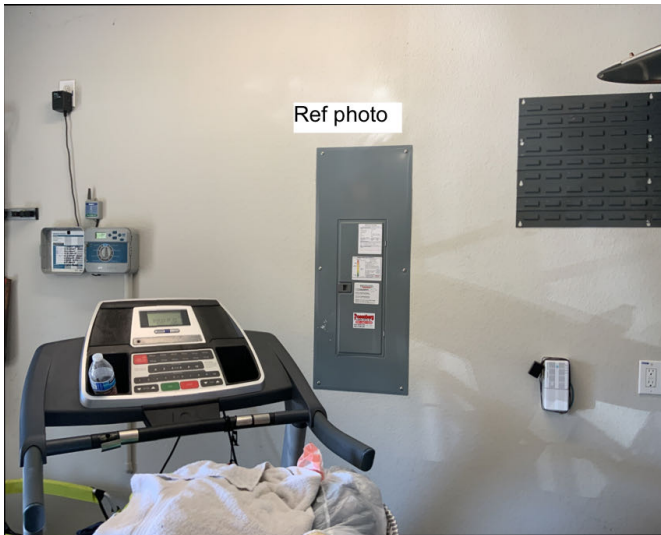
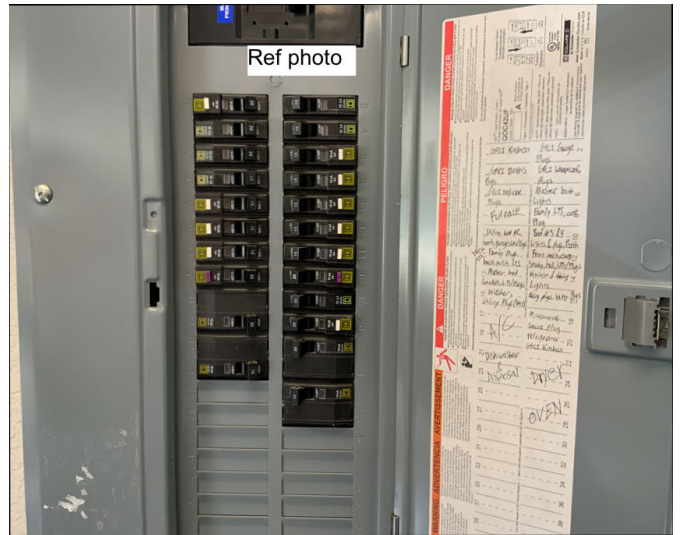
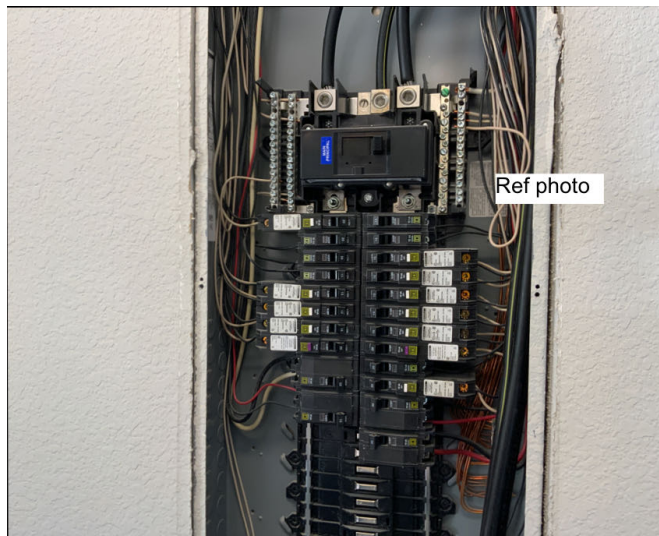
- Aluminum service wires are recommended to have an anti-oxidation compound applied to prevent aluminum wires from oxidation. Oxidation of the wires will cause poor connection and could lead to overheating.

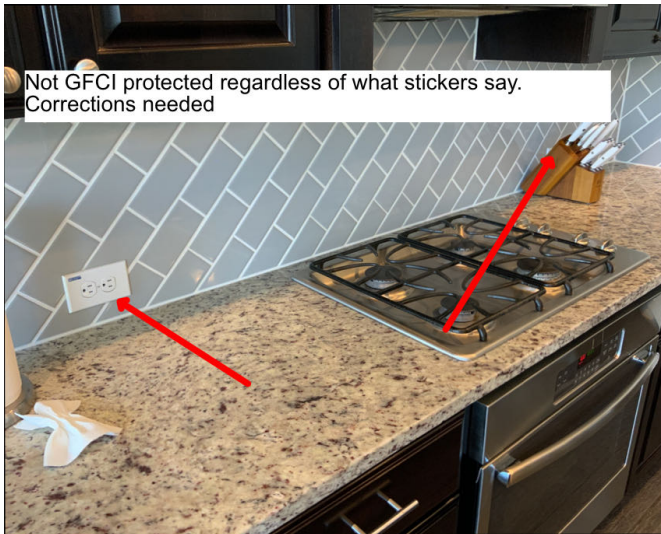
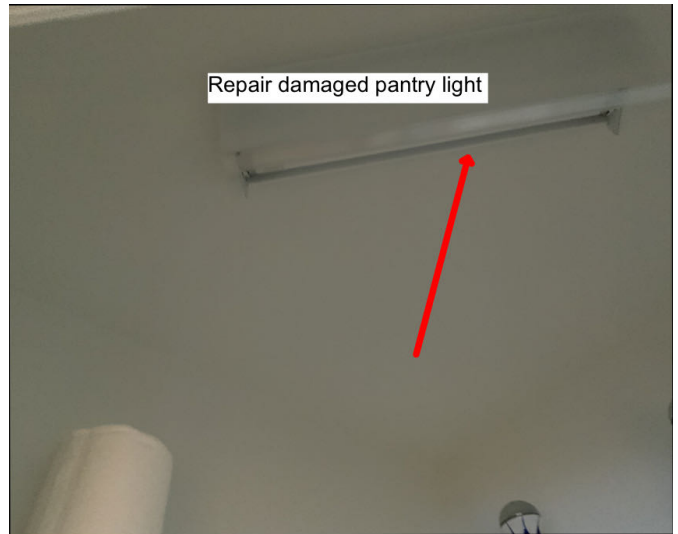
- A ground fault circuit interrupter (GFCI) outlet did not respond correctly to testing during the inspection. This receptacle should be replaced.
- A ground fault circuit interrupter (GFCI) outlet is inoperative. This circuit should be investigated and/or replaced.

- Missing GFCI outlets/ circuits required within 6' of water. GFCI protection has been required since 1971 at the exterior of home. In 1975 it was required in bathrooms. In 1978 in garages and in 1987 protection was required in kitchens. If ANY electrical alterations have made since these times (renovations, design changes or additions) GFCI is required at any outlet within 6' of water. See codes for further explanation.

- The damaged light fixture should be repaired or replaced.

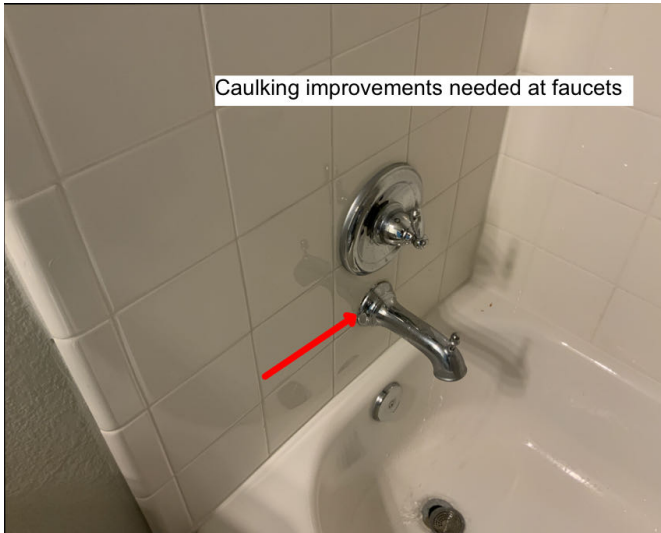
Caulking improvements needed at faucets

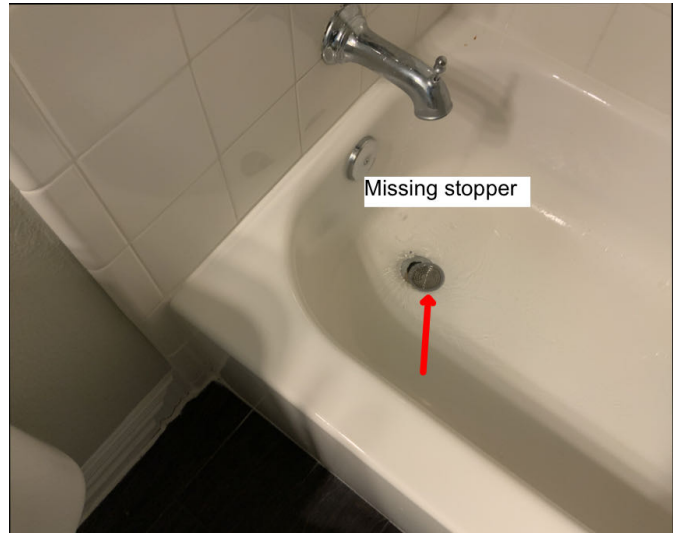
Missing stopper

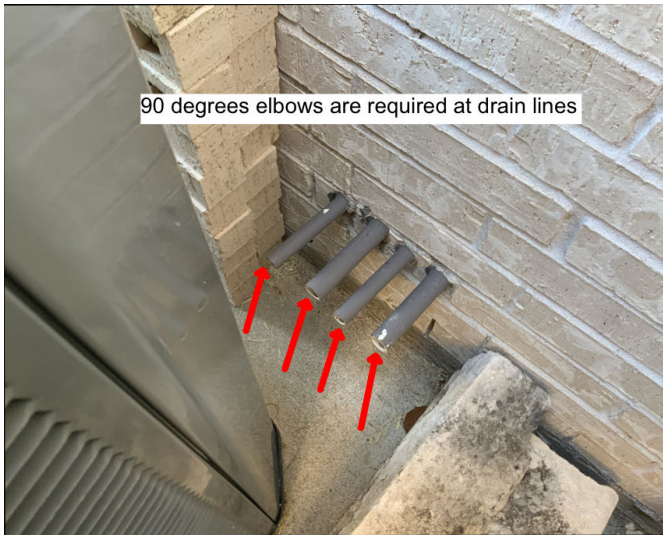
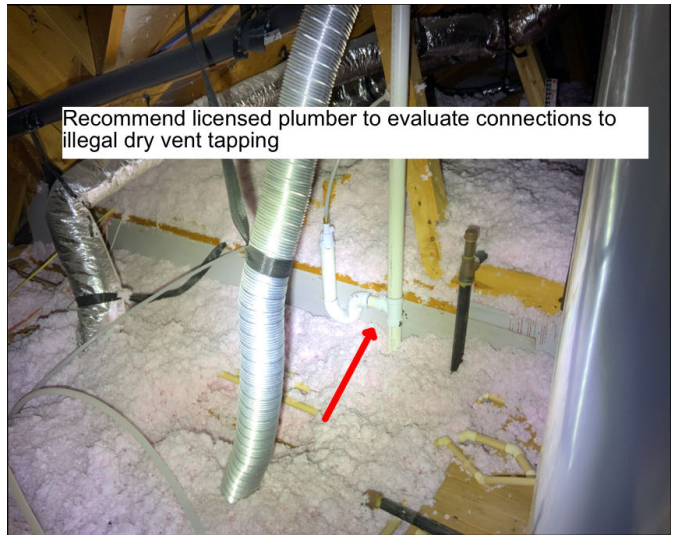
- The inspector only reports on exposed drain lines visible at the time of inspection. It is unlawful for the home inspector to use a camera in drain lines (this requires a plumber's license). If the inspector feels further evaluation is needed she will recommend a licensed plumber do so. Performance Inspections PLLC and it's employees take no responsibility for connections that are not visible at the time of inspection.
- The drain pipes should extend from the exterior walls and end in a 90 degree bend to direct water away from draining onto the exterior walls. Repairs are needed by a licensed plumber.
- **Recommend licensed plumber to evaluate and correct illegal dry vent tapping**

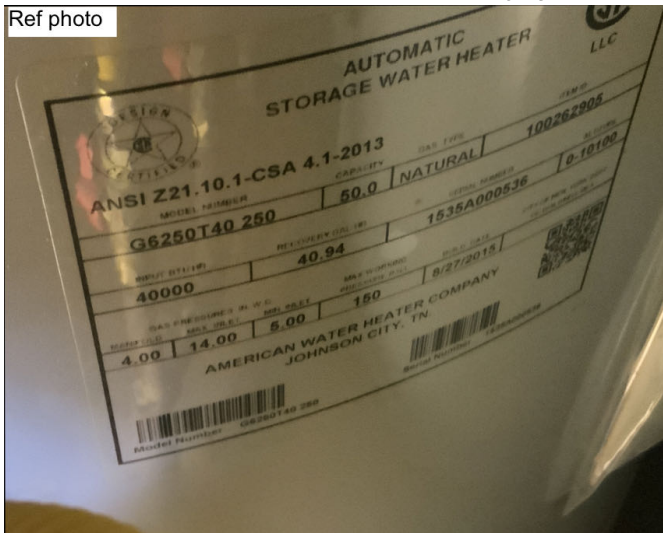
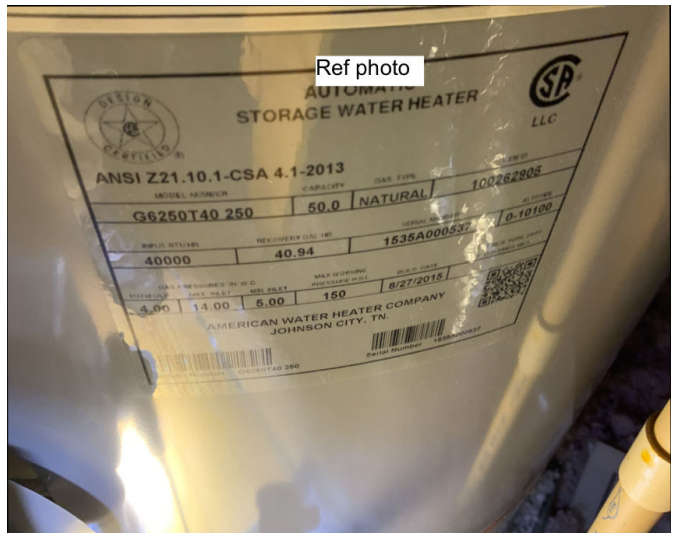
- Its recommended that a water heater leak detector be added to drip pan near drain line. These devices can be purchased online at Amazon. They connect to WIFI and you download an app on cell phone for notification of water entering pan(s). Great first alert device.
- The water was found to be higher than what is considered safe. The water should not exceed 120 degrees for safety purposes. Adjustments should be made to lower the water temperature to reduce the risk of injury.

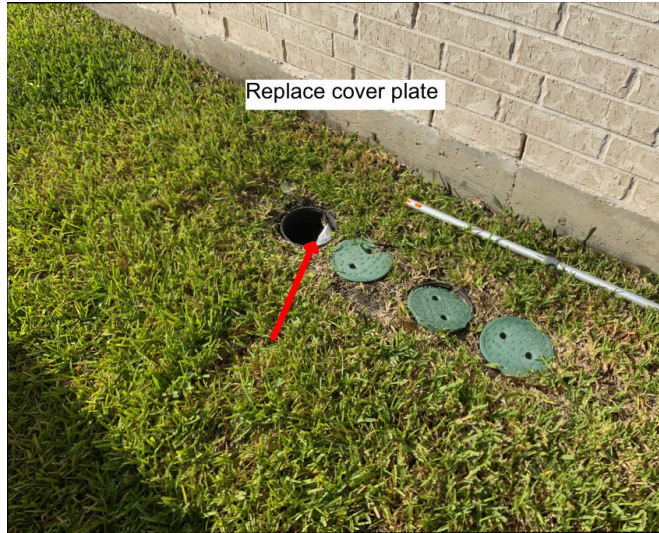
- The valve box cover is missing. Replacement of the cover is needed to reduce the risk of damage to the valve.
