Jimmy Longoria Lic #7746
First Quality Home Inspections

2623 Oakcliff St
Inspection Prepared For: Amanda Palacios
Agent:

Date of Inspection: 5/7/2024

#### PROPERTY INSPECTION REPORT FORM

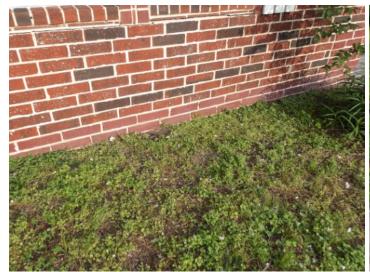
Inadequate grading - high soil

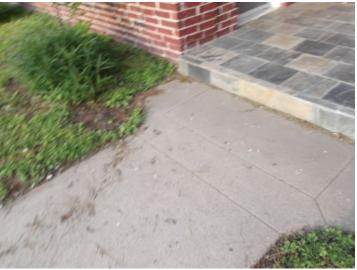
Inadequate grading - improper slope in some areas

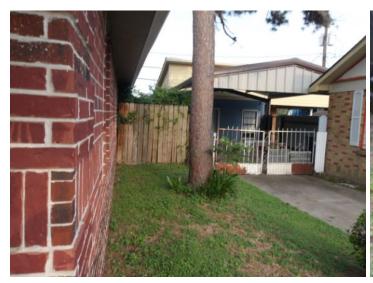
Tree too close to structure

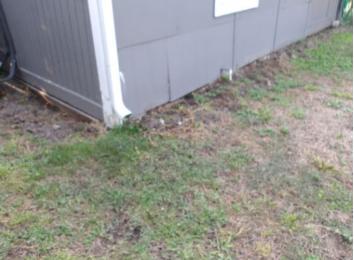
Inadequate grading - improper slope in some

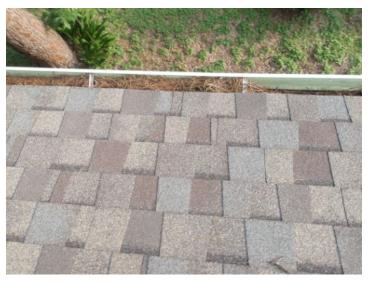
Debris in gutters

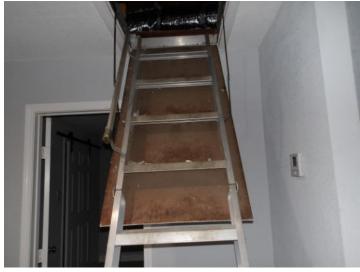
Missing weatherstripping and insulation on attic door

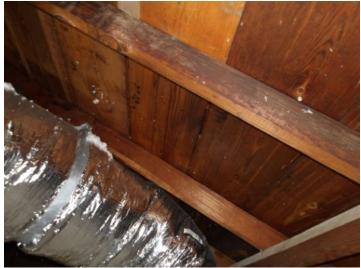
Previous water stains noted on roof sheeting in

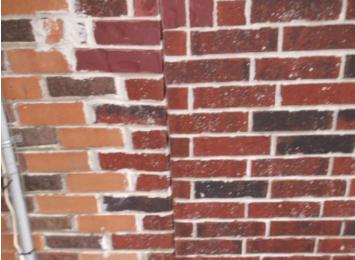
Reseal expansion joints

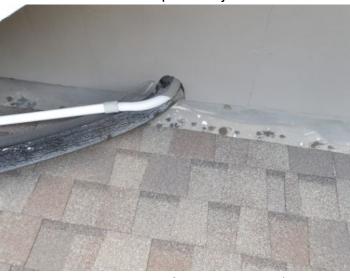
Enclose opening at roof level around a/c supply line into home

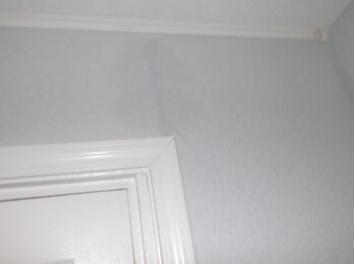
Cracks on sheetrock in different areas

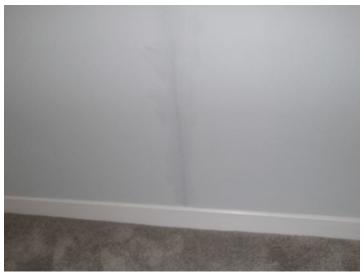
Previous patches on sheetrock in some areas

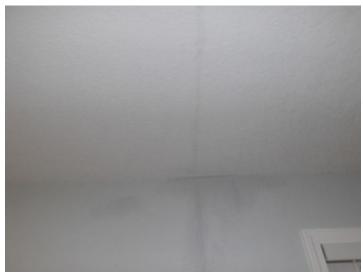
Crack on ceiling in Living Area

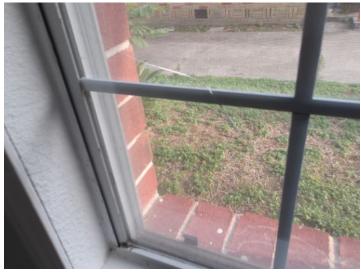
Cracked window pane in Master Bedroom and in Living Area

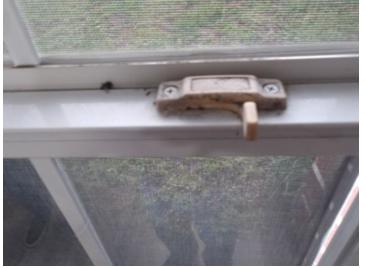
Some windows do not lock

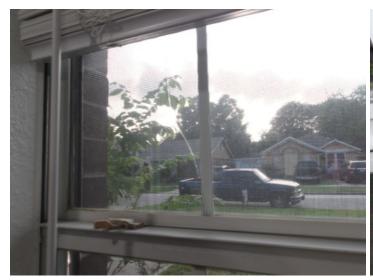
Cracked window pane in Master Bedroom and in Living Area

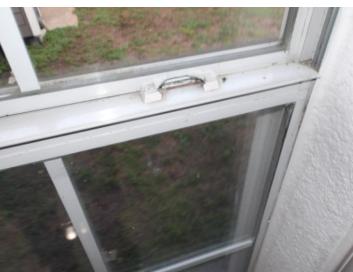
Broken locks on window in Laundry Room

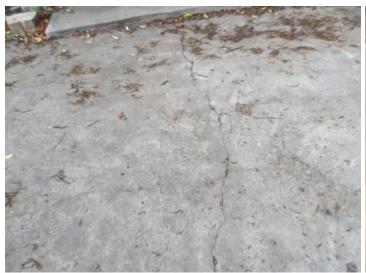
Cracks noted on driveway

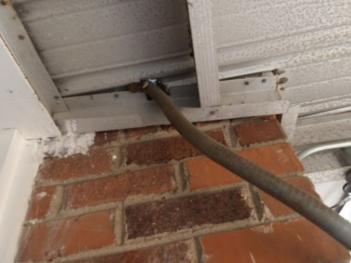
Enclose opening on carport at side of house

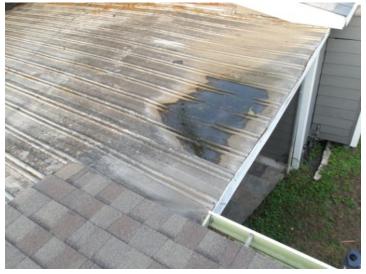
Water standing on roof of carport

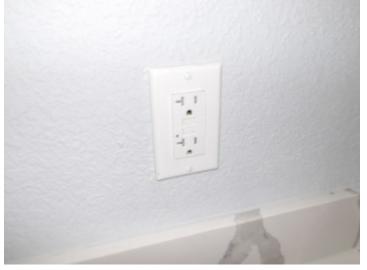
GFCI outlet in Hall Bath did not function at the time of inspection

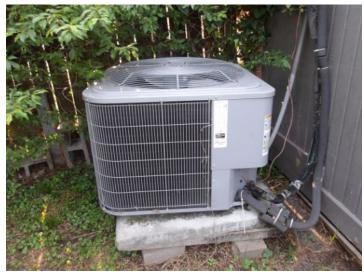
- Condenser 2020 model
- 3 ton unit
- Unit did not cool sufficiently
- Return Air = 69 degrees; Supply Air = 57 degrees; Differential = 12 degrees
- Recommend service and further evaluation by a licensed professional
- No cut off switch on secondary drain pan

Unit did not cool sufficiently

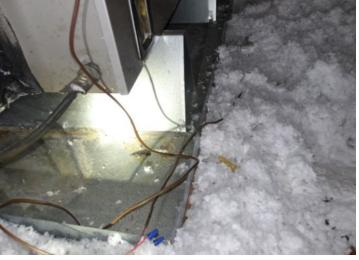
No cut off switch on secondary drain pan

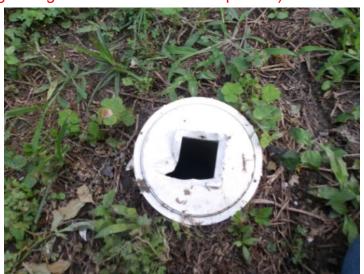
Broken cap on exterior drain - Unable to determine source of drain (no water flowing through drain at the time of inspection)

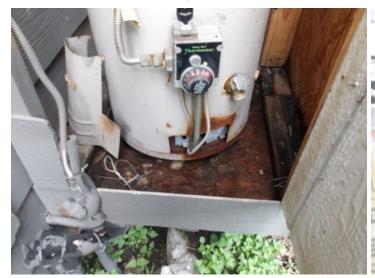
Rust damage on unit

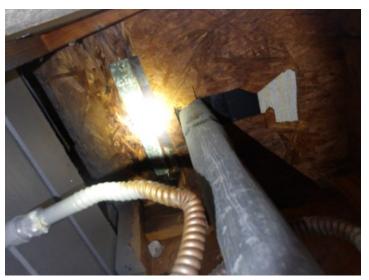
Flue vent too close to combustible material

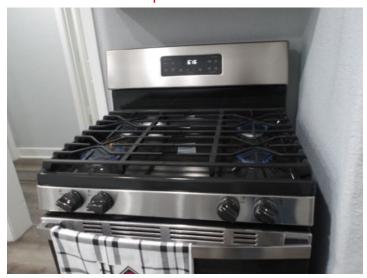
No anti-tilt device bracket present

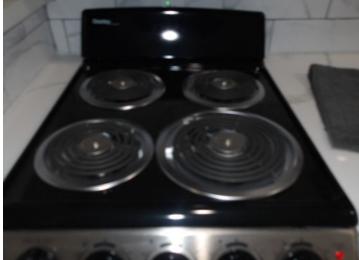
No anti-tilt device bracket present on oven in Back Building

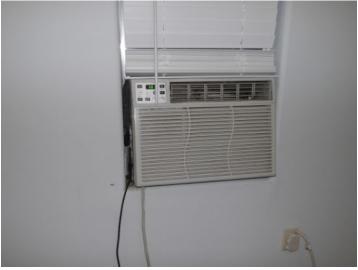
A/C window unit blocking only window in bedroom is a safety hazard - does not provide adequate exit in the case of a fire in Back Building

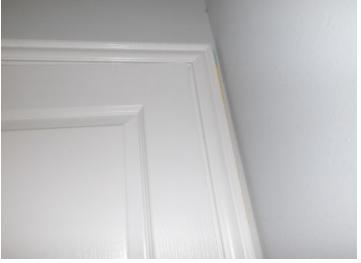
Bedrrom door rubs on frame in Back Building

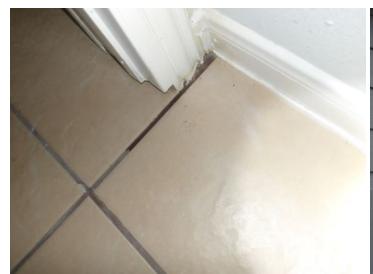
Bath in Back Building - some type of leak coming from shower - unable to determine source

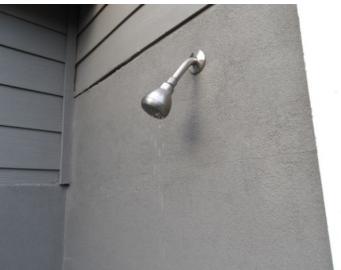
No water out of exterior shower

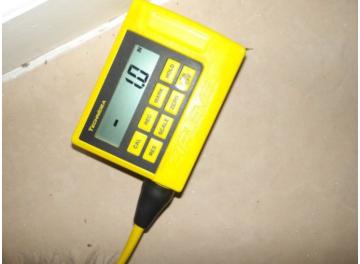
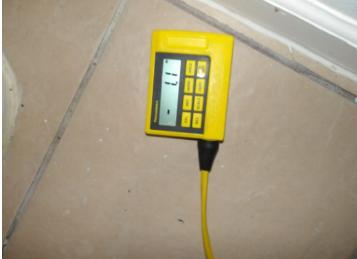
Structural movement and/or settling noted in Back Building. Suggest that a licensed professional be consulted for further evaluation.

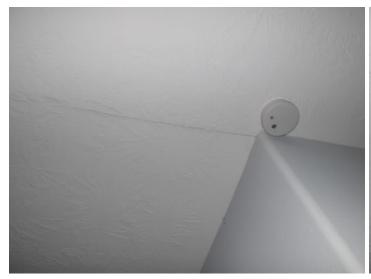
Cracks on ceiling in Back Building

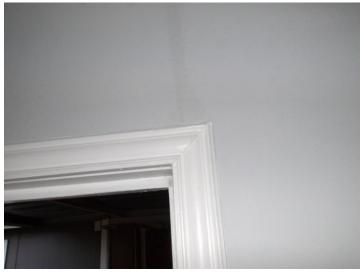
Cracks on sheetrock in Back Building

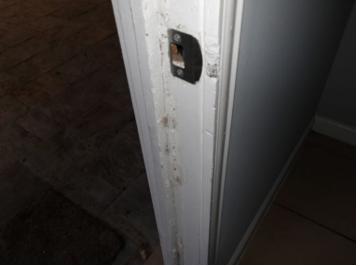
Missing weatherstripping on Front Door of Back Building

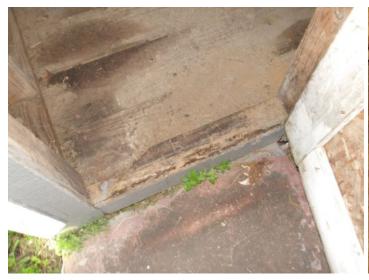
Rotted and damaged boards on Back shed

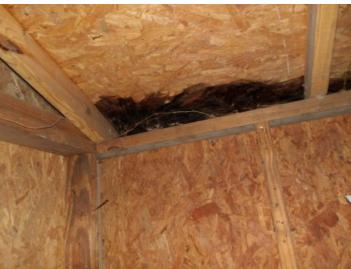
Rotted and damaged roof sheeting on Back shed

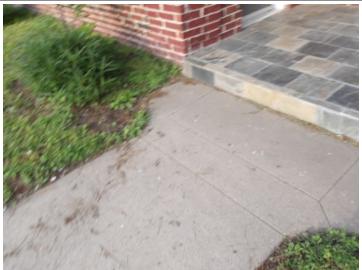
Inadequate grading - improper slope in some areas
