Inspection Report

Property Address: 2623 Oakcliff Street Houston TX 77023

PROPERTY INSPECTION REPORT FORM

Chris Hale	7/26/2024	
Name of Client	Date of Inspection	
2623 Oakcliff Street, Houston, TX 77023		
Address of Inspected Property		
Pat McInturff	23279	
Name of Inspector	TREC License #	
Name of Sponsor (if applicable)	TREC License #

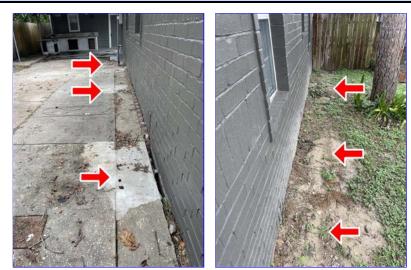
A. Item 1(Picture)

(3) Previous repairs to foundation were detected.

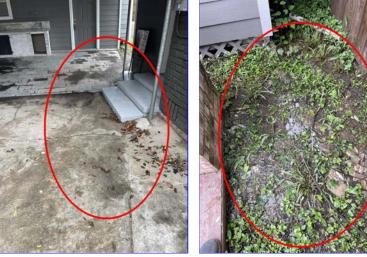
B. Item 1(Picture)

(3) There is a negative slope at the various locations and can cause or contribute to water intrusion or deterioration. I recommend correcting landscape to drain water away from home.

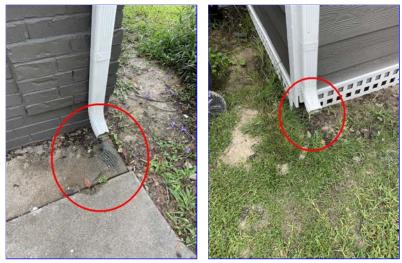
B. Item 3(Picture)

(4) Recommend gutter extensions or splash blocks for all gutter turn-outs to facilitate proper drainage away from the structure. Discharging roof water next to the structure has the potential of causing foundation movement

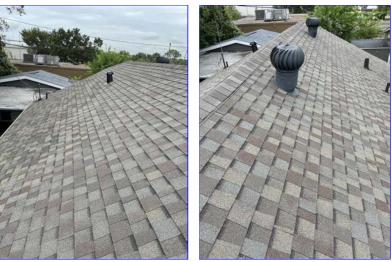
C. Item 1(Picture)

(3) Tree limbs that are in contact with roof or hanging near roof should be trimmed back 3-5'. Areas damaged by limb contact should be repaired. There were damaged areas observed. A roofer should evaluate areas beneath tree limbs for need of repair. (photos are for representation only, and may not depict all areas observed)

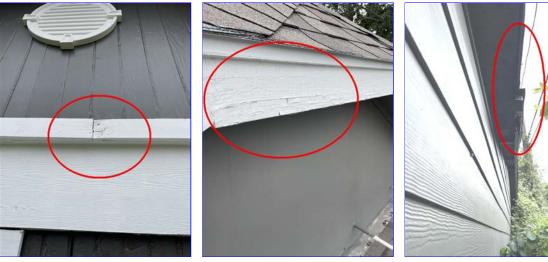
E. Item 1(Picture)

(2) There are areas of the exterior wood siding, trim, Fascia, Drip edge, door jambs, etc. that have sustained varying levels of water (rot) damage and is in need of repair

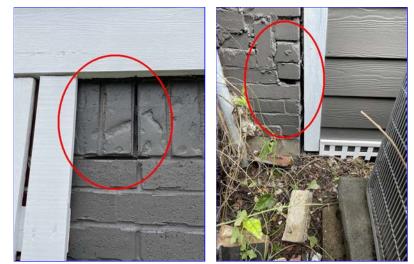
E. Item 10(Picture)

(6) Mortar improvements are recommended for the exterior brick veneer on the side of the house. Recommend sealing (mortar) gaps to prevent moisture incursion.

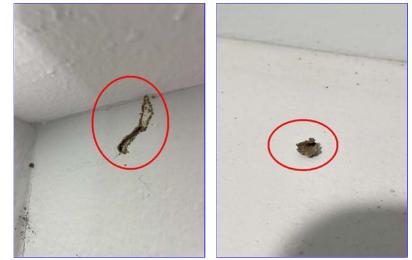
E. Item 13(Picture)

(8) Possible termite activity in apartment.

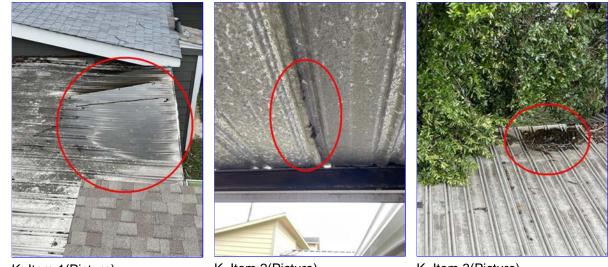
K. Item 1(Picture)

(2) Carport roof has sags where water pools and won't drain. Tin has rusted and is leaking. Recommend repair to plug leak and add support to eliminate the water ponding.

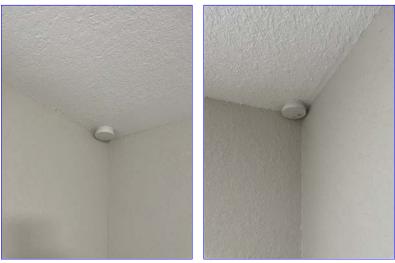
B. Item 1(Picture)

(2) Smoke alarms were functional. Recommend moving smoke detectors to the ceiling just inside the entry door.

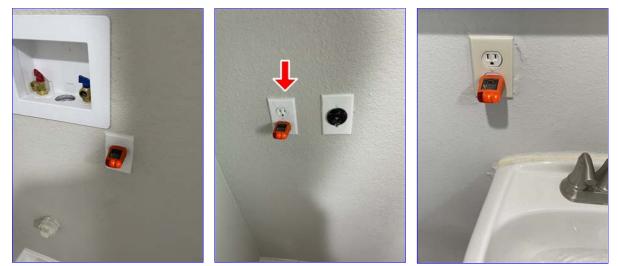
B. Item 3(Picture)

(4) There are no GFCI (Ground Fault Circuit Interrupt) protected outlets in locations called for by today's standards (all kitchen, baths, non dedicated garage below 6', laundry, and exterior outlets)

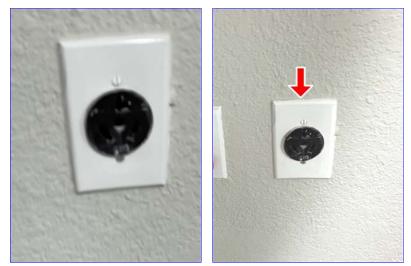
B. Item 10(Picture)

(8) Reversed polarity (hot neutral reversed) observed in one or more locations, should be further evaluated and corrected.

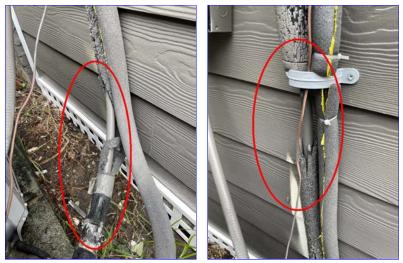
B. Item 9(Picture)

(4) Repair/replace insulation on refrigerant lines between house and condenser.

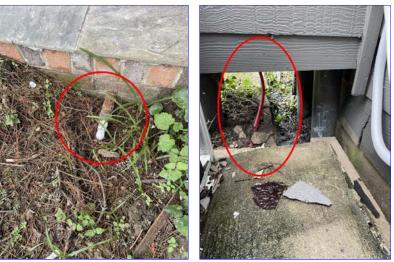
A. Item 3(Picture)

(5) All exterior piping exposed to weather needs to be completely insulated.

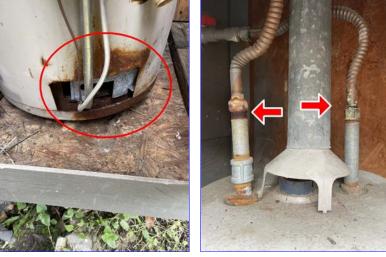
C. Item 3(Picture)

(5) Corrosion and rust observed on one or more of the following, shut off, line connection, body near controls or fitting on tank. Should be further evaluated and corrected by professional.
