# Inspection Report

**Property Address:**  
2623 Oakcliff Street  
Houston TX 77023

# PROPERTY INSPECTION REPORT FORM

| Chris Hale | 7/26/2024 |

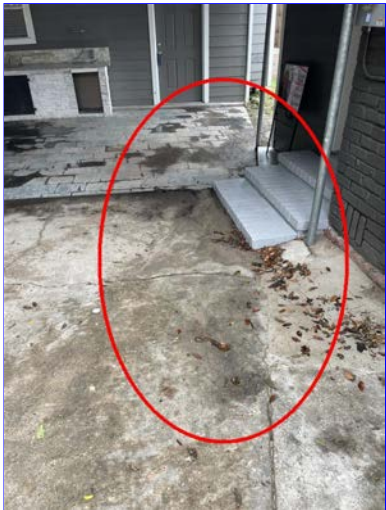
B. Item 1(Picture)

● (2) There is a negative slope at the various locations and can cause or contribute to water intrusion or deterioration. I recommend correcting landscape to drain water away from home.

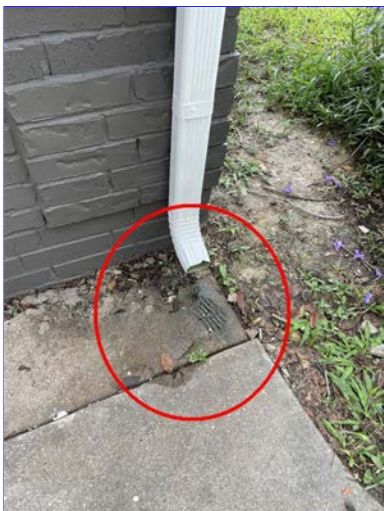
B. Item 3(Picture)

● (3) Recommend gutter extensions or splash blocks for all gutter turn-outs to facilitate proper drainage away from the structure. Discharging roof water next to the structure has the potential of causing foundation movement.

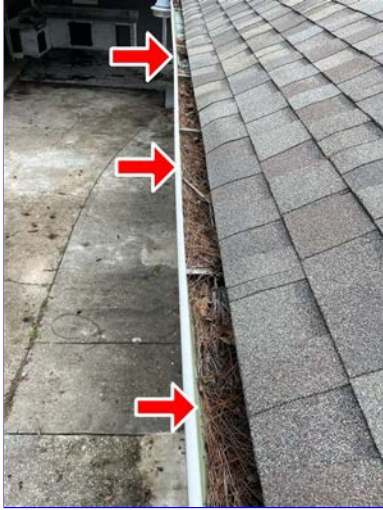
B. Item 8(Picture)

● (4) The gutters have debris in areas and should be cleaned. The debris in gutters can also conceal rust, deterioration or leaks that are not visible until cleaned.

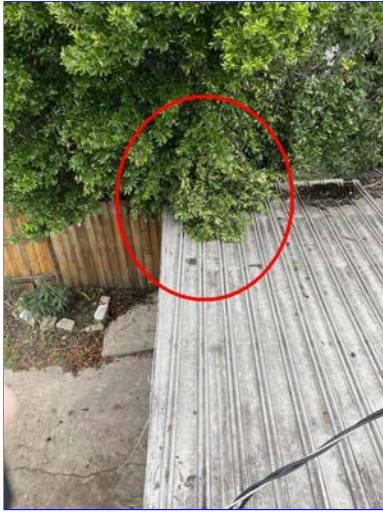
C. Item 1(Picture)

- (1) Tree limbs that are in contact with roof or hanging near roof should be trimmed back 3-5'. Areas damaged by limb contact should be repaired. There were damaged areas observed. A roofer should evaluate areas beneath tree limbs for need of repair. (photos are for representation only, and may not depict all areas observed)

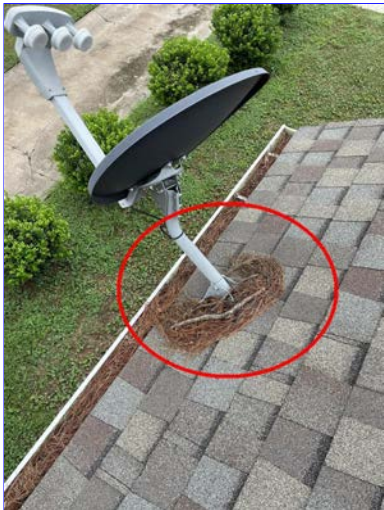
C. Item 7(Picture)

(2) Satellite dish mounted directly through roof not recommended. Better installation is on side wall or eaves. Extra sealant needed on fastening bolts.

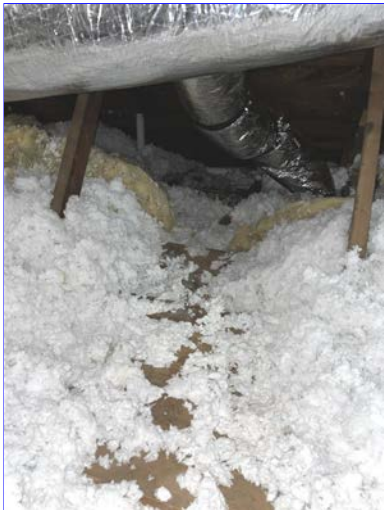
D. Item 1(Picture)

- (1) Level and fluff the attic insulation in various locations where it has been compacted, add where missing.

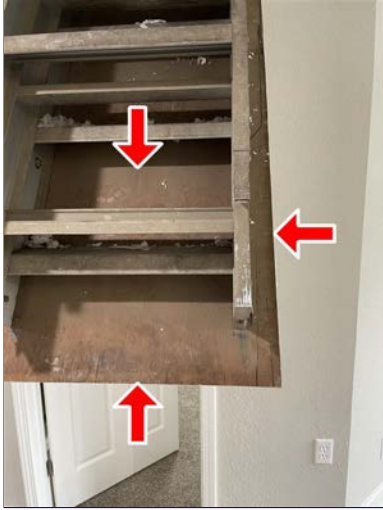
D. Item 5(Picture)

● (2) The attic stairs missing insulation and or weather stripping. This can cause some heat loss in winter and loss of cool air in summer if not corrected. A qualified contractor should inspect and repair as needed.

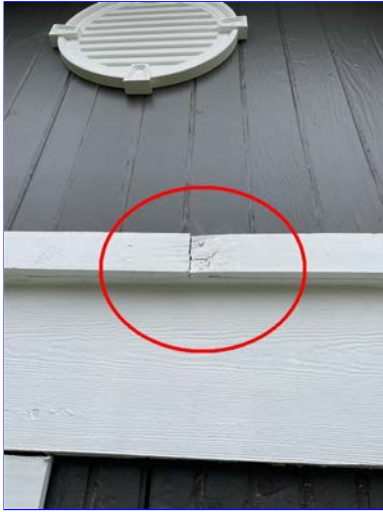
E. Item 1(Picture)

- (1) There are areas of the exterior wood siding, trim, Fascia, Drip edge, door jambs, etc. that have sustained varying levels of water (rot) damage and is in need of repair

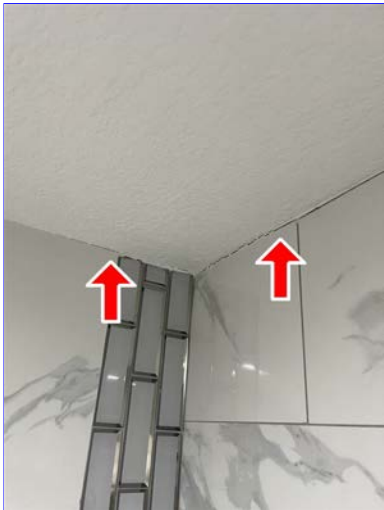
E. Item 7(Picture)

● (2) Grout and/or caulk is cracked, deteriorated and/or missing at showers and or bathtub enclosure should be repaired or replaced as necessary.

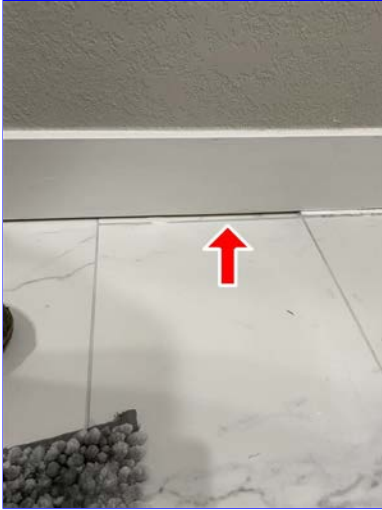
E. Item 15(Picture)

- (3) Caulking improvements are recommended for the gaps in woodwork butt joints.

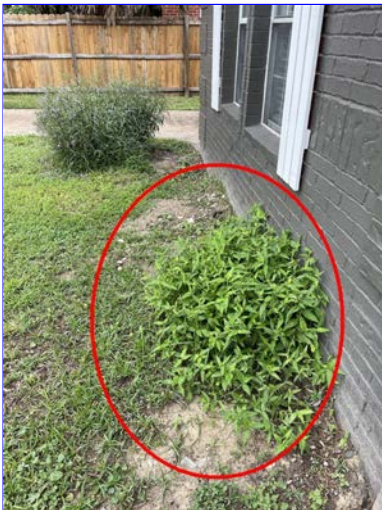
E. Item 16(Picture)

- (4) Trim all hedges, ivy and trees away from exterior wall surfaces. Heavy foliage against walls may be conducive to insect, rub or moisture damage. (Limited view of surfaces in these locations)

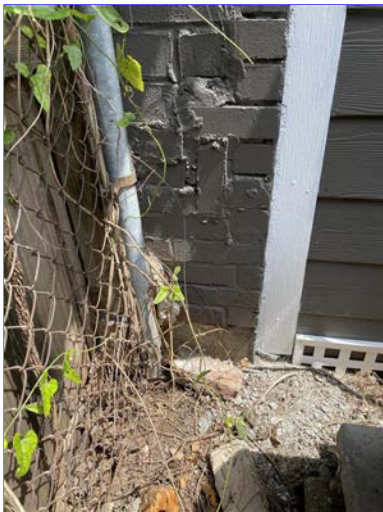
E. Item 21(Picture) Corrected

- (5) Mortar improvements are recommended for the exterior brick veneer on the side of the house. Recommend sealing (mortar) gaps to prevent moisture incursion.

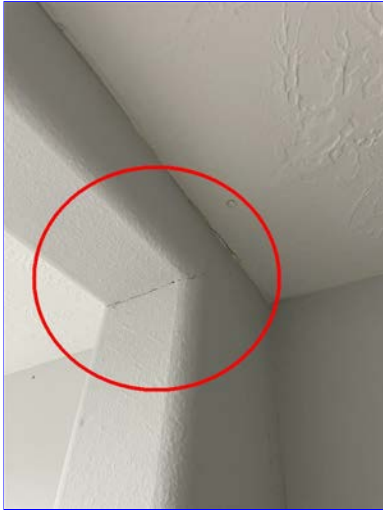
E. Item 22(Picture)

- (6) There are wall sheetrock cracks on the walls in various locations. These cracks appear to be typical settlement/shifting joint cracks with no other visible displacement. Recommend sealing crack to prevent moisture incursion and correct any further settlement/separation

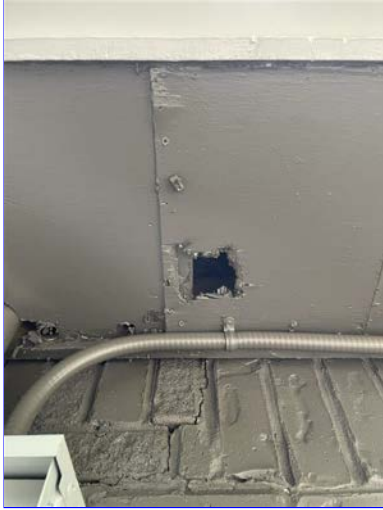
E. Item 27(Picture)

● (8) Screen or patch should be used to cover any gaps in eaves/soffits.

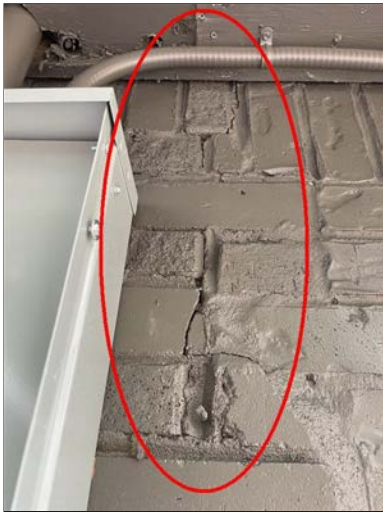
E. Item 28(Picture)

- (9) Structure has multiple cracks in brick veneer that appear to be consistent with settling of structure. This areas should be sealed, or mortar repair performed to prevent moisture into wallspace.

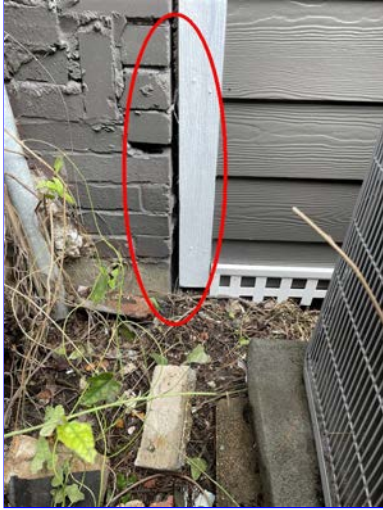
E. Item 30(Picture)

- (10) Caulking improvements are recommended for the area between the exterior brick veneer and the window frames, garage door trim boards, exterior doorframes, exterior water faucet(s), HVAC condenser/coils refrigerant lines needs to be properly sealed.

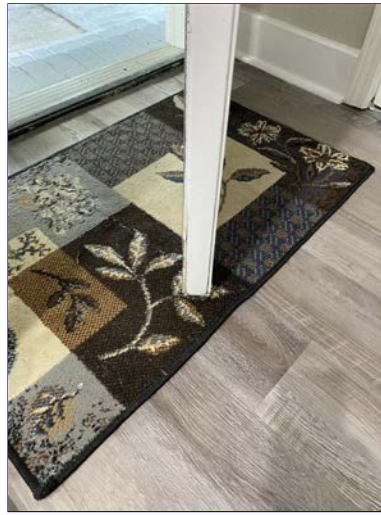
G. Item 2(Picture) Corrected

● (1) Finish / Frame deteriorated, delaminating, or damaged. Recommend new/additional or repairing coat(s) to preserve further problems.

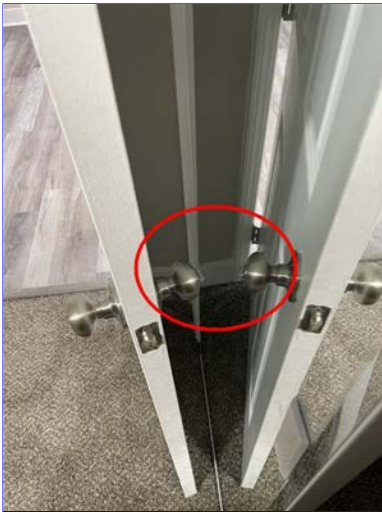
● (2) Doors in various areas are missing working door-stops. This is a maintenance issue and is for your information. A qualified person should repair or replace as needed.

G. Item 3(Picture) Hinge type recommended

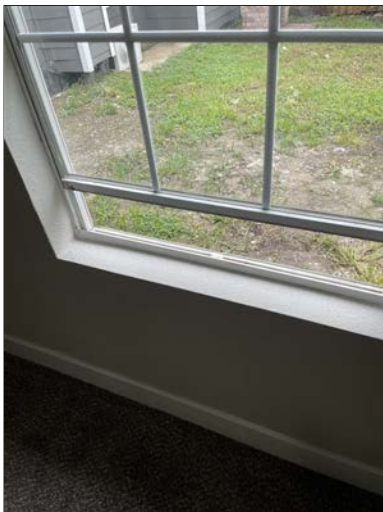
H. Item 1(Picture)

● (1) One or more of the window screens were observed to be missing. The current owner should be consulted regarding any screens that may be in storage.

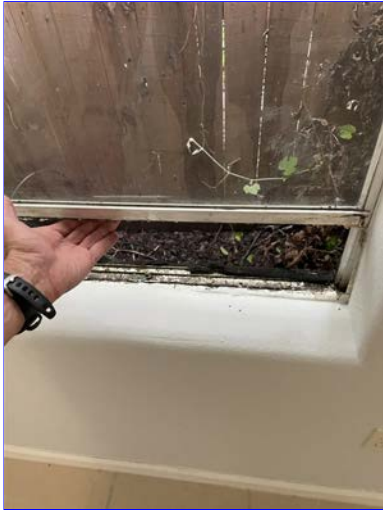
H. Item 3(Picture)

● (2) Window sash springs need adjustment or repair to allow windows to remain completely open, most notably in the apartment bedroom.

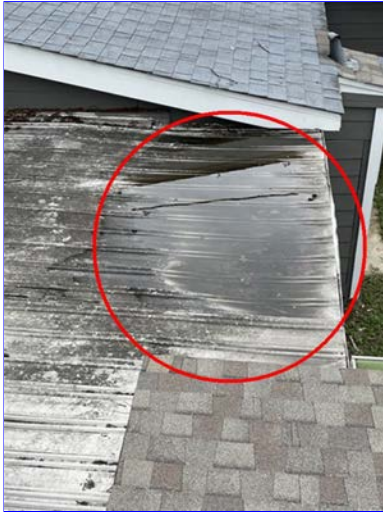
K. Item 1(Picture)

Carport roof has sags where water pools and won't drain. Tin has rusted and is leaking. Recommend repair to plug leak and add support to eliminate the water ponding.

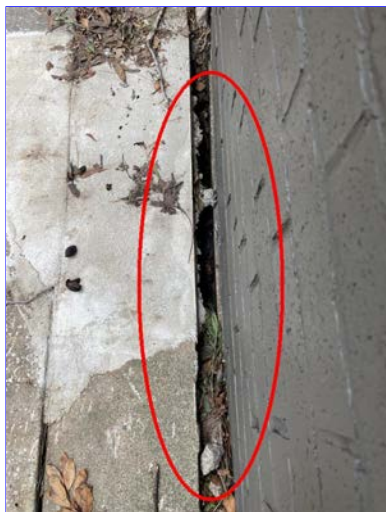
L. Item 1(Picture)

(2) Recommend filling with non-hardening joint compound to prevent water intrusion.

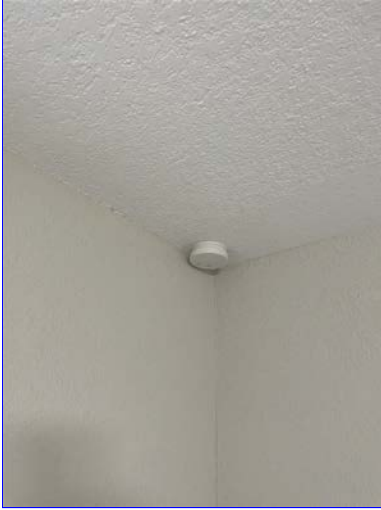
B. Item 1(Picture)

(1) Smoke alarms were functional. Recommend moving smoke detectors to the ceiling just inside the entry door.

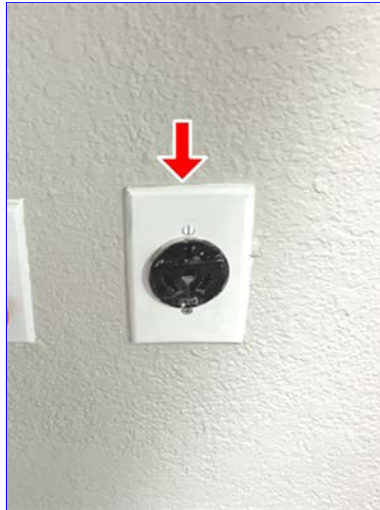
B. Item 16(Picture) Apartment

● (5) The utility 220 electric dryer outlet is a 3 prong type. Electric dryers today are now sold with a 4-prong plug. It may be necessary to swap out the 4-prong plug on newer units

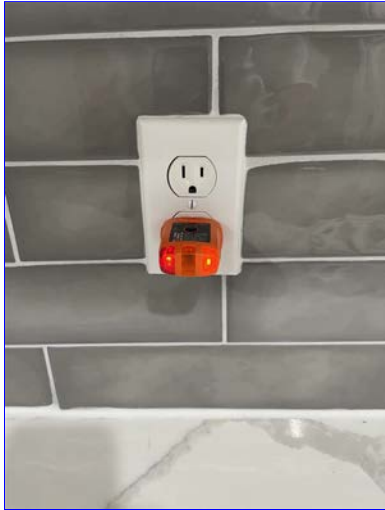
B. Item 17(Picture)

● (6) Reversed polarity (hot neutral reversed) observed in one or more locations, should be further evaluated and corrected.

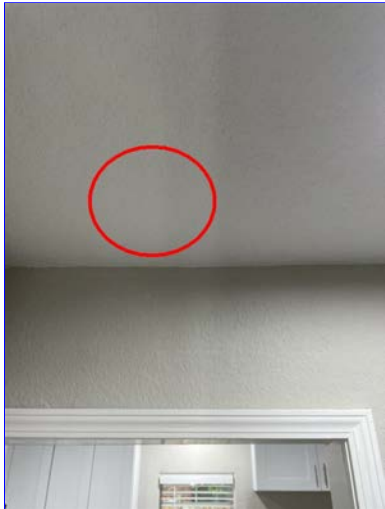
B. Item 19(Picture) Hallway to bedrooms

● (7) Smoke alarms not in all required locations (sleeping and adjoining common areas, interconnected, hard wired, battery back up). Recommend updating to current standards.

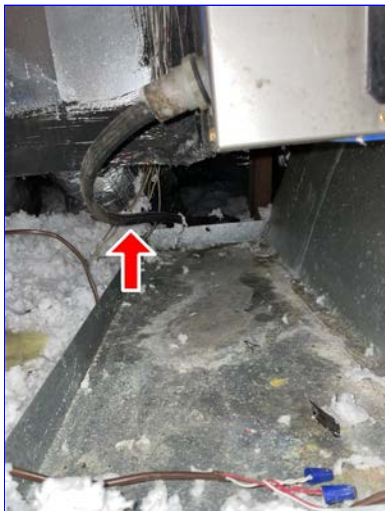
A. Item 8(Picture)

**●** (3) There was not a service disconnect observed on or around the unit. Unit inside breakers are not considers main service disconcert. Under current building standards, there should be a service disconnect within fifty feet (50 ft.) and within sight of the unit.

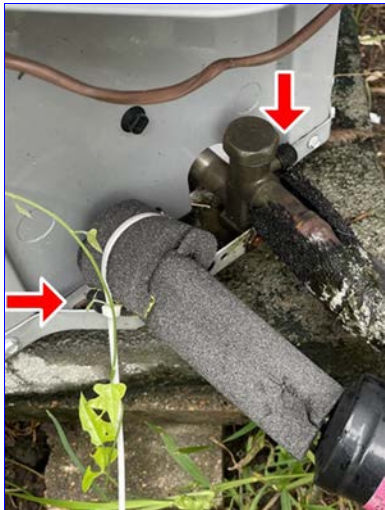
B. Item 1(Picture)

**●** (1) Locking caps for HVAC freon ports are missing as of 2009 (IRC M1411.6 /IMC 1101.10) any HVAC system is required to that all accessible access HVAC ports to be secured with tamper-resistant

caps, in residential or commercial. Residential, multifamily, may be subject to significant fines stemming from the lack of locking caps. Only a licensed HVAC company may install or remove.

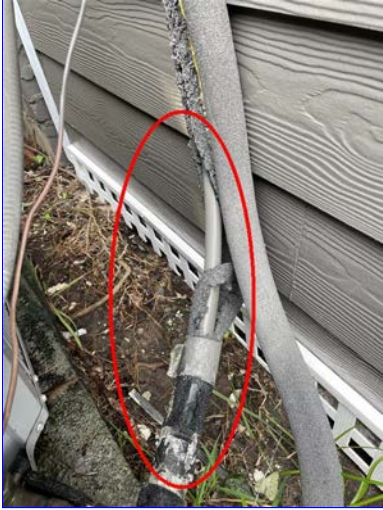
B. Item 2(Picture)

- (2) Repair/replace insulation on refrigerant lines between house and condenser.

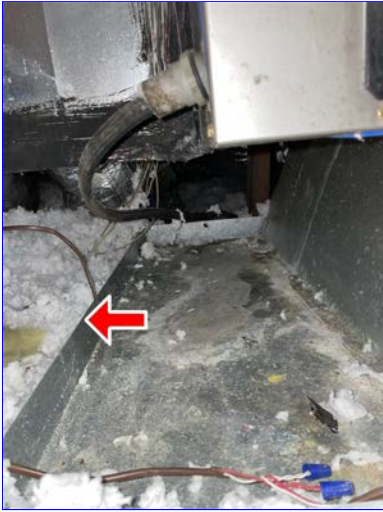
B. Item 6(Picture)

● (3) There is no emergency float electrical cutoff switch installed as called for by today's standards in locations where condensation overflow could cause interior water penetration. (During the cooling season line should be periodically flushed with a 50-50 mixture of bleach and water to prevent bio-growth blockage)

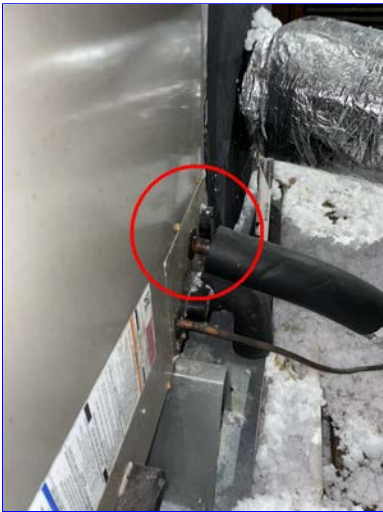
B. Item 8(Picture)

- (4) Refrigerant pipe insulation at the evaporator coil needs repairs to prevent condensation and moisture damage.

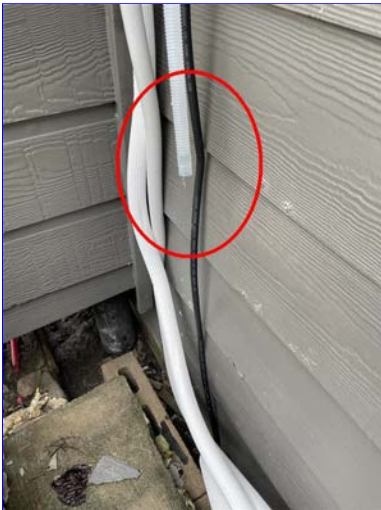
B. Item 12(Picture) Apartment

● (6) The cooling system exterior condensation drain line needs to be extended so that it terminates a minimum of 3' away from the foundation perimeter

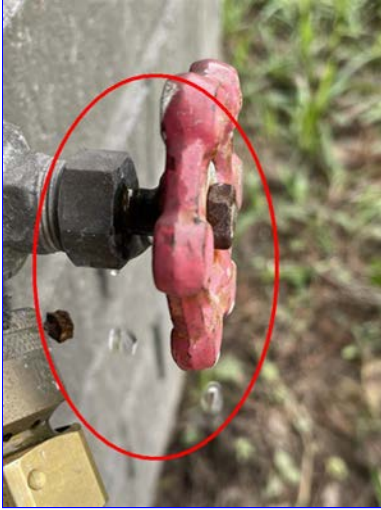
A. Item 1(Picture)

- (1) There is a leak at the hose bib turn valve. Recommend repair.

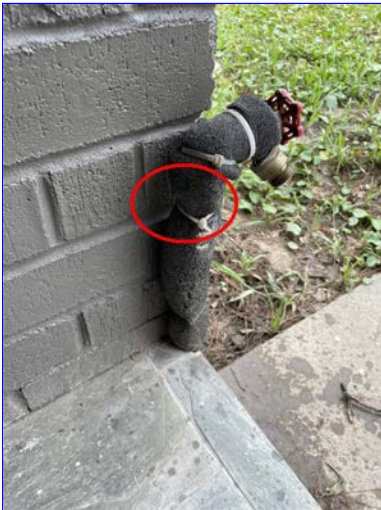
A. Item 3(Picture)

(2) Recommend installing a clamp around the water line to support the PVC riser from breakage.

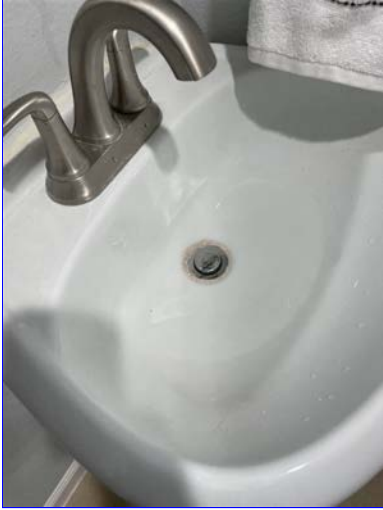
● Stopper(s) in tub(s), sink(s), or shower(s) where missing or not operating correctly, repair or replacement(s) is need.

B. Item 1(Picture) Not opening stem

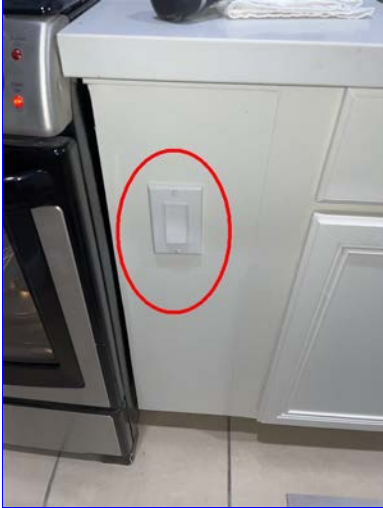
B. Item 1(Picture) Apartment

The food disposer power switch is too low, and does not prevent children from operating. I recommend repair as needed.
