August 30th, 2023

Reference: Foundation Inspection at
200 Beacon Ln. in Livingston, TX 77351
KESCORP File No. 2308124

Name: Koon
File #: 2308124

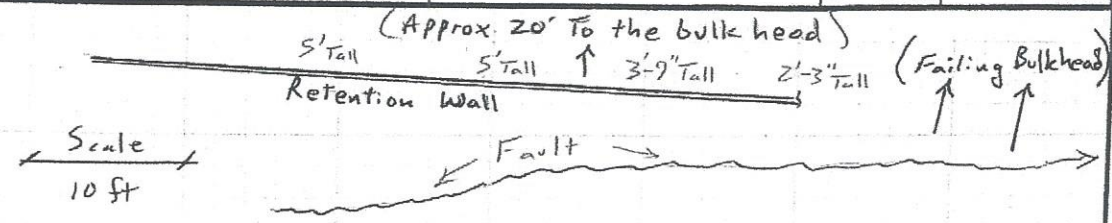
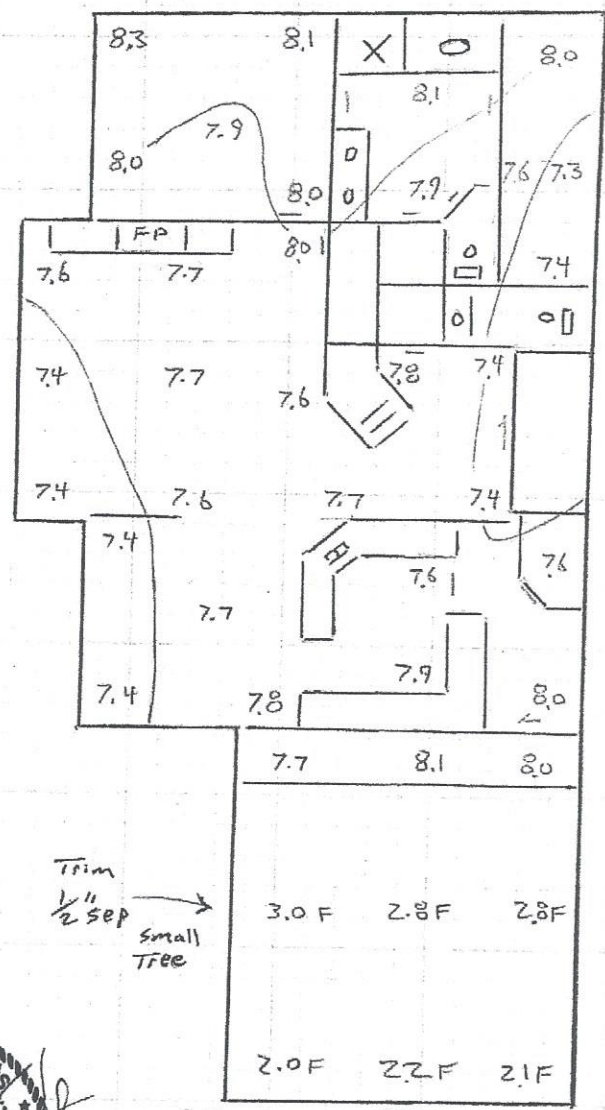
- 5) Door misalignment was not significant.
- 6) One tree was near the home on the side of the garage.
- 7) An apparent soil fault line runs along the end of the home. This fault is 4 to 7 feet from the house and is located between the house and the soil retention wall, which is located about 10 to 12-feet out from this end of the home. There is a bulkhead about 30-feet out from this end of the home. No obvious or apparent movement was seen in the bulkhead or the retention wall, both of which appear to be functioning as intended. Minor insignificant cracking was observed in the stonework of the retaining wall. See the attached drawing showing location of the fault and retention walls.

- 8) A bulkhead adjacent to the one mentioned above is failing. The soil fault line is parallel to the failing bulkhead and appears to be related to this bulkhead movement. The failing bulkhead appears to be related to the fault that is forming alongside the house, since the line of soil movement/faulting is connected and continuous.

Trim
1/2 sep
Small Tree

The soil fault line appears to be caused by the bulkhead failure in the adjacent lot, not directly out from the end of the house in question. The newer bulkhead and the soil retention wall, both located directly out from this end of the house, as shown on the drawing, appear to be functioning as intended. However, the dynamics of the soil movement is not clear, and I recommend a bulkhead specialist review this situation as soon as possible to make recommendations for stopping the soil movement.
