SELLER'S DISCLOSURE NOTICE

CONCERNING THE PROPERTY AT 200 Beacon Ln Livingston, Tx 77351

Reference: Foundation Inspection at
200 Beacon Ln. in Livingston, TX 77351
KESCORP File No. 2308124

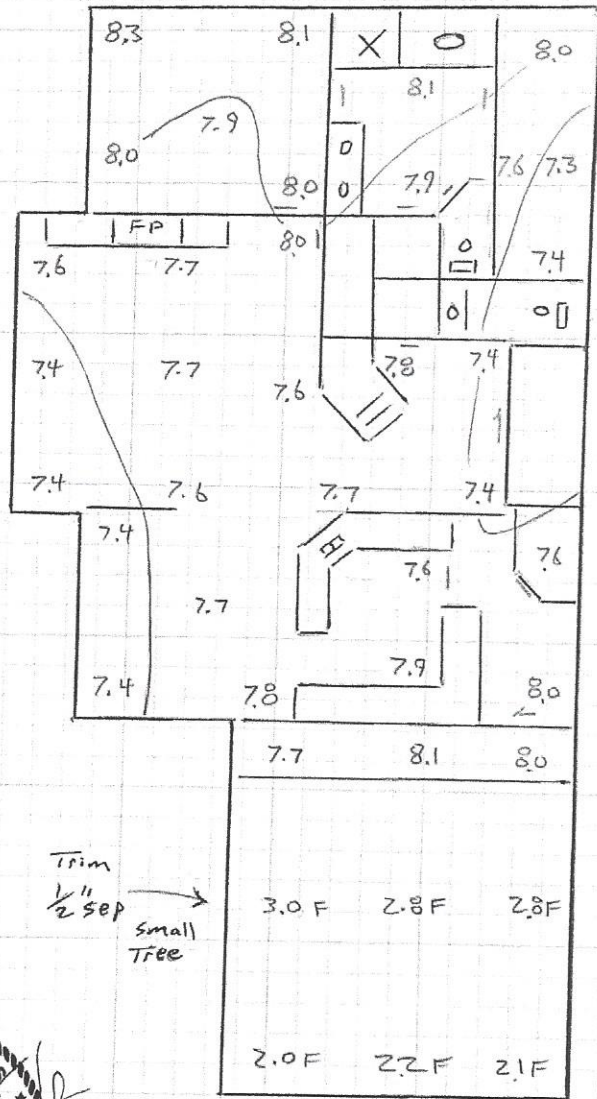
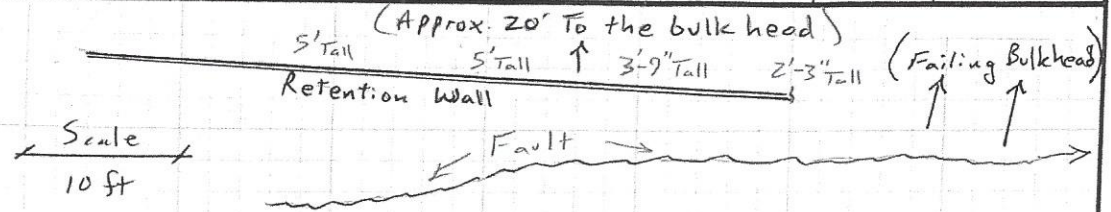
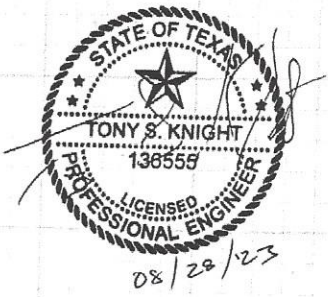
- 1) ½-inch wood trim separation at an upper window on the side of the garage. This separation appears to be unrelated to the foundation movements.
- 2) Brick cracks were significant above the overhead garage door, due to lintel sagging.

- 5) Door misalignment was not significant.
- 6) One tree was near the home on the side of the garage.
- 7) An apparent soil fault line runs along the end of the home. This fault is 4 to 7 feet from the house and is located between the house and the soil retention wall, which is located about 10 to 12-feet out from this end of the home. There is a bulkhead about 30-feet out from this end of the home. No obvious or apparent movement was seen in the bulkhead or the retention wall, both of which appear to be functioning as intended. Minor insignificant cracking was observed in the stonework of the retaining wall. See the attached drawing showing location of the fault and retention walls.

- 8) A bulkhead adjacent to the one mentioned above is failing. The soil fault line is parallel to the failing bulkhead and appears to be related to this bulkhead movement. The failing bulkhead appears to be related to the fault that is forming alongside the house, since the line of soil movement/faulting is connected and continuous.

This home has a normal differential of 1.0-inches and no abnormal floor slopes. Homes of this type normally have less than 1.5-inches of differential, and slopes less than 1-inch in 15-feet if the foundation is performing as intended. The intended elevation is probably about 8.0-inches as indicated on the attached drawing. The elevation contours and lack of significant distress indicate the foundation is performing as intended. No foundation repairs are recommended, and the soil movement noted above has not affected the house foundation.

The soil fault line appears to be caused by the bulkhead failure in the adjacent lot, not directly out from the end of the house in question. The newer bulkhead and the soil retention wall, both located directly out from this end of the house, as shown on the drawing, appear to be functioning as intended. However, the dynamics of the soil movement is not clear, and I recommend a bulkhead specialist review this situation as soon as possible to make recommendations for stopping the soil movement.

9.5 OH 8.8 OH 10.0 OH
 Mlt. Cracks Sagging Lintel (Approx. 1" Sag) Mlt. Cracks

I recommend that you monitor for and correct any ponding water or soil cavities that may occur. Water that ponds near the foundation or flows into cavities may cause differential movements resulting in damage to the structure. Do not fill low areas with rock, gravel, or sand since water migrates through these and may still get under the house. Do not use French Drains within 20-ft of the foundation.
