Prepared for Emerson Property Management

5/30/2024

8202 Furray Road A

Items that Need Attention Summary

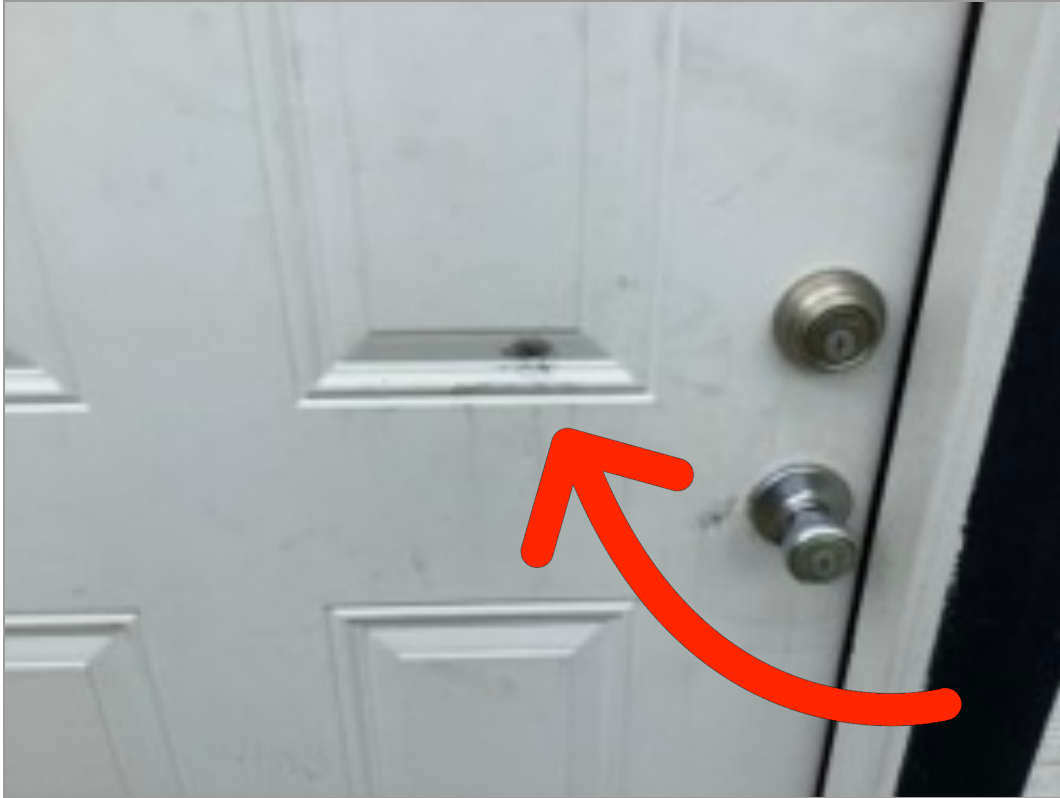
Entry
Front Door Exterior
Scratches; stains;
discoloration or
chipping of door
casing

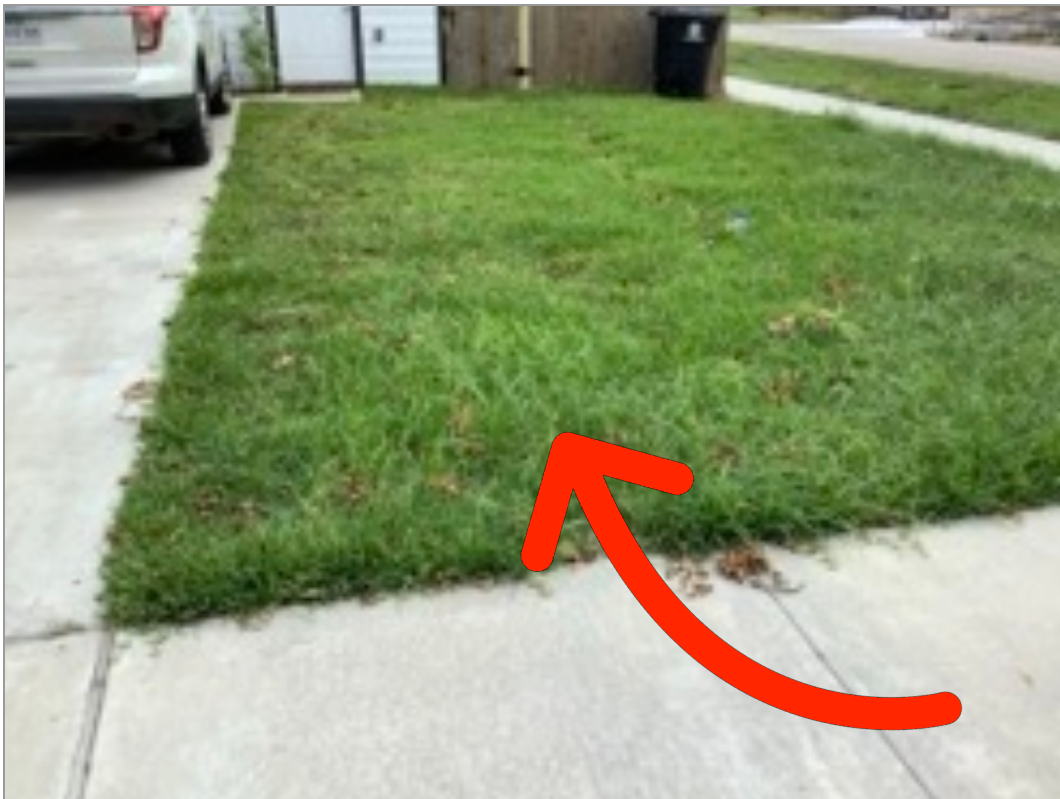
Front Exterior
Yard
Yard is overgrown

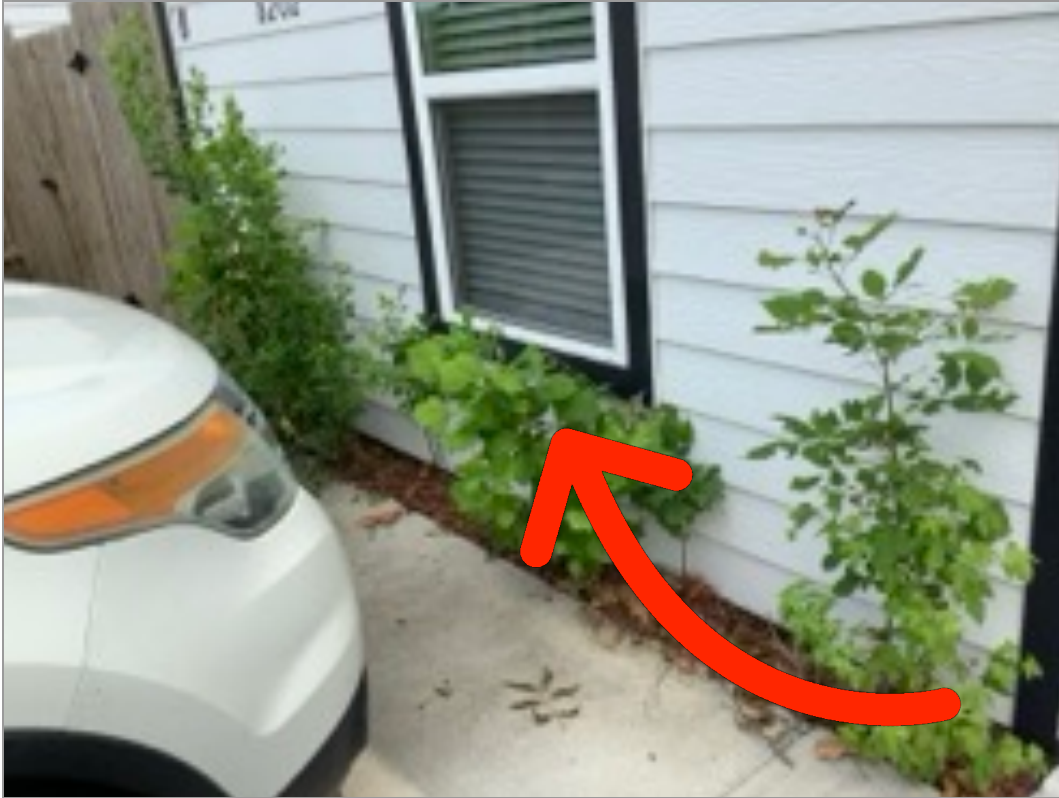
Front Exterior
Trees/Shrubs/Landscaping
Overgrown landscaping

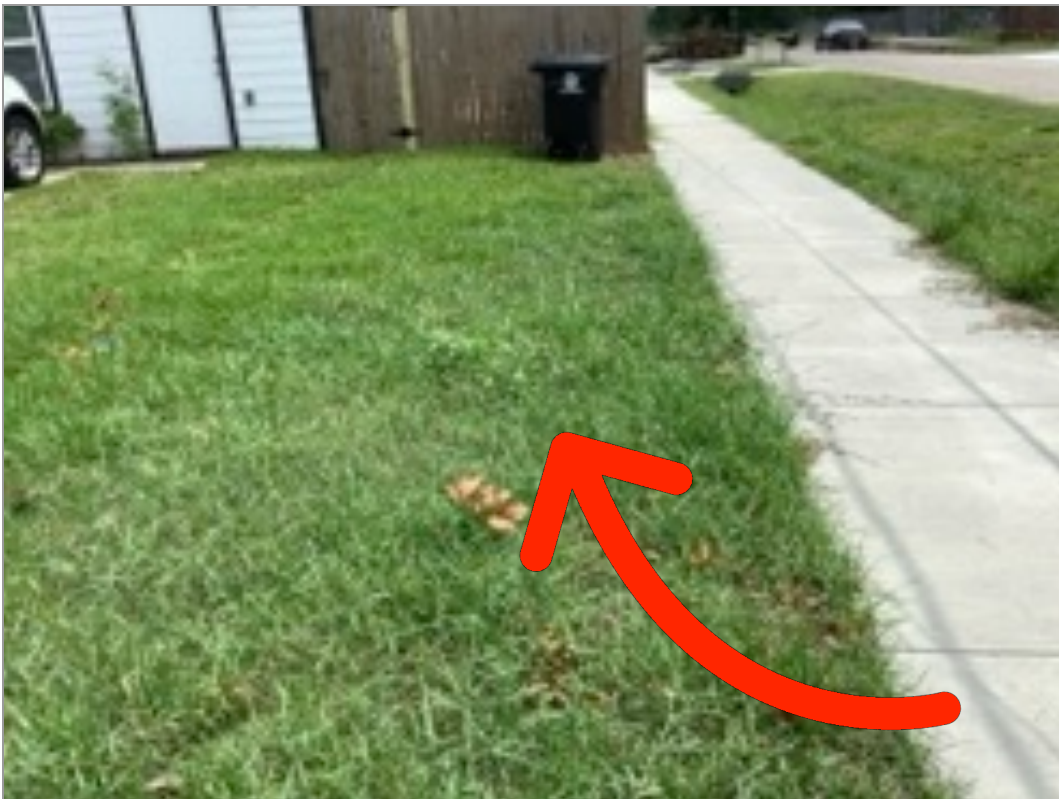
Front Exterior
Right Side Yard
Overgrown

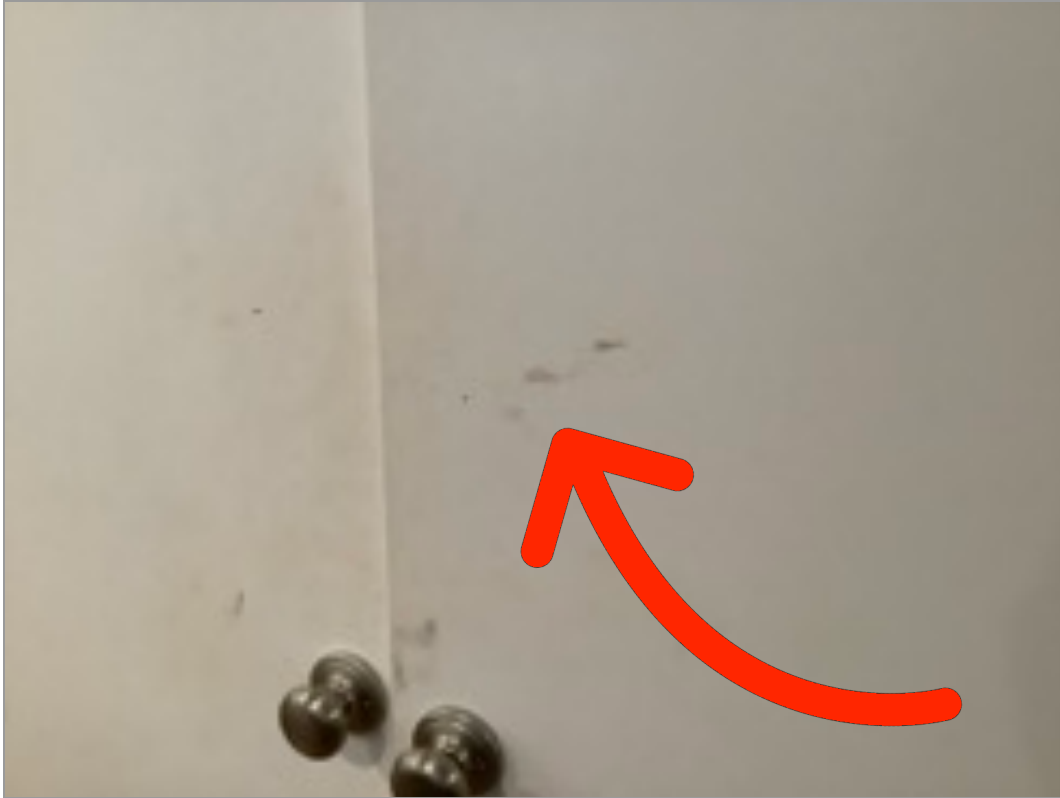
Laundry Room
Door
Scuffs on door.

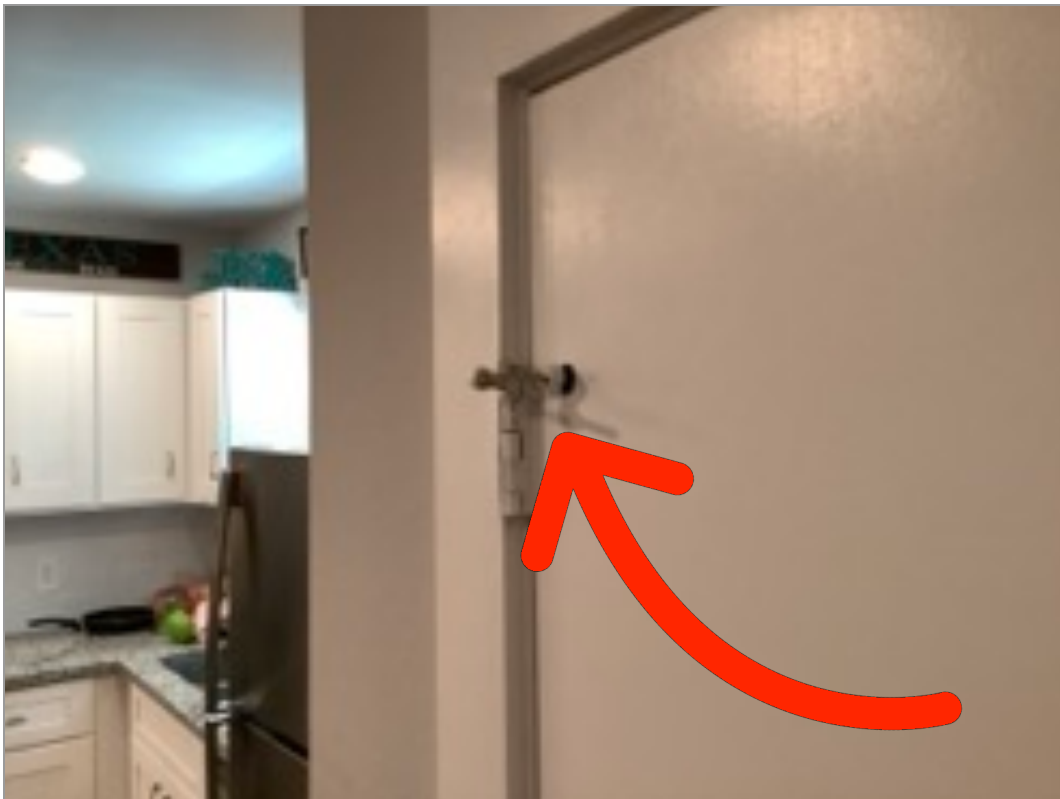
Laundry Room
Door Stop
Broken- no wall damage noted.

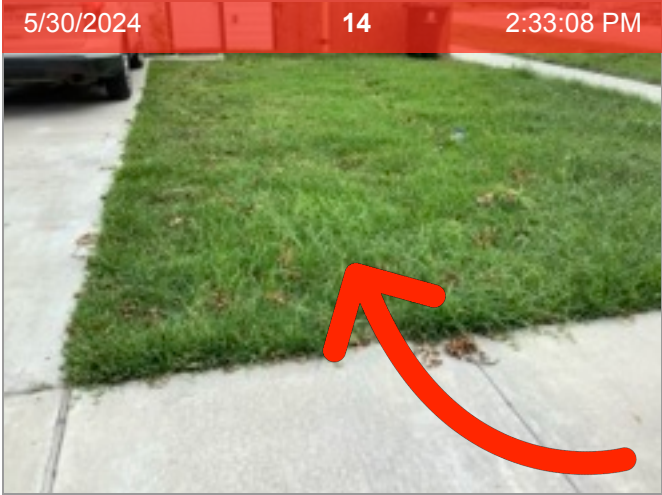
Yard | Yard is overgrown

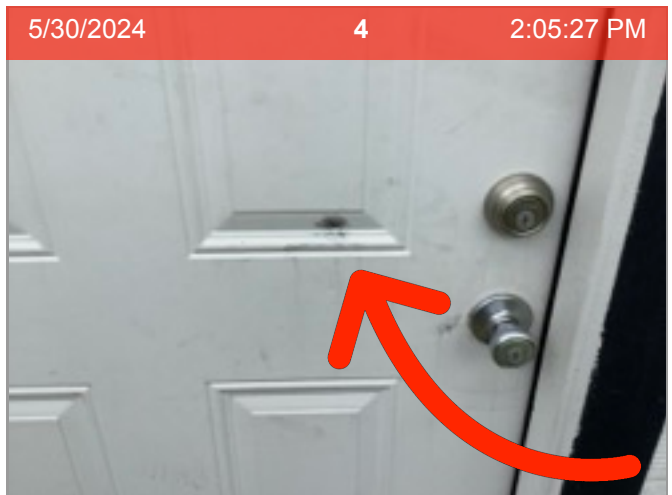
Front Door Exterior | Scratches; stains; discoloration or chipping of door casing

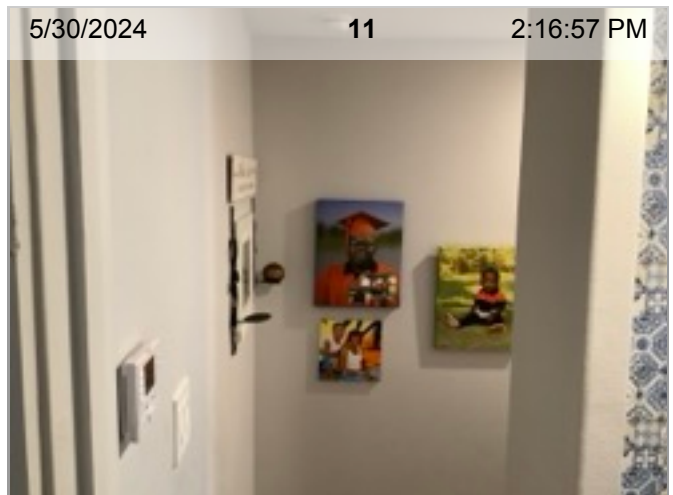
Wired Smoke/CO Combo Smoke Alarm | Smoke test: Not tested | Alarm in place | Alarms with no date are over 10 years old.

Wired Smoke/CO Combo Smoke Alarm | Smoke test: Not tested | Close-up of printed manufacture date

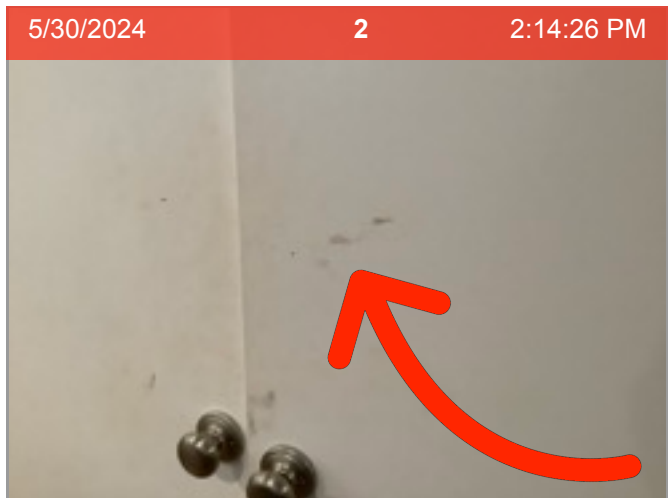
Door | Scuffs on door.

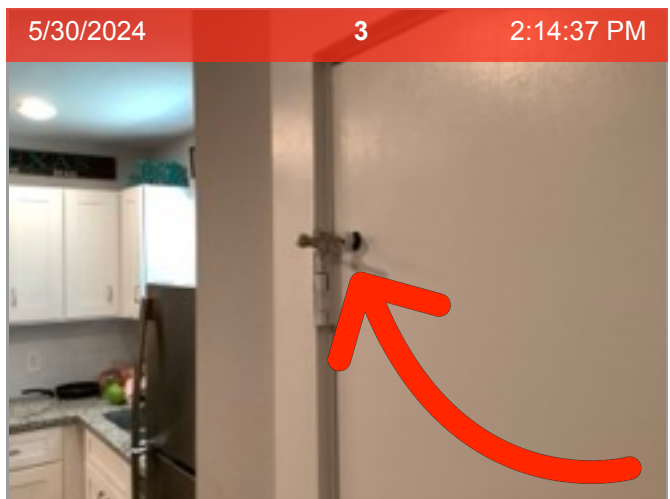
Door Stop | Broken- no wall damage noted.
