Prepared for Emerson Property Management

6/22/2024

8202 Furray Road #B

Houston TX 77028

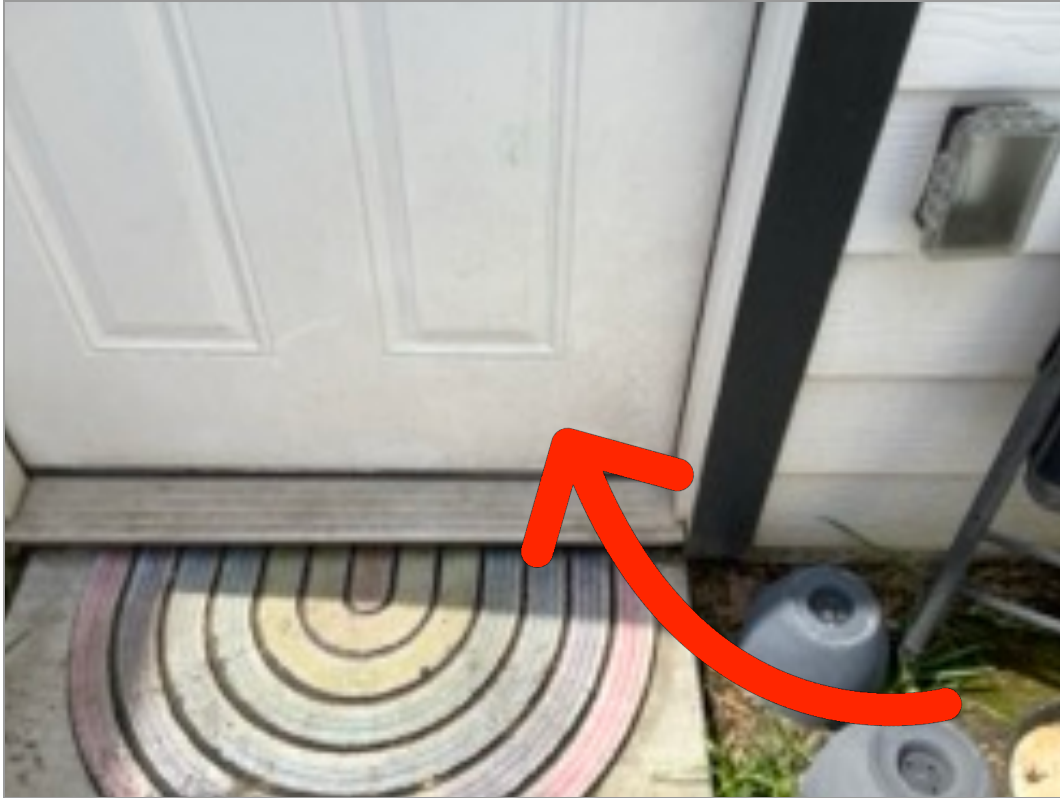
Entry
Front Door Exterior
Scratches; stains;
discoloration or
chipping of door
casing

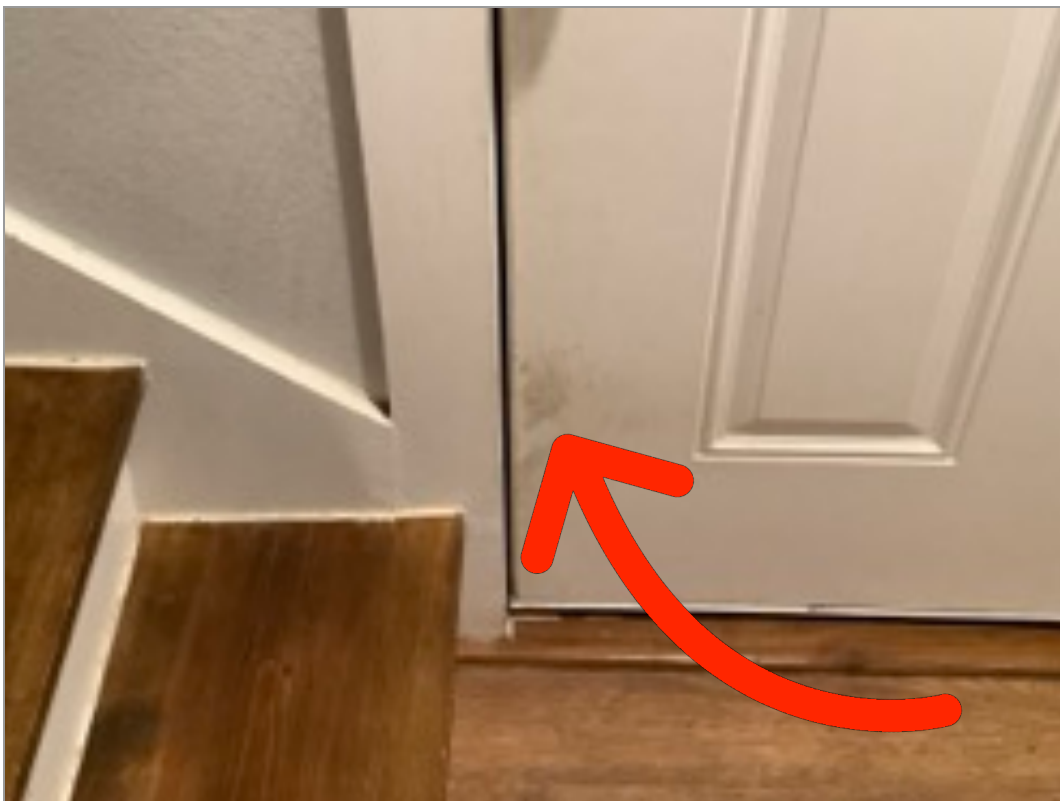
Entry
Front Door Interior
Scuffs on door

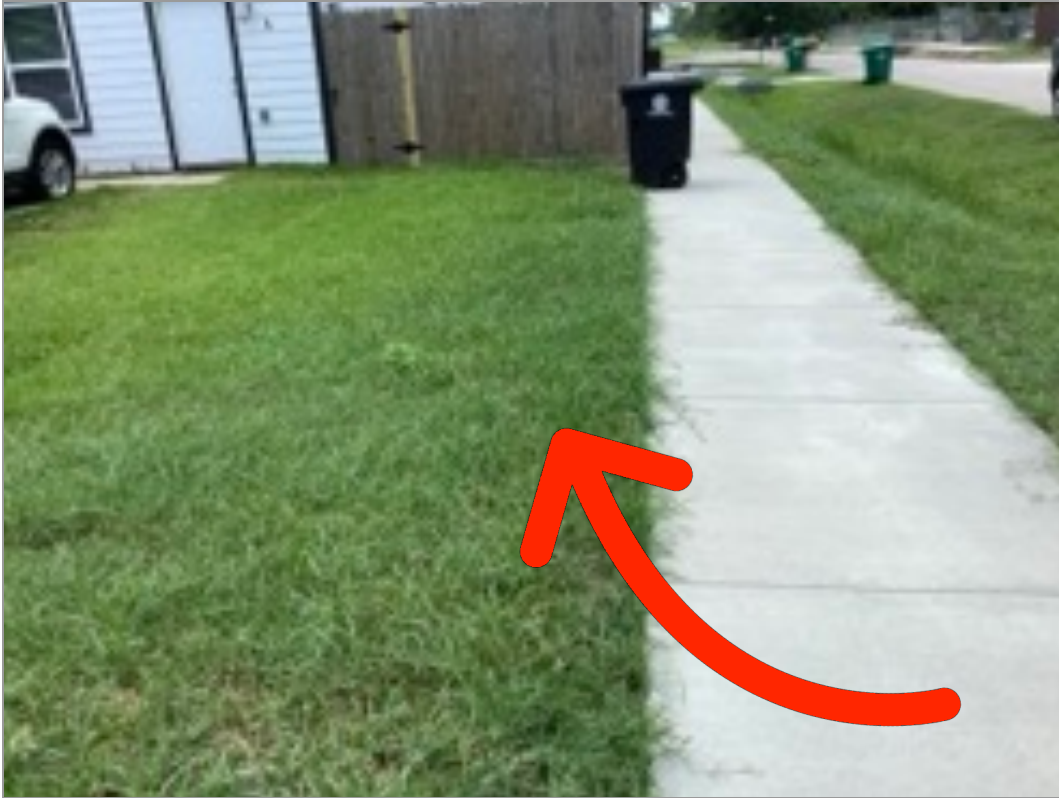
Front Exterior
Right Side Yard
Overgrown

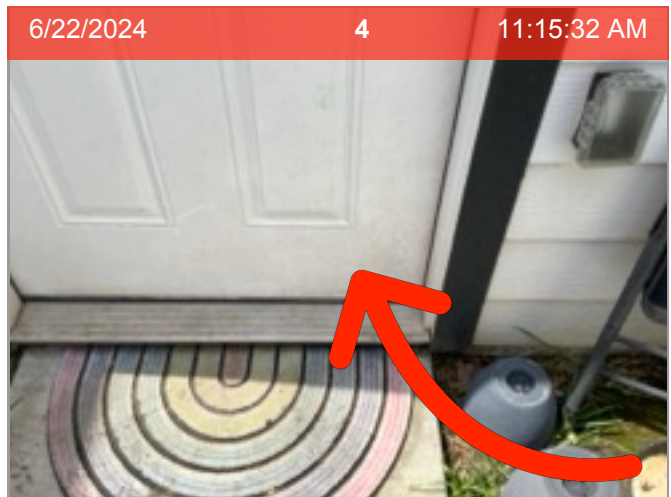
Front Door Exterior | Scratches; stains; discoloration or chipping of door casing

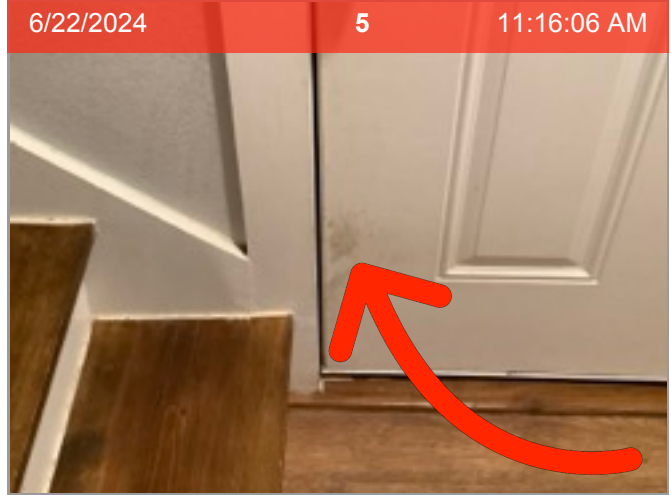
Front Door Interior | Scuffs on door

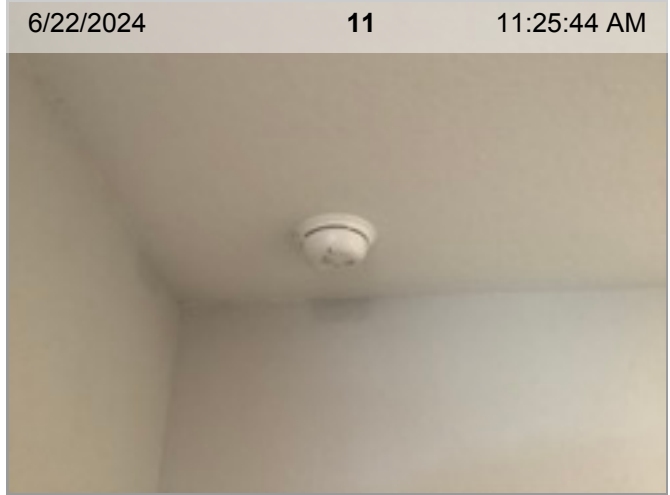
Wired Smoke/CO Combo Smoke Alarm | Smoke test: Not tested | Alarm in place | Alarms with no date are over 10 years old.
