4202 Dalmatian Drive Houston, Texas 77045

Major systems plus

Rio Bravo - Inspectify Pro - Houston

April 26, 2024, 3:30 PM

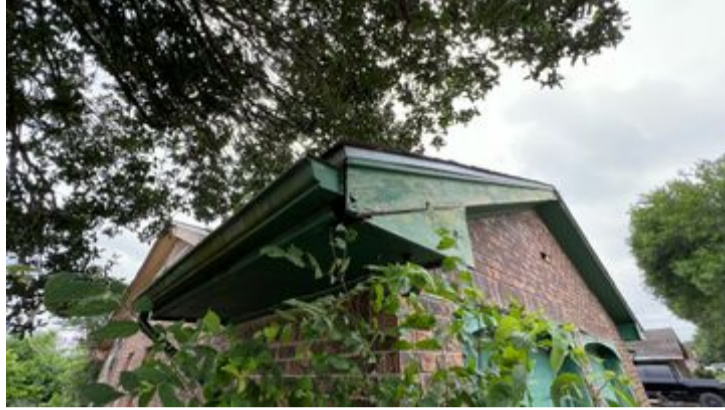
Rotted Fascia

One or more sections of the fascia are rotted. Wood Rot- Fascia/Soffit. Recommend further evaluation by a qualified professional.

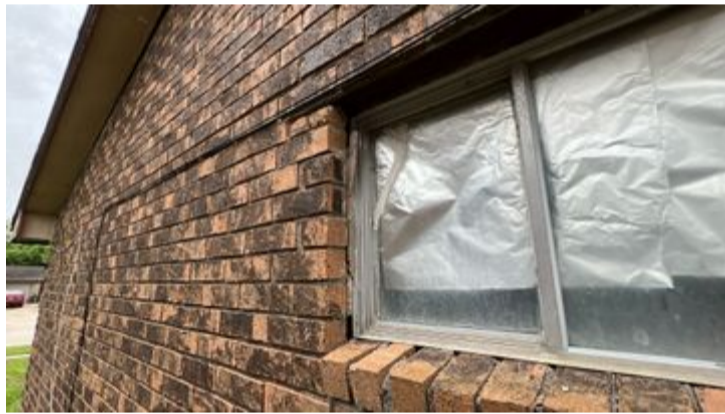
Damaged Brick Mortar

The mortar is cracked / damaged in one or more areas. Recommend repairs or replacing by a qualified professional.

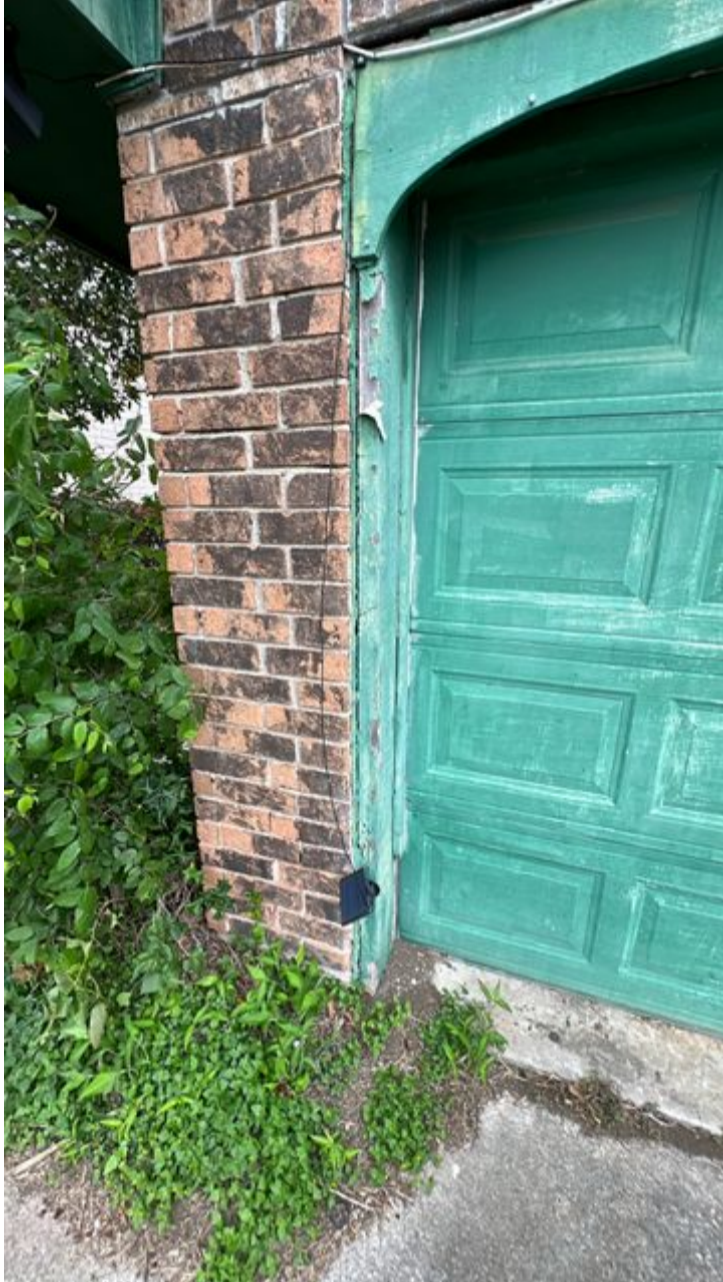
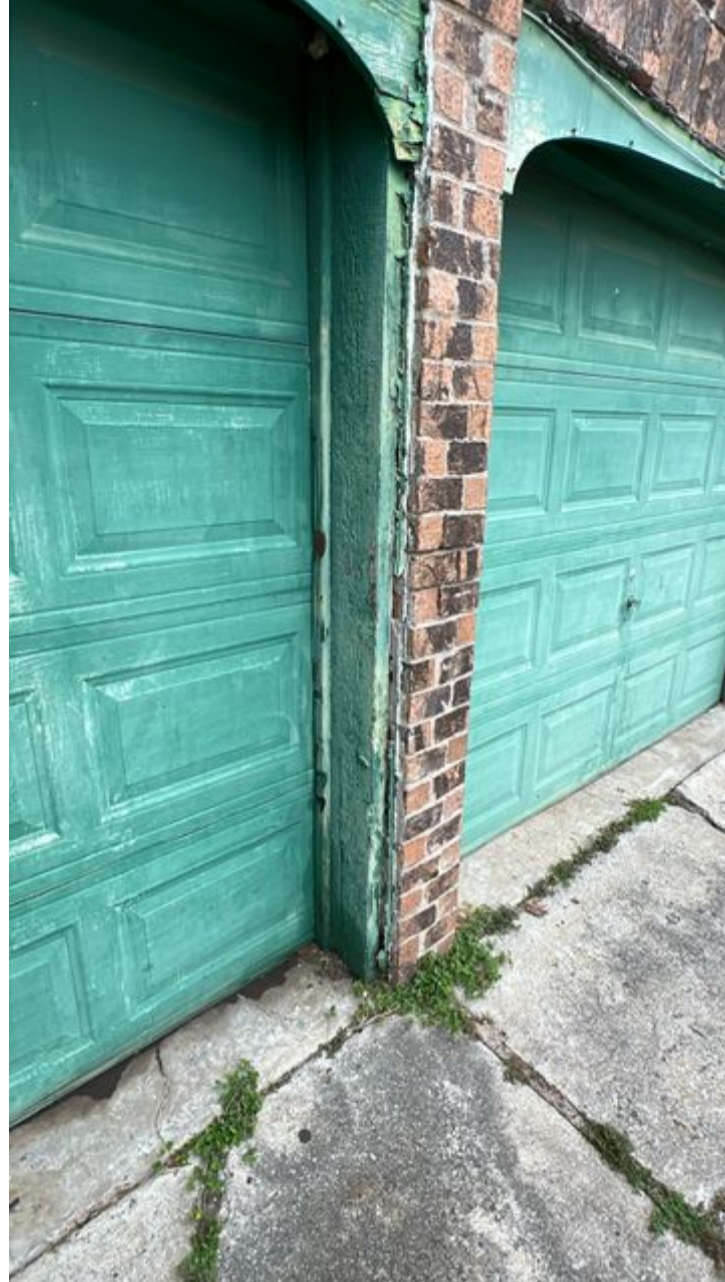
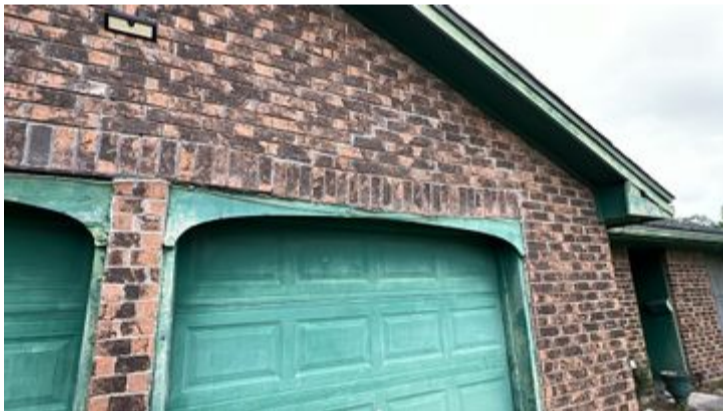
Damaged Garage Door Jamb / Trim

The jamb / trim surrounding the garage door is damaged / weathered. Recommend repairs or replacing by a qualified professional.

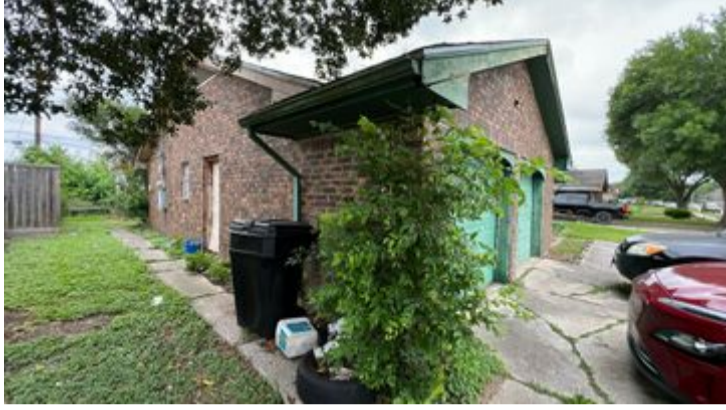
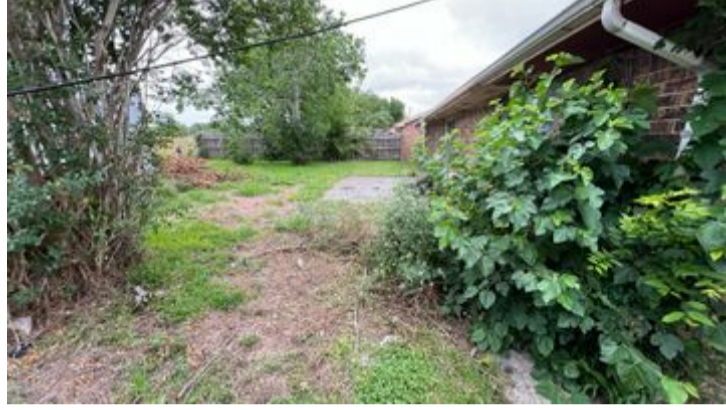
Vegetation is Too Close to the Structure

There is vegetation too close to the structure. Recommend repairs or replacing by a qualified professional.

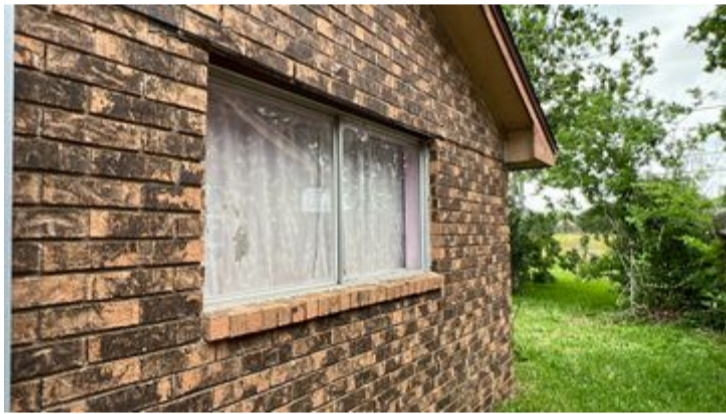
Missing Window Screen

One or more windows are missing a screen. Recommend repairs or replacing by a qualified professional.

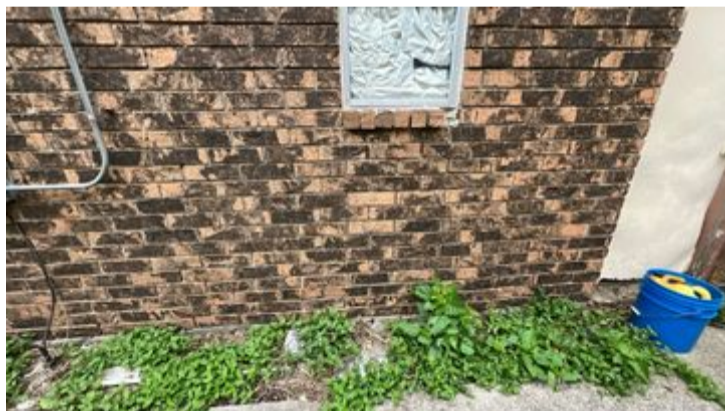
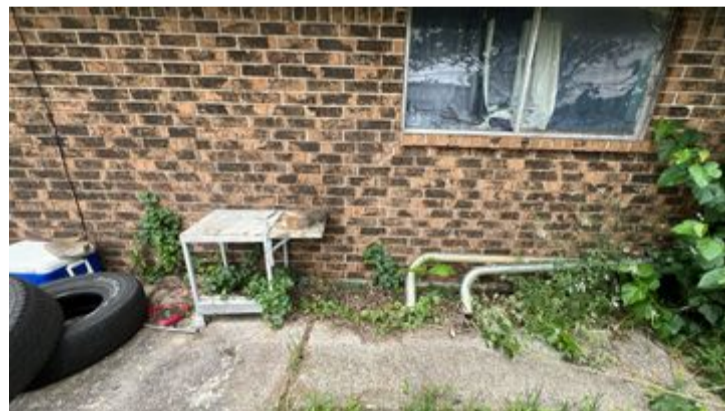
Walls Structural Damage

One or more walls have signs of structural damage. Recommend repairs or replacing by a qualified professional.

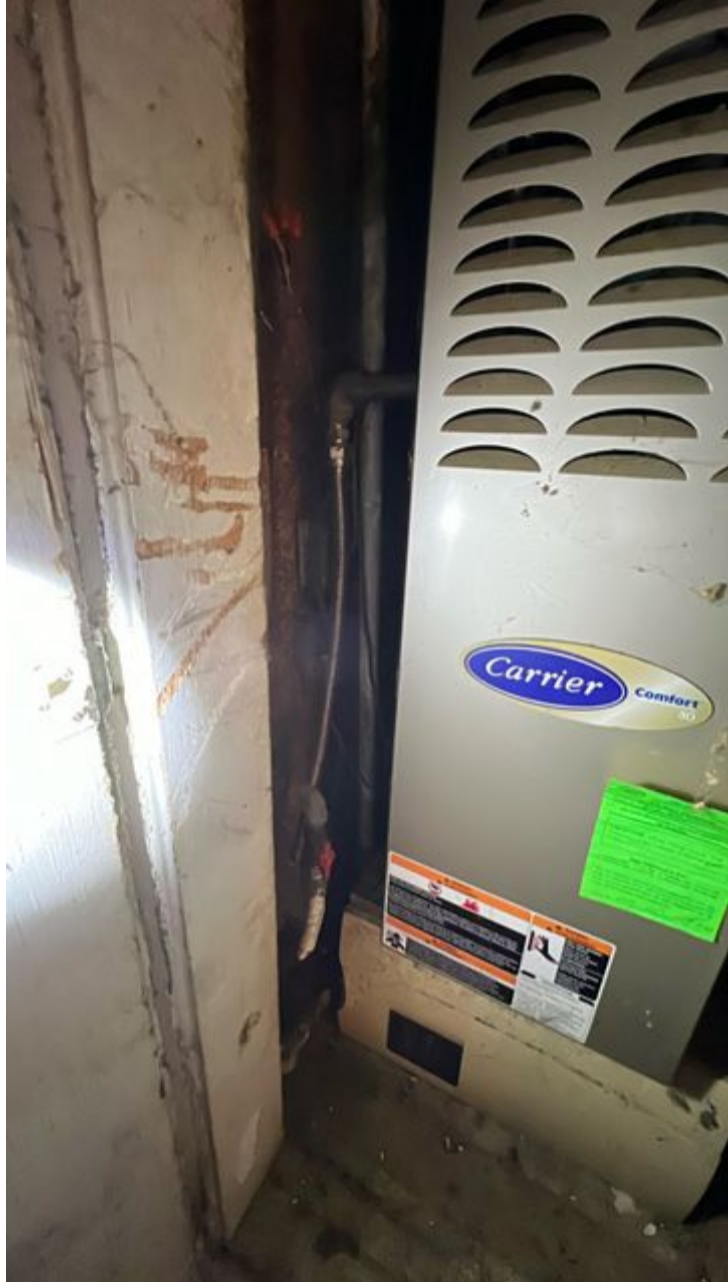
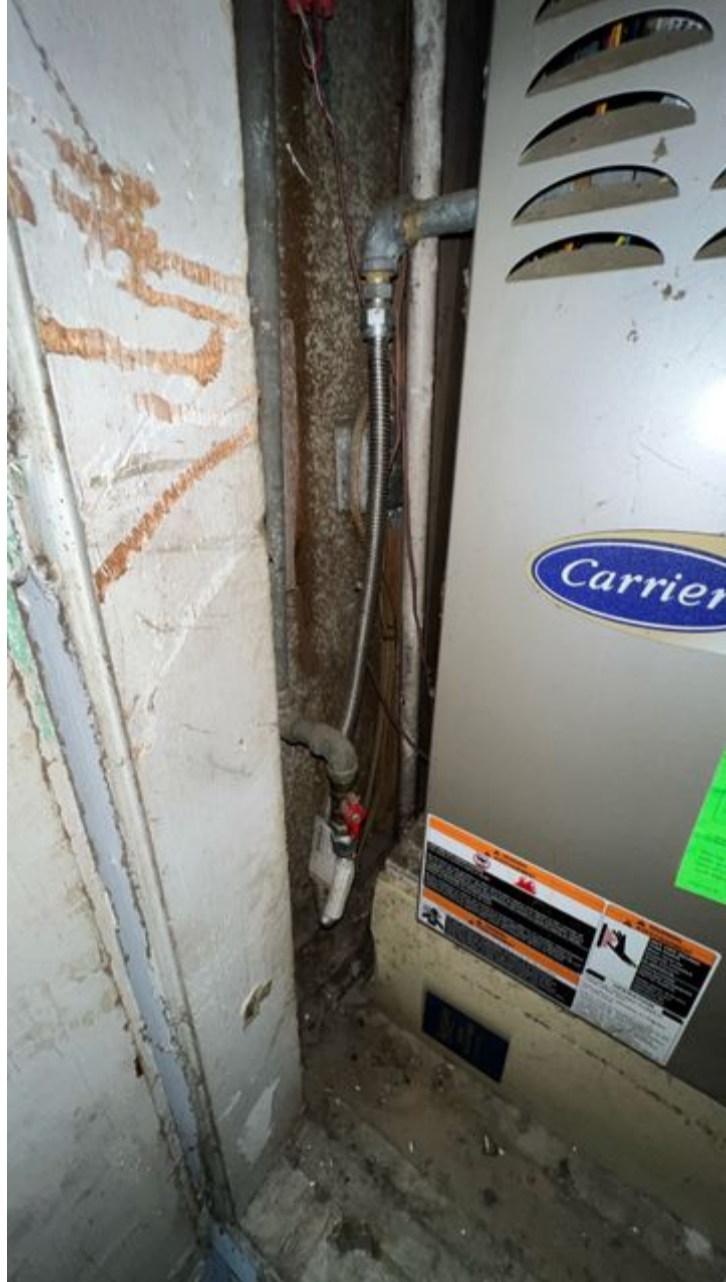
Missing Sediment Trap

There is no sediment trap on the furnace. Recommend repairs or replacing by a qualified professional.

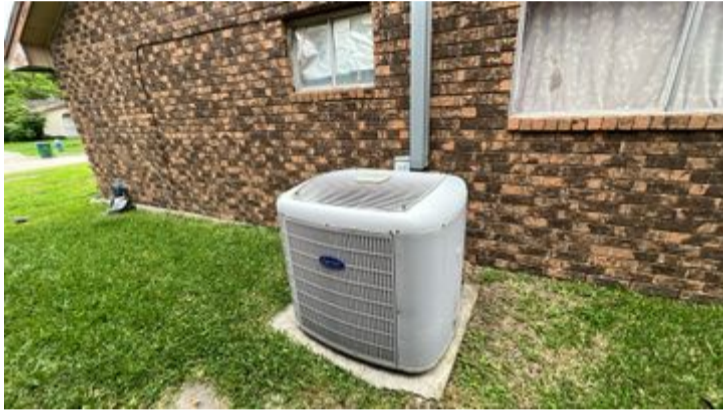
Inoperable Cooling System

The cooling system is working insufficiently. Recommend repairs or replacing by a qualified professional.

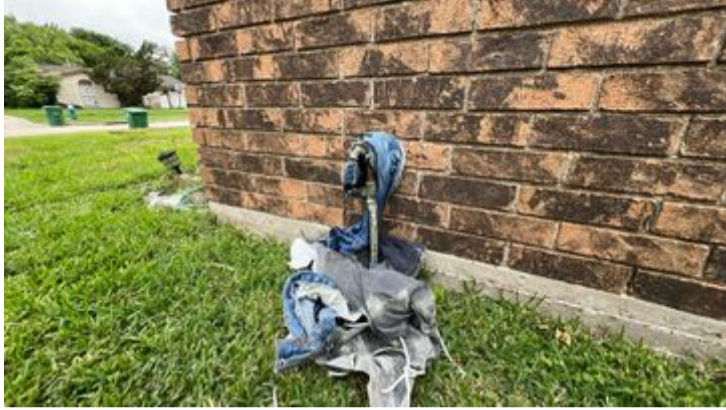
Missing Supply Line Insulation

The supply lines are not insulated. Recommend further evaluation by a qualified professional.

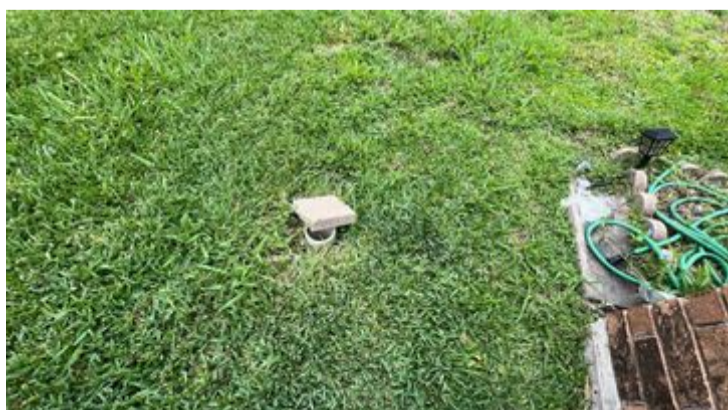
Missing Cleanout Cap

The cleanout cap is missing in one or more locations. Recommend repairs or replacing by a qualified professional.

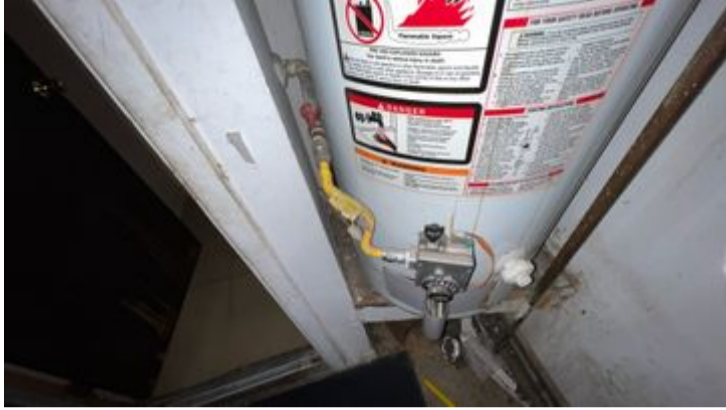
Missing Gas Line Sediment Trap

The gas line does not have a sediment trap installed. Recommend repairs or replacing by a qualified professional.

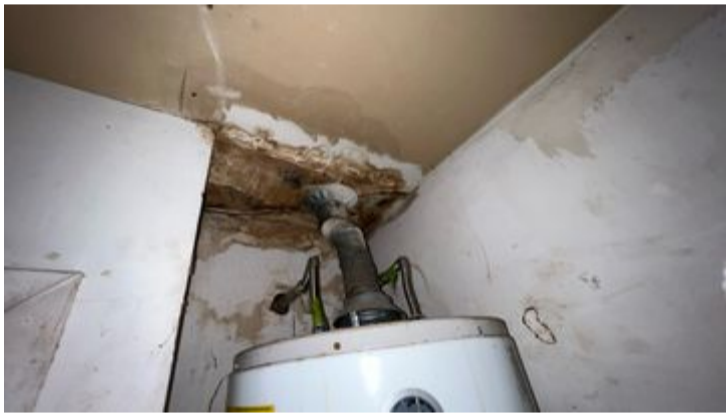
Water Stained Ceiling

The ceiling has one or more moisture stains. Recommend repairs or replacing by a qualified professional.

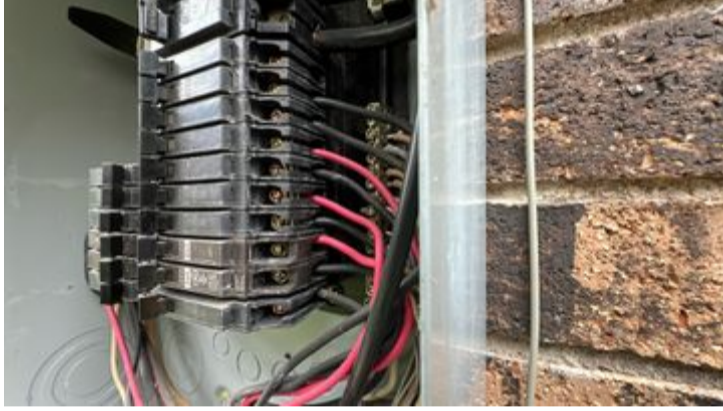
Aluminum Branch Circuits

There is an aluminum wire installed in the branch circuits. Recommend repairs or replacing by a qualified professional.

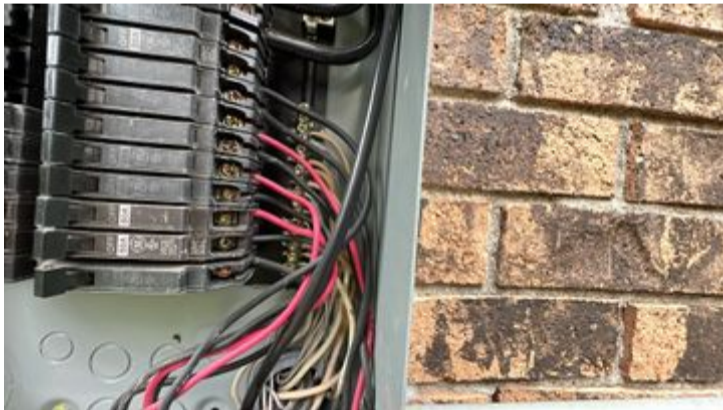
Neutral / Ground Shared Bus Bar

The neutral (white wire) and equipment grounding conductors (bare wire) terminate under the same lug. Recommend repairs or replacing by a qualified professional.

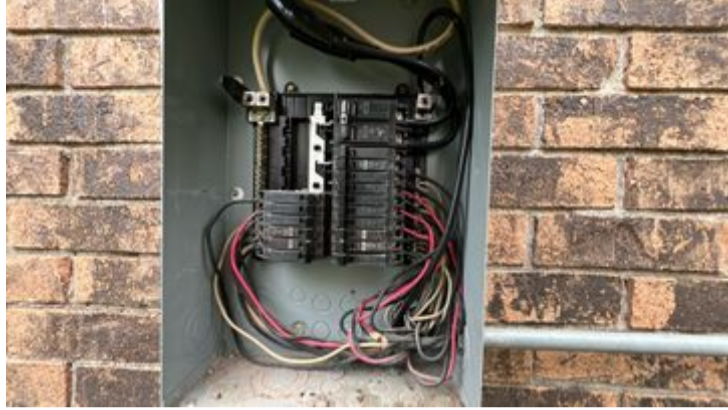
Missing AFCI Breaker

A required Arc-Fault Circuit Interrupter is missing. Recommend repairs or replacing by a qualified professional.

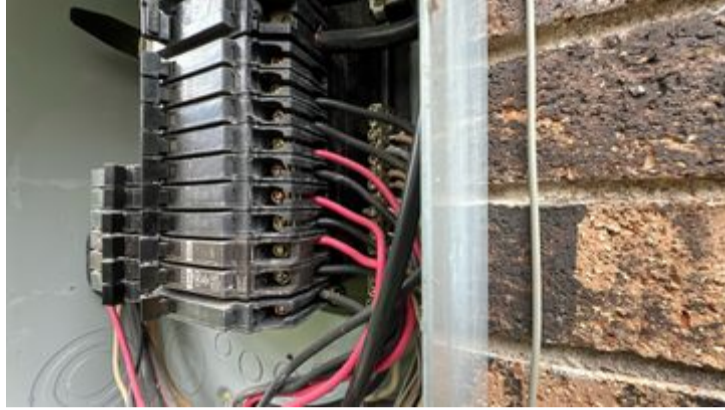
Aluminum Branch Circuits

There is an aluminum wire installed in the branch circuits. Recommend repairs or replacing by a qualified professional.

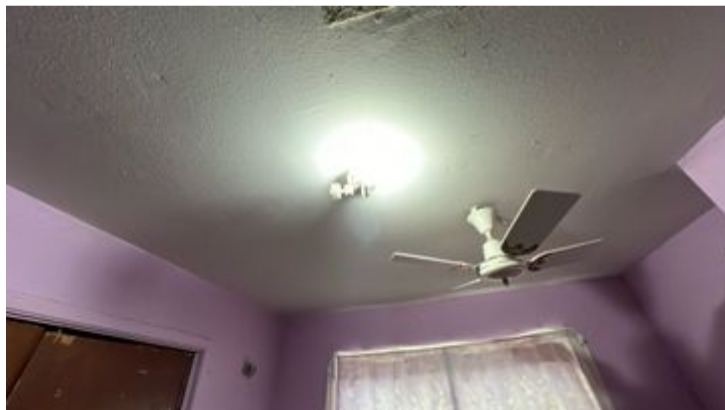
Missing Light Cover

One or more light fixtures have exposed bulbs. Recommend repairs or replacing by a qualified professional.

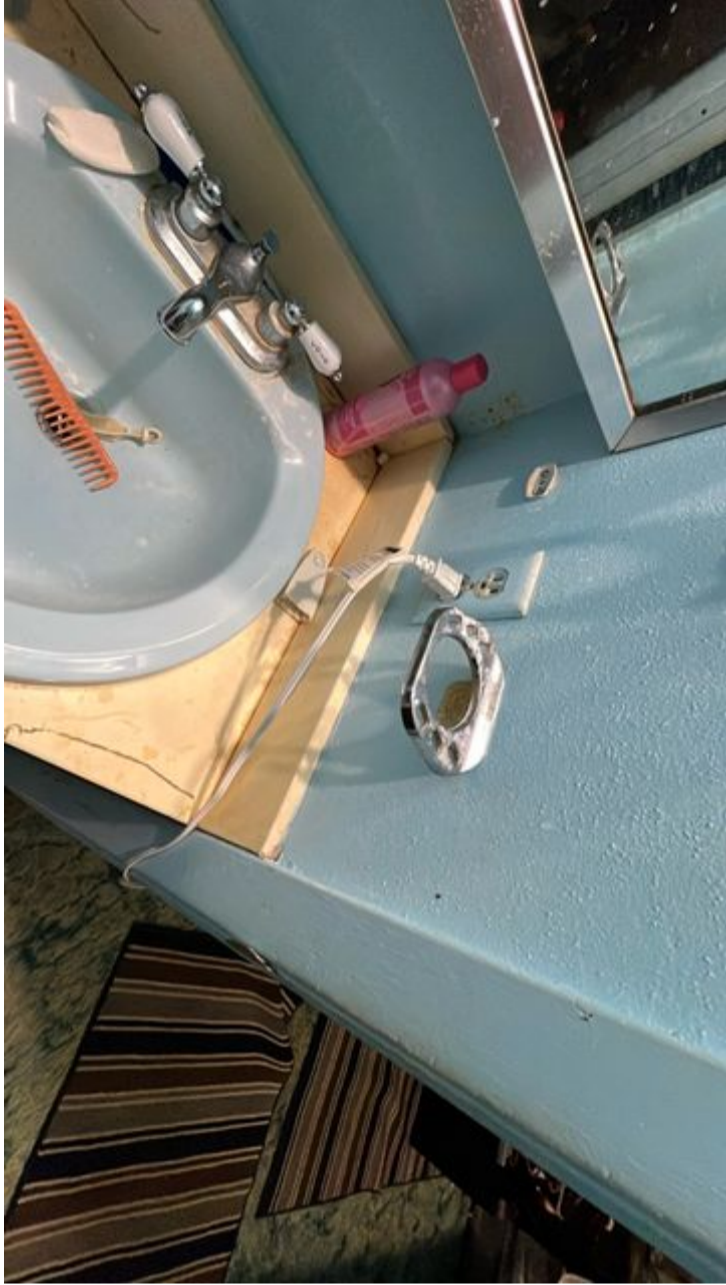
Missing GFCI

There is no GFCI (Ground-Fault Circuit Interrupter) protection. Recommend repairs or replacing by a qualified professional.

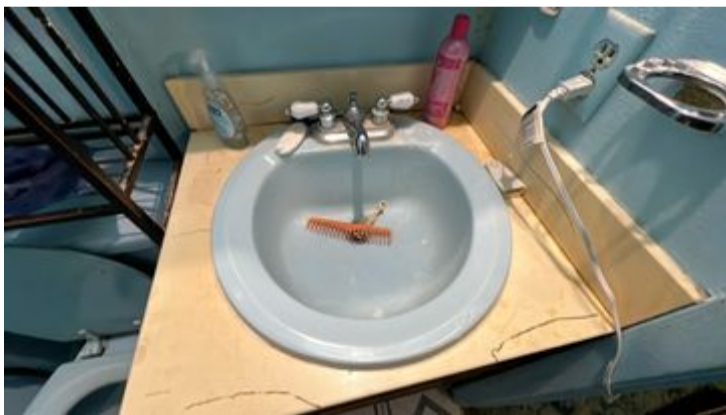
No Hot Water

There is no hot water to one or more sinks. Recommend further evaluation by a qualified professional.

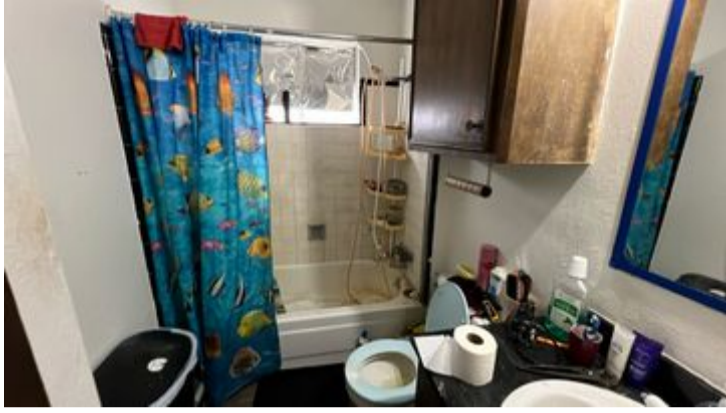
Plumbing

No hot water to tub Recommend repairs or replacing by a qualified professional.

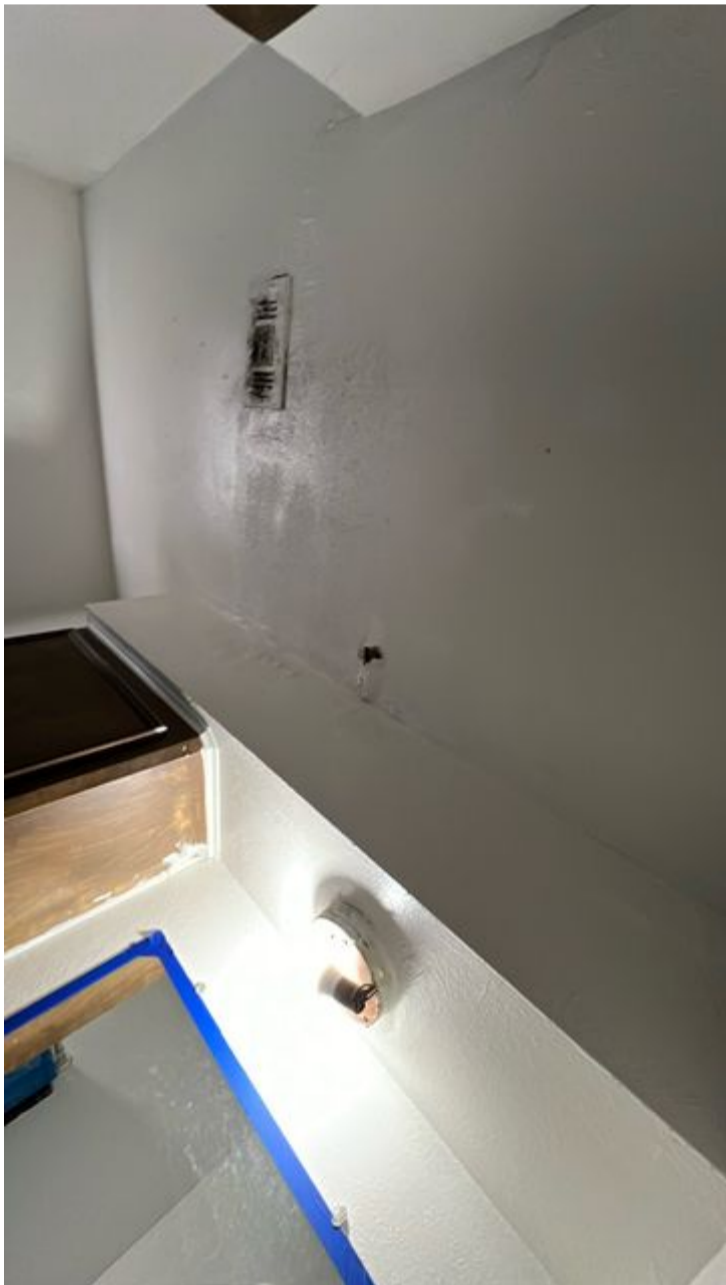
Water Stained Ceiling

The ceiling has one or more moisture stains. Recommend further evaluation by a qualified professional.

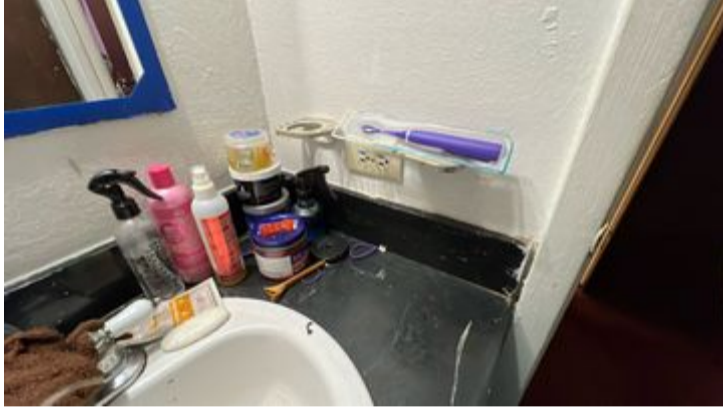
Missing GFCI

There is no GFCI (Ground-Fault Circuit Interrupter) protection.

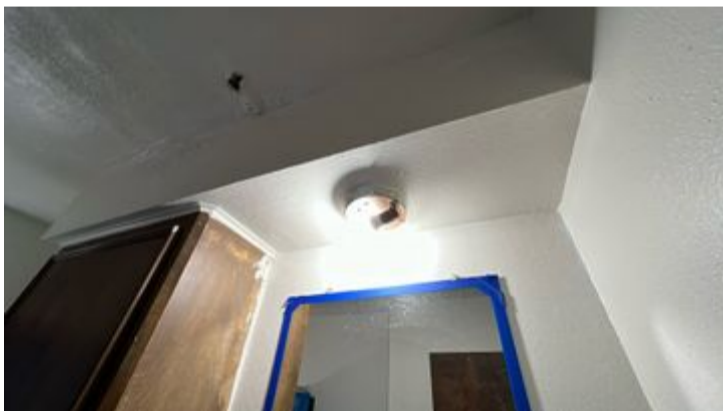
Missing Light Cover

One or more light fixtures have exposed bulbs. Recommend repairs or replacing by a qualified professional.

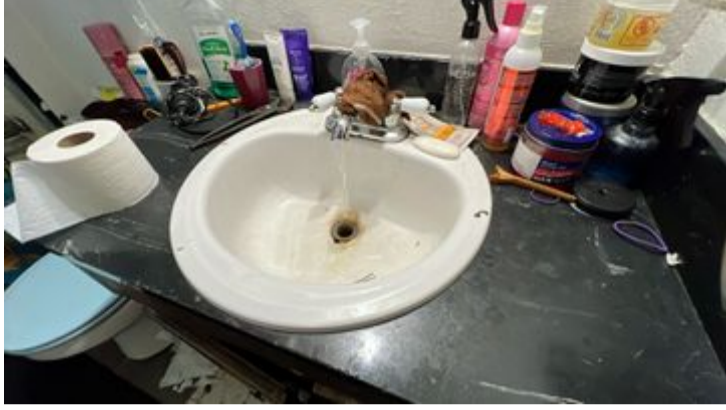
Damaged / Missing Faucet Aerator

The faucet aerator is damaged or missing. Recommend repairs or replacing by a qualified professional.

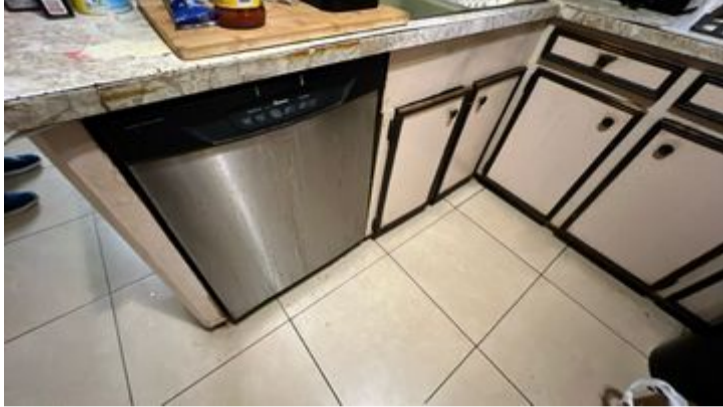
Inoperable Dishwasher

The dishwasher is not working / there is no power to the dishwasher. Recommend repairs or replacing by a qualified professional.
