Move-in Report

Prepared for Emerson Property Management

2/27/2024

7809 Glass St #7809

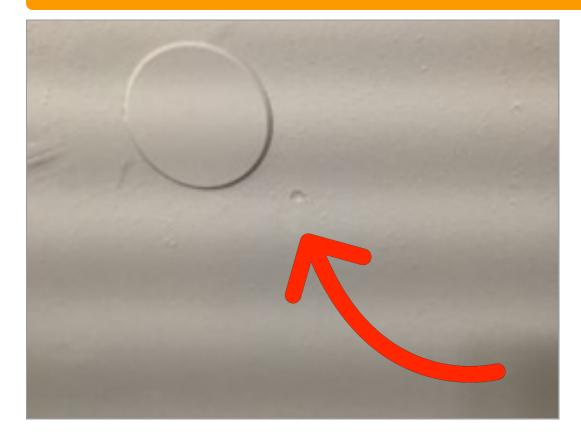
Bathroom 1 Walls/Paint Holes in wall.

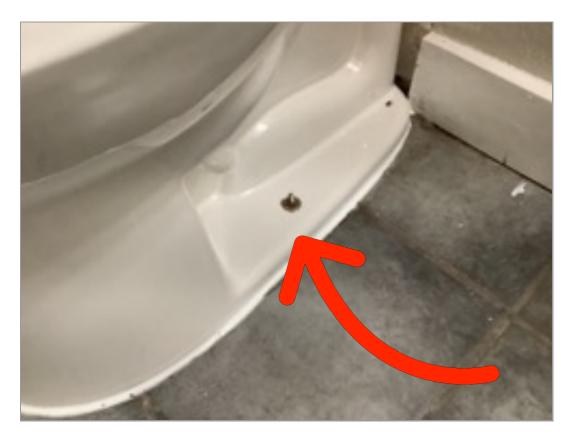
Bathroom 1 Commode Bolt caps missing

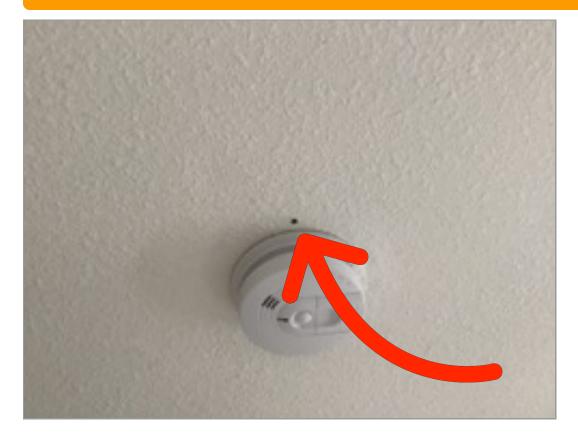
Bedroom 1 Ceiling Holes

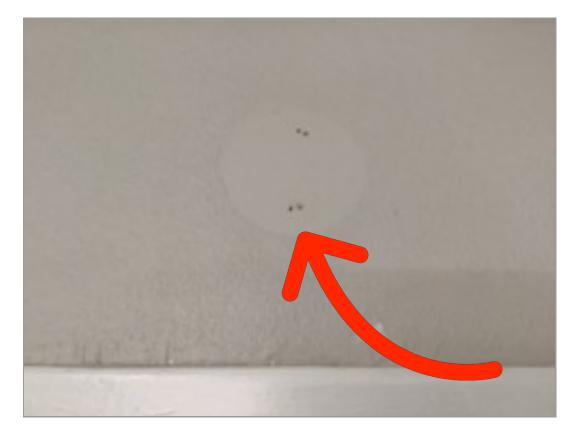
Bedroom 1 Walls/Paint Holes in wall.

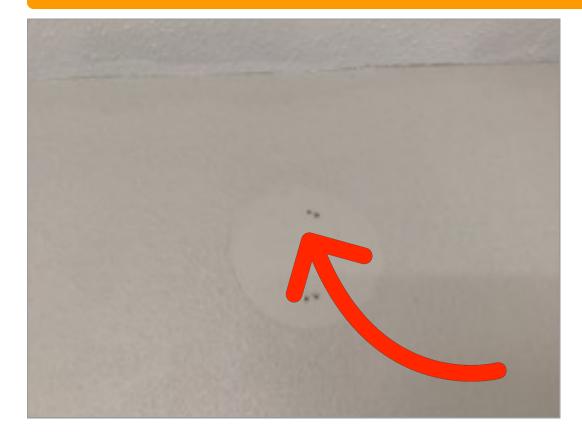
Bedroom 1 Walls/Paint Holes in wall.

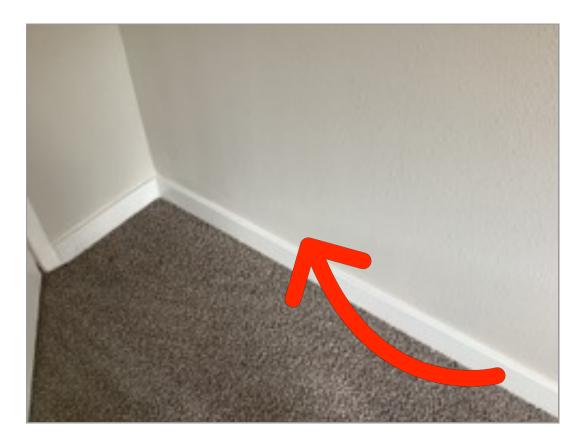
Bedroom 1 Door Stop Missing- no wall damage noted.

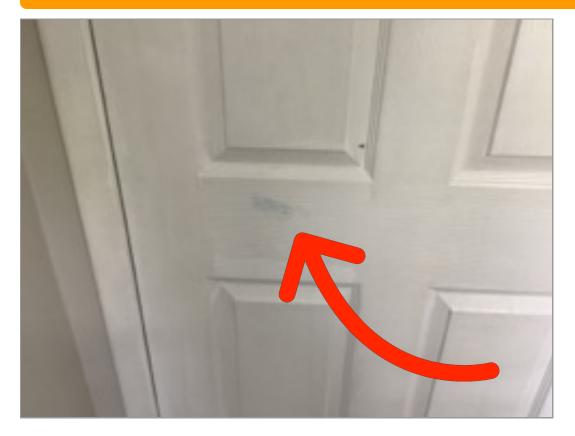
Bedroom 2 Door Discolored

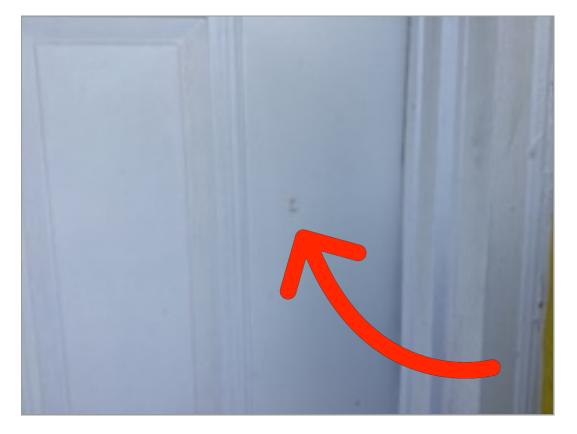
EntryFront Door Exterior Scratches; stains; discoloration or chipping of door casing

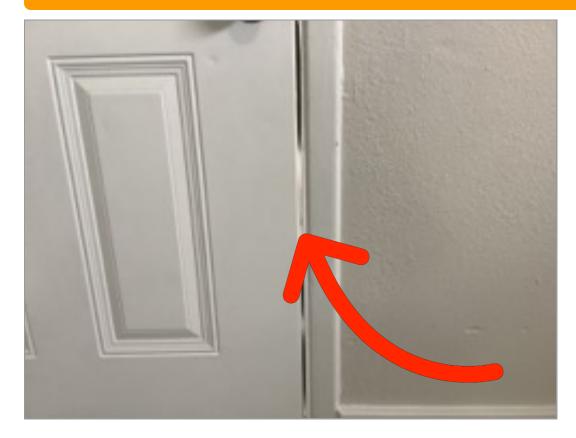
EntryFront Door Interior
Gaps in weather
stripping

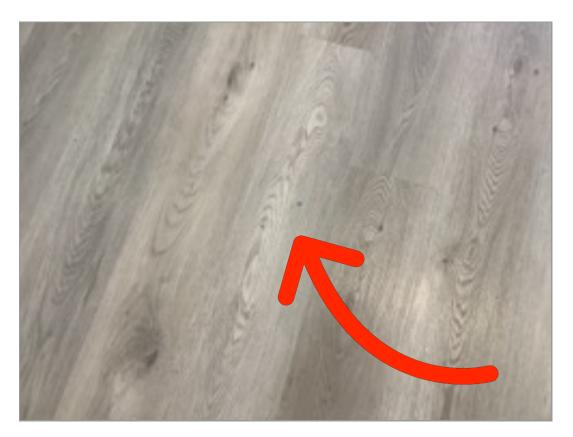
Entry Floors Flooring is stained.

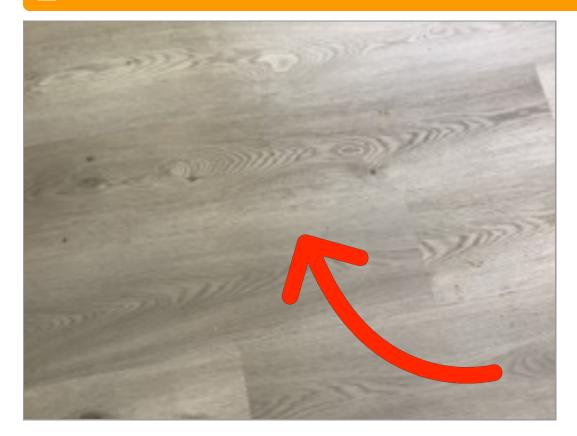
Entry Floors Flooring is scratched.

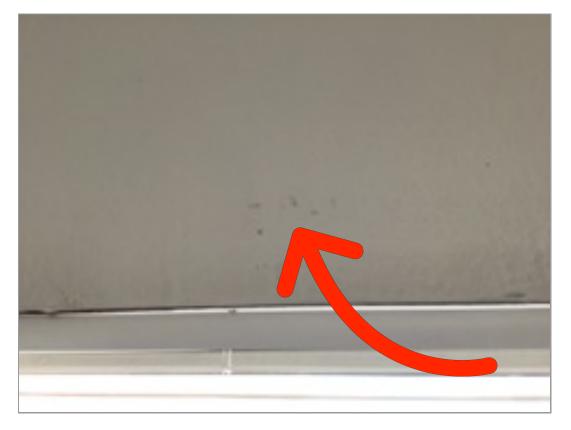
Entry Walls/Paint Scratches on the wall

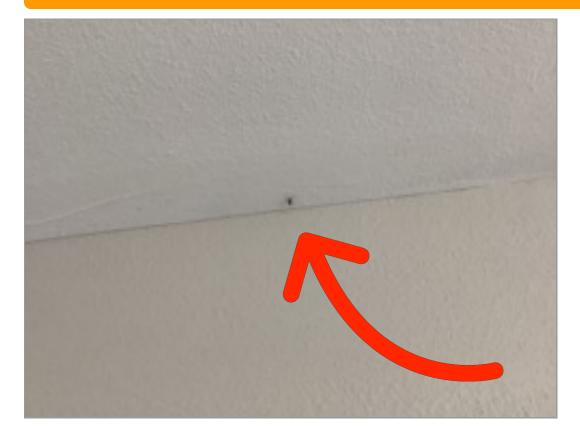
Entry Other Insects coming through entry door

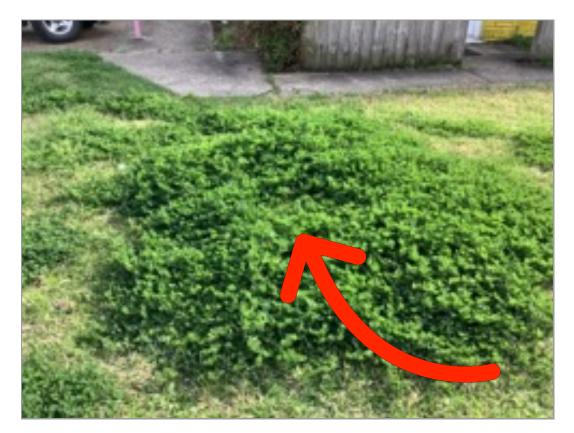
Front Exterior Left Side Yard Overgrown

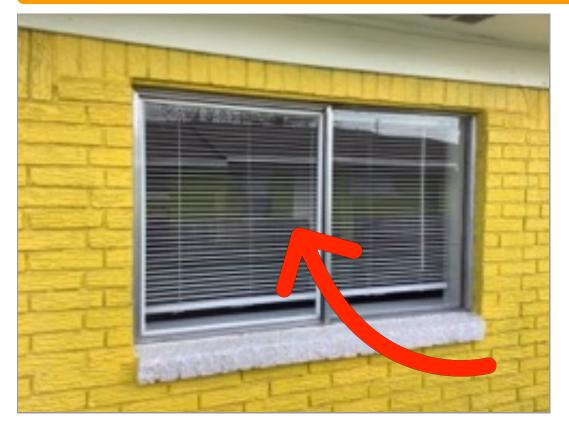
Front Exterior Window Screens Screen(s) are missing

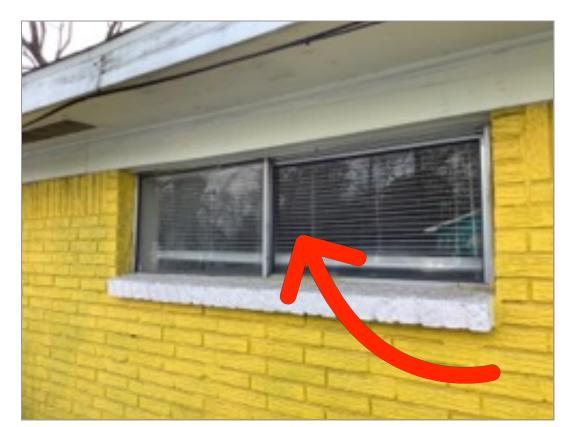
Front Exterior Window Screens Screen(s) are missing

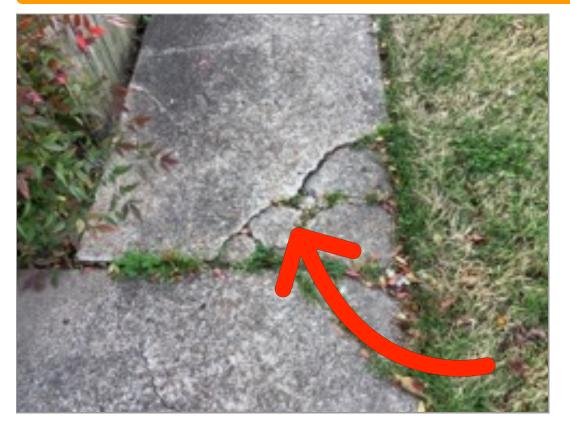
Front Exterior Walkways
Cracked or uneven

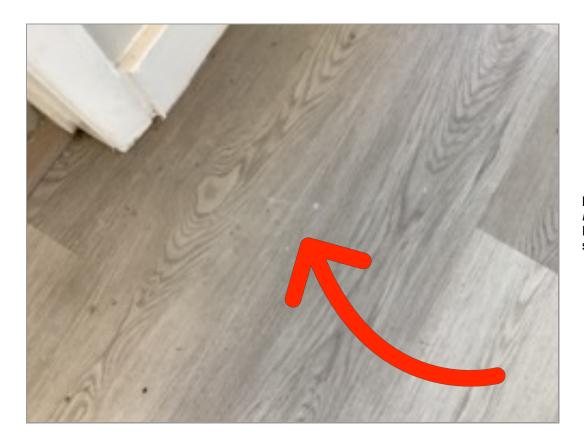
Hallway/Stairway Floors Flooring is scratched.

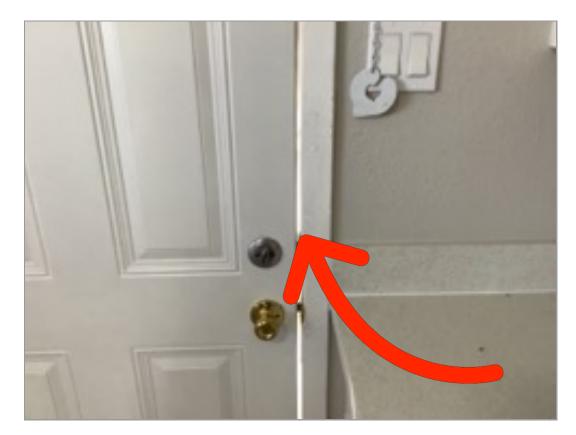
Kitchen Exterior Door Gaps in weather stripping

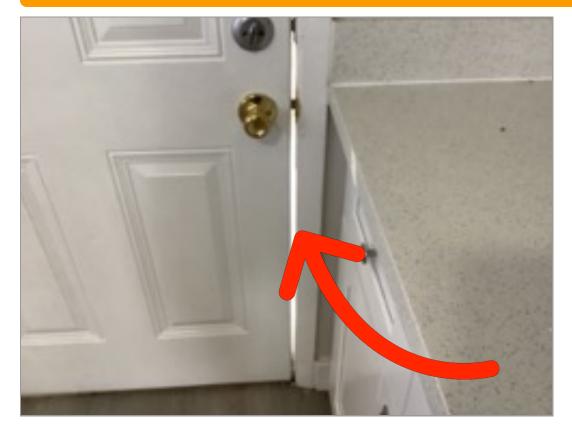
Kitchen Exterior Door Gaps in weather stripping

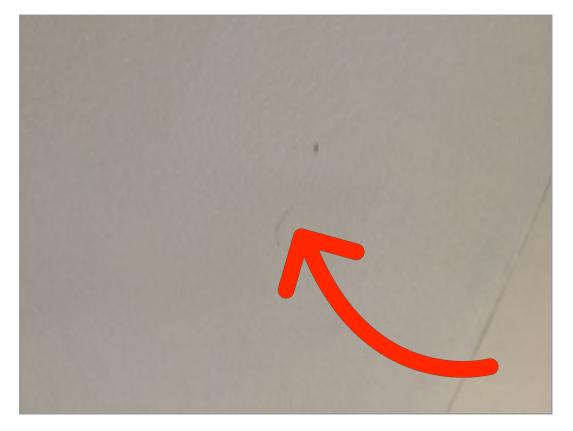
Kitchen Ceiling
The ceiling is discolored.

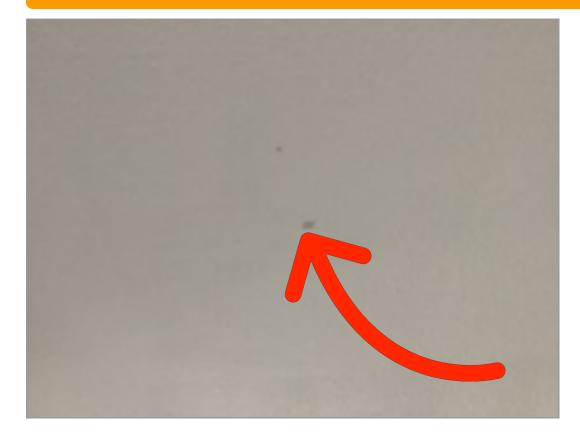
Kitchen Ceiling
The ceiling is discolored.

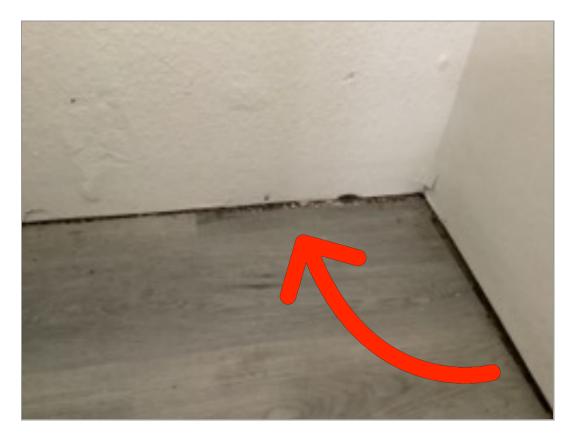
Laundry Room *Floors* Gap in flooring.

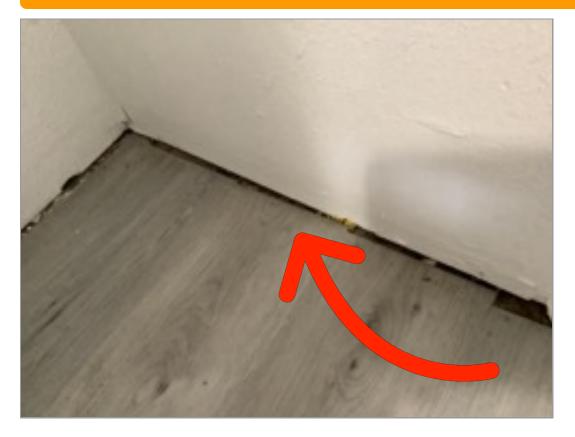
Laundry Room *Floors* Gap in flooring.

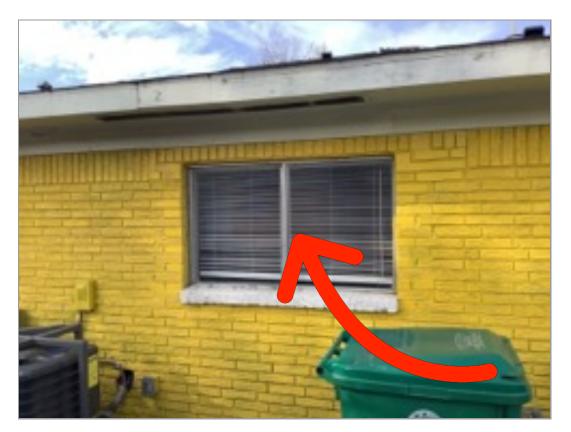
Rear Exterior Window Screens Screen(s) are missing

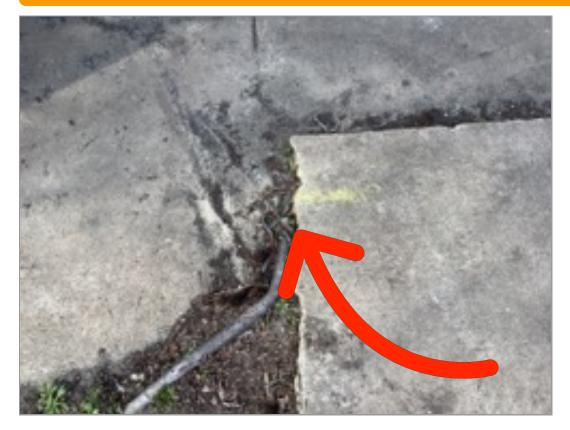
Rear Exterior Porch/Patio/Deck Cracked concrete

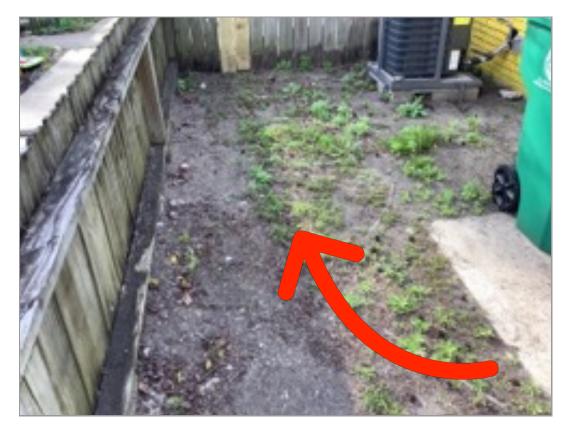
Rear Exterior Yard Patches/dead spots in the grass

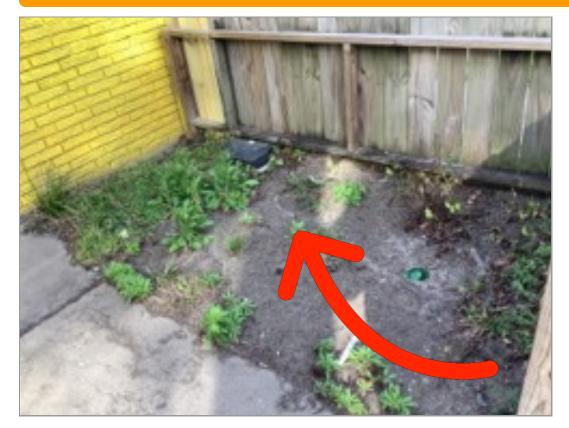
Rear Exterior Yard Patches/dead spots in the grass

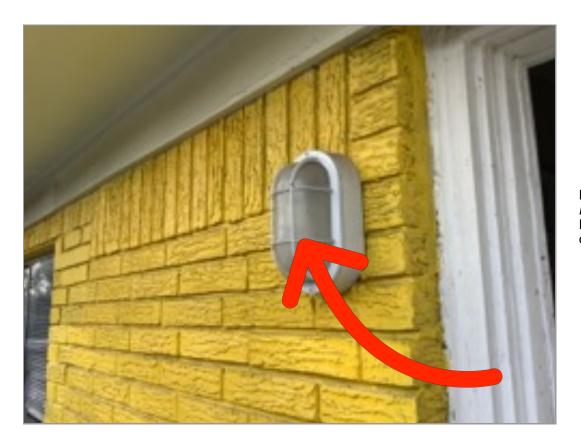
Rear Exterior Light Fixtures Light did not turn

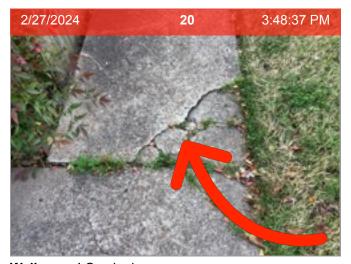
Walkways | Cracked or uneven

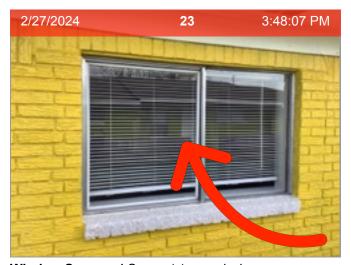
Window Screens | Screen(s) are missing

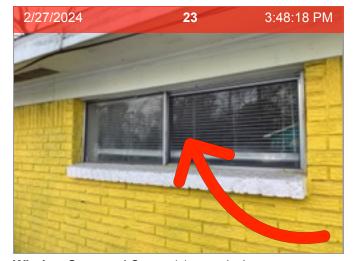
Window Screens | Screen(s) are missing

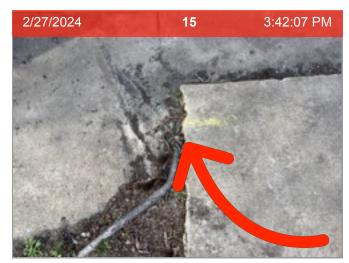
Porch/Patio/Deck | Cracked concrete

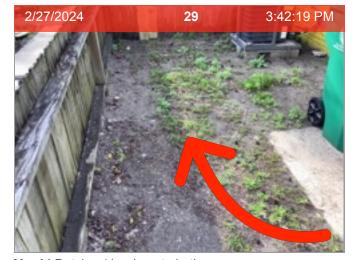
Yard | Patches/dead spots in the grass

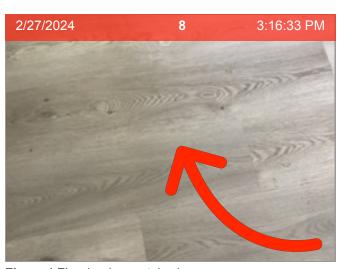
Floors | Flooring is stained.

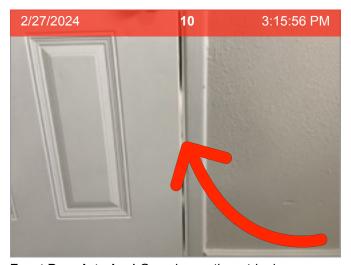
Front Door Interior | Gaps in weather stripping

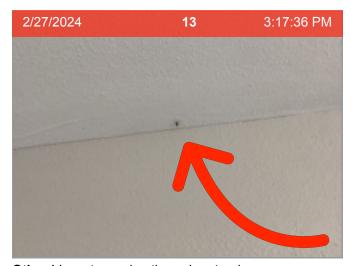
Other | Insects coming through entry door

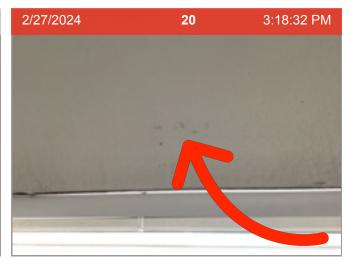
Walls/Paint | Scratches on the wall

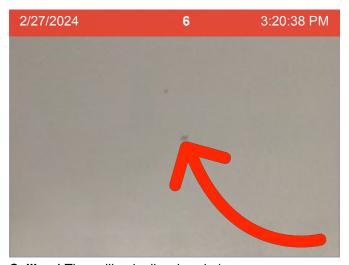
Ceiling | The ceiling is discolored. |

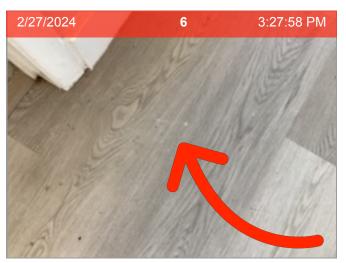
Floors | Flooring is scratched.

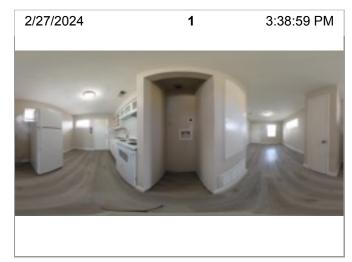
Floors | Gap in flooring. Floors | Gap in flooring.
