Prepared for Emerson Property Management

5/24/2024

7813 Glass Street #7813

Houston TX 77016

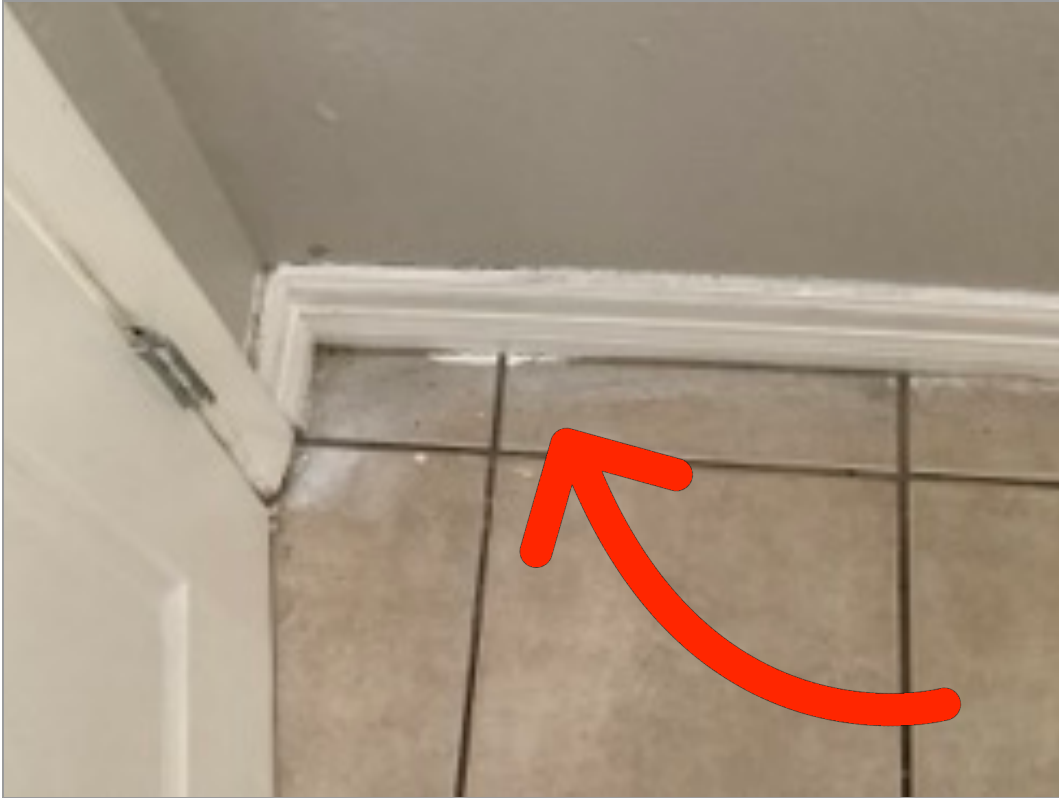
Bathroom 1
Floors
Flooring is stained.

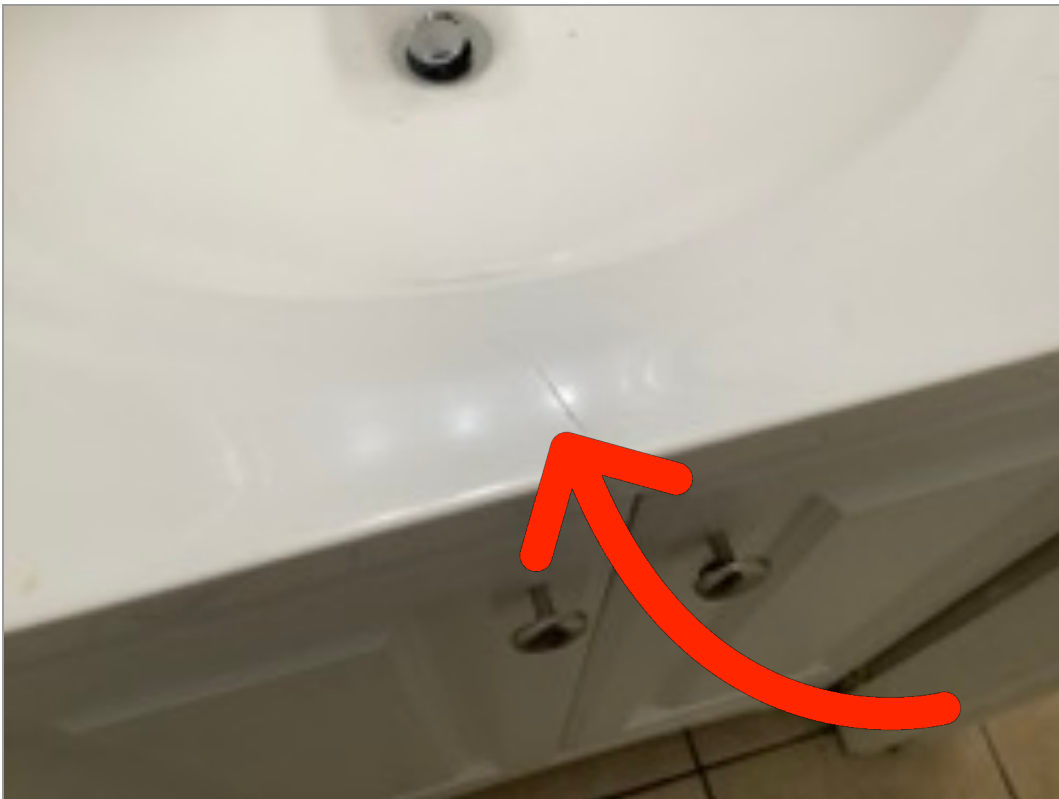
Bathroom 1
Sink/Faucet
Cracking front part of sink

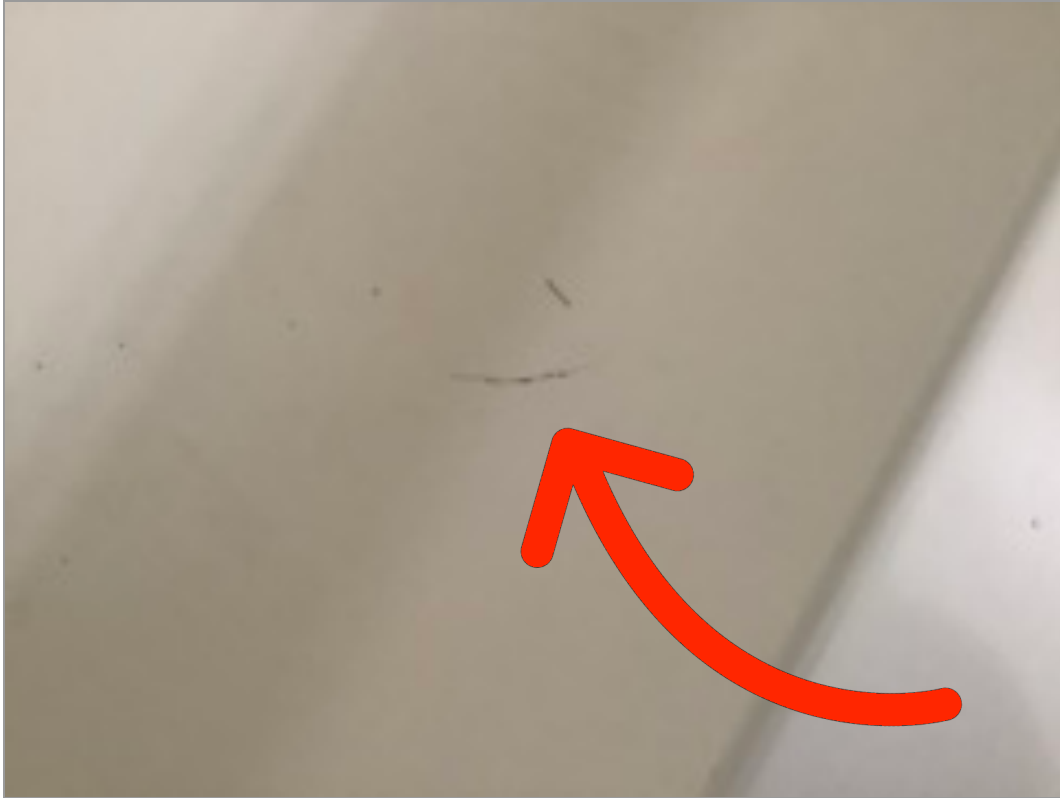
Bathroom 1
Tub/Fixture
The floor is discolored around the base of the tub.

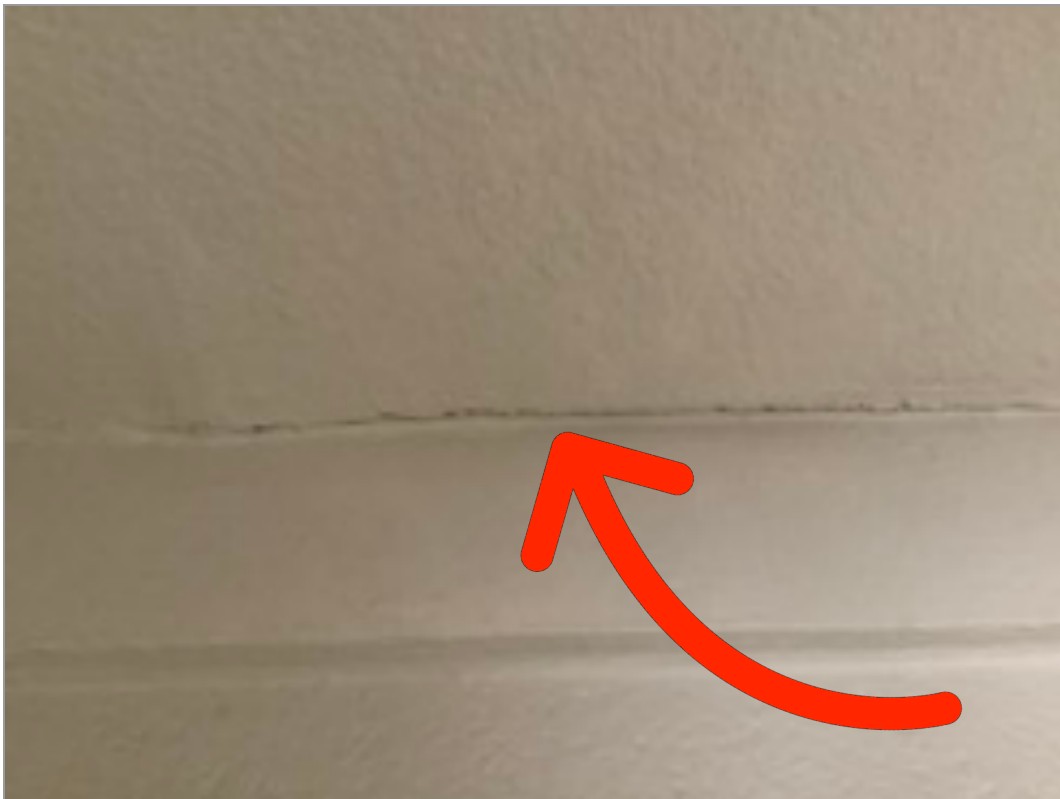
Bedroom 1
Closets
Cracks in ceiling

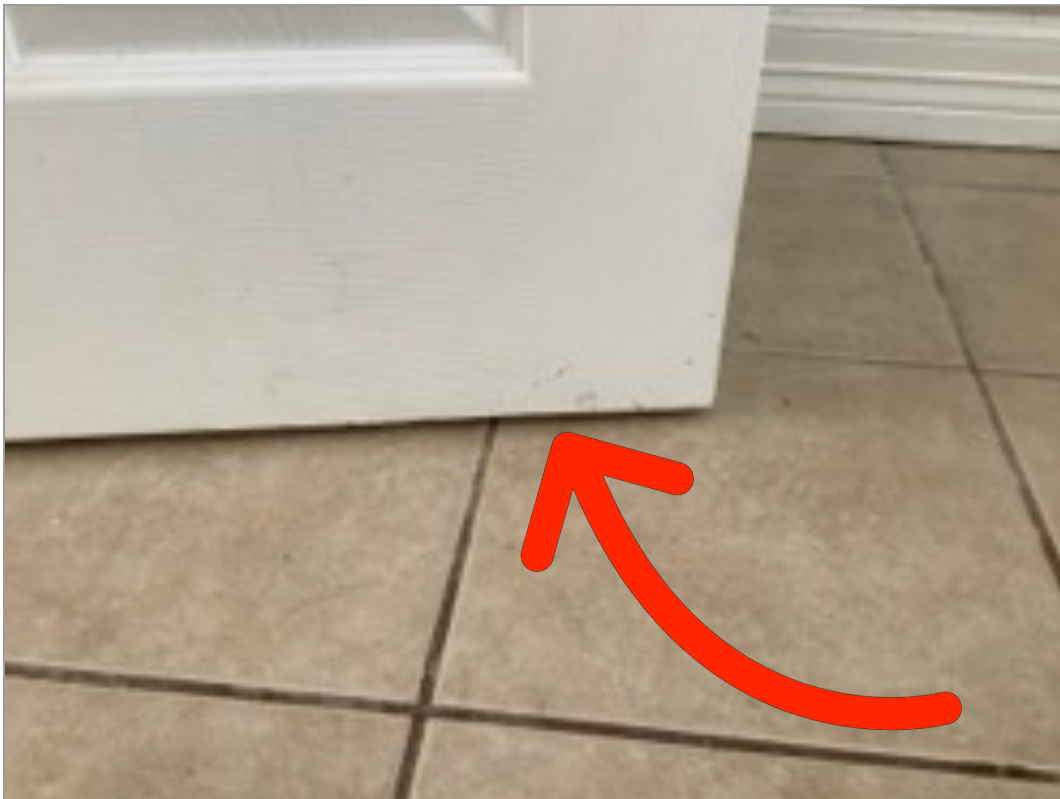
Bedroom 1
Door
Scuffs on door.

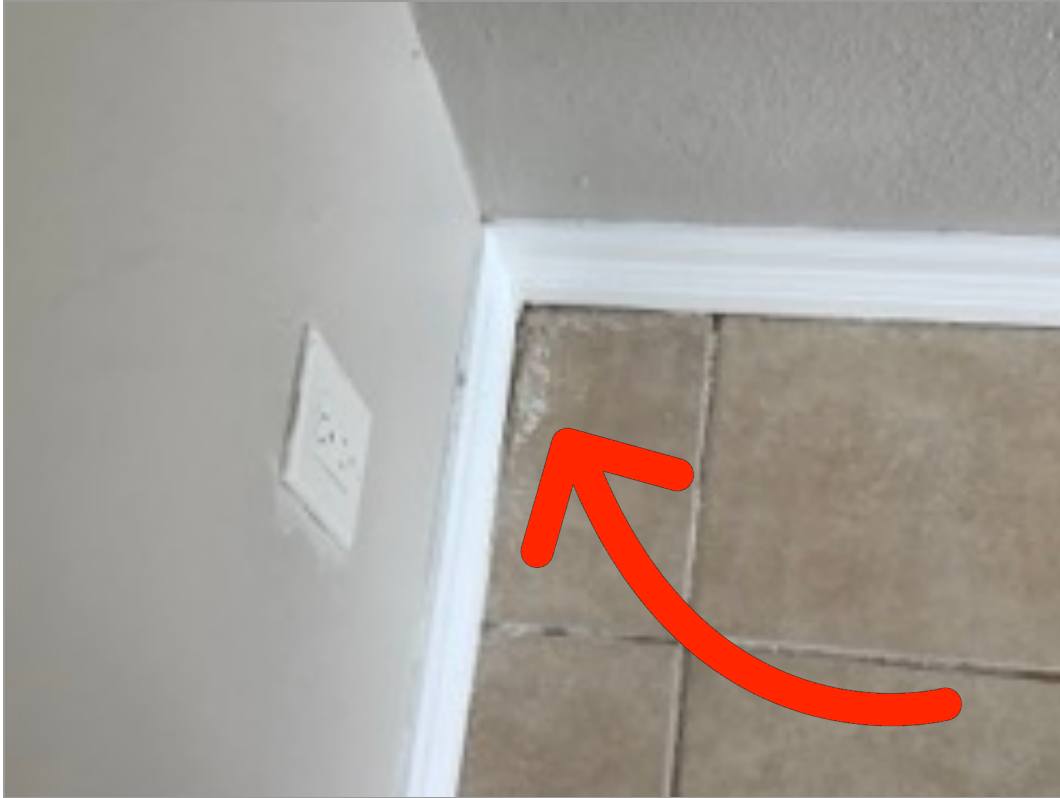
Bedroom 2
Floors
Flooring is stained.

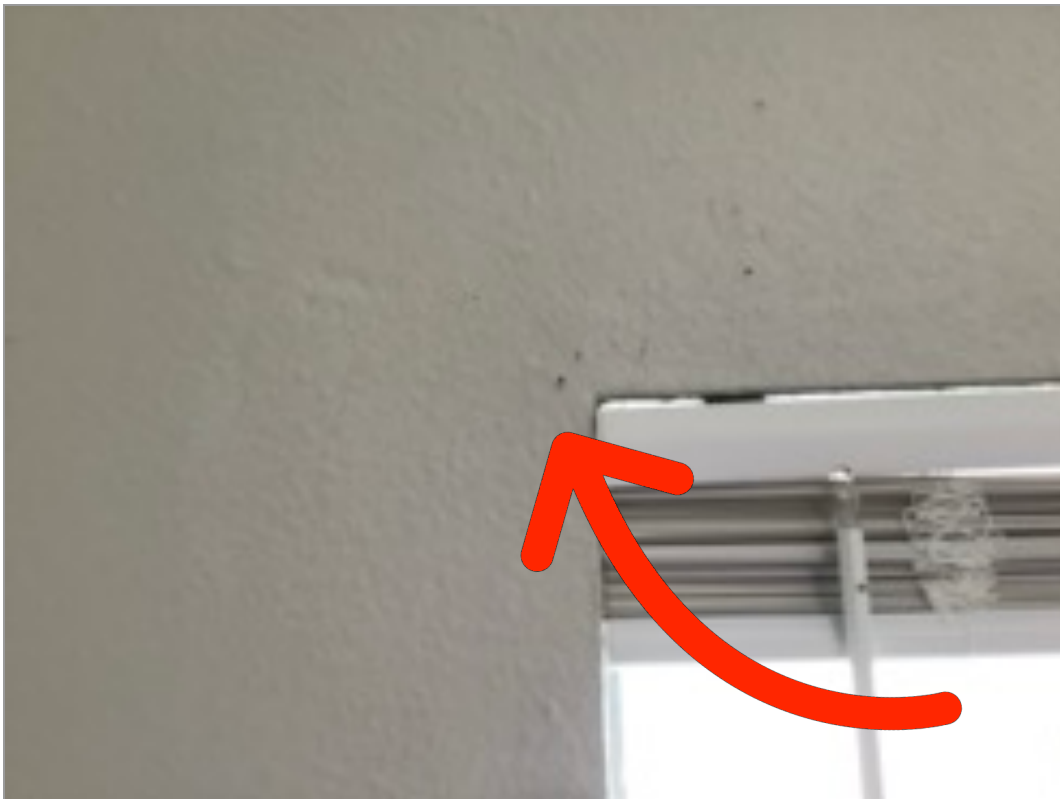
Bedroom 2
Walls/Paint
Holes in wall.

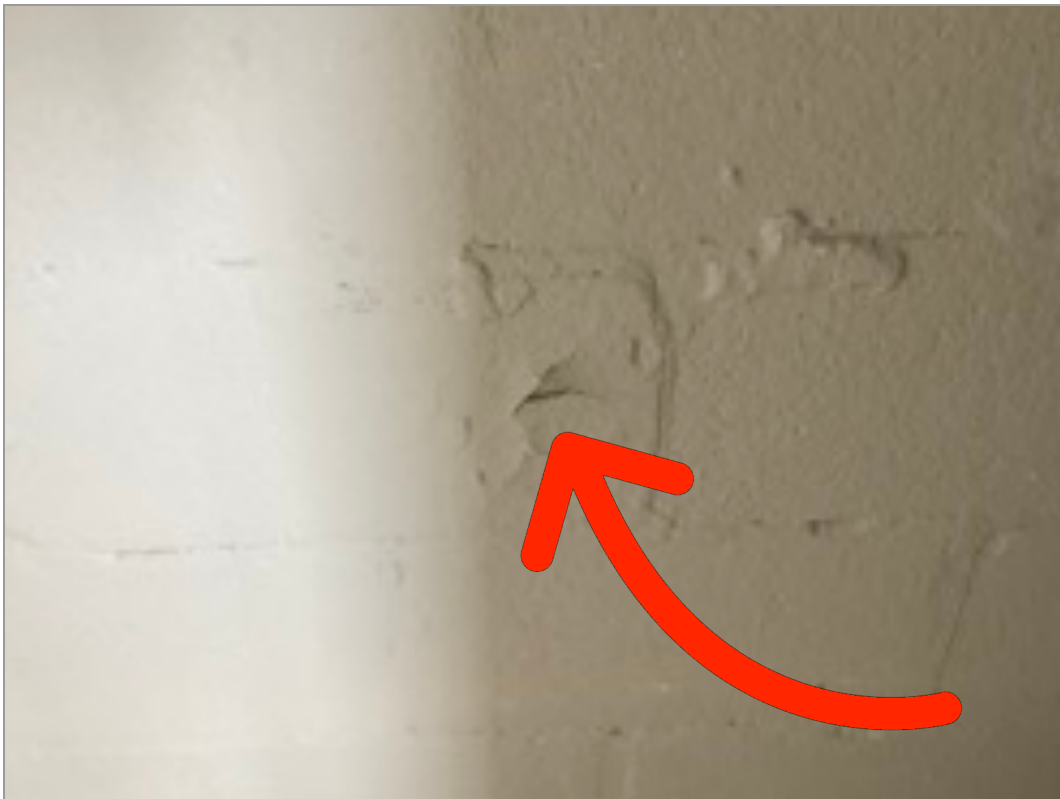
Bedroom 2
Closets
Cracks in texture

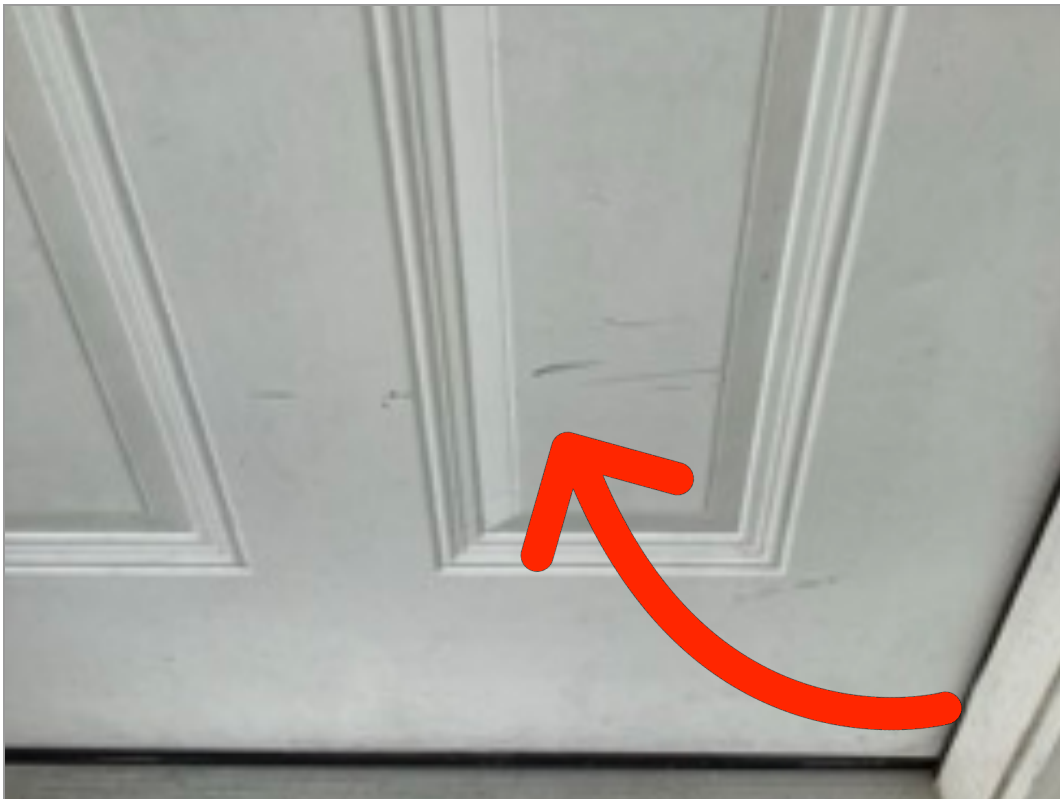
Entry
Front Door Exterior
Scratches; stains;
discoloration or
chipping of door
casing

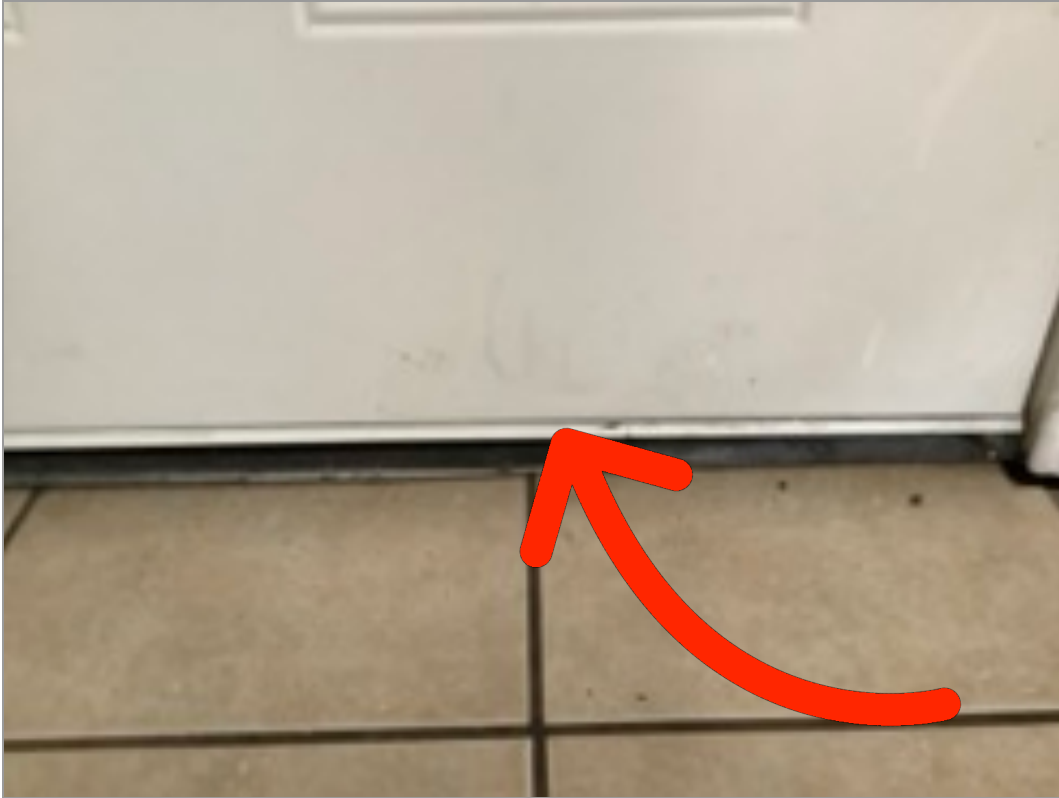
Entry
Front Door Interior
Scuffs on door

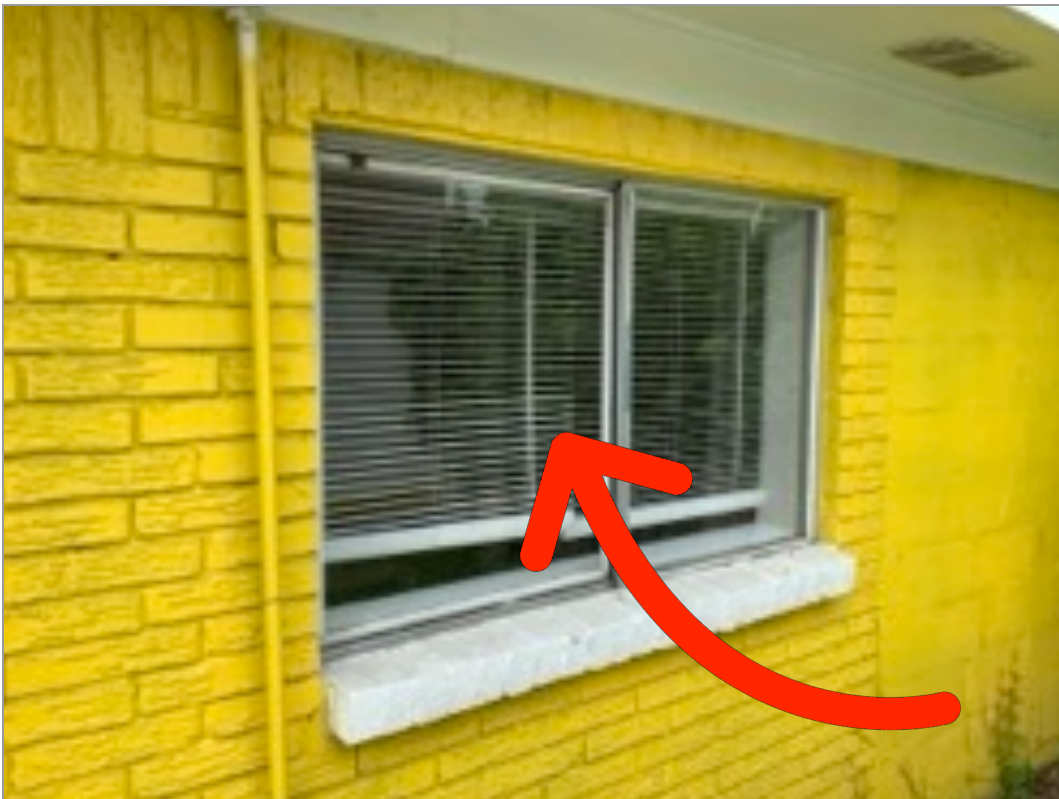
Front Exterior
Window Screens
Screen(s) are missing

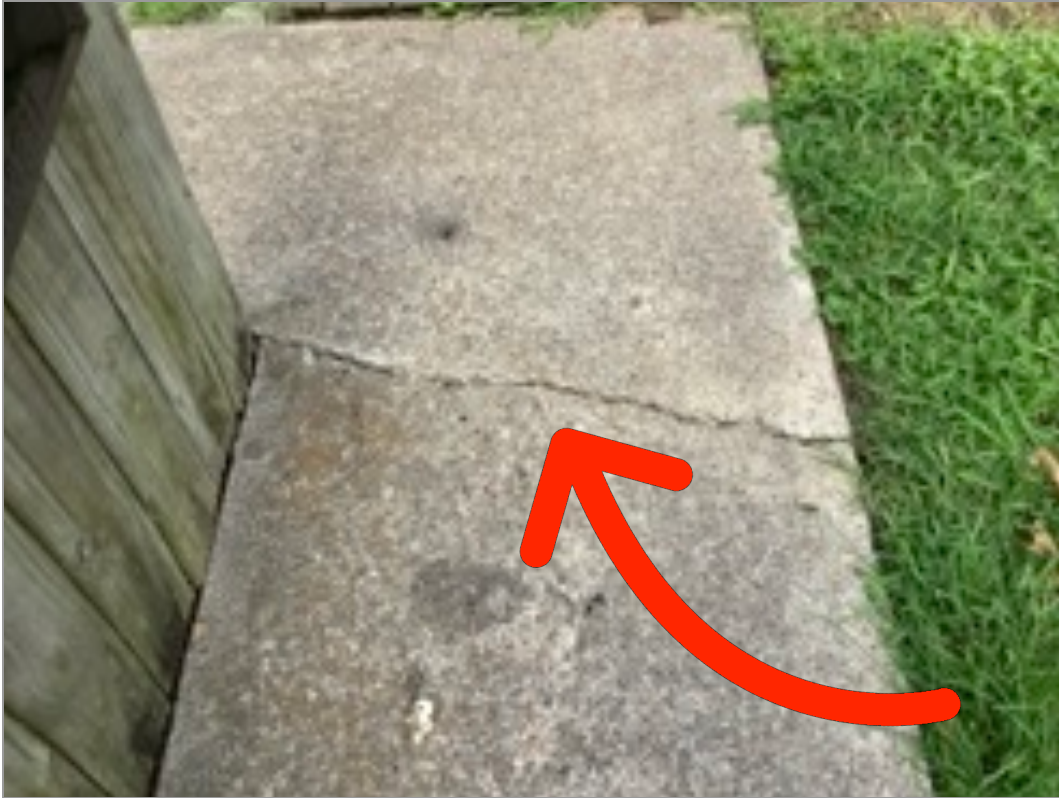
Front Exterior
Walkways
Cracked or uneven

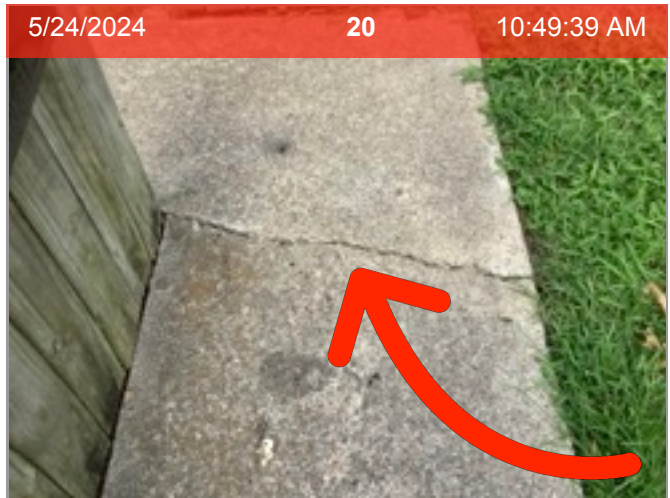
Walkways | Cracked or uneven

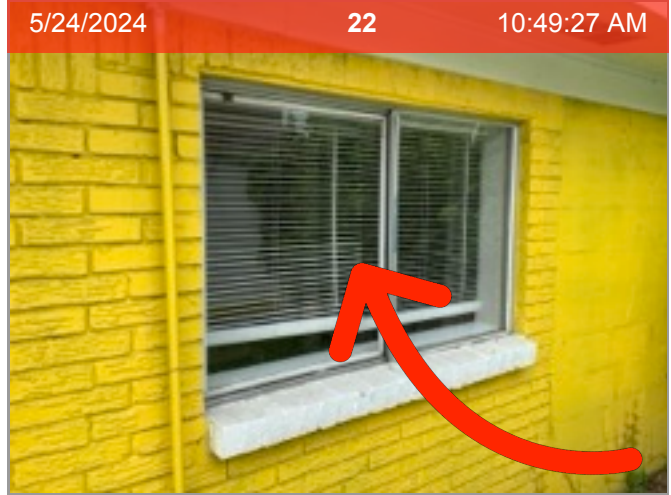
Window Screens | Screen(s) are missing

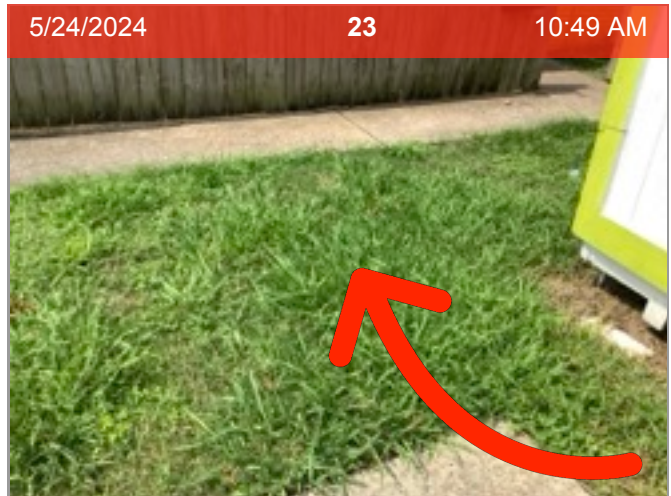
Yard | Yard is overgrown

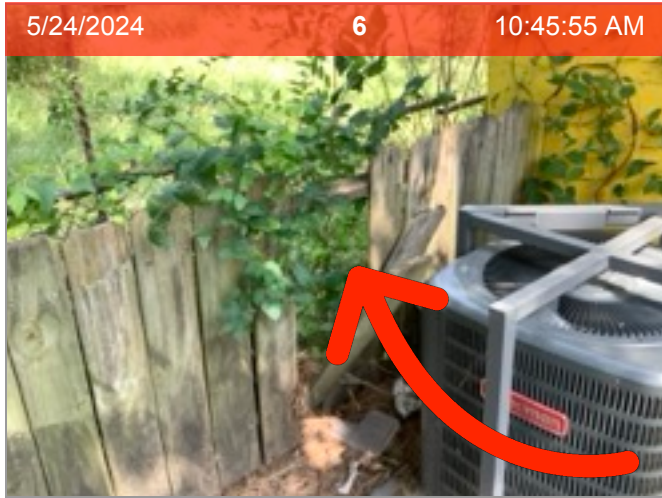
Fence | Damaged, rotten, or chipping fence materials; holes/gaps in fence; damaged clasps; gates that don't close securely

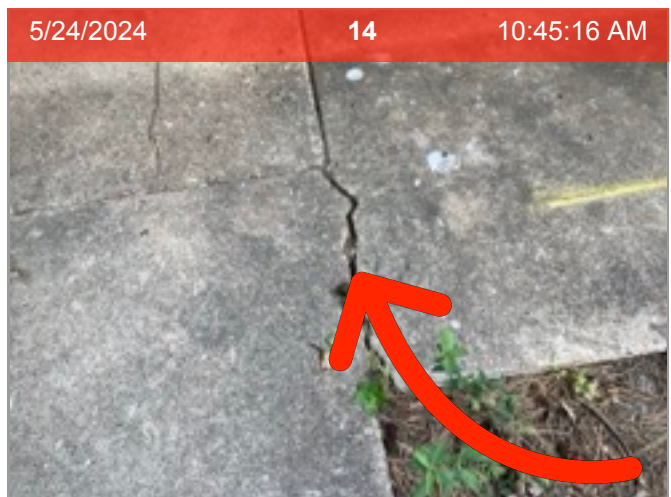
Porch/Patio/Deck | Cracked concrete

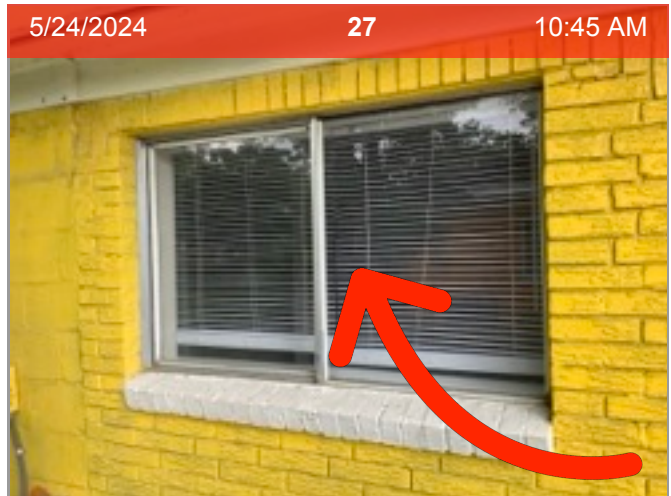
Window Screens | Screen(s) are missing

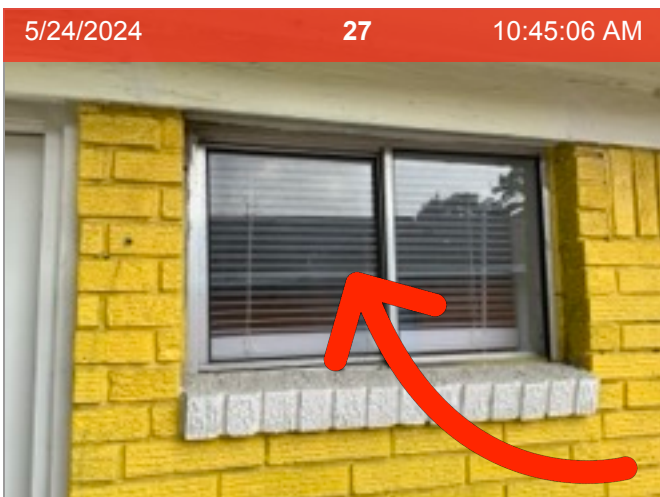
Window Screens | Screen(s) are missing

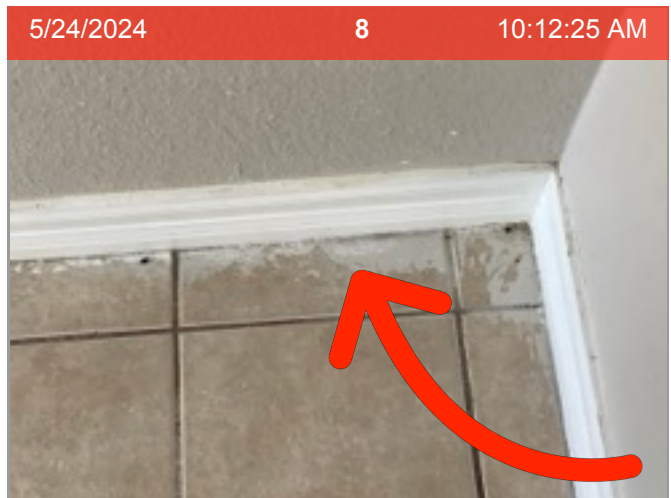
Floors | Flooring is stained.

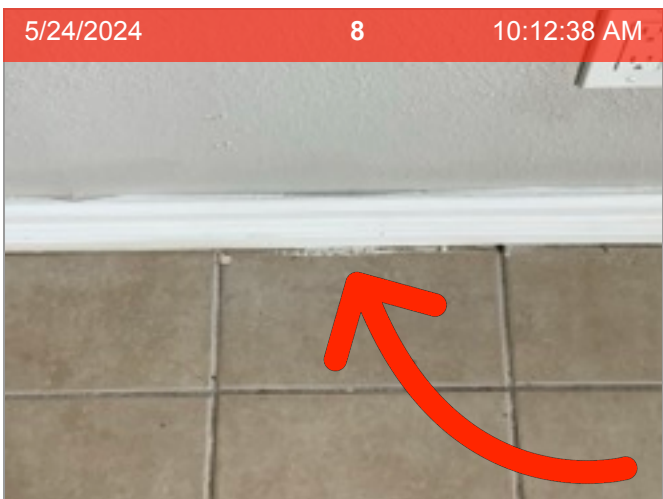
Floors | Flooring is stained.

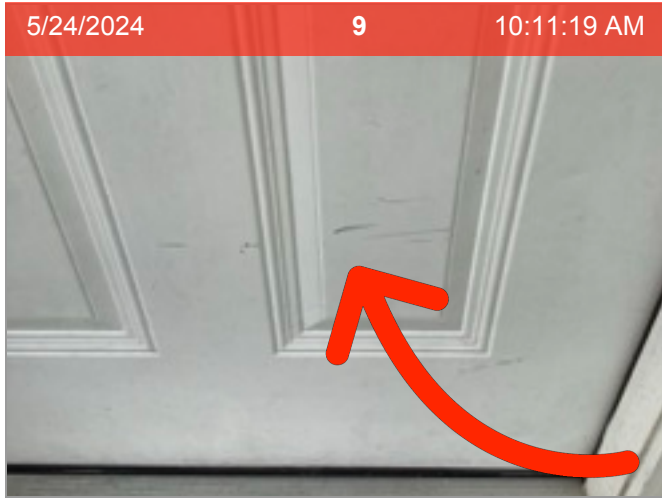
Front Door Exterior | Scratches; stains; discoloration or chipping of door casing

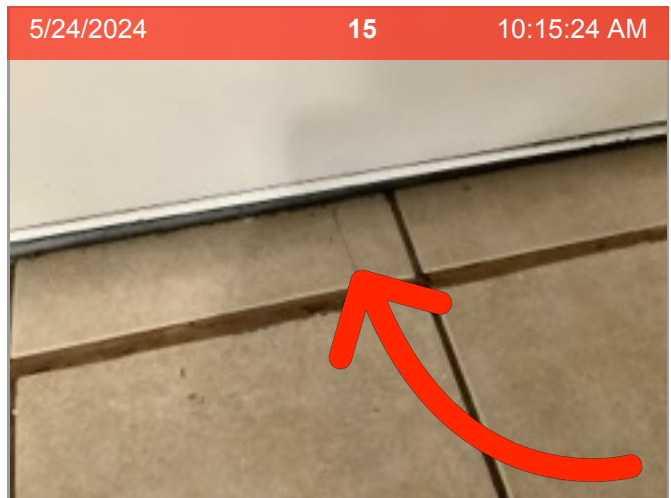
Floors | Crack in flooring.

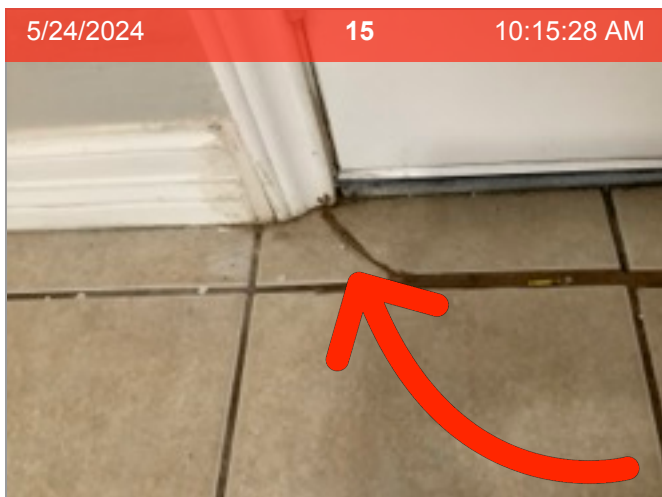
Floors | Crack in flooring.

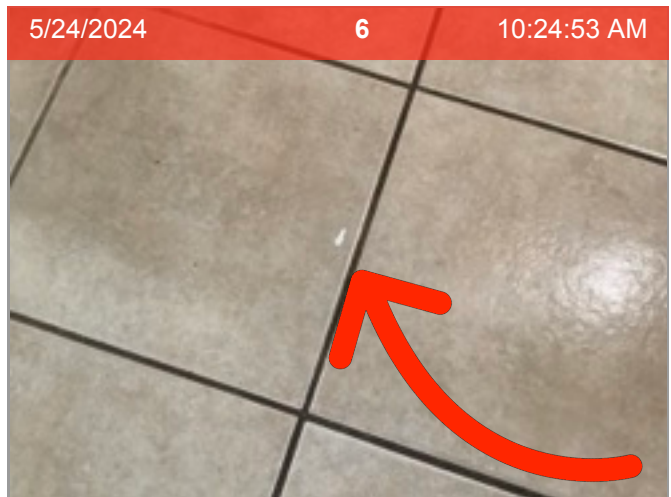
Floors | Flooring is stained.

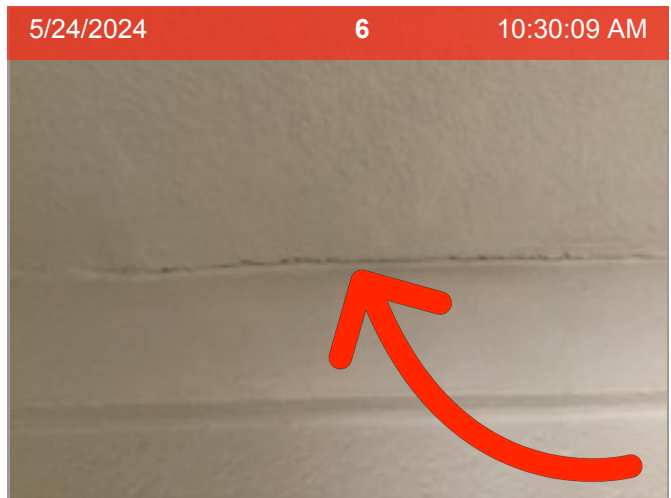
Closets | Cracks in ceiling

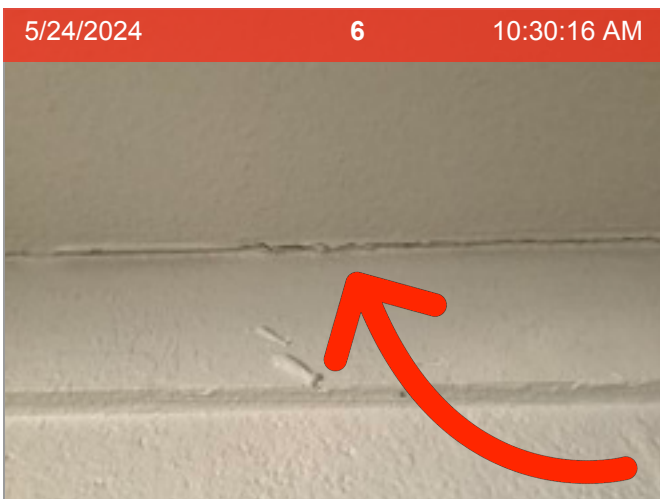
Closets | Cracks in ceiling

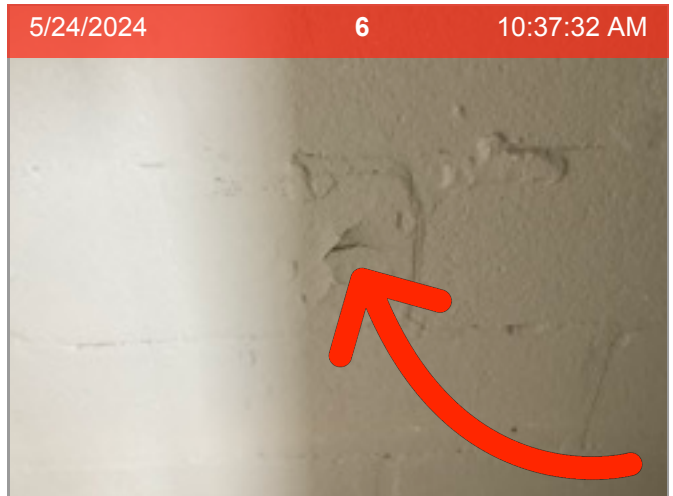
Closets | Cracks in texture

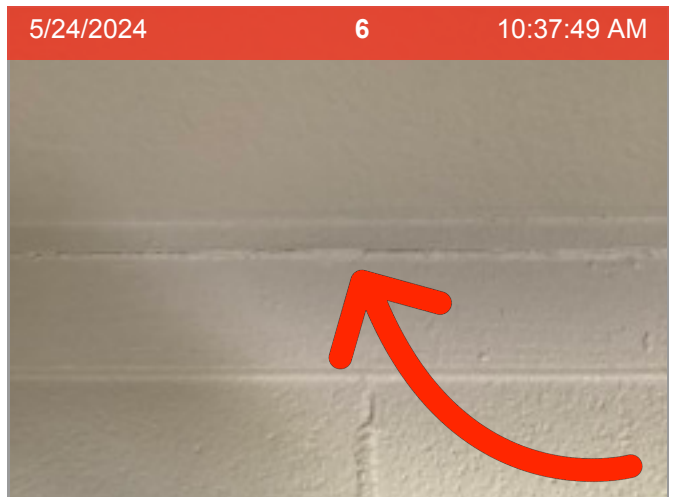
Closets | Cracks in texture

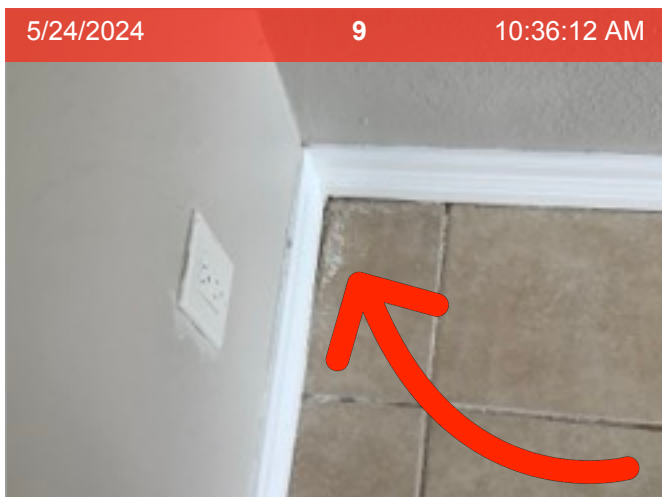
Floors | Flooring is stained.

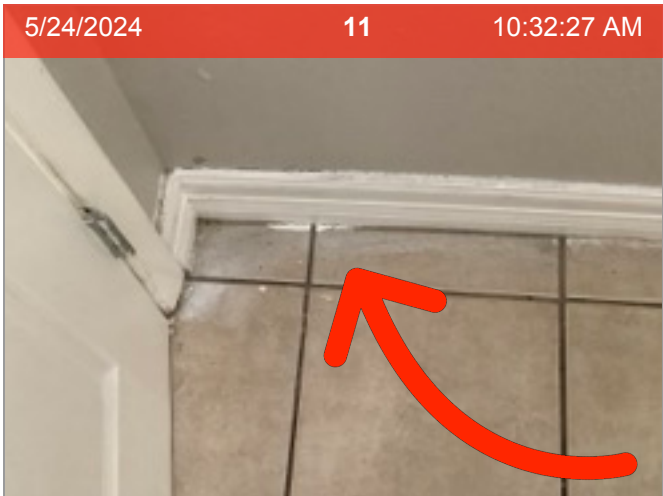
5/24/2024 11 10:32:27 AM
Floors | Flooring is stained.

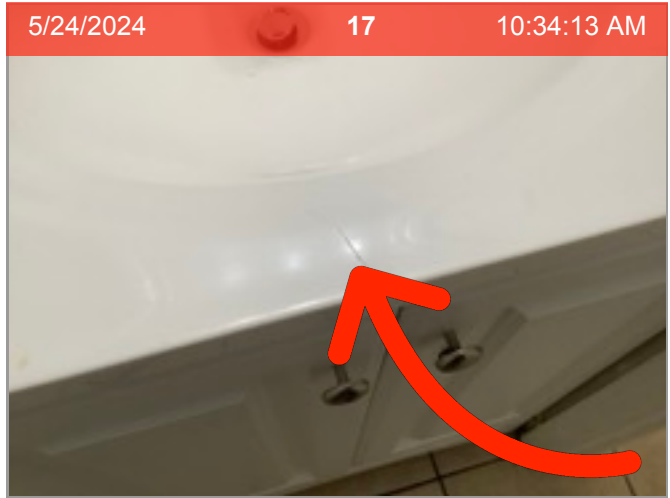
Sink/Faucet | Cracking front part of sink

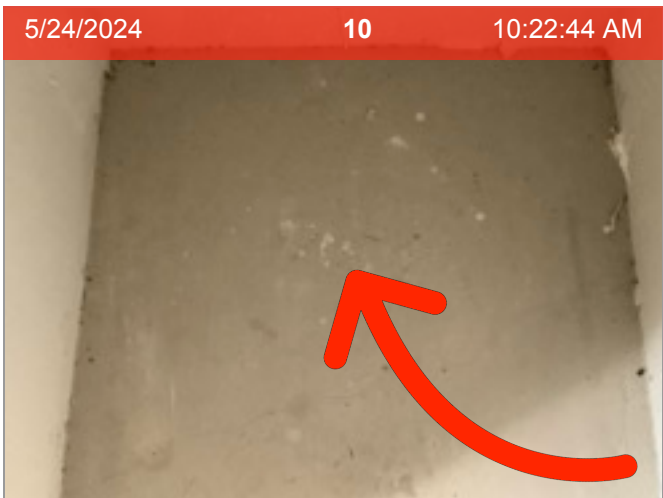
Floors | Flooring is stained.

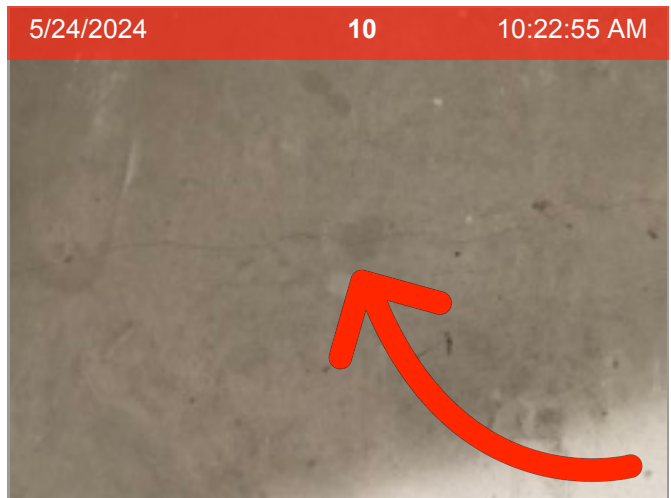
Floors | Crack in flooring.
