13007 Gulf Beach Drive, Freeport, TX 77541

ENGINEERING INSPECTION REPORT 13007 Gulf Beach, Freeport

On 29 January 2024, 13007 Gulf Beach, Freeport, TX was inspected. The purpose of the inspection was to evaluate the condition of the Foundation of the house.

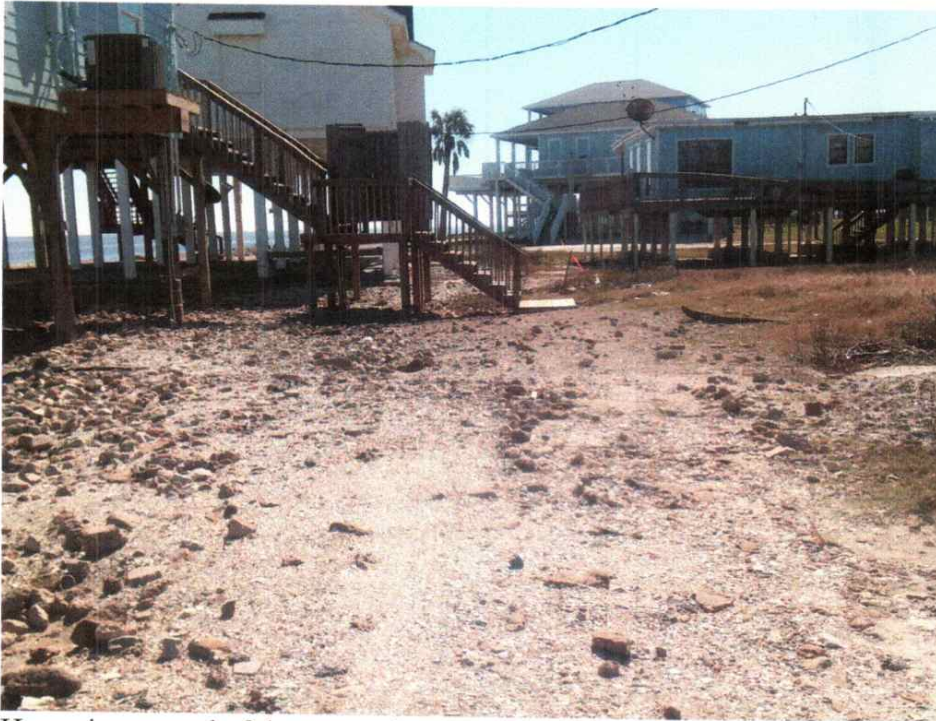
- **The house is seaward of the vegetation line**
- Unless there is a written waiver
 - The house rests on PUBLIC property -the beach
 - A General Land Office (GLO) permit to repair a house on the beach will be required.
 - GLO approvals are time consuming since the GLO has a scheduled meeting once per quarter
- **LEGAL ADVICE FROM A TEXAS BAR APPROVED LAWYER IS HIGHLY RECOMMENDED TO ADDRESS THIS ISSUE**

House is seaward of the vegetation line – this is a complicated issue

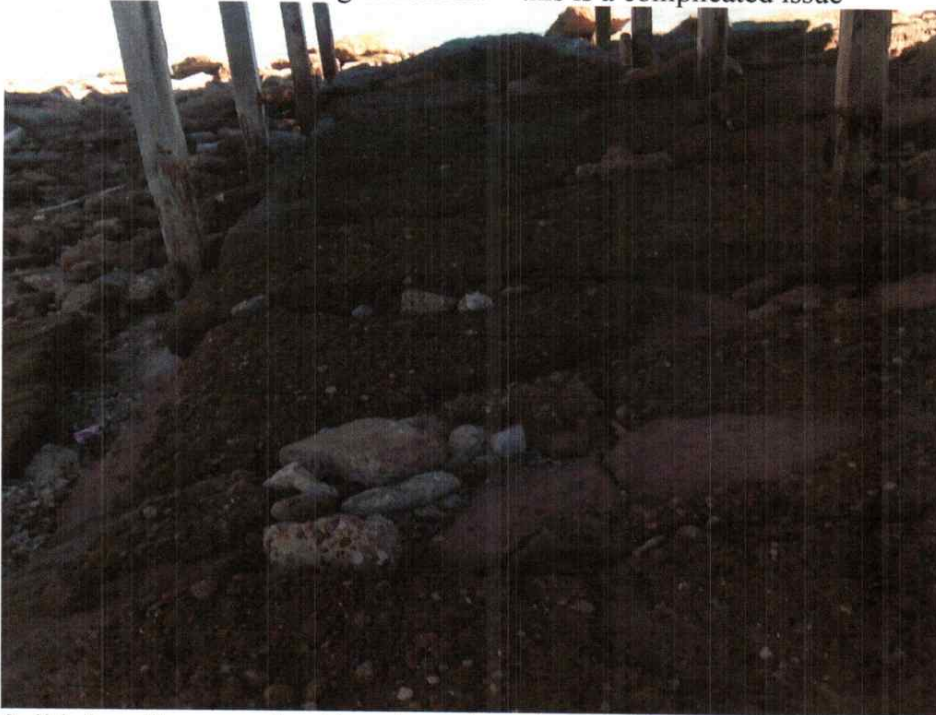
- Currently the soils supporting the foundation are in disrepair
 - The ground has been scoured
 - Surge waters from Hurricanes that landed in Beaumont (2021) moved the vegetation line landward
 - There are trenches running thru the earth and bare rock is exposed
 - The trenches are huge
 - Trenches run the entire length of the house (N-S)
 - The existing grade consists of bare rock
 - Repairs may require use of a bulkhead

Soil is heavily scoured – this reduces lateral support capacity

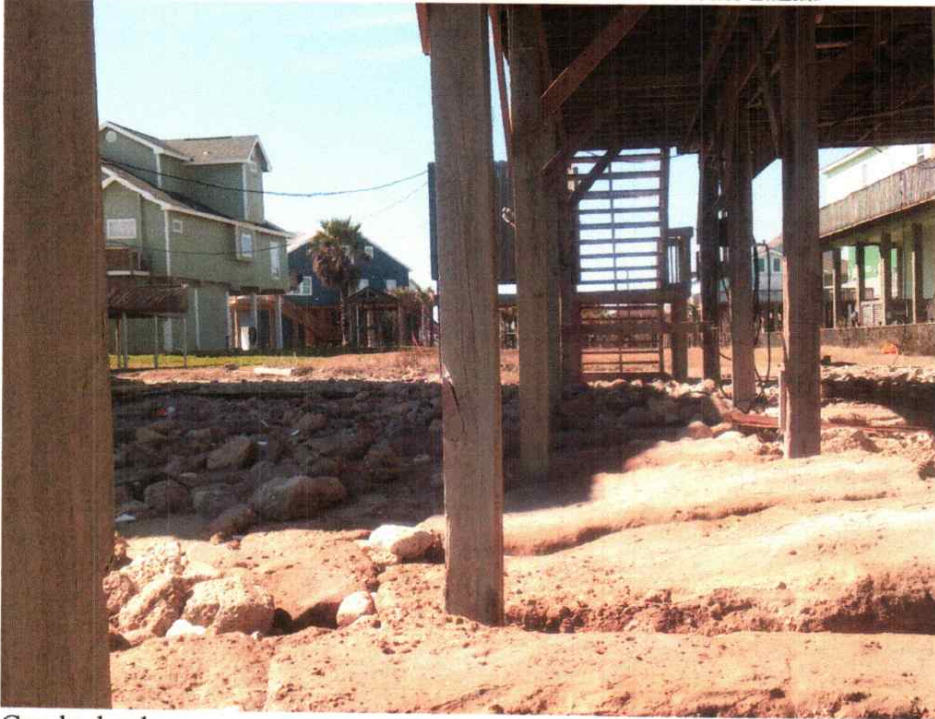
Cracked column

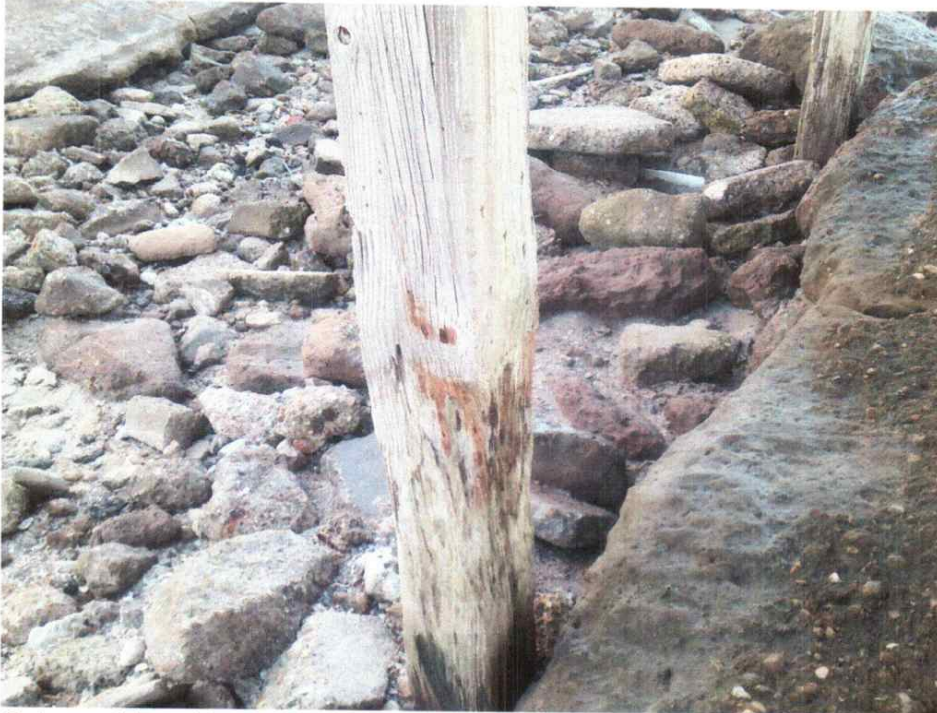
- Structure
 - Columns
 - Nominal 8 X 8
 - Scouring from tides has thinned the columns and created areas of water damage
 - Columns are not viable
 - Repairs, if permitted, will require some sort of water protection
 - Fiberglass sleeves
 - Concrete
 - New columns will need to be a minimum of 10 X 10
 - Stringers
 - Single 2 X12 stringer
 - One is broken due to overload
 - New stringer pattern will need to be designed
 - Attachment hardware
 - Bolts are severely rusted and not viable
 - Clips/hangers will need to be added
 - Joists
 - Will require metal clips and/or hanger
 - Lack overlap
 - Joints do not have sufficient overlap to be viable
 - Nails are rusted and not viable
 - Undocumented repairs
 - Braces have been added to joists and stringers
 - Bracing coincides with excessive deflections in the floor
 - Bracing scheme is ad hoc

Column thinned by scouring, note deteriorated wood – all columns are severely Deteriorated due to aging in the salt water environment

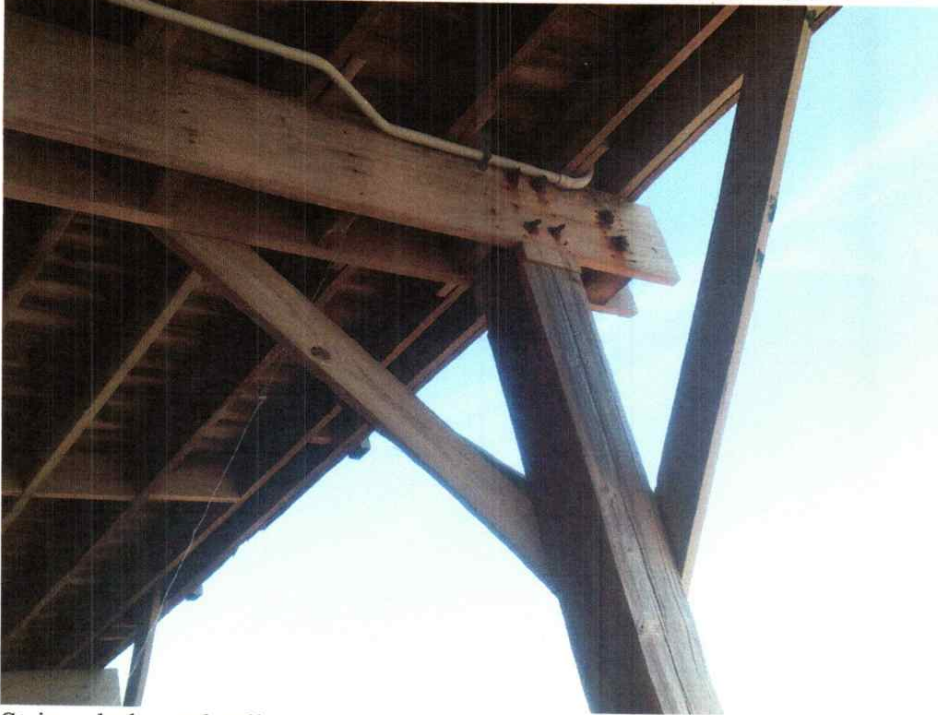
Stringer bolts and nails are severely rusted

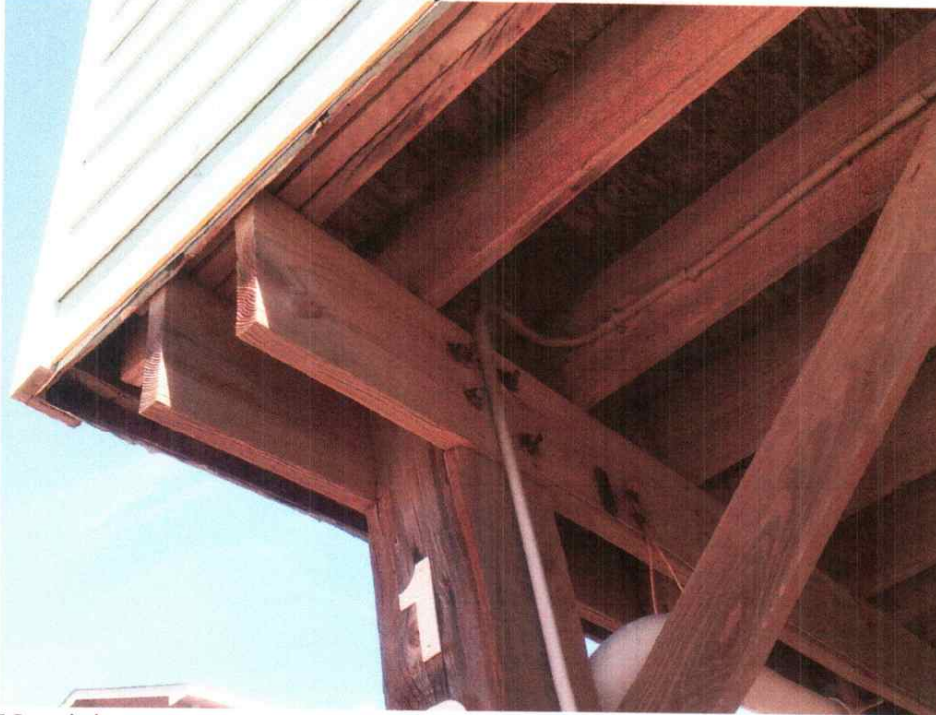
Note joists are not connected to stringer with metal fittings

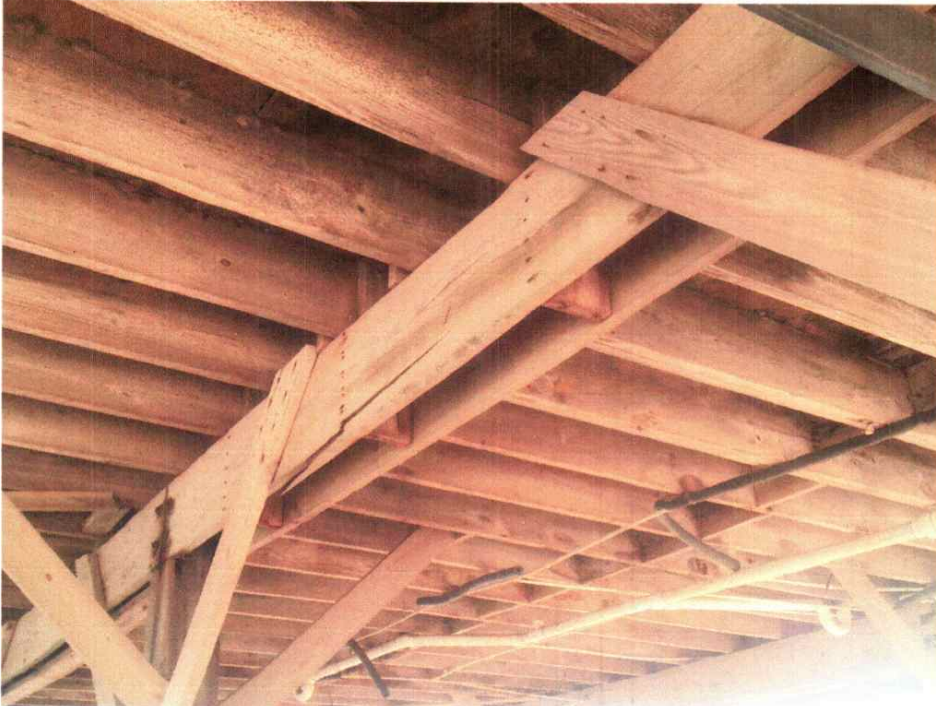
Broken stringer

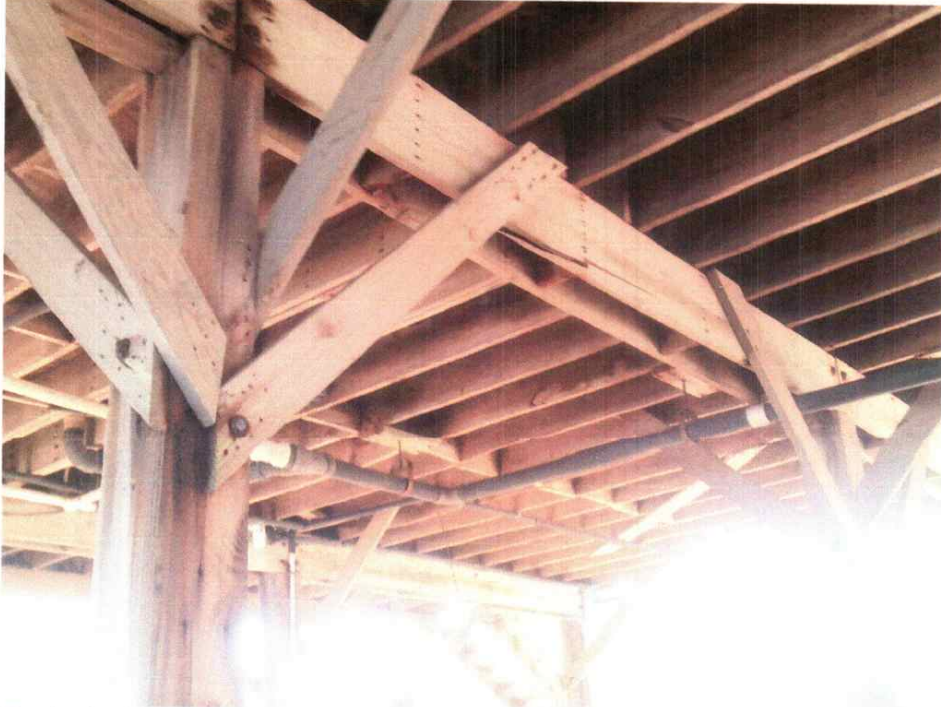
Typical ad hoc bracing scheme – note sistered joists with inadequate overlap
