# Your Inspection Report

5603 Armillary Dr  
Katy, TX 77449

**INSPECTION DATE:**  
Tuesday, June 25, 2024

# PROPERTY INSPECTION REPORT FORM

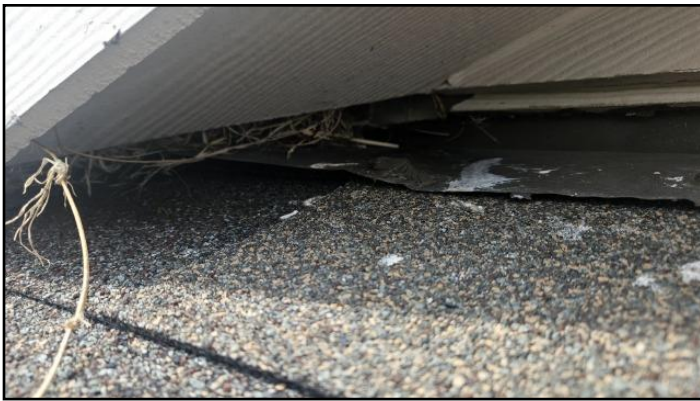
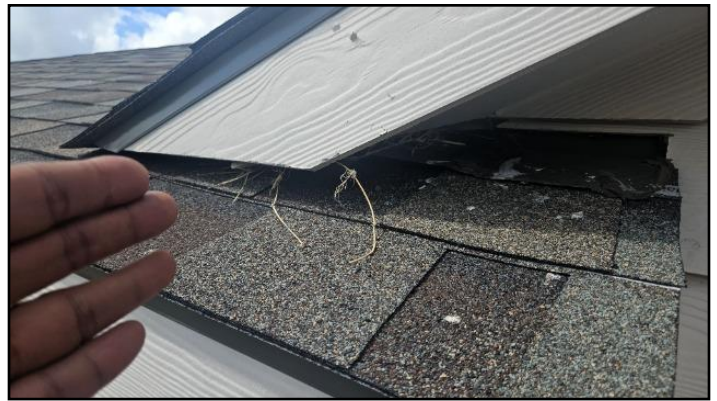
**2. Condition:** • The inspector observed a bird's nest on the side of the roof eave. To prevent potential damage, such as clogged gutters and material corrosion, it is recommended to have the nest professionally removed. This will help maintain the home's structural integrity and cleanliness.

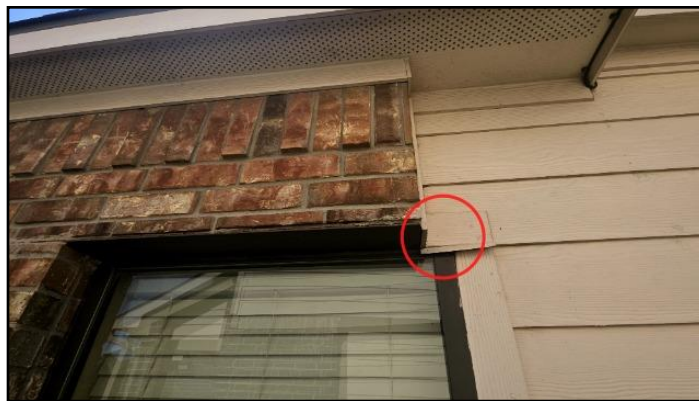
33.

**7. Condition:** • The inspector observed that the window lintel is not properly supported, with one end lacking adequate support. This issue can compromise the structural integrity of the window frame and surrounding wall. It is recommended to have the lintel properly supported to ensure the stability and safety of the window structure.

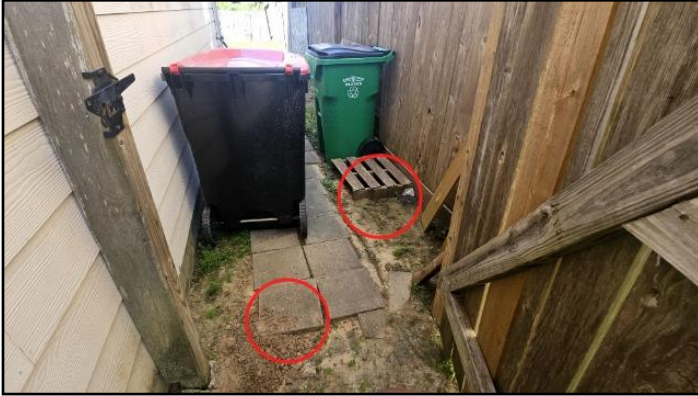
40.

**11. Condition:** • Water ponding noted near the foundation, excessive water will saturate the clay soils around and under the perimeter of the homes foundation. Inspector recommends backfill in the problematic area(s). Water should be move 6-inch drop in elevation for every 10 feet of distance from the base of the foundation. The rainwater should flow down the slope into the street and storm sewers.

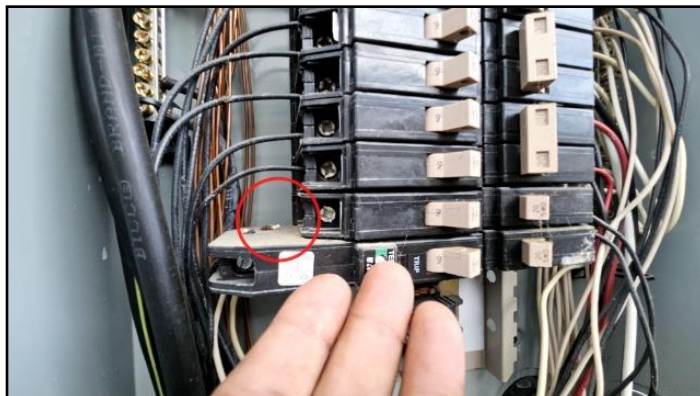
50.

**16. Condition:** • The inspector observed that there is a breaker in the electrical panel without any wires connected to it. This could indicate potential issues with the electrical system. It is recommended to have a licensed electrician inspect the panel and address any necessary repairs or replacements to ensure the safety and functionality of the electrical system.

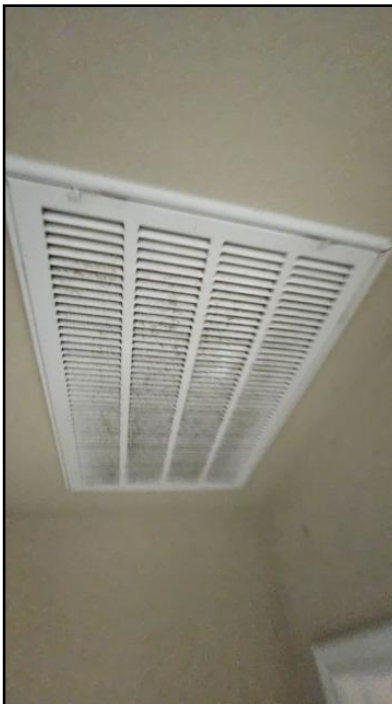
79.

**22. Condition:** • Dirty filter/Grille - At the time of inspection, the inspector noted dirty air filter/Grilles. Filters should be checked every three months and replaced when they reach a condition in which accumulation of particles becomes so thick that particles may be blown loose from the filter and into indoor air. Homes in areas with high indoor levels of airborne pollen or dust may need to have air filters checked and changed more frequently. Failure to change the filter when needed may result in the following problems: - Reduced blower life due to dirt build-up on vanes, which increasing operating costs. - Reduced indoor air quality. - Increased resistance resulting in the filter being sucked into the blower.

Recommend the grilles cleaned and replace with new filters.

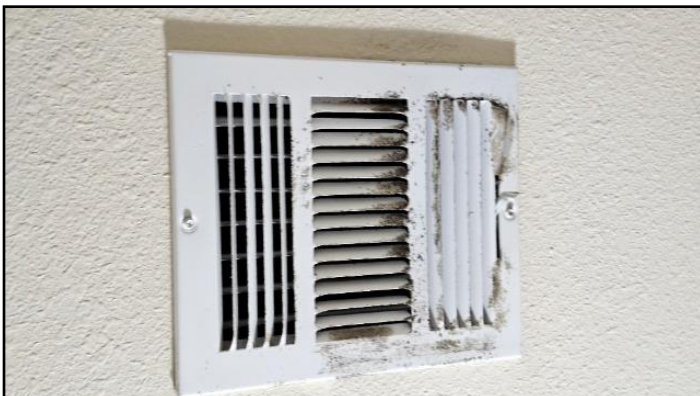
80.

**23. Condition:** • Mold / mildew like substance noted on the HVAC registers.

Recommended have it further evaluated repair and replace a needed.

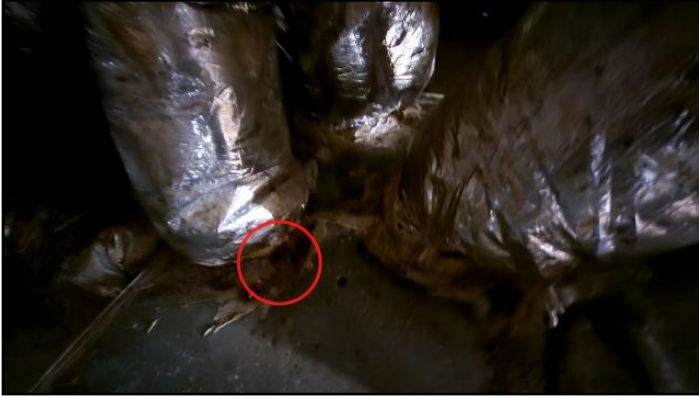
82.

**24. Condition:** • The inspector observed condensation on the HVAC plenum in the attic during the inspection. This condensation can be a sign of potential issues such as inadequate insulation, improper ventilation, or a malfunctioning HVAC system. Excess moisture can lead to mold growth, water damage, and decreased efficiency of the HVAC system. It is recommended to have a qualified HVAC technician evaluate the situation to determine the underlying cause of the condensation

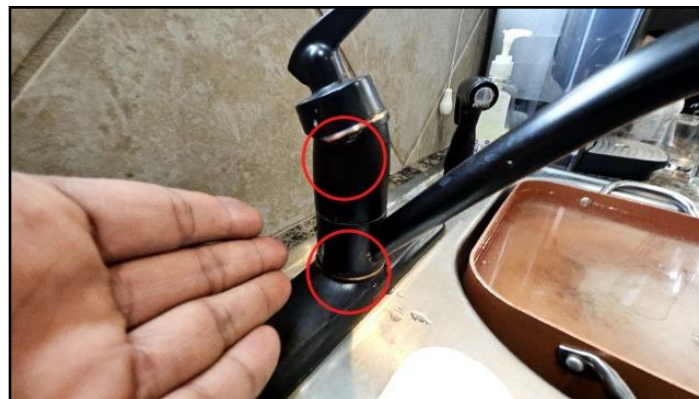
102.

**32. Condition:** • The inspector noted at the time of inspection that there is a leak present at the faucet. This observation requires immediate attention due to its implications for safety, functionality, and code compliance. Recommend having a licensed plumber service the house.

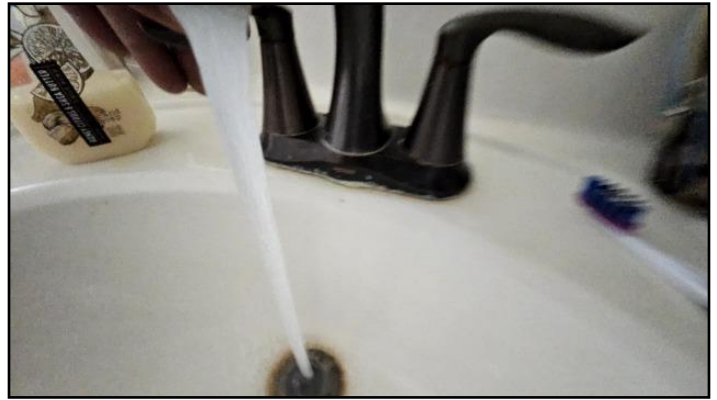
104.

**33. Condition:** • The inspector observed that the faucets are exhibiting signs of a manufacturing defect. Specifically, the color of the faucets is fading, and discoloration is becoming apparent. This could potentially lead to further deterioration over time. Therefore, it is recommended to have the faucets either repaired or replaced to ensure they function properly and maintain the aesthetic quality of the home. Taking prompt action will help prevent any potential issues that could arise from continued use of the defective faucets.

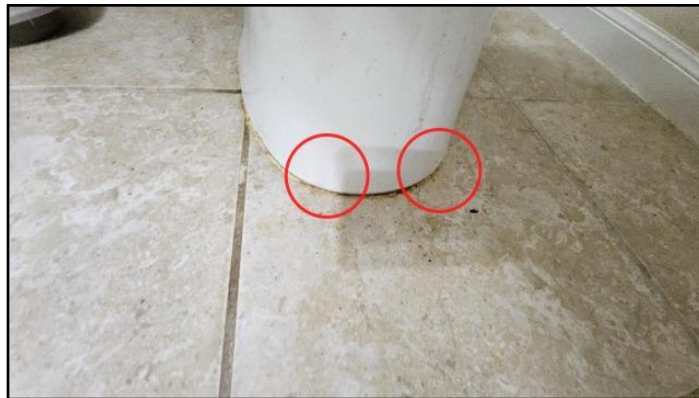
106.

Caulking line failure/breaks down over time in a bathroom and kitchen between various plumbing fixtures and floor joints in a bathroom, especially around sinks, bathtubs, and showers.

The inspector noted at the time of inspection existing caulking has deteriorated/missing. The Inspector recommends that this sealant be removed and replaced to help prevent the development of unhealthy conditions.

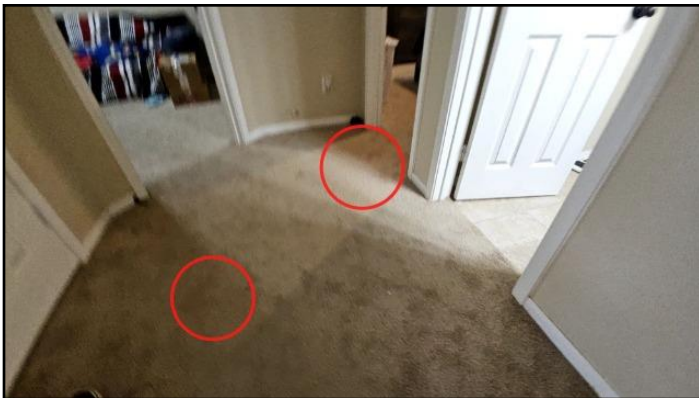
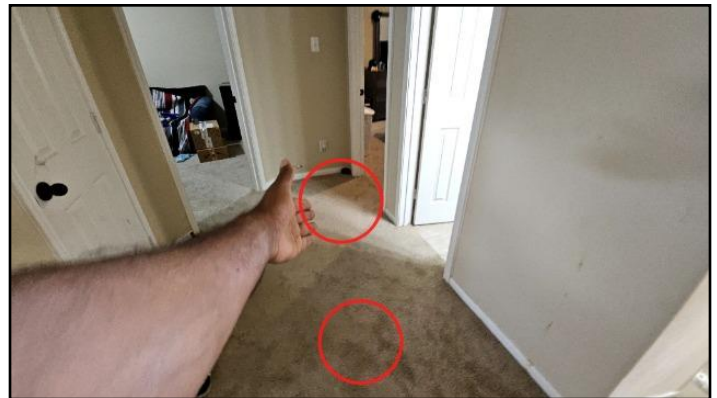
**41. Condition:** • Floor is not at level.

During the inspection, the inspector noted that the flooring in the is not level and feels bouncy or squeaks. As a result, there can be several consequences, including damage to the subfloor and/or joists over time, excessive wear and tear on the flooring, and noise and discomfort when walking on the floor. The inspector recommends having the flooring further evaluated by a professional prior to making any decisions about repair or replacement. Based on the evaluation, the necessary repairs or replacements should be made as needed to ensure the safety and comfort of the occupants."

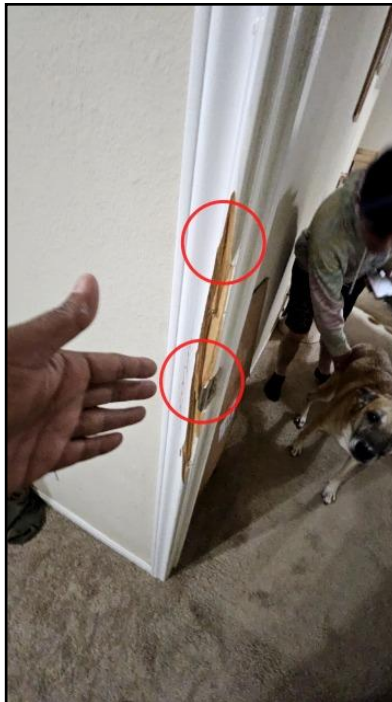
138.

**43. Condition:** • The Inspector observed that the door on the inside of the house was damaged and suggested that it be replaced.

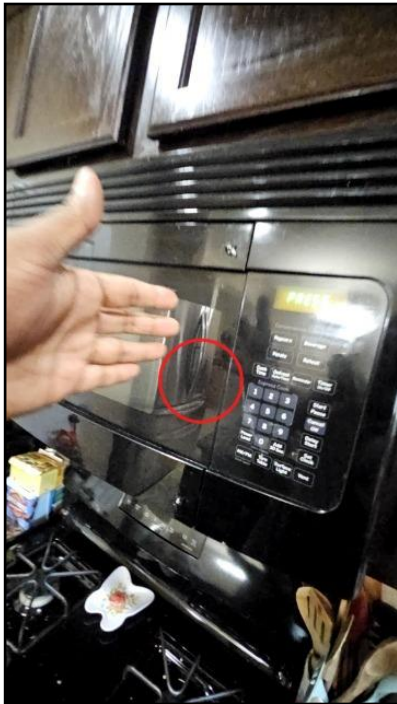
144.

**46. Condition:** • The microwave handle is broken/missing and needs to be repaired or replaced. The handle is essential for opening and closing the microwave door. Recommend having it corrected.
