September 10, 2024

PROPERTY INSPECTION REPORT FORM

310 Terminal St. A,B,C, Houston, TX 77020

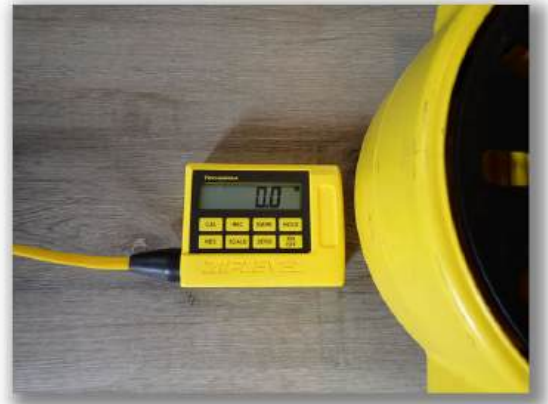
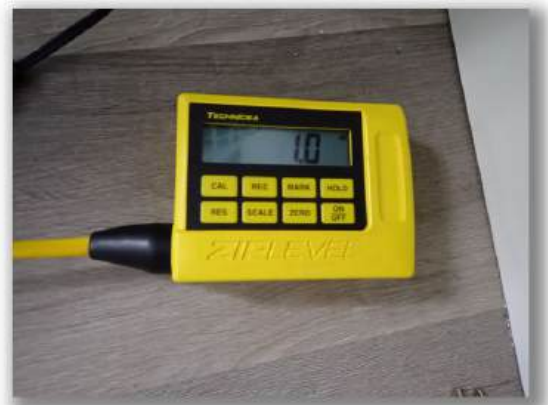
Unit B Foundation

The foundation appears to have had movement that may be beyond normal. A Professional Engineer licensed by the State of Texas should be consulted on the current integrity of the foundation and any repairs that may be necessary (If Any). The observations made to support the rendering of this opinion are listed but not limited to the following:

- In my opinion, this foundation is showing signs of movement that exceeds normal tolerances. The changes in the floor elevation of the house were greater than what would normally be expected.
- Floor slopes and/or unlevelness were observed.

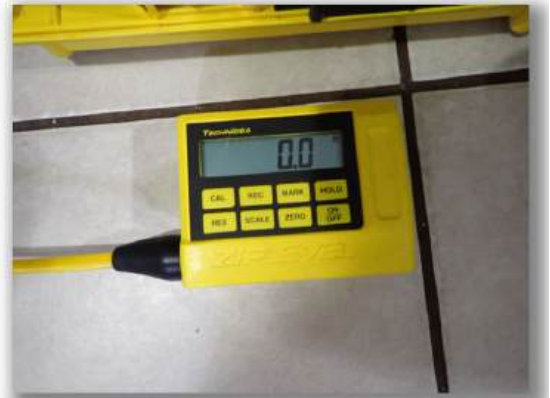
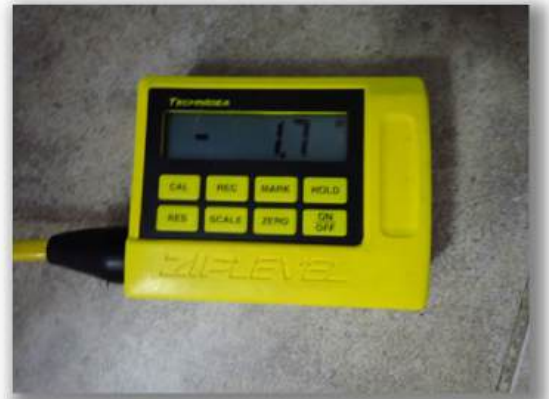
Unit C Foundation

The foundation appears to have had movement that may be beyond normal. A Professional Engineer licensed by the State of Texas should be consulted on the current integrity of the foundation and any repairs that may be necessary (If Any). The observations made to support the rendering of this opinion are listed but not limited to the following:

- In my opinion, this foundation is showing signs of movement that exceeds normal tolerances. The changes in the floor elevation of the house were greater than what would normally be expected.
- Floor slopes and/or unlevelness were observed.

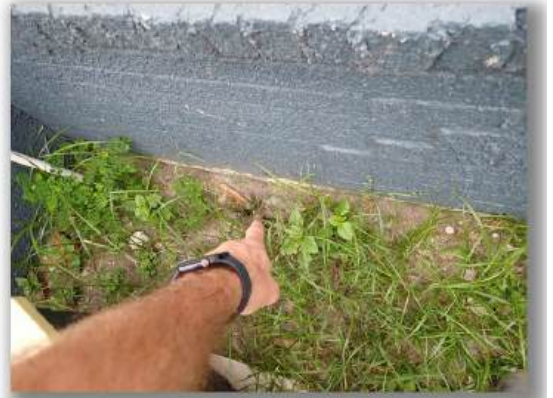
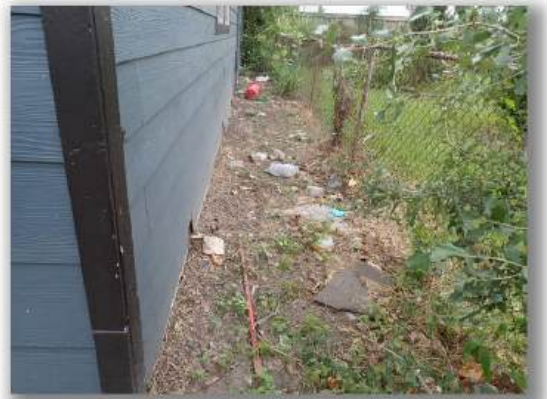
- Fill dirt is needed against the foundation perimeter wall where the soil line is too low to help support the foundation beam footer properly on the south side of the structure.
- **Poor to negative site drainage** was observed on the north, east, west and south sides of the structure. Proper drainage is needed to help prevent water from standing and/or pooling next to the foundation beam. Corrective measures may be needed if the water stands within 10-feet of the foundation perimeter beam for more than 24-hours.

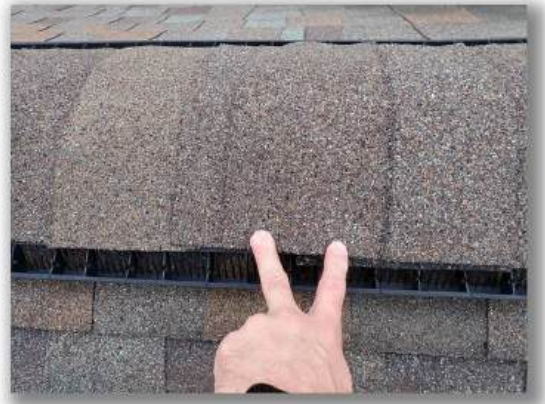
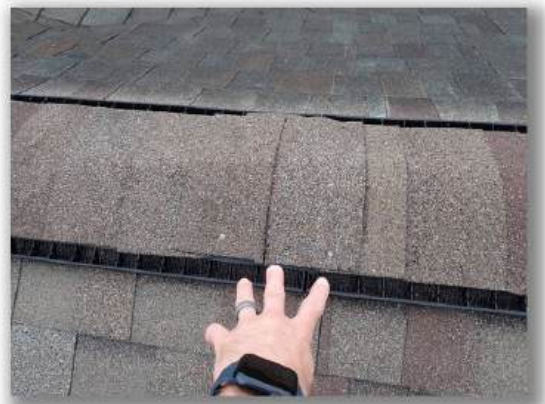
- Exposed fasteners were observed at the shingles in one or more locations.
- The felt paper was observed to be installed under the lower metal drip edge flashing detail. The manufacturer installation requires the felt paper to be installed over the top of the metal drip edge flashing, in shingle like fashion, to help prevent water intrusion and/or damage to occur behind the fascia board and soffit/eave areas.
- One or more of the shingles were observed to be lifting on the east and west sides of the roof structure.
- Shingle fasteners (staples and/or nails) were observed to be pushing through the roofing material.
- Damaged shingles were observed on the west side of the roof structure.
- Scaling or granular loss of the low slope roof membrane was observed. This condition should be further evaluated and corrected if necessary.

You are strongly encouraged to have a properly certified roofing contractor to physically inspect the roof, prior to the expiration of any time limitations such as option or warranty periods, to fully evaluate the condition of the roofing material. The observation made to support the rendering of this opinion are listed but not limited to the following:

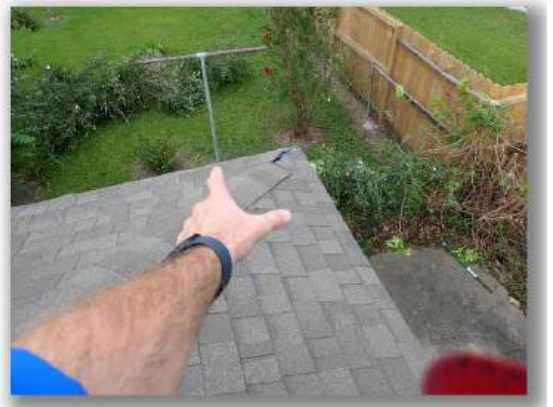
Roof Covering, Unit C

- Damaged shingles were observed on the west side of the roof structure.
- The tree branches are too close to the roof and should be trimmed.
- The inspector identified soft decking in one or more locations of the roof structure. It is recommended to add additional support in this area.

- Exposed fasteners were observed at the shingles in one or more locations.
- The felt paper was observed to be installed under the lower metal drip edge flashing detail. The manufacturer installation requires the felt paper to be installed over the top of the metal drip edge flashing, in shingle like fashion, to help prevent water intrusion and/or damage to occur behind the fascia board and soffit/eave areas.

- One or more of the shingles were observed to be lifting on the east and west sides of the roof structure.
- Shingle fasteners (staples and/or nails) were observed to be pushing through the roofing material.

You are strongly encouraged to have a properly certified roofing contractor to physically inspect the roof, prior to the expiration of any time limitations such as option or warranty periods, to fully evaluate the condition of the roofing material. The observation made to support the rendering of this opinion are listed but not limited to the following:

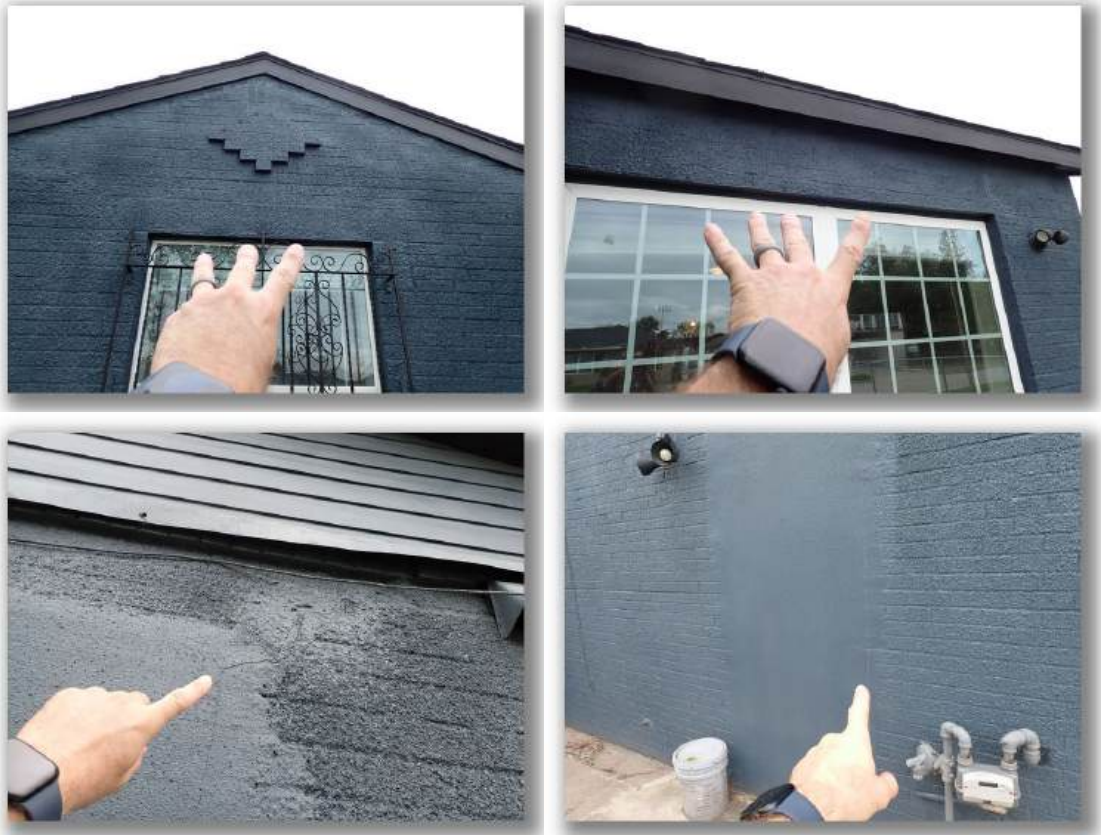
Note: Previous repairs to the exterior masonry mortar / grout was observed on the north, east, west and south sides of the structure.

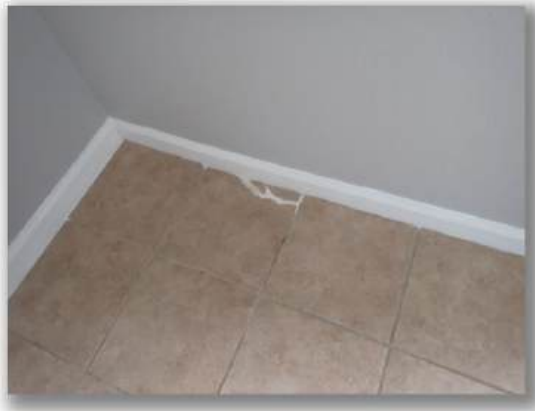
- The floor tile(s) were observed to be cracked and/or damaged in the several locations throughout the house.

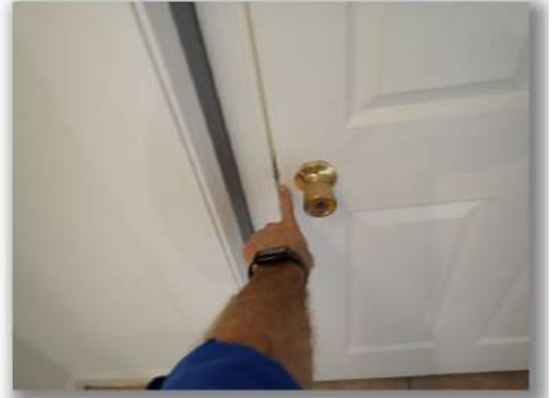
- The door does not stay in position to the rear corner bedroom.
- The door is sticking to the front corner bedroom.
- The door hardware is loose to the primary bathroom.

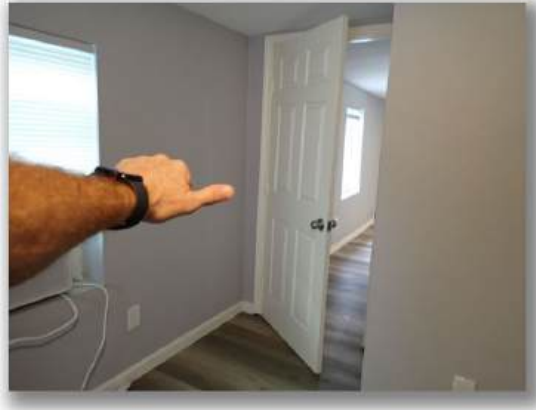
- The door does not stay in position to the primary bedroom.

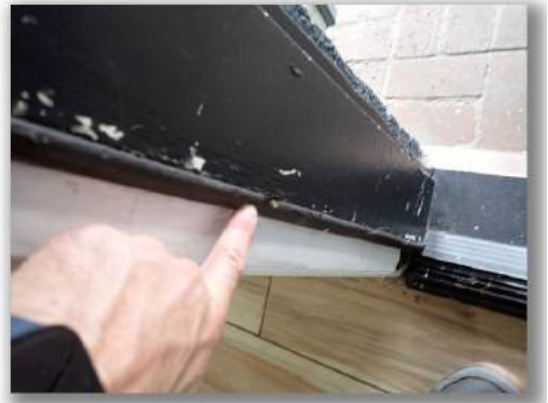
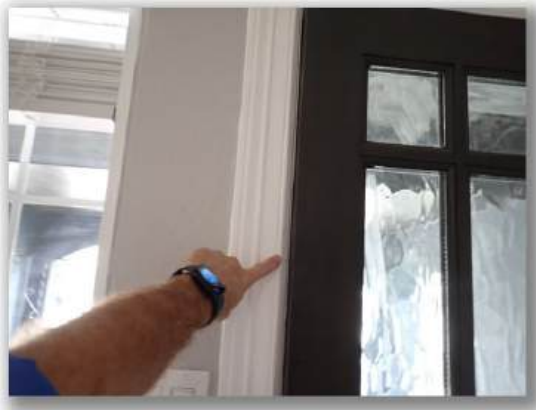
Exterior Doors A

- The door hardware is loose to the front entry door.
- The door is sticking to the front entry door.
- Weather-stripping improvements are recommended for the front entry exterior door(s).

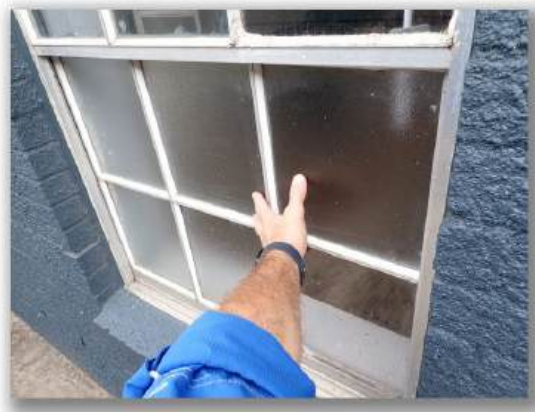
- One or more of the window screens were observed to be missing.

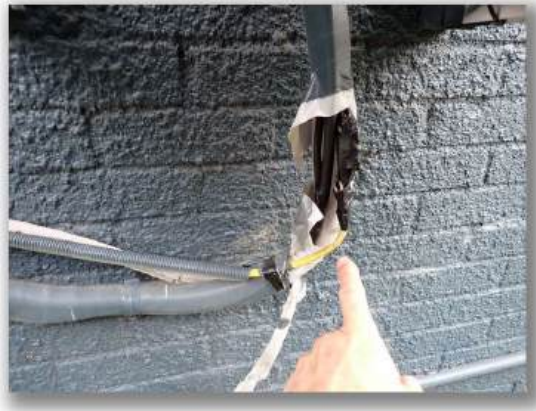
- Spliced electrical wires were observed in the south exterior wall. Spliced wires should be properly enclosed in junction box(es) for reasons of safety.

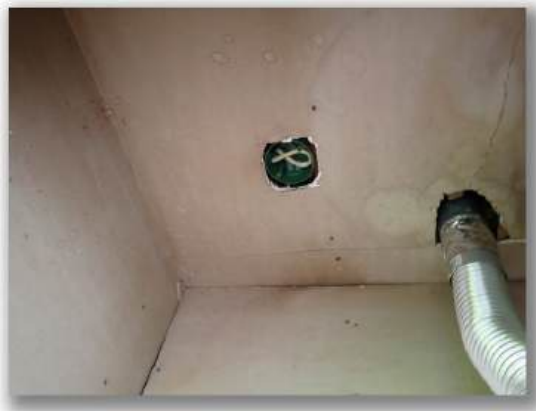
Distribution Wiring Unit C

- Open electrical junction box(es) were observed in the attic area, utility room. All open junction box(es) should be properly enclosed for reasons of safety.
- Spliced electrical wires were observed in the attic area. Spliced wires should be properly enclosed in junction box(es) for reasons of safety.

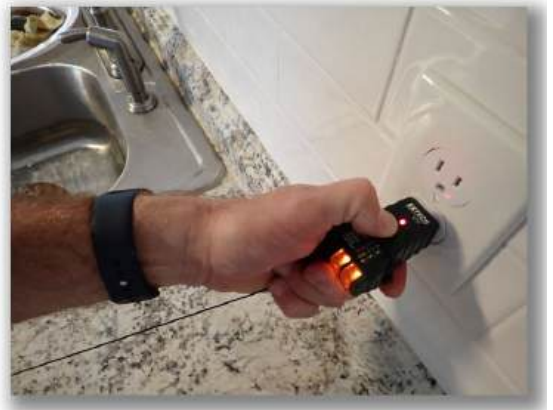
Receptacle Outlets Unit B

- Not all of the receptacles in the wet/damp areas have ground fault circuit interrupter (GFCI) protection. Under current electrical standards all of the exterior/accessory building receptacles, all crawl space receptacles, all kitchen counter top receptacles, all bathroom receptacles, all attic receptacles, all laundry room receptacles, all garage receptacles, dishwasher receptacle, receptacle in cabinet under kitchen sink, any receptacle within 6-feet of the sink, all wet bar area receptacles and pool equipment should have GFCI protection.

- One or more of the receptacles were observed to be loose at the wall mount in the several locations throughout the house.
- There are no tamper resistant receptacles installed at the time of inspection. Under current building standards, all receptacles that are less than five and a half feet above the floor should be tamper resistant. This is an "as built" condition, but per TREC standards of practice, we are required to report this condition as deficient. Tamper Resistant outlets are required per the 2008 National Electric Code. You may consider corrective measures for improved safety.

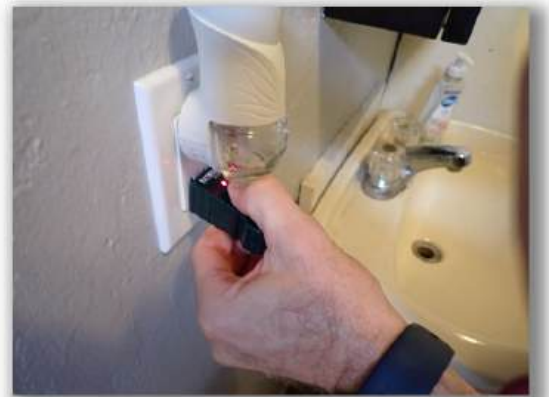
Receptacle Outlets Unit C

- One or more of the receptacles were observed to be damaged in the kitchen.
- One or more of the receptacles were observed to be loose at the wall mount in the several locations throughout the house.

- There are no tamper resistant receptacles installed at the time of inspection. Under current building standards, all receptacles that are less than five and a half feet above the floor should be tamper resistant. This is an "as built" condition, but per TREC standards of practice, we are required to report this condition as deficient. Tamper Resistant outlets are required per the 2008 National Electric Code. You may consider corrective measures for improved safety.

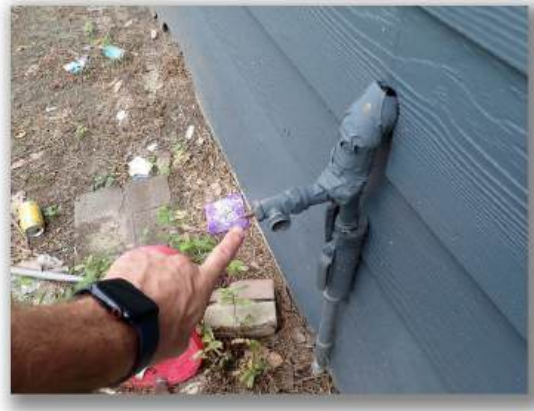
Exterior Faucets/Fixtures

- One or more of the exterior water hose bibs (faucet) do not have a back-flow or anti-siphon device (Vacuum Breakers) in place.
- The exterior water hose bib (faucet) handle is damaged and/or missing on the west side of the structure.

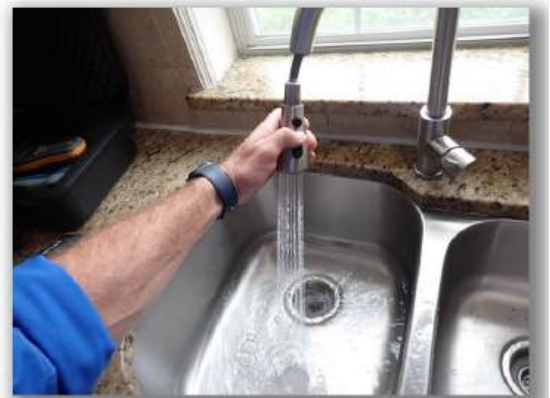
Unit A, Kitchen Sink

- The faucet assembly is loose.
- The faucet assembly or drain leaks water into the cabinet when operated.

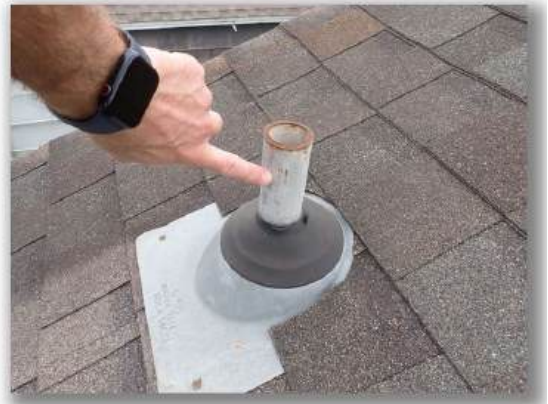
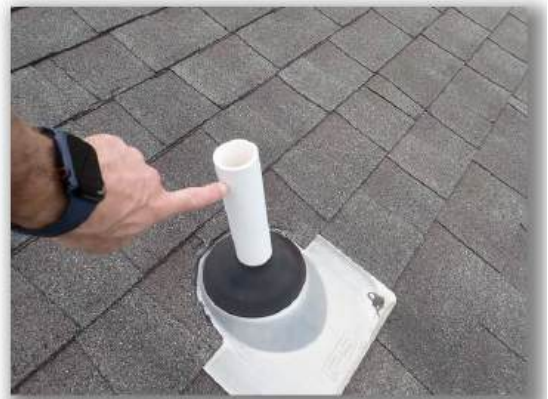
- The plumbing cleanout and/or cover(s) located in the yard were observed to be damaged on the west side of the structure.
- The roof level plumbing vents stacks are not painted. It is recommended to paint the roof level vent stacks and flashing details to help prevent UV breakdown.

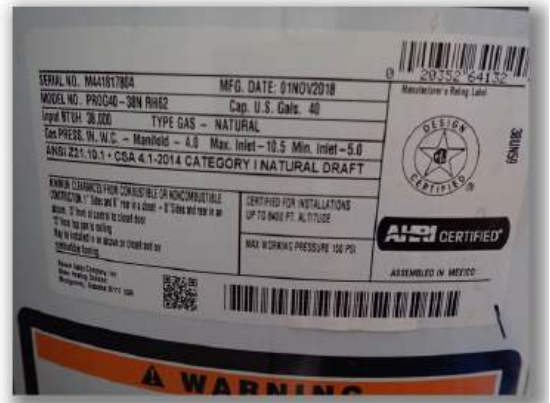
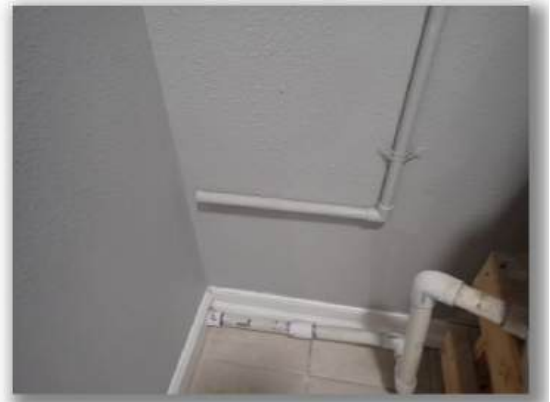
Note: The water temperature was observed to be over 140 degrees Fahrenheit when running the hot water. This high temperature could cause scalding/burning of the skin. It is recommended to adjust the temperature on the water heater to a lower setting. The general recommended setting for water heaters is between 120-130 degrees Fahrenheit.

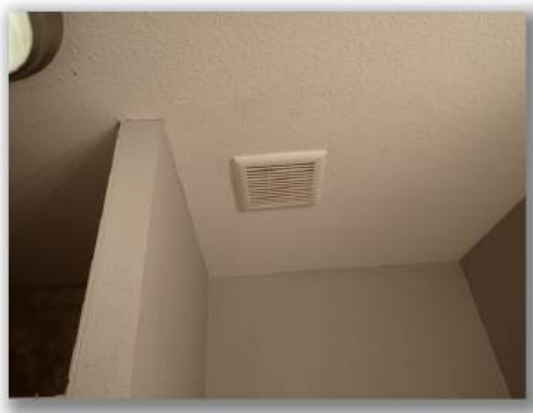
- The mechanical exhaust vents were venting into the attic area. Under current building standards, all mechanical exhaust vents should vent to the exterior of the structure. This is an **“as-built”** condition.

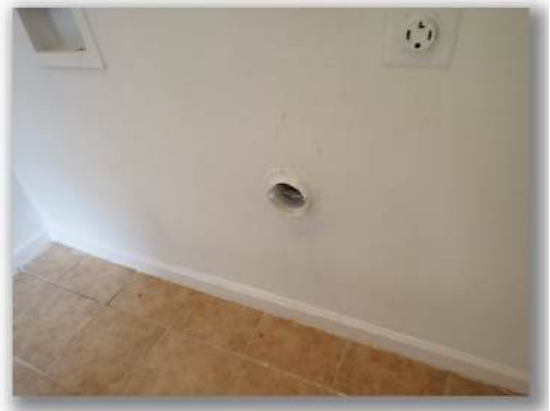
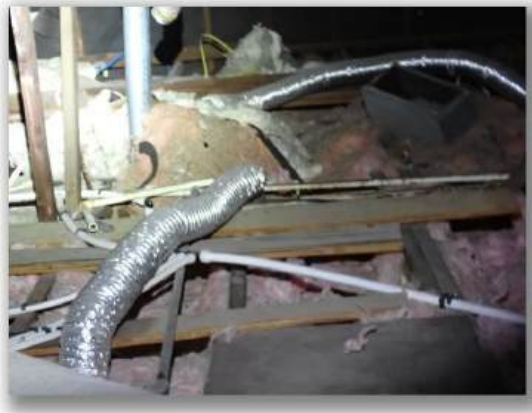
- The dryer duct was observed to terminate into the attic area. Under current installation standards the dryer should vent to the exterior of the structure and not into the attic.
- The material used for the dryer duct is not listed or labeled for this type of installation.

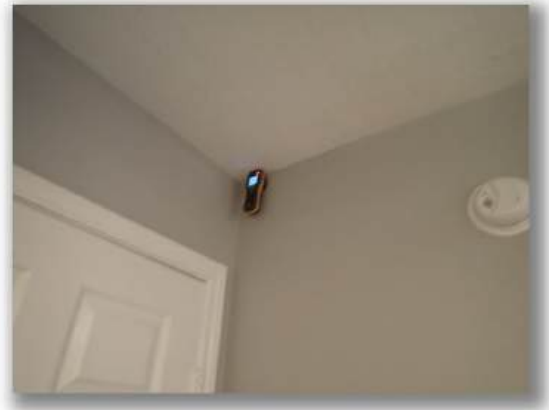
- Elevated moisture was observed in the bedroom hallway. The cause should be further evaluated and corrected as necessary. **Additional Note:** Due to the elevated moisture, other adverse conditions such as mold-like substance growth, wood rot/deterioration and wood destroying insects are possible.
- Missing insulation was observed within the wall cavity in several locations throughout the house.
- Missing insulation was observed at the ceiling in several locations throughout the house.

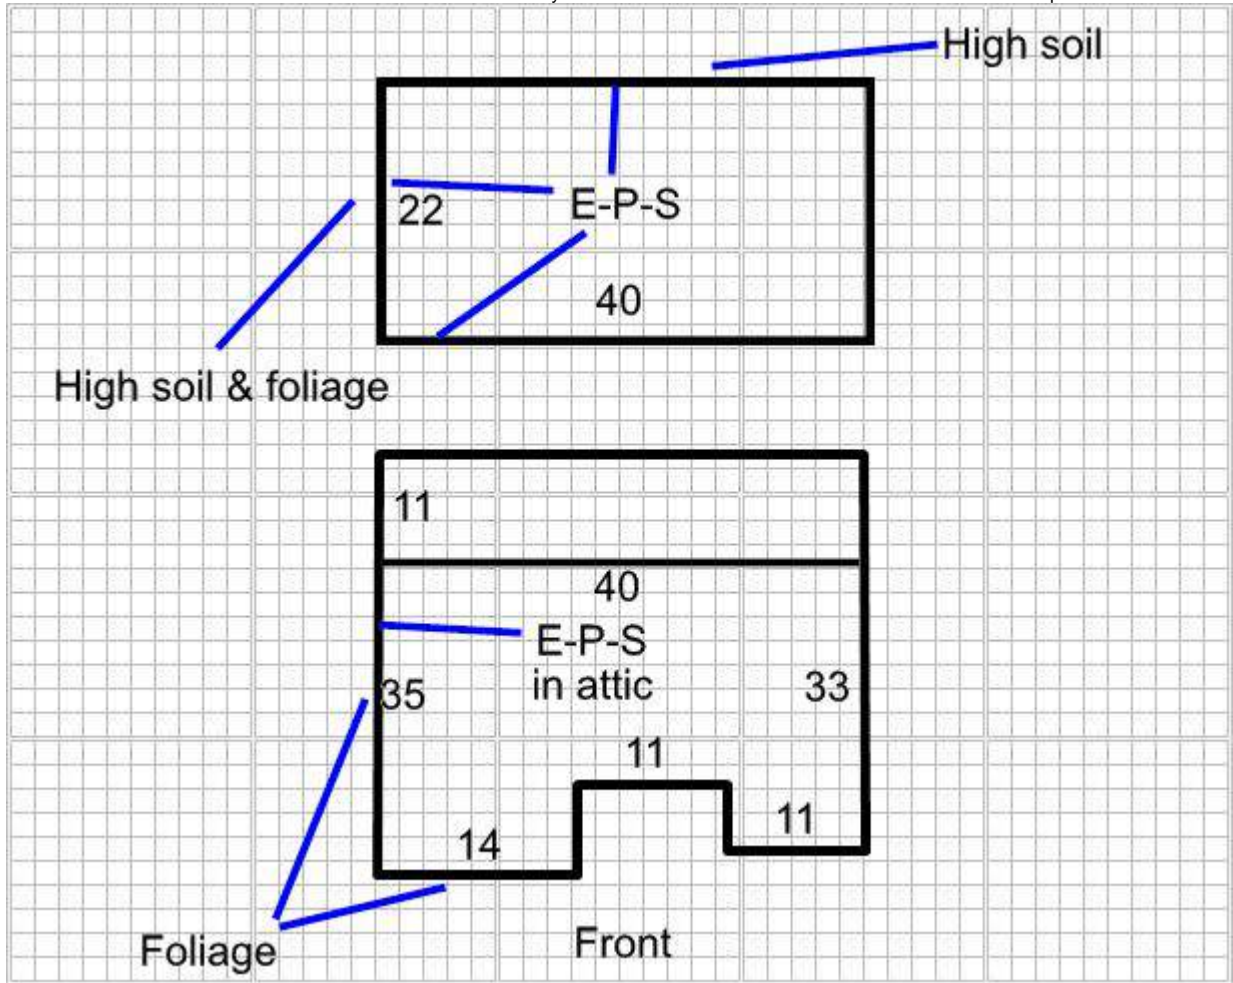
Additional Comments An ACTIVE Infestation of termites was discovered at the time of this inspection. See diagram for location(s). Treatment Recommended., There is visible evidence of a previous WDI infestation at the time of this inspection without signs of previous treatment or records of previous treatment. Treatment is recommended at this time. See diagram for location(s).
