# INSPECTION REPORT

Property Address: 7707 Chateau Point Lane

## PROPERTY INSPECTION REPORT

**Concerning:** 7707 Chateau Point Lane, Houston, TX 77041  
(Address or Other Identification of Inspected Property)

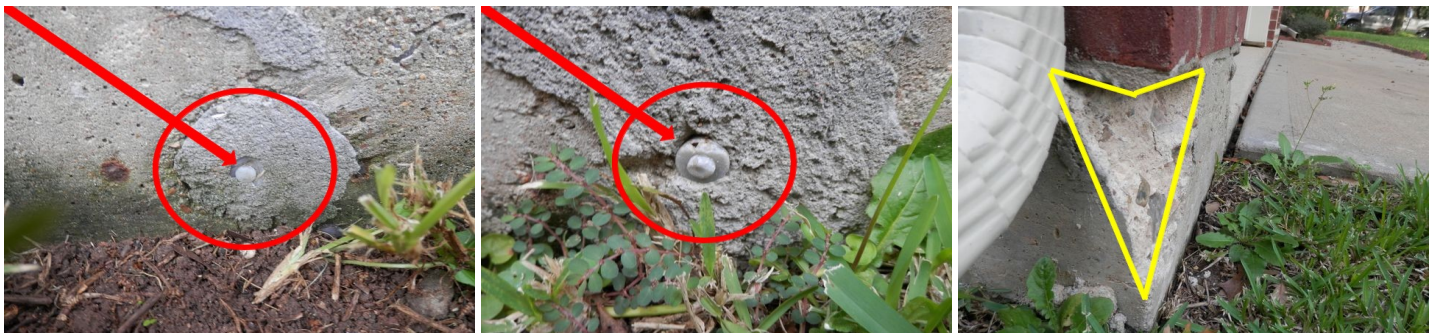
- **INFORMATION / MAINTENANCE:** The perimeter slab had exposed structural steel/cable ends. By being exposed to the elements, the steel could rust, which would cause expansion of the metal and possible damage to the foundation concrete. I recommend that the exposed steel be sealed with a concrete/epoxy mix to prevent future damage. **At this time, the remedial work needed is considered to be a maintenance issue.**

**INFORMATION:** One or more of the foundation perimeter corners were observed to be sheared off, AKA Spalling, Corner Pop, Wedge Crack, etc.. Such conditions were observed to be within 12" of the corners. This condition does not adversely affect the foundation performance. This damage did not appear structurally significant.

sample of exposed cable ends - sample of a wedge crack

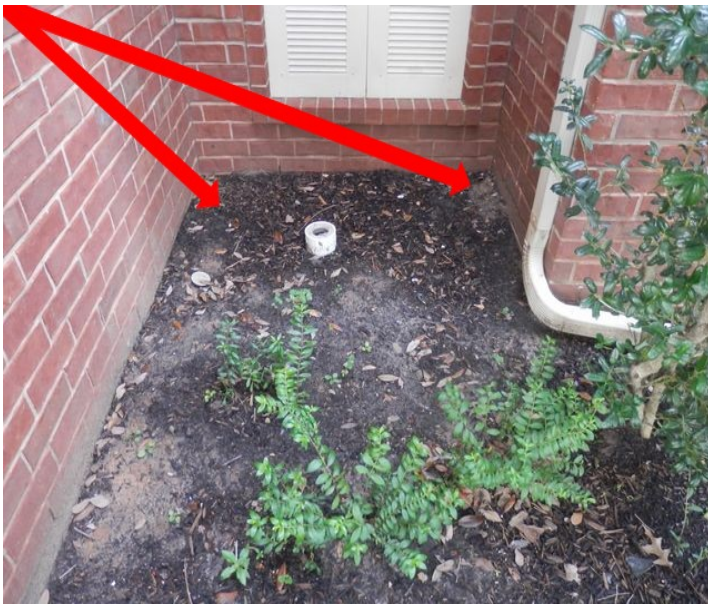
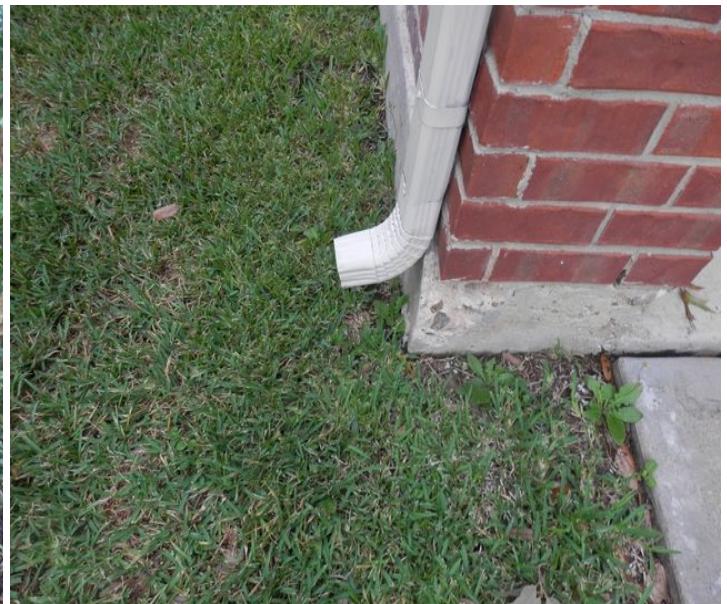
When soil and/or vegetation levels are high against the face of the foundation it promotes water penetration, wood rot and insect infestation. Brick veneer wall cladding should have about 4" of clearance between the soil and the first course of bricks, and other materials should have 6" of clearance between other materials and the soil.

sample of high soil (at left and right of the front entry) - sample of no splash block at gutter downspout end

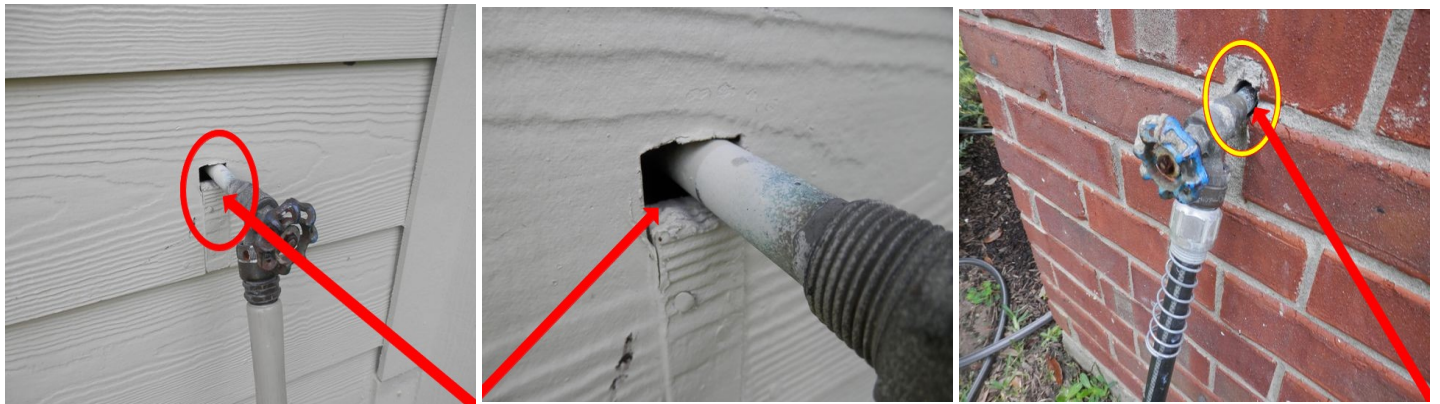
- One or more gaps was observed around the exterior wall coverings at the attachments and/or penetrations were not sealed. Areas such as utility connections, electric boxes, lighting fixtures, receptacles, etc should be properly sealed. I recommend gaps be sealed with appropriate exterior grade caulk to prevent infiltration by insects, moisture and weather.

sample of areas to be caulked or sealed

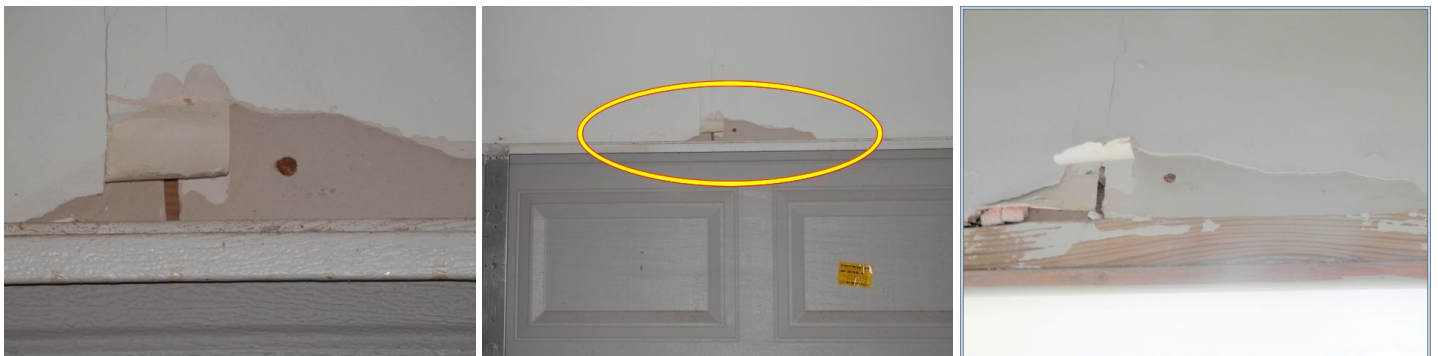
**INFORMATION:** The Sheetrock type wall covering, in the garage above the right door, showed signs of possible previous water penetration. The area was checked with a moisture meter, and it showed the area to be dry at the time of this observation.

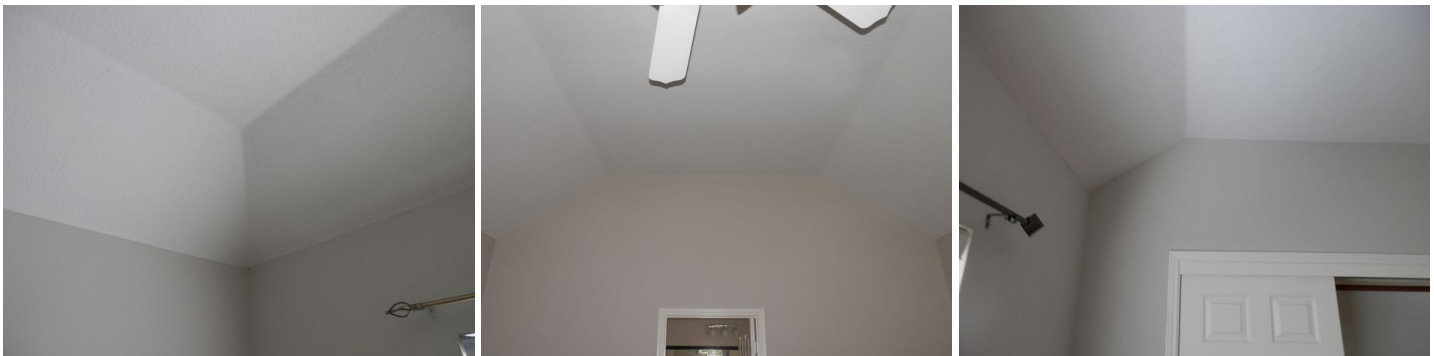
Sheetrock joints at walls and/or ceiling that come together at angles greater than 90 degrees will often have cracks in the tape joint and/or nails backing out in the area of tape joints. generally this is not a structural issue, rather of a cosmetic nature due to normal movement of the foundation and/or framing system.

sample of ceilings with angles

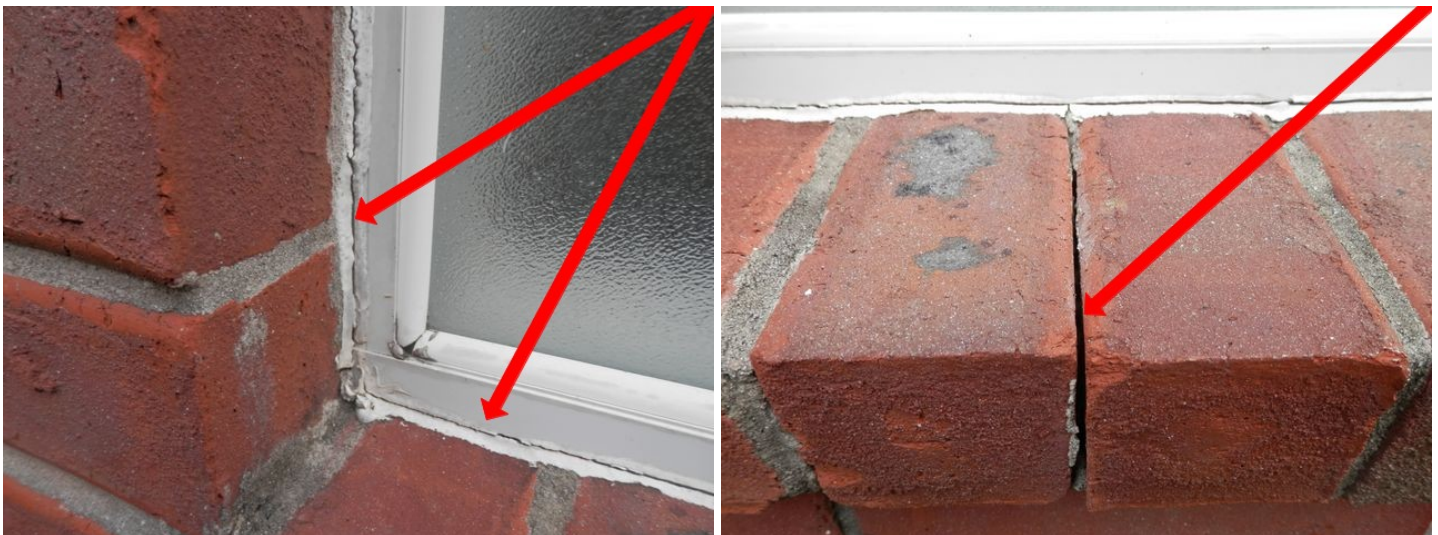
The lack of caulk can allow water into the wall cavity and can allow a more ready transfer of air from the exterior of the house to the interior of the house. All of the wall openings should be properly sealed to reduce water penetration, to reduce access of pest and insects and to limit the transference of air from the interior of the house to the exterior atmosphere.

sample of caulking / sealing needed at one or more window (master bath window shown)

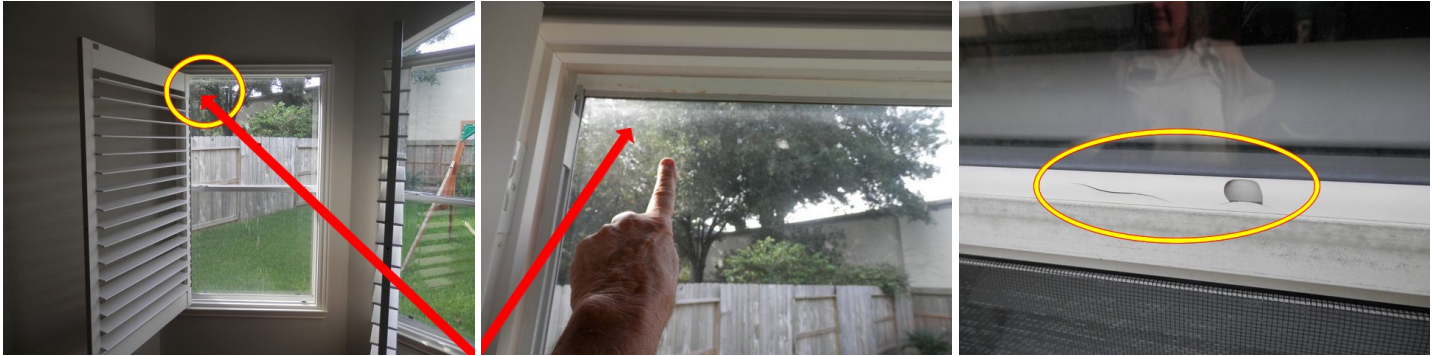
sample of broken glass at the master bedroom - sample of damaged window glaze material

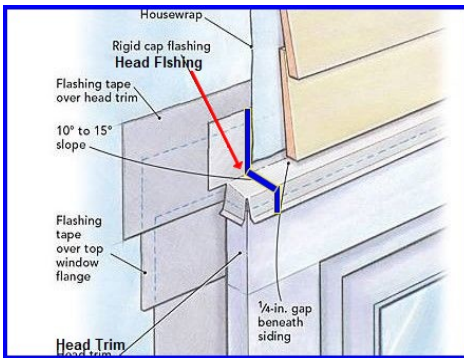
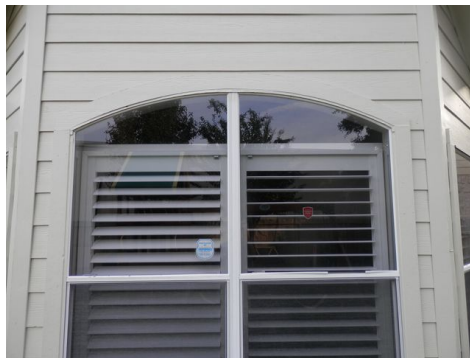
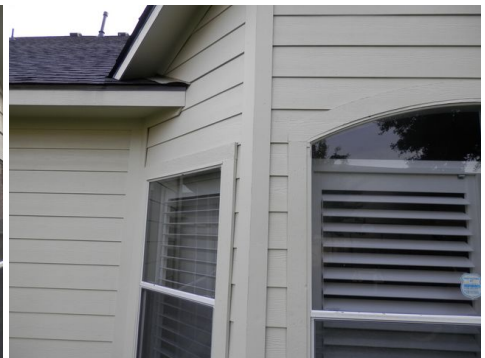
Metal flashing, call "Z" flashing, should have been installed during construction of the structure. Z flashing is cut into the frame siding and covers the top piece of trim to prevent water from entering the trim or window / door frame. Z flashing is meant to prevent water penetration, not to act as a drain after water penetration has occurred. Proper Z flashing material should be installed to prevent water penetration. The lack of head flashing may void siding and/or window warranties.

sketch of head flashing - sample of windows without head flashing

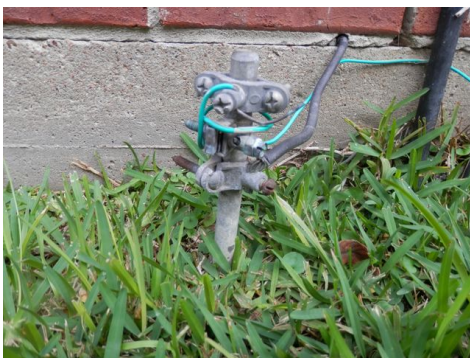
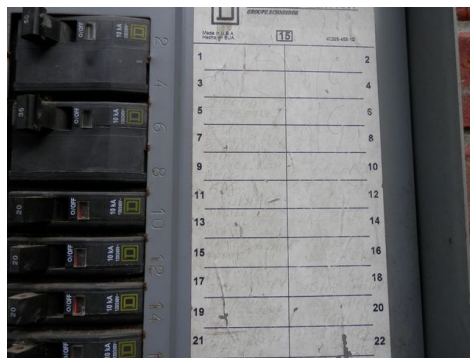
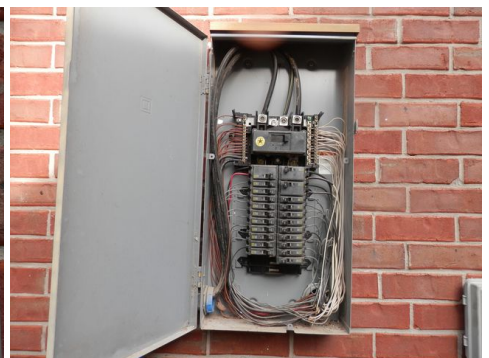
ground rod not below the soil - breakers not labeled - general view of the service panel

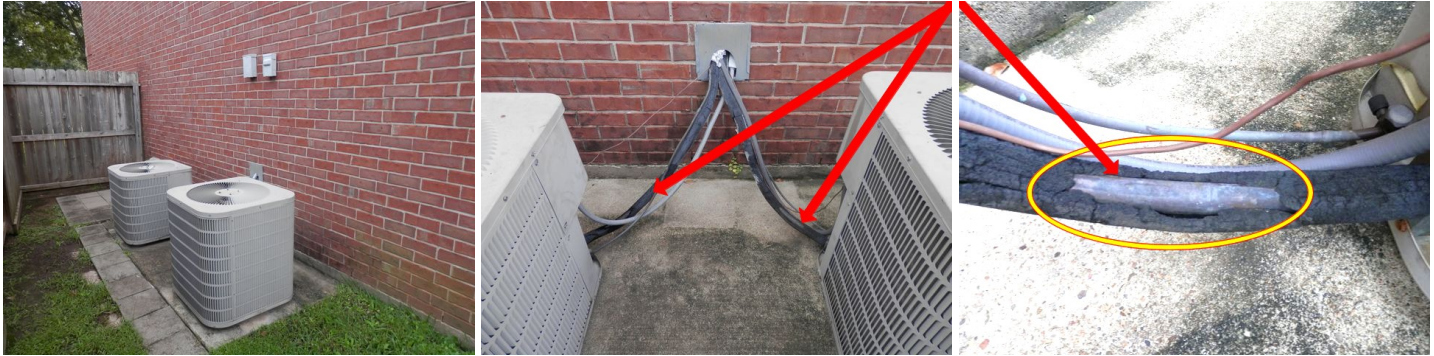
two outside a/c units with a disconnect - insulation on suction lines was damaged

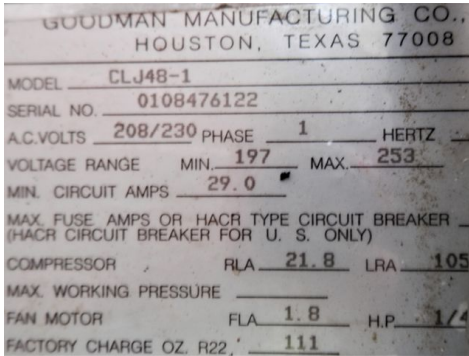
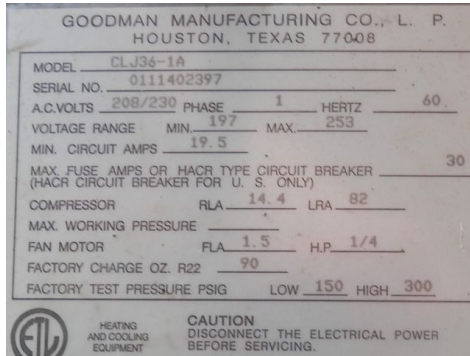
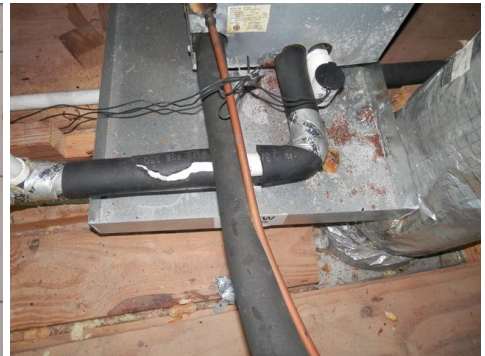
the data plates appeared to be dated 2001 (20 years old)

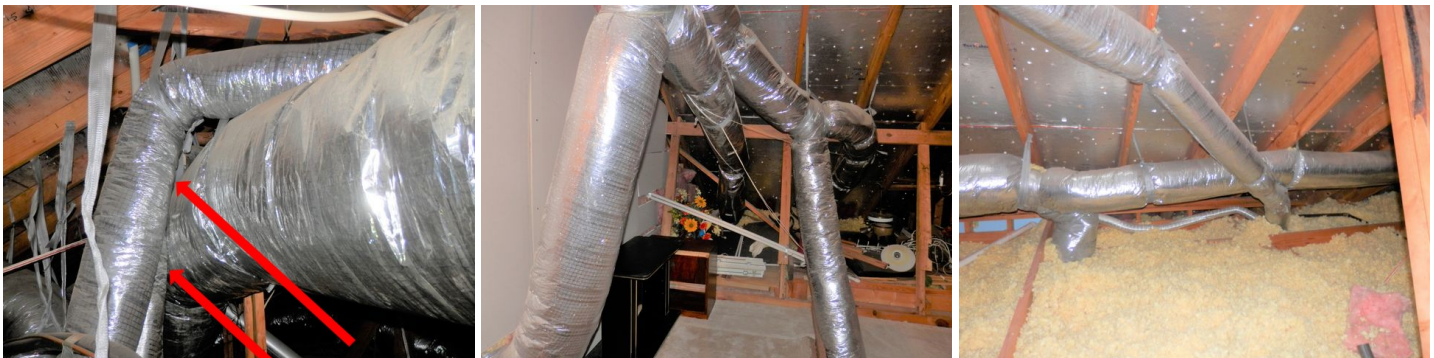
[ref: IRC M1601.2 factory made ducts; IMC 603.11 pg. 53; CABO 1901.2; SBCCI 606.2.1; "provisions shall be made to prevent the formation of condensation on the exterior of any duct"; TREC 535.230(d)(1).] Where ducts are separated by insulation blankets condensation moisture is generally increased (as the insulation traps hot air against the cooler ducts).

sample of ducts touching other duct lines - general view of the duct line system in the attic

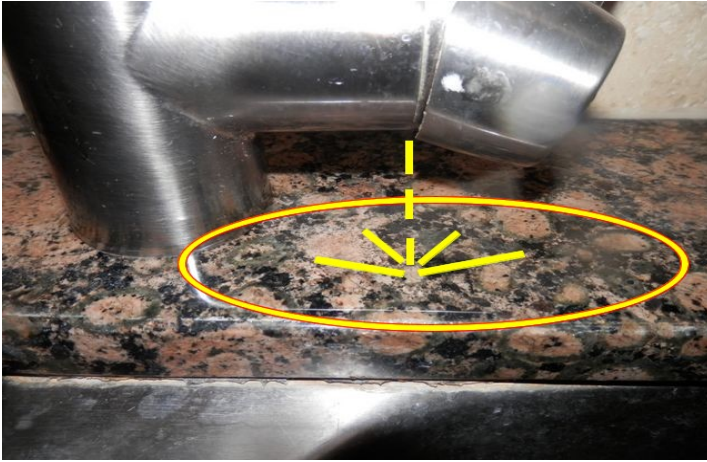
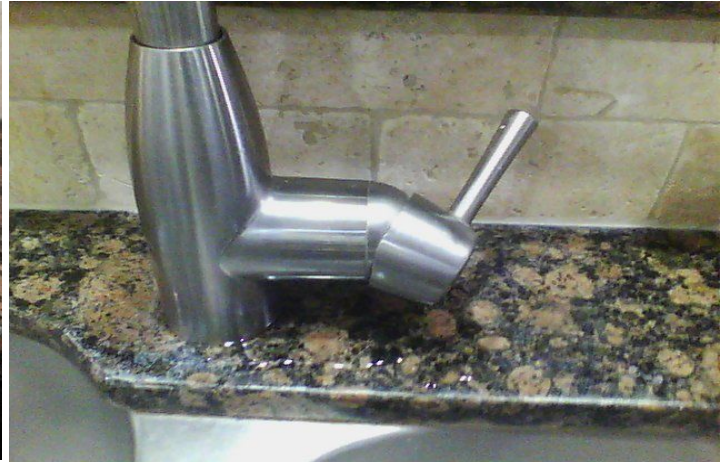
leak at the kitchen sink faucet

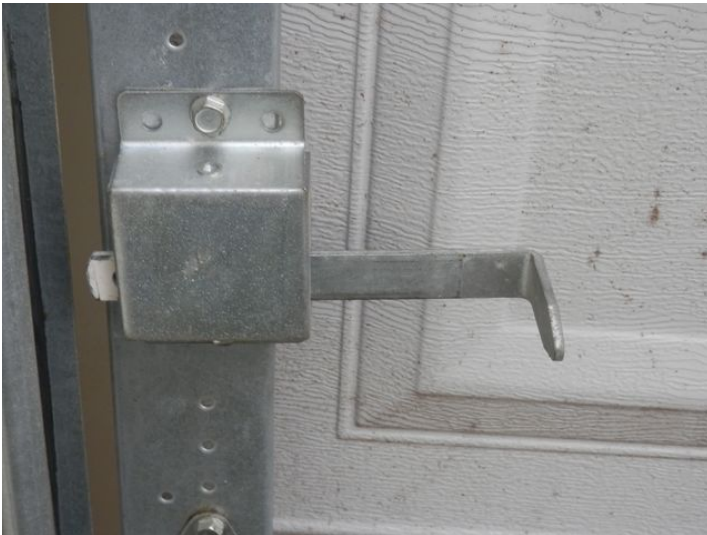
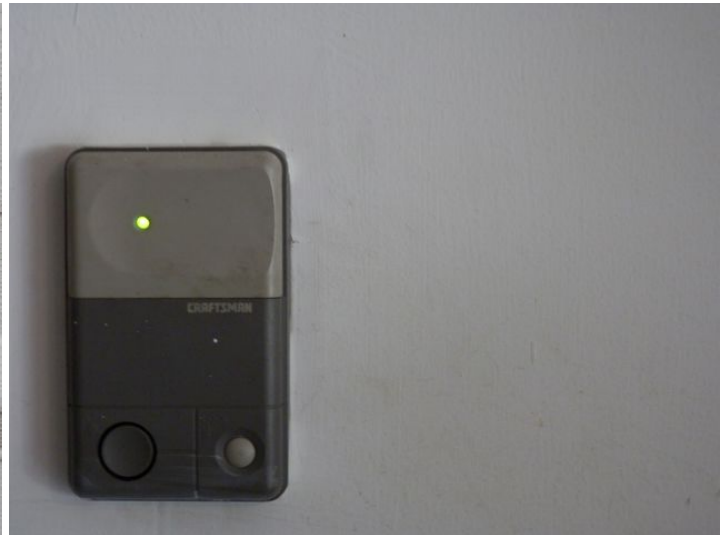
manual lock is recommended to be disabled or removed - no safety sticker at the push-button for auto-opener

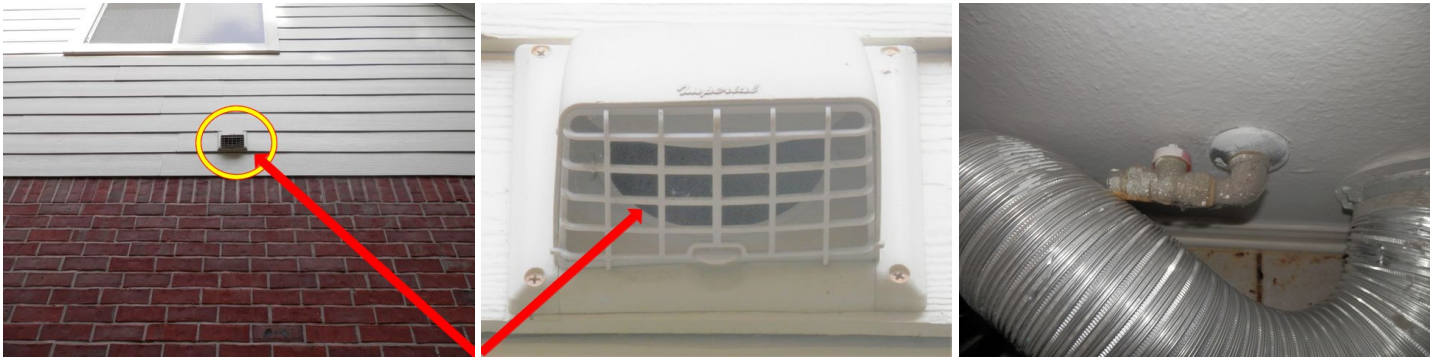
basket, snap-in cover is recommended to be moved - view of dryer vent at utility and the gas valve
