BPG Inspection, LLC

**837 West Little York Unit A
Houston TX 77091**

Client(s): Bowen
Inspection Date: 10/29/2023
Inspector: Billy Cook , (TX) 25062

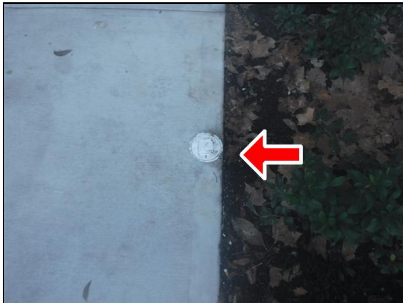
Sewer Cleanout Access [Inspected]

- ◆ There is one sewer access at the right side (facing front). The sewer scope camera was inserted into the cleanout that leads towards the street.

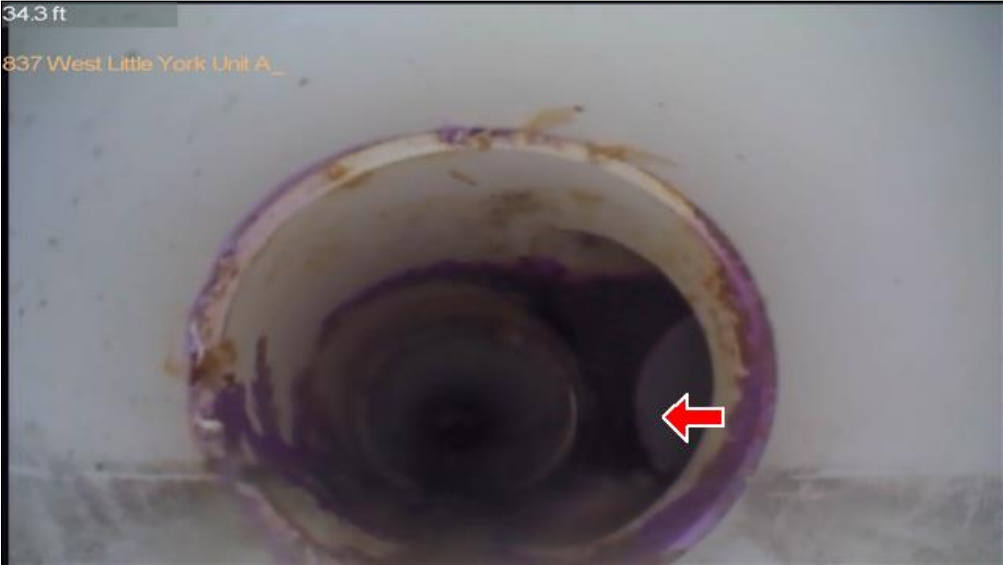
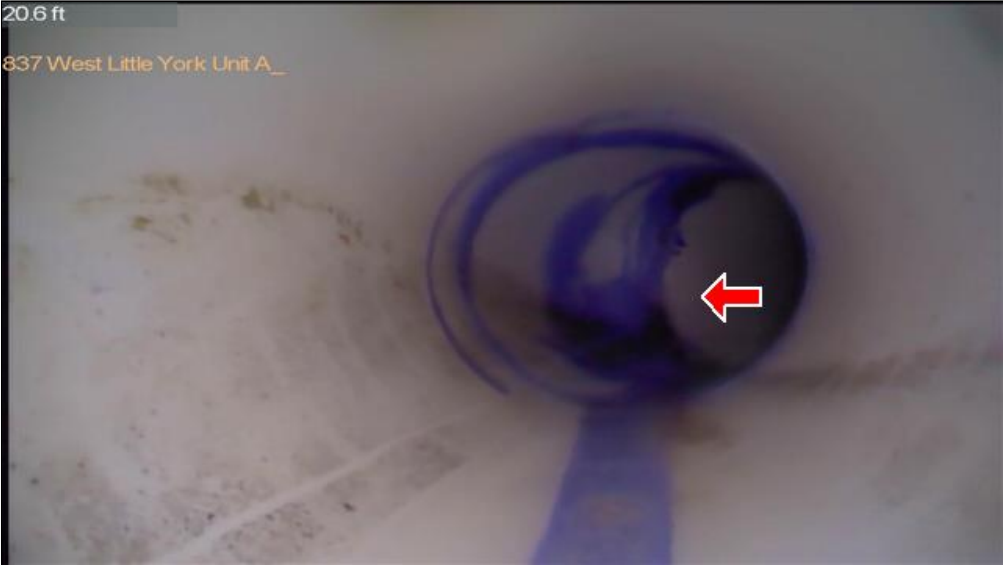
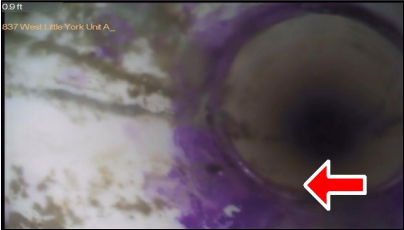
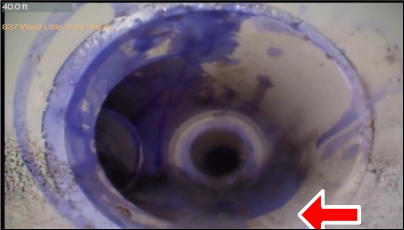
Sewer Line Condition [Inspected]

- ◆ The sewer line is functioning and no conditions requiring repairs were observed.
