BPG Inspection, LLC

**837 West Little York Unit B
Houston TX 77091**

Client(s): Bowen
Inspection Date: 10/29/2023
Inspector: Billy Cook , (TX) 25062

1. Plumbing

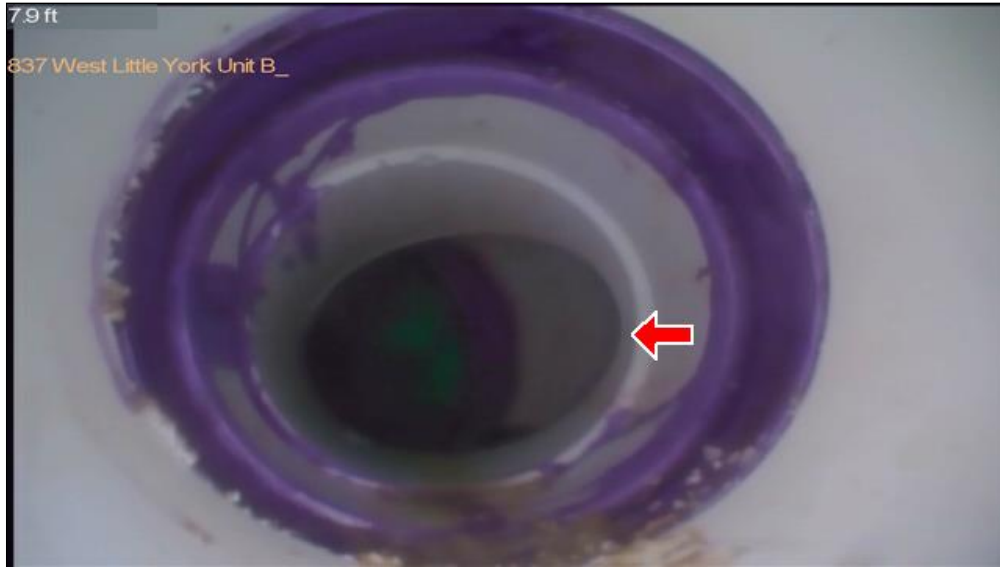
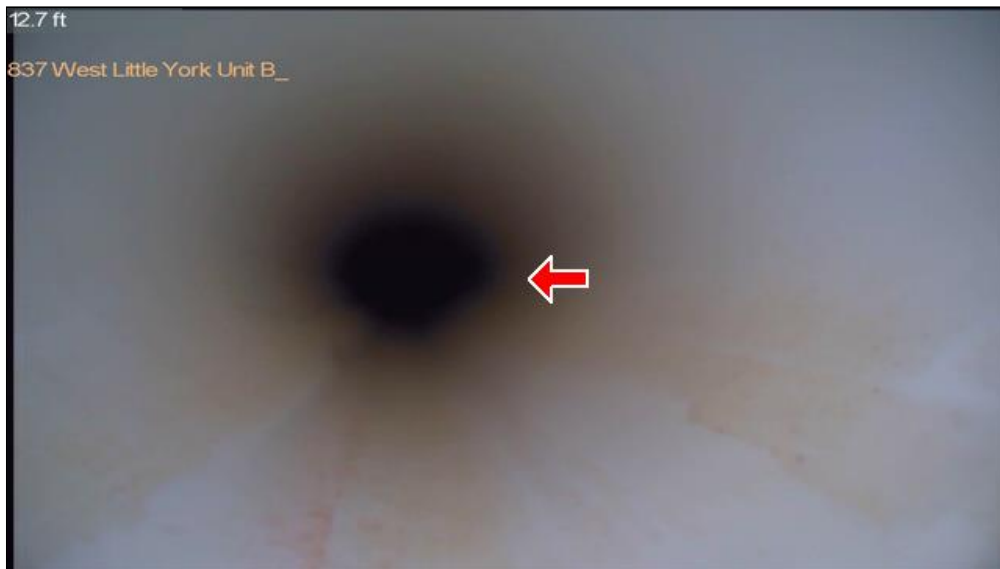
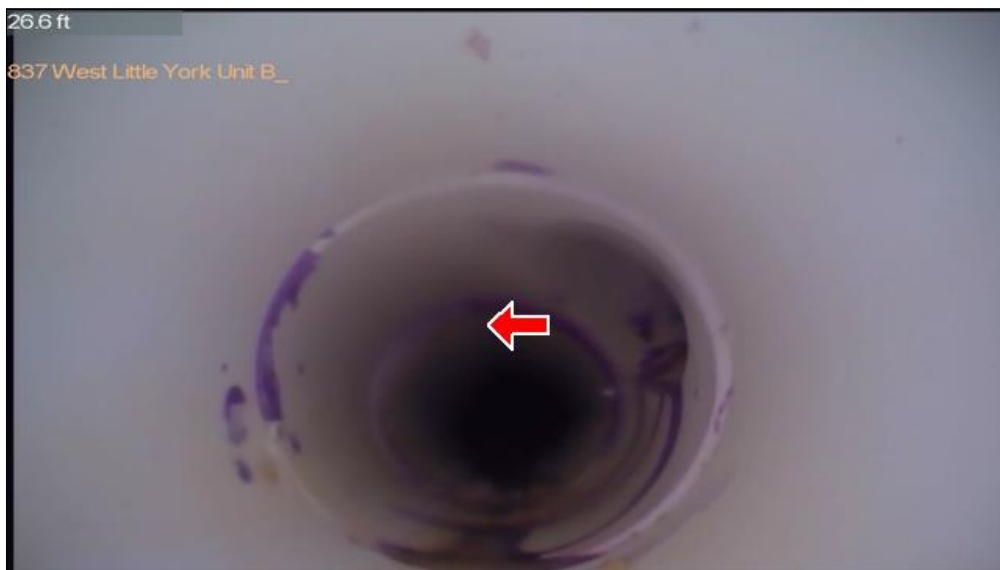
- ◆ The sewer line is functioning and no conditions requiring repairs were observed.

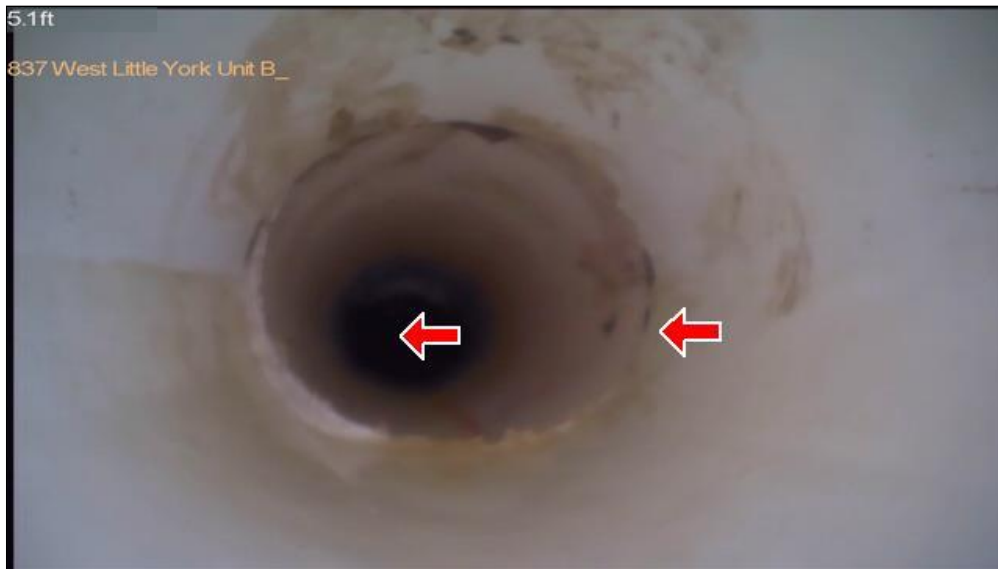
- ◆ Repair has been made.
