EVALUATION SUMMARY
GMS Home/Commercial Inspection Service, LLC
281-413-1511
28342 Emerald Oaks
Magnolia, TX 77355

As requested a review of the foundation system was performed on 12/26/24. The home is a two story wood frame home approximately 3387 sq ft with a brick and siding exterior. The foundation system type is a conventional rebar floating slab.

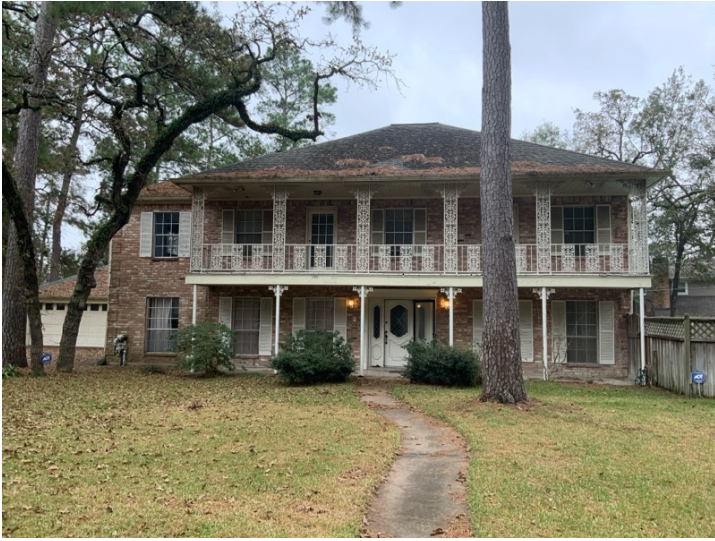
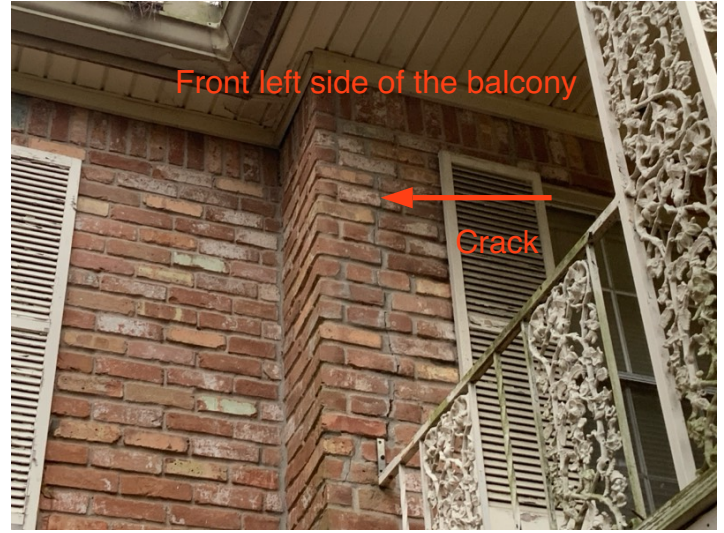
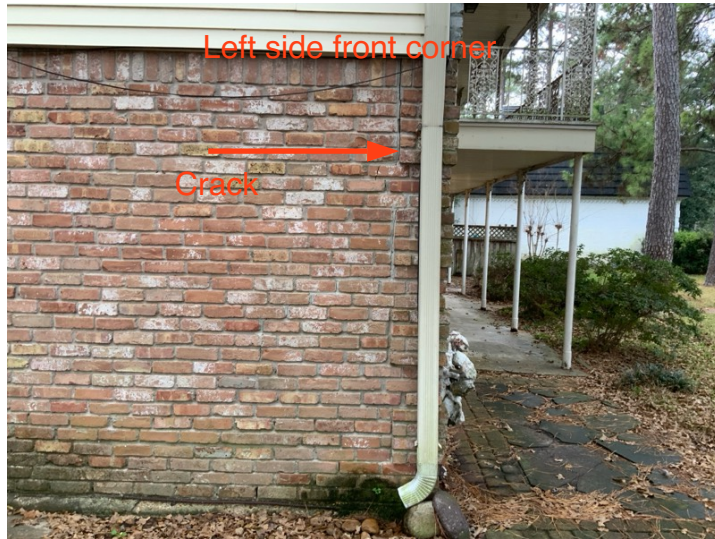
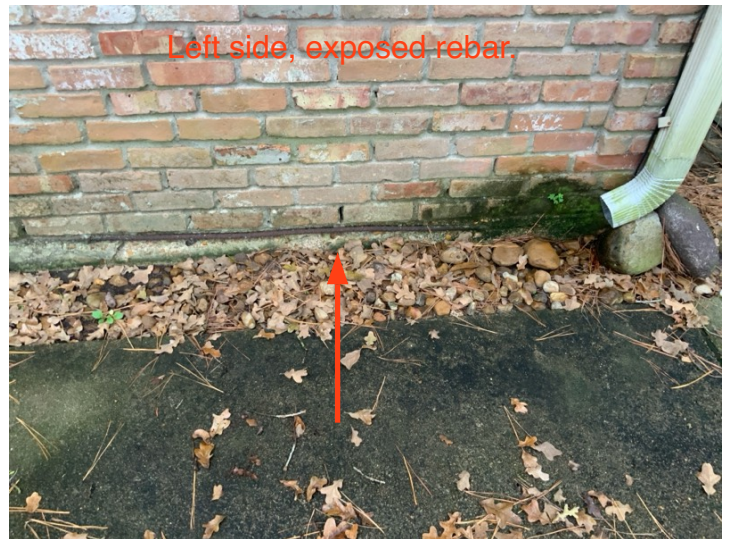
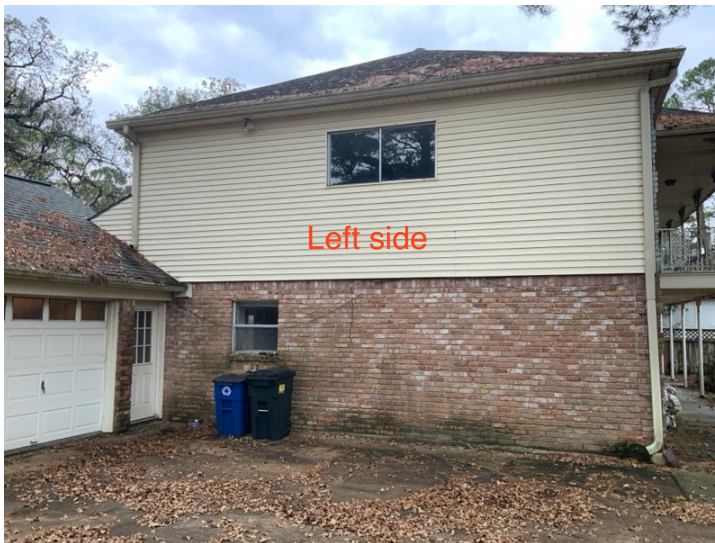
The home is built on a floating concrete slab movement and settlement is expected and considered normal. Some minor cracking/seperation in the exterior brick was found. This condition is considered normal. Brick is a non structural component of the home. See pictures on page 4 and 5. No excessive movement in the exterior was noted.
