Property Inspection Report

Texas Premium Inspections

6611 Etchstone Dr
Inspection Prepared For: Janice Christiansen
Agent: Lori Delaney -

Date of Inspection: 9/19/2024
Year Built: 1994 Size: 2983
Weather: 79°, sunny, no breeze

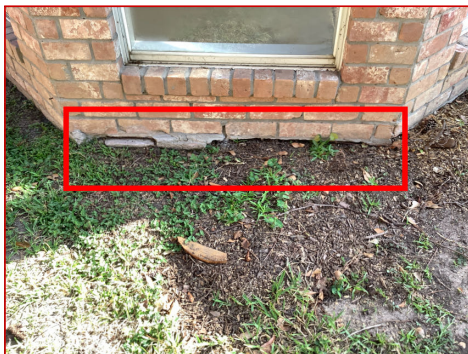
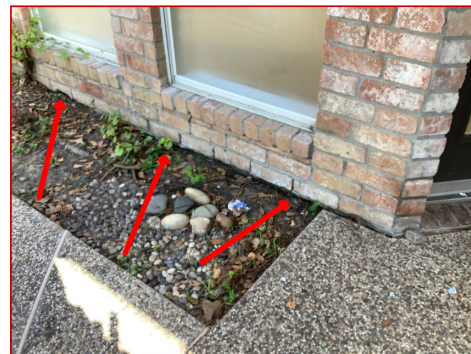
- Voids in the foundation or deterioration need to be patched.

Foundation voids

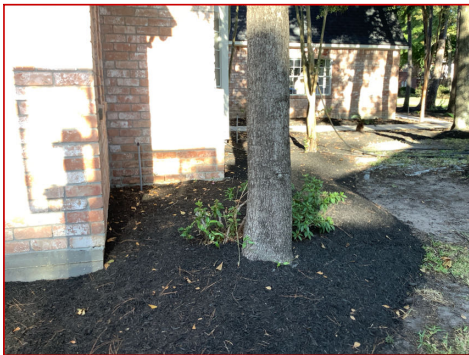
- Recommend all downspouts, roof drains must discharge a minimum of 5' (five feet) from footing or too an approved drain system
- The inspector feels that there are trees too close to the structure and may cause damage to the foundation and or structure in the future.

Tree too close

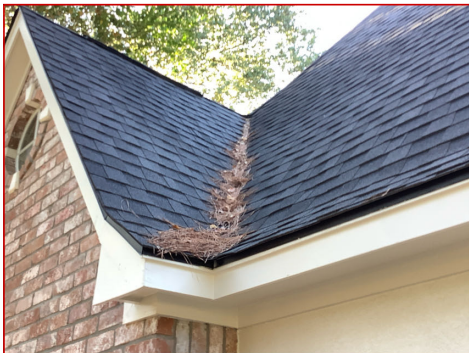
Debris

- Debris should be removed from the roof to avoid moisture damage to the shingles.

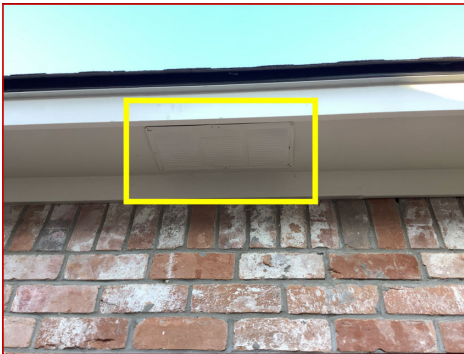
Backwards soffit vents

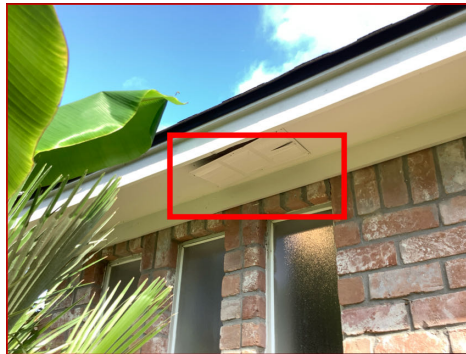
Loose covers

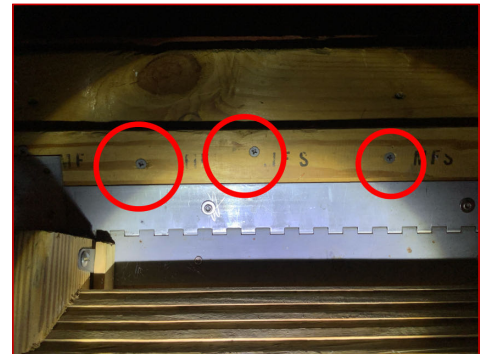
Improper fasteners

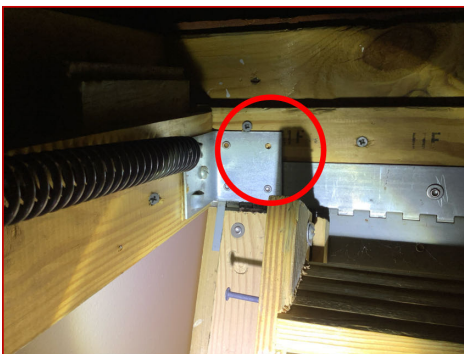
Improper installation

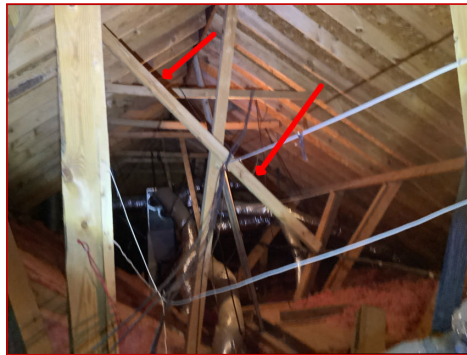
- The roof framing had loose, damaged or missing collar ties. Collar ties are specified by engineers or architects for structural reasons. The Inspector recommends that before the expiration of your Inspection Objection Deadline you consult with a qualified contractor to gain an idea of options and costs for replacement of damaged collar ties.
- One or more soffit vents are loose, damaged or missing and should be repaired or replaced to prevent vermin from entering the attic space.

Loose collar tie

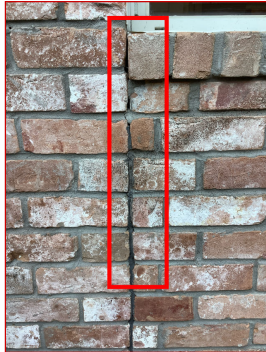
Deteriorating sealant

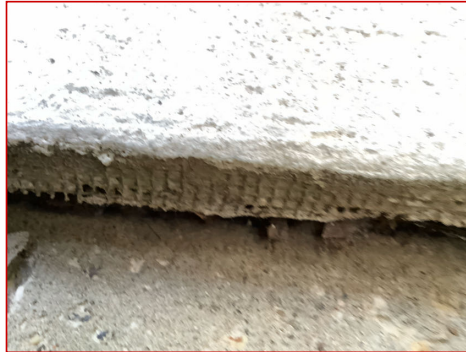
• All weep screed must have at least 4" inches of clearance covering the foundation.

No weep screed

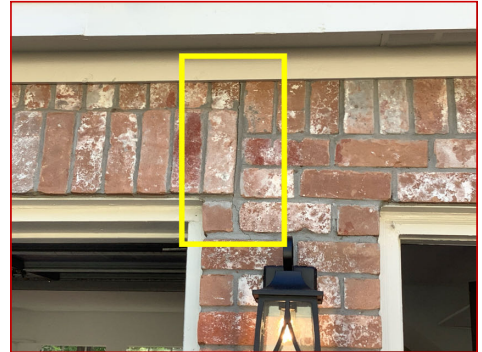
Mortar cracks

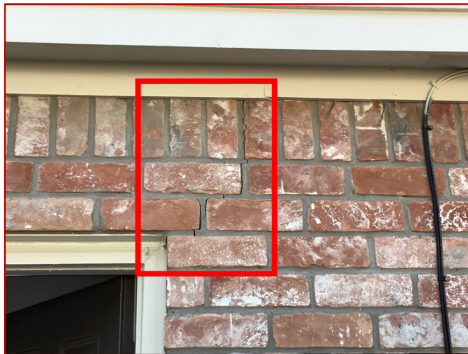
Mortar Step cracks

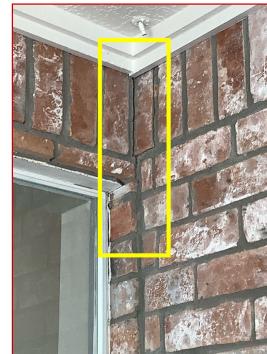
Mortar cracks

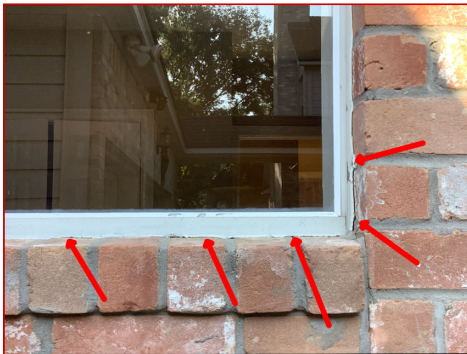
Sealant maintenance needed around windows

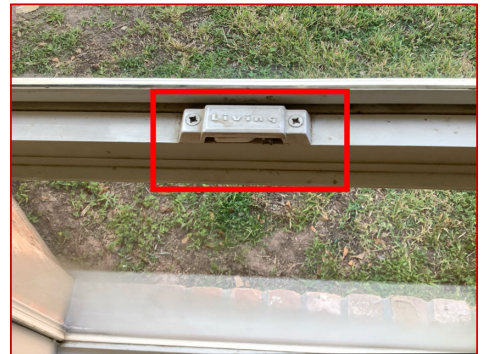
Damaged locks

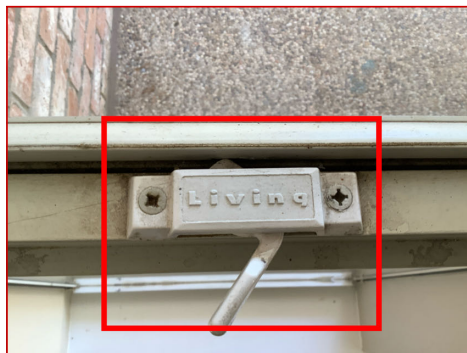
Inoperative latch

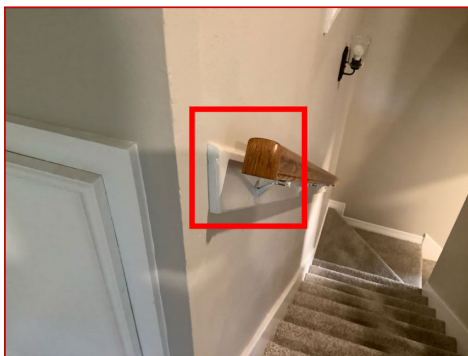
• A handrail at this staircase did not terminate at a wall or newel post as is required by generally-accepted current safety standards. SAFETY HAZARD!

Improper termination

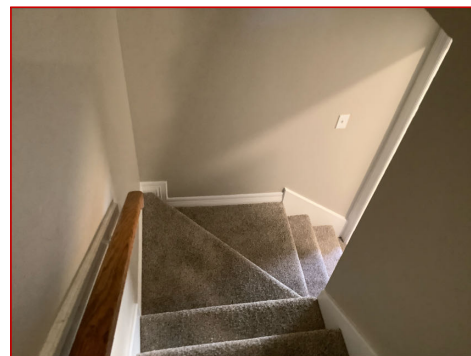
• A handrail at this staircase did not comply with generally-accepted current standards which require that handrails be continuous over the full length of the flight of stairs from top riser to bottom riser. For safety reasons, the Inspector recommends that the handrail be altered or replaced to protect the entire staircase.

Non-continuous / absent

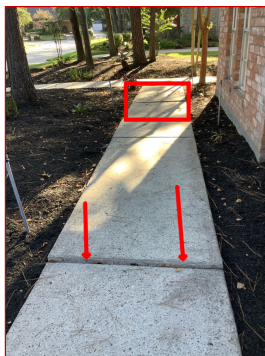
- There are locations in the sidewalks that the concrete has shifted, creating uneven areas that are above 1/4" rise and are creating a possible trip or fall hazard to an individual, potentially causing severe or serious injury.

Trip hazard

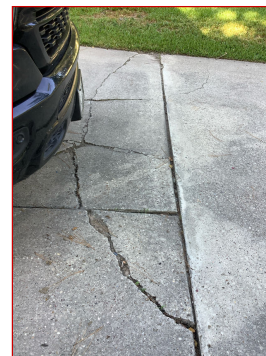
- There is one or more minor cracks in the driveway that, in the inspectors professional opinion, will not cause a trip hazard or deficiency of any type. No further recommendation is required.

Cracked driveway

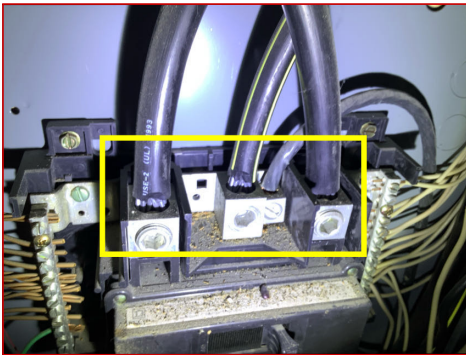
Anti corrosion material absent

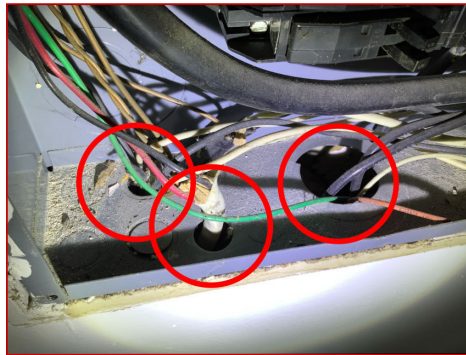
Bushings absent

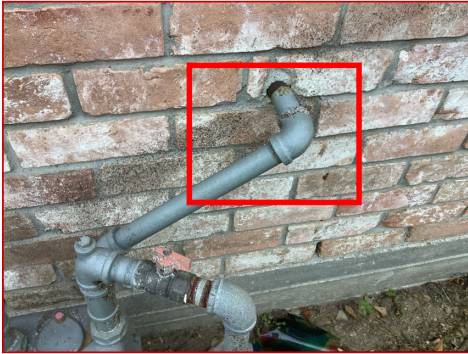
No visible bonding on gas pipe

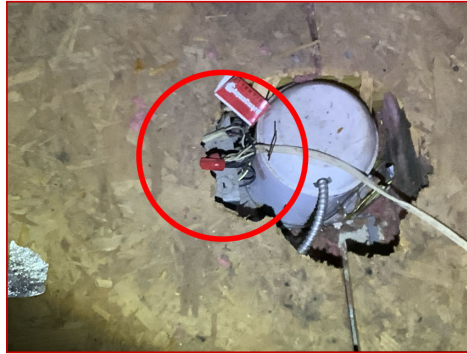
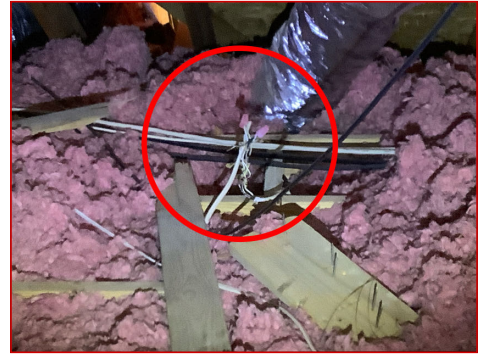
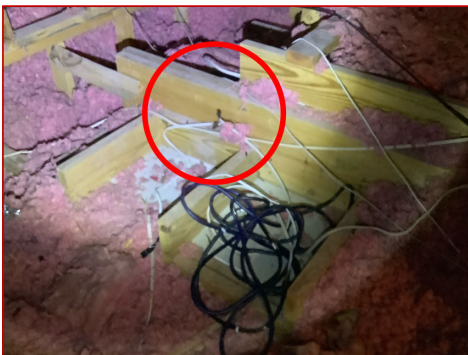
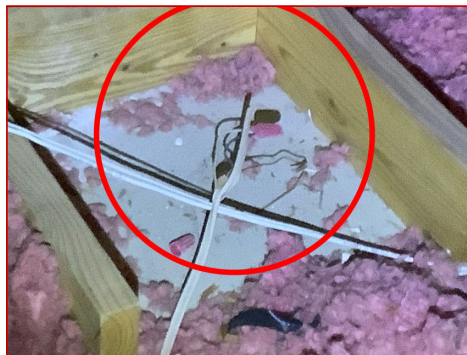
Improperly spliced and terminated wires

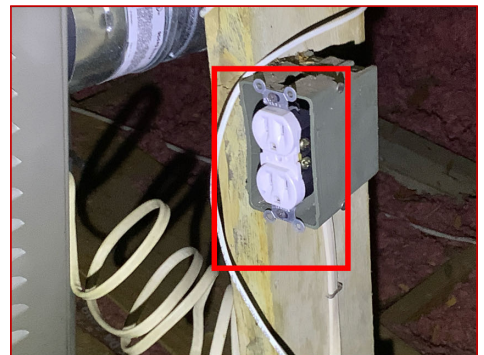
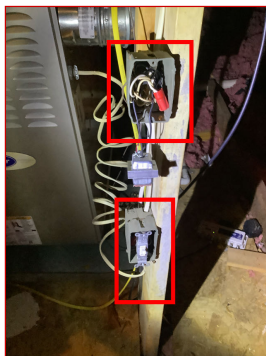
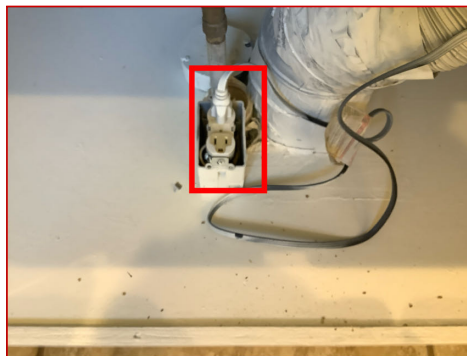
Missing cover plates

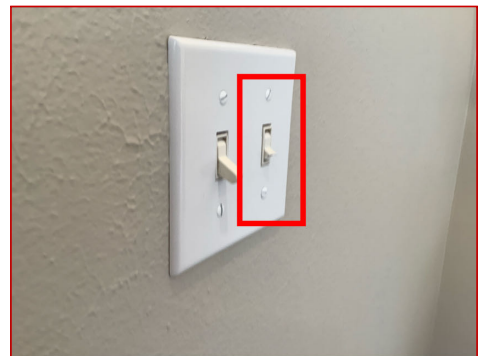
Damaged switch

• The damaged light switch should be repaired. This light switch is located in the kitchen.

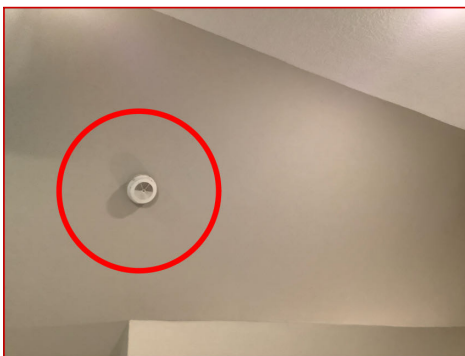
- Proper placement of smoke detectors is as follows: smoke detectors can be located on the ceiling with the side of the detector greater than four (4) inches from the wall - or - on the wall of a bedroom with the top of the detector located four (4) to twelve (12) inches down from the ceiling. A smoke detector cannot be installed and placed within three feet from the end of a fan paddle or the return registers of a forced air HVAC system

Improper placement

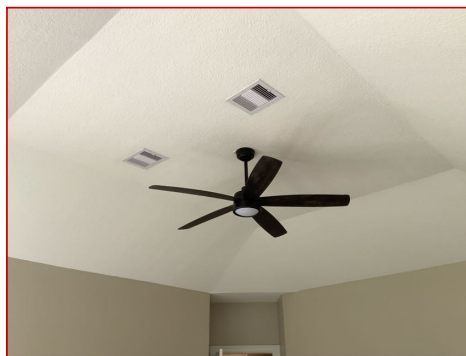
- There are fire or smoke detectors missing or not present in all locations required. Alarms are required in each sleeping room and directly outside each sleeping area in the immediate vicinity. A smoke alarm is also required in the room containing a fireplace. SAFETY HAZARD! All smoke detectors should be installed in accordance with the manufacturer's recommendation and be UL listed.

Smoke detectors absent

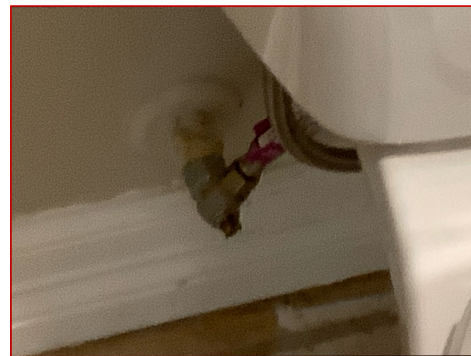
- The shower had functional flow and functional drainage at the time of the inspection.
- At the time of the inspection, the kitchen sink and operation of the faucet, spray unit, sink basin and under sink plumbing appeared to be in serviceable condition in the kitchen.
- The kitchen sink had functional flow and functional drainage at the time of the inspection.
- It is recommended that a backflow preventer device be added to the hose bib(s). (i.e. vacuum breaker/ anti-siphon device)
- A supply faucet was missing a handle at the time of the inspection.

Missing handle

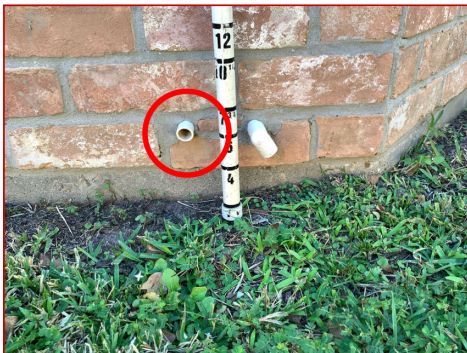
- The discharge pipe serving the catch pan for the water heater should is required to terminate in indirect waste or 6" to 24" inches from grade, pointing downwards with no threads on the end or 6" above the floor in the garage and diverted away from damageable materials. Repairs should be taken for safety reasons.

T&P relief valve and catch pan drain termination

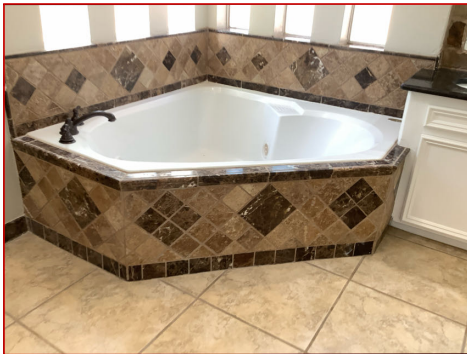
- The hydro-massage therapy tub was inoperative at the time of inspection. This should be investigated further and repairs undertaken, if necessary.
- The drain plug for the hydro-massage therapy tub is missing and should be replaced.

Hydro massage tub

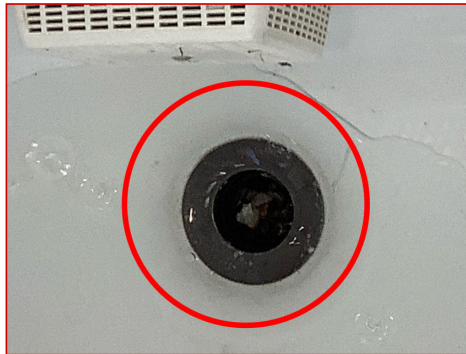
Missing drain plug

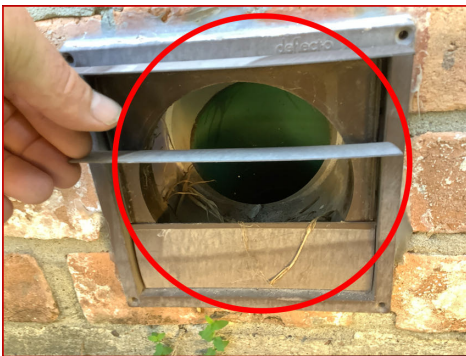
- The exhaust vent for the stove top downdrafts and discharges the exhaust to the exterior.
- The range hood was not tested due to unit was in disrepair.
- The exhaust fan appeared to be inoperable at the time of the inspection.
- The screen for the exterior exhaust hood vent is missing and should be replaced to prevent unwanted vermin from entering.

No exterior screen

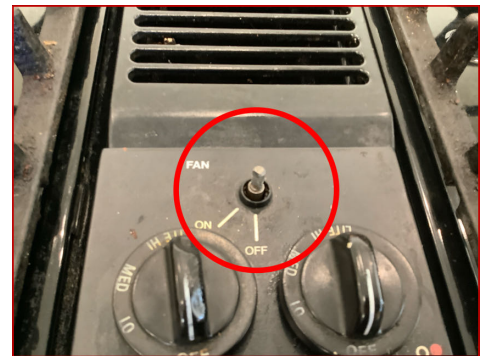
Missing knob

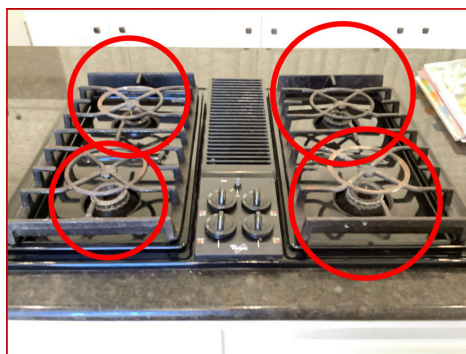
- The range/ oven was not tested due to unit was in disrepair.
- The built in oven was powered by electric.
- The upper and lower electric oven elements were tested at the time of inspection and appeared to function properly. These can fail at anytime without warning. No warranty, guarantee, or certification is given as to future failures. The General Home Inspection testing of ovens does not include testing of all oven features, but is limited to confirmation of bake and broil features. You should ask the seller about the functionality of any other features.
- A control knob for the oven is damaged and should be repaired.
- The gas countertop unit was found to be inoperative under normal operating procedures when tested. Recommend repair or replacing.

Inoperative

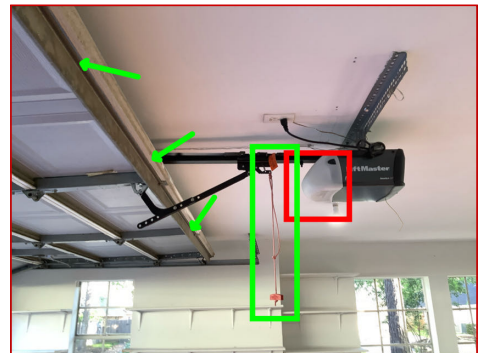
Inoperative opener light, strut and lanyard ok

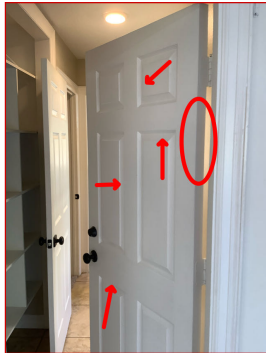
No self closing apparatus present / not a proper fire rated door

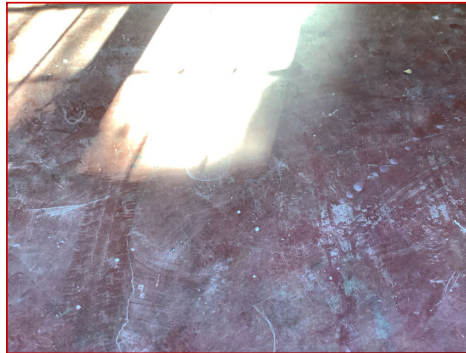
Shrinkage / random cracks

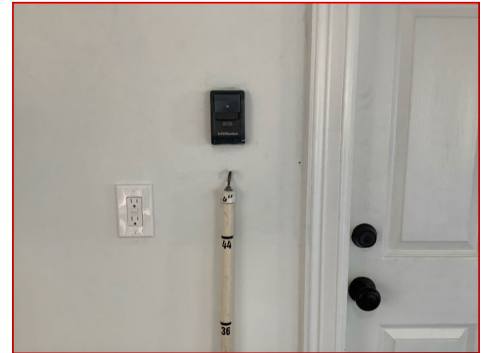
Switch height

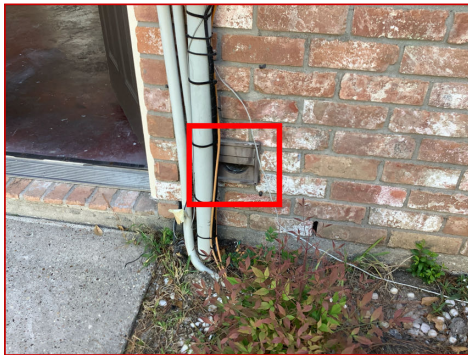
- The Inspector observed few deficiencies during inspection of the dryer vent cover and dryer tube. Notable exceptions will be listed in this report.
- The dryer vent terminated horizontally through the laundry area wall straight to the exterior.
- For safety reasons and good maintenance practice, the dryer vent tube should be cleaned.
- The dryer vent has a damaged exterior cover and should be repaired or replaced to keep vermin from entering the house.

Dryer vent
