## MECHANICAL REPORT

3763 Rice Boulevard  
Houston, TX 77005

# PROPERTY INSPECTION REPORT FORM

3763 Rice Boulevard, Houston, TX 77005

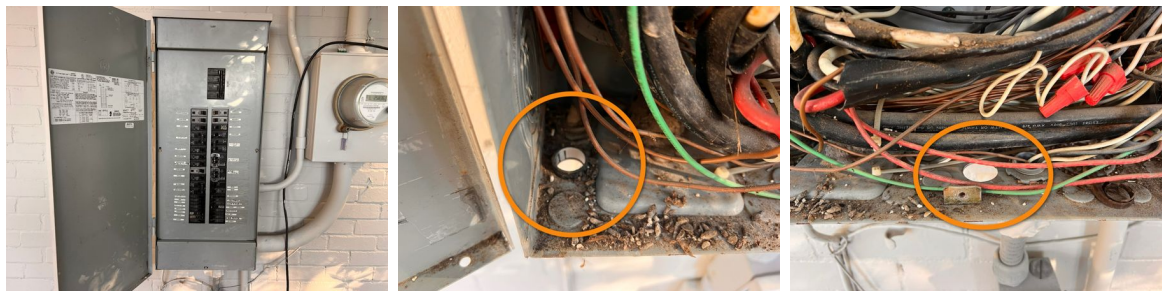
**1: Knockout missing inside box**

A knockout opening that was not being used was missing a cover inside the electrical box. The opening needs to be covered in an approved panel.

Recommendation: Contact a qualified professional.

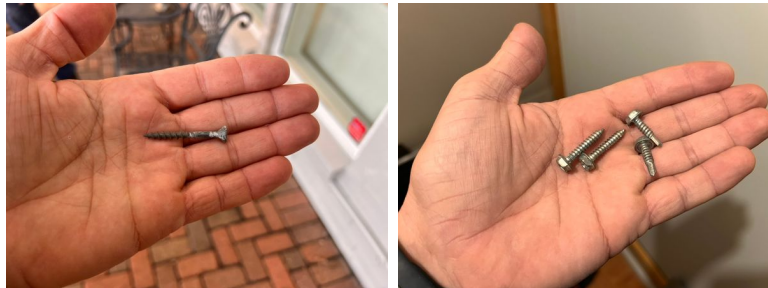
One or more of the breaker panel screws had a pointed end, rather than a blunt end. This can be a safety hazard, as the point can easily penetrate one of the conductors, causing a short circuit.

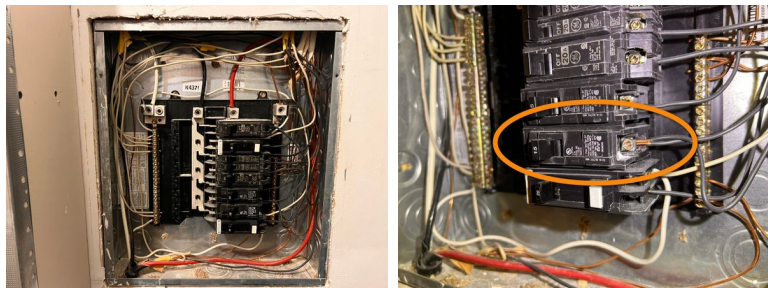
### 5: Breaker - Double lugged

A breaker was observed inside the panel with more than one wire attached. Each wire should be on its own breaker.

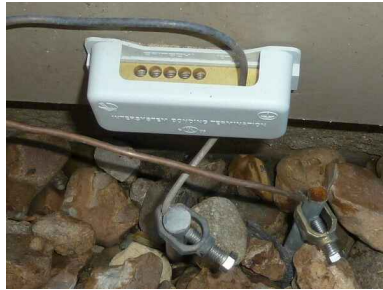
### 6: Low Voltage Block - Not Present

A low voltage grounding block for the low voltage service was not installed at the grounding rod. A grounding block may need to be installed for low voltage network service, such as phone and cable.

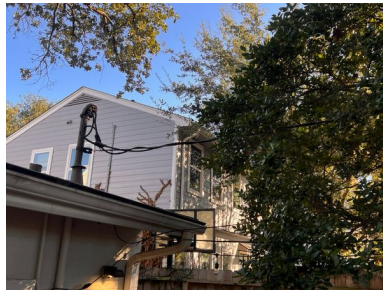
### 7: Service Conductors - Contact with trees

The overhead service entrance conductors were in contact with tree limbs, and the tree limbs need to be cut back.

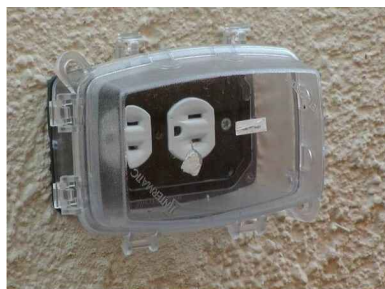
An exterior outlet that was not protected by a water tight cover plate was observed.

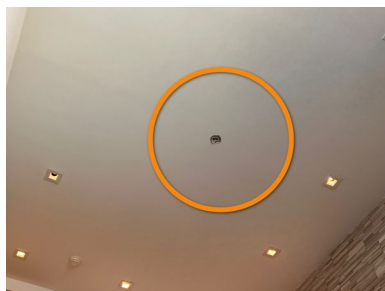
### 5: Light Fixture - Missing

A light fixture was missing.

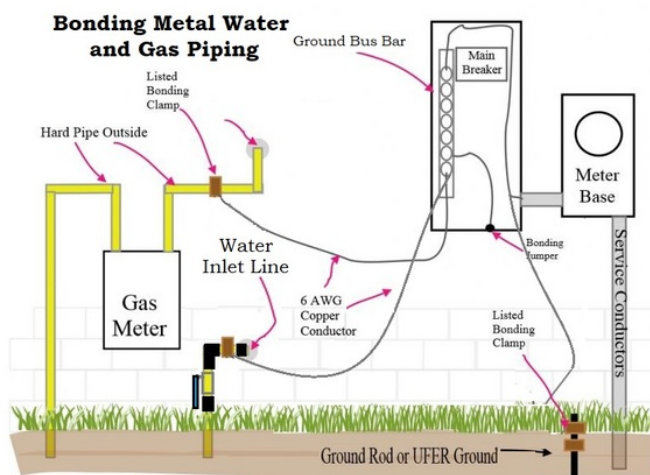
**7: Gas and/or Water Piping - Bonding Not visible**

The location(s) where the water supply piping and/or gas supply piping were bonded together and/or back to the electrical ground system were not visible at the time of the inspection. It is recommended that an electrician be contacted to determine if the plumbing in the house is properly bonded and to make any needed repairs.

Recommendation: Contact a qualified professional.

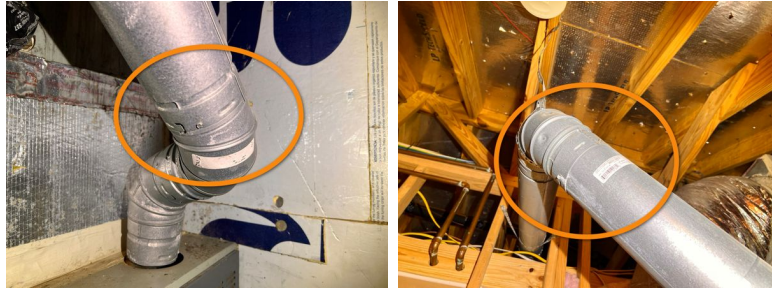
The vent pipe was fastened with screws, which is improper. The vent is designed to connect without fasteners, as screws holes can allow carbon monoxide to seep from the vent pipe. The portions of the vent pipe that were damaged with screws should be repaired.

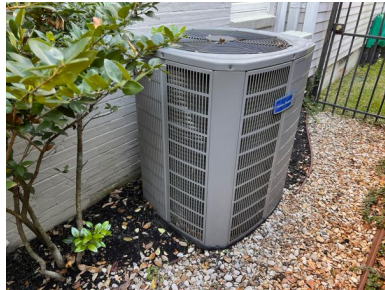
The support pad for the condensing unit was sitting too low and allows the bottom of the condensing unit housing to touch the soil or be covered by water. This condition can rust out the housing, and the condensing unit should be raised to three inches above the ground.

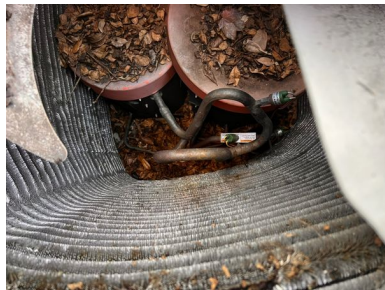
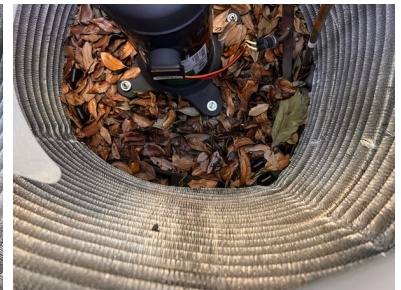
#### 6: Condensing Unit - Debris inside housing

Debris was observed to be inside of the housing and needs to be removed and the inside of the unit thoroughly cleaned by a service company.

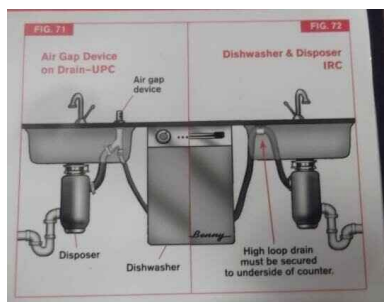
#### 1: No Anti-Siphon

The drain line under the sink was not equipped with an anti-siphon device, nor was it looped up so that the top of the loop is at least six inches above the entrance of the drain line into the disposal. It is recommended at least that the drain line be looped to prevent the water from the garbage disposal from siphoning back into the dishwasher, or an anti-siphon device installed.
