HEDDERMAN ENGINEERING. INC.

## STRUCTURAL REPORT

3763 Rice Boulevard  
Houston, TX 77005

REF: CONDITION OF PROPERTY SURVEY

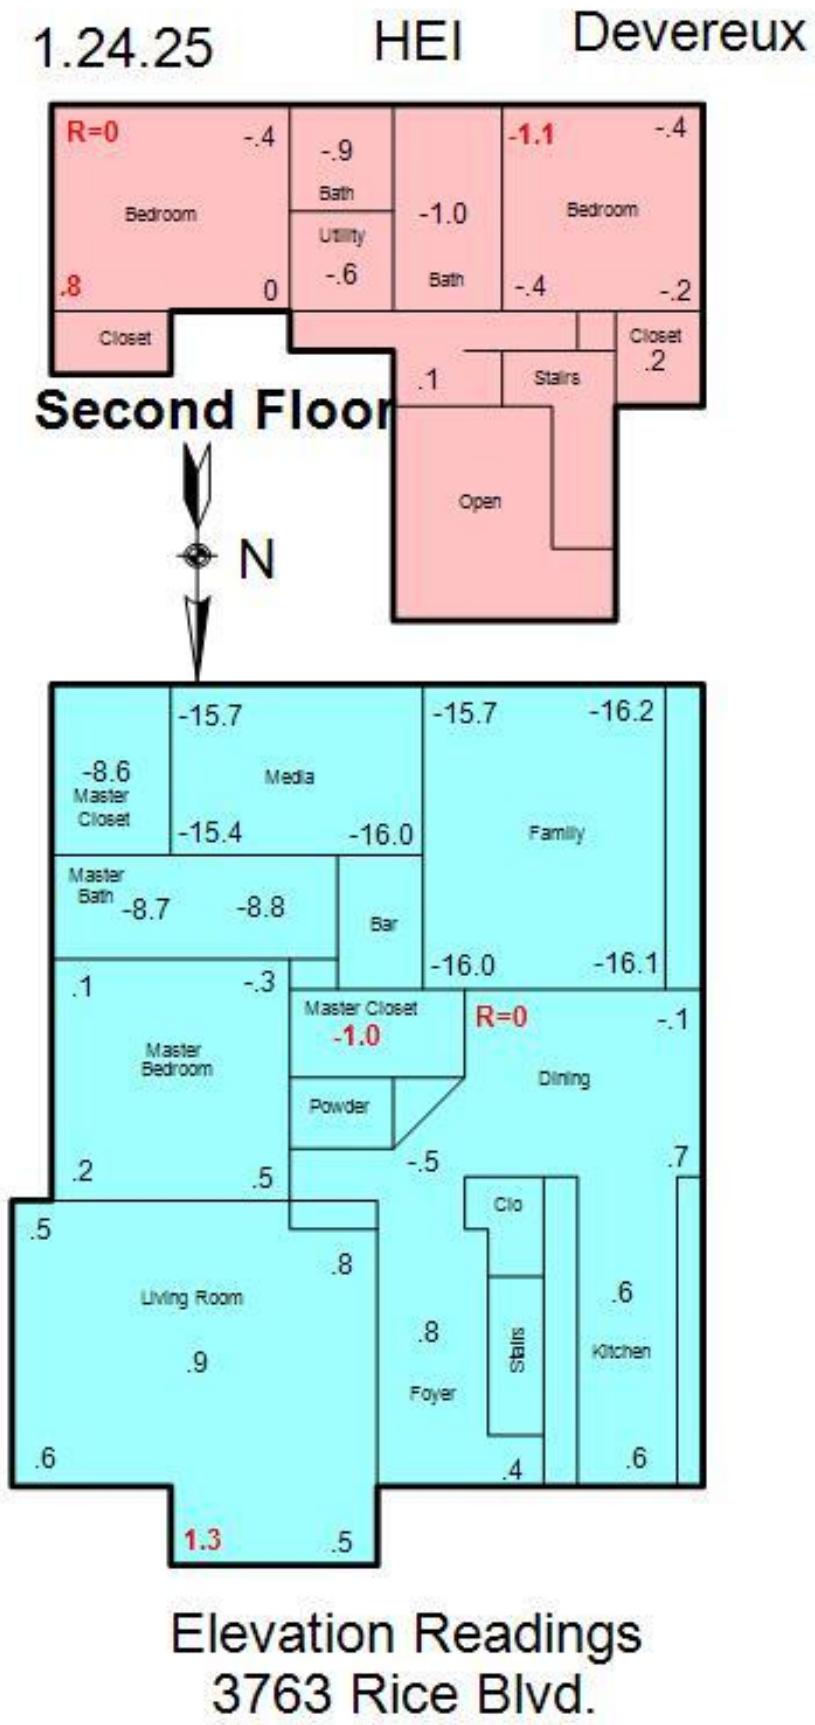
##### Second Floor:

The difference in elevation between the high point and low point was 1.9 inches. The high point was located at the east bedroom, and the low point was located at the west bedroom. The unlevelness takes place over a horizontal distance of approximately 30 feet.

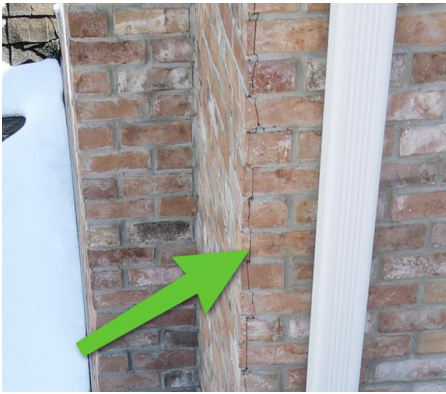
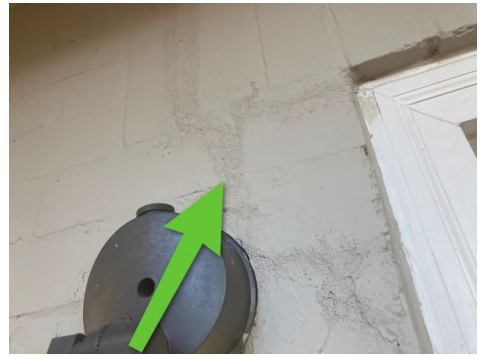
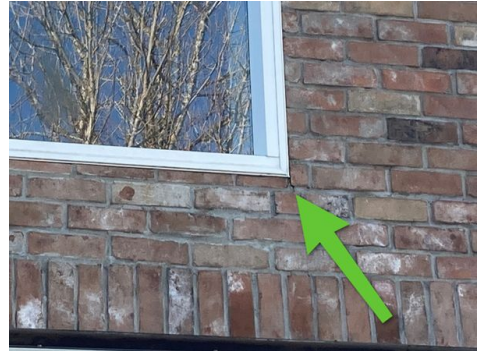
**Differential Movement: Veneer - Cracks/Patches**

Cracks and/or patches were observed in the exterior veneer at the time of the inspection, including at the locations shown in the photos. It is recommended that the cracks be repaired for cosmetic purposes.

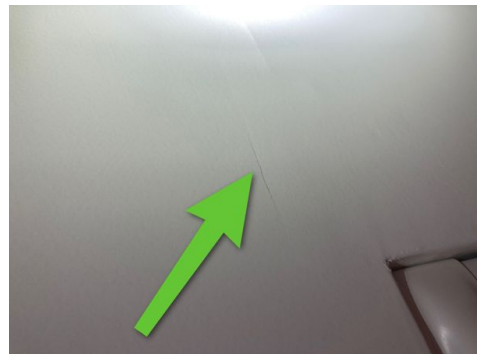
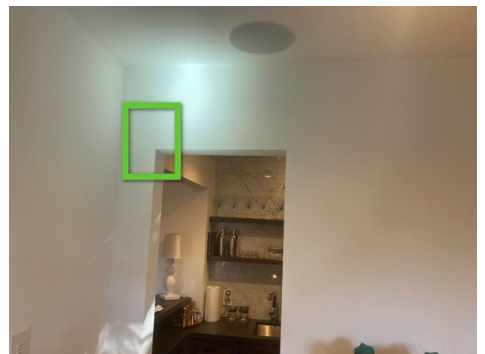
Dining room, family, living room, and the west bedroom closet.

**Differential Movement: Sheetrock Cracks - Minimal**

We observed that sheetrock cracks were minimal in number and degree at the time of the inspection.

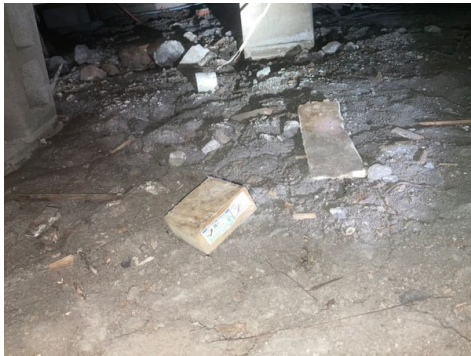
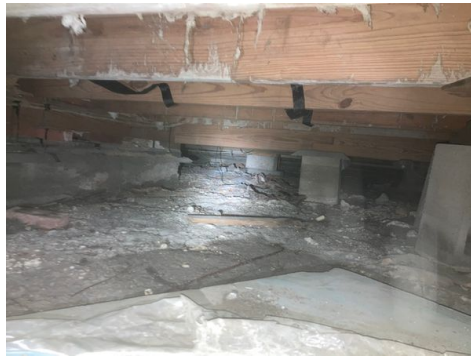
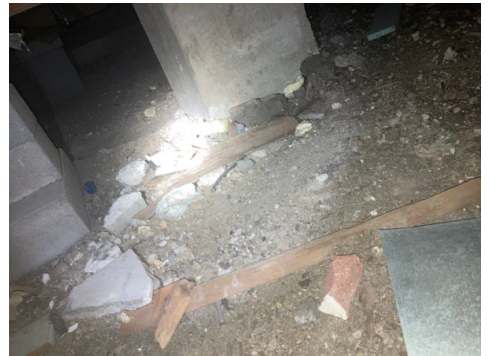
We observed debris on the ground at the crawlspace, and it is recommended the debris be removed.

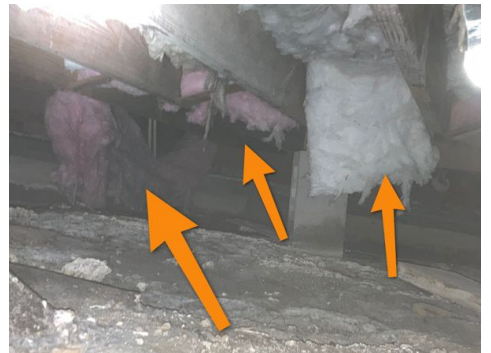
**INSULATION LOOSE**

We observed that the fiberglass batt insulation between the floor framing at the crawlspace was loose and falling down at some locations in the crawlspace, and repair is needed.

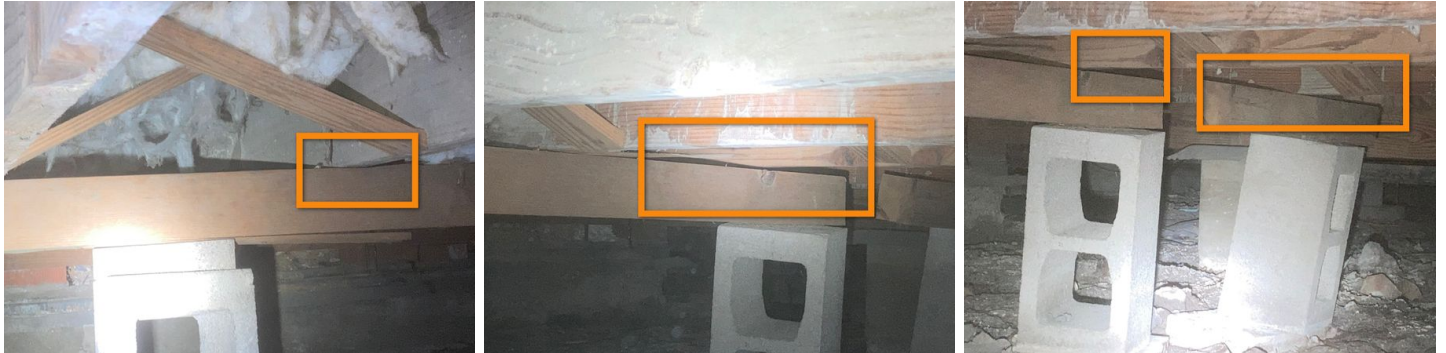
### PIERS SETTLED - REPAIR

We observed piers under the house at the crawlspace that have settled, and are no longer supporting the house framing. It is recommended that a foundation repair contractor be contacted to make the needed repairs.

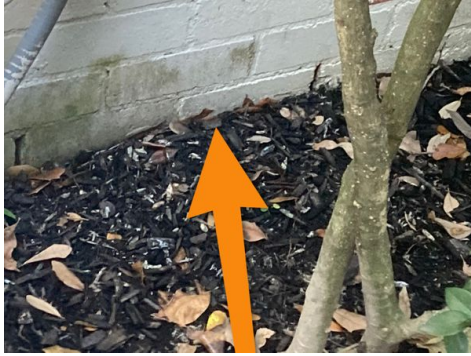
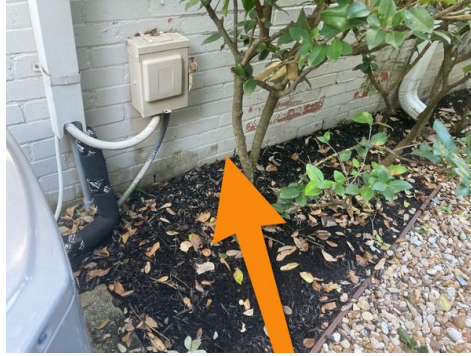
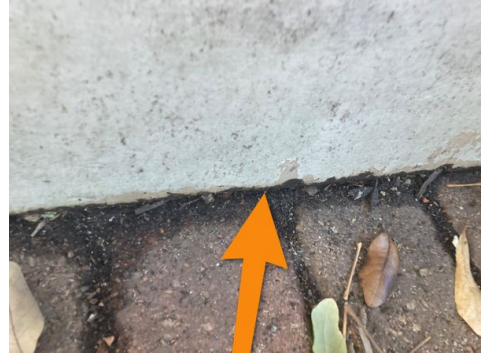
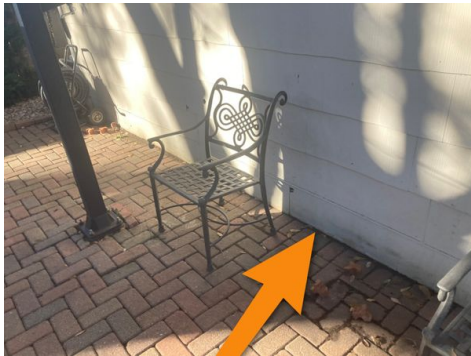
The perimeter grading and/or flower beds was too high at some areas, and was graded near or above the top of the foundation. It is recommended that the beds/soil be regraded as needed to prevent water penetration into the house, and to allow for proper drainage.

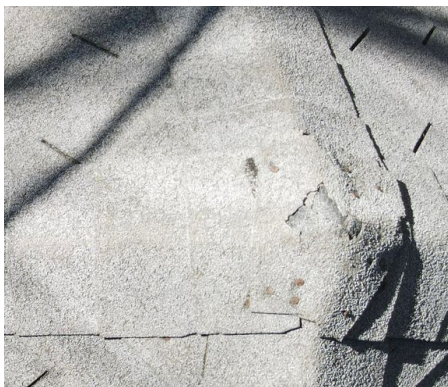
**Wear and Deterioration: Composition - Some**

Discolored, Nail Heads not Sealed, Aggregate Missing

The composition roof surface was showing evidences of some deterioration of the roof surface as described above and shown below.

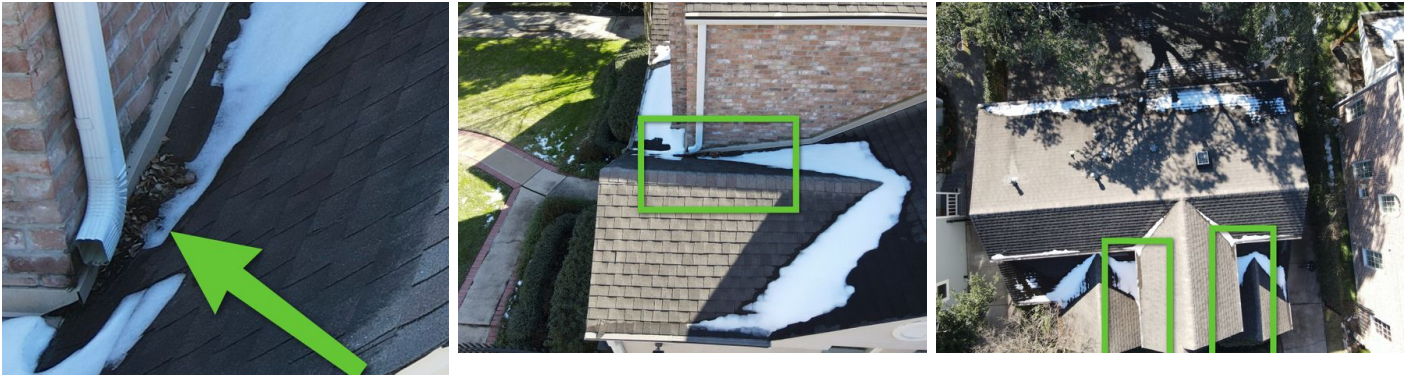
**Roof Details: Valley Narrow**

Front of the house

There was a narrow valley in the roof, where the valley narrows down and will be susceptible to the accumulation of leaves and other debris. This can cause a damming of water running down the valley, possibly causing a roof leak. It is recommended that this valley be monitored, and cleaned on a regular basis.

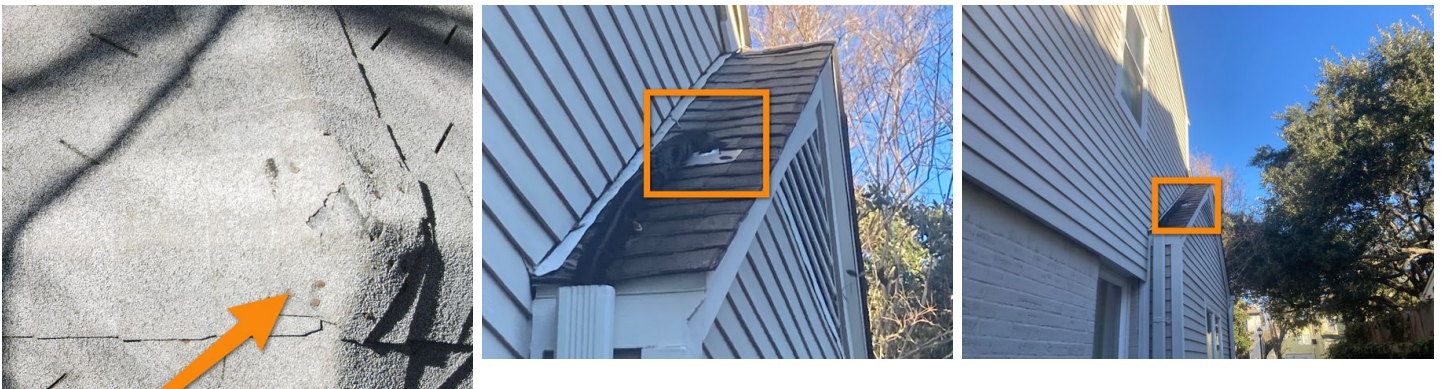
#### DETERIORATED/MISSING SEALANTS

We observed sealants that were cracked/separated/missing and repair is needed.

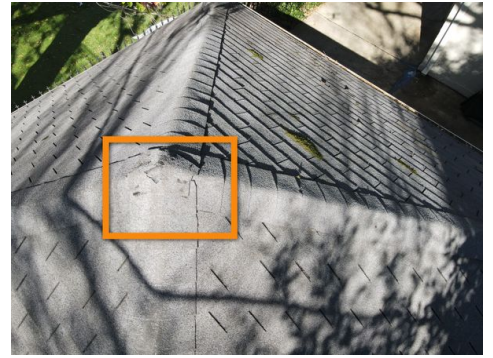
**SHINGLES DAMAGED**

Shingles were observed to be damaged and the roof is in need of repair. Contact a roofing contractor to obtain a cost estimate for repairs.

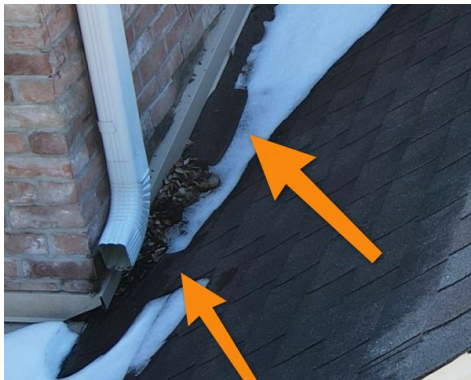
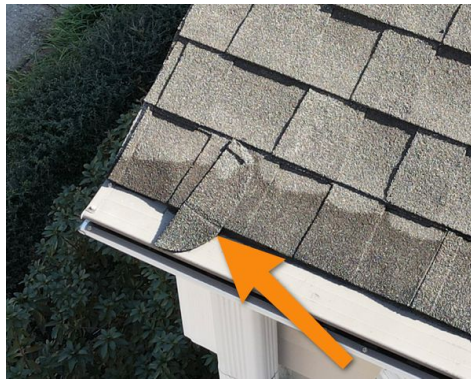
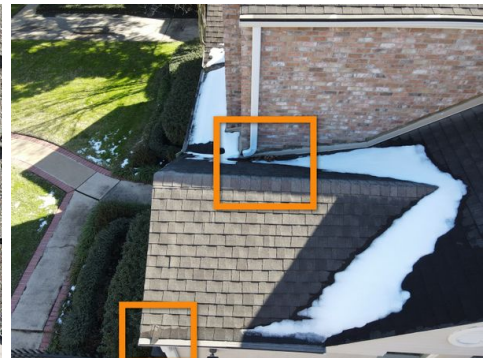
**SHINGLES LIFTED**

Loose/broken shingles were observed at the front lower roof. Further investigation and repairs are recommended with a roofer.

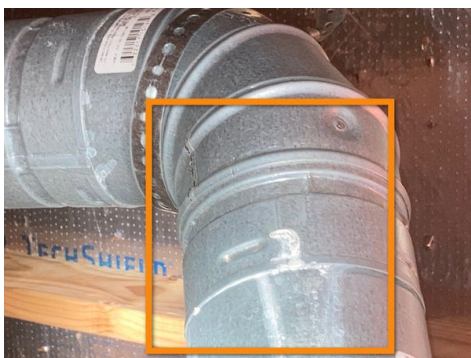
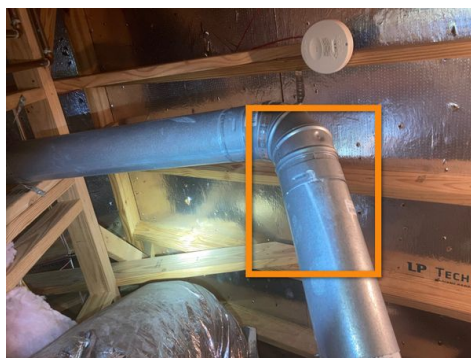
**ATTIC AT VENT PIPE**

We observed water stains on a vent pipe that penetrated the roof surface. Further investigation is recommended with a roofing company to find the source of the leak, and make any needed repairs.

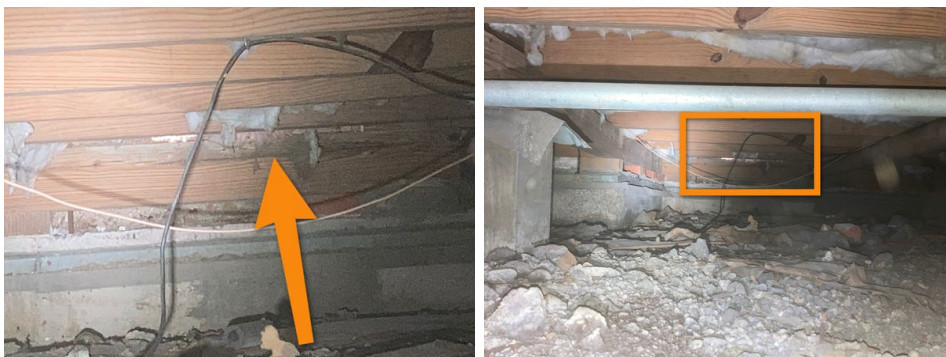
#### WATER STAINS ON FRAMING

Water stains were observed at the crawlspace on the framing members. The materials did not appear to be rotted at the time of the inspection, and the water staining has not affected the ability of these framing members to perform their intended function. Therefore, no repairs are recommended at this time. It is recommended, however, that the source of the water that is causing the staining condition be eliminated.

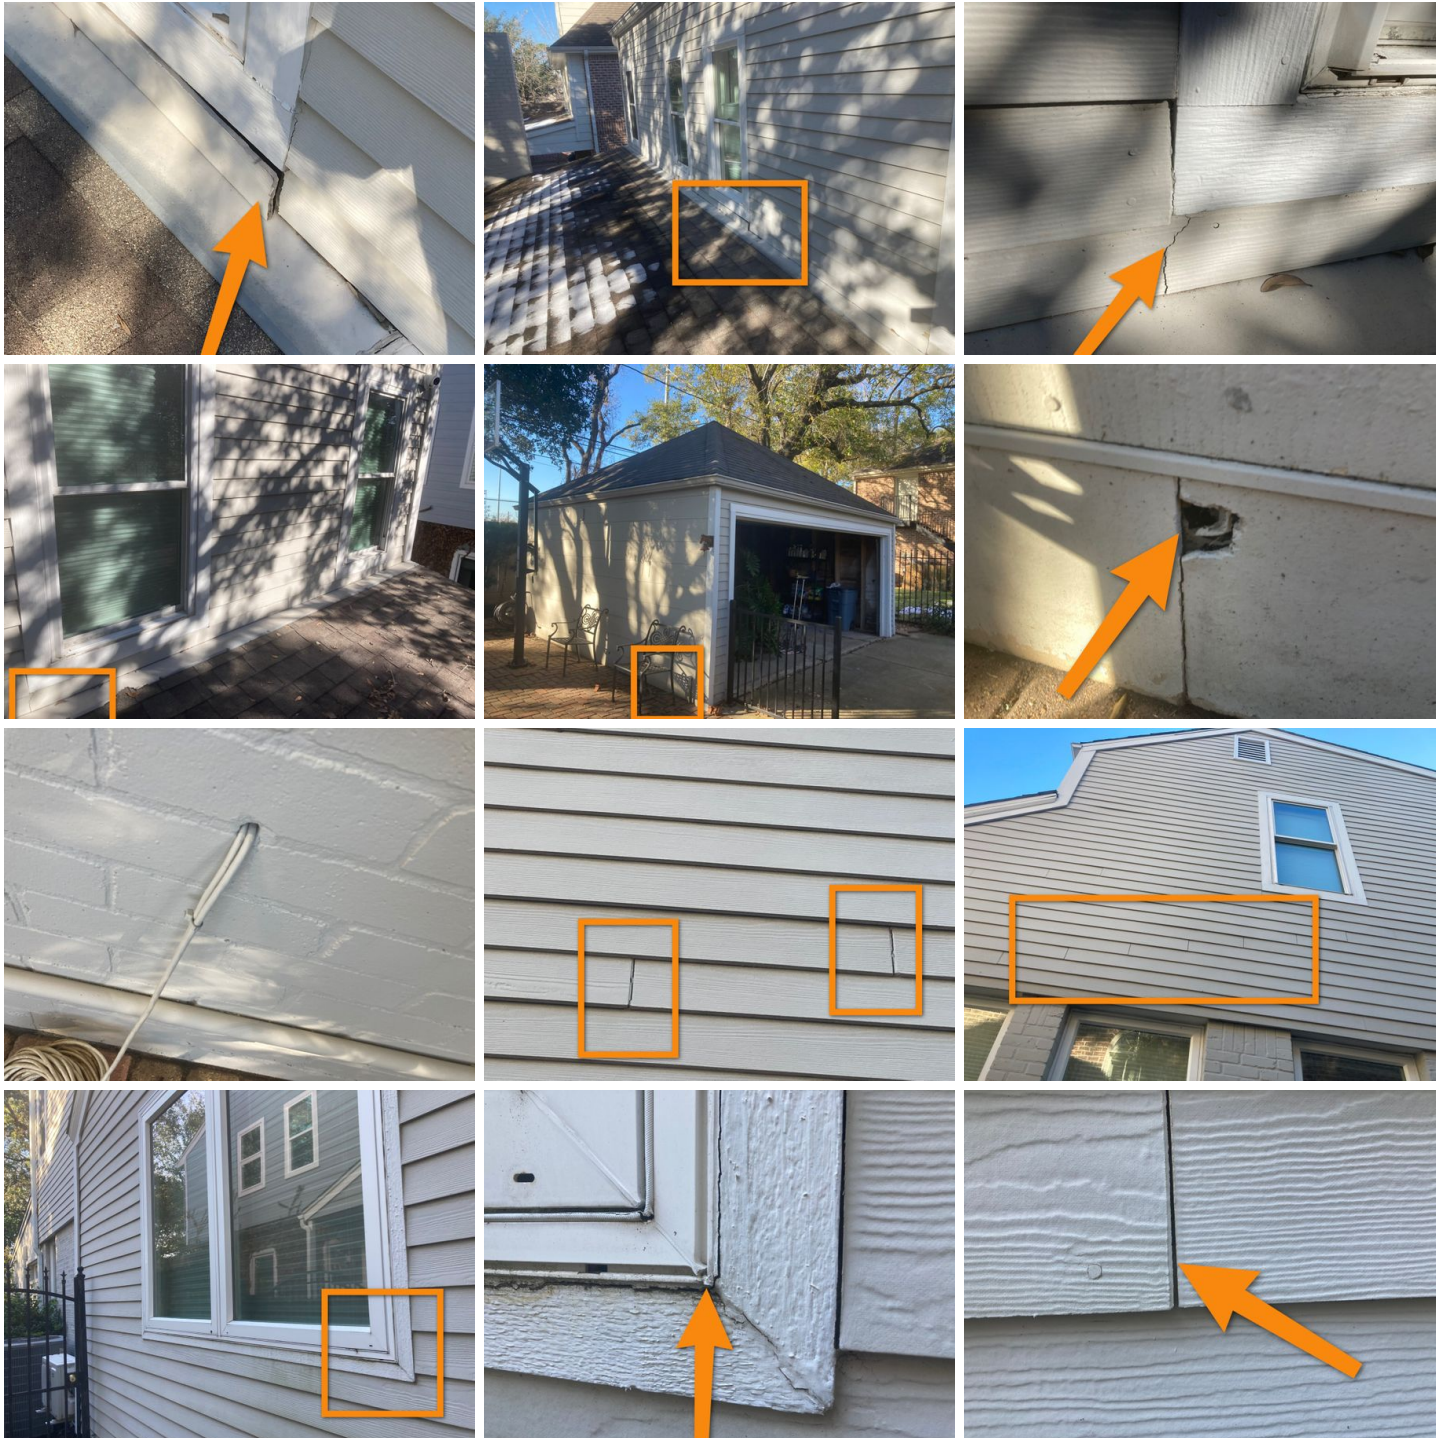
Window sealants, Sealants deteriorated/missing, Light Fixtures, Vent Caps, Hose Bibb, Electric outlet, Piping, Door Threshold, Vertical joint between materials

A substantial vulnerability to water penetration was observed at penetrations/openings through the exterior building envelope, and it is recommended that all penetrations/openings be sealed against water penetration. Typical examples on a structure may include light fixtures, air conditioning refrigerant lines, water piping, gas piping, vent caps, windows, doors, expansion joints, etc. Below is a representative sample of locations and/or photographs showing some, but not necessarily all, locations where there is a vulnerability to water penetration. Have a contractor provide a cost estimate to seal all vulnerable areas on the exterior building envelope against water penetration and/or open up any clogged weepholes in the veneer.

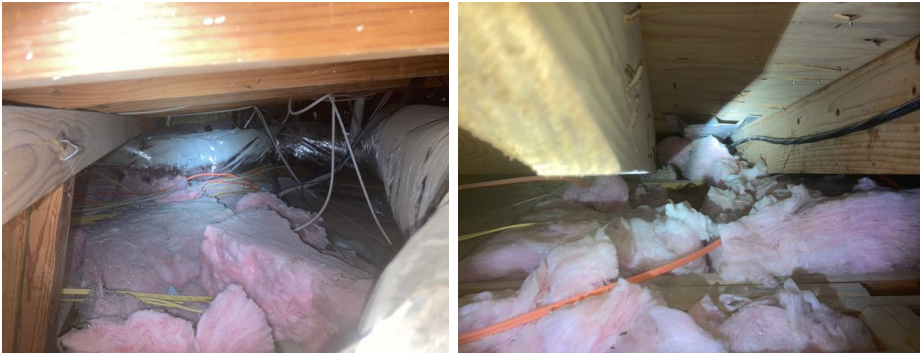
##### Insulation: R30 Batt

The insulation in the attic was average by today's standards. The normal amount of insulation for attics in this area is an R38 energy rating. This attic had approximately 9-10 inches of fiberglass batt insulation in the ceiling, which was marked as being an R30. It is pointed out that the insulation requirements according to the latest standard for new houses in this area is an R38 energy rating.

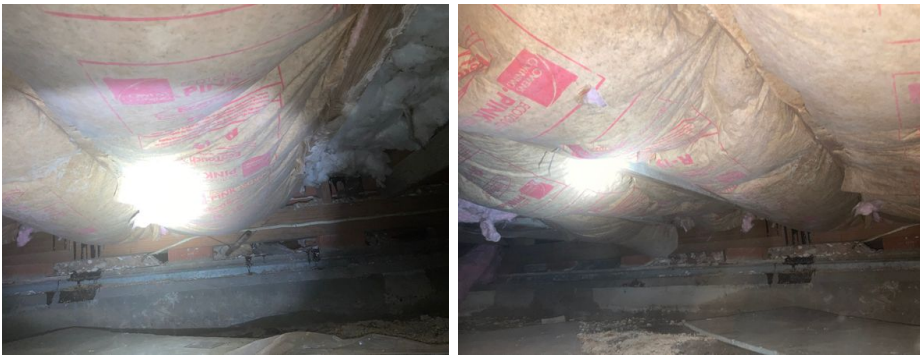
### Insulation: Insulation installed with vapor barrier backwards

Some of the insulation in the crawlspace was installed with the vapor barrier towards the crawlspace area, rather than down against the subfloor. This layout it's a fire hazard and the insulation should be flipped.

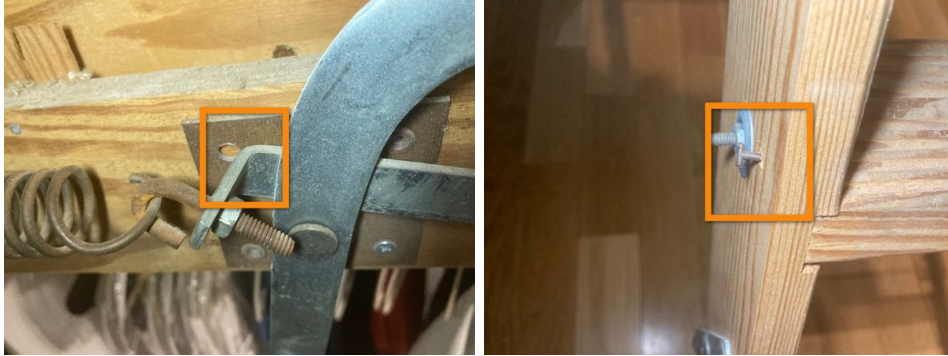
The stair assembly was not properly installed or secured to the framing members, and repair is needed for safety purposes. The condition(s) can be a safety hazard, and repair is needed, as an improperly installed stair assembly can possibly collapse.

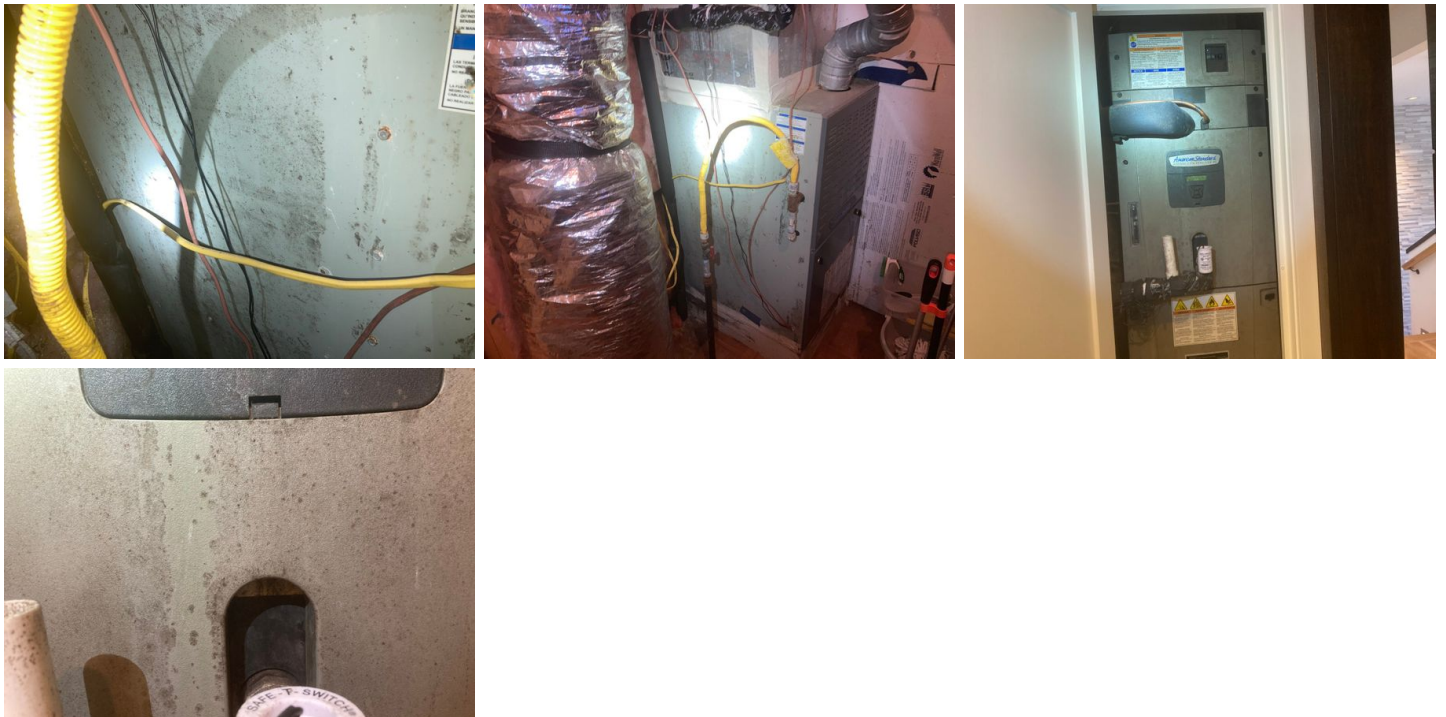
**MICROBIAL GROWTH - HVAC EQUIPMENT**

A microbial growth was observed in the attic on the HVAC equipment/ductwork. This condition can be an indication of inadequate attic ventilation. Further investigation with a service company is recommended to determine if additional attic ventilation is needed.

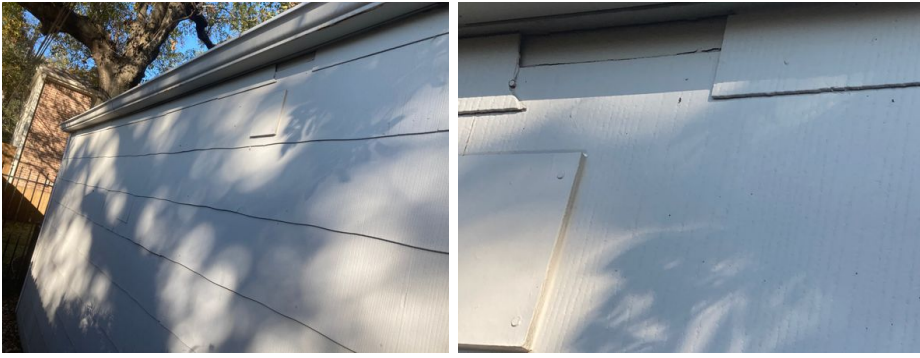
##### Garage siding

Although our inspection specically excludes searching for materials containing asbestos, we occasionally see a material in a readily accessible location that may contain asbestos fibers, and we feel that we would be negligent not to point it out and recommend that further investigations be performed by a qualified professional. The suspected asbestos containing material was located at the siding.

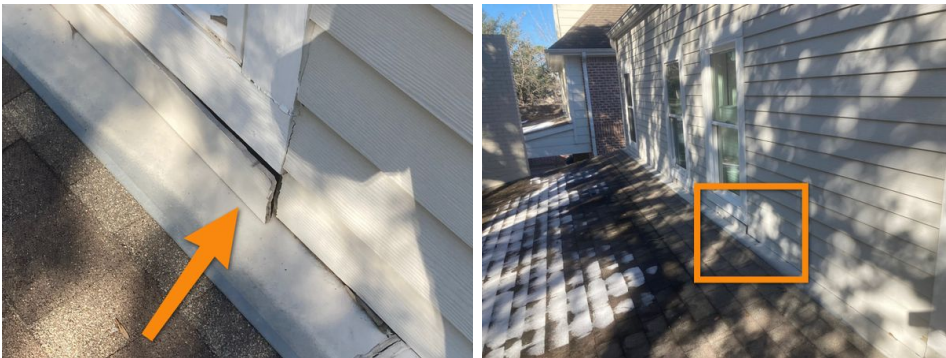
The siding was loose and needs to be secured. Have a contractor provide a cost estimate for all needed repairs.

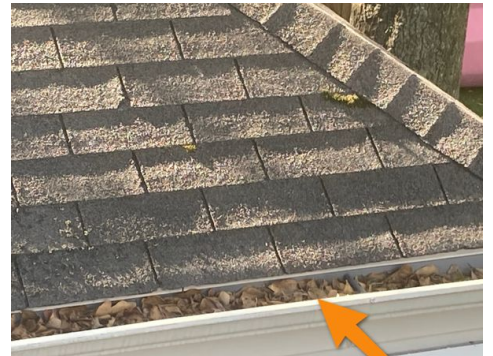
The gutters were observed to have debris in them and are in need of cleaning.

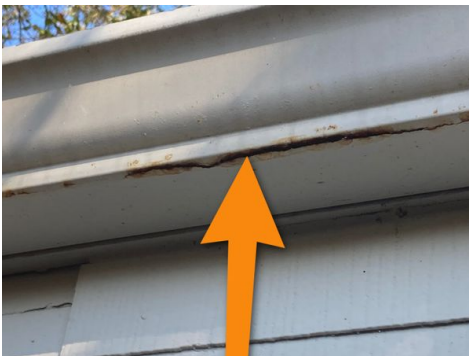
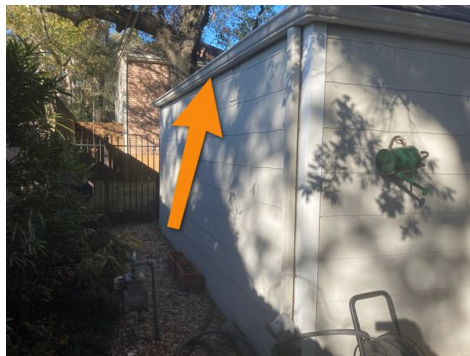
#### GUTTER DAMAGED

The gutter was damaged and needs to be repaired.

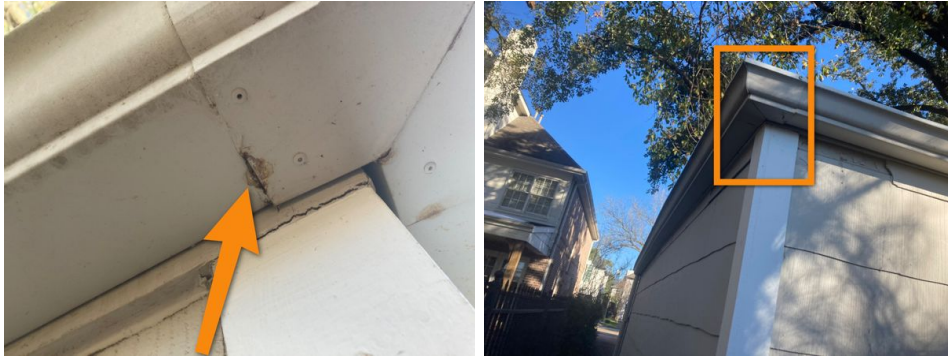
**LEAKING**

The gutters were leaking at the joints and need to be sealed and made watertight.

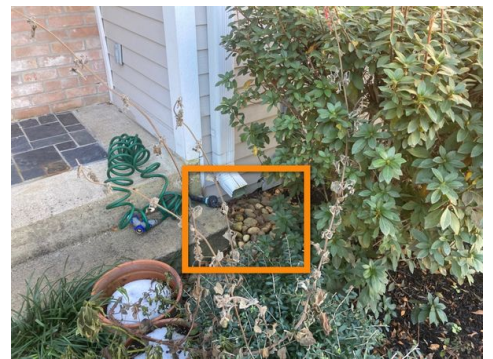
**DS SPLASH BLOCK**

Some of the downspouts were missing splash blocks.

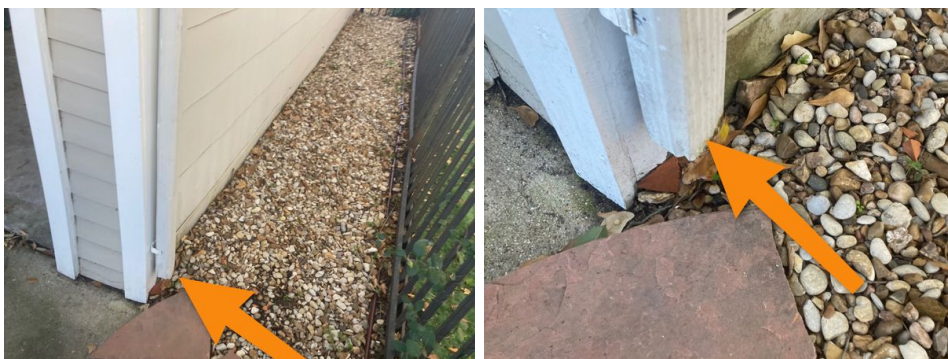
**ELBOW DIVERTERS**

Some of the elbow diverters were missing/damaged at the bottom of the downspouts. It is recommended to install the missing/damaged elbows.

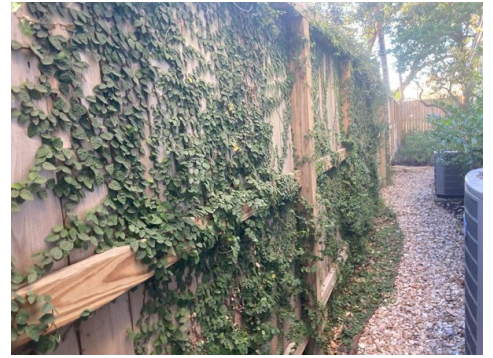
**WOOD FENCE**

The wood fence was in need of some repairs.

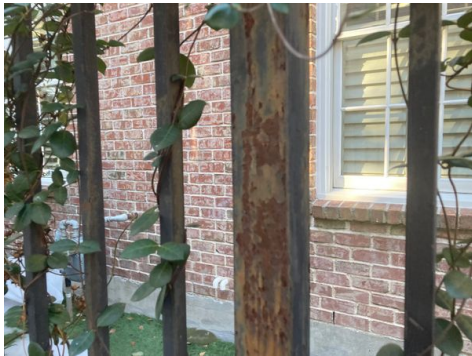
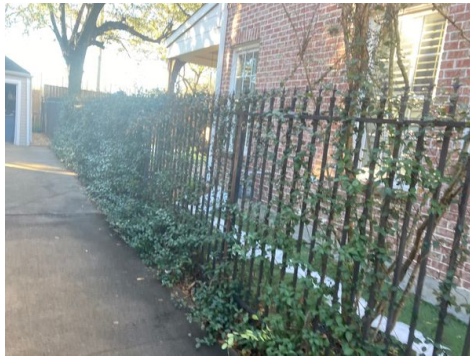
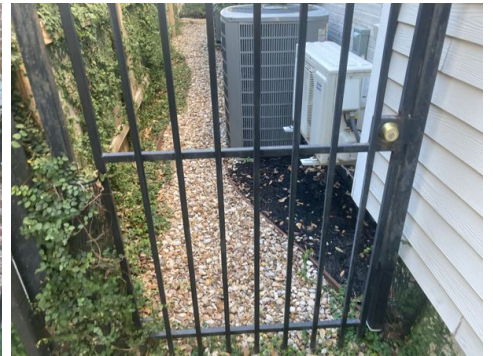
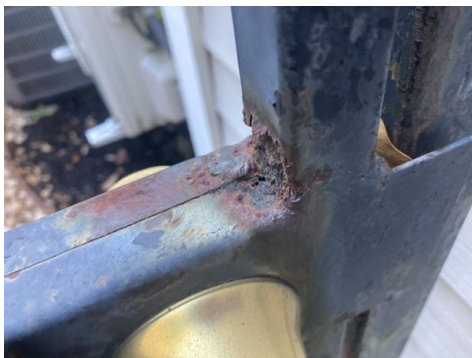
**WROUGHT IRON FENCE**

Rusted

The wrought iron fence was in need of some repairs.

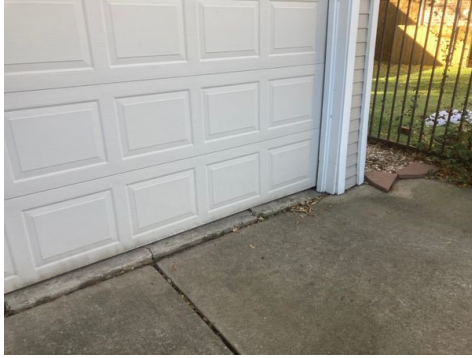
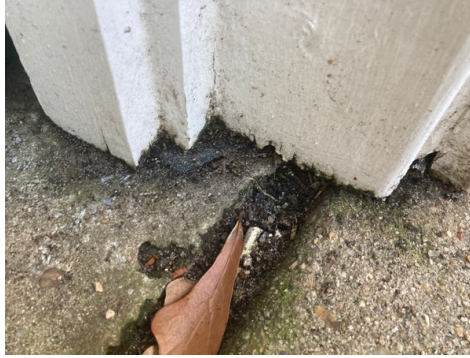
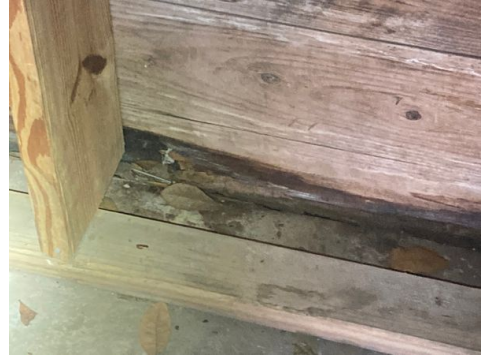
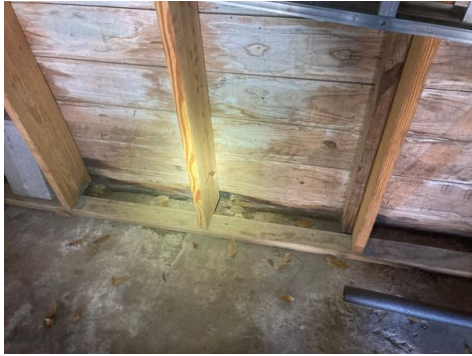
**WOOD ROT**

We observed evidences of wood rot and it is recommended that all rotted wood be replaced. Have a contractor provide a cost estimate to determine the entire scope of the wood rot, and provide a cost estimate to replace all rotted wood in the house.

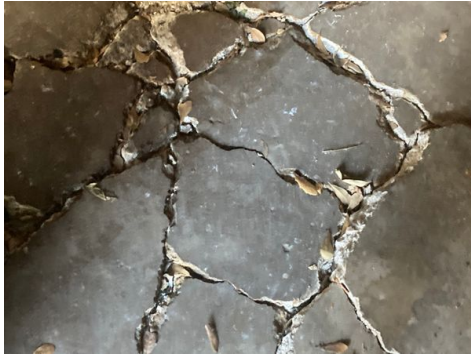
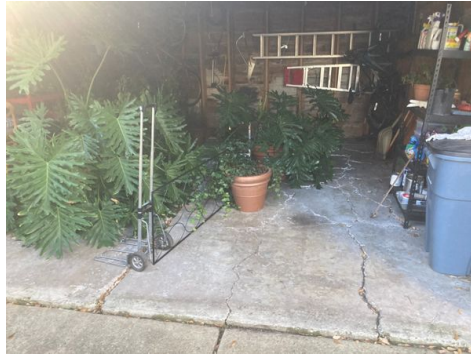
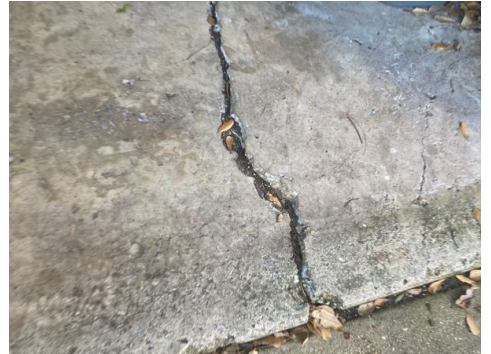
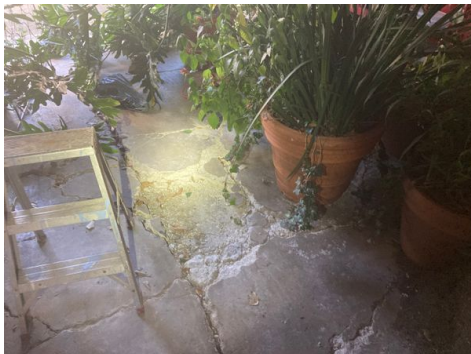
**FOUNDATION IRREPAIRABLE**

The concrete floor of the garage was badly cracked and has experienced significant foundation settlement. The degree of the cracking was such that the concrete floor is, in our opinion, essentially irreparable without removing the garage foundation and replacing it with a new concrete foundation. It is cautioned that, if the floor is not replaced, then movement of the walls and other structural framing members can occur if the damaged foundation moves. Further investigation with a contractor is recommended to obtain cost estimates for replacing the foundation vs. tearing the garage down and replacing it.

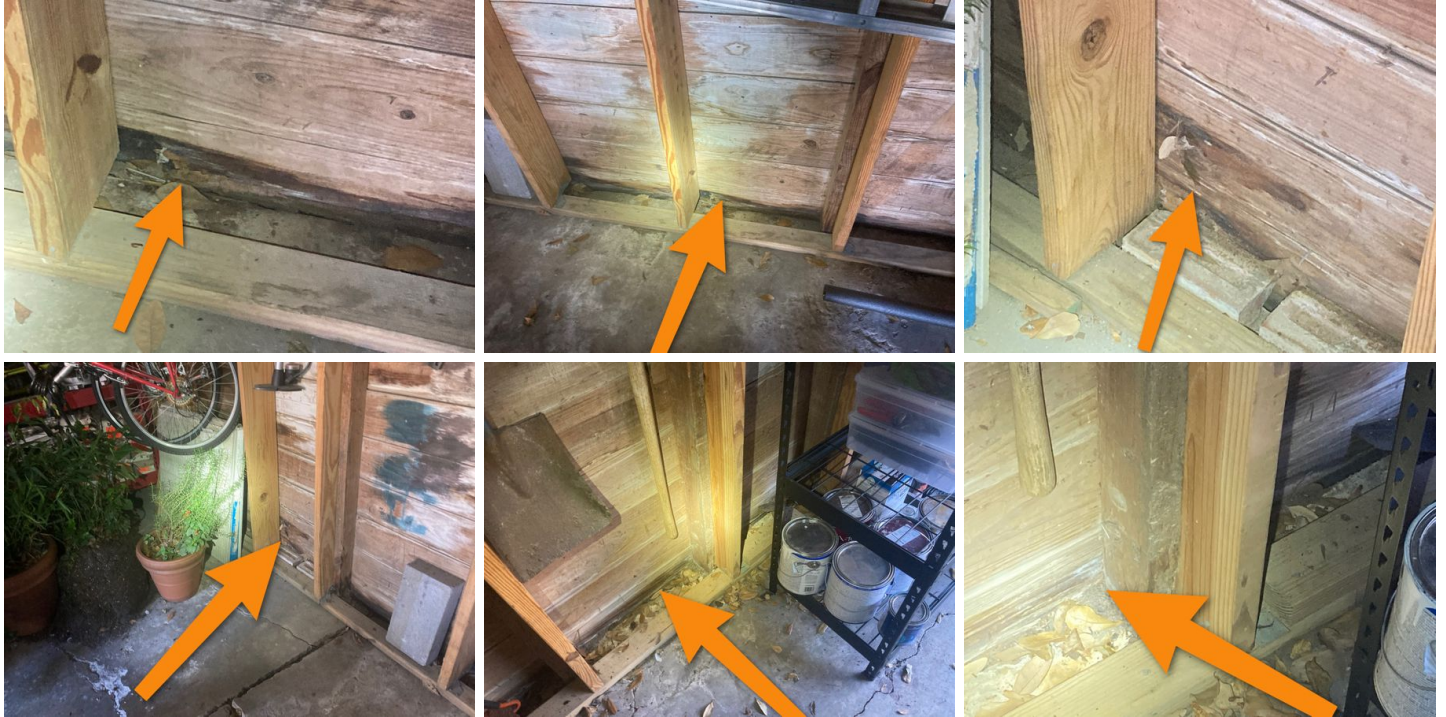
**WATER PENETRATION**

We observed water penetration into the garage. Have a service company provide a solution and cost estimate for repairs.

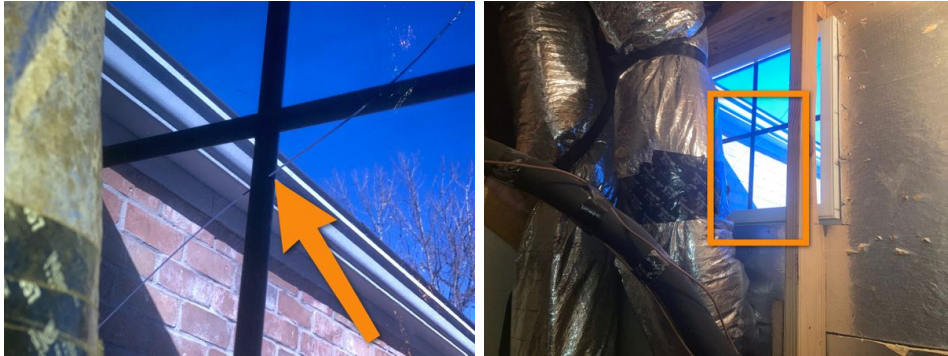
Cracked/broken windows were observed that need to be replaced.

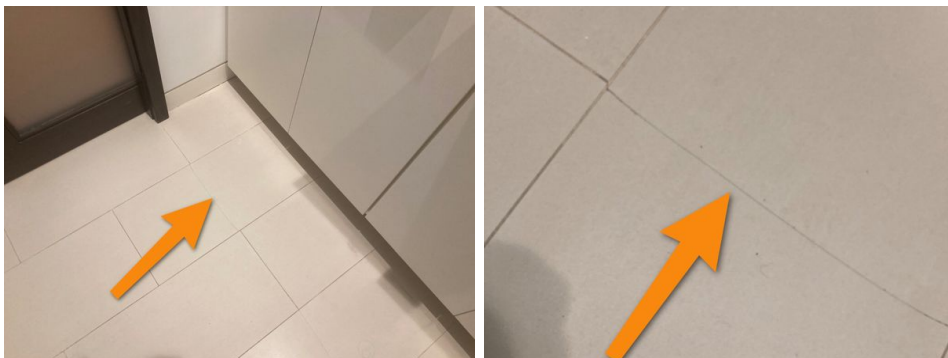
Floor tiles were cracked and it is recommended they be replaced.

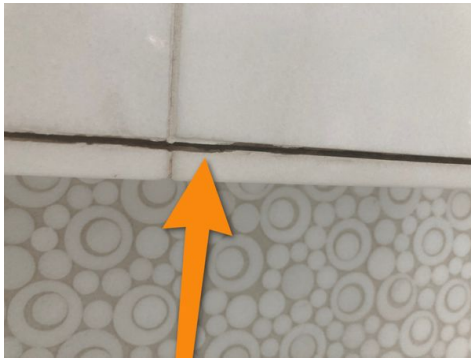
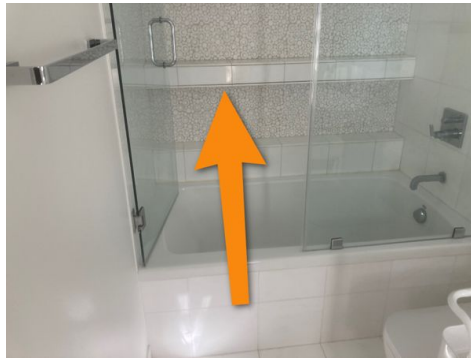
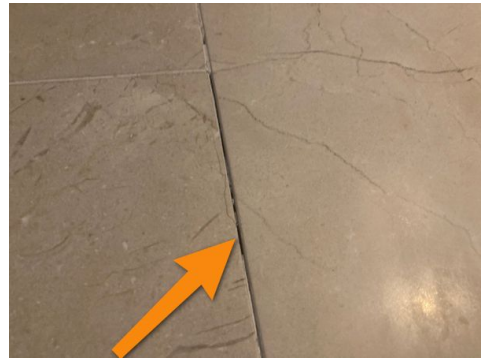
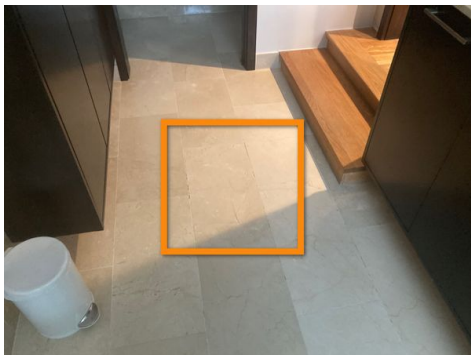
**TILES GROUT CRACKED/MISSING**

The grout was cracked/missing and needs to be repaired.

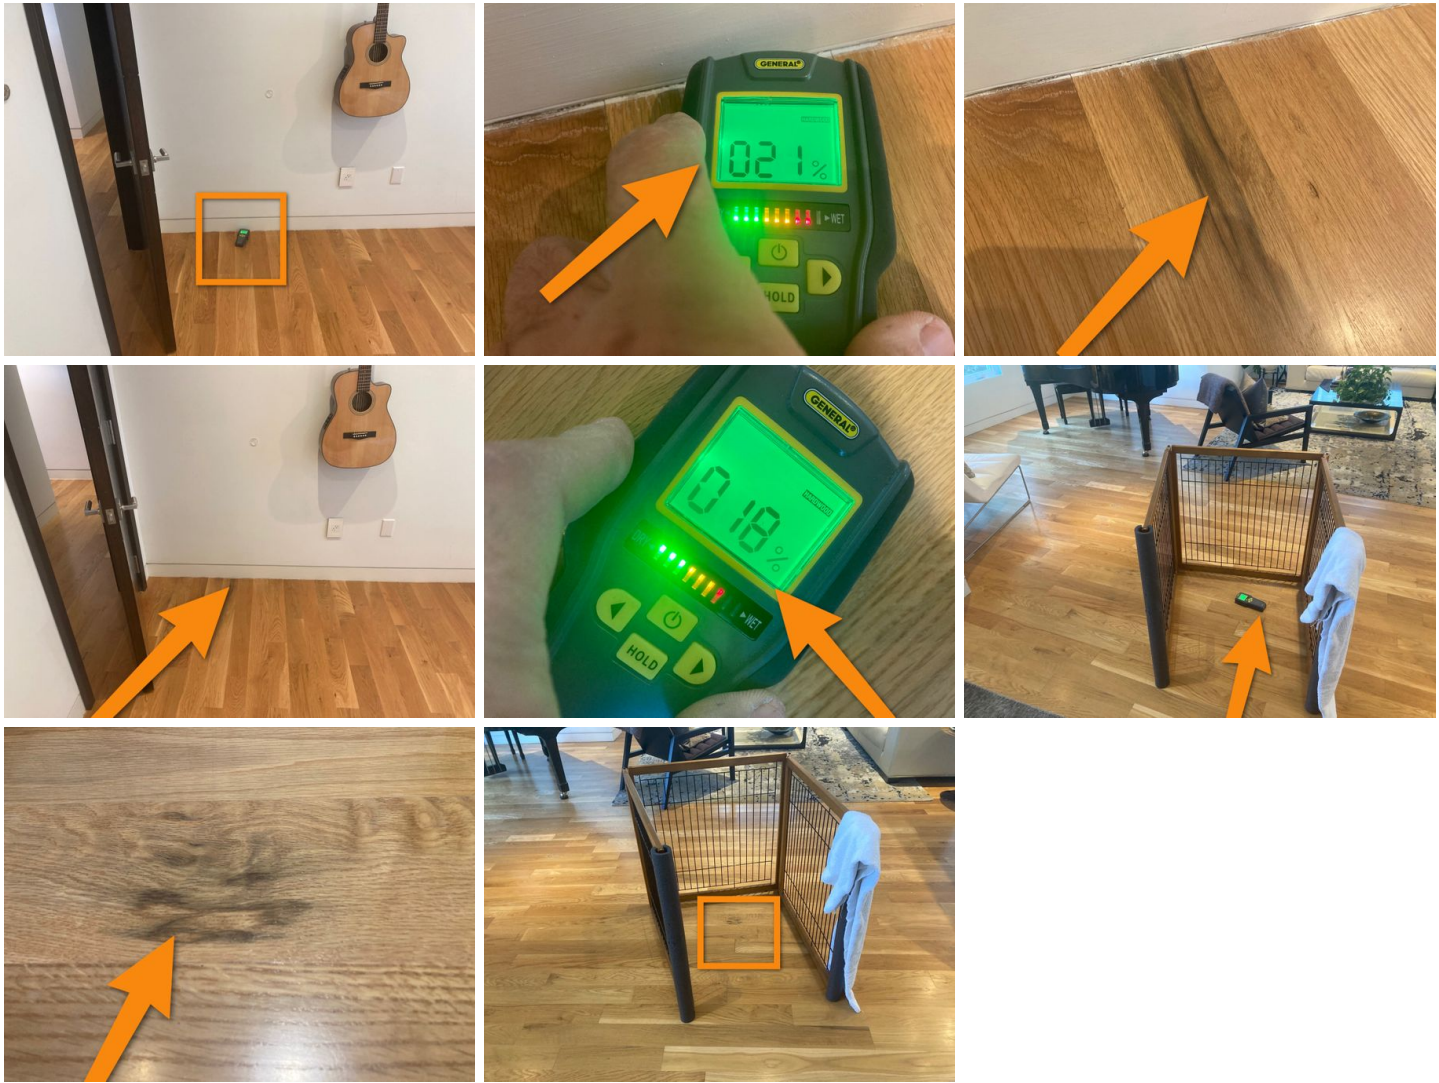
**WOOD FLOOR - DISCOLORED**

The wood floor was discolored and have high moisture at some locations. Further investigation with a service company is recommended to determine the cause of the staining and the extent of any needed repairs.

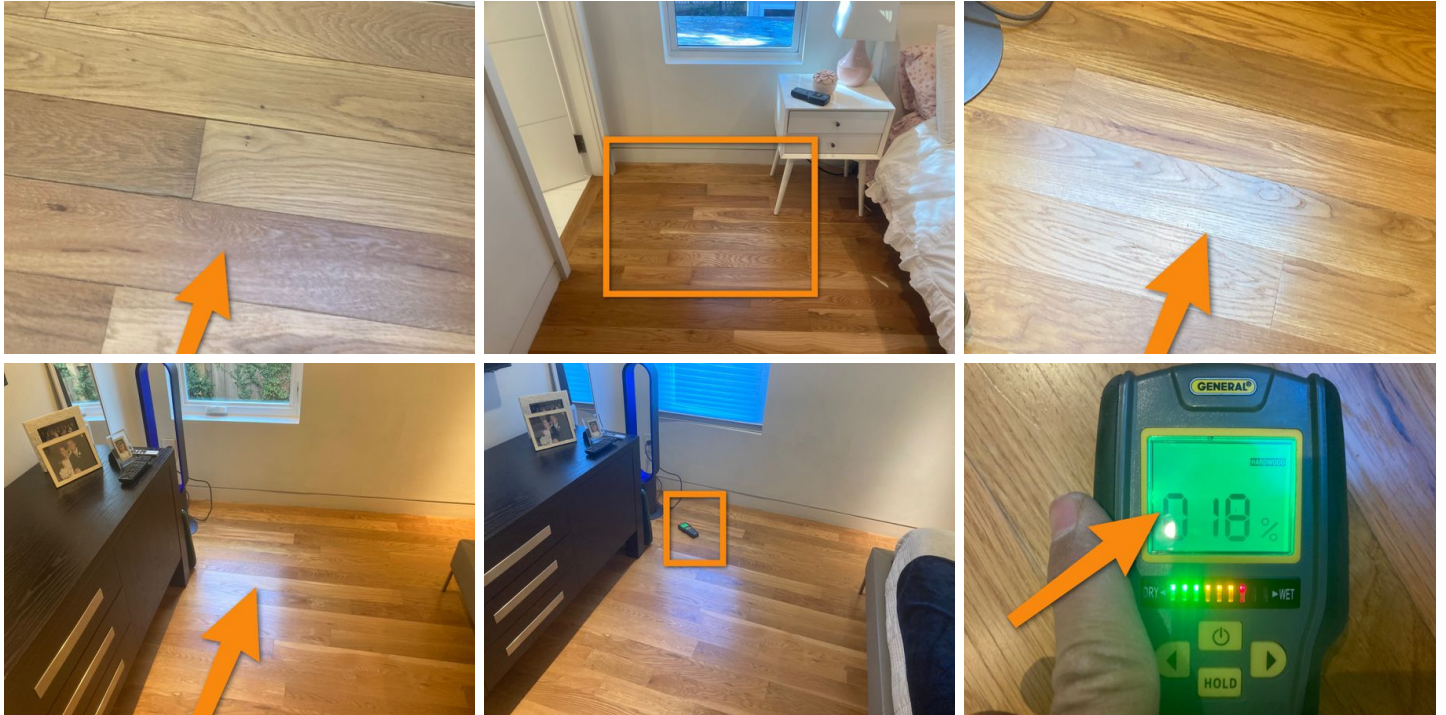
**WOOD FLOOR WASHBOARD**

The wood floor boards were observed to be cupped, with the edges of the boards curling upwards into a “washboard” effect. This condition is typically caused by moisture entering the wood and causing the boards to swell in size, causing peaking of the edges as they are pressed together. Further investigation with a wood floor specialist and/or a service company is recommended to determine the source of the moisture, and to make any needed repairs.
