HEDDERMAN ENGINEERING. INC.

## STRUCTURAL REPORT

3763 Rice Boulevard  
Houston, TX 77005

REF: CONDITION OF PROPERTY SURVEY

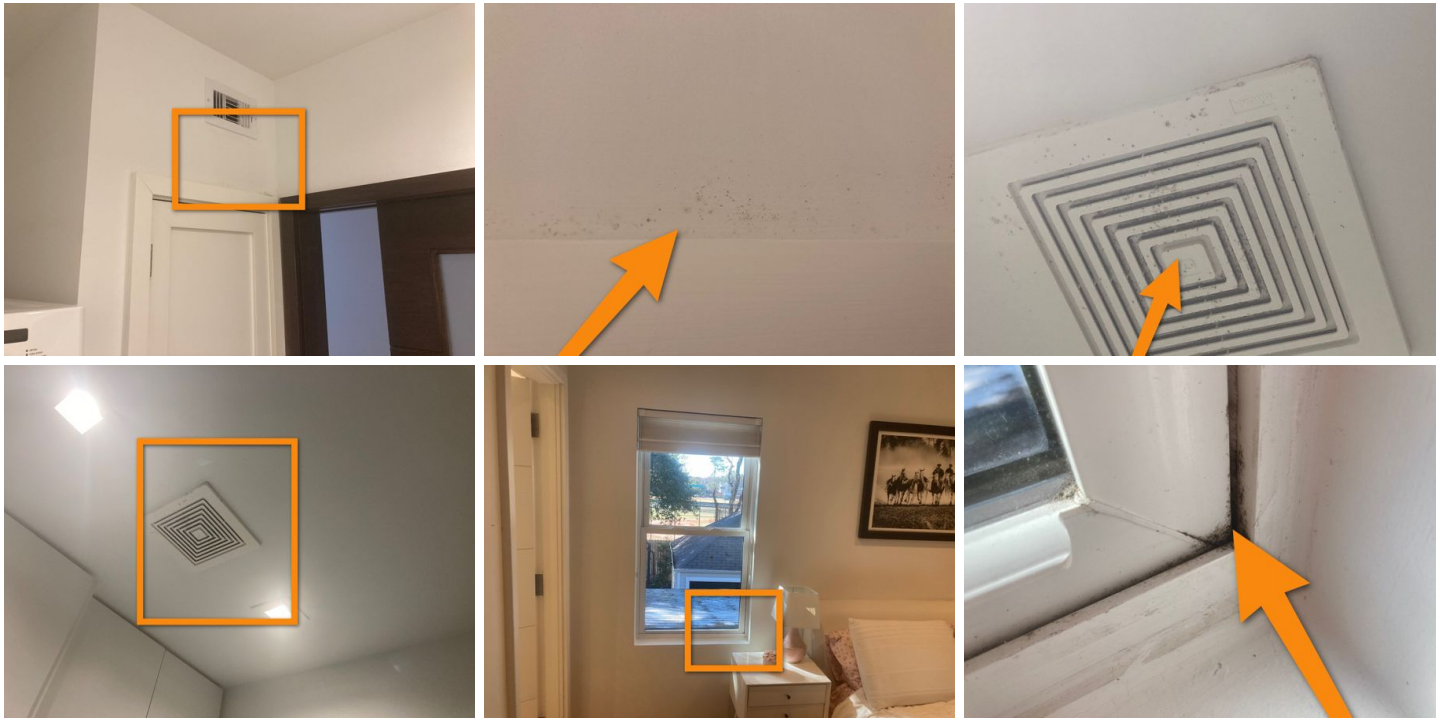
**MICROBIAL GROWTH**

A microbial growth was observed, and further investigation is recommended with a service company to determine the cause of the growth, and to provide a cost estimate for any needed repairs.
