# Wood Destroying Insect Report

Inspection Performed by Sam Cox TPCL #0929703 1/24/2025

3763 Rice Boulevard

## TEXAS OFFICIAL WOOD DESTROYING INSECT REPORT

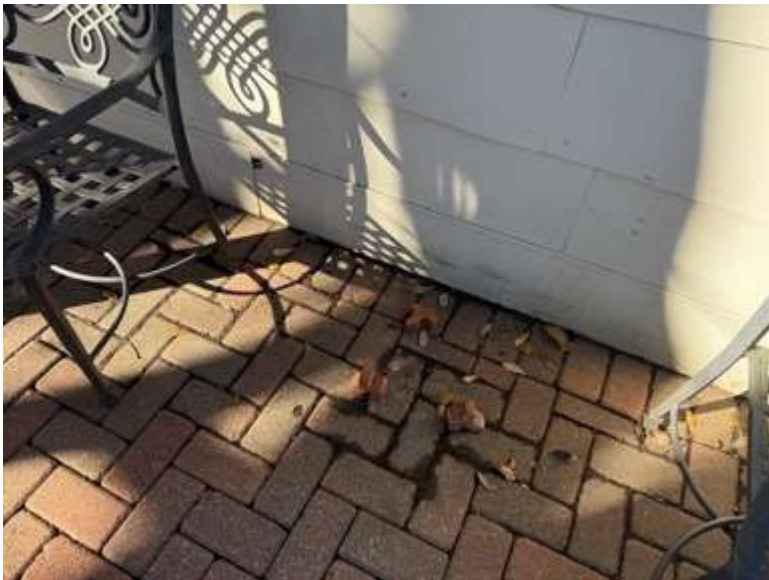
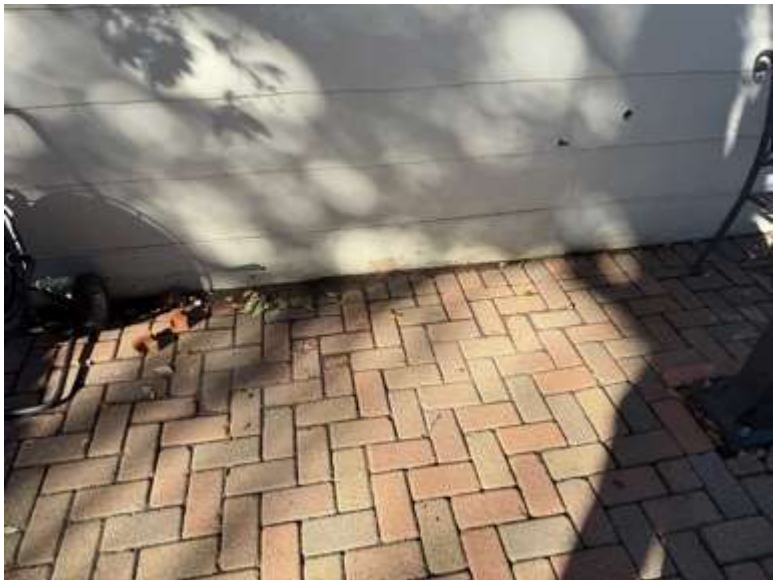
Pavers cover portions of the foundation.

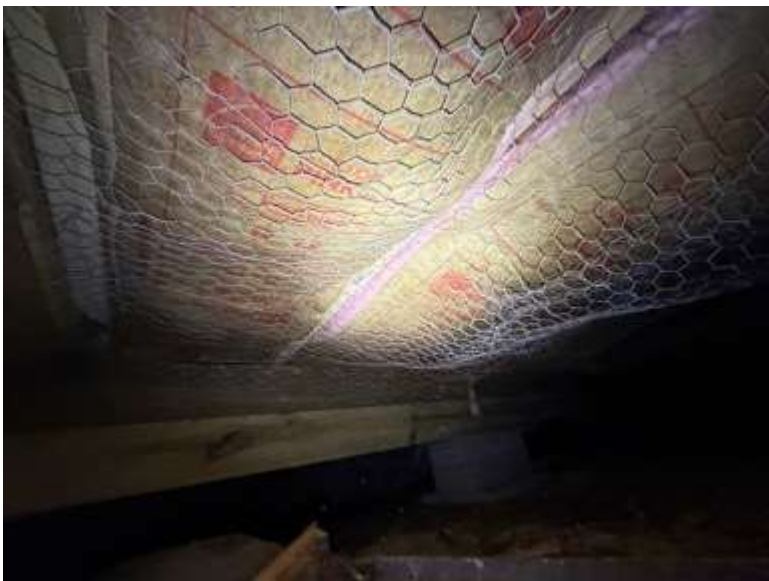
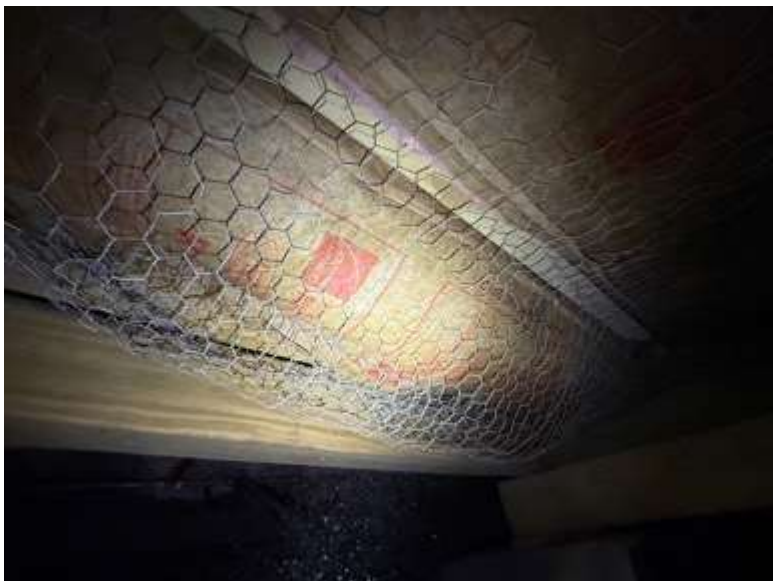
Insulation obstructs view of subfloors.

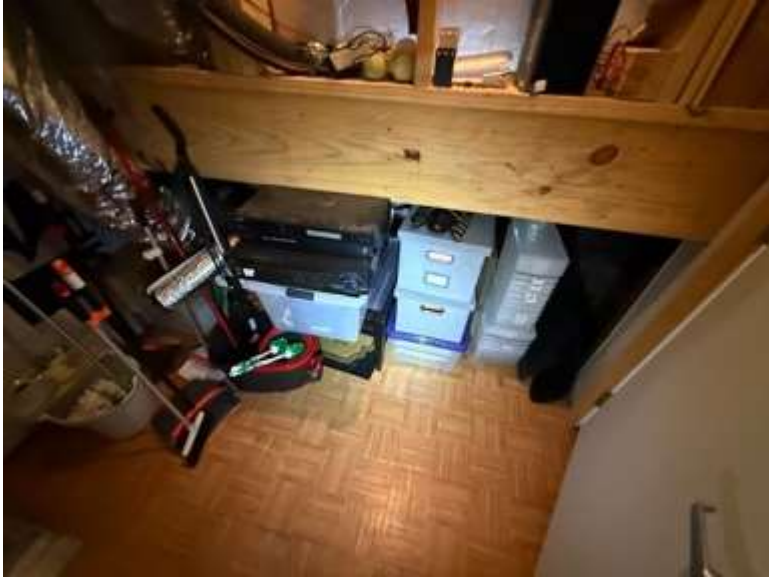
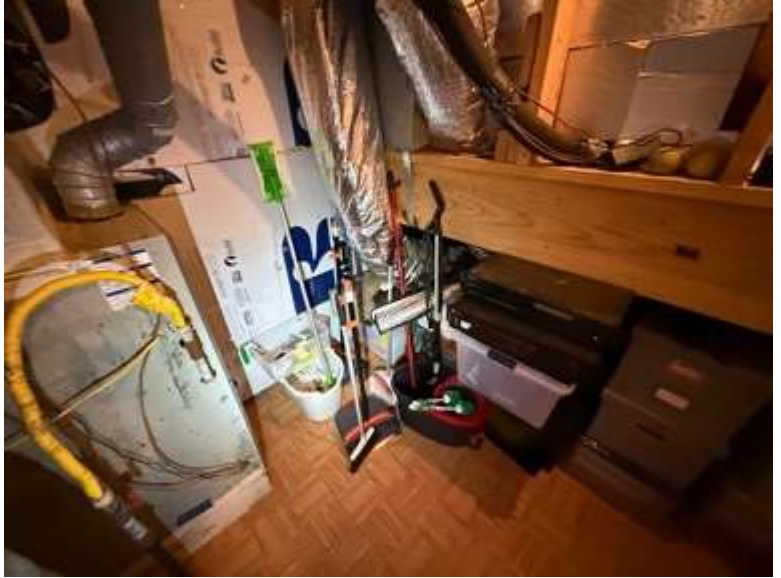
Stored items in the attic.

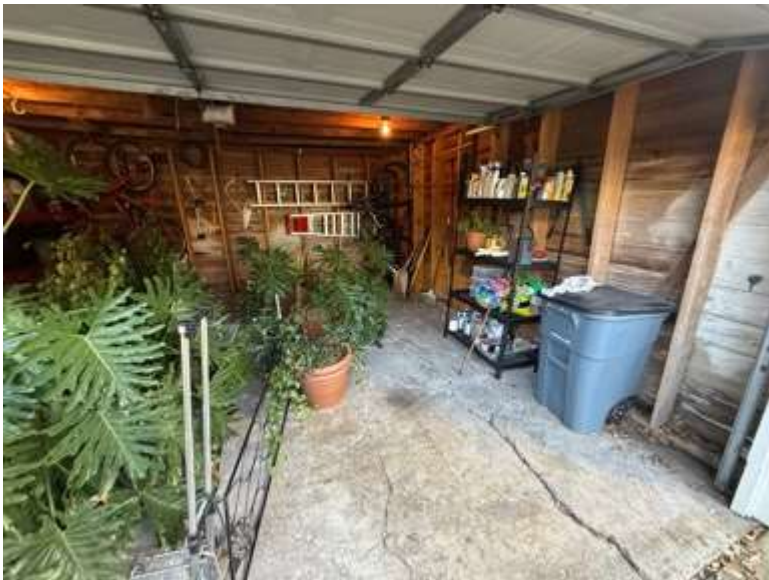
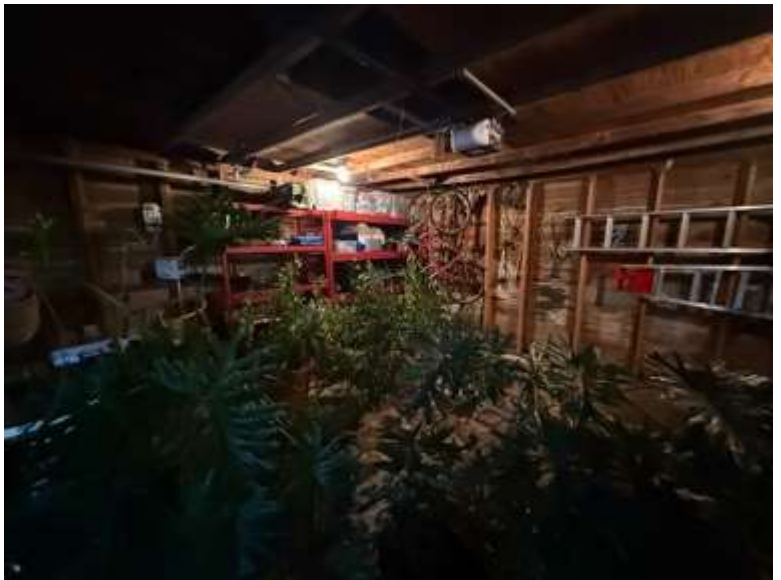
Stored items in the garage.

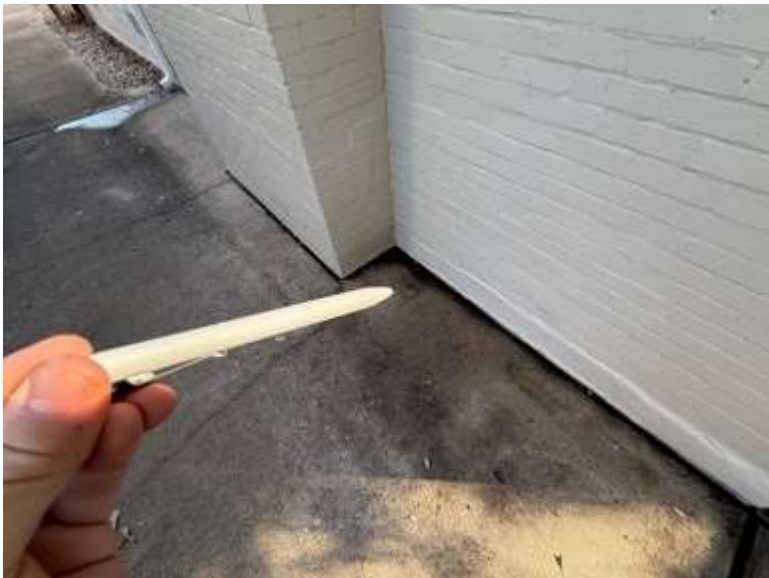
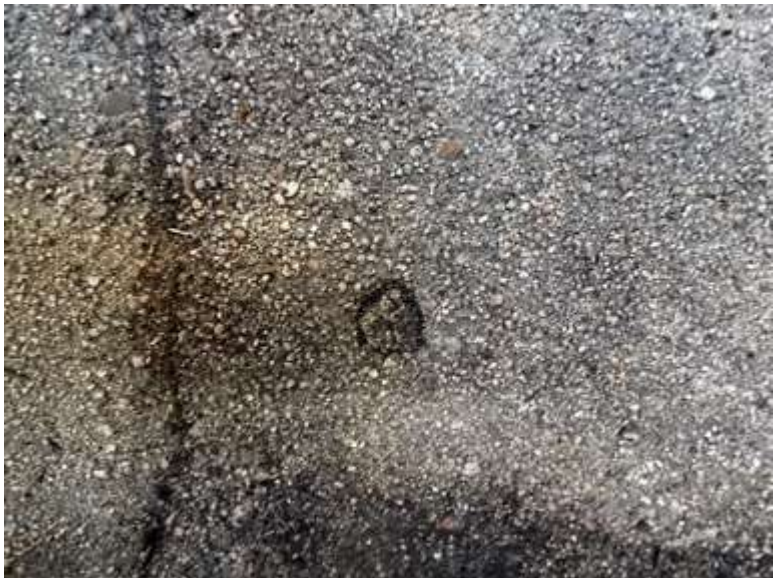
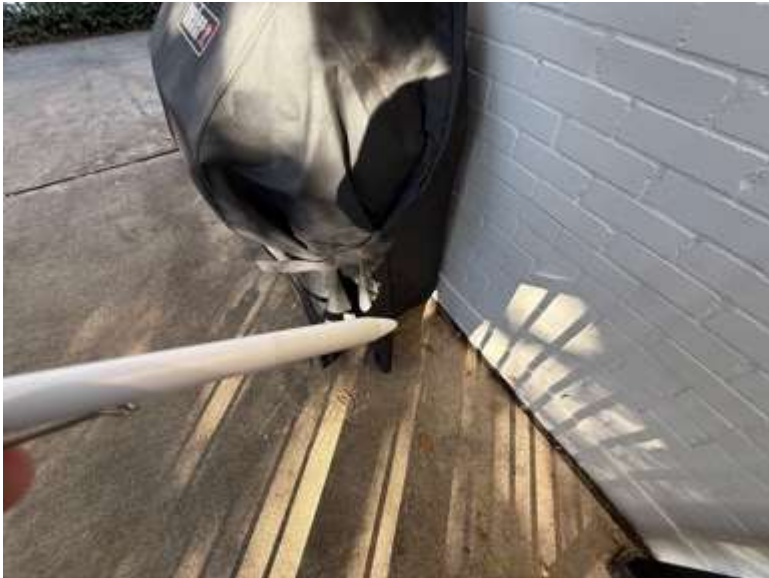
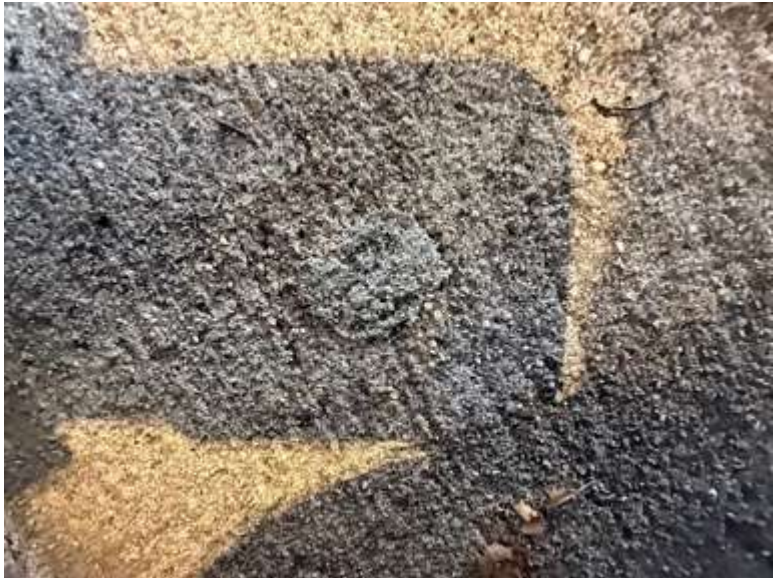
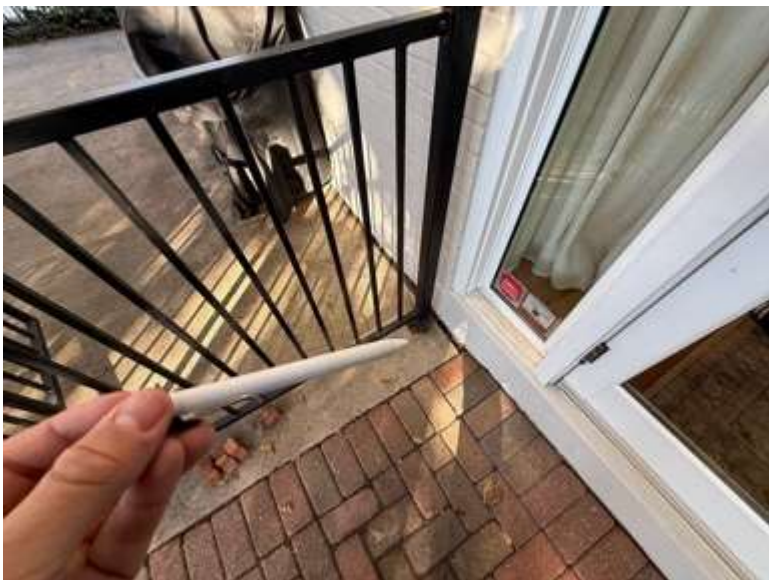
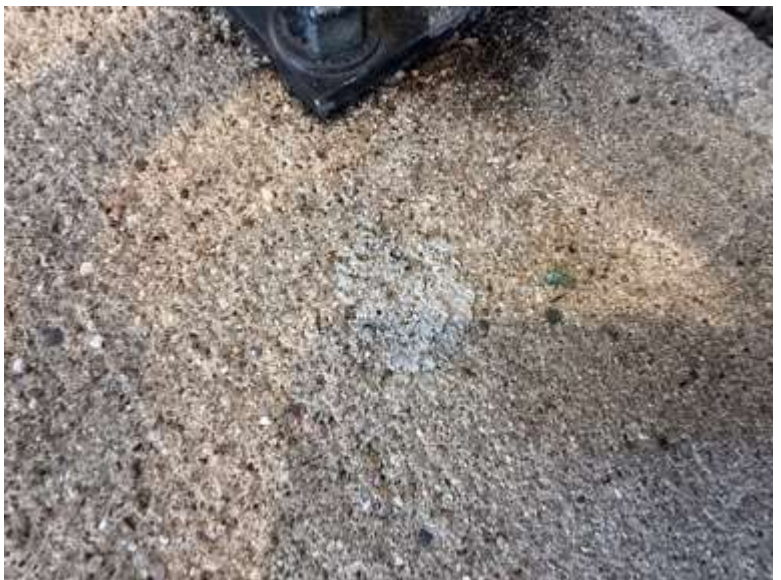
Treatment drill holes observed along the structure.

**Treatment drill holes present - Further investigation with owner and treating company is recommended regarding subterranean termite treatment and warranty.**

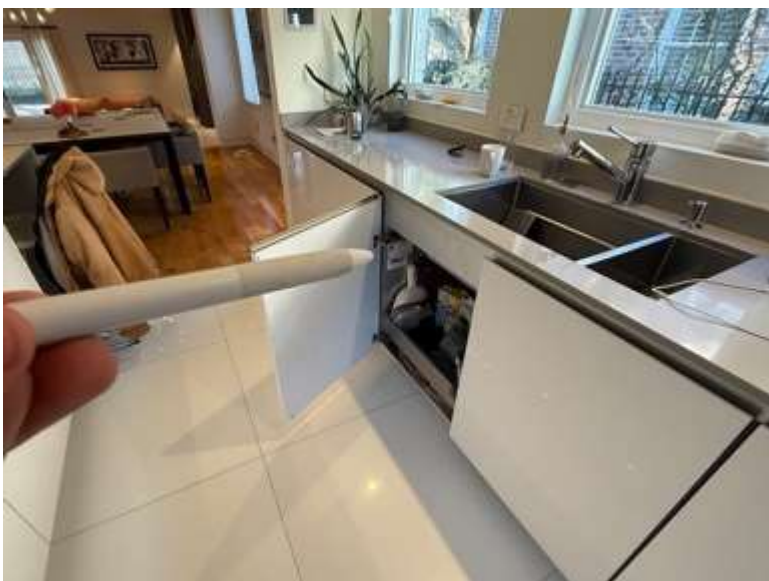
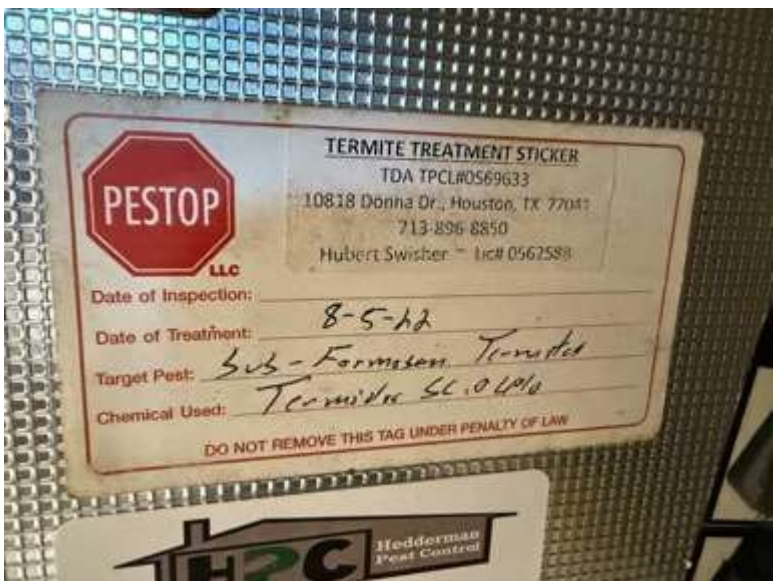
Treatment sticker posted under the kitchen sink.

**A sticker indicating previous treatment for subterranean termites was observed. Further investigation is recommended with owner and treating company regarding treatment and warranty.**

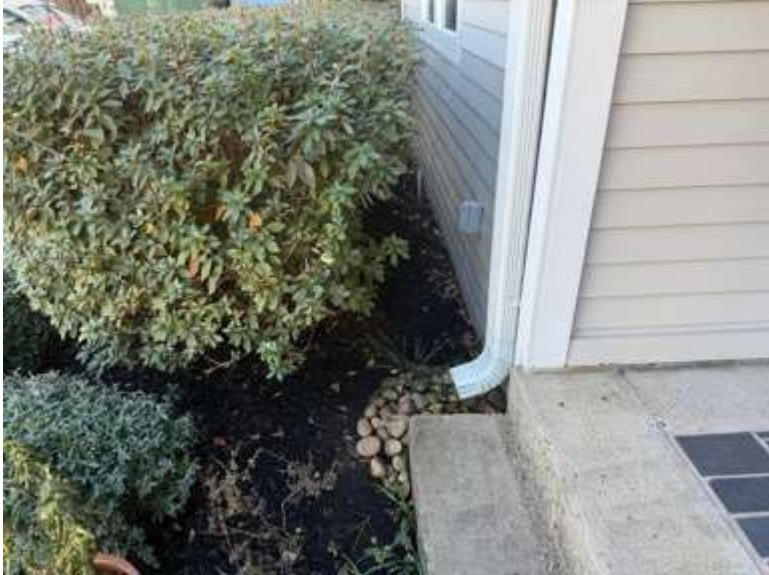
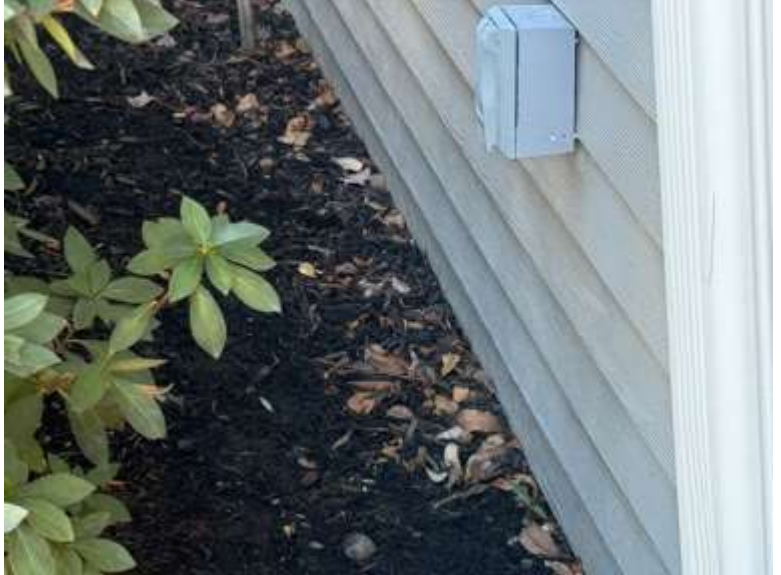
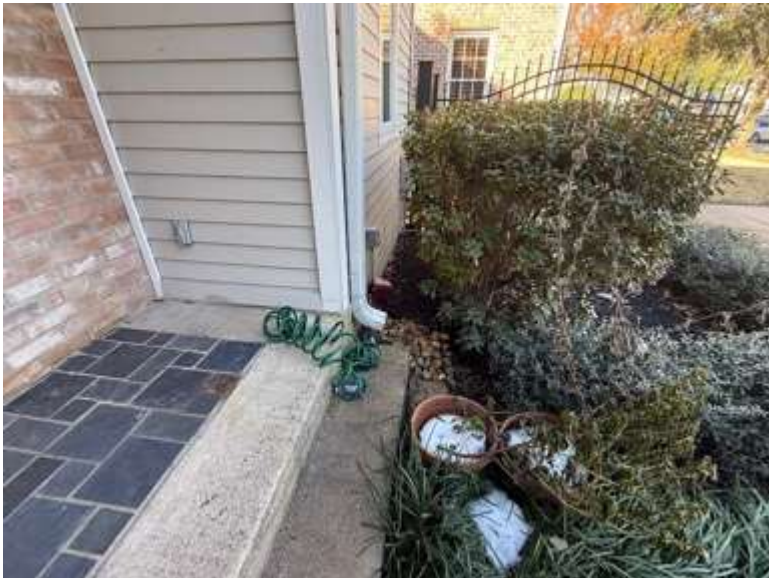
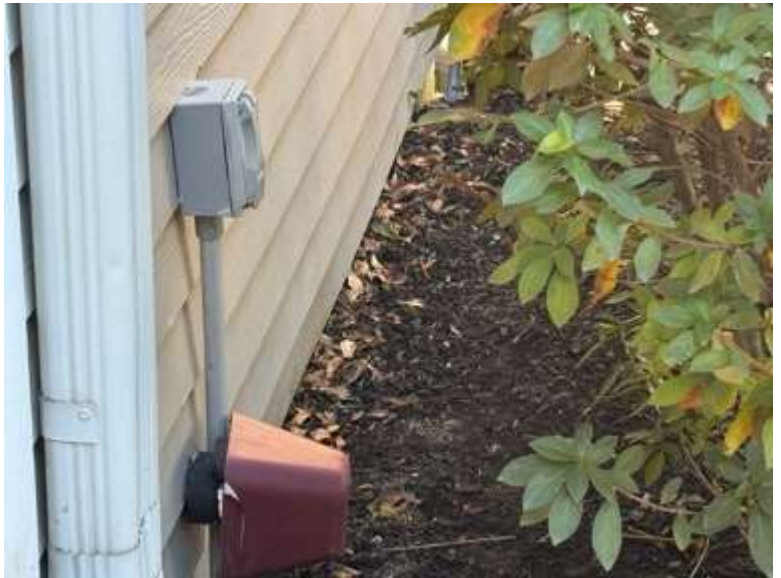
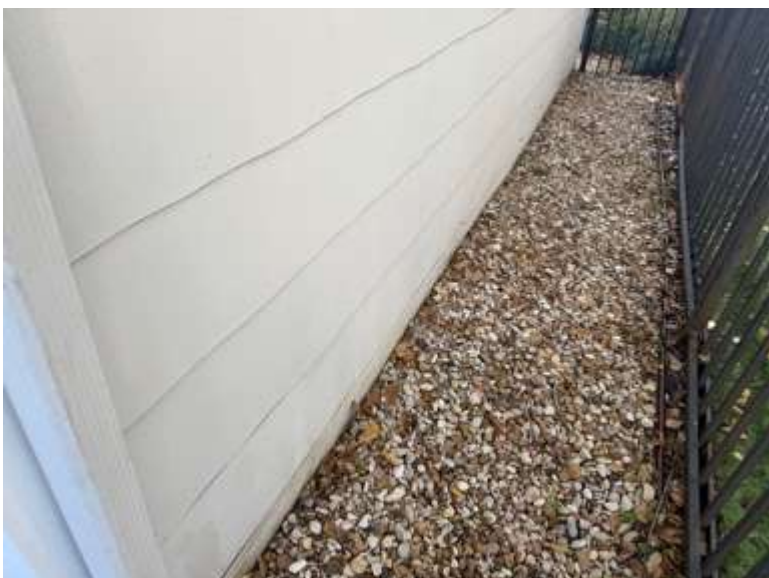
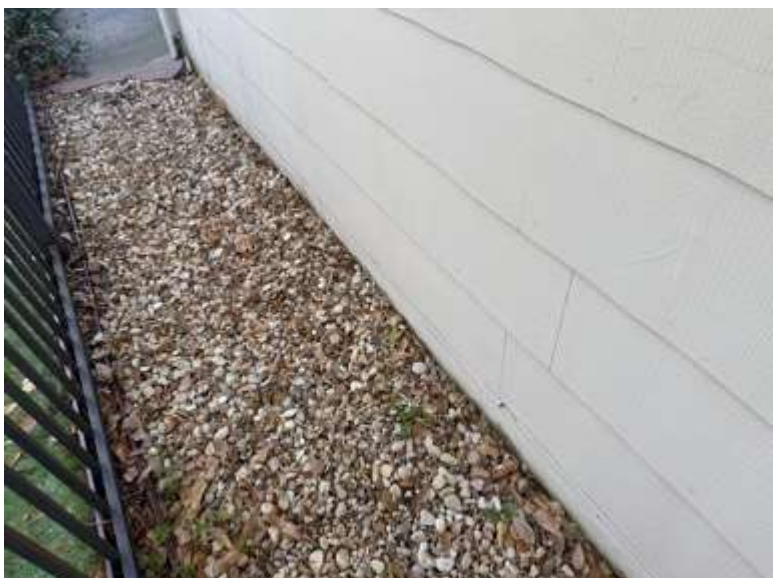
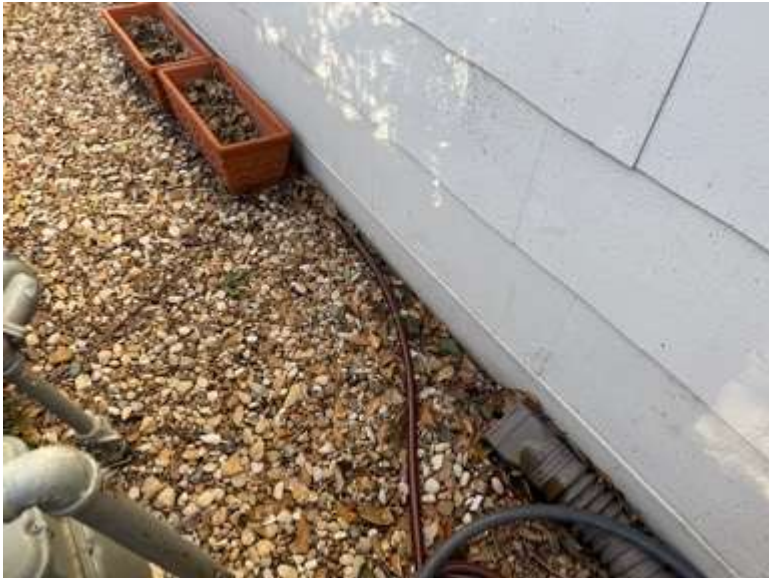
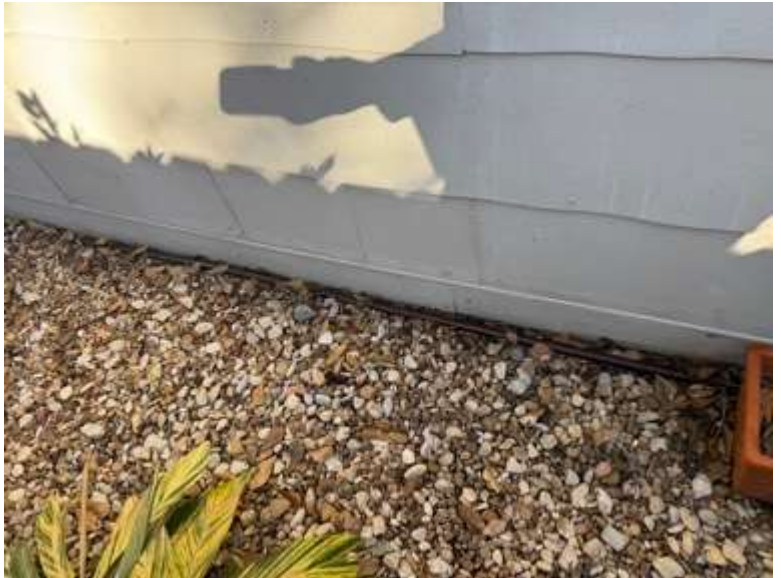
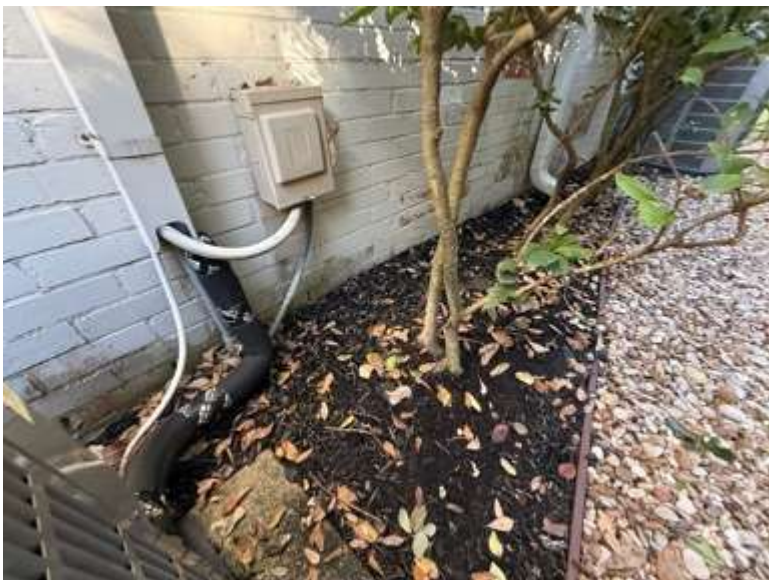
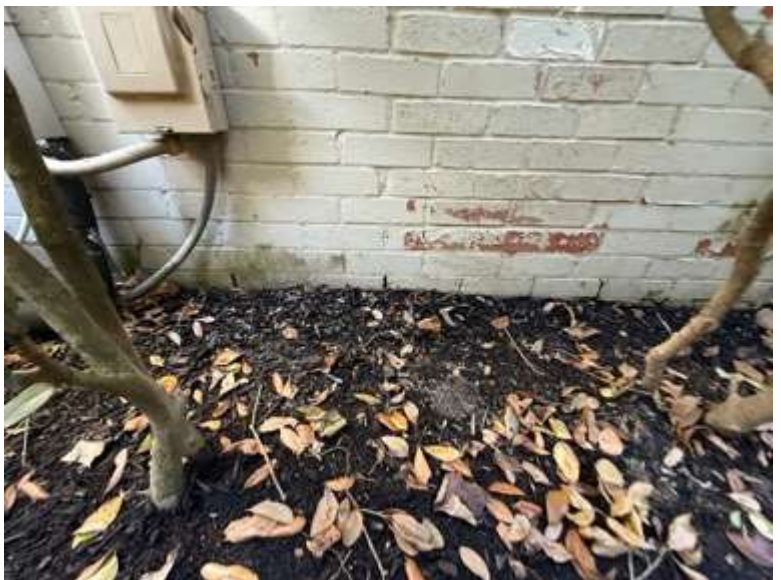
High soil should be lowered.

Comments: **(L) High Soil – Soil should be lowered to below the top of the foundation.**

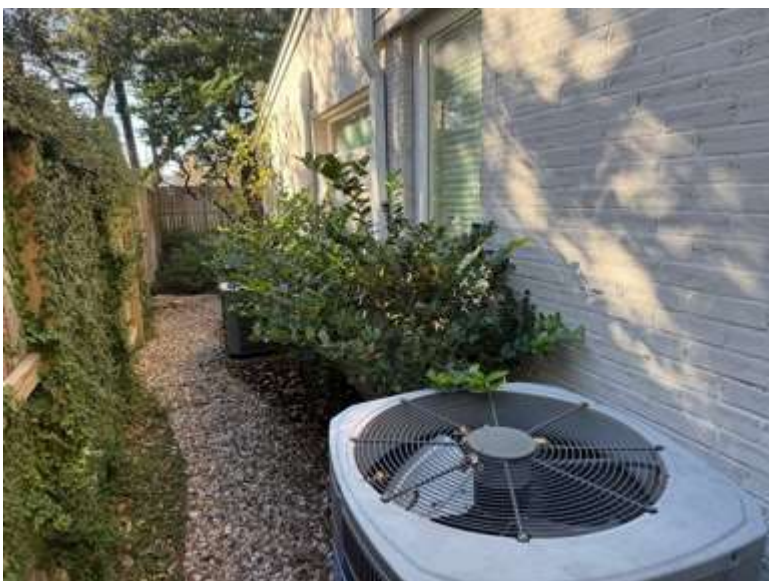
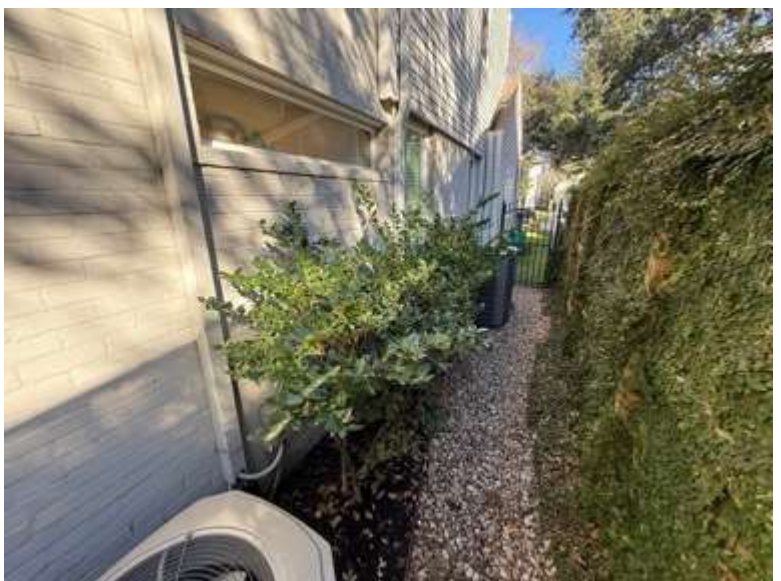
Heavy foliage should be trimmed back from structure.

**(N) Heavy Foliage – Foliage should be cut back to provide at least 3 inches of clearance to the structure.**

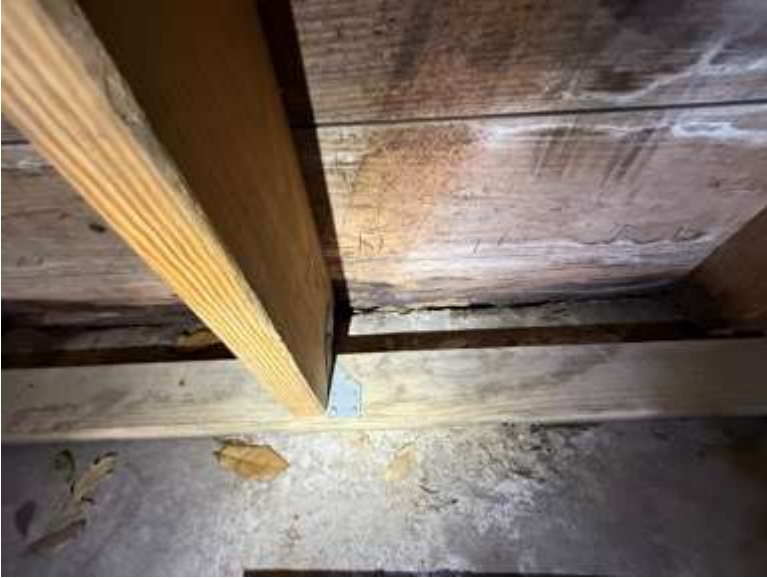
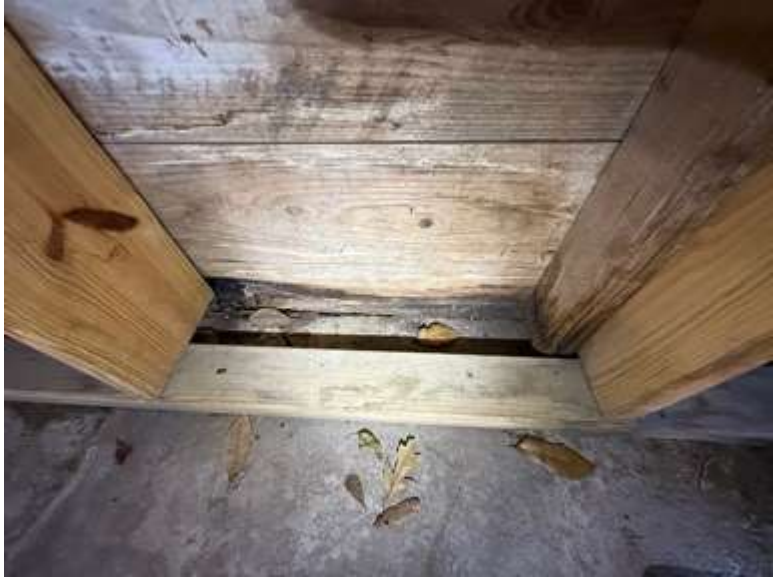
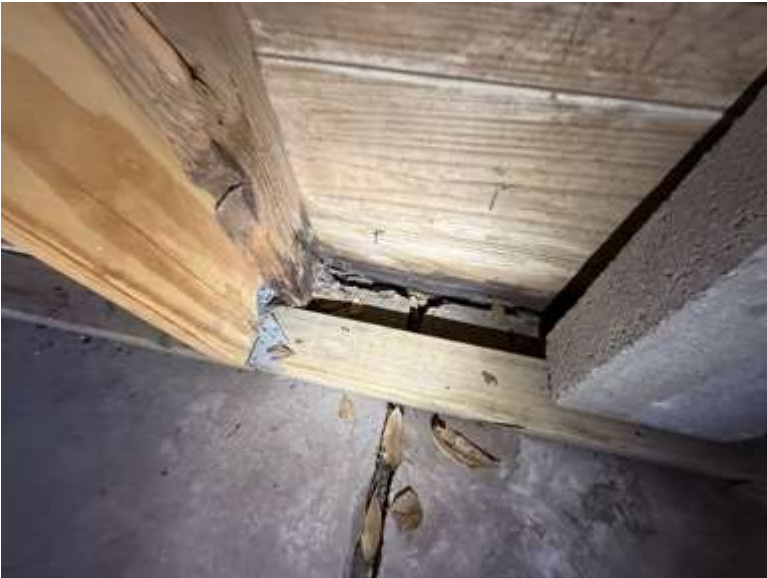
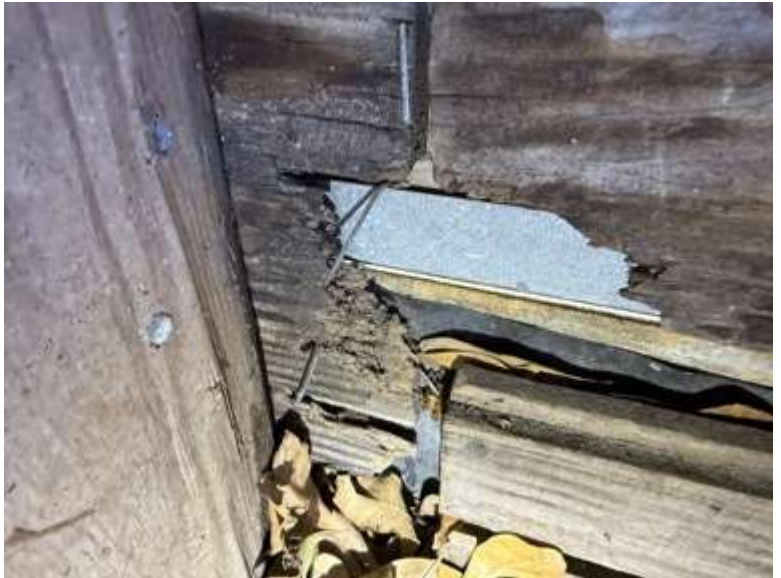
Wood rot should be repaired.

**(M) Wood Rot – All damaged or affected wood materials should be properly repaired or replaced.**

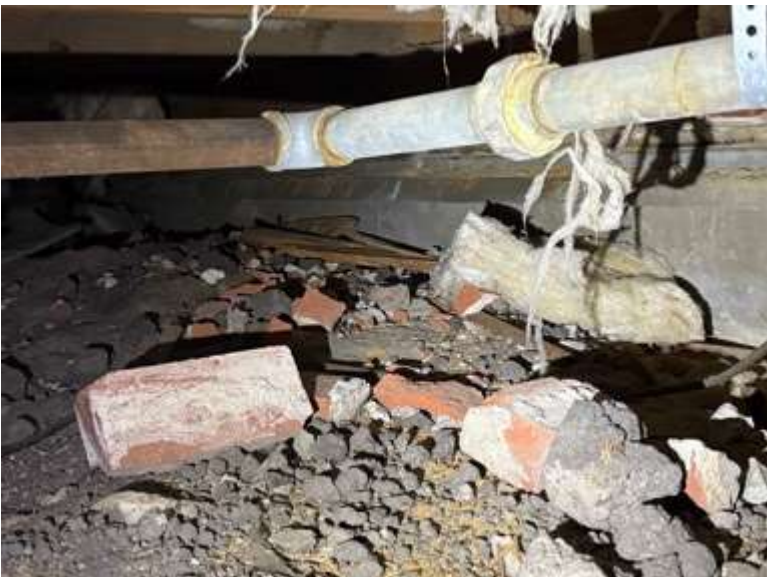
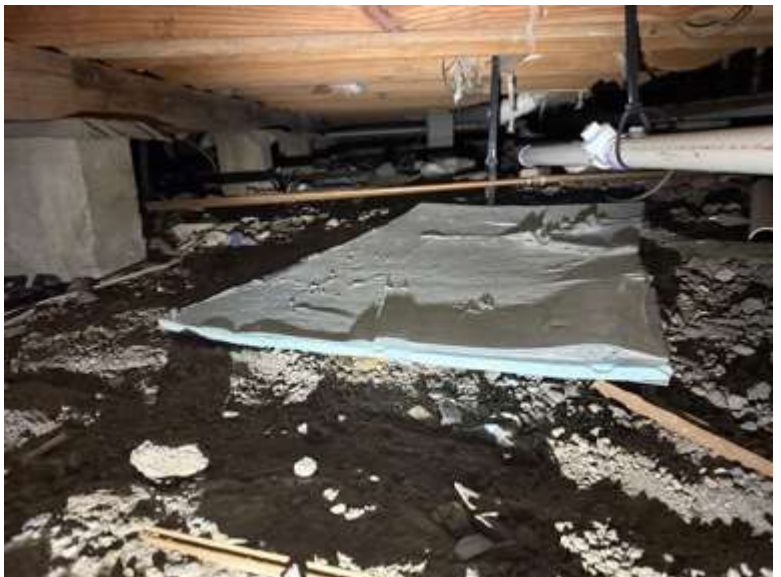
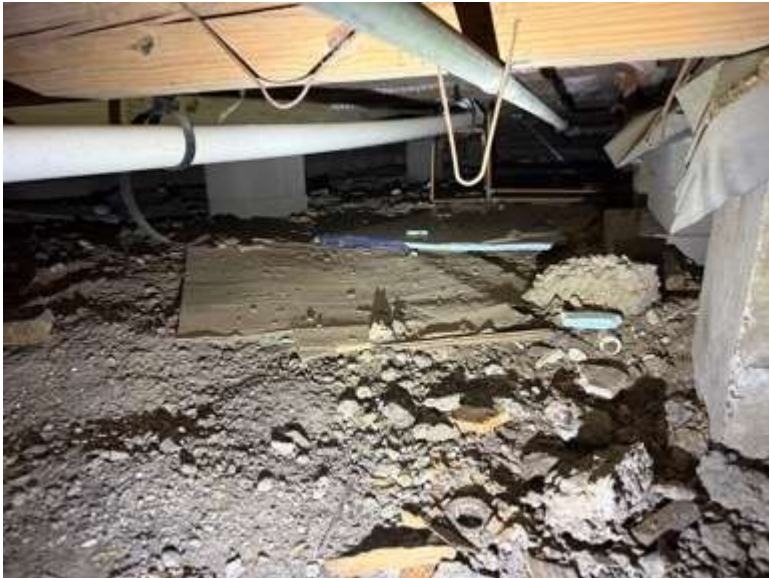
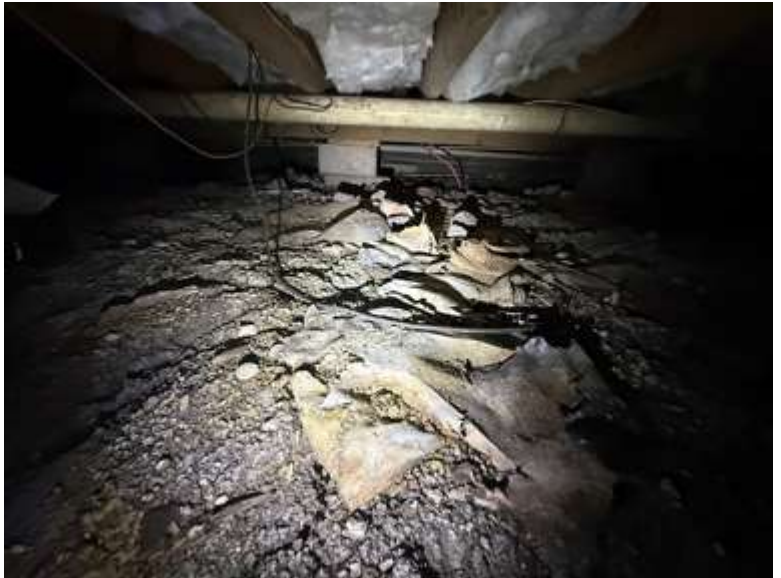
Debris under the structure should be removed.

**(K) Debris – Debris should be cleared from under the structure.**

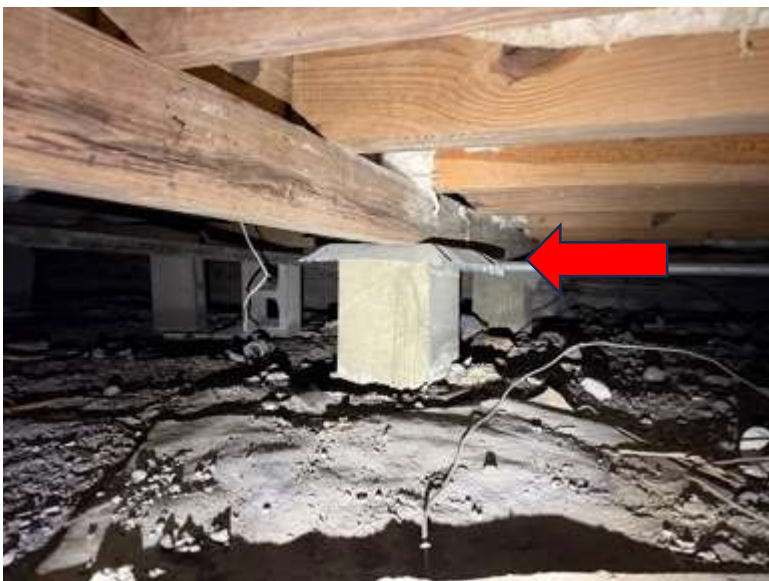
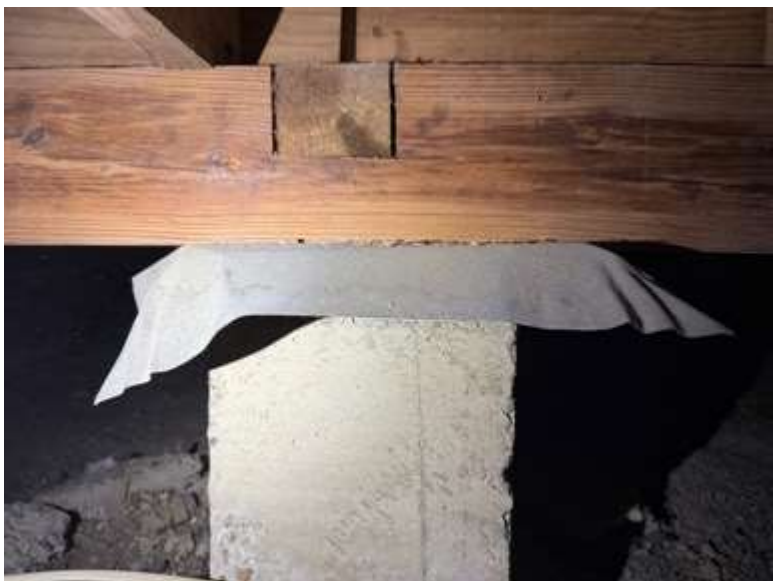
Termite shields observed in the crawlspace.

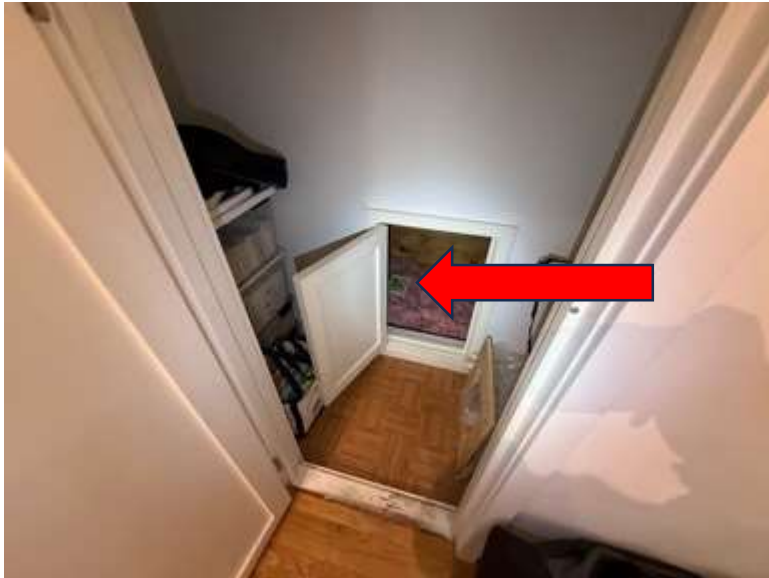
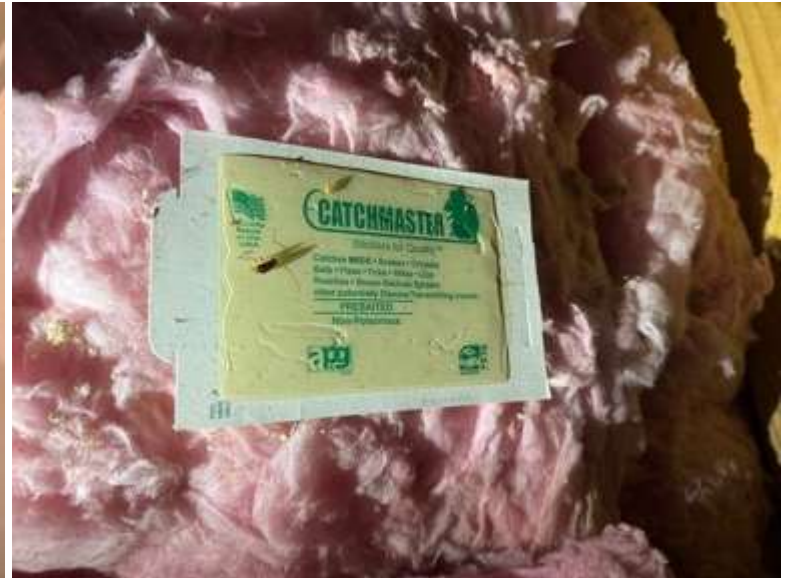
Rodent traps observed in the attic.
