3327 Liberty Way Drive
Missouri City, TX 77459

PROPERTY INSPECTION REPORT FORM

April Scott <i>Name of Client</i>	10/15/2024 <i>Date of Inspection</i>
3327 Liberty Way Drive, Missouri City, TX 77459 <i>Address of Inspected Property</i>	
Mike L Weible <i>Name of Inspector</i>	4596 <i>TREC License #</i>
<i>Name of Sponsor (if applicable)</i>	<i>TREC License #</i>

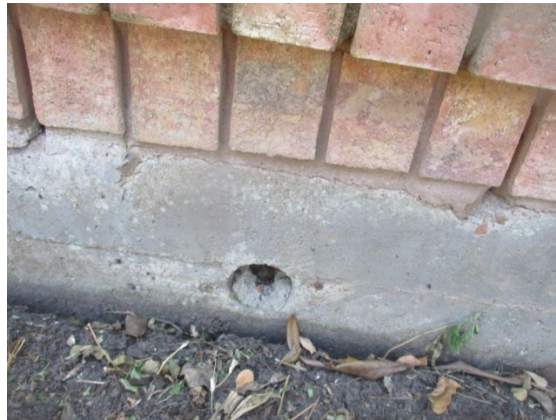
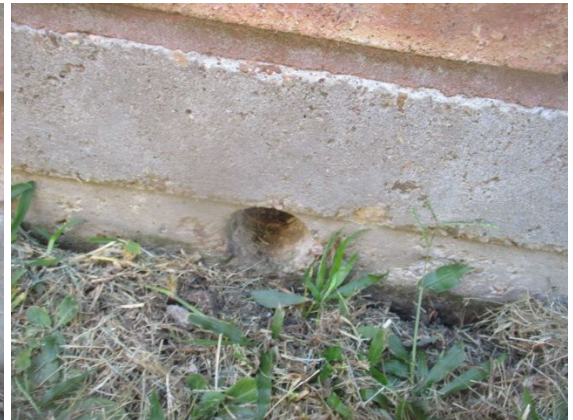
The ends of some of the post tension cables are exposed at the edge of the foundation. Recommend sealing by a qualified post tension contractor to reduce water penetration, corrosion, and failure of the cable retainer.

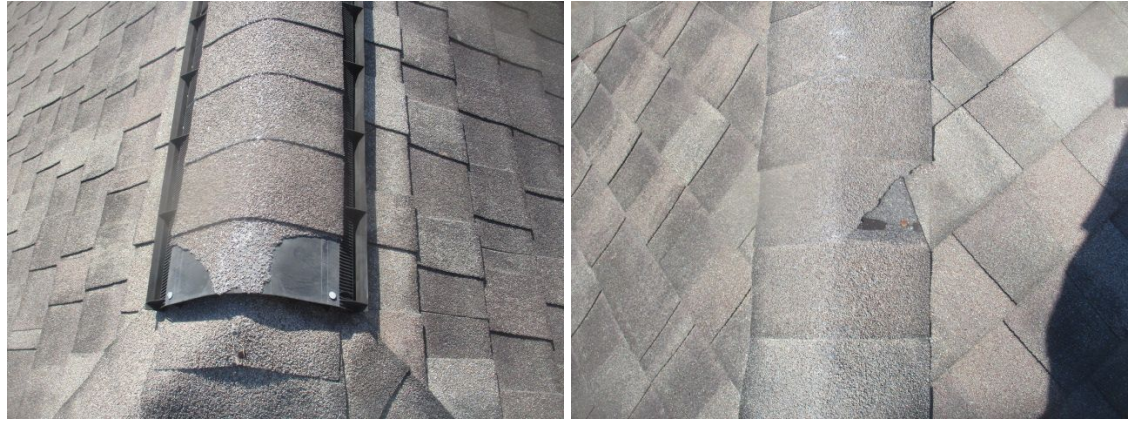
The roof covering is composition shingles, one layer, showing signs of age, such as mildew, missing and damaged shingles, and loss of granules. The roof appears to be performing its intended function at the time of the inspection, but may have limited life expectancy. Recommend further evaluation by a qualified roofing contractor.

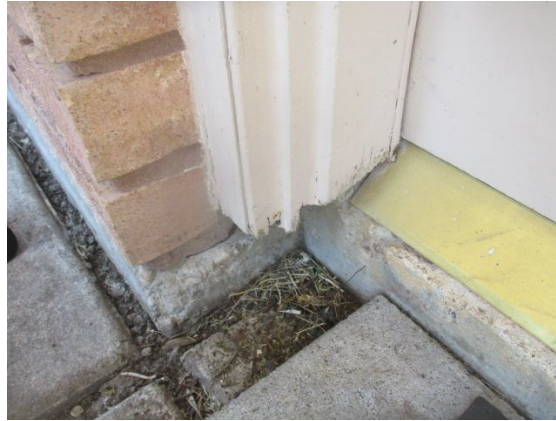
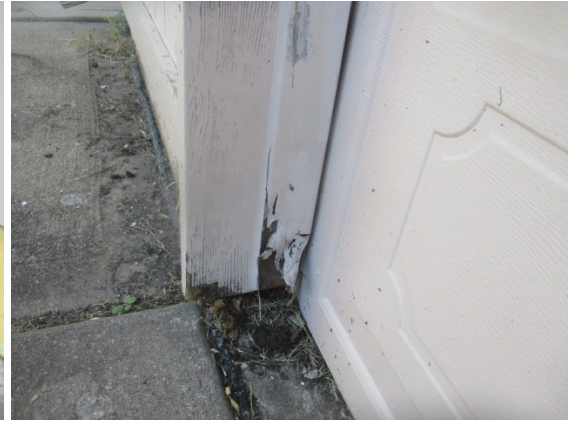
The siding at the sides and back of the garage are loose at the bottom.

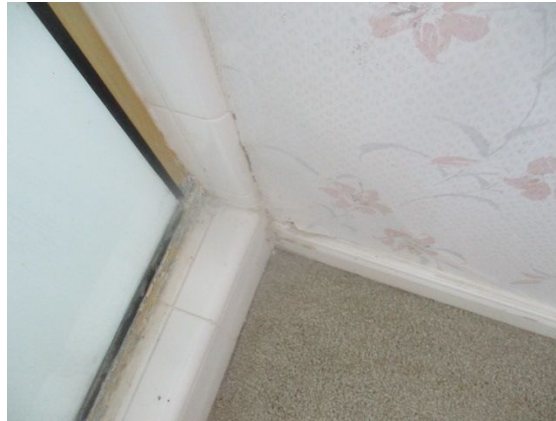
There are high levels of moisture in the base of the interior walls on the sides of the master shower and guest tub. See 'Plumbing Systems'.

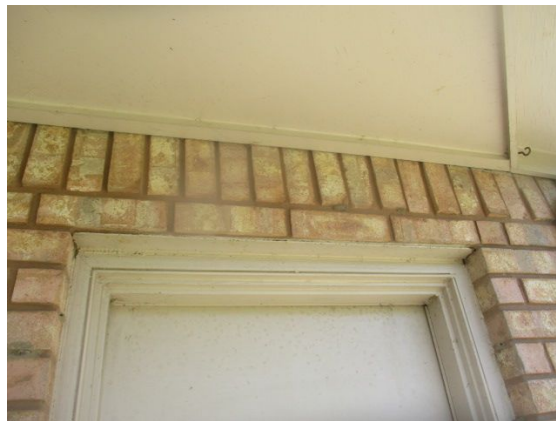
There are no weepholes in the brick mortar joints above the windows and doors.

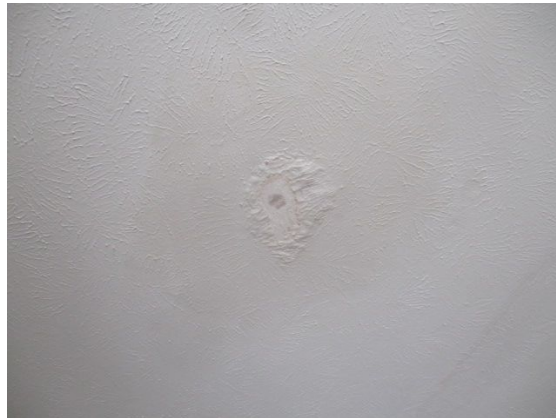
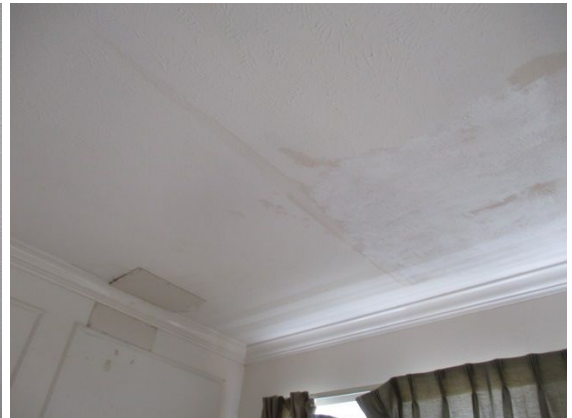
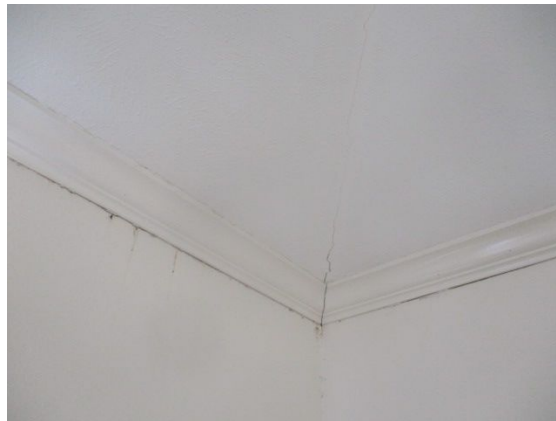
There is what appears to be water damage / water stains to the ceilings in some areas:

- family room
- master bedroom.

No moisture was present at the time of the inspection.

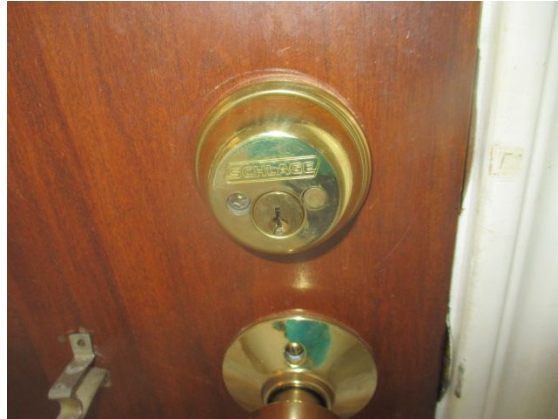
The deadbolts on the front exterior door must be unlocked from the inside with a key. This is a potential fire hazard. Recommend replacing with a deadbolt that operates with a knob.

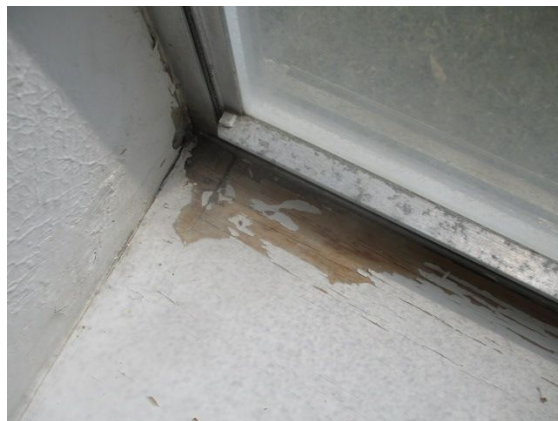
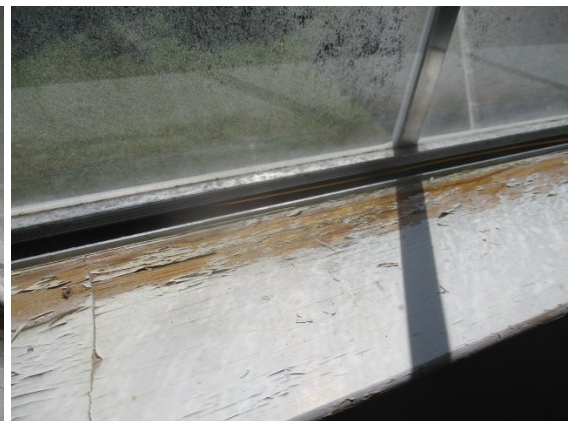
There is water damage to some of the interior windowsills, likely caused by condensation on the single-paned windows. No moisture was present at the time of the inspection.

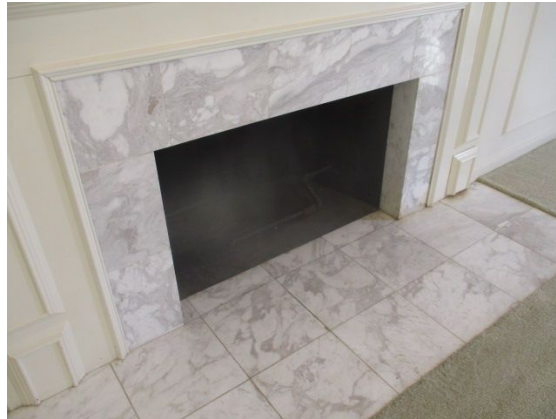
There is no permanent screen or enclosure at the fireplace opening.

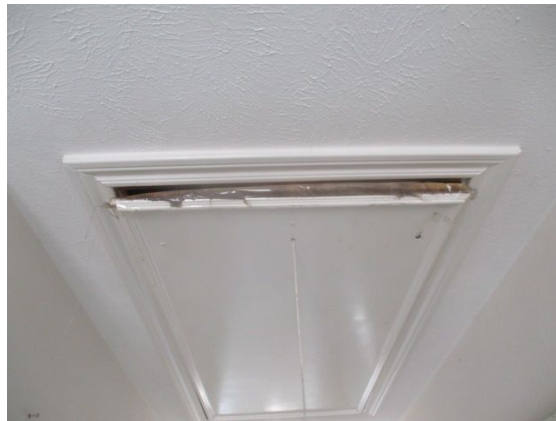
The attic stairs do not seal well when closed. Recommend repairs to reduce energy losses.

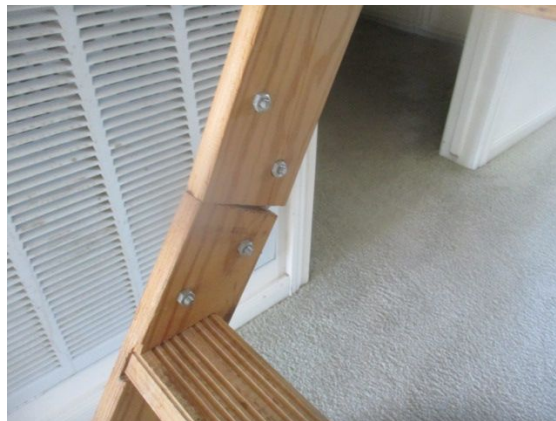
The attic access stairs should be trimmed at the bottom for proper alignment of the hinges.

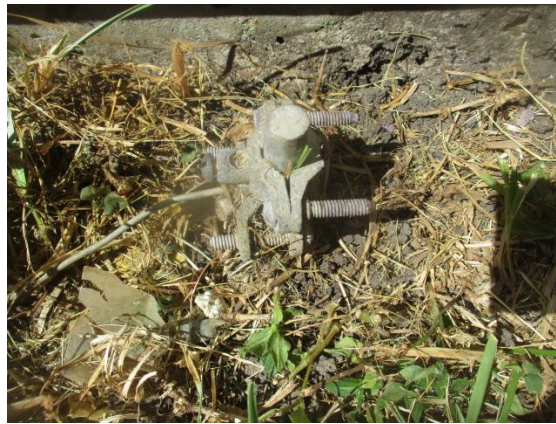
The clamp that connects the ground wire to the ground rod is the incorrect type. It should be a clamp that is listed and approved for a ground rod, such as an acorn clamp. Additionally, the ground wire is not clamped to the ground rod.

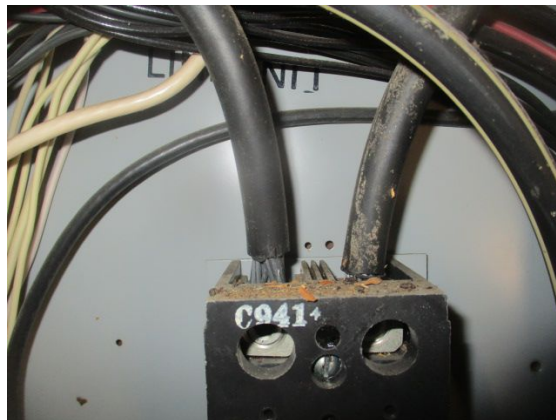
There is no antioxidant paste on the aluminum service entrance wires where they connect to the main breaker and the neutral bus.

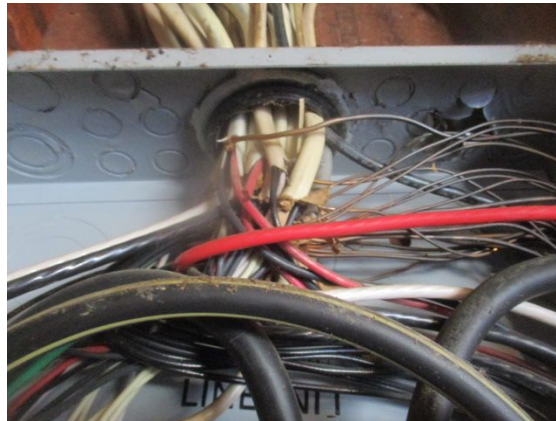
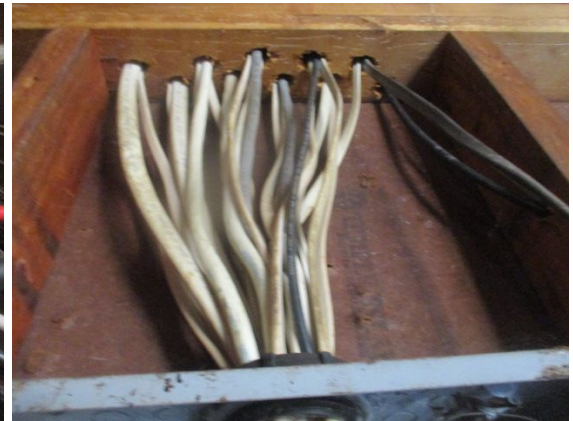
All of the electrical wires enter the top of the panel through one hole with none of the cables secured to the panel. Each cable is required to be secured to the panel to provide a firestop in the wall of the panel. Additionally, these wires should be stapled to the wall within 12 inches of exiting the panel. Recommend further evaluation and repair by a licensed electrician.

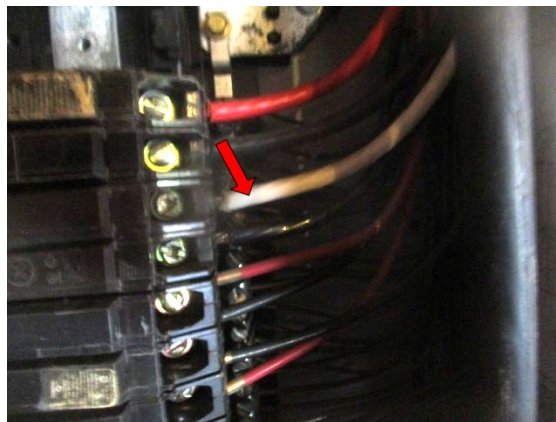
There are white wires used as hot conductors connected to one or more of the 240 volt breakers. Normally the white wires are neutral. When used as a hot conductor, the white wires should be color coded.

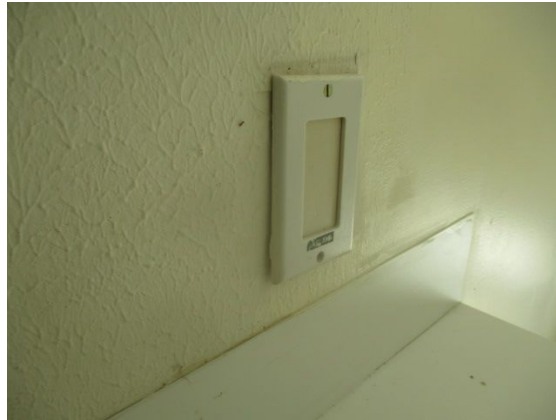
The receptacle at the wet bar has been removed.
The light fixture in the formal living room has been removed.

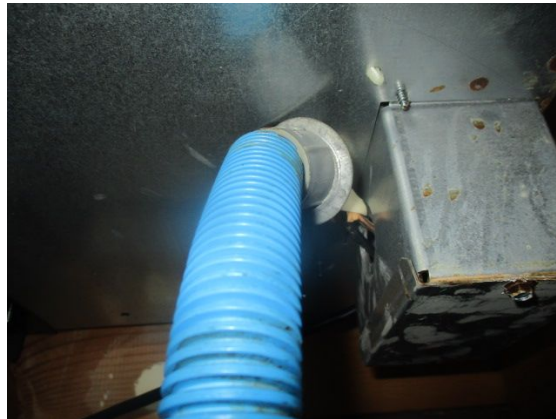
The conduit on the electric cable to the cooktop is not terminated properly and a short section of the wiring is exposed.

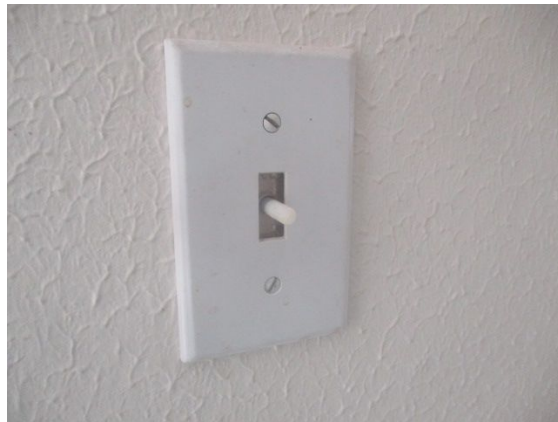
The ceiling fan in the family room needs balancing. One of the dimmer knobs for this fixture is missing.

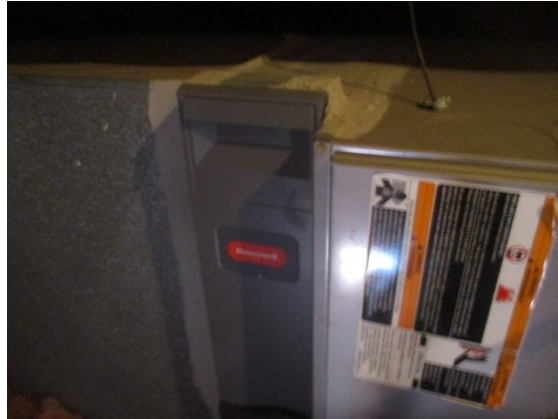
There is what appears to be fungal growth on most of the heating / cooling vents and on the adjacent walls and ceiling. Recommend further investigation and cleaning of the duct system by a qualified contractor.

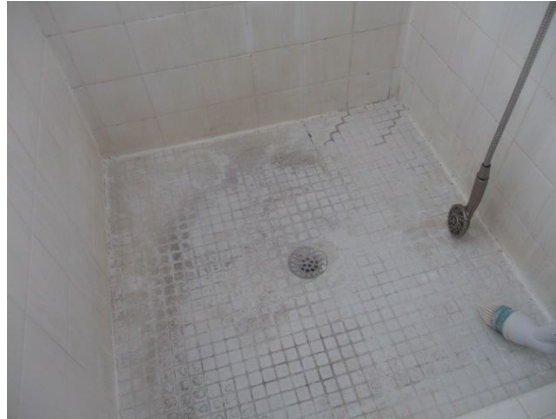
There are high levels of moisture in the base of the interior walls on the sides of the master shower and guest tub. There are cracks and gaps in the grout and caulking around tubs, shower pans, tub spouts, and faucets. There are what appear to be cracks in the master shower floor. Recommend repairs by a licensed plumber to prevent water penetration in the walls.

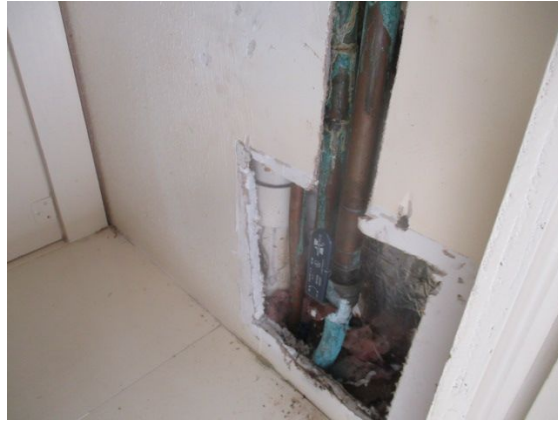
There is no water supply to the bar sink. There are high levels of moisture in the wall around the valve below and excessive corrosion on the connections under this sink. Recommend further investigation and repair by a licensed plumber.

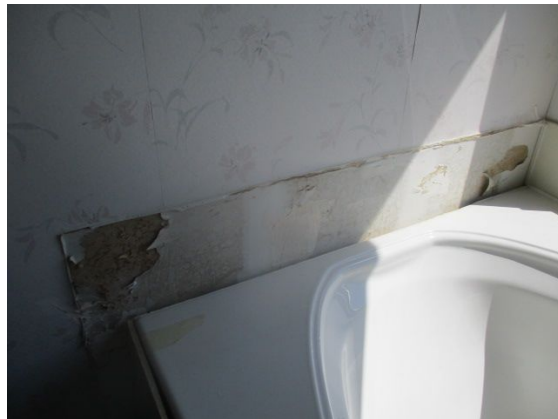
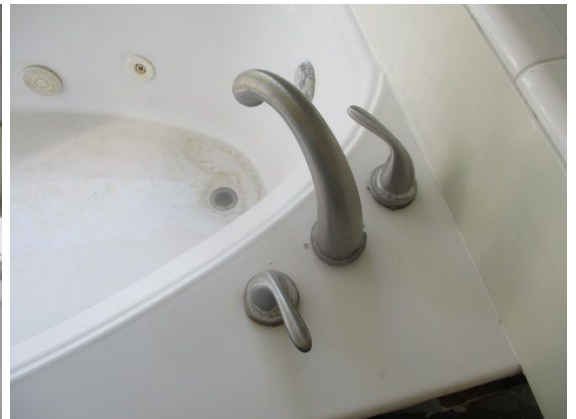
The master tub and the faucet handles at the master tub are not installed properly.

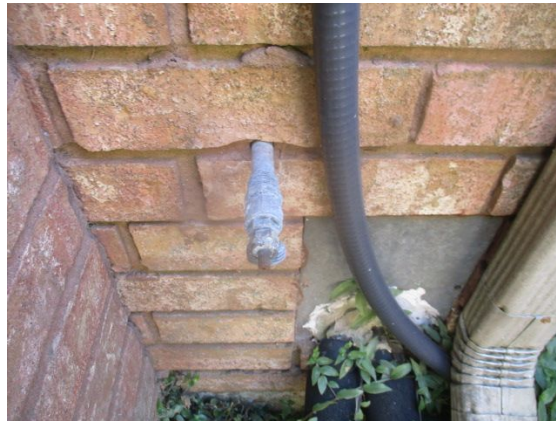
There is no handle on the outside faucet on the exterior north wall by the condensing units.

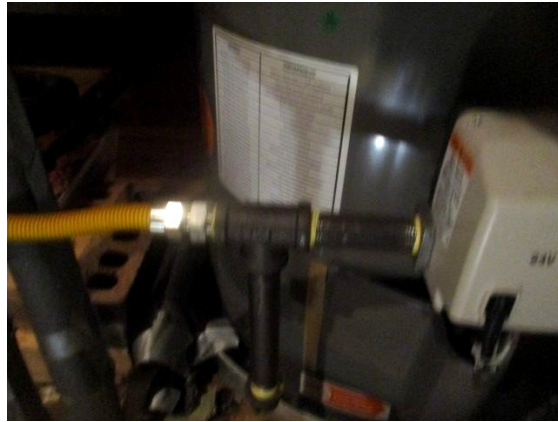
The sediment trap in the gas line to the water heater is not installed properly.

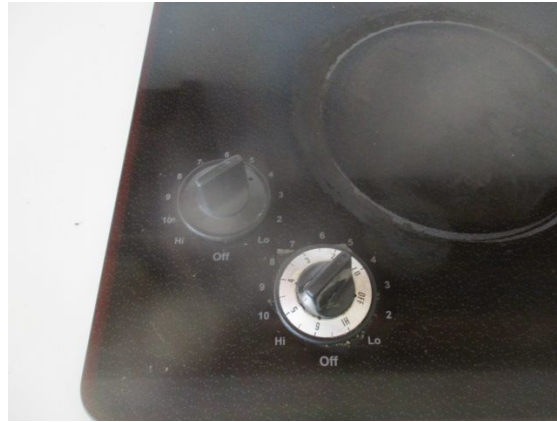
The knobs for the two left burners could not be turned.
