PROPERTY INSPECTION REPORT

Concerning: 128 Dolphin Avenue, Galveston, TX 77550
(Address or Other Identification of Inspected Property)

By: Danny Marlow Lic.#: 23187 04/23/2021
(Name and License Number of Inspector) (Date)

DATE OF INSPECTION: 04/23/2021
Inspection No. 521350-683

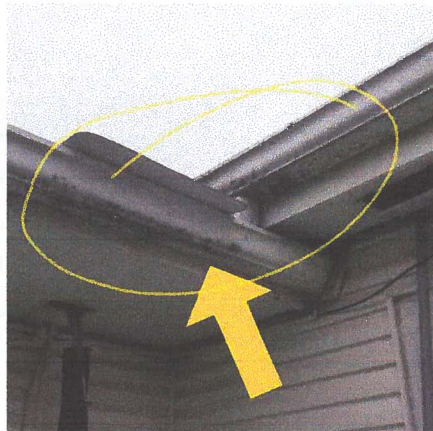
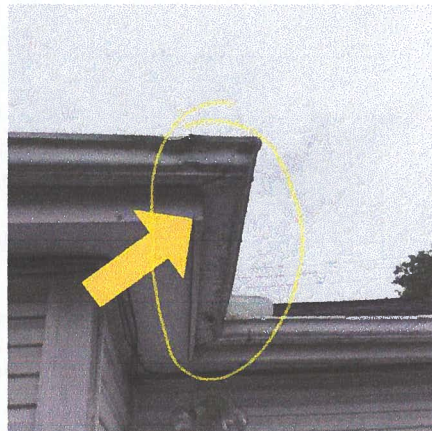
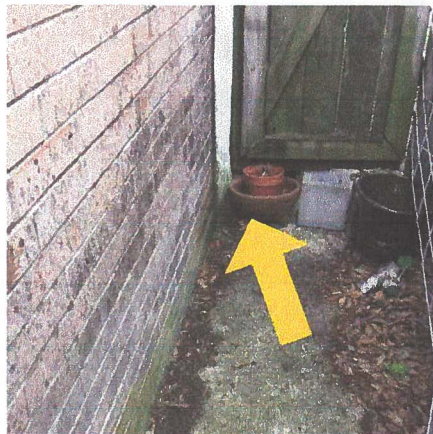
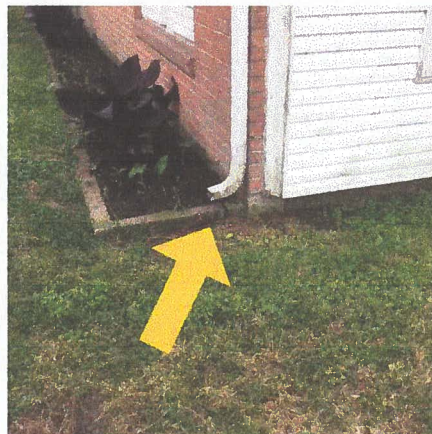
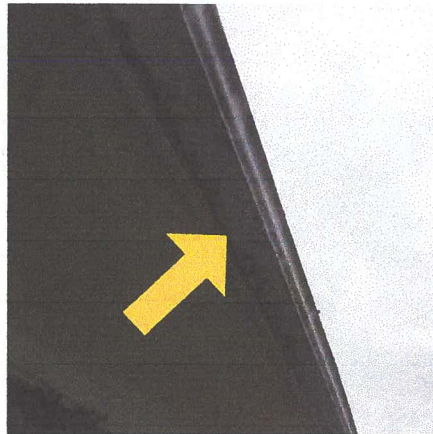
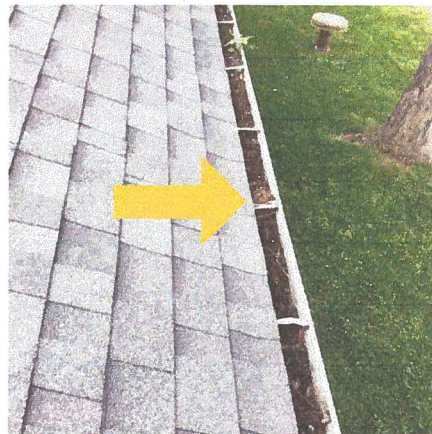
B. Grading and Drainage

- Various gutters were noted as being damaged and should be repaired or replaced as required for proper drainage.
- Downspouts improperly discharging water against foundation. Redirect and extend all downspouts away from foundation.

See above - all gutters
replaced.

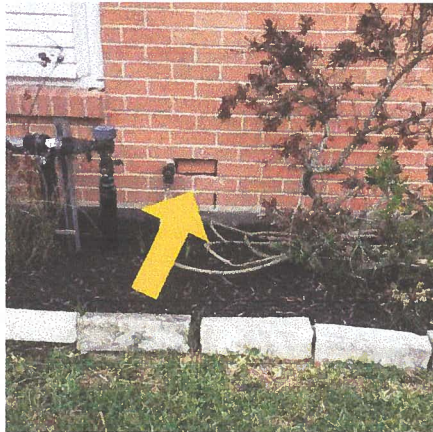
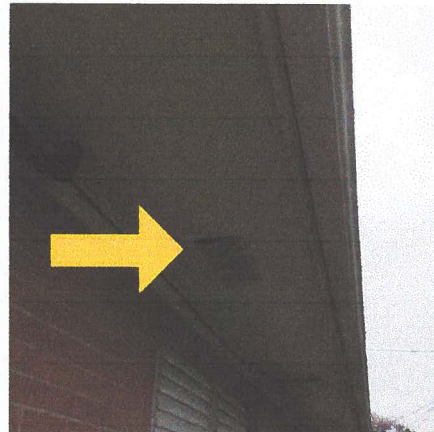
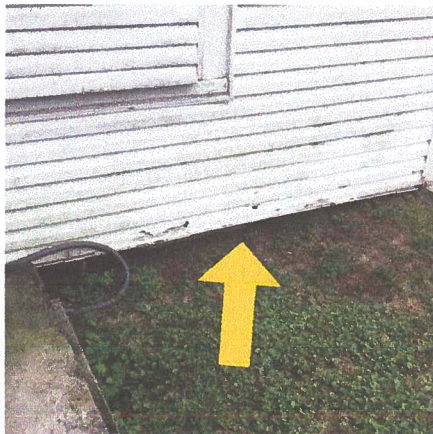
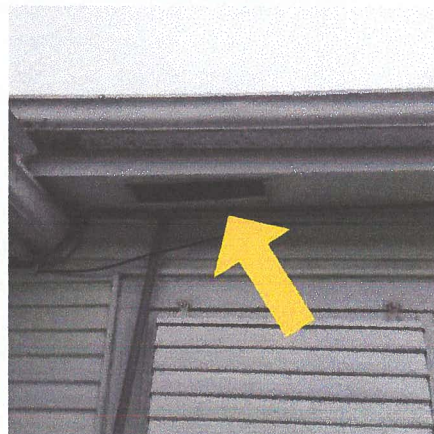
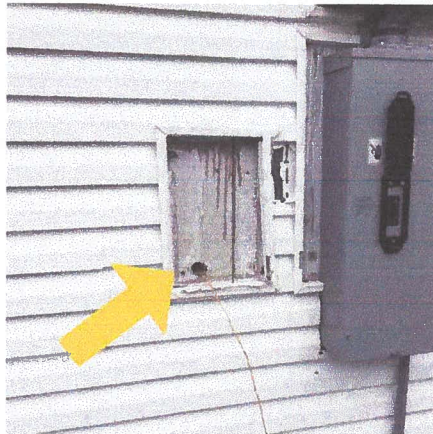
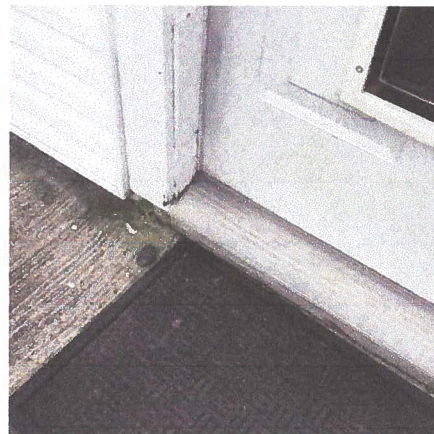
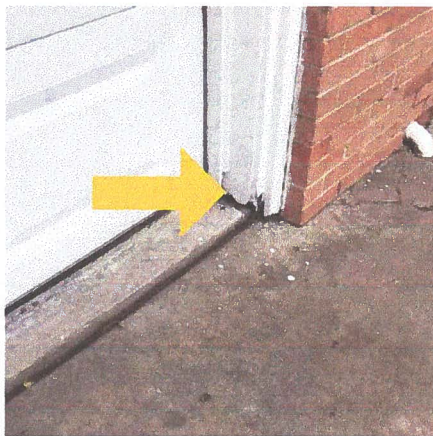
- Brick veneer / vinyl siding with wood trim (exterior). Drywall with wood trim (interior).
- There was a damaged/loose brick noted at front of home. Recommend repairs as needed to prevent possible water penetration and further damages.
- There were two soffit vents noted as being damaged/loose. Recommend repairs as needed to prevent possible pest infestation.
- Garage door trim was noted as showing wood rot/deterioration. Recommend having qualified contractor evaluate and repair as needed to prevent further deterioration and damages.
- There was a hole noted in siding on back of garage. Recommend repairs/sealing to prevent possible water penetration and further damages.
- There was damage noted at vinyl siding on back exterior of garage. Recommend repairs as needed to prevent possible water penetration and further damages.

The soffit vents were repaired

Sealed and painted

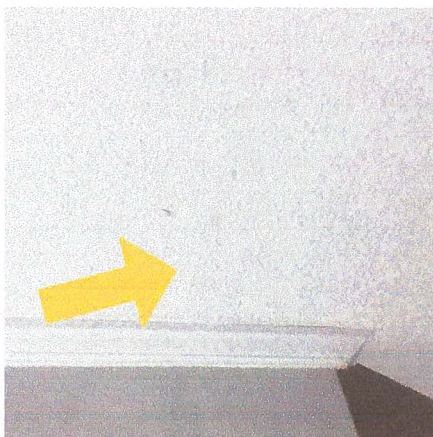
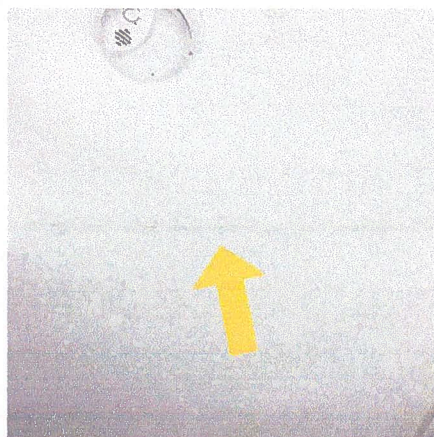
F. Ceilings and Floors

- There were minor stress cracks noted at ceilings in living area and master bedroom (typically associated with settlement). [Living room ceiling retextured and painted](#)

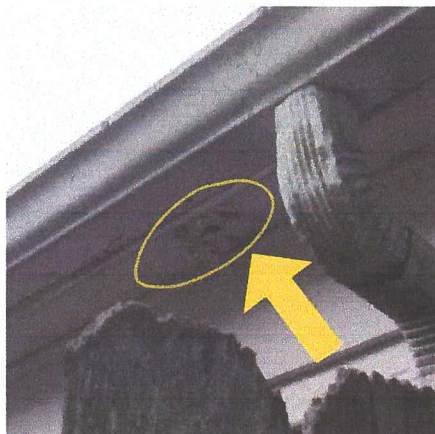
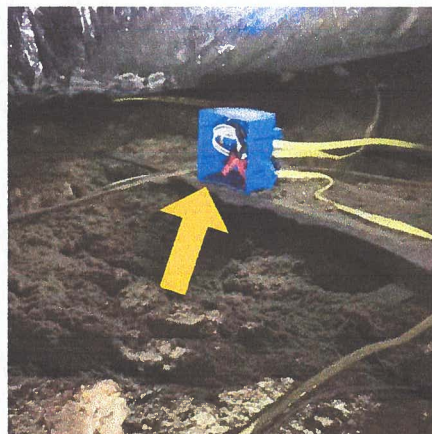
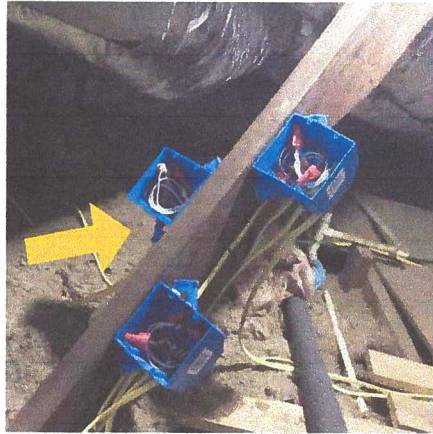
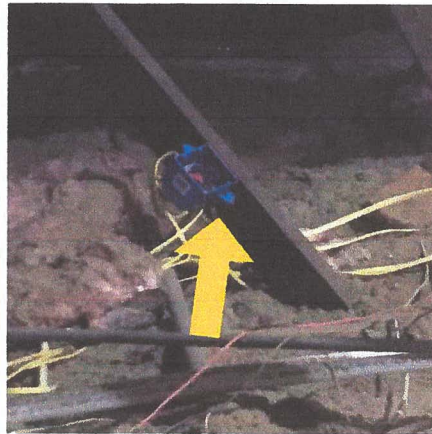
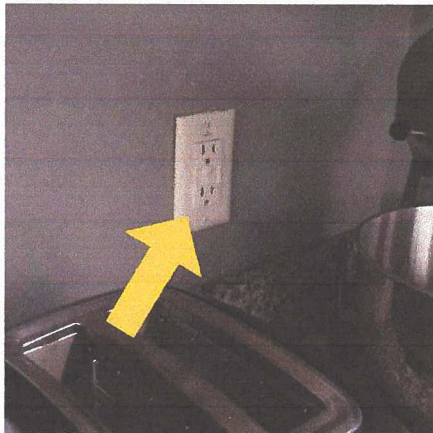
☒ ☐ ☐ ☒**B. Branch Circuits, Connected Devices, and Fixtures***Comments:*

- All wiring appears to be copper and is in good condition.
- Smoke detectors responded normally to function testing but were not found in all required areas. Smoke detectors are required in all sleeping rooms in areas just outside of sleeping rooms and in living area of each floor. Recommend installing smoke detector in living area for safety.
- There were multiple open junction boxes noted in attic. Recommend installing cover plates for intended protection and safety.
- There was on GFCI receptacle in kitchen that was not resetting. replaced
Recommend replacement for proper operation and safety.
- Receptacles in garage were not GFCI protected as required.
Recommend having GFCI receptacles installed in garage for safety.

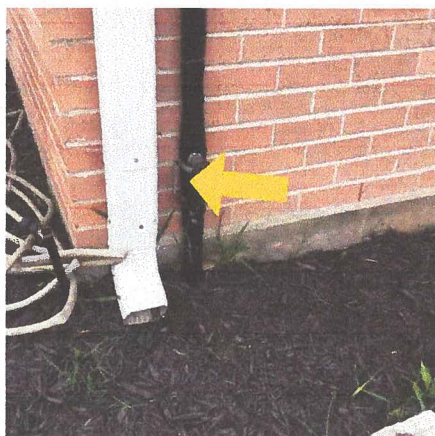
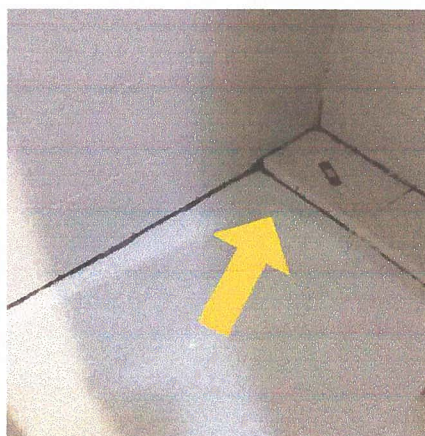
A. Plumbing Supply, Distribution Systems, Fixtures

- Water meter is located in front yard at street.
- Main water cut off is located on right exterior of the home.
- Static water pressure was 58 psi. at time of inspection. Normal water pressures should be between 40 and 80 psi.
- Bathtub/shower enclosure in master bathroom was noted as having damaged/missing caulking. Recommend repairs as needed to prevent possible water penetration and further damages. [Recaulked](#)

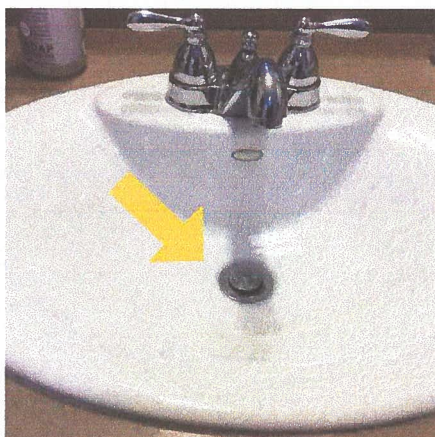
B. Drains, Wastes and Vents

- Multiple mechanical drain stops were noted as not functioning properly. Recommend repairs for proper operation.

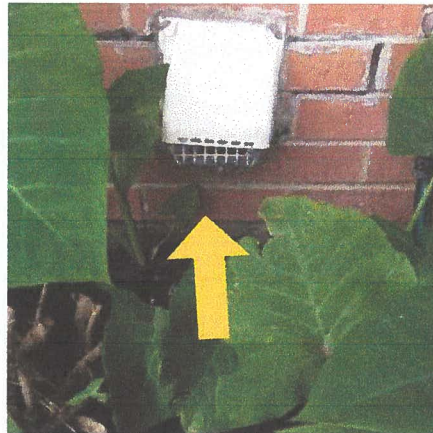
☒ ☐ ☐ ☒**H. Dryer Exhaust Systems***Comments:*

- Dryer vents appears to vent to the outside through a "screened" vent connector. Lint from dyers will clog vents obstructing air flow from the dryers. This is a fire safety concern. Recommend replacement for safety.

- they clean
we replace
