PROPERTY INSPECTION REPORT FORM

Marleen DeLeon <i>Name of Client</i>	12/13/2023 <i>Date of Inspection</i>
5319 Laurel Creek Way , Houston, TX 77017 <i>Address of Inspected Property</i>	
Kevin Akins <i>Name of Inspector</i>	22211 <i>TREC License #</i>
<i>Name of Sponsor (if applicable)</i>	<i>TREC License #</i>

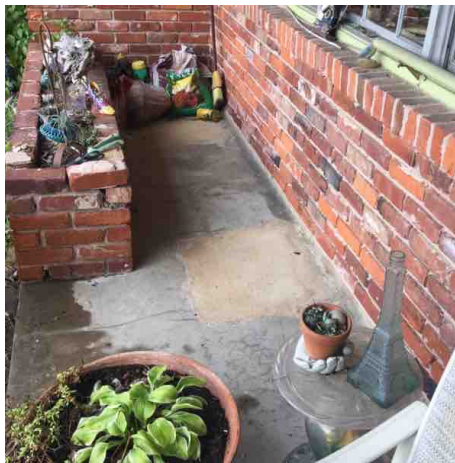
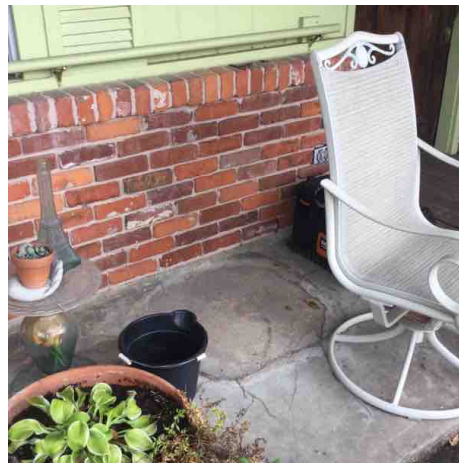
- The type of foundation is concrete slab-on-grade. At the time of inspection the foundation appears to be performing its intended function. This evaluation does not determine how the foundation will perform in the future.
- **The foundation has signs of previous foundation repairs. There are no indications of current structural movement. Buyers should obtain all transferable warranty information regarding repairs from the seller.**

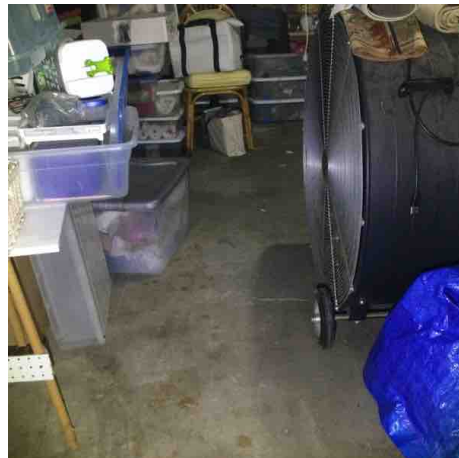
- **Cracks and buckling noted at the garage floor. This indicates adverse settling. Corrections should be made by a foundation specialist.**

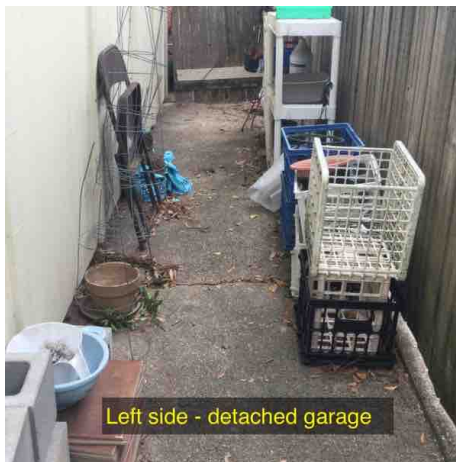
- Grading and walkway is slopping towards the foundation. Soil and walkway should be sloped away from the foundation to reduce possible moisture intrusion and related damages.

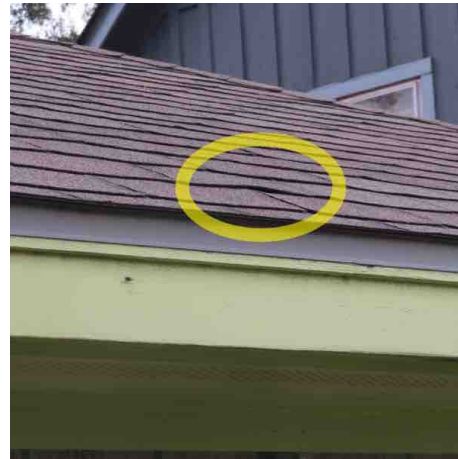
- **Lifted shingles noted at the roof covering which could peel back under heavy wind conditions (see photo). A qualified roofing contractor should make repairs where needed.**

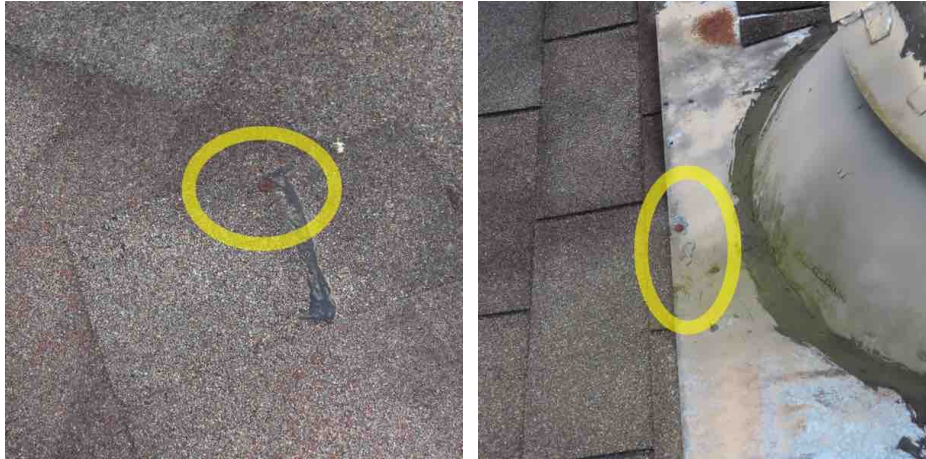
- Several areas of the roof have exposed nails. Exposed nail heads should be sealed to prevent the intrusion of storm water (See photos).

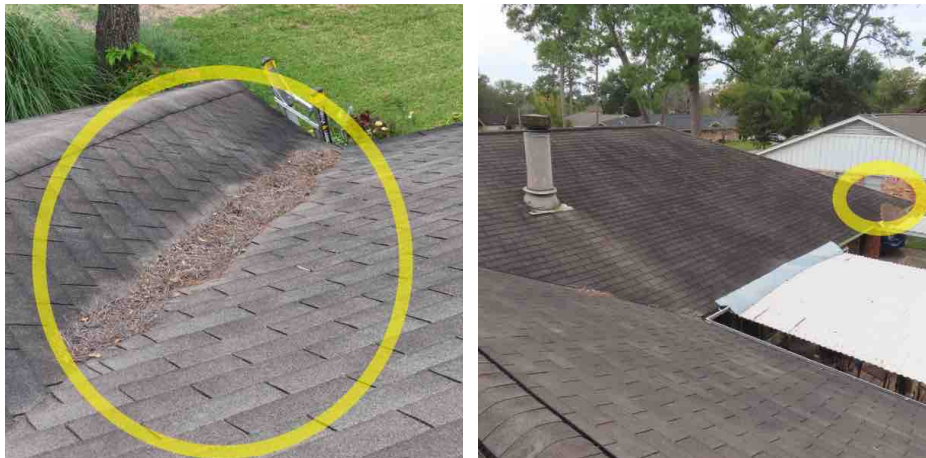
- Roof covering has debris from nearby trees. Failing to clean roof of all debris seasonally will cause the covering to remain wet, deteriorate and cause roof leaks.

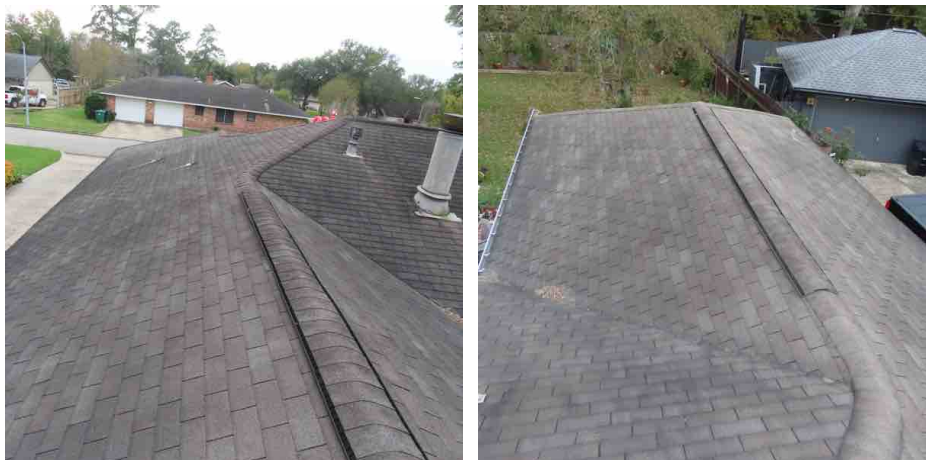
- Some areas of the roof covering are showing excessive granular loss. Roof covering may be nearing the end of its life expectancy.

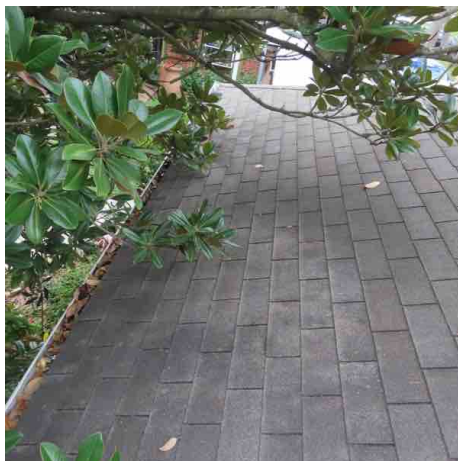
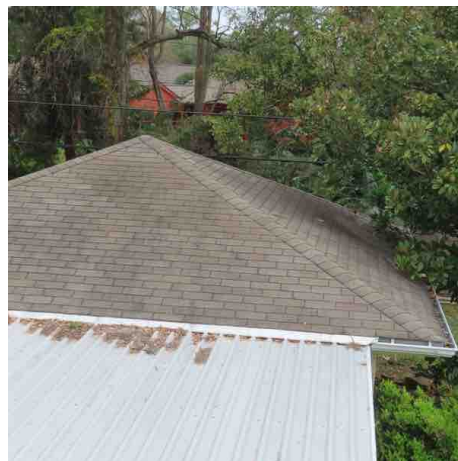
• **Tree branches were observed to be overhanging and in contact with the roof covering. During windy conditions branches can swipe away shingle granules and cause the covering to accelerate deterioration. Branches should be cut back away as needed. (Garage)**

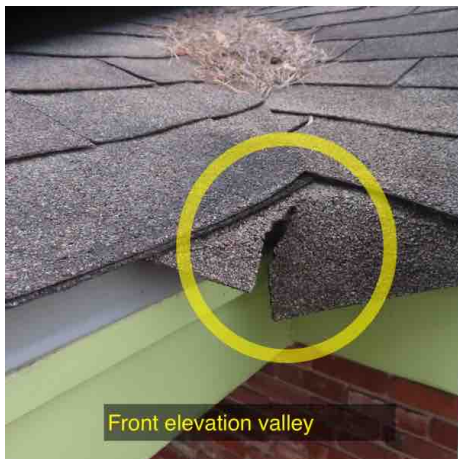
• **Damaged shingles observed at the roof covering. Roof covering appears to be at the end of its life expectancy and should be replaced.**

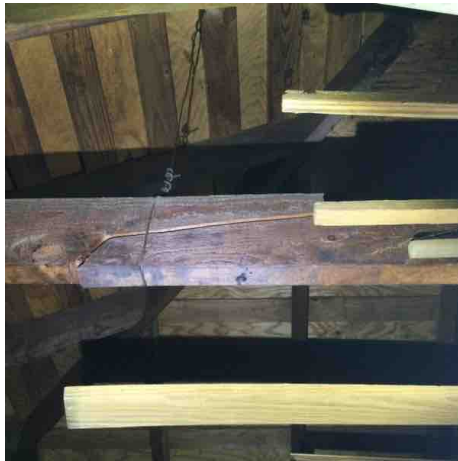
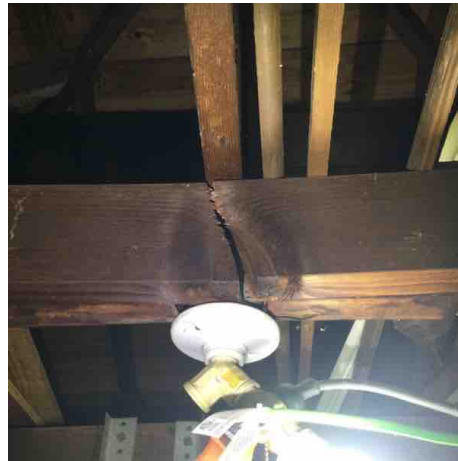
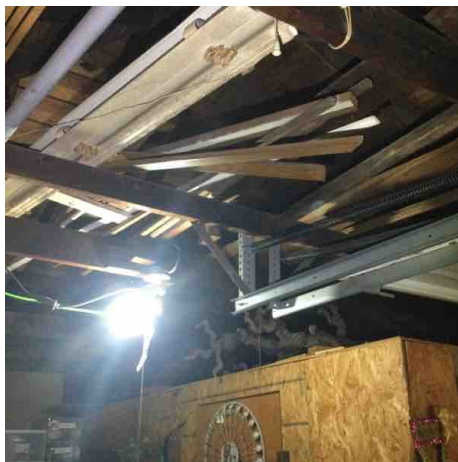
- Split and sagging ceiling joists noted. Corrections should be made by a qualified framing contractor. (Garage)

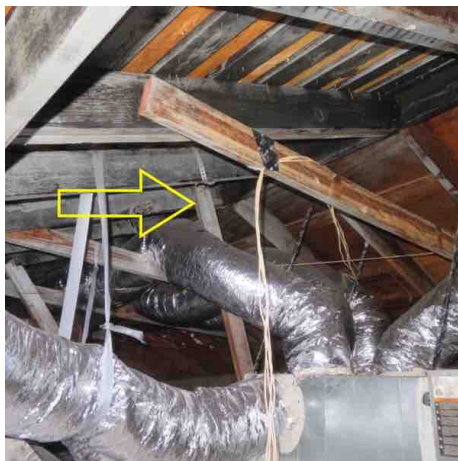
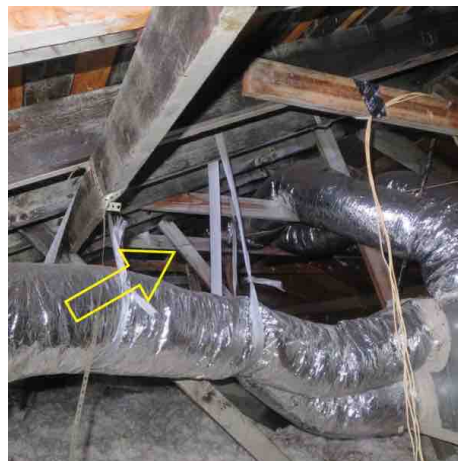
- The Inspector noted (2) loose ridge bracing in the attic. A qualified framing contractor should add additional braces for an even distribution of weight.

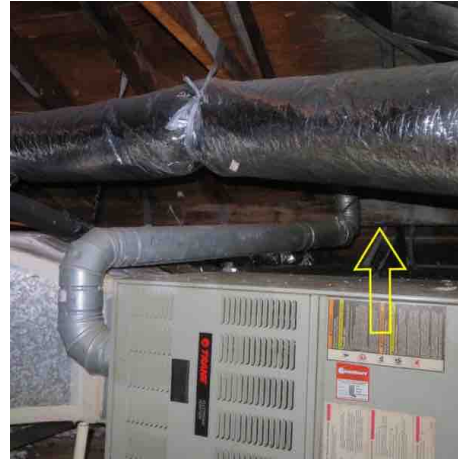
- **Structural purling's observed in the attic do not have enough purling braces (see photo). Recommend adding additional purling braces such that bracing spans do not exceed 48" on-center.**

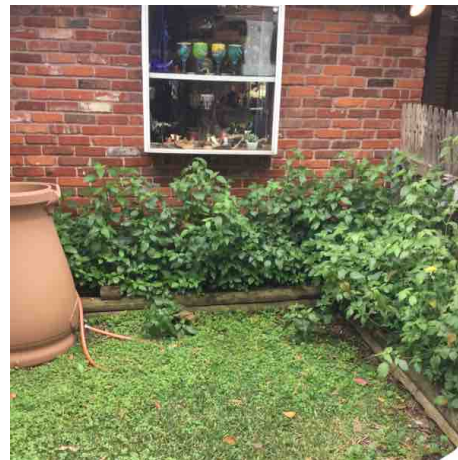
- The walls are inspected for structural performance and water penetration. Specifically excluded from this report is the presence of cosmetic concerns such as paint, minor cracks, scuffs and dings.
- **Observe general painting needs, gaps and caulking touch-ups around the structure. Recommend corrective actions by a painting and general contractor as needed.**
- **Vegetation was in direct contact with the structure at several locations around perimeter of the residence creating a conducive condition for potential pest infestation. Recommend pruning / cutting back vegetation so that a minimum of 6 - 8" of distance exists between the structure and the vegetation.**

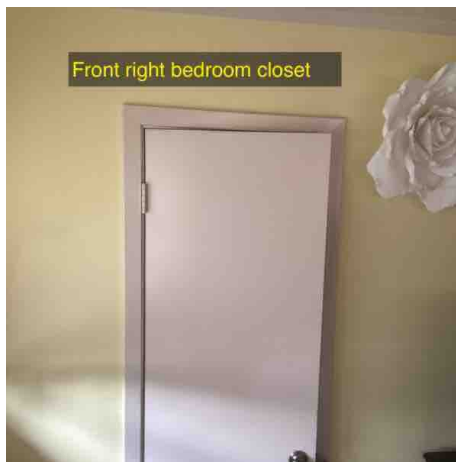
- **Door noted binding inside the door jamb. Repairs should be made by a qualified contractor.**

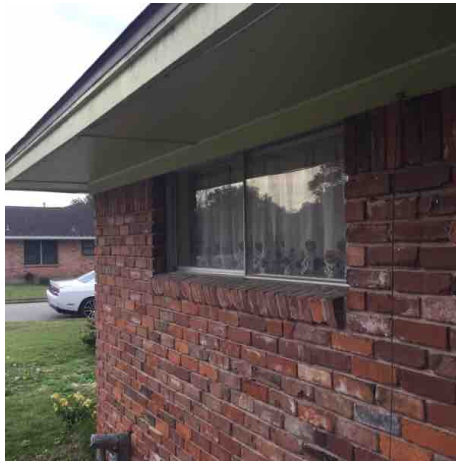
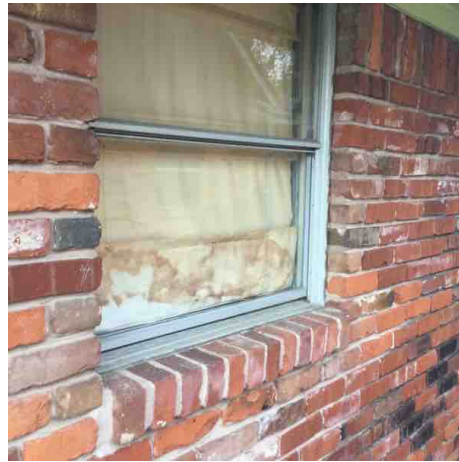
- **Screens missing on venting windows around the perimeter of the residence. Recommend installing new screens on venting units as needed.**

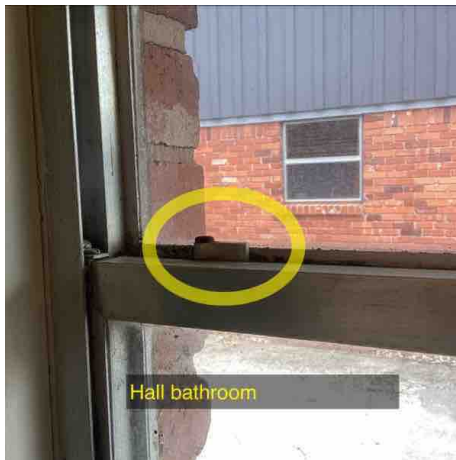
- **Ineffective securing latches noted. Recommend repairs by a qualified window contractor as needed.**

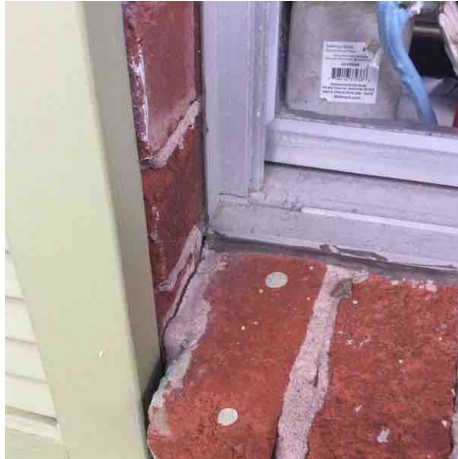
• Windows around the structure have missing and deteriorated caulking. Caulking windows with a good exterior grade caulking will prevent storm water intrusion.

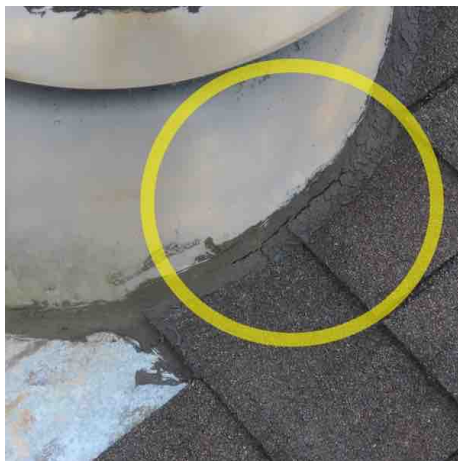
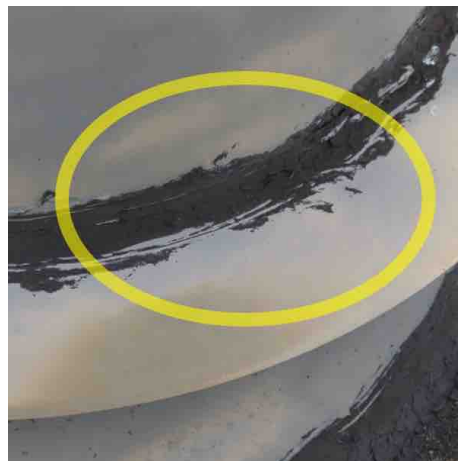
• Noted gaps and deteriorated caulking at the chimney stack counterflashing. This area is highly susceptible to moisture intrusion and caulking should be maintained moving forward.

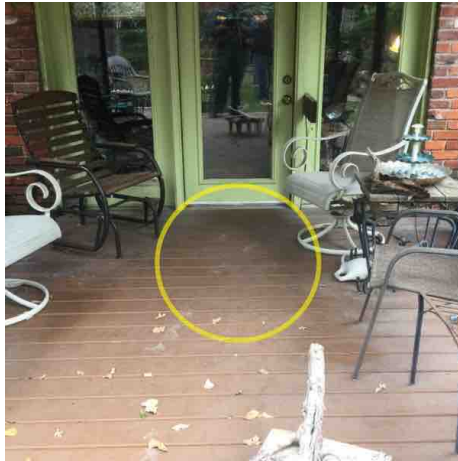
- **Loose boards noted at the rear patio flooring. Corrections should be made by a qualified contractor.**

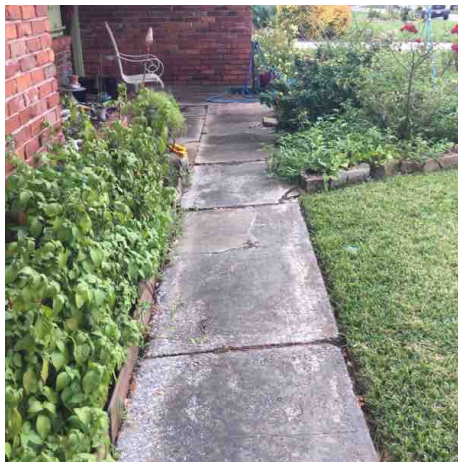
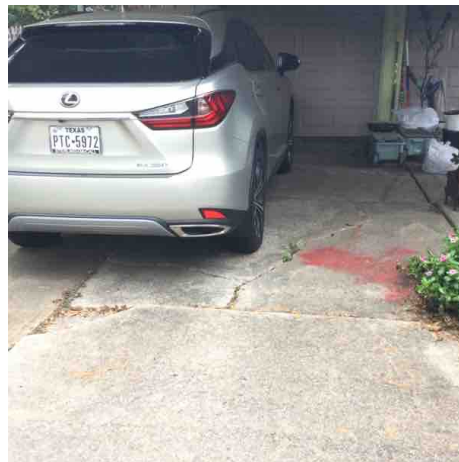
- **Ants, other insects and rodents can occupy a home at any time, especially if the home is unoccupied at any point during the transition from the seller to the buyer. Therefore, an initial pest control treatment is recommended.**
- **Broken driveway and walkway sections noted. Repairs should be made by a qualified concrete contractor as needed.**

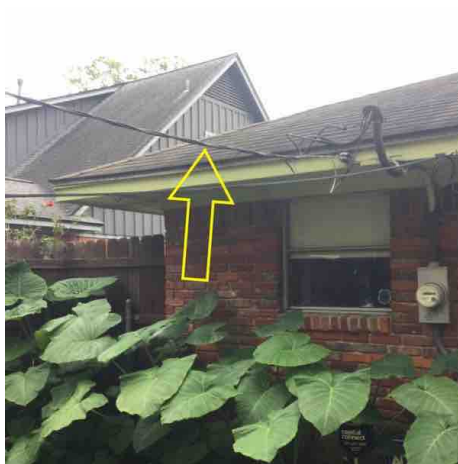
- Service wires and mast are too low and does not have adequate clearance from the ground, which is 10 ft. over any walk-able area. Recommending corrective action by a licensed electrician.

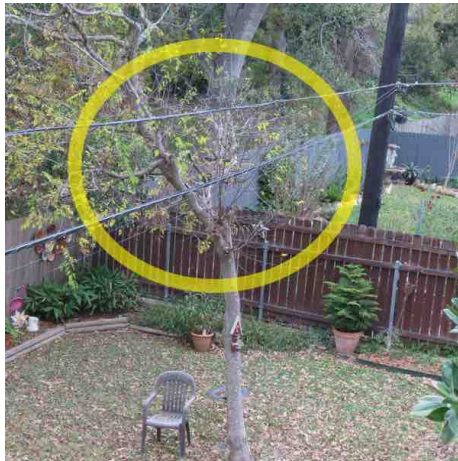
- Tree in back yard is interfering with the service wires in the rear easement. This should be addressed for safety reasons. The local electrical provider should be contacted for corrections.

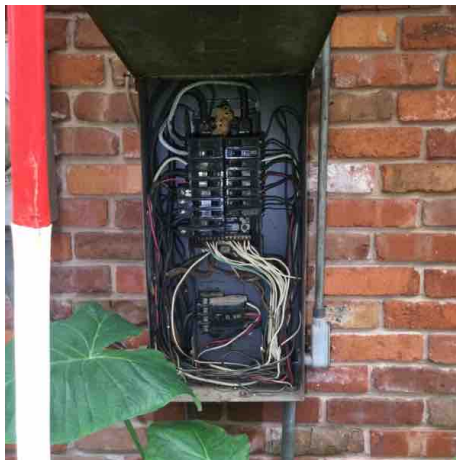
- **Dead-front panel cover is missing at the main distribution panel creating a significant safety hazard. Recommend installation of new dead-front panel cover or replacement.**

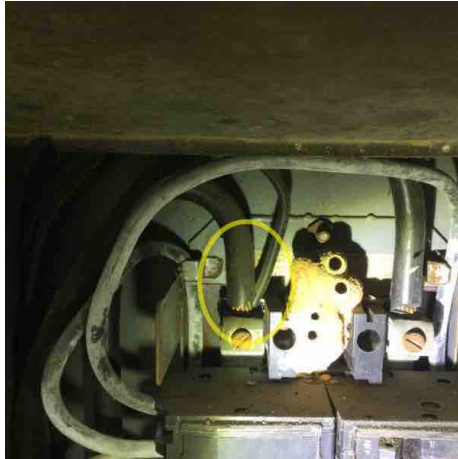
- Double lugging noted at the main service connection (see photo). This condition is considered unsafe. Recommend a Licensed electrical contractor makes necessary repairs.

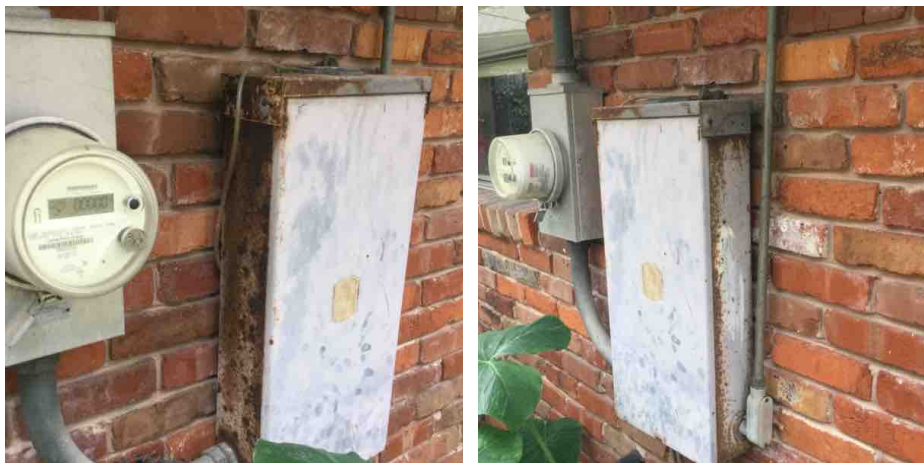
- The Inspector noted the service panel was excessively rusted. Recommend replacements by a licensed Electrician.

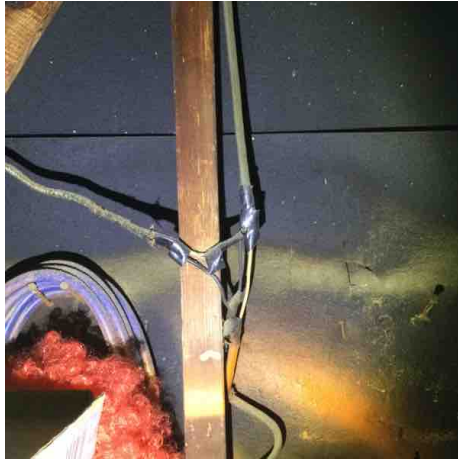
- **Improper electrical connection outside of an approved junction box was observed in the detached garage. Recommend corrective actions by a qualified electrical contractor. (Garage)**

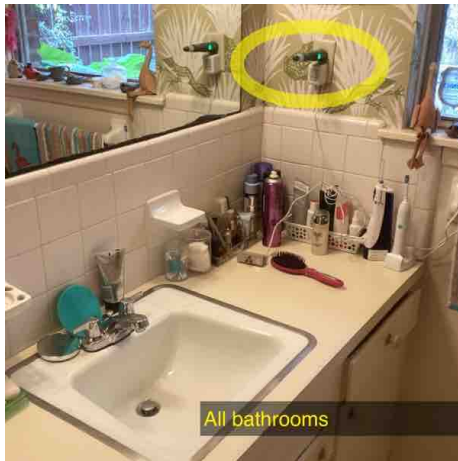
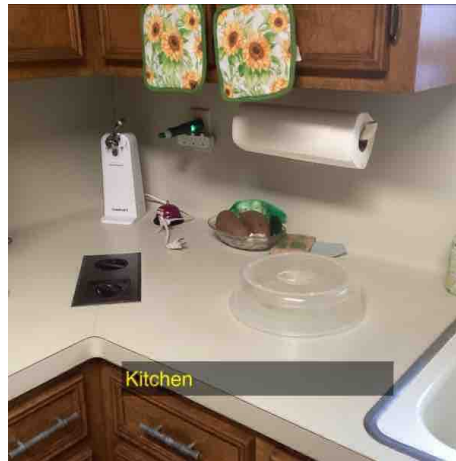
- **It is recommended that this home be equipped with ground fault circuit interrupters (GFCI) at all required locations (exterior, garage, bathrooms, kitchens and within 6 feet of the outside edge of a sink). The purpose of a GFCI circuit is to provide positive protection against a shock hazard since it will “trip” almost instantaneous if it detects moisture.**

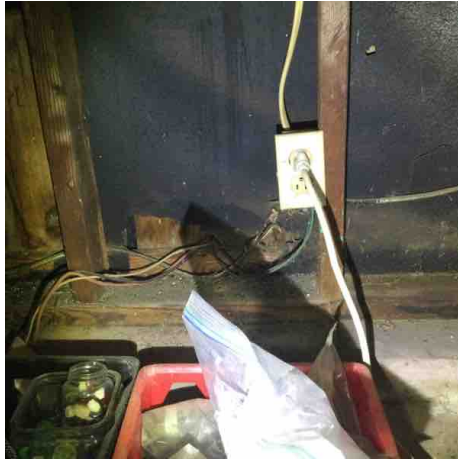
- Outlets improperly installed in the garage. All garage outlets should be installed at least 18" from the standing surface.

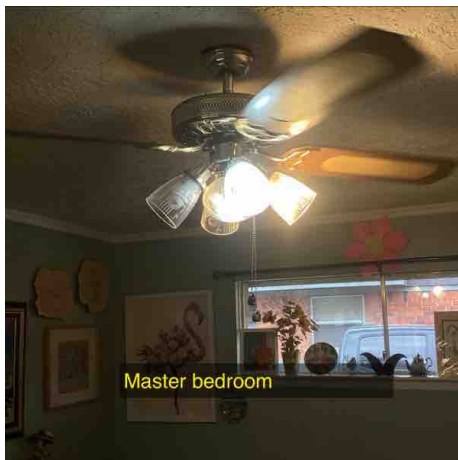
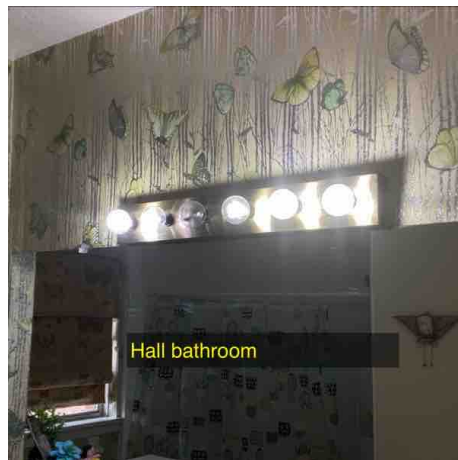
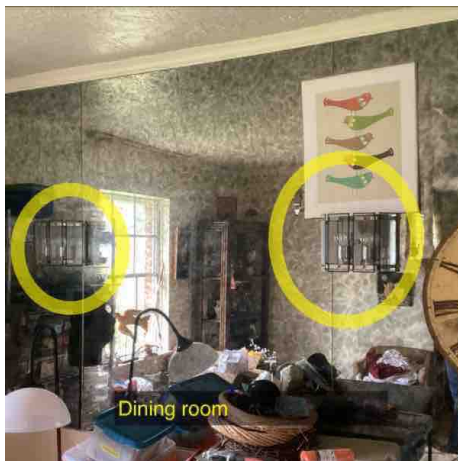
- Some light bulbs were not functioning during the inspection. Light bulbs should be replaced, and fixture operation verified to ensure an underlying electrical issue does not exist.

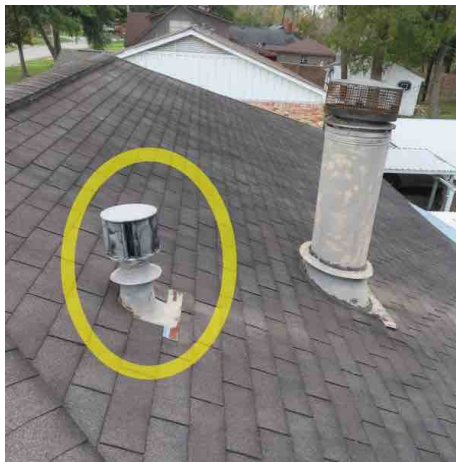
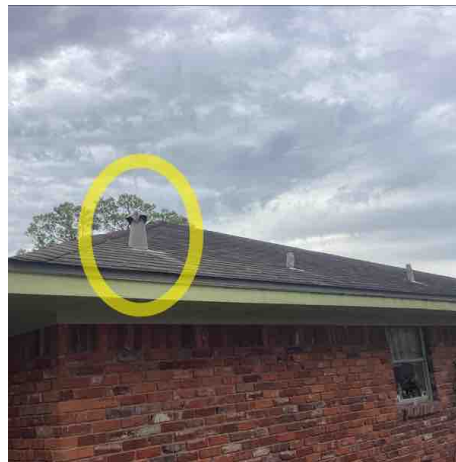
- **Roof vents for the furnace/water heater did not have the required clearance (2 feet above anything within 10 feet). Recommend repairs by a qualified contractor to establish proper clearance.**

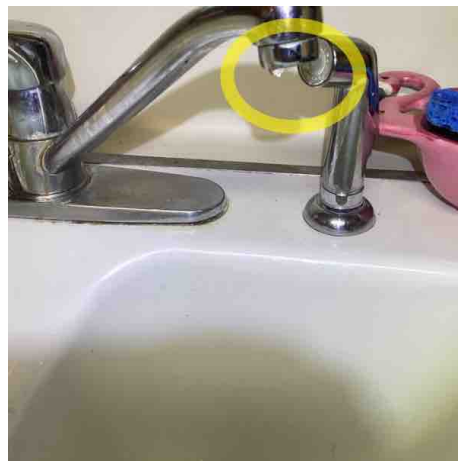
- Leaks observed at the kitchen faucet. Recommend corrective actions by a licensed Plumber.

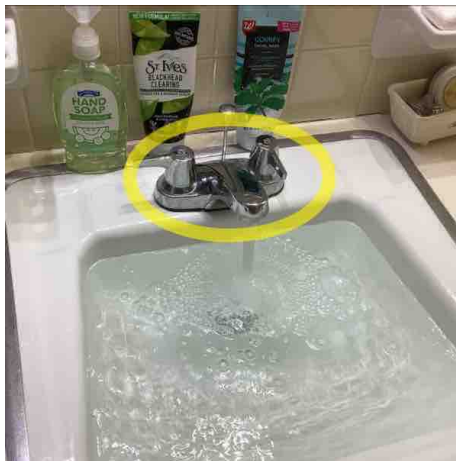
- **Loose faucet noted. Repairs should be performed by a qualified person or plumbing contractor. (Hall Bathroom)**

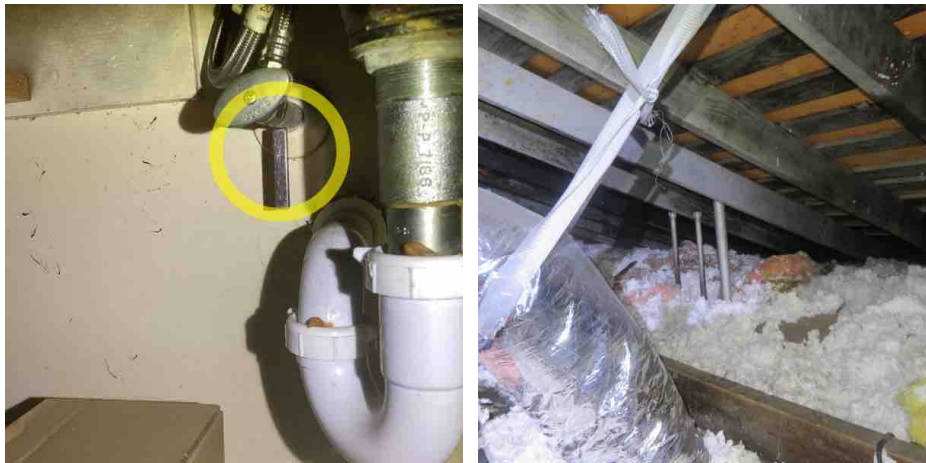
• Water supply piping is galvanized steel. Galvanized piping, normally, has a useful life expectancy of approximately 25 - 30 years, but actual life can vary depending on the amount of usage and the chemical composition of the water running through it. As the piping ages, rust accumulates on the inside which can cause restricted water flow or a reduction of water pressure to all water sources. Water exiting faucets may appear to be orangish or brownish at first but will generally clear up quickly. Continuous flow of discolored water typically indicates piping is nearing the end of its useful life expectancy. Since the piping deteriorates from the inside out, leaks can occur before there are any visible signs of potential problems. Consideration should be given to the replacement of all galvanized piping and fittings.

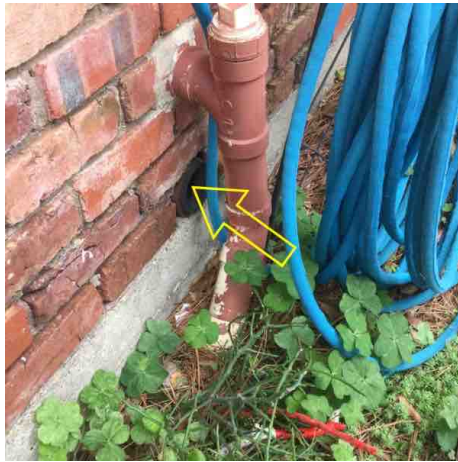
• This home has cast iron drain lines. Cast iron sewer pipes are very common in homes built from 1900 to 1970's. As a result of what runs through cast iron sewer pipes, corrosive actions take place within the pipe. As the pipe corrodes; scale, calcification, and rust forms. This scale continues to accumulate slowly over time. When scale builds to a certain level, it will decrease the diameter of the pipe. Consequently, drain clogs and sewer backups occur more frequently. Problems with the plumbing waste pipes under the slab can only be detected by an under-slab plumbing leak test, which should be obtained as a precaution.

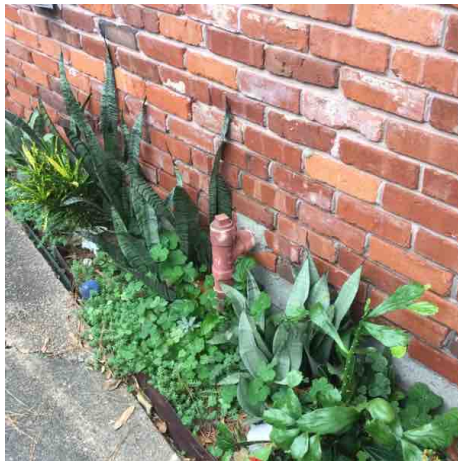
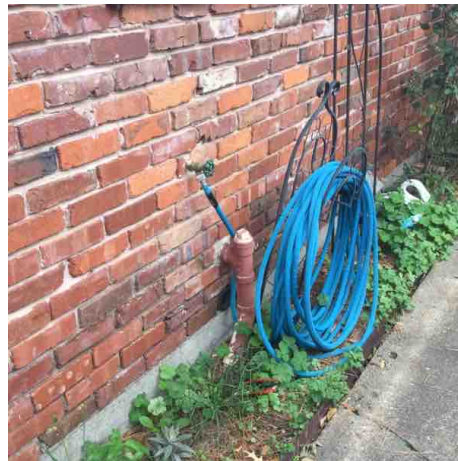
• Bypass drain lines noted. This is a result of the original drain line being blocked or compromised. Continued monitoring is recommended. **(Exterior Left)**

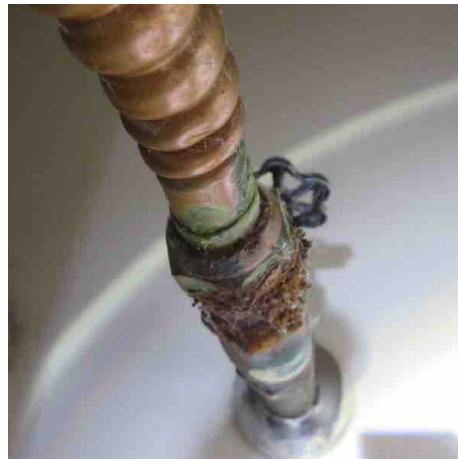
- A gas-fired water heater is present and was in operation at the time of the inspection. The capacity of the hot water system appears adequate for the normal needs of this size house.
- **Corrosion observed at the water heater connections (see photo). Repairs should be performed by a licensed Plumber.**

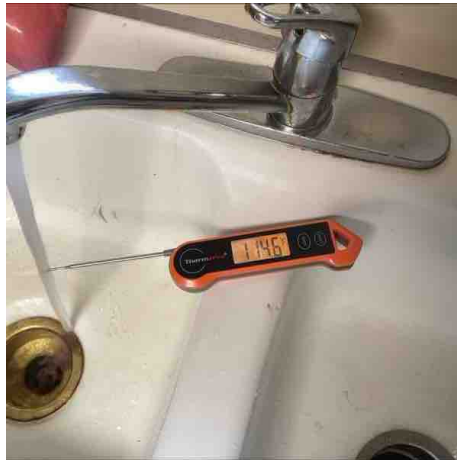
Although functioning normally at time of inspection, hot water heater is older (manufactured in 2002) and has exceeded its normal life expectancy. Recommend replacement.

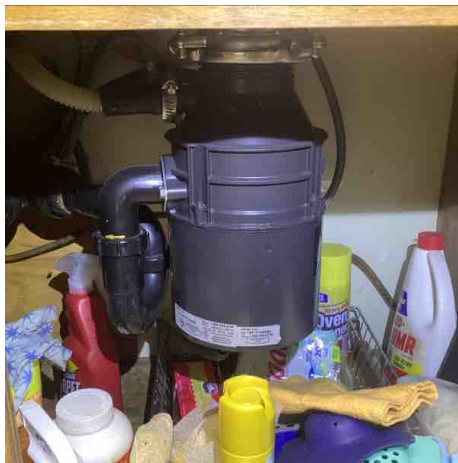
- Impeller blades heard grinding at the time of the inspection. Repairs should be made by a licensed Plumber.

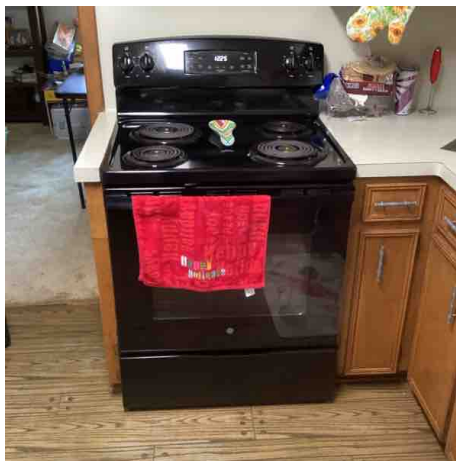
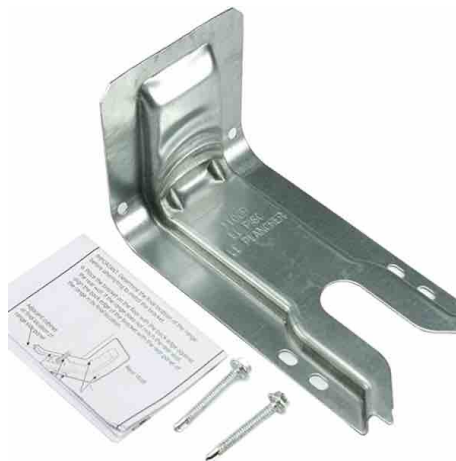
- Anti-tip mechanism on the range was not installed which is considered a safety hazard. Recommend a qualified technician for corrections as needed. (Kitchen)

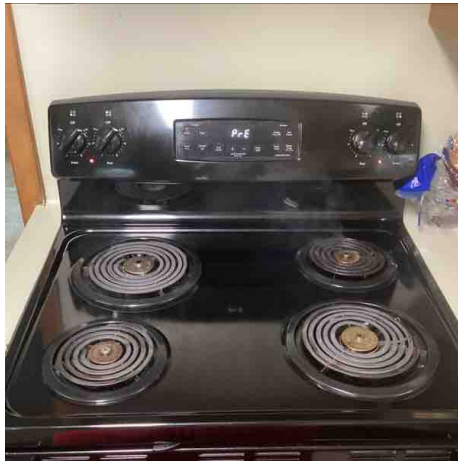
- Although operated, be advised this unit does not have a hot lamp light to indicate burners are hot. Operate with caution.
